PROPERTY INSPECTION REPORT

Concerning: 374 CR 4151, Woodville, TX 75979
(Address or Other Identification of Inspected Property)

By: Herbert Lee Johnson III, Lic #22058 08/16/2019
(Name and License Number of Inspector) (Date)

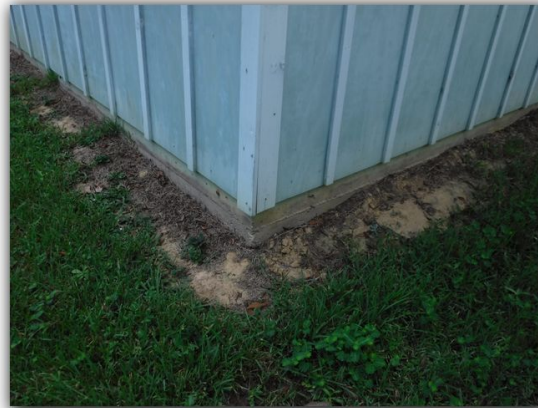
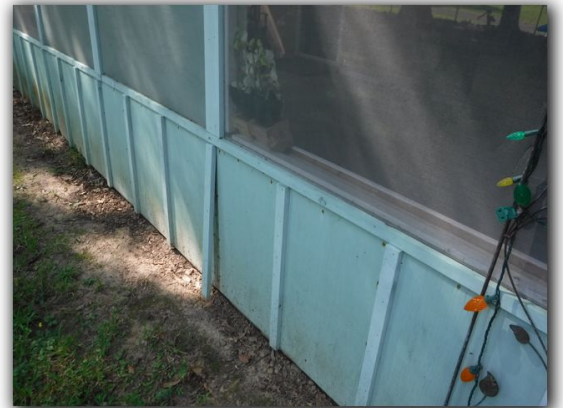
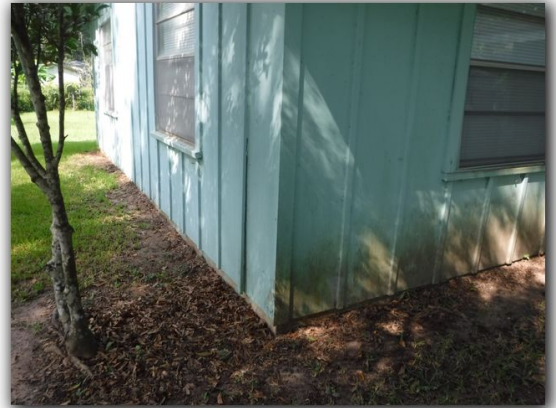
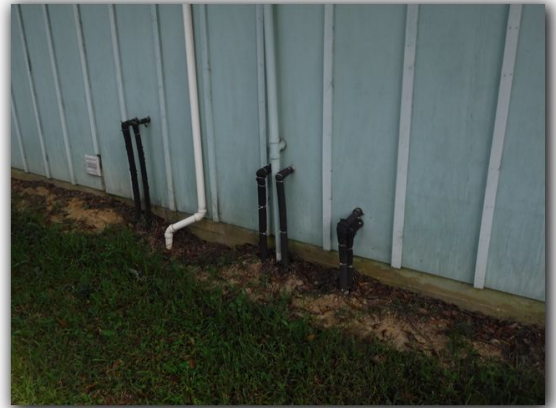
Comments: Limited visual inspection of the foundation due to less than 6" of soil clearance around the home to view the foundation, carpet, and fresh paint.

Drywall crack over the front left bedroom doorway.

Structural movement and/or settling noted; however, the foundation is supporting the structure at this time.

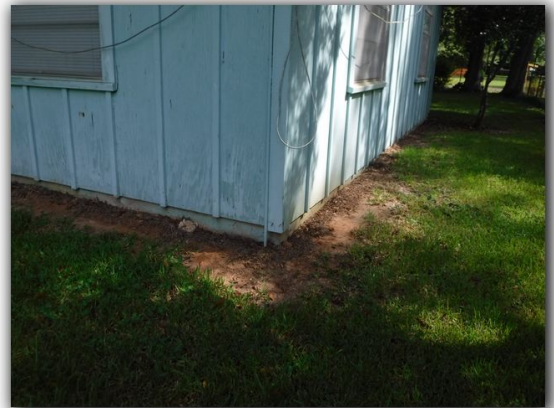
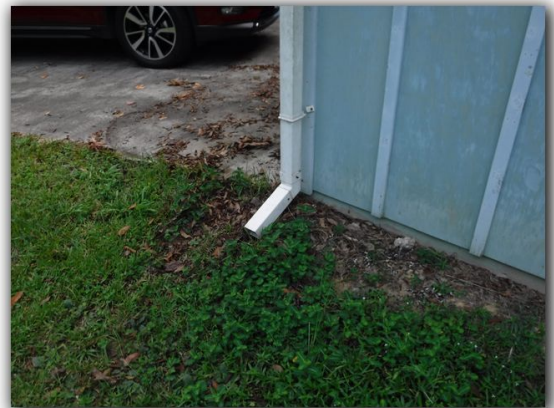
- Improper drainage from foundation/Less than 6" soil clearance
- Gutters draining too close to the structure, no splash blocks for proper runoff from gutters.

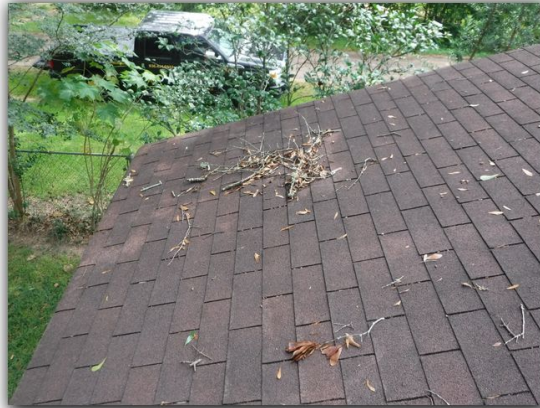
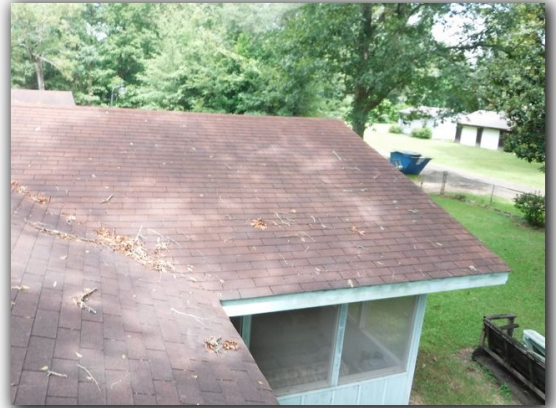
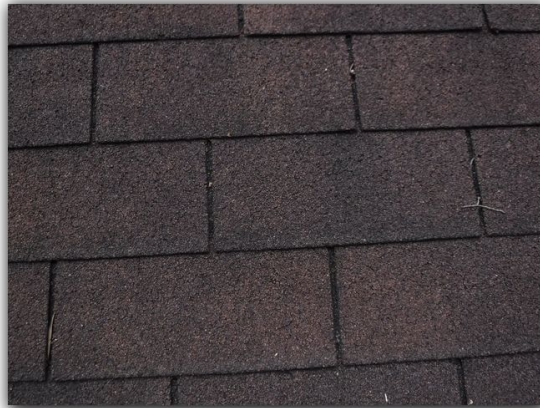
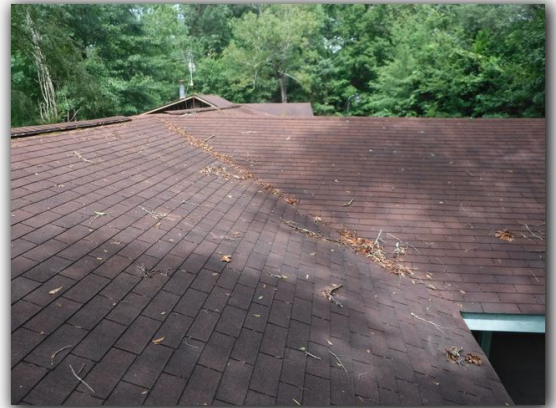
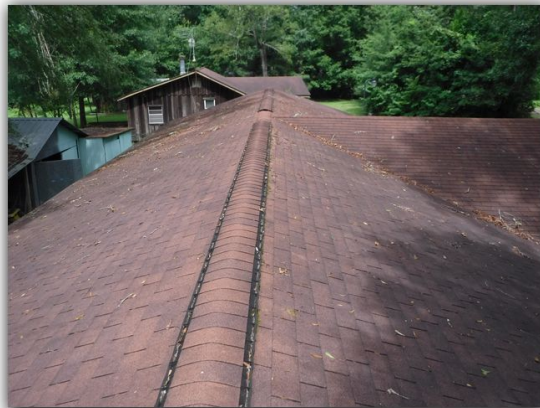
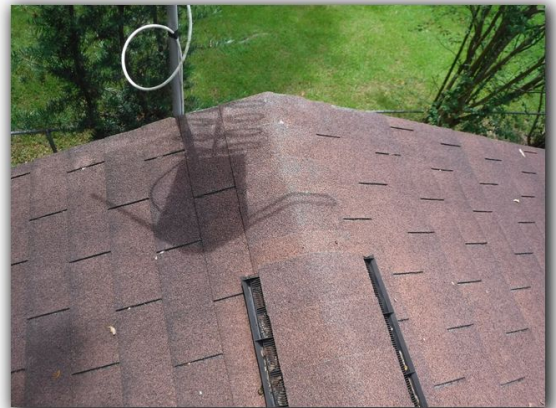
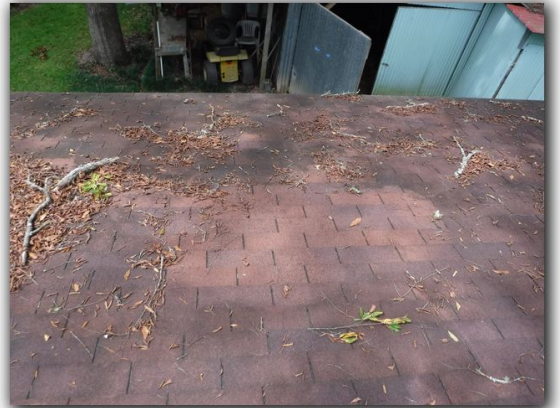
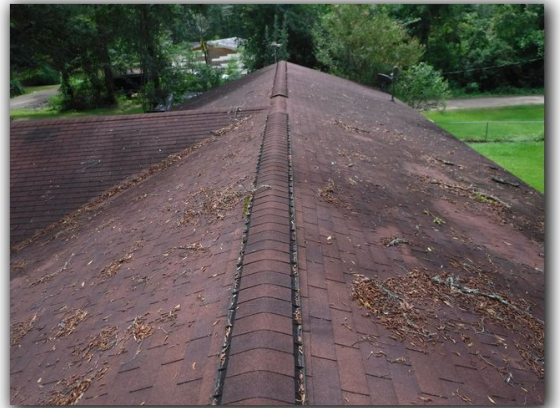
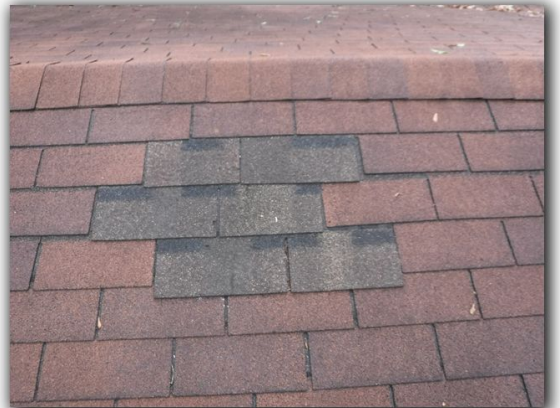
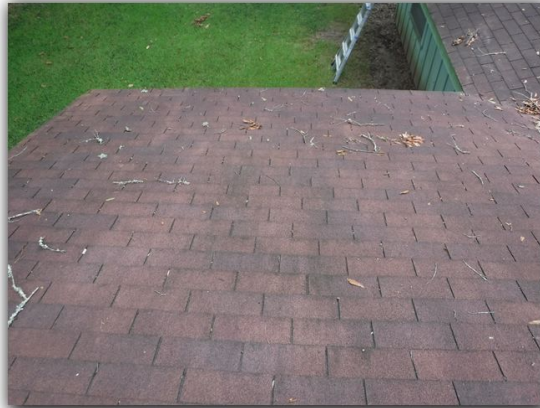
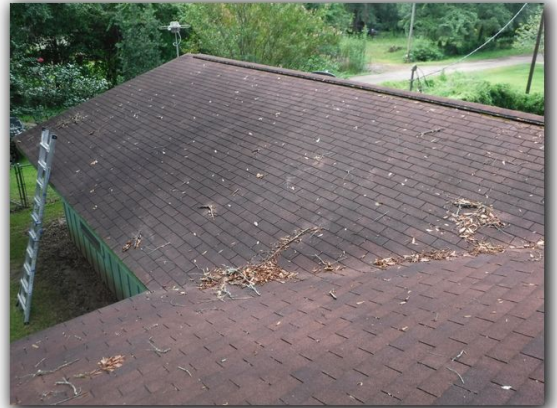
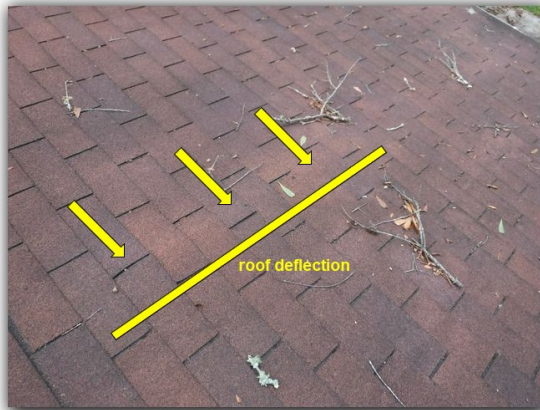
Comments: Minor to moderate gravel loss to shingles, worse at the ridges.

- Roof decking deflection over the screened in three season porch.
- Trim, soffit, fascia boards are in need of repair
- Leaves / debris in the gutters and down spouts

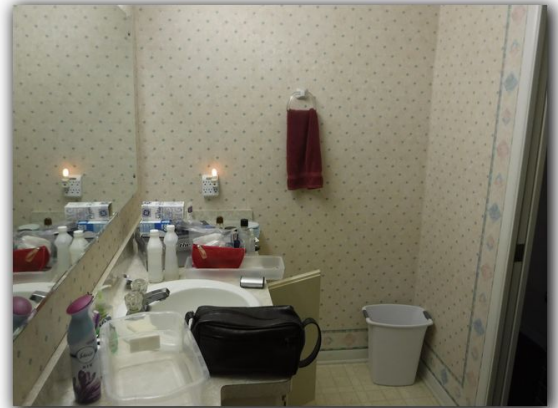
- Minor cracking above front left bedroom door
- Water stains on walls and/or ceilings

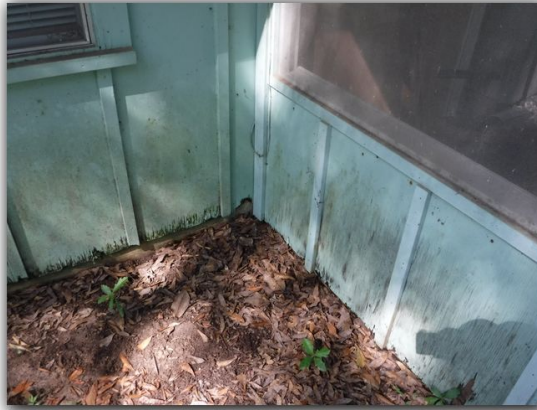
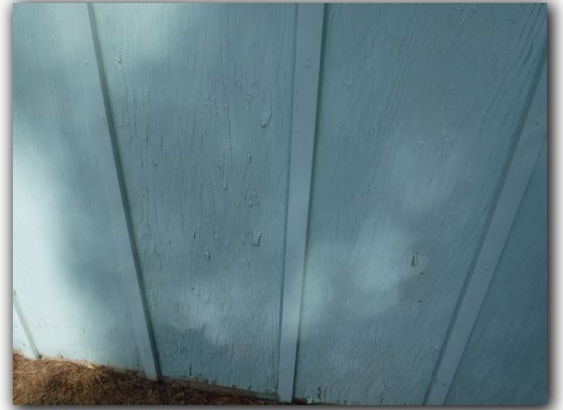
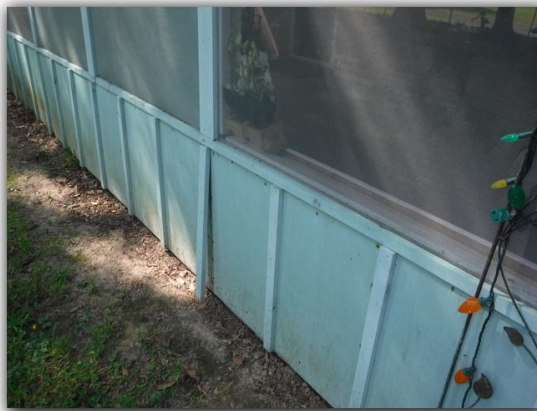
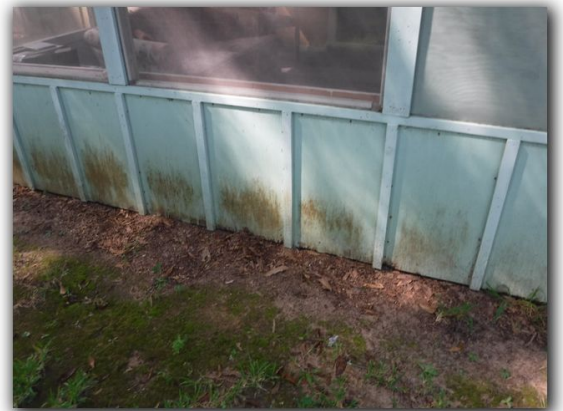
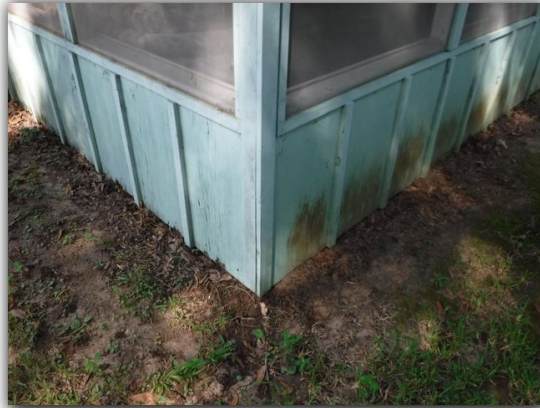
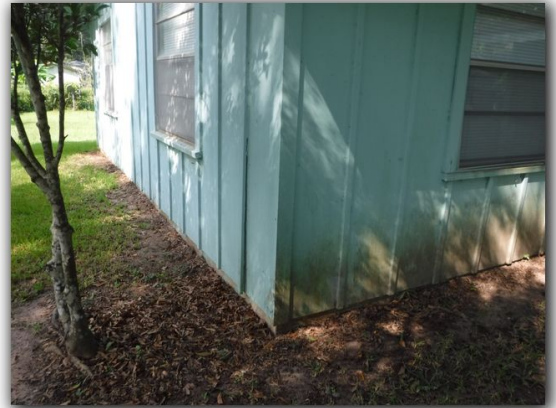
- Wood siding is water damaged in some areas along the ground on the front, left and rear sides. Around the water heater closet and the deck.
- One or more areas were obstructed
- Inadequate clearance between siding and grade, less than 6".
- Wood/soil contact in some areas
- Rotten wood at base of siding on left side and in front
- Battens loose on siding on front and left side
- Paint peeling in some areas

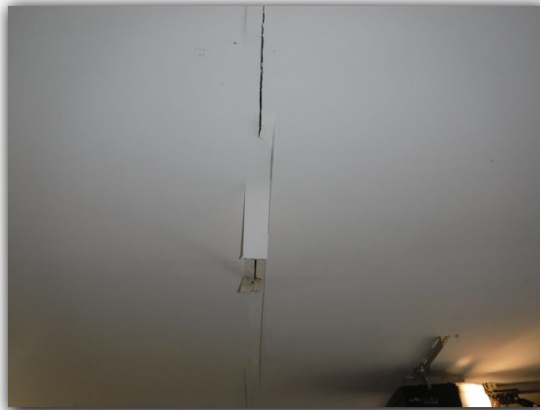
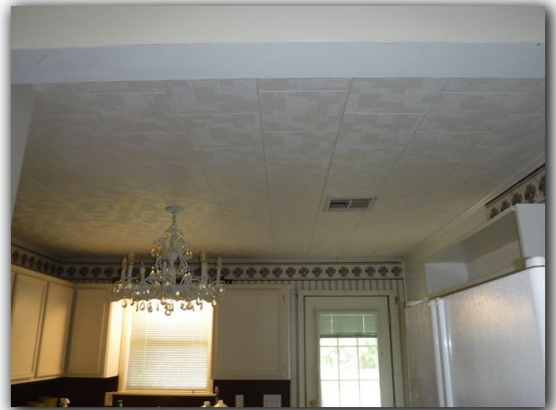
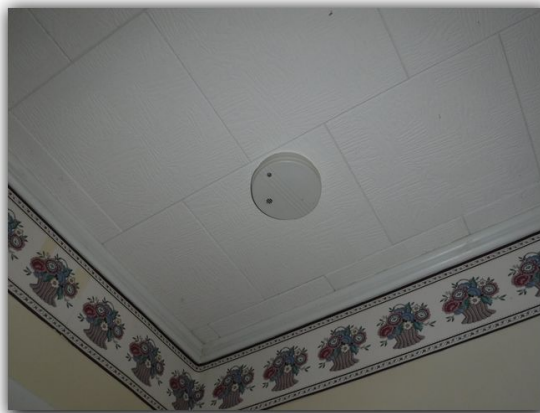
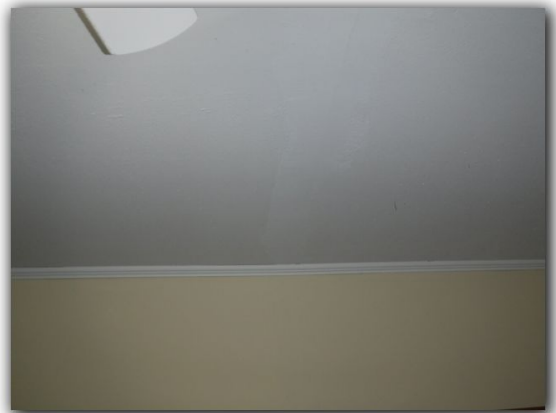
- Ceiling cracks in some areas, above the garage, typical when used for storage.
- Previous repairs noted in left front bedroom

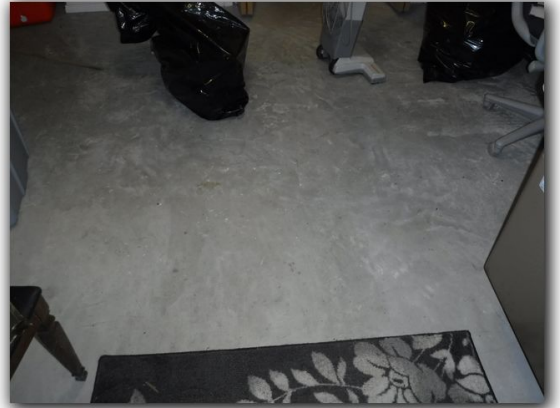
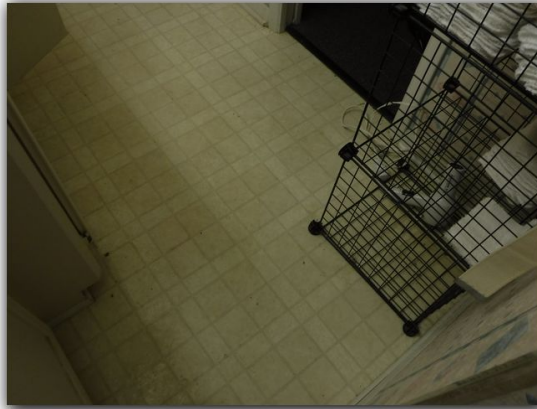
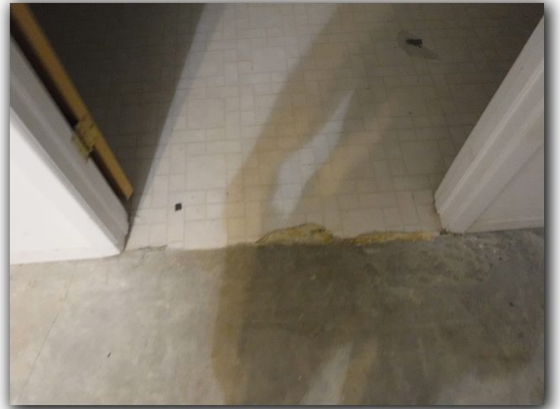
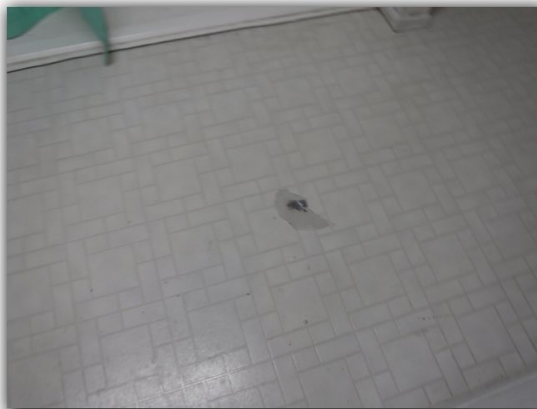
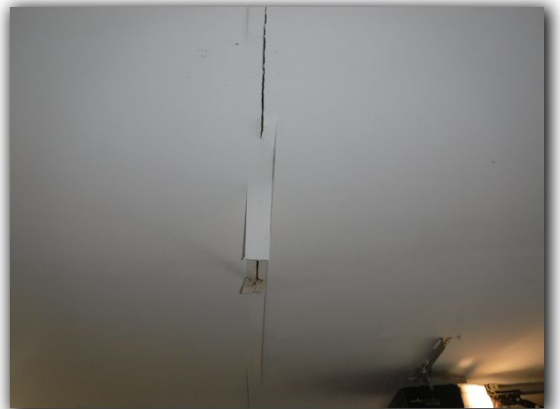
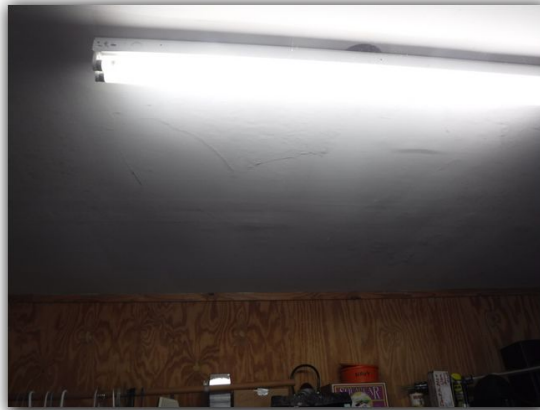
- Carpet older/stained
- Vinyl flooring damaged in bathroom.

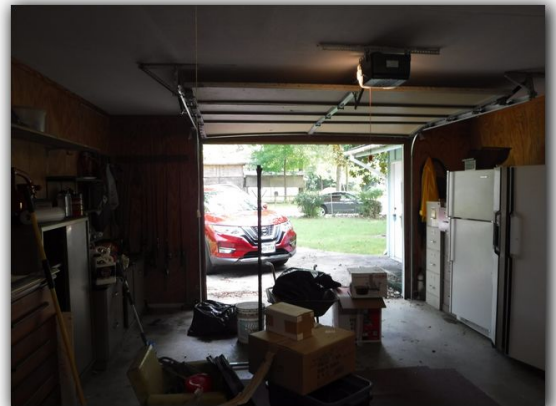
Type: Metal Wood Fiberglass Damaged panels

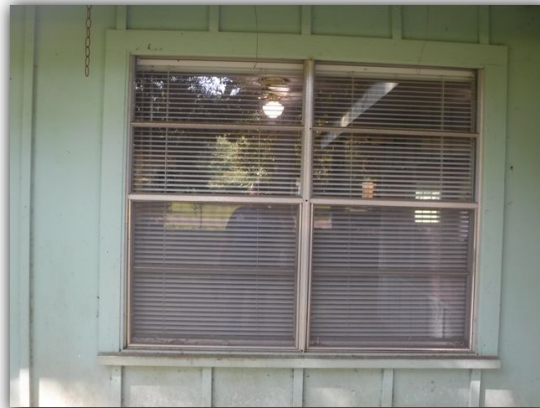
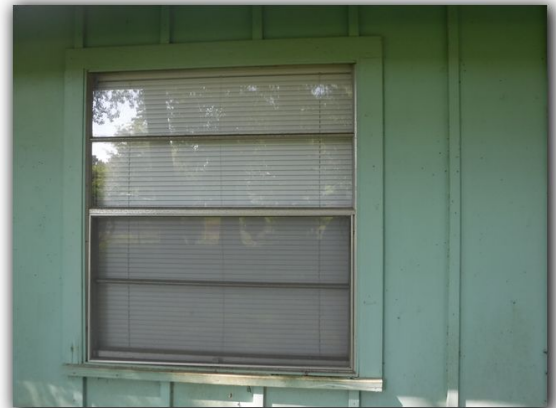
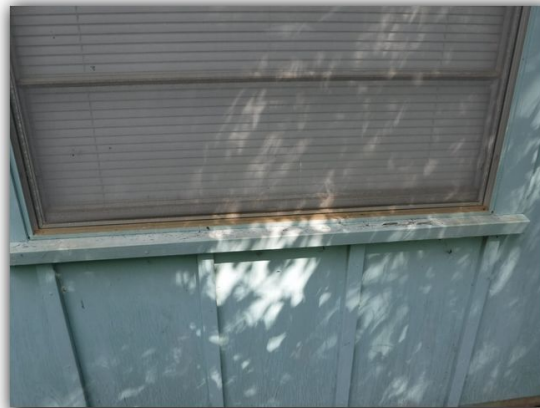
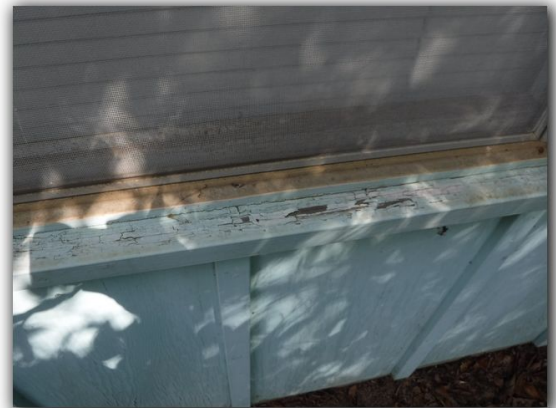
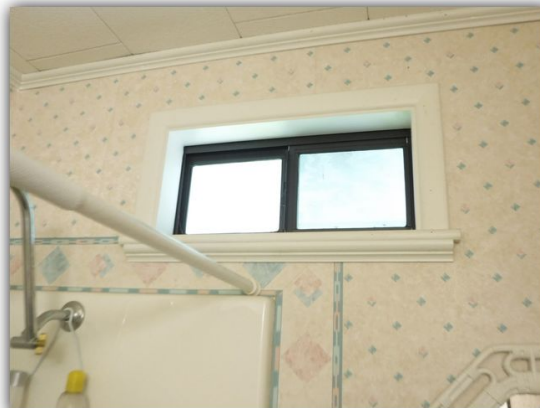
Some windows have peeling paint on exterior trim and minor water damage to trim.

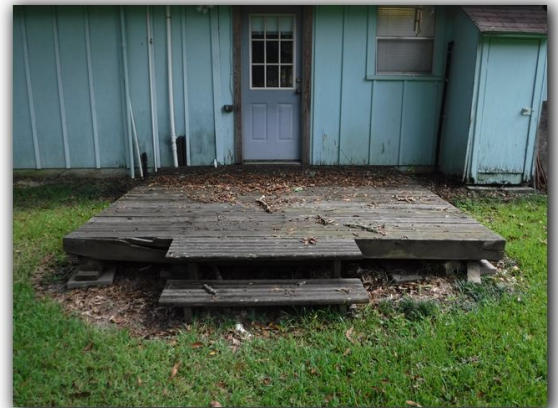
Structural deficiencies, old, deteriorated deck with wood on soil contact and split or damaged wood supports, I recommend repair or replacement of this deck.

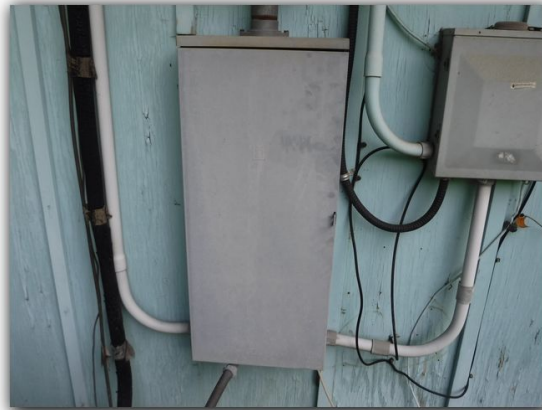
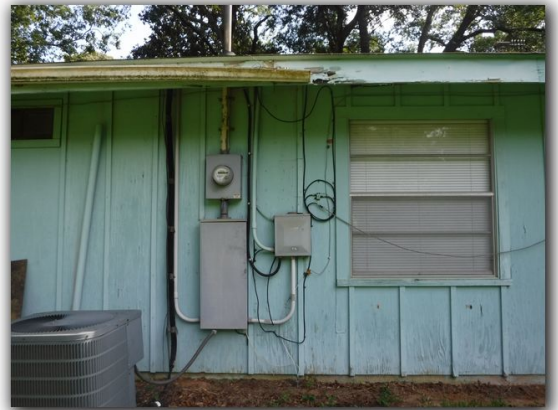
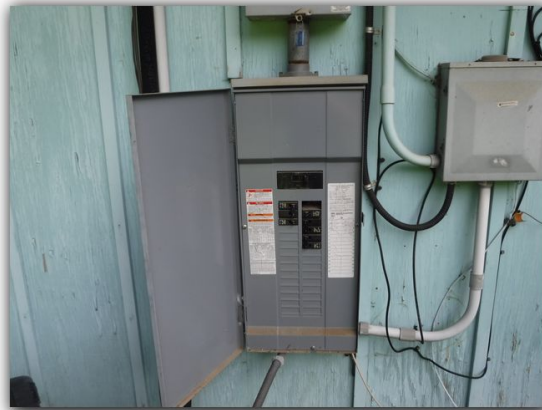
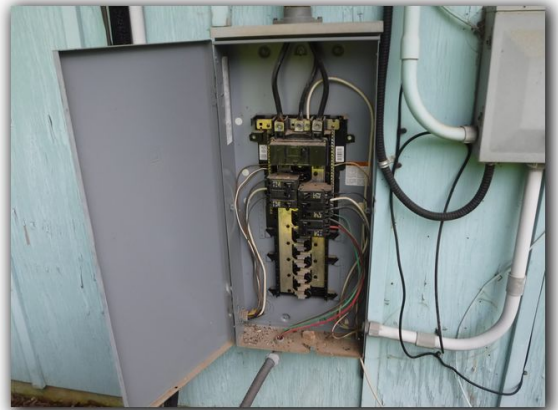
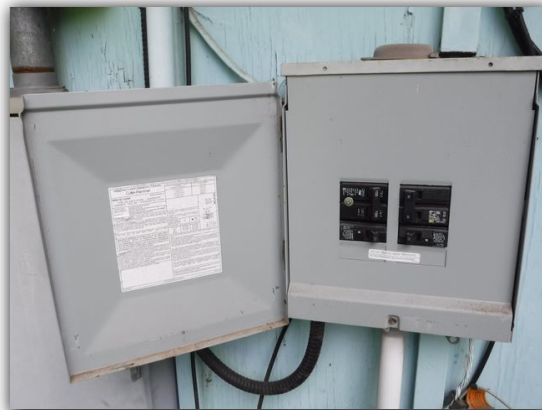
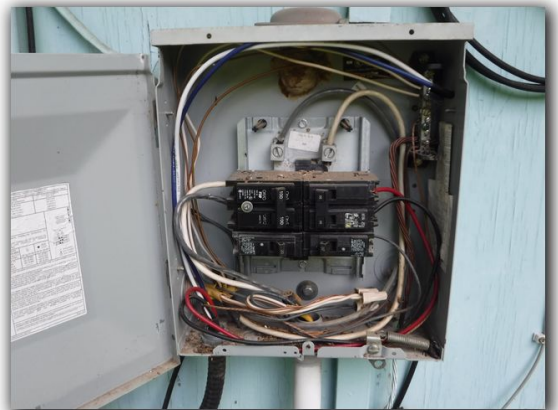
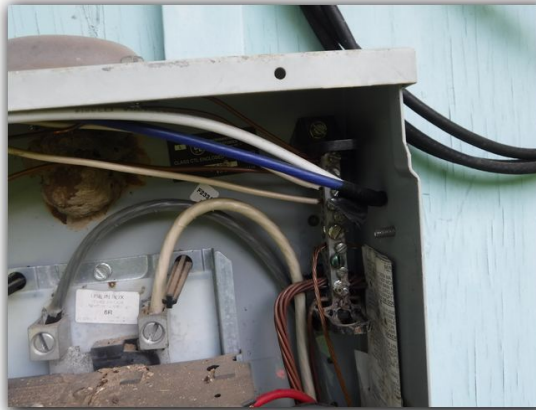
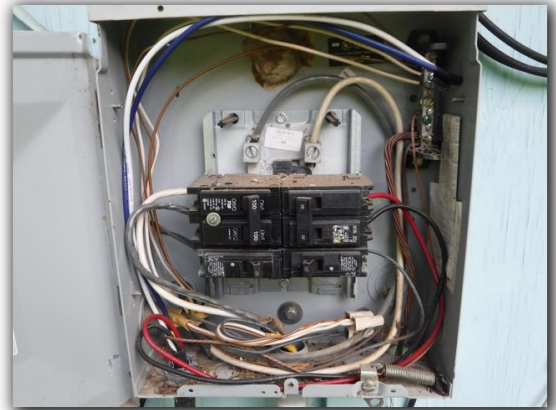
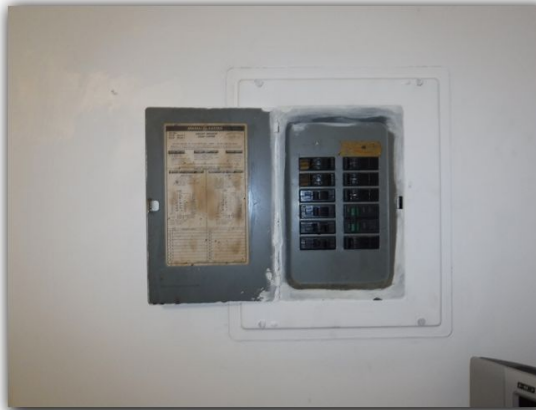
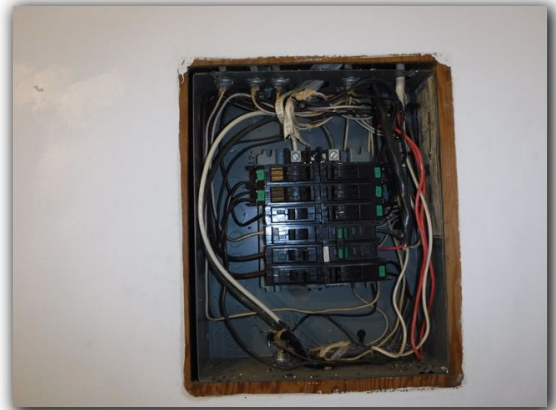
Specifies max amp breaker of 20A and an (Unknown) amp breaker is in use

Panels are not labeled

Grounds and neutrals on same bus bar

Panel covers, knockouts, cable clamps missing/ loose

Defects may exist in certain electrical sub panels and have been known to be unsafe in some instances and should be thoroughly evaluated by a licensed electrician as to present and future performance.

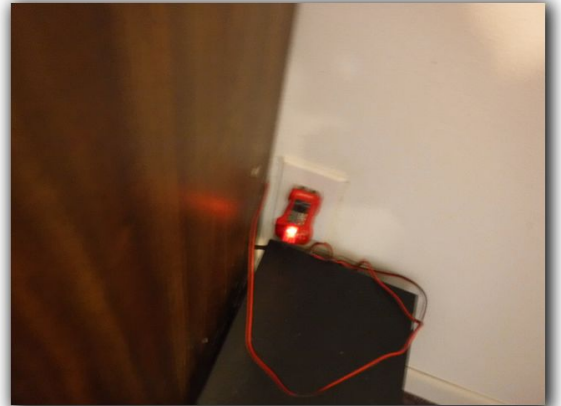
- GFCI are not properly installed or operate properly
- Concealed connections of copper and aluminum wires / electrical components were not inspected
- Inappropriate Ground Type receptacles installed on two conductor system, most plugs in the main side of the home are not grounded.

- No GFCI/ARC Fault protection at one or more location. This is considered a recognized safety hazard.

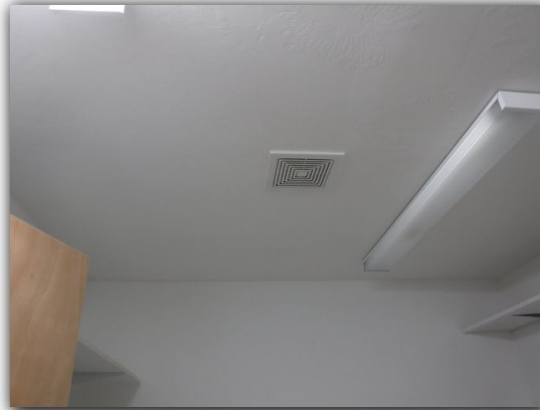
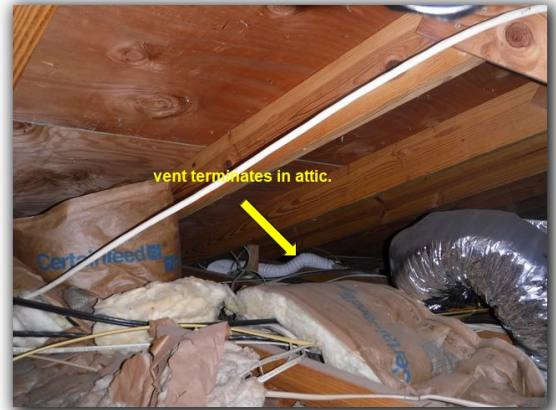
Vent pipes that do not terminate outside the structure, terminate in the attic.
