Your Professional Inspection Report Has Been Prepared Exclusively For You.

**Frank Gonzalez
421 Huckleberry Dr
Lake Jackson, TX 77566
November 3, 2022**

Inspected By: Christian Jorsch TREC 22321
(832) 331-6999

PROPERTY INSPECTION REPORT FORM

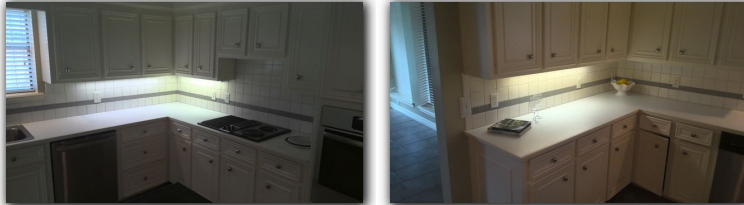
D-Not all kitchen counter top outlets are GFCI protected. This is a recommended statement by the T.R.E.C. (6/13/94) GFCI breakers are recommended to be installed in accordance with the latest version of the NEC.

2011 National Electrical Code 210.8 Ground-Fault Circuit-Interrupter Protection for Personnel.
(A) Dwelling Units. All 125-volt, single-phase, 15- and 20-ampere receptacles installed in the locations specified in (1) through (8) shall have ground-fault circuit-interrupter protection for personnel.
Bathrooms
Garages - also accessory buildings that have a floor located at or below grade level not intended as habitable rooms and limited to storage areas, work areas, and areas of similar use
Outdoors - (Exception to (3): Receptacles that are not readily accessible and are supplied by a dedicated branch circuit for electric snow-melting or deicing equipment shall be permitted to be installed in accordance with 426.28.)
Crawl spaces - at or below grade level
Unfinished basements —for purposes of this section, unfinished basements are defined as portions or areas of the basement not intended as habitable rooms and limited to storage areas, work areas, and the like

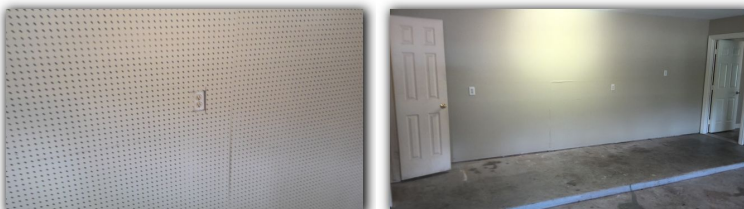
D - The installation of a ground fault circuit interrupter (GFCI) is recommended. A ground fault circuit interrupter (GFCI) offers protection from shock or electrocution.

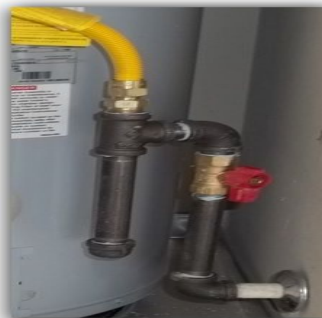
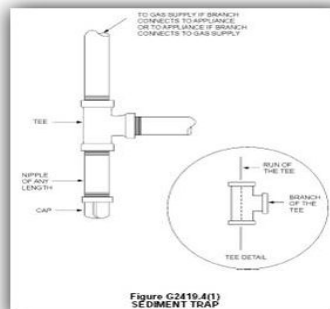
Samples of correct sediment trap installations

D - The heater gas supply line is not equipped with a sediment trap just before the gas appliance connector. This condition does not meet current installation requirements and should be corrected.

International Residential Code for One & Two Family Dwellings G2419.4 (408.4) Sediment trap. Where a sediment trap is not incorporated as part of the appliance, a sediment trap shall be installed downstream of the appliance shutoff valve as close to the inlet of the appliance as practical. The sediment trap shall be either a tee fitting having a capped nipple of any length installed vertically in the bottommost opening of the tee as illustrated in Figure G2419.4 or other device approved as an effective sediment trap. Illuminating appliances, ranges, clothes dryers, decorative vented appliances for installation in vented fireplaces, gas fireplaces, and outdoor grills need not be so equipped.
