PROPERTY INSPECTION REPORT

Concerning: 3039 Thicket Path Way, Katy, TX 77493

By: David Wooley - TREC Professional Inspector License # 20722 02/21/2021 3:00 pm

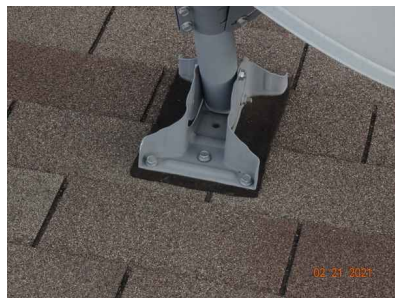
1: Shingles - Satellite Dish

There is a satellite dish(s) mounted to the roof covering. Ensure the anchor bolts are sealed properly. The Inspector cannot verify the condition of roof decking material under the mounted satellite dish.

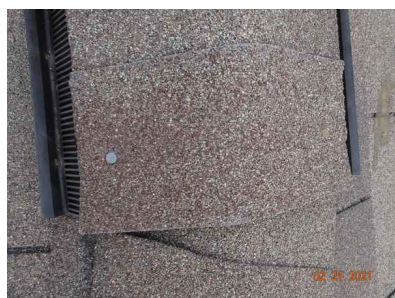
2: Exposed Fasteners

Noted nails installed on the exterior of the shingles with no apparent sealant.

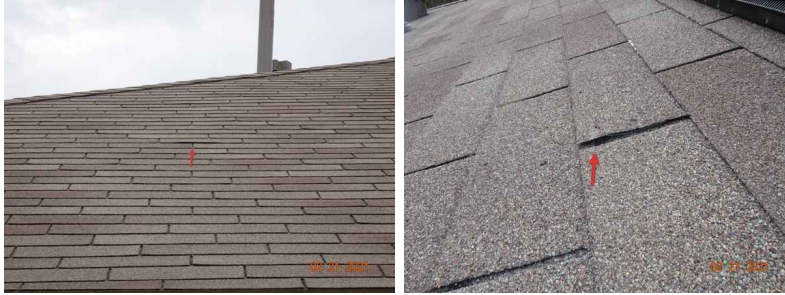
3: Shingles - Loose Shingles

Loose shingles were observed. Secure as needed by a qualified roofing contractor.

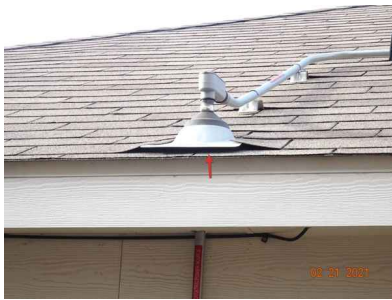
4: Flashing - Lifted Vent Flashing

Lifted vent flashings may allow for water penetration. Secure and seal as needed.

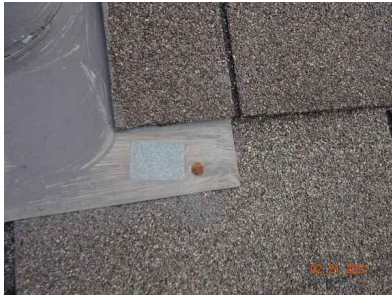
5: Fasteners - Exposed Flashing Nails

Exposed flashing nails should be properly secured and sealed to prevent water penetration.

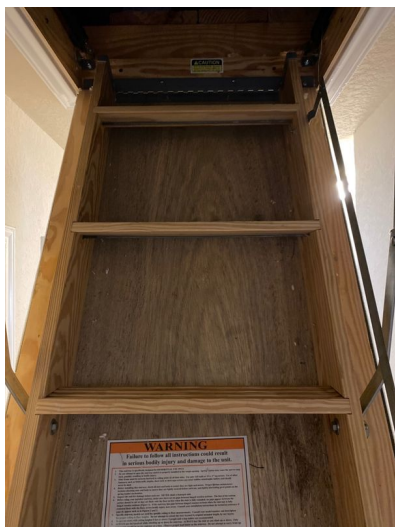
1: Attic Ladder - Not Insulated/Sealed

The attic ladder door is not proper insulated or weather-stripped. This will help with keeping hot air inside the attic and not be pulled into the home.

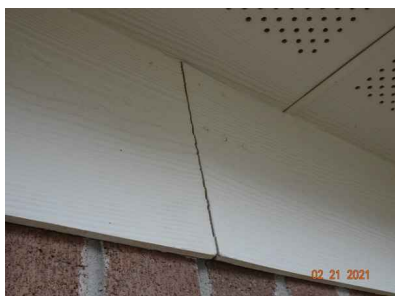
1: Trim - Loose/Missing Caulk

Loose/missing caulking was observed at trim board(s). Seal as needed to prevent moisture intrusion.

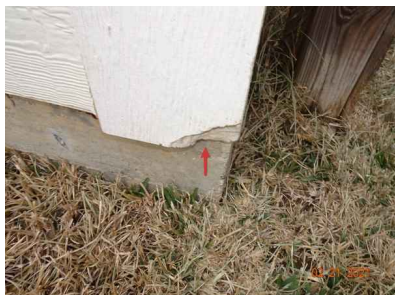
2: Fiber - Damaged Trim

Sections of damaged fiber cement board trim were observed. Repair or replace as needed.

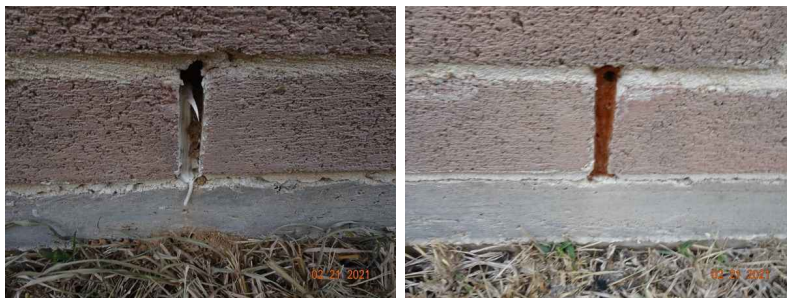
3: Brick - Weeps Filled

"Weep Holes" in the brick veneer at random areas are not properly cleared. Various weep holes have been filled. Filler material should be removed to ensure adequate air flow behind the brick veneer.

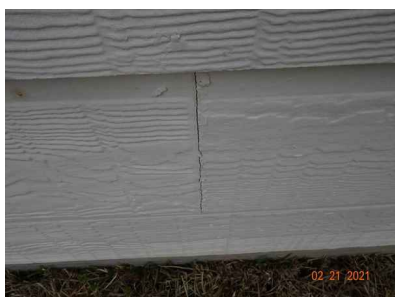
4: Fiber - Open Buttress Joints

Fiber cement board, commonly referred to as "Hardie plank", has buttress joints (end-to-end) that should be sealed (caulked) to prevent water penetration.

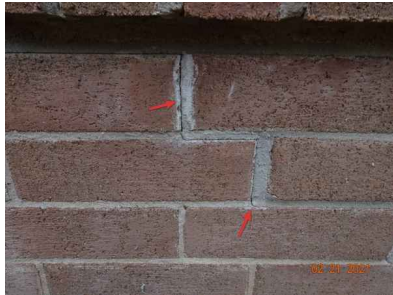
5: Brick - Stress Cracks

Stress cracks were observed in the exterior brick veneer. The cracks noted are consistent with the structural settlement of the home. Seal as needed or consult with a qualified brick mason to determine the best method of remedy.

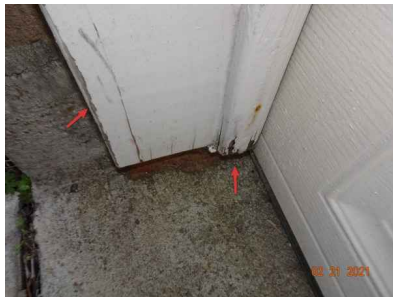
6: Trim: Missing/Worn Paint

Trim boards have missing and or worn paint/stain. Proper preparation and painting/staining is recommended to prevent deterioration of the wood.

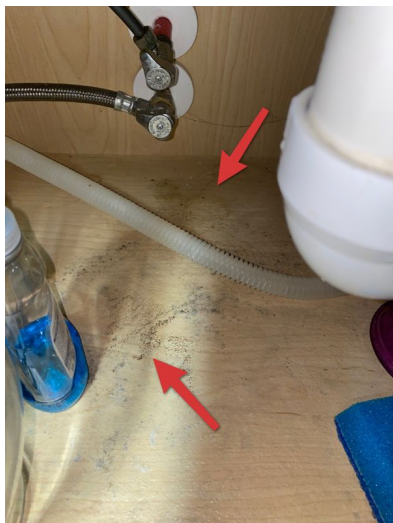
7: Cabinet - Water Damage

Water damage was noted to the platform inside the cabinet below the faucet. Repair or replacement is recommended

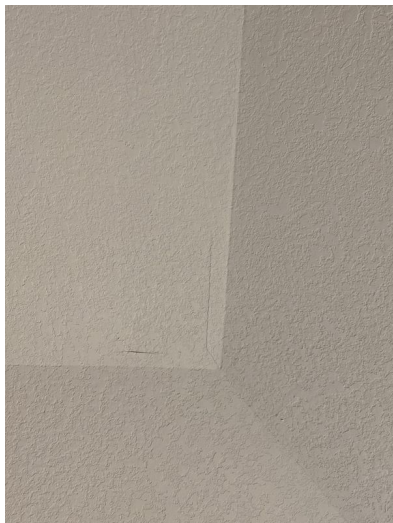
Vaulted Ceiling Cracks: **Note:** Texturing cracks are observed in vaulted ceiling joints. These are typically caused by thermal expansion and are cosmetic in nature and show no evidence of structural defect.

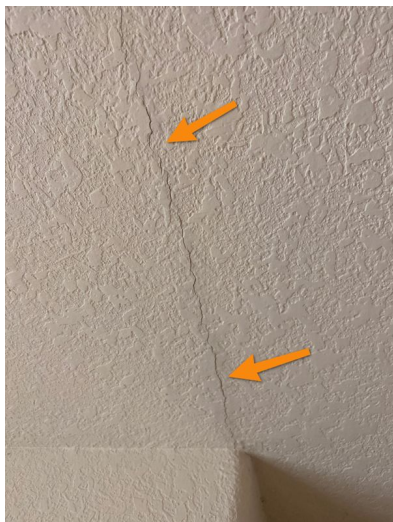
1: Ceiling -Stress Cracks

Stress cracks were observed in random areas of the ceiling, This is typically considered to be a cosmetic issue.

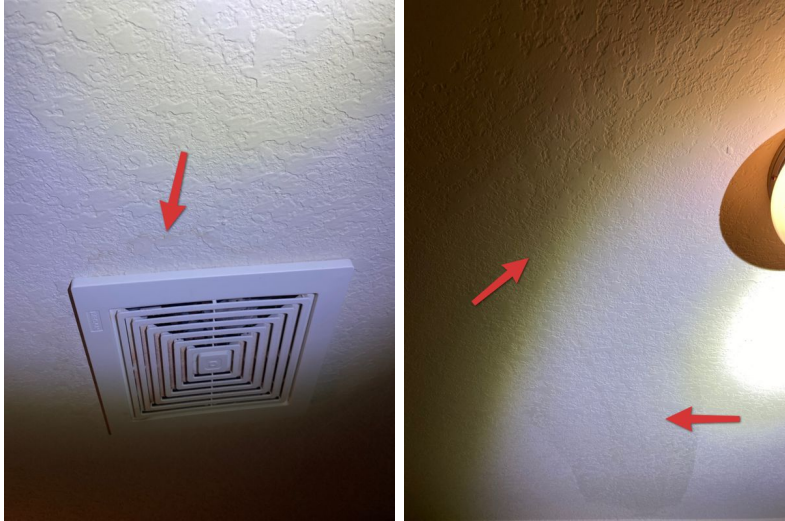
2: Ceiling - Water Staining; No Moisture Detected

Discolored drywall ceiling indicates prior water contact. No moisture was detected using a surface moisture meter and or a thermal imaging camera at the time of inspection. The cause could not be determined, evaluation by a qualified contractor is recommended.

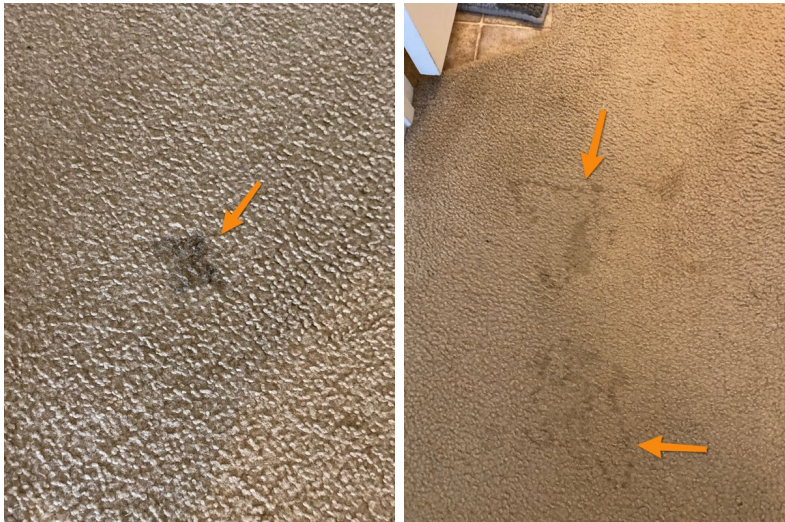
3: Floors - Stains

Staining/discoloration was noted at areas of carpet. Remedy as needed.

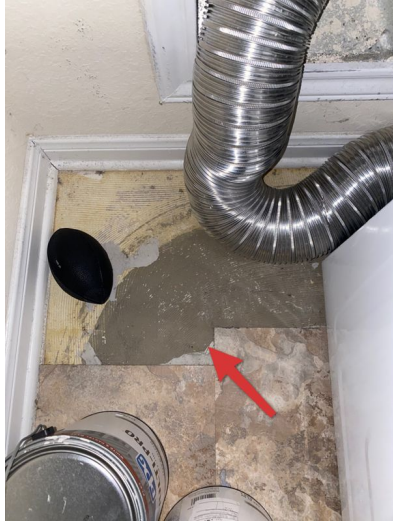
4: Missing: Flooring Material

Missing flooring and or trim was observed, further evaluation is recommended.

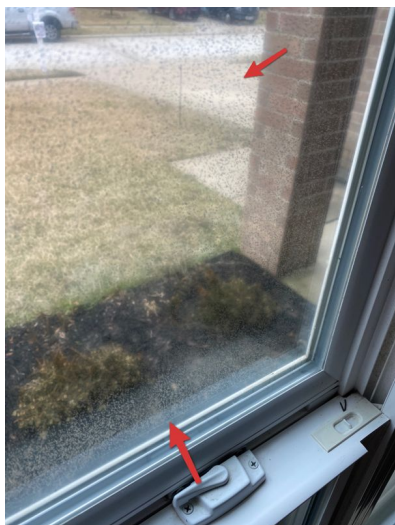
Initial wear of the window thermal "bronzing" is observed which affects the window clarity and thermal performance.

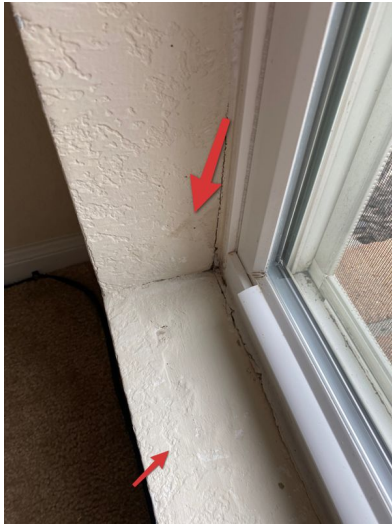
3: Frame - Evidence of Prior Moisture; No Moisture Detected

Evidence of previous water intrusion was noted at the window. No moisture was detected at the time of inspection using a surface moisture meter. Monitor and/or evaluate and remedy as needed.

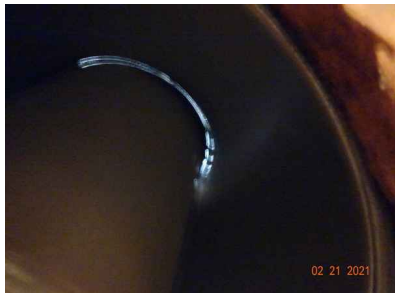
Daylight was observed around the furnace vent pipe in the attic. Sealing around the vent pipe and flashing is recommended to prevent moisture intrusion.

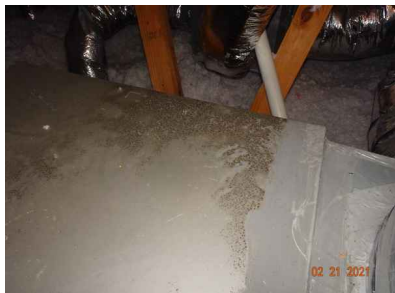
Mildew type growth/discoloration was observed. Further evaluation is recommended by a qualified HVAC contractor.

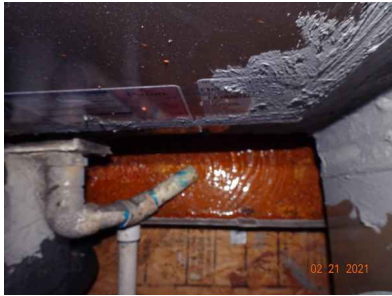
Water is observed in the A/C emergency overflow pan indicating restriction in the condensate drain system. Evaluate and remedy as needed by a qualified HVAC Company.

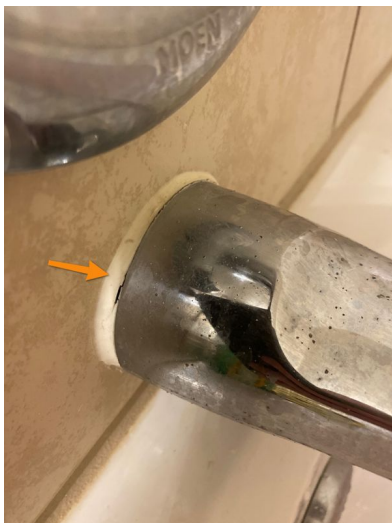
Seal (caulk) the gap between the bathtub spigot and bathtub stall wall to prevent water penetration.

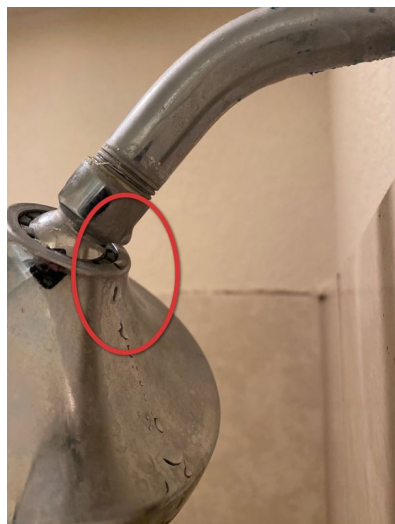
4: Showerhead - Leaks/Sprays

Water leaks/sprays around the showerhead during operation; remedy as needed.

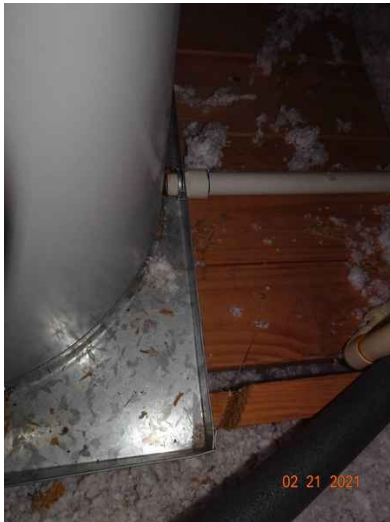
Insulation and all foreign debris should be removed from inside the overflow pan to prevent clogging of the overflow pan drain line.

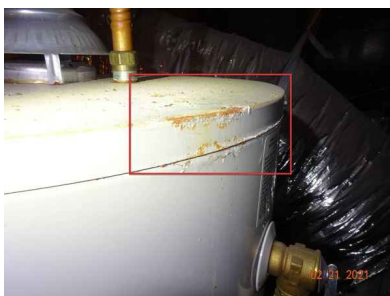
2: Tank - Rusting

There is visible rusting on the external tank of the water heater. This condition indicates possible leakage from internal components. Evaluation is needed to determine the best method of remedy..

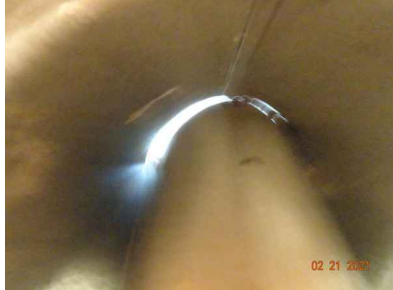
The water heater vent pipe is not properly sealed at the vent flashing on the roof. Daylight is visible in the attic around the vent pipe. Sealing around the vent pipe and vent flashing is recommended to prevent moisture intrusion.

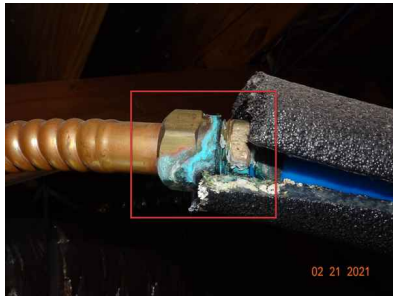
4: Supply Lines - Corroded

Corroded water line fittings are observed. Evaluate by a qualified plumber and clean or replace as needed.

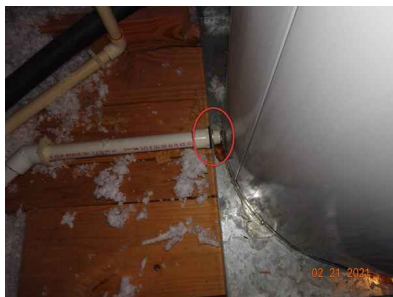
5: Overflow Pan - Tank Too Close to Drain

The drain for the pan appears to be obstructed by the tank. If the pan fills with water it may not drain adequately.

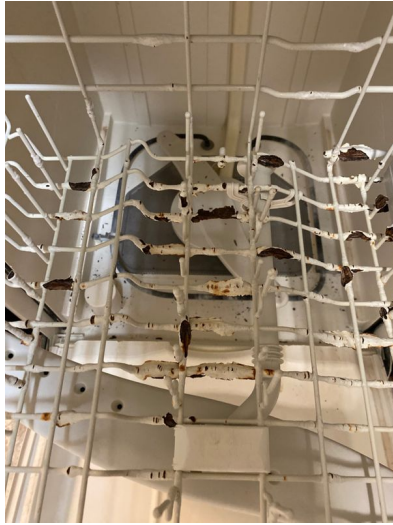
1: Rusted Dish Racks

Rusting is observed on the dishwasher rack(s); evaluate and remedy as needed.

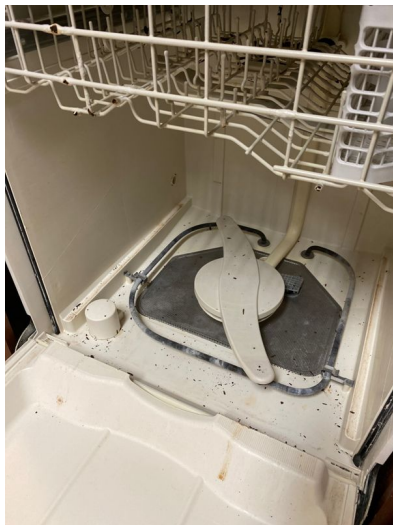
2: Rack: Missing

The dishwasher rack is missing, remedy as needed

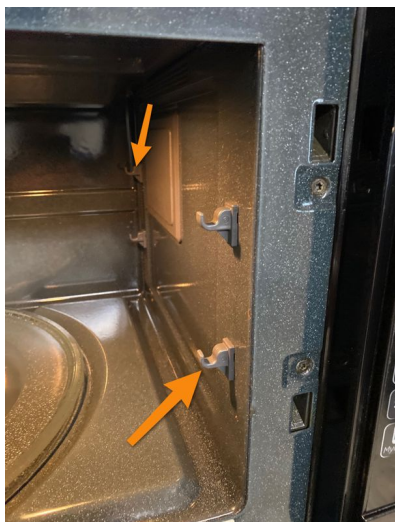
1: Missing Rack

Interior microwave rack was missing at the time of inspection. Remedy as needed.

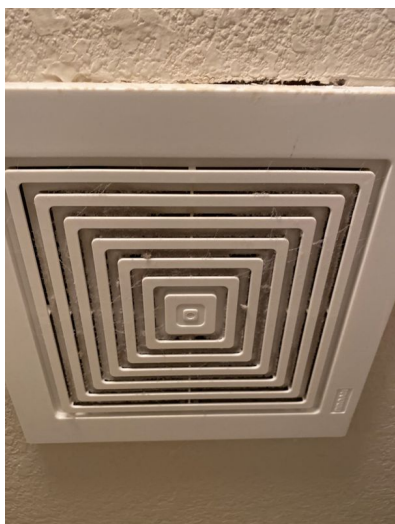
1: Clogged Vent Cover

Cleaning of the exhaust vent cover is needed to ensure unrestricted air flow.
