**BPG Inspection, LLC**

**19722 Rippling Brook Lane  
Tomball TX 77375**

Inspection Date: 8/23/2022

Inspector: Orlando Martinez , TREC 21694 (TX)

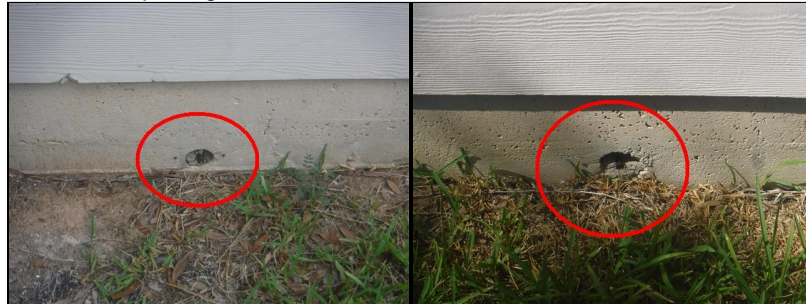
☒ Post tension cable ends are exposed in areas. Seal all exposed post tension cable ends at foundation walls to prevent corrosion and spalling of concrete..

1. Post tension cable ends are exposed in areas. Seal all exposed post tension cable ends at foundation walls to prevent corrosion and spalling of concrete..

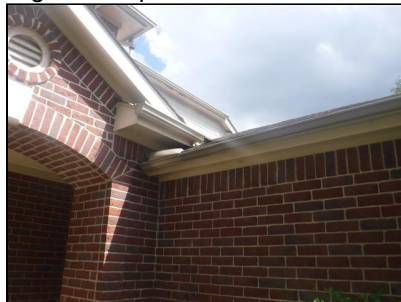
☒ Some gutter sections are bent and not sloped for proper drainage. The excess water will not be properly drained away from the structure as designed. A qualified contractor should perform repairs.

2. Some gutter sections are bent and not sloped for proper drainage. The excess water will not be properly drained away from the structure as designed. A qualified contractor should perform repairs.
-

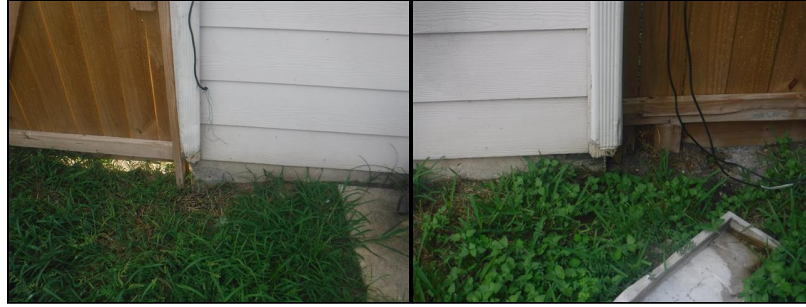
☒ There is a downspout and/or turnout missing. Replace the missing components and extend 3ft from foundation.

3. There is a downspout and/or turnout missing. Replace the missing components and extend 3ft from foundation.

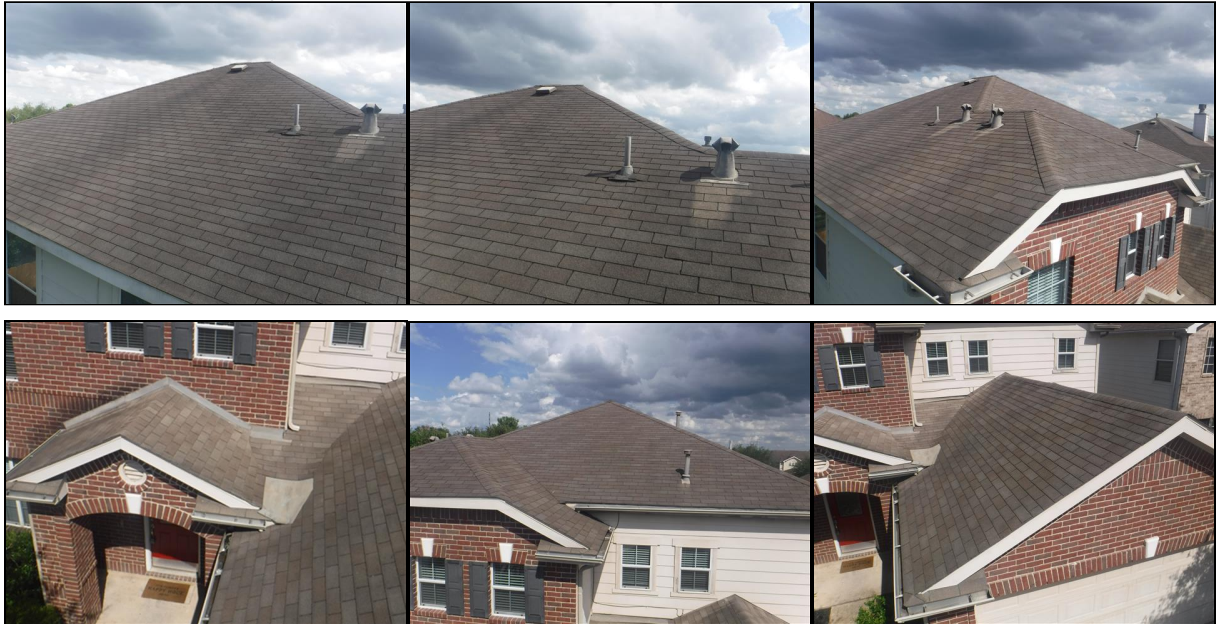
☒ The roof covering is old, and the life of covering has or is near expired. Significant & readily apparent deterioration and/or damage to shingles, tiles, flashing or other roof covering was observed. The covering does need to be replaced. While it could last a year or so, some areas may need patching with tar as leaks develop. Buyer is strongly encouraged to have a properly certified / licensed roofing contractor to physically inspect the roof prior to expiration of any time limitations, such as option or warranty periods, to fully evaluate the condition of the roofing material.

4. The roof covering is old, and the life of covering has or is near expired. Significant & readily apparent deterioration and/or damage to shingles, tiles, flashing or other roof covering was observed. The covering does need to be replaced. While it could last a year or so, some areas may need patching with tar as leaks develop. Buyer is strongly encouraged to have a properly certified / licensed roofing contractor to physically inspect the roof prior to expiration of any time limitations, such as option or warranty periods, to fully evaluate the condition of the roofing material.

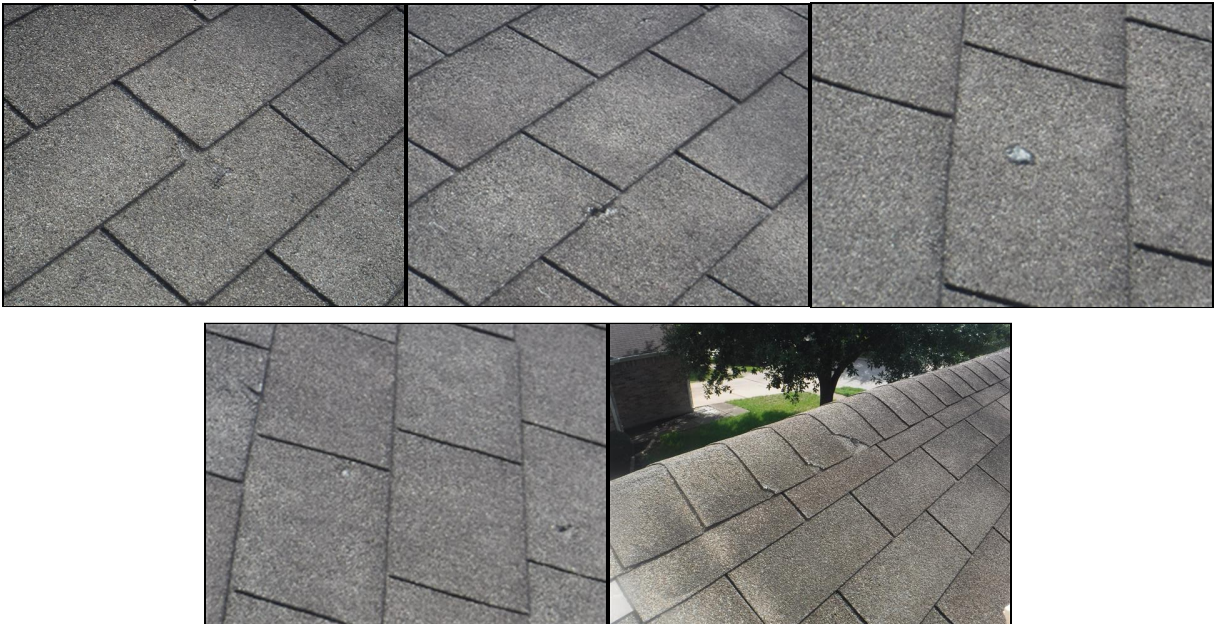
☒ There are damage shingles at the front of the home that may allow water penetration. I recommend having a licensed roofer repair as needed.

5. There are damage shingles at the front of the home that may allow water penetration. I recommend having a licensed roofer repair as needed.
-

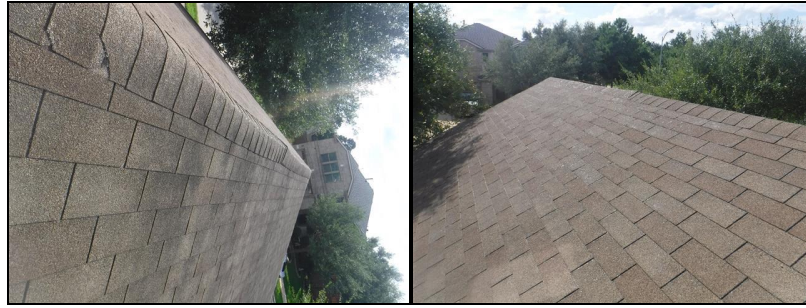
☒ Some worn shingles with granular loss/damage in various areas throughout the roof. A roofer should perform a maintenance check on the covering for needed repairs, patching or replacement of worn shingles.

6. Some worn shingles with granular loss/damage in various areas throughout the roof. A roofer should perform a maintenance check on the covering for needed repairs, patching or replacement of worn shingles.

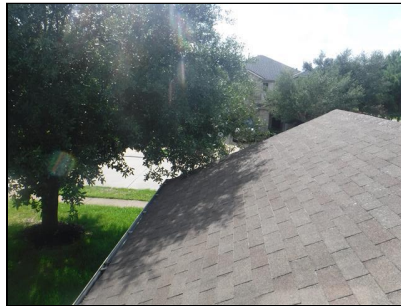
Tree limbs that are in contact with roof or hanging near roof should be trimmed back 3-5' to prevent any damage to the roof covering.

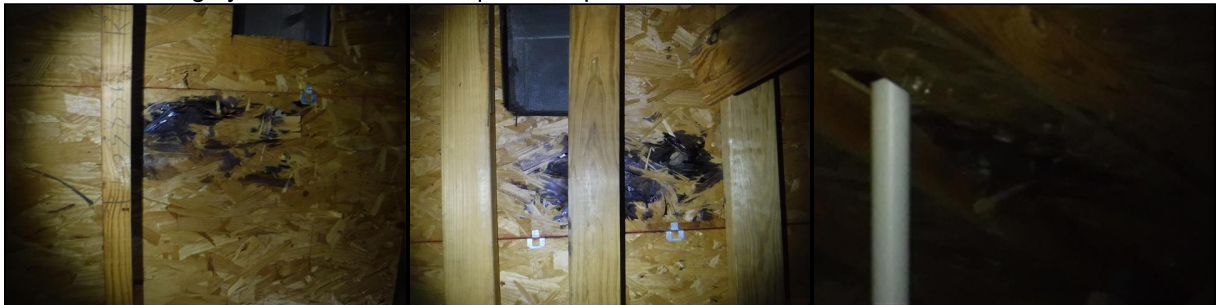
☒ There was evidence of leaks in areas of the attic (flue pipe penetrations, chimney, valleys etc.). Some areas of the deck may require repair. Replacement of flashings, jackboots or possibly parts of the covering at these areas may be necessary to ensure it is leak free. A roofer should further evaluate roof covering, deck and exterior flashing systems for need of repair or replacement.

7. There was evidence of leaks in areas of the attic (flue pipe penetrations, chimney, valleys etc.). Some areas of the deck may require repair. Replacement of flashings, jackboots or possibly parts of the covering at these areas may be necessary to ensure it is leak free. A roofer should further evaluate roof covering, deck and exterior flashing systems for need of repair or replacement.
-

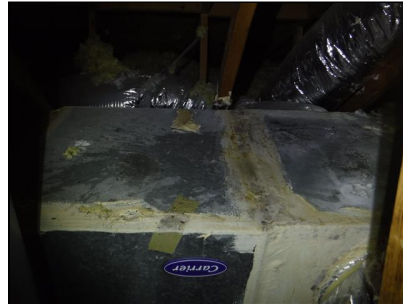
Moisture was found on the air handle from a possible roof leak. I recommend having a licensed contractor evaluate for repair.

8. Moisture was found on the air handle from a possible roof leak. I recommend having a licensed contractor evaluate for repair.
-

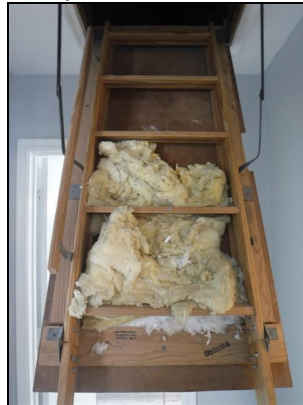
The attic ladder treads have been reduced in depth by the insulation on the door. This can present a safety hazard. A better alternative is to insulate the top side of the door with foam board insulation.

9. The attic ladder treads have been reduced in depth by the insulation on the door. This can present a safety hazard. A better alternative is to insulate the top side of the door with foam board insulation.

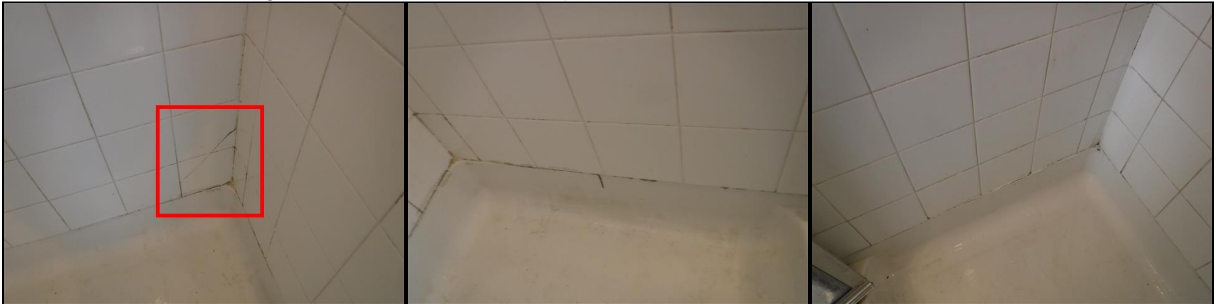
☒ Master tile wall has cracks on tiles at base of the wall. Seal is also deteriorating at tub wall connection point. I recommend having a licensed contractor repair as needed.

11. Master tile wall has cracks on tiles at base of the wall. Seal is also deteriorating at tub wall connection point. I recommend having a licensed contractor repair as needed.

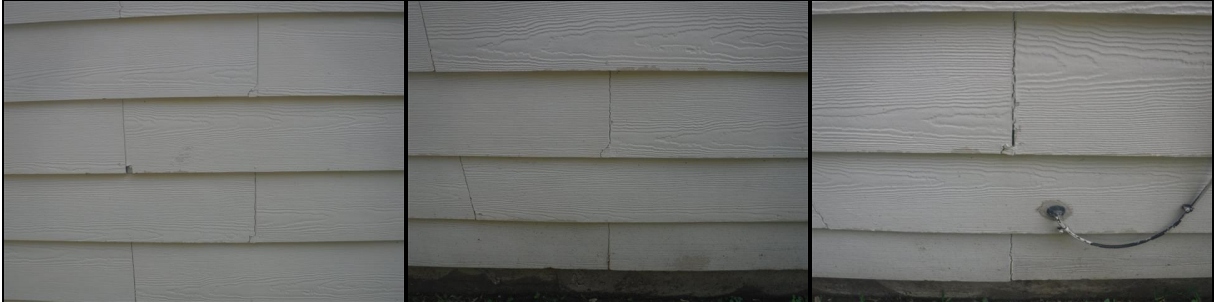
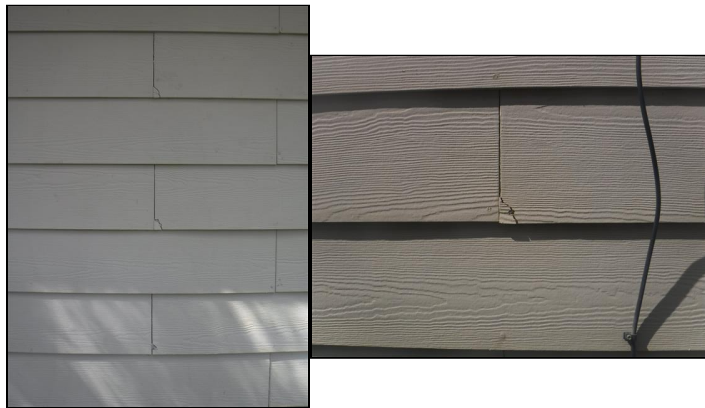
☒ Hardi plank slat siding has been improperly attached to structure: nail fasteners are driven too close to corners and edges of planks causing them to split and crack. Additional fasteners are recommended to center areas to ensure slats remain in place. Repair and sealant to damaged areas will be an ongoing maintenance item if damaged slats are not replaced.

12. Hardi plank slat siding has been improperly attached to structure: nail fasteners are driven too close to corners and edges of planks causing them to split and crack. Additional fasteners are recommended to center areas to ensure slats remain in place. Repair and sealant to damaged areas will be an ongoing maintenance item if damaged slats are not replaced.

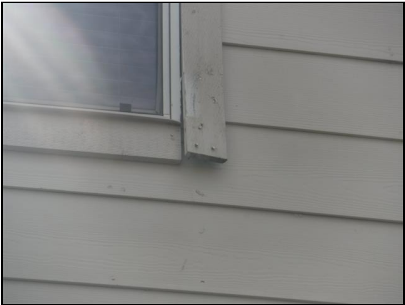
Window siding is coming loose. Repair as needed.

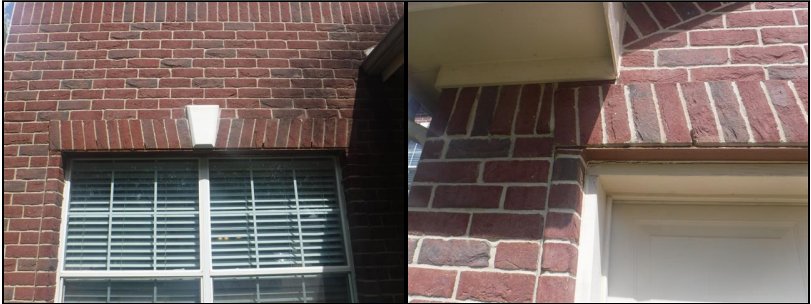
Lintels/headers above doorways, windows are rusting, and are exposed at the ends. Recommend remediation of rust, application of rust prohibitive paint, and seal ends into mortar joints.

14. Lintels/headers above doorways, windows are rusting, and are exposed at the ends. Recommend remediation of rust, application of rust prohibitive paint, and seal ends into mortar joints.

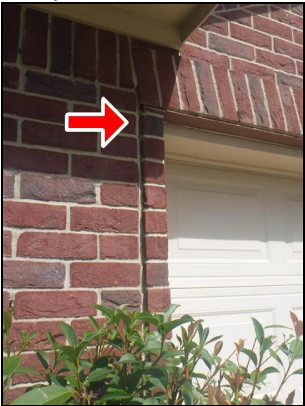
There are joint cracks on the walls in various locations. These cracks appear to be typical settlement/shifting joint cracks with no other visible displacement. Recommend sealing (mortar) crack to prevent moisture incursion and monitor for further settlement/separation.

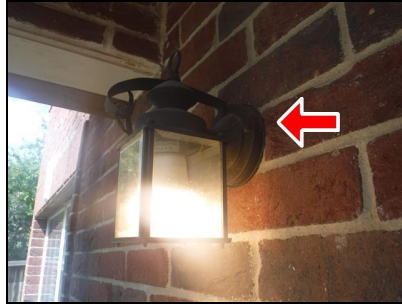
It is recommended that all protrusions through the exterior siding and fixtures mounted on the exterior be sealed in order to prevent moisture incursion. Using a quality exterior caulk type sealant around pipes, wires, light fixtures etc. can prevent moisture related failure of electrical components and siding materials.

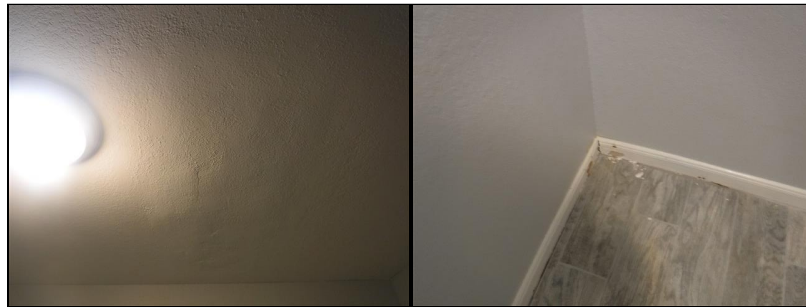
There is evidence of previous repairs on the ceiling in the master bedroom closet. There was no prior disclosure of this repair, and no evidence of damage in the attic. I recommend you query the owner for the history on this area.

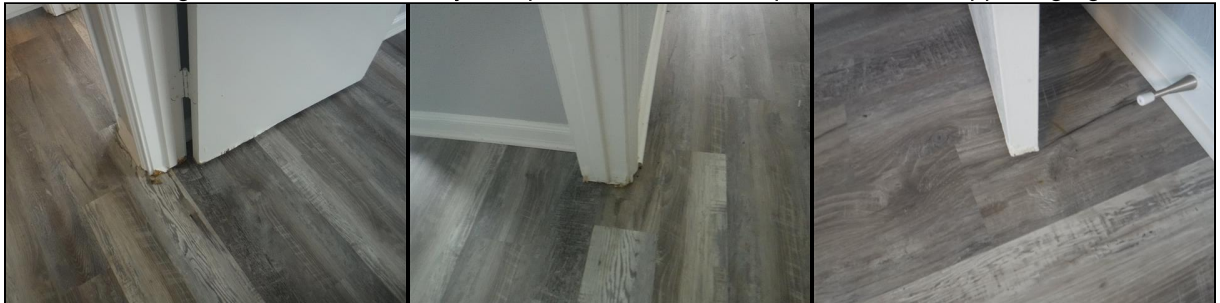
☒ There is water damage to door and door jams at upstairs bedroom. No active moisture was found. I recommend asking seller about the history of repairs in this area. To prevent issue happening again.

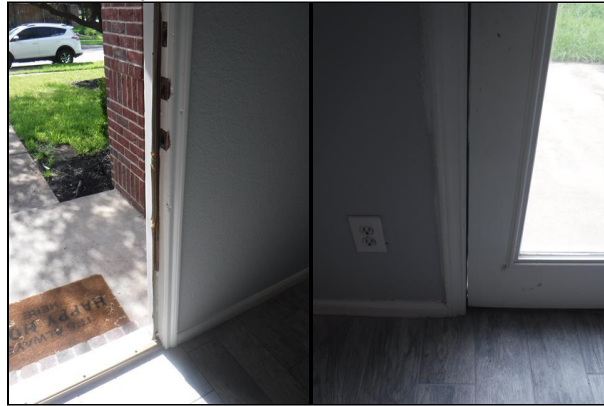
Doors and frames should be sealed, made weather tight with proper seal contact between the frame structure and door. The seals at the entry and rear door are deficient and should be improved or replaced.

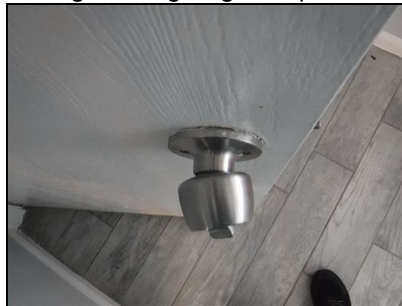
Door knob was damaged at door leading to the garage. Repair as needed.

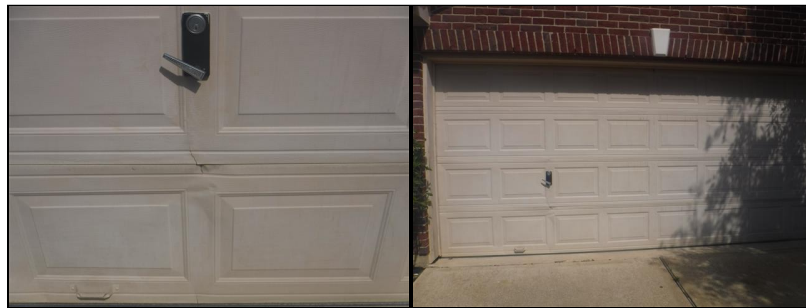
The garage door had damage but was functional. I recommend monitoring panel for further damage due to function.

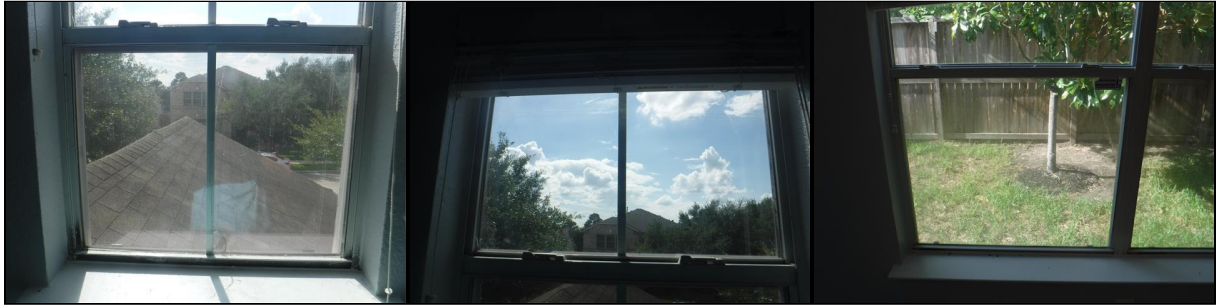
☒ There is a cracked window at the guest bedroom. Recommend replacement by qualified tradesman.

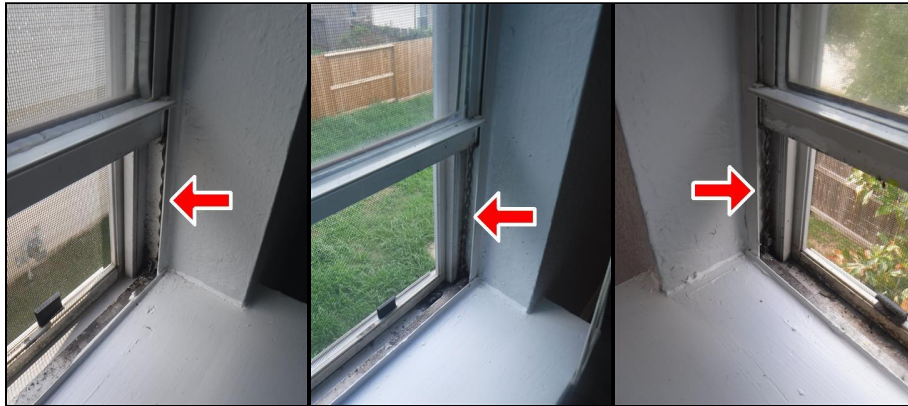
☒ Window sash springs need adjustment or repair to allow windows to remain completely open, most notably in the bedrooms

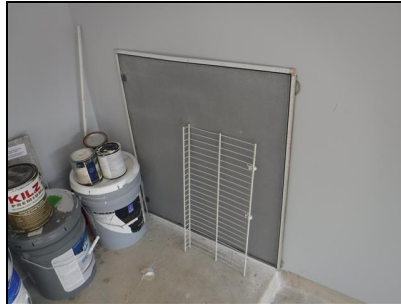
Some window screens are stored in the garage. Re-hang and check for damage and/or missing screens

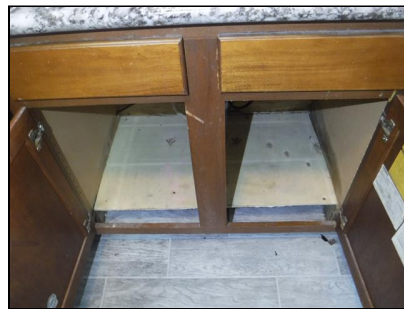
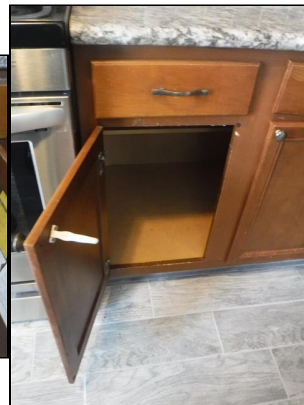
☒ There is missing under board at the kitchen sink and a cabinet door has a damaged hinge. I recommend having a licensed carpenter repair as needed.

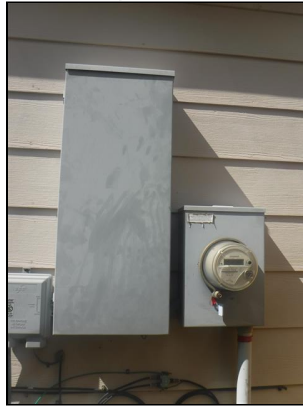
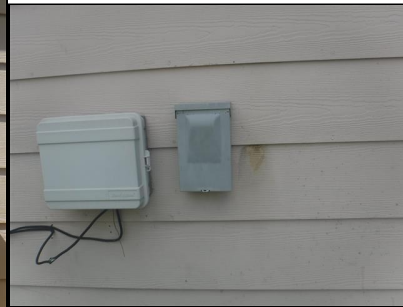
☒ Recommend sealant between panels/meters and wall to prevent moisture entry into wall.

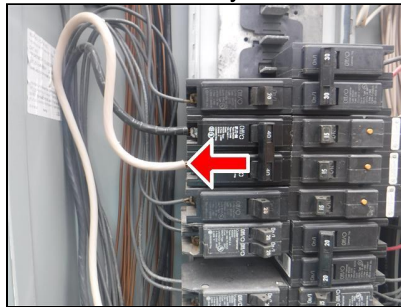
White (neutral) wires are being used as hot wires in the main breaker panel, without the proper identifiers. These should be marked black or red to indicate that they are hot.

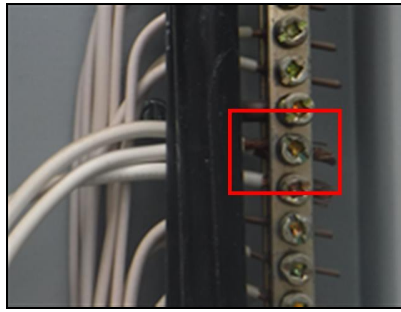
Neutral wires are not individually lugged to the sub panel neutral bus bar as called for by today's standards.

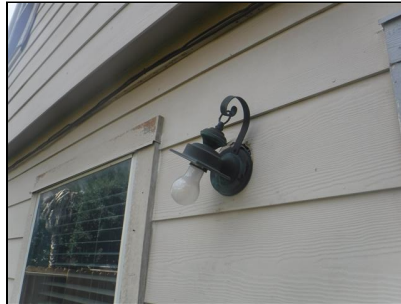
☒ Rear exterior light fixture is damaged and missing parts. I recommend repair or replacement by an electrician.

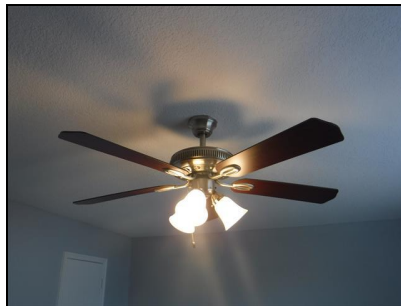
☒ Back left bedroom ceiling fan was not operational on the day of the inspection. Repair is needed by an electrician.

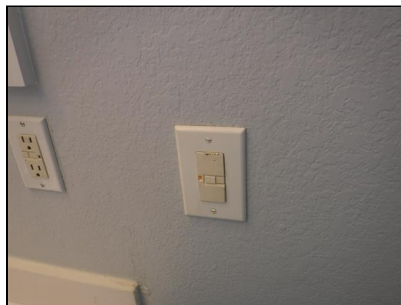
☒ A GFCI is not functioning in the master bedroom. I recommend an electrician to evaluate and repair or replace as needed.

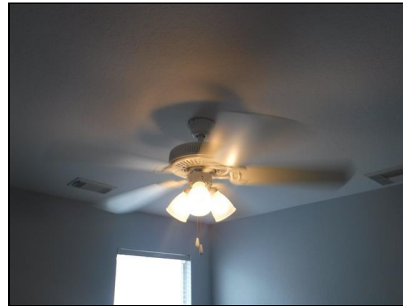
Observed ceiling fan wobbles at high and medium speed. Ceiling fans over a period of time can loosen support through a steady wobbling. Recommend that the ceiling fan is balanced and its support is checked to ensure safety.

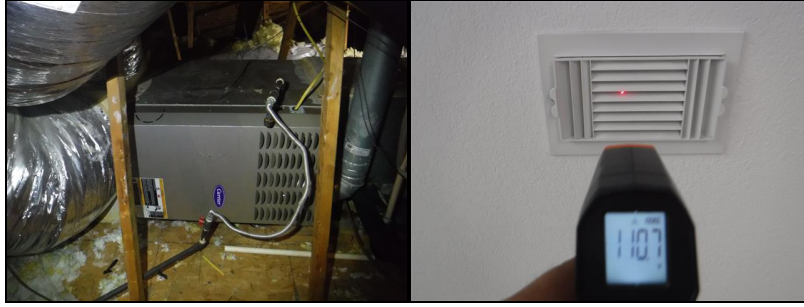
Furnace

The furnace is very old but did work at time of inspection. I am unable to determine life remaining.

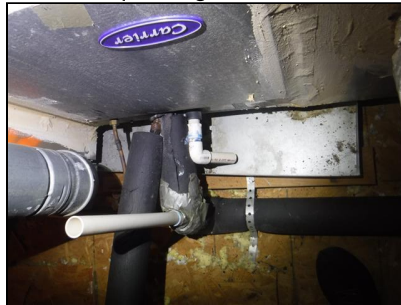
☒ There is no emergency float electrical cutoff switch installed as called for by today's standards. These devices prevent condensate from overflowing into the interior house structure, and turn the unit off until service is performed to the unit. I recommend updating to current standards to prevent water incursion.

- ☐ 27. There is no emergency float electrical cutoff switch installed as called for by today's standards. These devices prevent condensate from overflowing into the interior house structure, and turn the unit off until service is performed to the unit. I recommend updating to current standards to prevent water incursion.

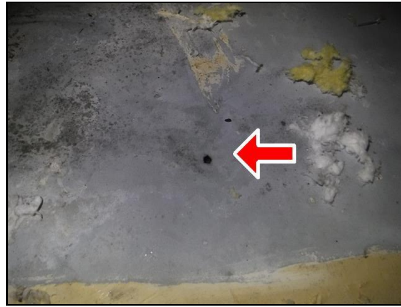
There was a small air leak in the plenum. Repair is needed.

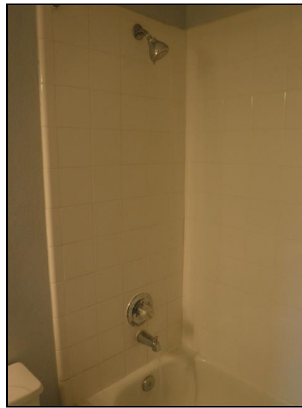
The water at tub nozzle would not terminate when showerhead was activate over the tub. Each is to dispense water independently of each other at 100%. Recommend properly repair/replace the shower diverter at the tub.

- ☐ 28. The water at tub nozzle would not terminate when showerhead was activate over the tub. Each is to dispense water independently of each other at 100%. Recommend properly repair/replace the shower diverter at the tub.
- ☐ 29. Home has original galvanized supply lines. Lines of this age are known to develop leaks and clogs overtime. Supply problems may not be detectable until they actually fail. Consider updating these supply lines. Consult with licensed plumber for options and pricing.

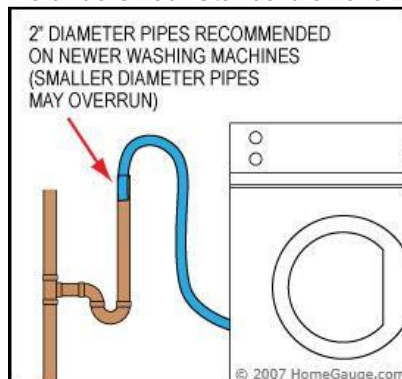
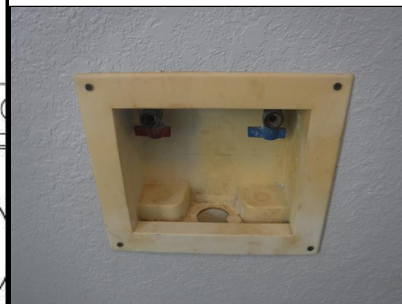
The washer drain is undersized. Standard size is 2" diameter, to prevent overrun.

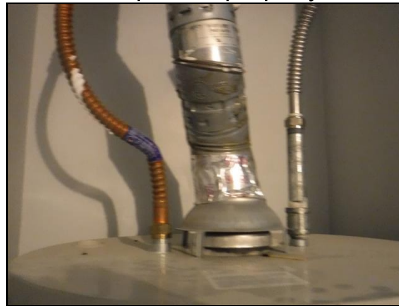
**☒** Flue vents not properly secured at elbows with sheet metal screws. Tape is currently being used, which can become a source of combustion. Remove tape and properly secure vents with sheet metal screws.

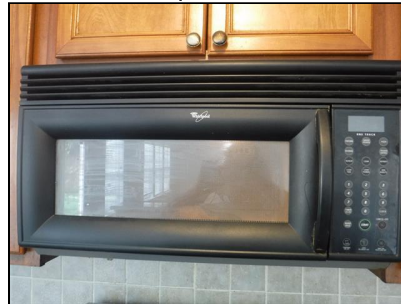
☒ The microwave did not function. I recommend repair as needed.

- ✘ 34. The microwave did not function. I recommend repair as needed.

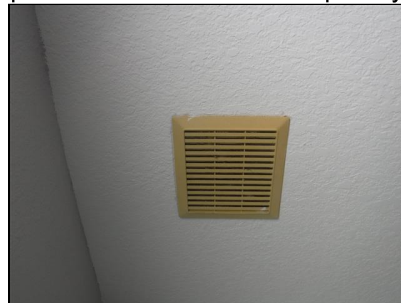
☒ Laundry room exhaust fan is not operational. Recommend repair by an electrician.

- ✘ 35. Laundry room exhaust fan is not operational. Recommend repair by an electrician.

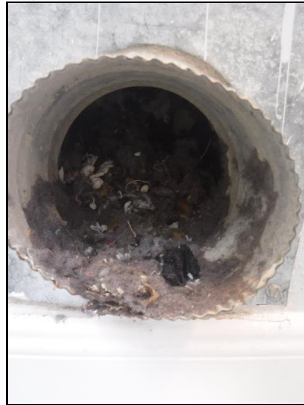
☒ The dryer vent has excessive lint build-up and should be cleaned prior to use.

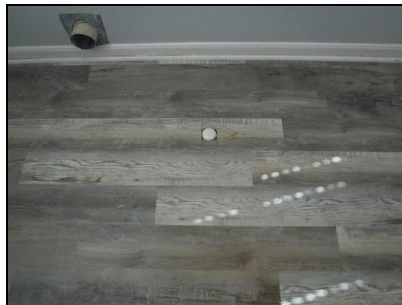
☒ There is no drain pan installed under the clothes washer. Drain pans are required for second story washer installations.
