Inspection Report

Property Address:
13719 Greenway Drive
Sugar Land Texas 77498

PROPERTY INSPECTION REPORT FORM

Hampson Properties	8/9/2022
<i>Name of Client</i>	<i>Date of Inspection</i>
13719 Greenway Drive, Sugar Land, Texas 77498	
<i>Address of Inspected Property</i>	
Keaton Harris TREC# 25552	
<i>Name of Inspector</i>	<i>TREC License #</i>
<i>Name of Sponsor (if applicable)</i>	<i>TREC License #</i>

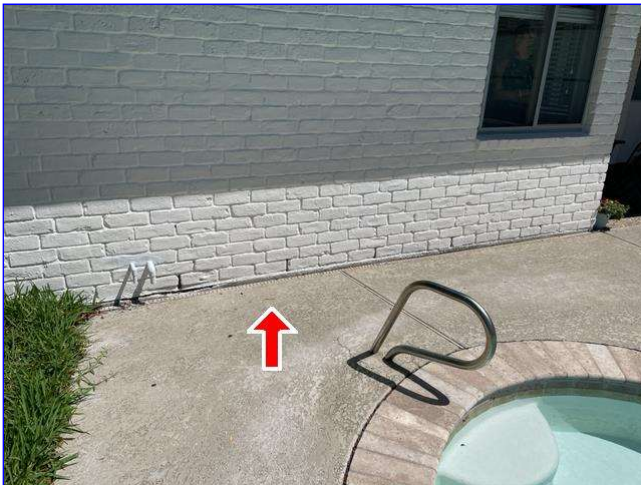
A. Item 2(Picture)

(4) Slab is obstructed from view at rear of house.

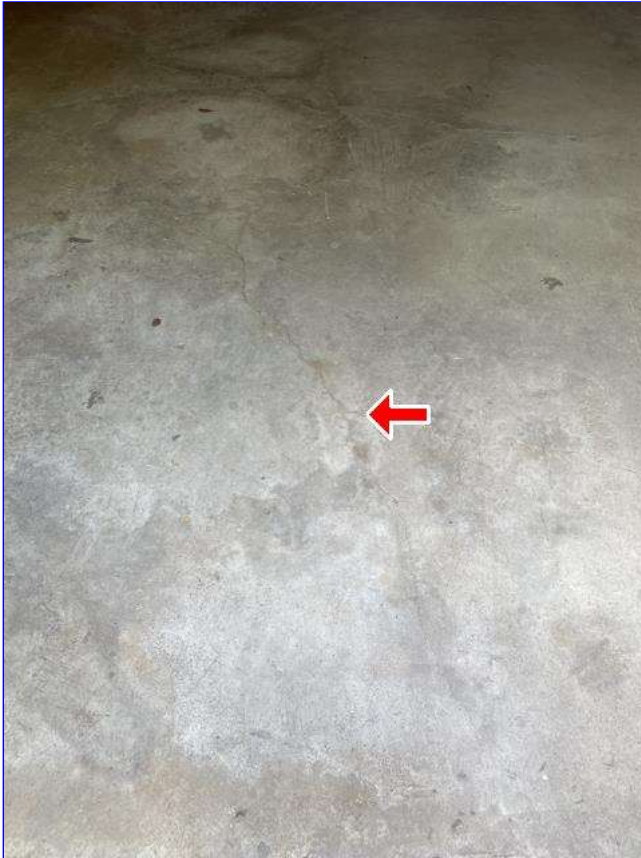
A. Item 3(Picture)

(5) Cracks in exposed concrete floors at garage

(6) Significant signs of structural movement noted; suggest that an expert in this field be consulted for further evaluation of the foundation and to provide suggestions as to what corrective actions should be taken.

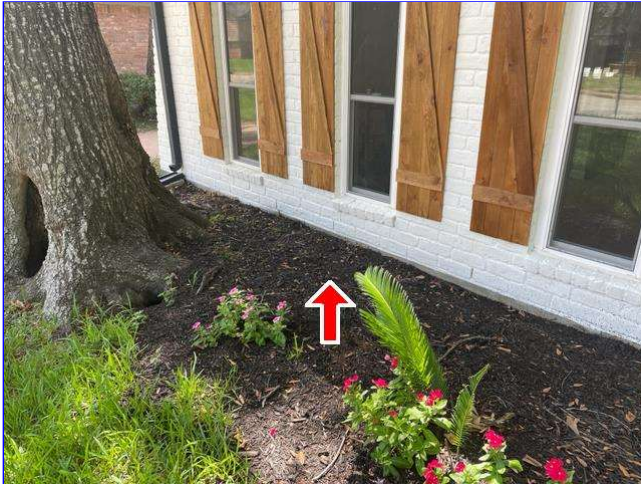
B. Item 1(Picture)

(2) High soil level observed at front and side of house.

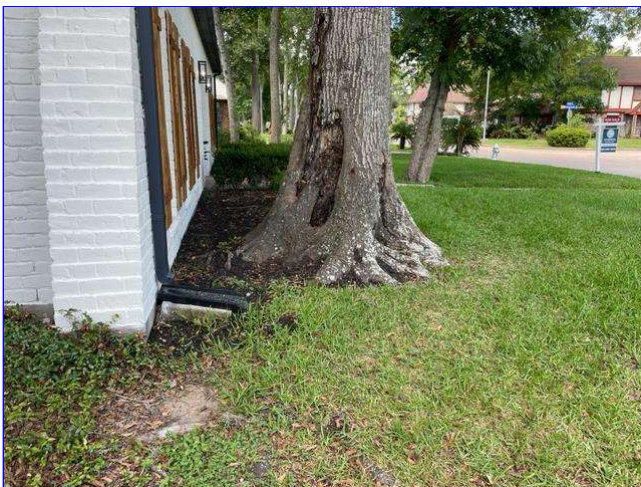
B. Item 3(Picture)

(3) Grading does not slope away from foundation 6" within the first 10'

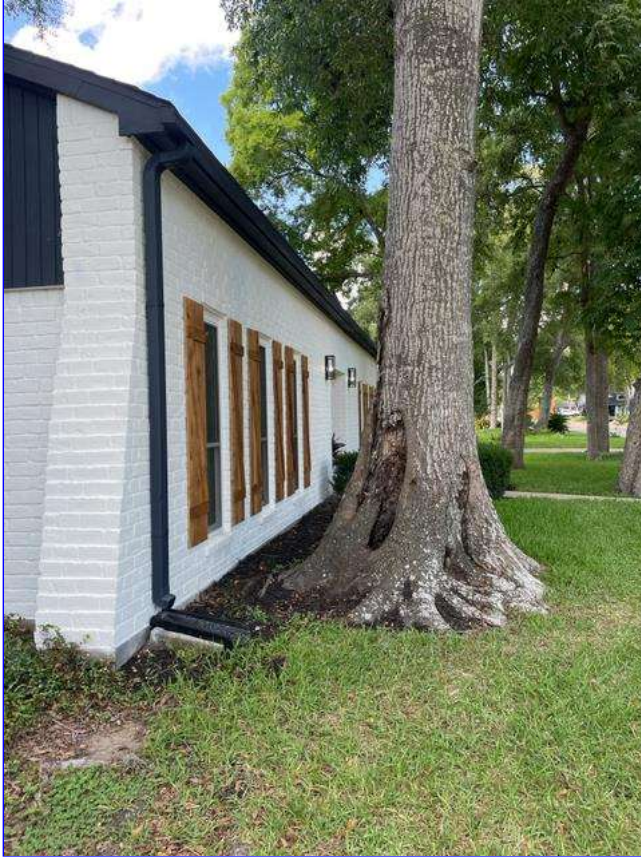
B. Item 4(Picture)

(4) Large tree close to foundation.

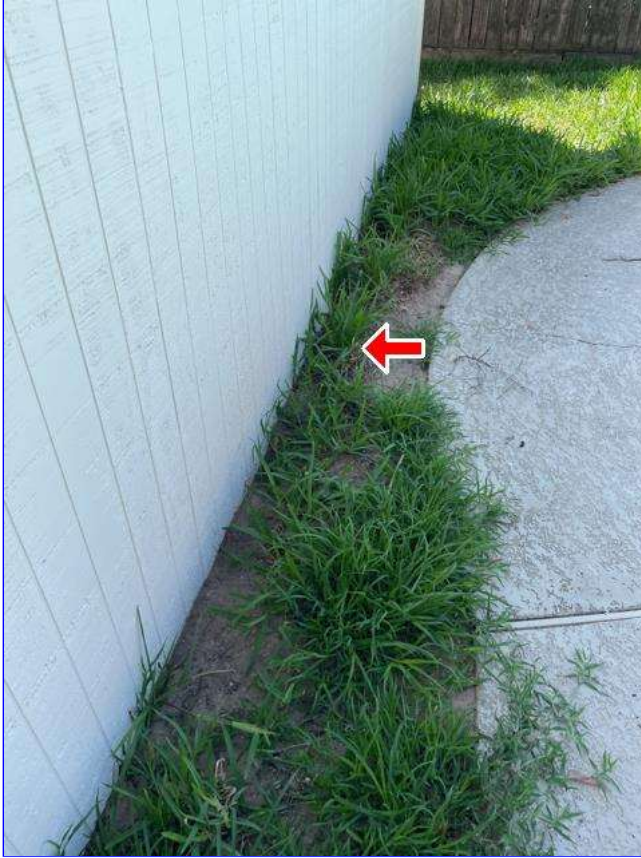
B. Item 5(Picture)

(5) Foundation lacks 6" exposure below siding/stucco.

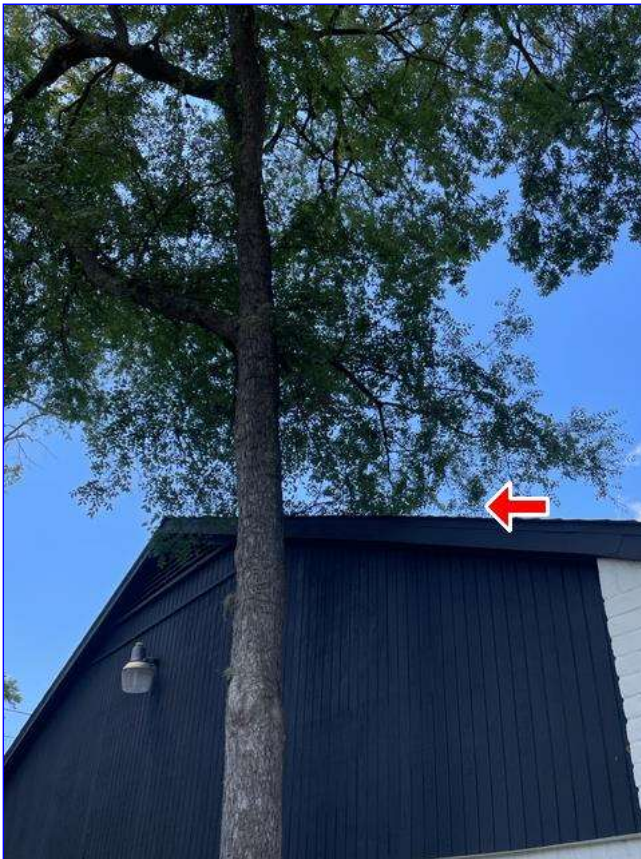
C. Item 2(Picture)

(2) Tree branches are too close and/or in contact with roof surface.

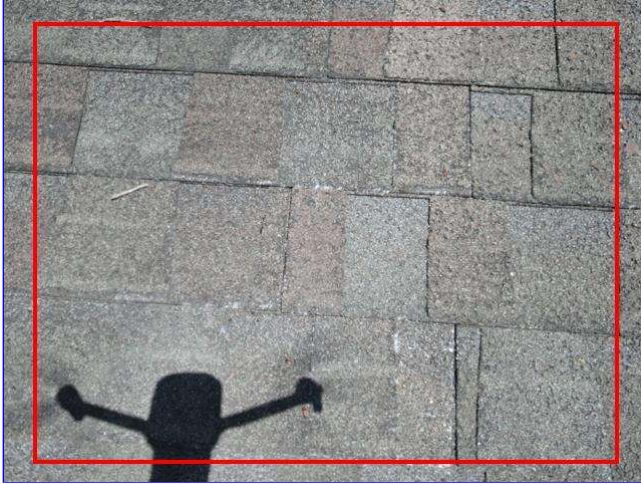
C. Item 3(Picture)

(3) Worn aggregate or gravel finish observed.

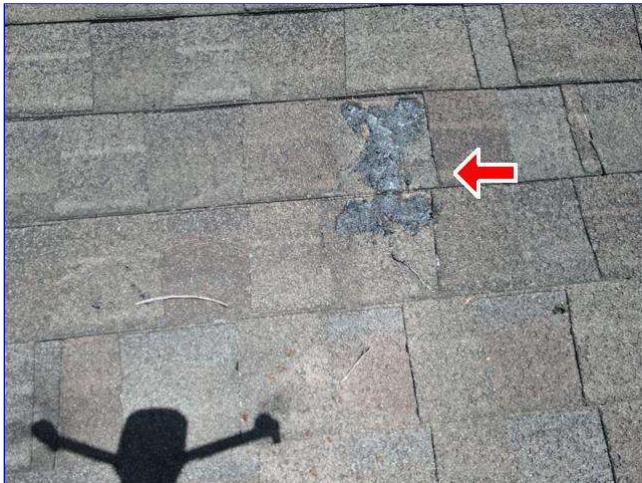
C. Item 5(Picture)

(4) Previous repairs to roof observed.

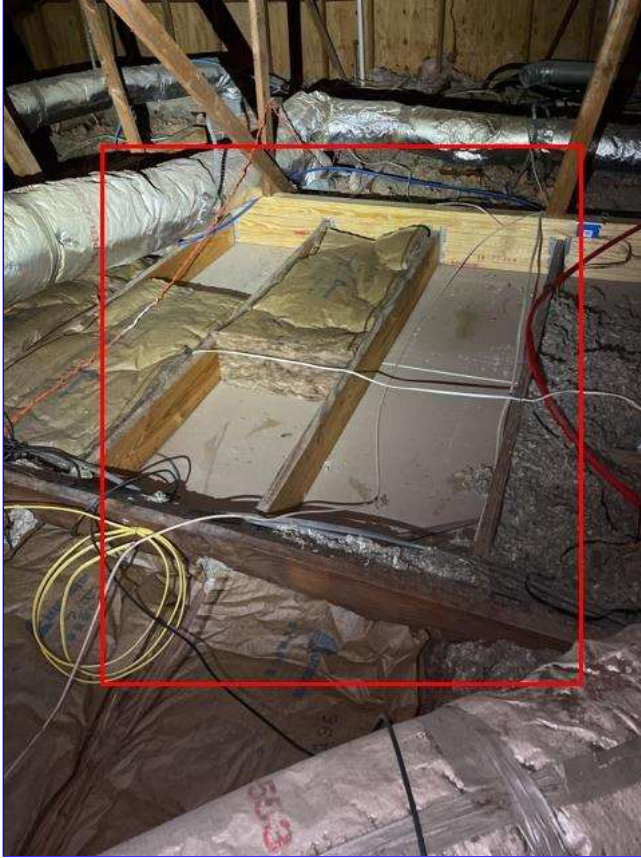
D. Item 1(Picture)

(2) Insulation is missing on attic floor.

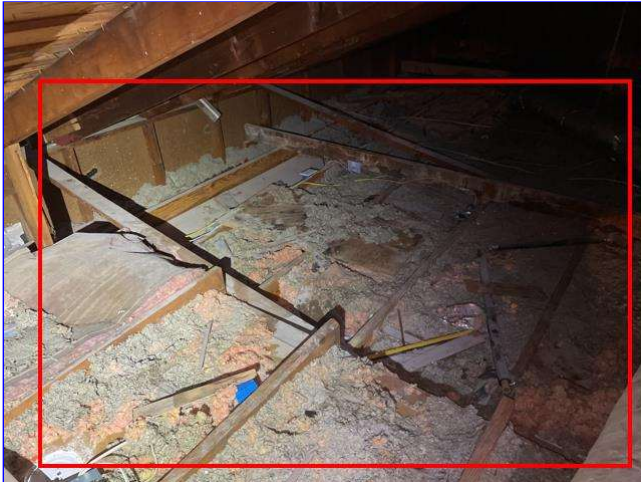
D. Item 3(Picture)

- (3) Attic insulation level is well below the recommended 8" for rockwool.
- (4) Attic insulation is not uniformly distributed on attic floor.

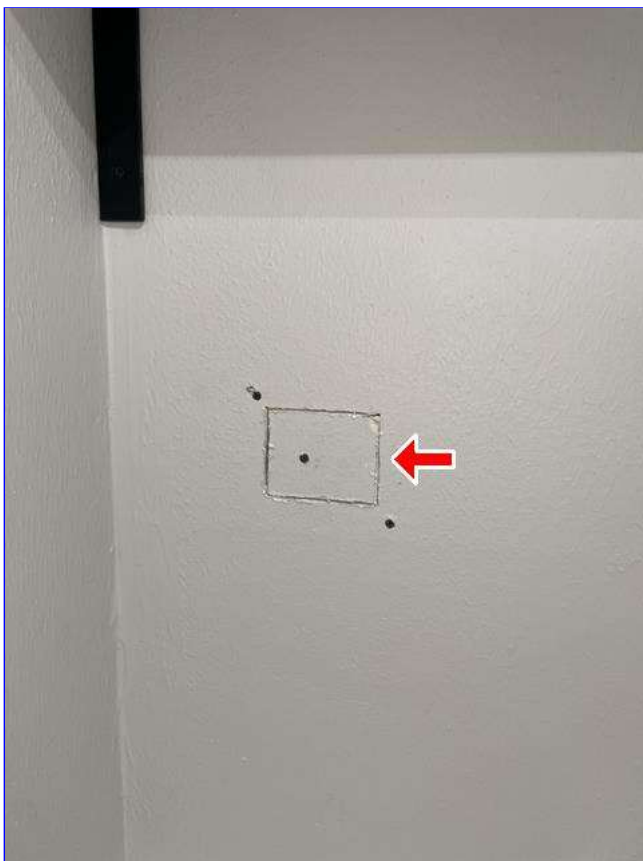
E. Item 1(Picture)

- (1) *The interior and exterior wall surfaces of the home were visually inspected from ground level. Interior walls were checked for sheet rock damage, cracking and signs of water penetration. Minor cosmetic flaws and deficiencies are not normally noted. Exterior walls were inspected for deteriorated wood, brick cracks, warping, levelness, proper flashing, caulking and proper installation of materials. Again, cosmetic deficiencies are not normally noted. The type of exterior wall material is listed below.*
- (2) Freshly painted walls previous repairs or deficiencies may not be observable.
- (3) Previously repaired sheetrock observed at pantry

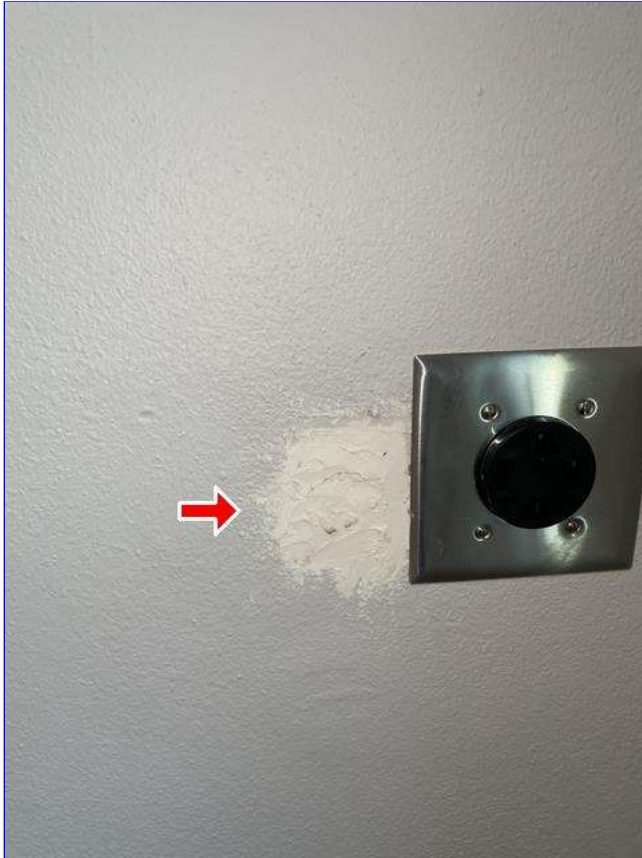
E. Item 2(Picture)

- (4) Previously repaired sheetrock observed at laundry room

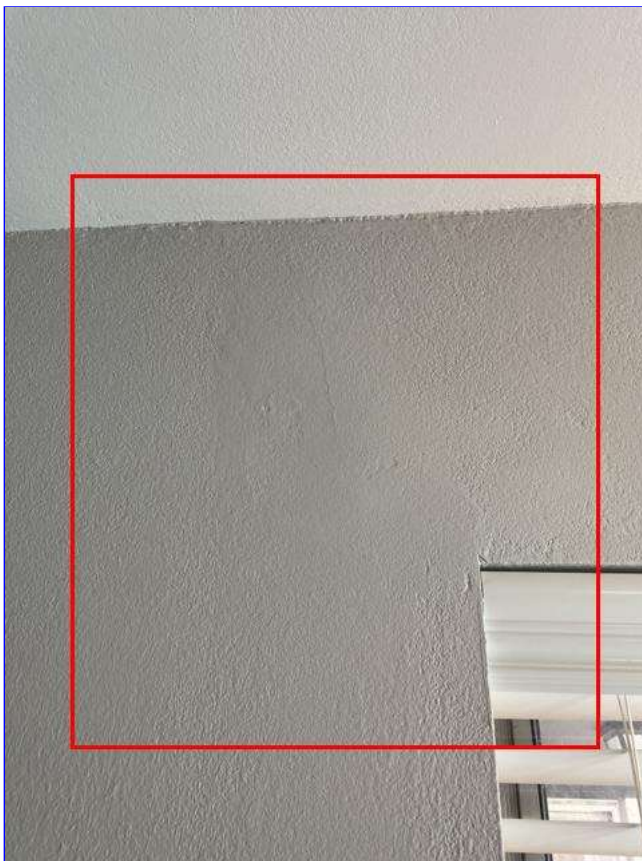
E. Item 4(Picture)

(5) Cracks in sheetrock observed at master bedroom.

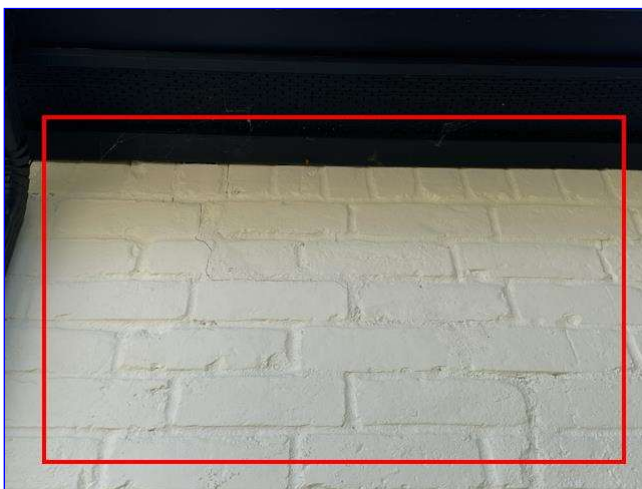
E. Item 5(Picture)

(6) Mortar is cracked and/or missing.

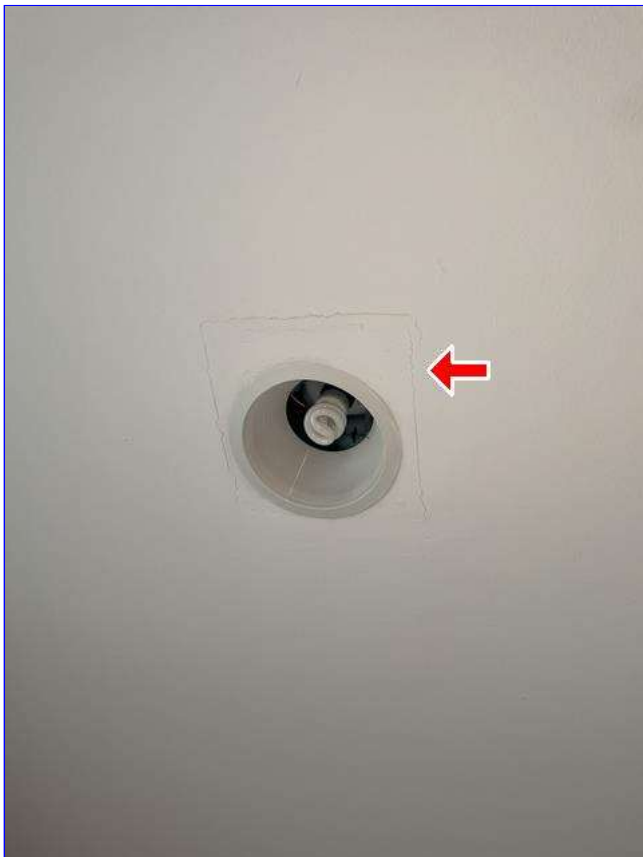
F. Item 1(Picture)

(3) Cracks in sheetrock observed at guest bath near light fixture.

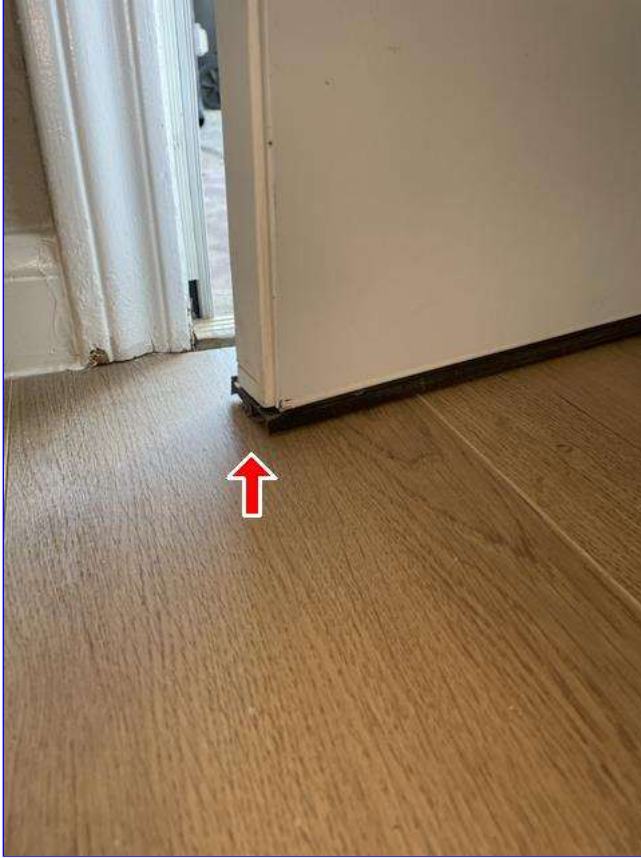
G. Item 2(Picture)

(3) Doors drag on flooring at back door.

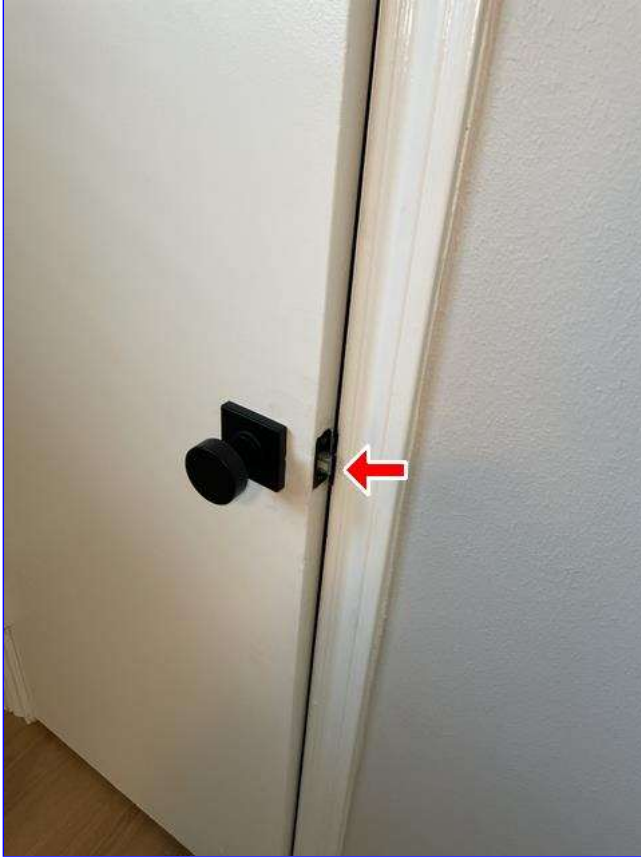
G. Item 3(Picture)

(4) Doors do not latch properly at guest bedroom closet

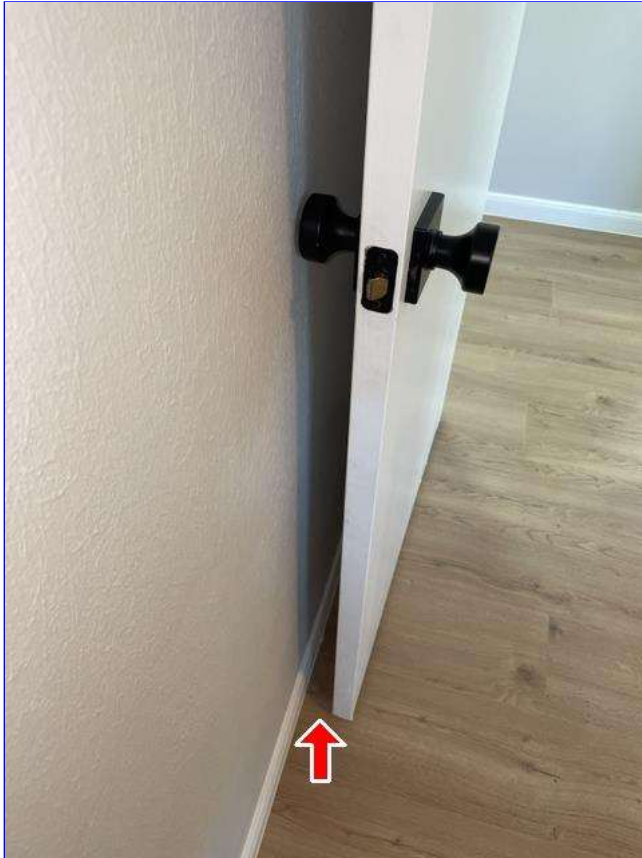
G. Item 4(Picture)

(5) Door stops are missing at multiple locations.

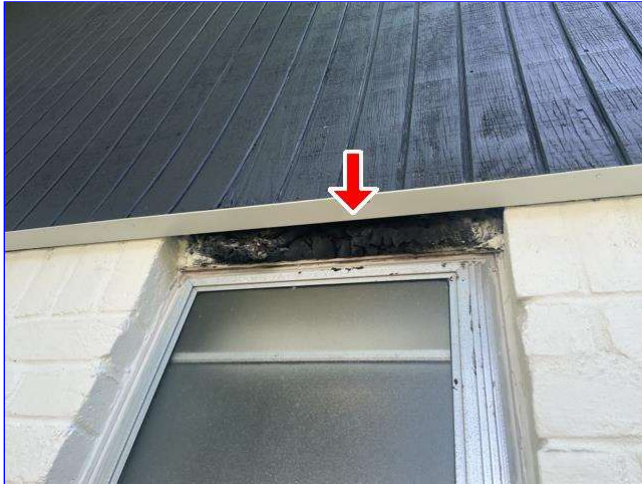
H. Item 1(Picture)

(2) Missing lintel at left side of house. Exterior not finished at this location.

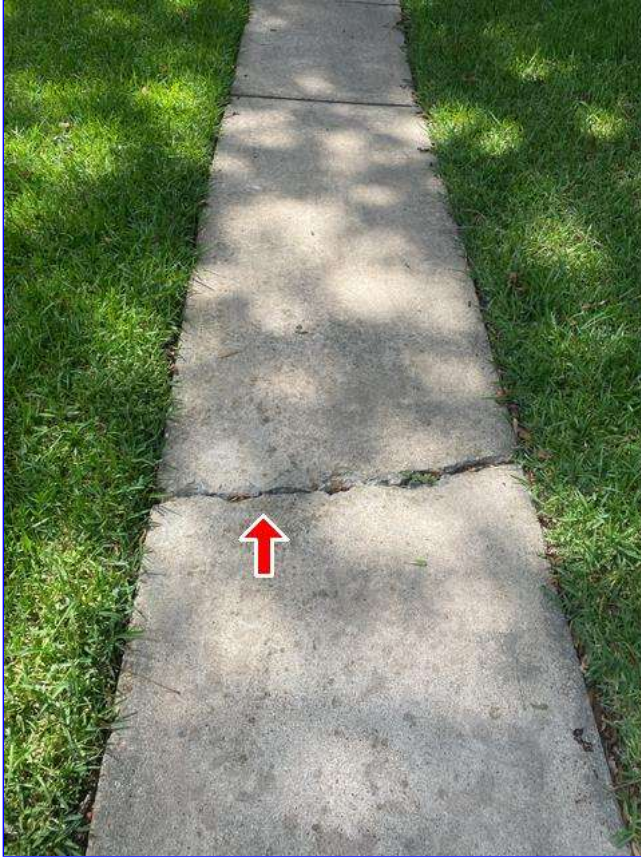
L. Item 1(Picture)

(1) Driveway or sidewalk is cracked at multiple locations

Cracks or separations in driveway or sidewalk exceed 1" in height or separations - This is considered a trip hazard

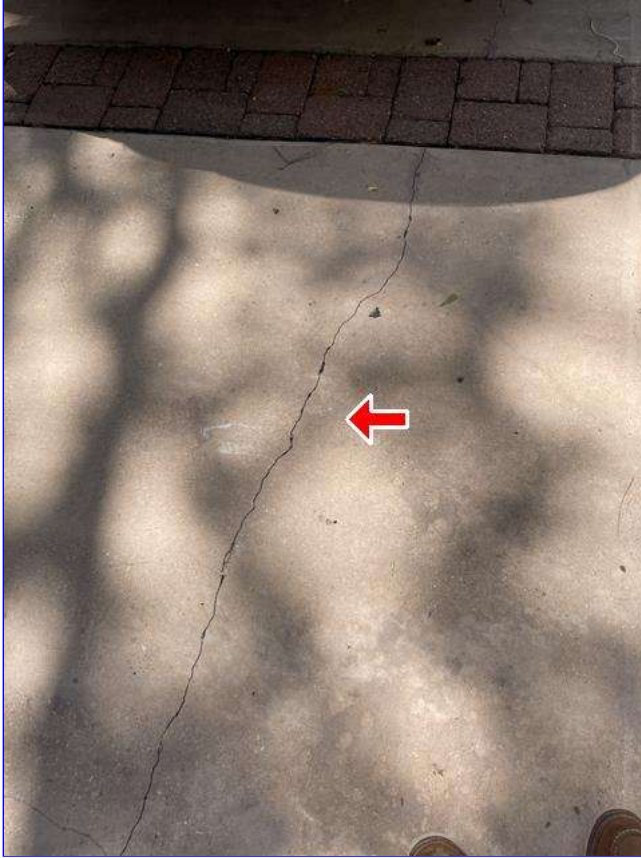
L. Item 3(Picture)

(2) Driveway or sidewalk is cracked at multiple locations

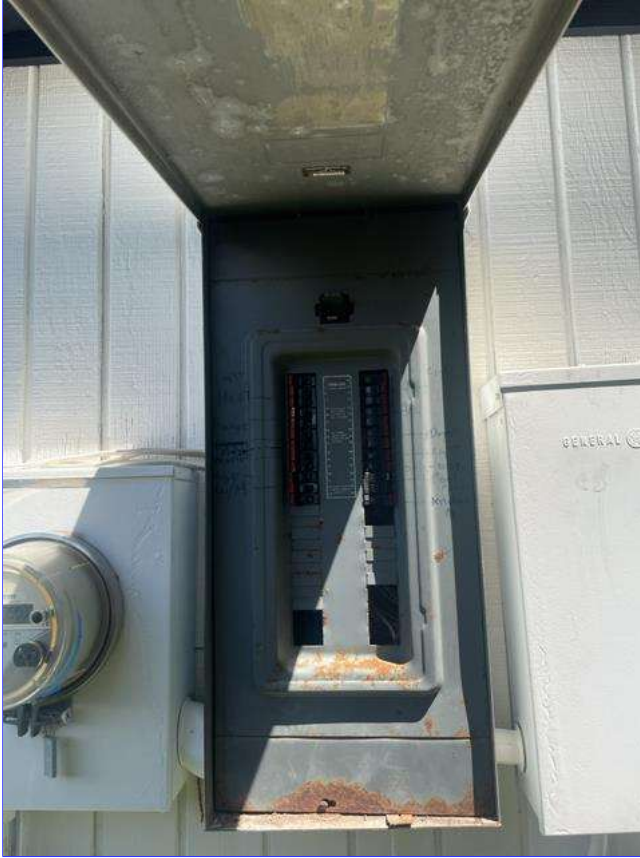
A. Item 3(Picture)

(2) Federal Pacific panels have a known history of electrical problems. Further evaluation recommended by a qualified electrical contractor

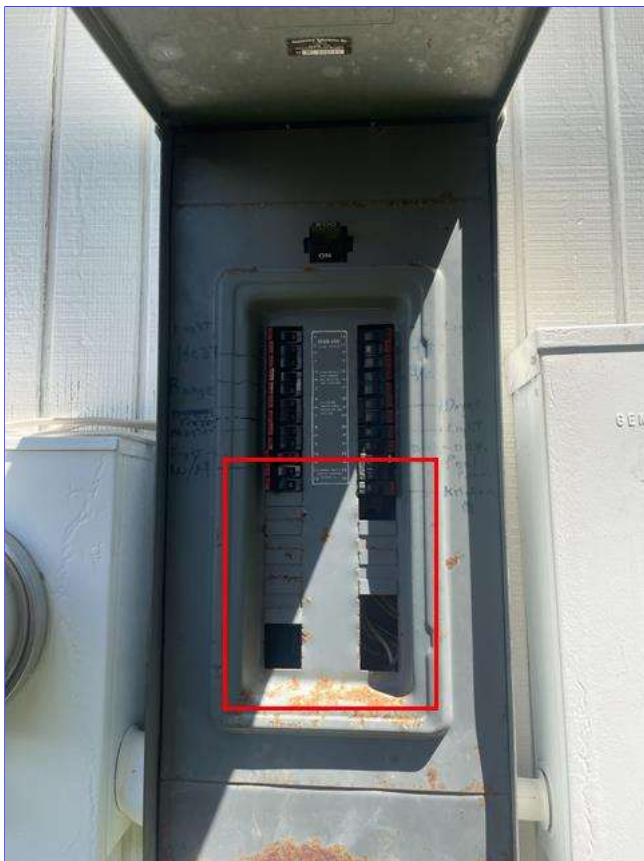
A. Item 4(Picture)

(3) Knockouts are missing

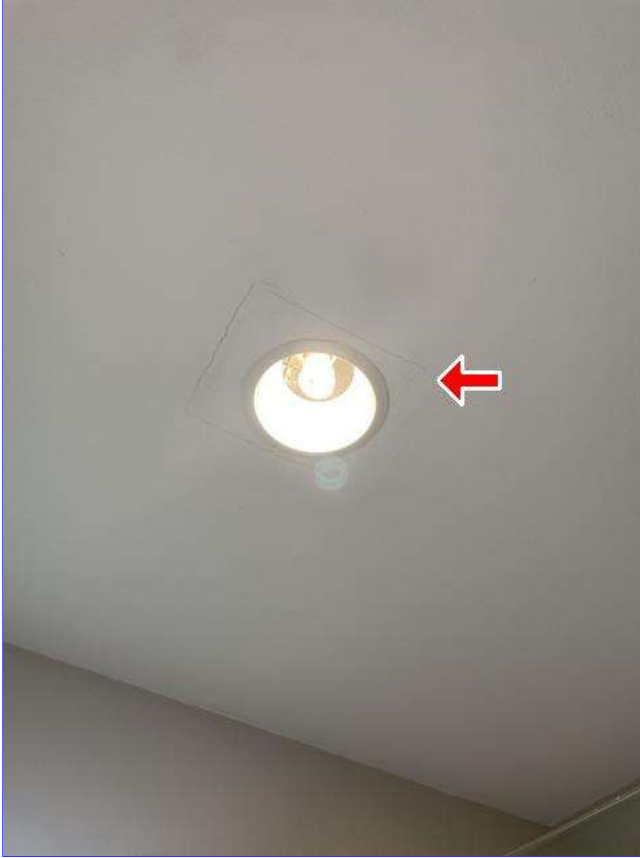
B. Item 1(Picture)

(2) Light fixture globes or covers are damaged / missing at guest bath.

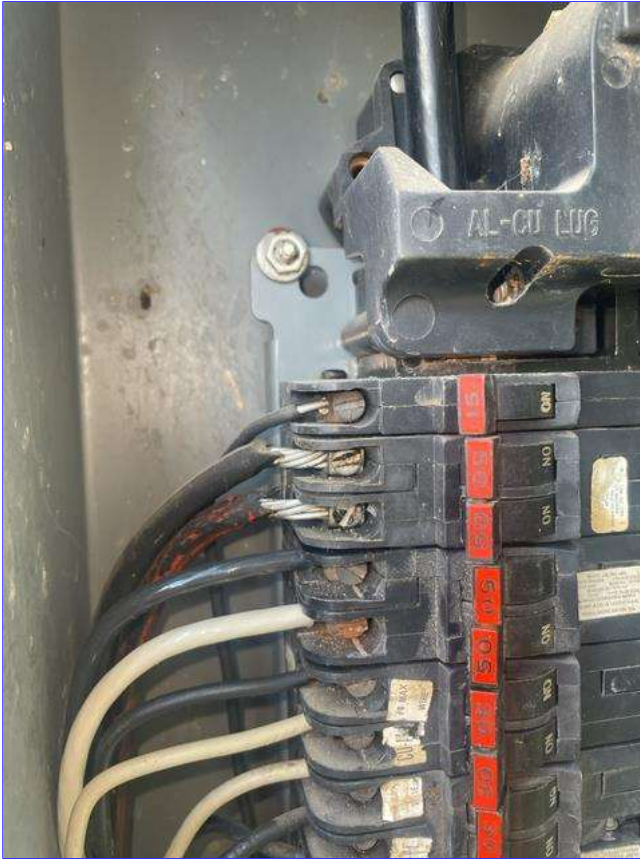
B. Item 2(Picture)

(3) Aluminum wiring was observed on branch circuits - Further evaluation recommended by a licensed electrician

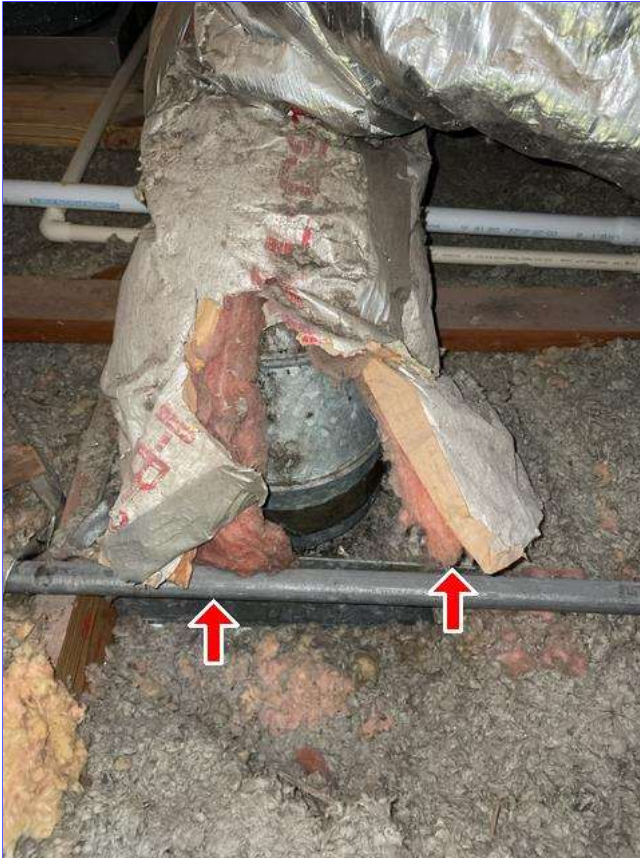
C. Item 1(Picture)

(2) Attic ducting is in poor condition or deteriorated

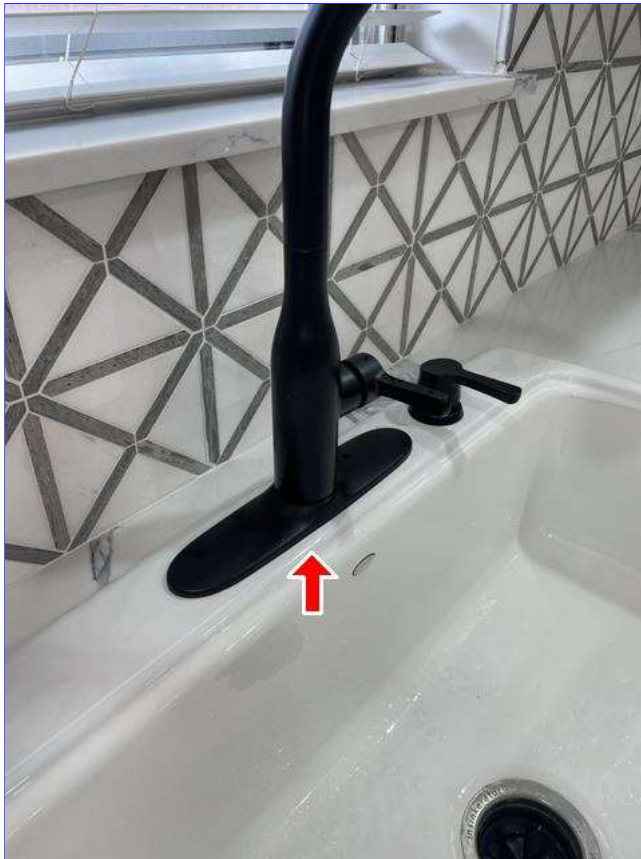
A. Item 1(Picture)

(2) Faucet is not securely mounted

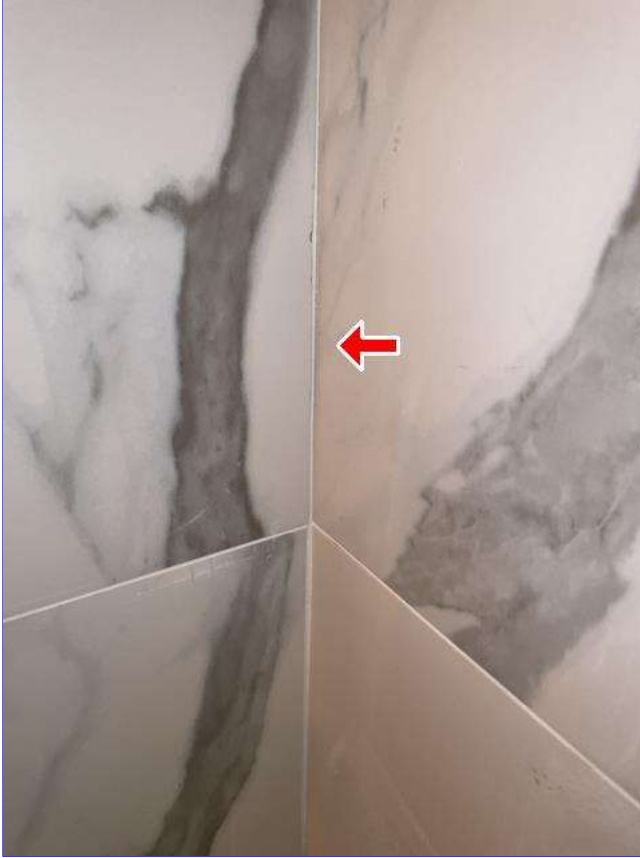
A. Item 2(Picture)

(3) Tub or shower requires caulking at corners of master bath.

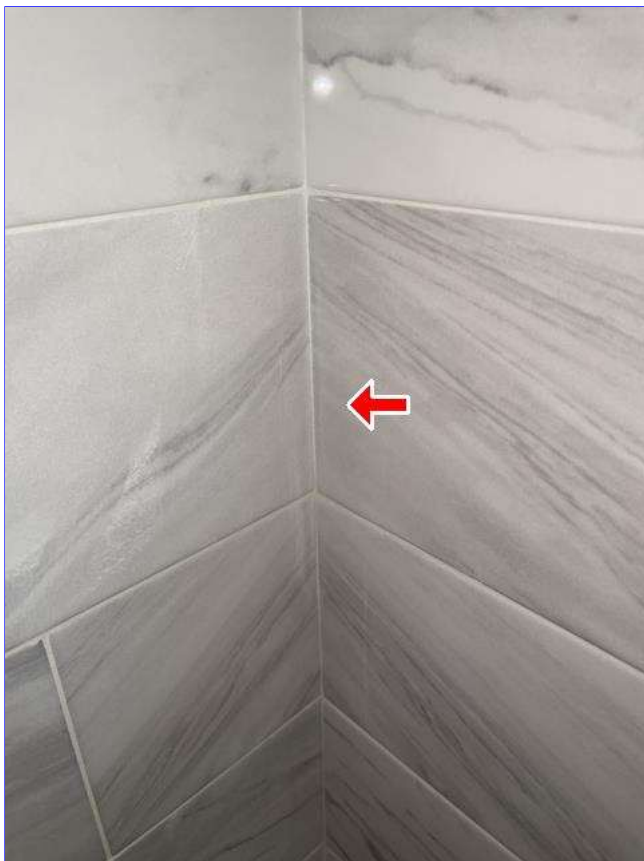
A. Item 3(Picture)

(4) Tub or shower requires caulking at corners of guest shower.

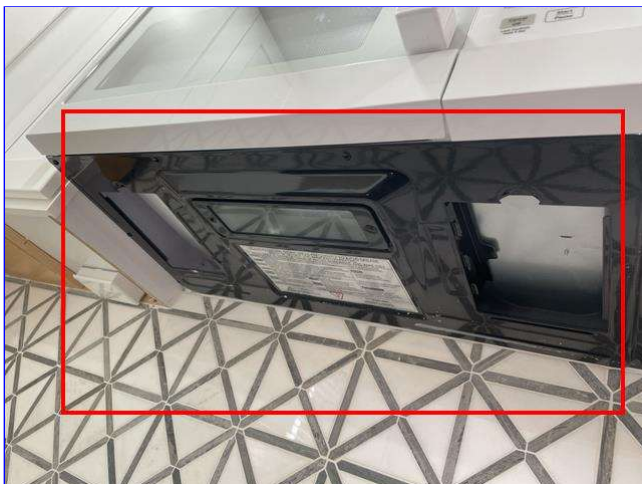
C. Item 1(Picture)

(2) Filter is missing
