THREE 17 INSPECTIONS REPORT

PROPERTY INSPECTION REPORT

Concerning: 24242 Palomino Sage Trl, Katy, TX 77493

By: Aaron Prager - TREC License #24240 01/29/2022 1:30 pm

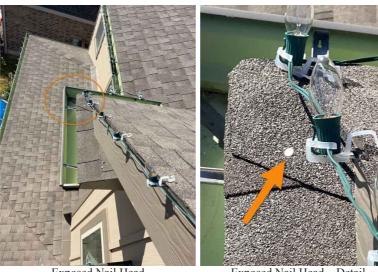
Exposed Nail Head

Nail heads were exposed in some areas. Exposed nail heads will rust over time and lose their fastening abilities, making the roof vulnerable to moisture penetration. They should be sealed to reduce the risk of

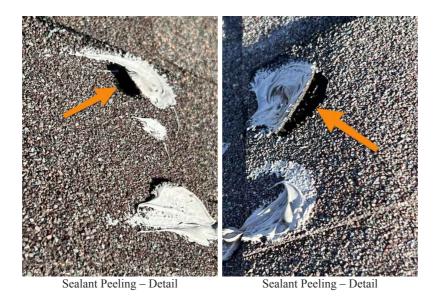
Sealant Peeling

The sealant used to seal the nail heads was found to be peeling away from the shingle exposing the nail head to weather. This can lead to degradation of the nail head and eventual leaks. Recommend correction.

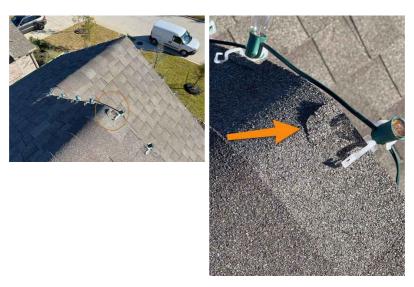
The roof had torn or split shingles. No signs of roof leakage were observed at these locations during the inspection. I recommend the sealing/repairing of any damaged shingles to avoid future problems.

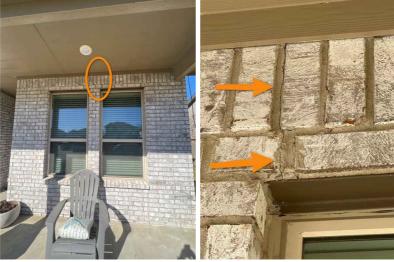
Minor Brick Crack

Minor cracks were observed at the brick veneer mortar joints on the exterior walls of the house. This implies that some settling or movement of the brick veneer wall has occurred, as is typical of most houses. Recommend sealing any brick cracks to prevent moisture entry, and monitoring of these areas for any growth or changes.

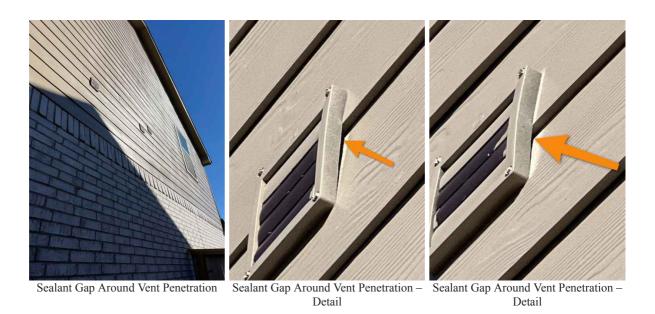
Sealant Gap Around Vent Penetration

Exterior wall penetrations had gaps that should to be sealed with an appropriate sealant to prevent moisture and insect entry.

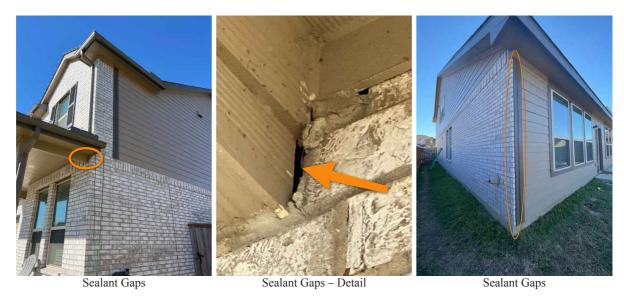
Exterior trim joints had opened at corners and splices in areas around the home. Repair where needed and caulk/sealant is recommended to help prevent moisture intrusion into the structure.

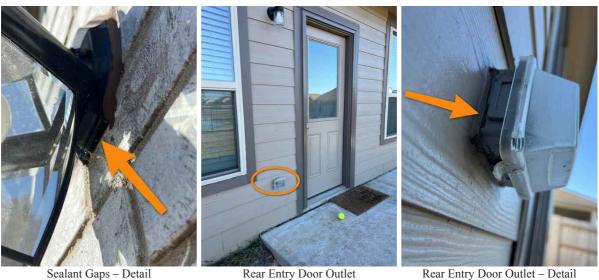
Sealant Gaps

Sealant was missing at several electrical penetrations. Improvement is recommended to prevent moisture entry and to increase energy efficiency.

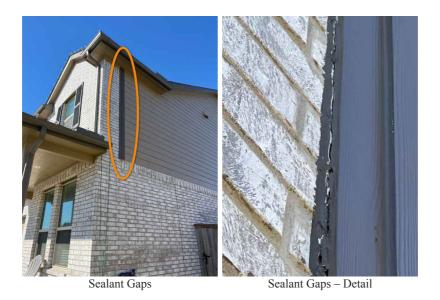
The sealant between some of the wooden trim pieces (brick mold, etc.) and the brick was missing/deteriorated. I recommend sealing any openings the exterior wall to prevent insect/vermin entry.

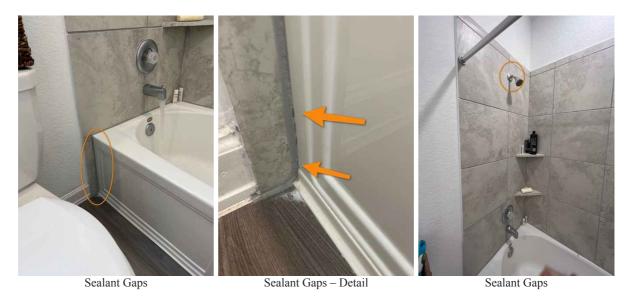
The sealant between the tub and the wall was missing/deteriorated in some places. I recommend removing any old/deteriorated sealant and applying new elastomeric sealant to prevent water entry into the wall cavity.

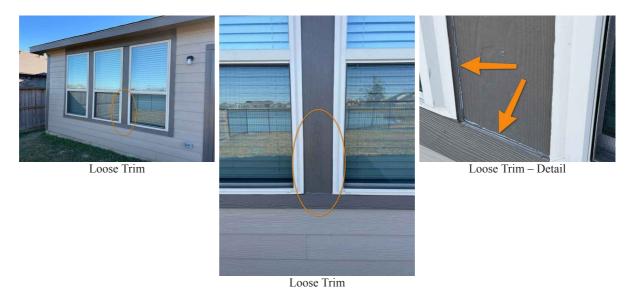
A section of trim appeared to be slightly loose creating gaps in the joint sealant. Recommend re-securing this location and applying new sealant to maintain a water-tight seal.

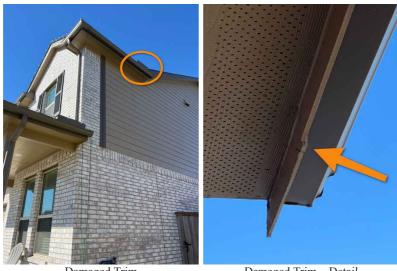
Damaged Trim

Some of the exterior trim was damaged and susceptible to moisture entry. Recommend repair.

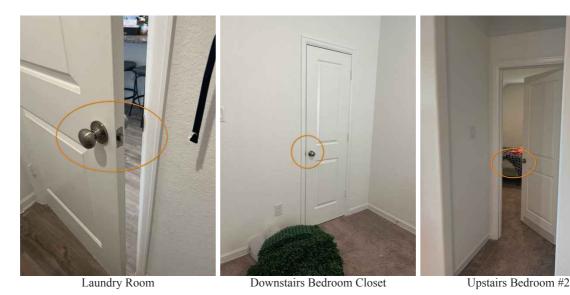
The latches on some of the doorknobs did not align with the hole in the strike plate and did not hold the door closed. This door will need adjustment to operate properly.

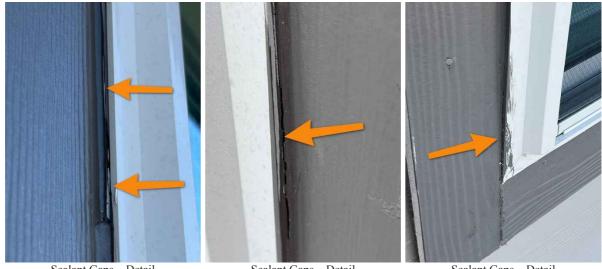
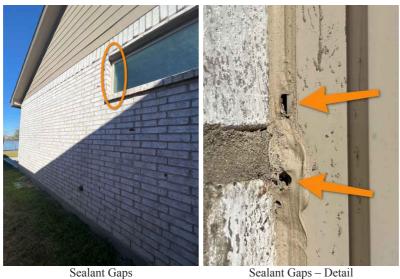
Some of the windows had missing or separated sealant between the window frame and the siding and/or brick. Sealant will shrink over time and any open spaces between the window frames and the siding and/or brick should be re-sealed with an elastomeric caulk to prevent water entry and improve energy efficiency.

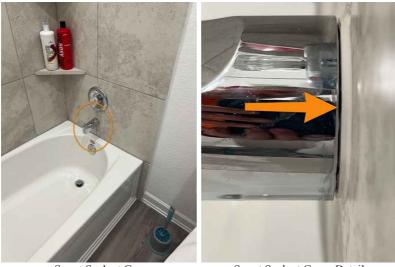
Spout Sealant Gap

The tub spout was not sealed completely up against the shower wall and a gap was observed, which could allow water to enter the wall cavity. Recommend resealing this gap.

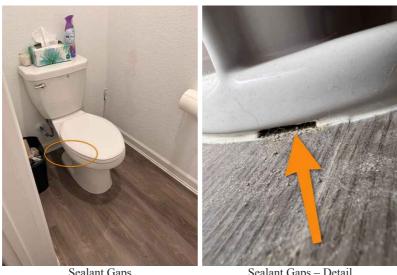
Sealant Gaps

The base of the commode should be sealed to floor to prevent the escape of sewer gases.
