Lone Star Stucco, LLC

Moisture Assessment Report

1607 W 24th Street, Unit B

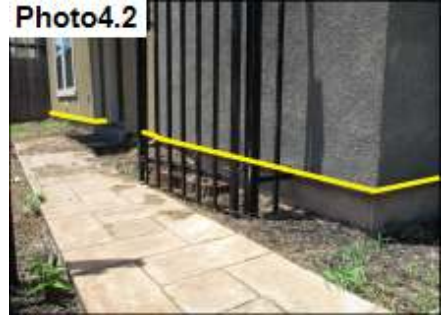
Photo4.2

Proper Grade Termination with Weep Screed/ Positive Detail

Grid Location	Item Description	Moisture Readings	Substrate Condition	Observations
Yellow Lines	Grade Termination			Stucco appears to be typically detailed at grade for the time of this construction. The inspector suggests that this is a positive detail and recommends no modification at this time but to always keep soil away from the structure. Please refer to photos #4.2, #4.3, #4.4, #4.5 and #4.6 for more detail.

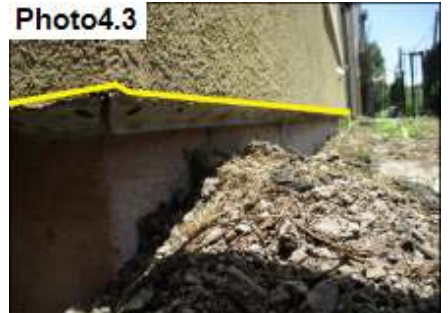
Photo4.3

Proper Grade Termination with Weep Screed/ Positive Detail

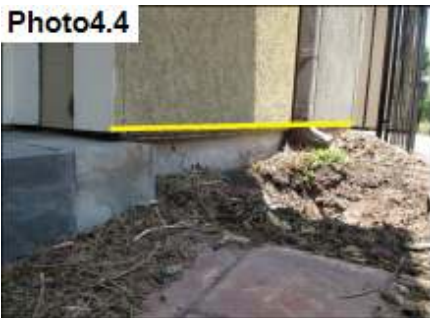
Photo4.4

Proper Grade Termination with Weep Screed/ Positive Detail

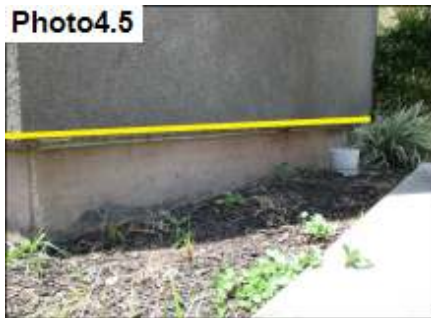
Photo4.5

Proper Grade Termination with Weep Screed/ Positive Detail

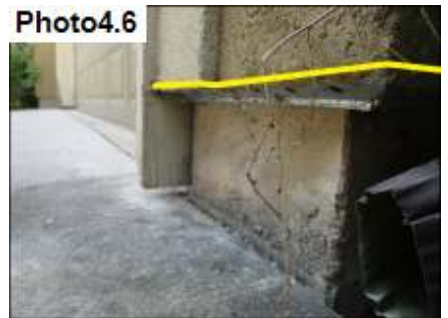
Photo4.6

Proper Grade Termination with Weep Screed/ Positive Detail

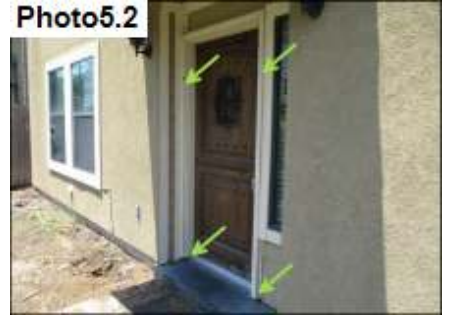
Photo5.2

Door Sealants / Seal

Grid Location	Item Description	Moisture Readings	Substrate Condition	Observations
Green Arrows	Doors			The door trim and miter sealants are aged, separated or missing at this location. The inspector suggests to have a qualified waterproofing contractor seal this area with a low modulus sealant in an effort to prevent moisture intrusion. These types of sealants are of high quality and compatible with stucco and other termination points. Please refer to photos #5.2, #5.3, #5.4, #5.5 and #5.6 for more detail.

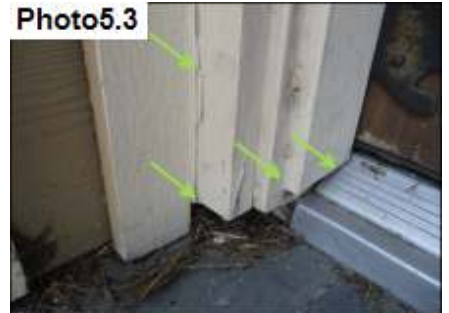
Photo5.3

Door Sealants / Seal

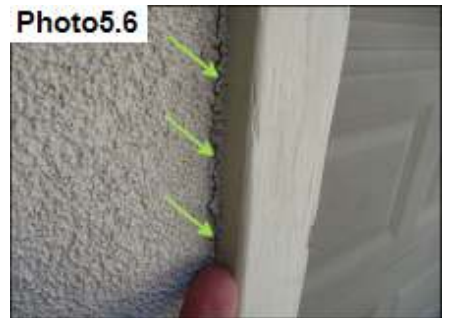
Photo5.6

Door Sealants / Seal

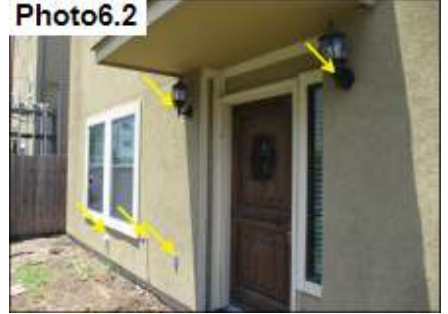
Photo6.2

Penetration Sealants / Seal

Grid Location	Item Description	Moisture Readings	Substrate Condition	Observations
Yellow Arrows	Penetrations			The penetration sealants are aged, separated or missing in these locations. The inspector suggests to have a qualified waterproofing contractor seal these areas with a low modulus sealant in an effort to prevent moisture intrusion. These types of sealants are of high quality and compatible with stucco and other termination points. Please refer to photos #6.2, #6.3, #6.4, #6.5 and #6.6 for more detail.

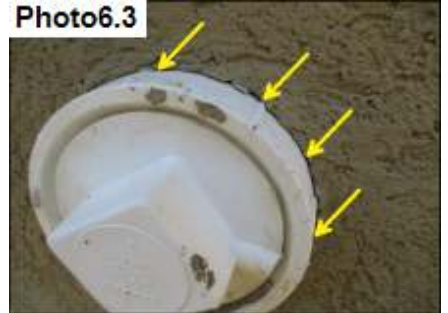
Photo6.3

Penetration Sealants / Seal

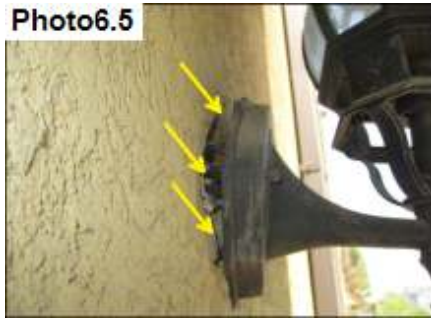
Photo6.5

Penetration Sealants / Seal

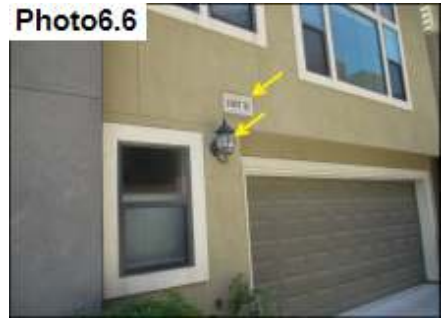
Photo6.6

Penetration Sealants / Seal

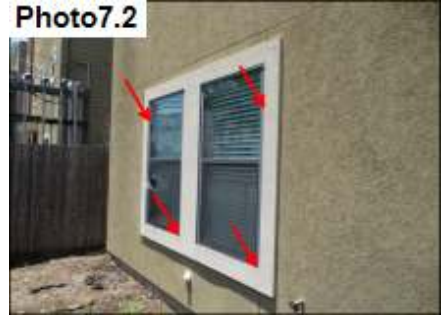
Photo7.2

Window Sealants / Seal

Grid Location	Item Description	Moisture Readings	Substrate Condition	Observations
Red Arrows	Windows			The window sealants are aged or separated. The inspector suggests to have a qualified waterproofing contractor further assess and seal this area with a low modulus sealant in an effort to prevent moisture intrusion. These types of sealants are of high quality and compatible with stucco and other termination points. Please refer to photos #7.2, #7.3, #7.4, #7.5, #7.6, #8.1, #8.2, #8.3 and #8.4 for more detail.

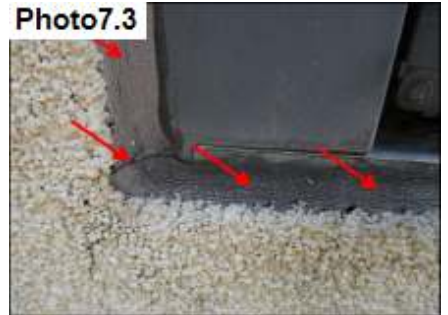
Photo7.3

Window Sealants / Seal

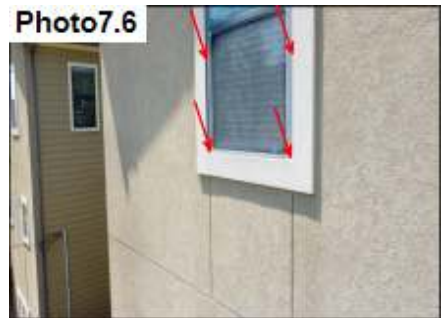
Photo7.6

Window Sealants / Seal

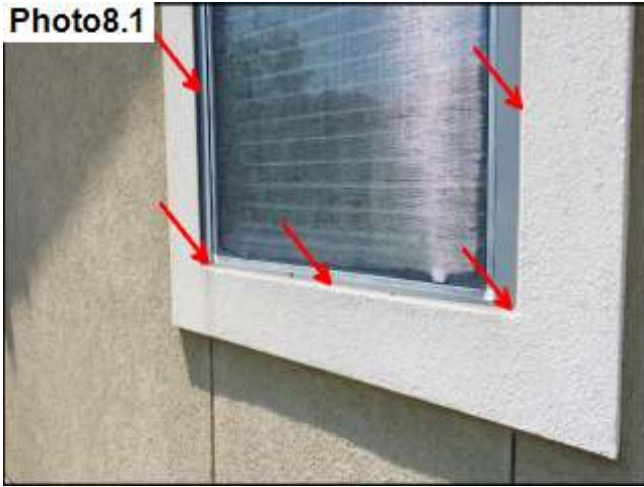
Photo8.1

Window Sealants / Seal

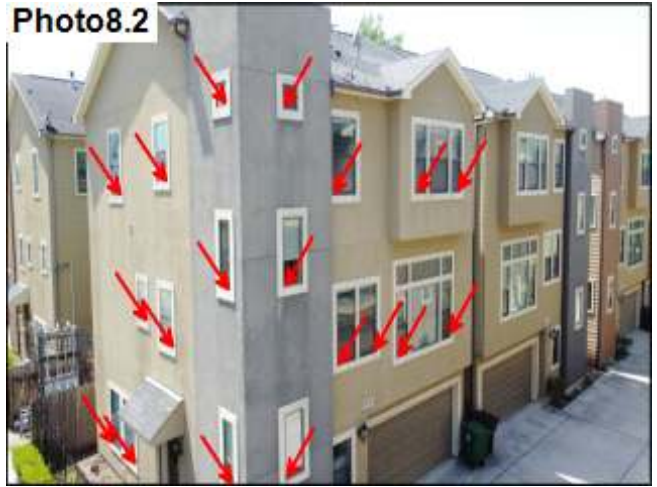
Photo8.2

Window Sealants / Seal

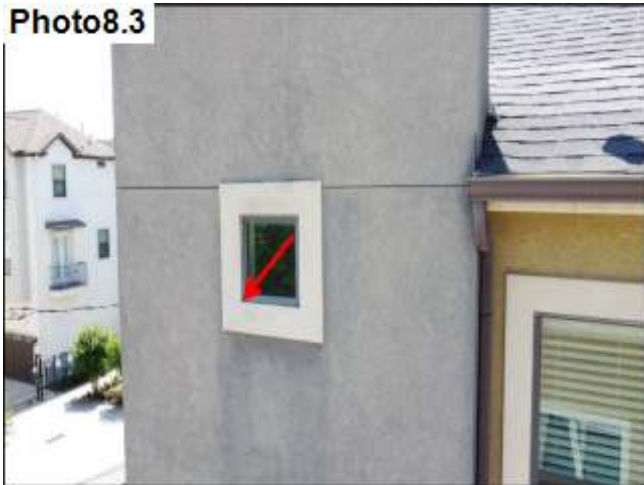
Photo8.3

Window Sealants / Seal

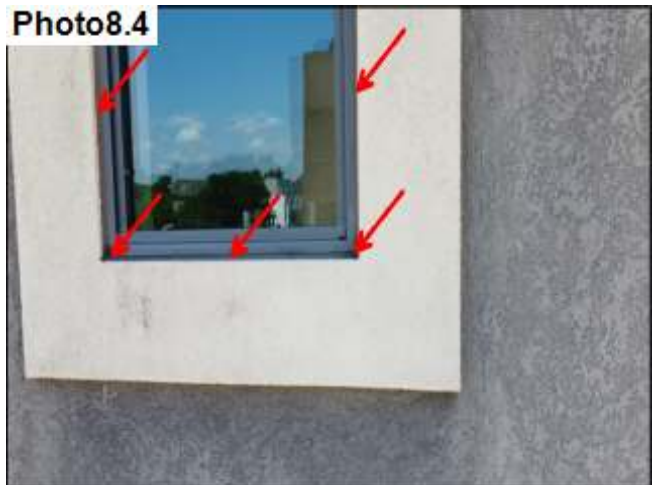
Photo8.4

Window Sealants / Seal

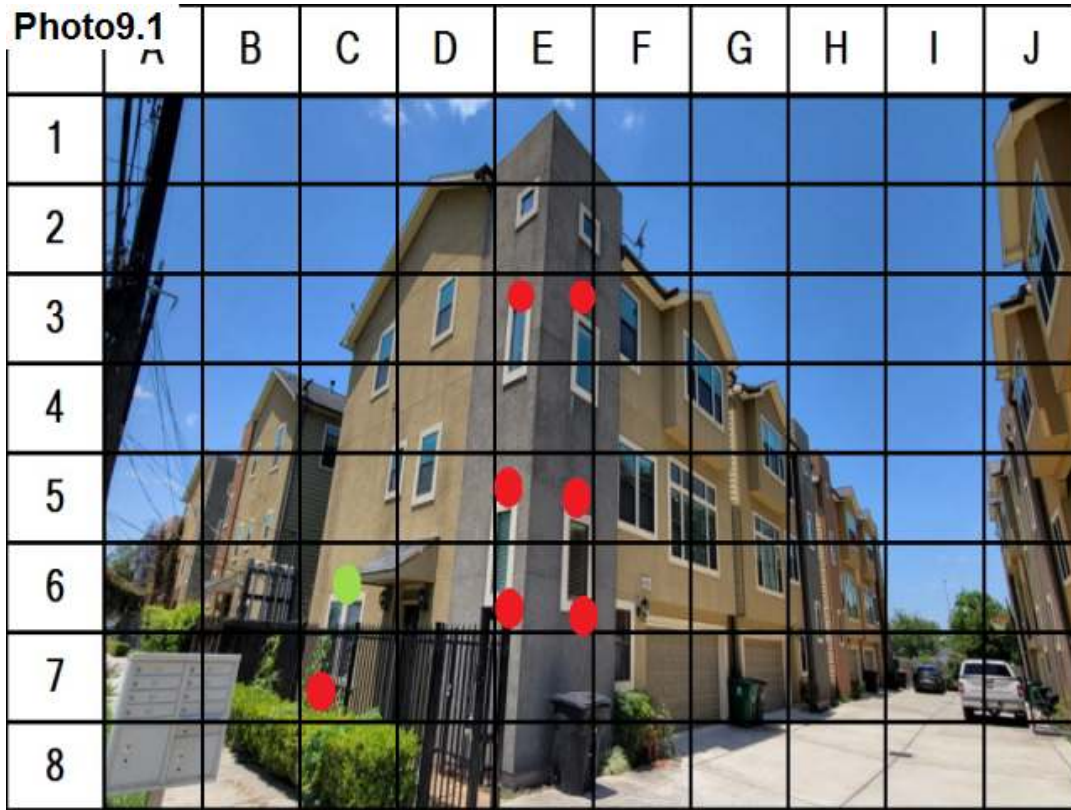
Grid Location	Item Description	Moisture Readings	Substrate Condition	Observations
C7	Window Lower Left	20%	Firm	A moisture probe was taken at the window lower left. An elevated moisture reading was noted with a firm substrate.
C6	Window Header	16%	Firm	A moisture probe was taken at window header. The substrate was firm with no damage noted at this time.
E6	Window Lower Right		None	A moisture probe was taken at the window lower right. No substrate was noted at this time, modify as needed.
E6	Window Lower Right	22%	Semi-Firm	A moisture probe was taken at the window lower right. An elevated moisture reading was noted with a semi-firm substrate.
E5	Window Lower Right	22%	Firm	A moisture probe was taken at the window header. An elevated moisture reading was noted with a semi-firm substrate.
E5	Window Header		None	A moisture probe was taken at the window header. No substrate was noted at this time, modify as needed.

E2 Left	Window Header	22%	Semi-Firm	A moisture probe was taken at the window header. An elevated moisture reading was noted with a semi-firm substrate.
E3 Right	Window Header	23%	Semi-Firm	A moisture probe was taken at the window header. An elevated moisture reading was noted with a semi-firm substrate.

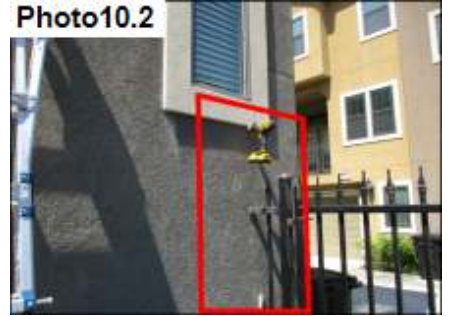
Photo10.2

Substrate Damage / Assess & Repair

Grid Location	Item Description	Moisture Readings	Substrate Condition	Observations
Red Boxes	Damage			Confirmed substrate and potential frame damage is noted at these locations. The inspector suggests to have a qualified waterproofing contractor further assess the extent of damage and repair as needed in an effort to prevent moisture intrusion. Please refer to photos #10.2, #10.3, #10.4, #10.5 and #10.6 for more detail.

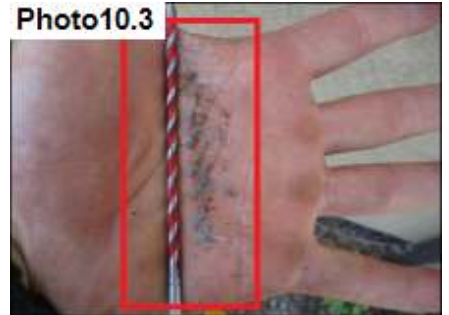
Photo10.3

Substrate Damage / Assess & Repair

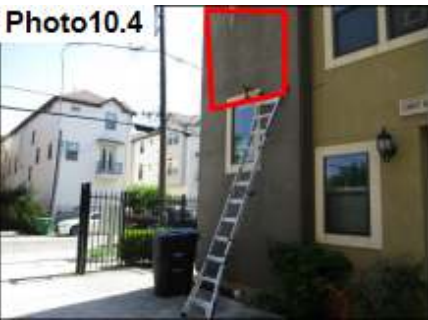
Photo10.4

Substrate Damage / Assess & Repair

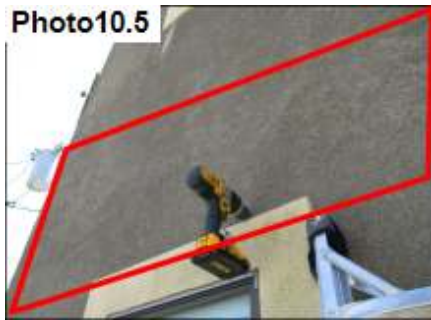
Photo10.5

Substrate Damage / Assess & Repair

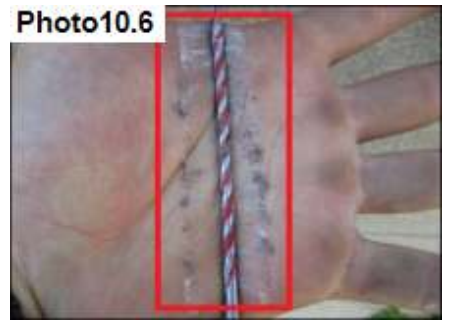
Photo10.6

Substrate Damage / Assess & Repair

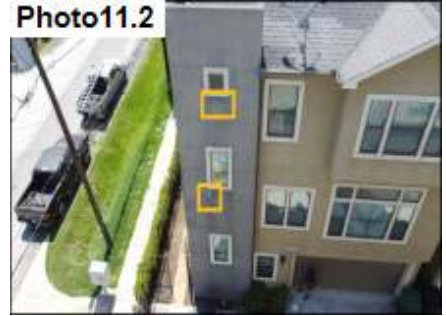
Photo11.2

Efflorescence / Clean as Needed

Grid Location	Item Description	Moisture Readings	Substrate Condition	Observations
Orange Boxes	Efflorescence			Efflorescence has been noted in these areas of the home. This is when a naturally occurring salt migrates to the surface of the system causing a coating. The inspector suggests to consult with a qualified stucco contractor to treat these areas with commercial cleaners or contact the system manufacturer for the best explanation of removal. Please refer to photos #11.2, #11.3, #11.4, #11.5 and #11.6 for more detail.

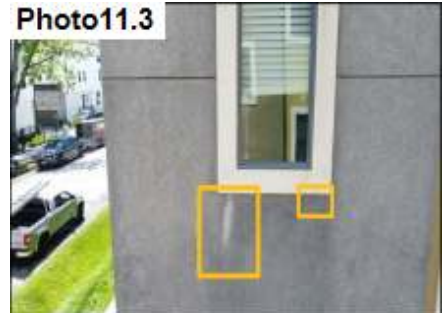
Photo11.3

Efflorescence / Clean as Needed

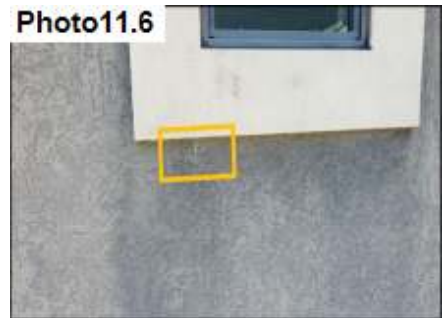
Photo11.6

Efflorescence / Clean as Needed

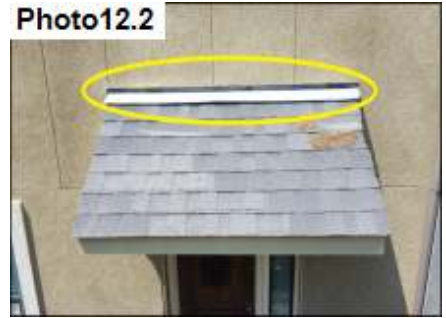
Roof Flashing / Seal

Grid Location	Item Description	Moisture Readings	Substrate Condition	Observations
Yellow Circle	Roof Flashing			The roof flashing sealants are aged at this location. The inspector suggests to have a qualified waterproofing contractor further assess and seal this area with a low modulus sealant in an effort to prevent moisture intrusion. These types of sealants are of high quality and compatible with stucco and other termination points. Please refer to photos #12.2, #12.3, #12.4, #12.5 and #12.6 for more detail.
C6	Below Roof Flashing	12%	Firm	A moisture probe was taken below the roof flashing. The substrate was firm with no damage noted at this time.
D6	Below Roof Flashing	14%	Firm	A moisture probe was taken below the roof flashing. The substrate was firm with no damage noted at this time.

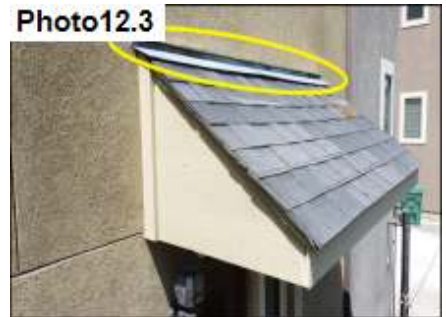
Roof Flashing / Seal

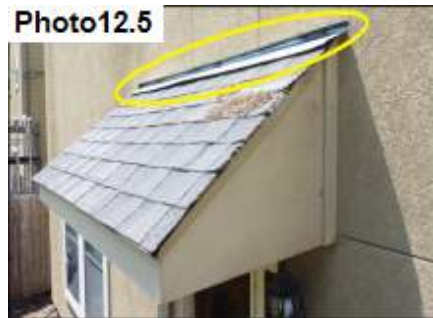
Roof Flashing / Seal

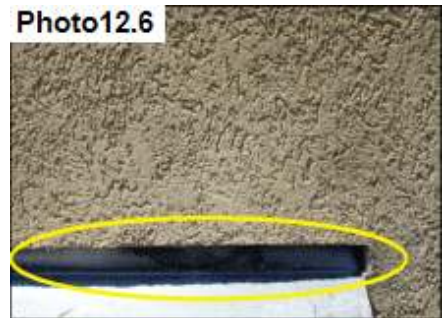
Roof Flashing / Seal

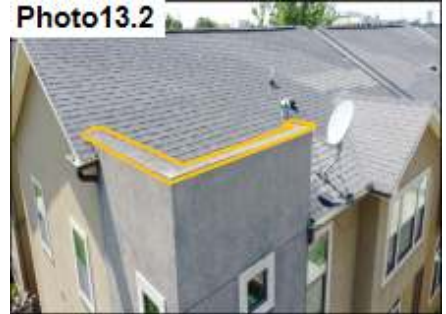
Photo13.2

Missing Metal Cap / Install

Grid Location	Item Description	Moisture Readings	Substrate Condition	Observations
Orange Lines	Missing Metal Cap			A metal cap is missing at the parapet wall allowing moisture to penetrate the system at this location. The inspector suggests having a qualified waterproofing contractor further assess and install proper a metal cap with a minimum of a 3" overlap of the stucco, then seal in an effort to prevent moisture intrusion. Please refer to photos #13.2, #13.3, #13.4, #13.5 and #13.6 for more detail.

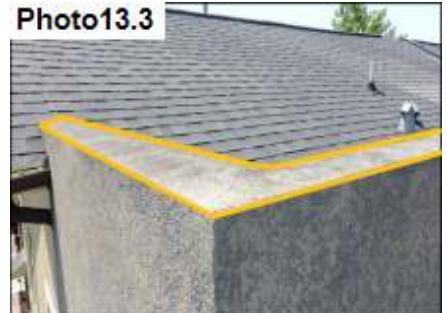
Photo13.3

Missing Metal Cap / Install

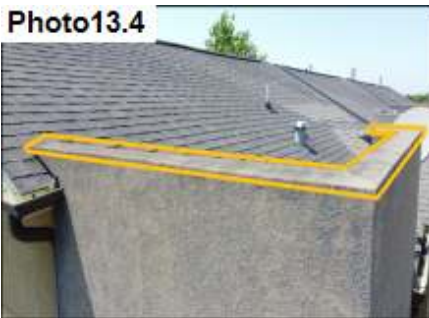
Photo13.4

Missing Metal Cap / Install

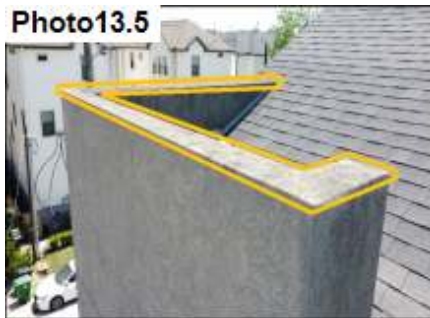
Photo13.5

Missing Metal Cap / Install

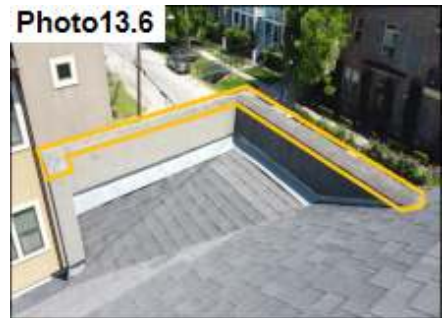
Photo13.6

Missing Metal Cap / Install

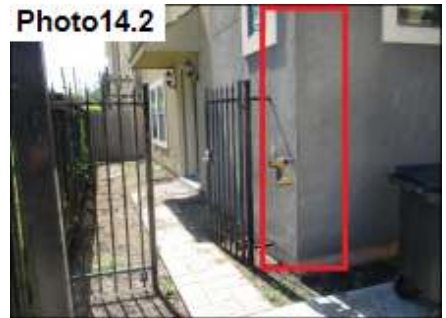
Substrate Damage / Assess & Repair

Grid Location	Item Description	Moisture Readings	Substrate Condition	Observations
Red Box	Damage			Confirmed substrate and potential frame damage is noted on the outside corner wall below the failing parapet wall. The inspector suggests to have a qualified waterproofing contractor further assess the extent of damage, repair and modify this area as needed in an effort to prevent moisture intrusion. Please refer to photos #14.2, #14.3 and #14.4 for more detail.
E7	Corner Wall		None	A moisture probe was taken at corner wall below the failing parapet wall. No substrate was noted at this time, modify as needed.
E4	Corner Wall		None	A moisture probe was taken at corner wall below the failing parapet wall. No substrate was noted at this time, modify as needed.

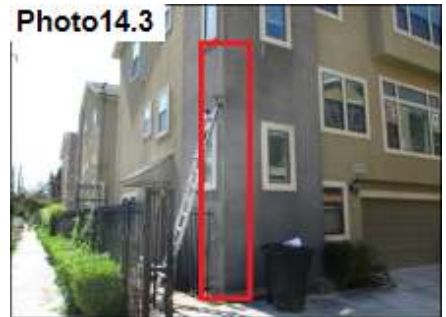
Substrate Damage / Assess & Repair

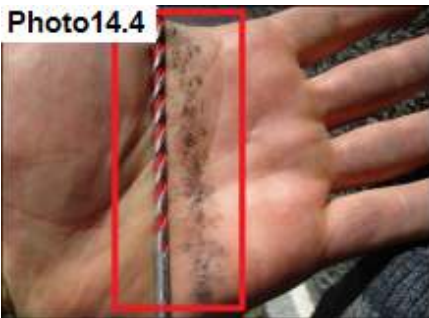
Substrate Damage / Assess & Repair

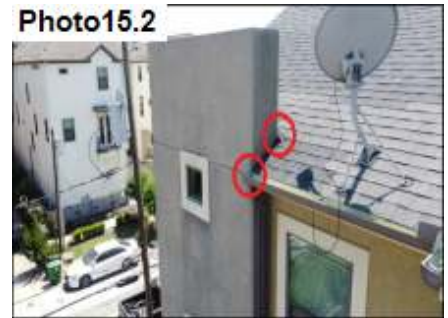
Roof Diverter Flashing / Modify

Grid Location	Item Description	Moisture Readings	Substrate Condition	Observations
Red Circle	Roof Diverter Flashing			Roof diverter flashing is failing at this location allowing moisture to penetrate the system causing potential substrate damage (Red Boxes) below. The inspector suggests to have a qualified waterproofing contractor further assess core sample the probe locations then modify this area as needed in an effort to prevent further moisture intrusion. Please refer to photos #15.2, #15.3, #15.4 and #15.5 for more detail.
F7	Below Roof Diverter Flashing	24%	Semi-Firm	A moisture probe was taken at the corner wall below the roof diverter flashing. An elevated moisture reading was noted with a firm substrate.
F5	Below Roof Diverter Flashing	22%	Semi-Firm	A moisture probe was taken at the corner wall below the roof diverter flashing. An elevated moisture reading was noted with a firm substrate.

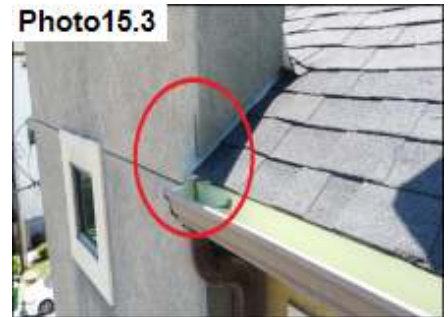
Roof Diverter Flashing / Modify

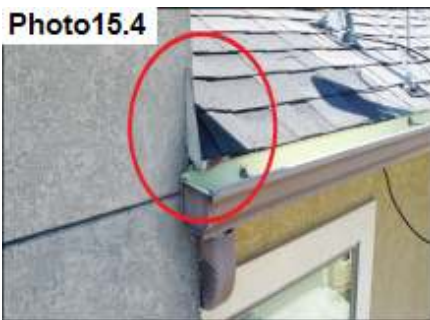
Roof Diverter Flashing / Modify

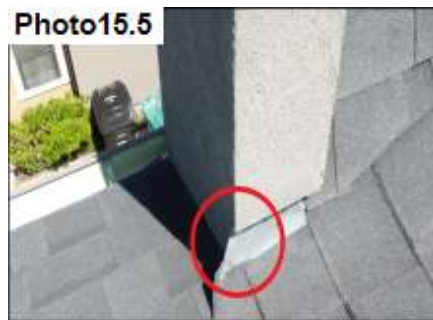
Roof Diverter Flashing / Modify

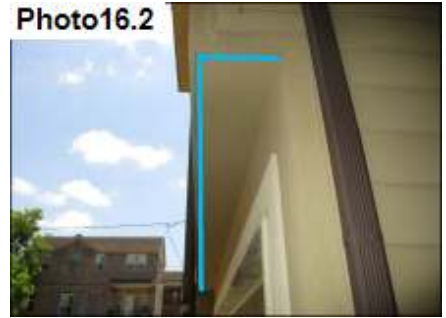
No Relief / No Modification

Grid Location	Item Description	Moisture Readings	Substrate Condition	Observations
Blue Line	Relief			Although the bottom of the wall noted does not have a proper relief, this was a proper detail at the time of construction. Upon invasive testing at this location, the substrate was firm with low moisture readings. The inspector recommends no modification at this point in time but recommends to maintain all sealants above this location to prevent potential moisture intrusion. Please refer to photos #16.2, #16.3, #16.4, #16.5 and #16.6 for more detail.
F6	Bottom Wall Below Window	12%	Firm	A moisture probe was taken at bottom wall below the second floor window. The substrate was firm with no damage noted at this time.
G6	Bottom Wall Below Window	12%	Firm	A moisture probe was taken at bottom wall below the second floor window. The substrate was firm with no damage noted at this time.

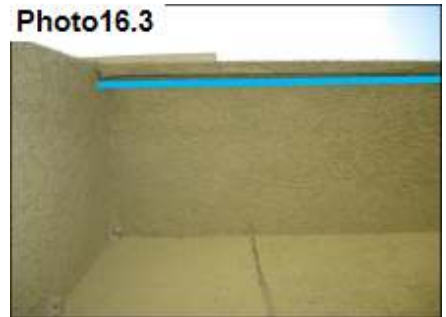
No Relief / No Modification

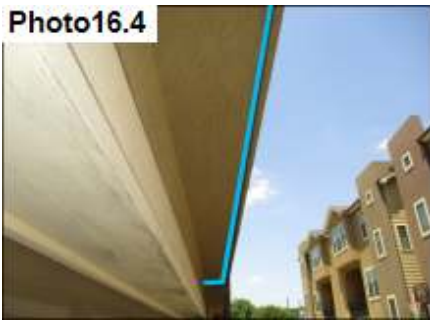
No Relief / No Modification

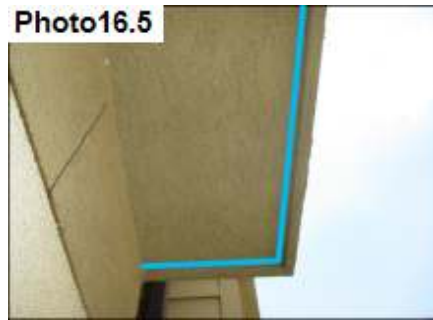
No Relief / No Modification

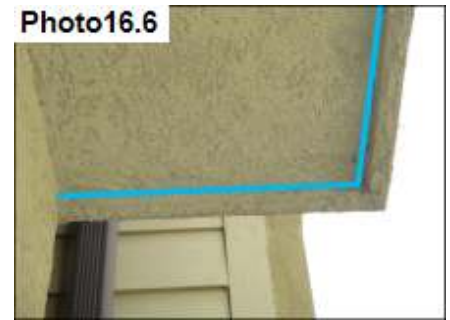
No Relief / No Modification

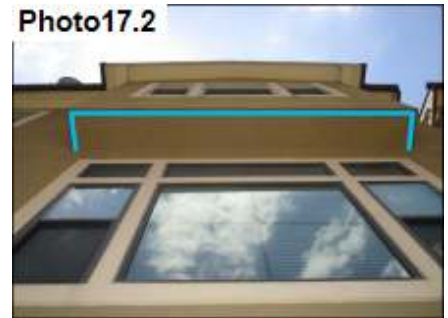
No Relief / No Modification

Grid Location	Item Description	Moisture Readings	Substrate Condition	Observations
Blue Line	Relief			Although the bottom of the wall noted does not have a proper relief, this was a proper detail at the time of construction. Upon invasive testing at this location, the substrate was firm with low moisture readings. The inspector recommends no modification at this point in time but recommends to maintain all sealants above this location to prevent potential moisture intrusion. Please refer to photos #17.2, #17.3, #17.4 and #17.5 for more detail.
F3	Bottom Bumpout Wall Below Window	14%	Firm	A moisture probe was taken at bottom bumpout wall below the third floor window. The substrate was firm with no damage noted at this time.
G3	Bottom Bumpout Wall Below Window	16%	Firm	A moisture probe was taken at bottom bumpout wall below the third floor window. The substrate was firm with no damage noted at this time.

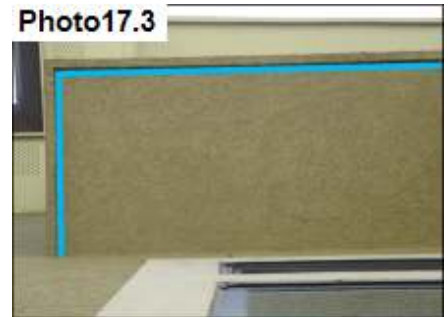
No Relief / No Modification

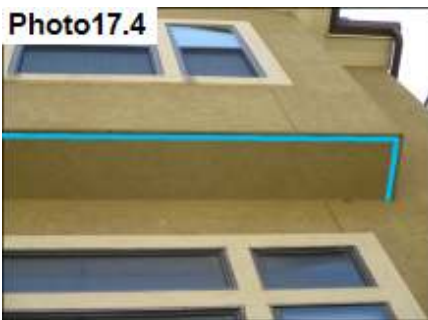
No Relief / No Modification

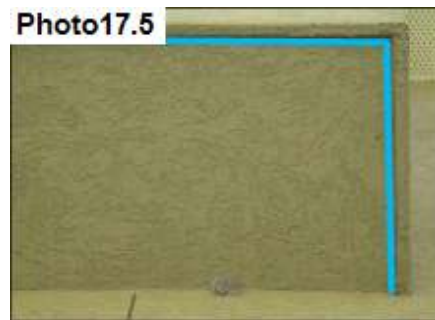
No Relief / No Modification

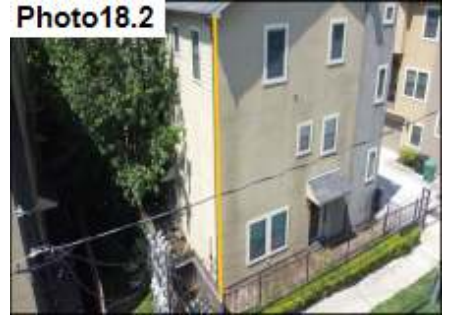
Photo18.2

Trim & Stucco Termination / Seal

Grid Location	Item Description	Moisture Readings	Substrate Condition	Observations
Orange Line	Trim & Stucco Termination			The trim/stucco termination sealants are missing at this location. The inspector suggests to have a qualified waterproofing contractor further assess and seal this area with a low modulus sealant in an effort to prevent moisture intrusion. These types of sealants are of high quality and compatible with stucco and other termination points. Please refer to photos #18.2, #18.3, #18.4, #18.5 and #18.6 for more detail.

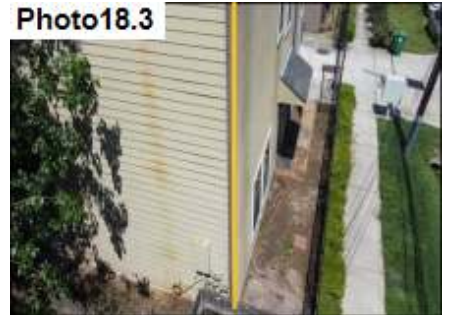
Photo18.3

Trim & Stucco Termination / Seal

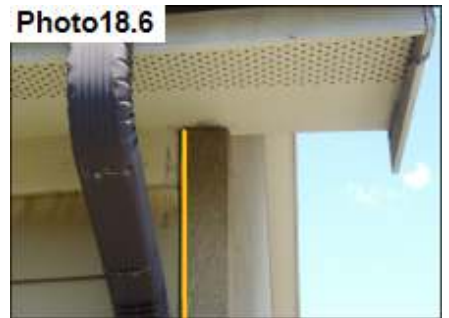
Photo18.6

Trim & Stucco Termination / Seal
