March 27, 2019

PROPERTY INSPECTION REPORT

Concerning: 30415 Avera Creek Dr, Spring, TX 77386
(Address or Other Identification of Inspected Property)

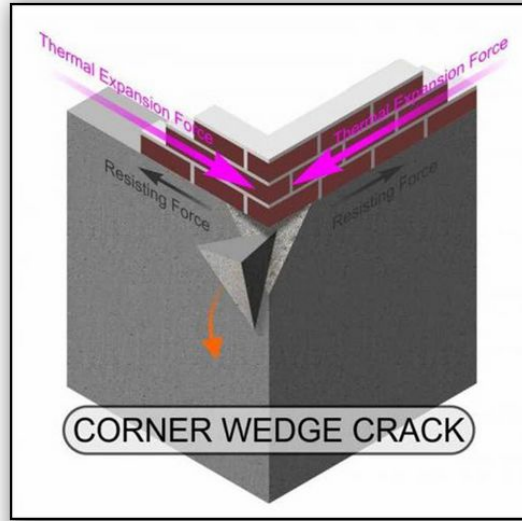
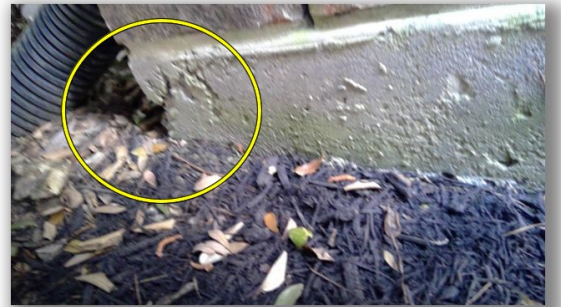
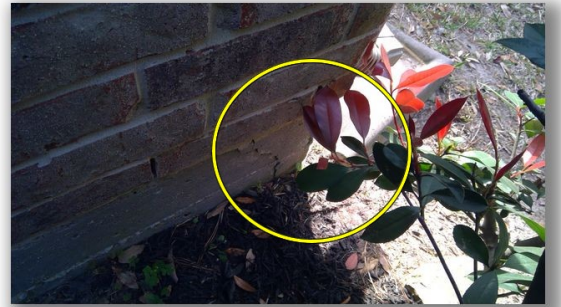
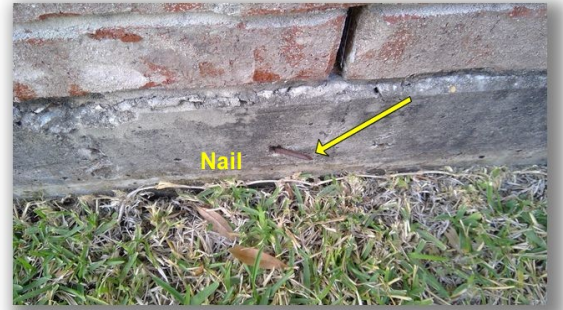
- Recommend trim back nail from post tension cable anchor area.
- Observed areas of honeycombing on foundation. The is believed to be a cosmetic issue and not due to any structural failure.
- One or more of the foundation perimeter beam corners were observed to be sheared off (corner pop). This is a common condition to observe and is do to thermal expansion and contraction of the different building materials. This condition does not adversely affect the foundation performance. However, in some cases, some cosmetic improvements may be necessary.

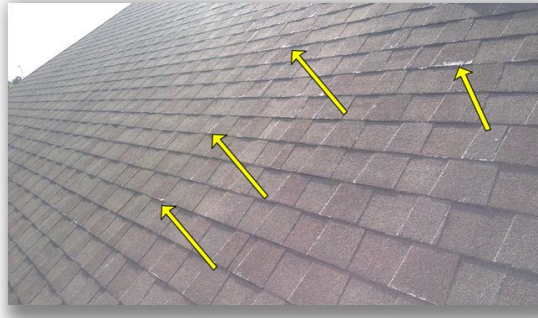
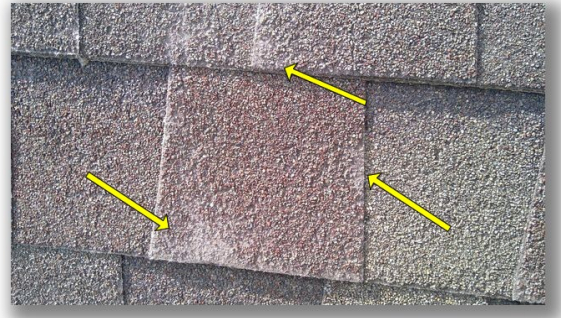
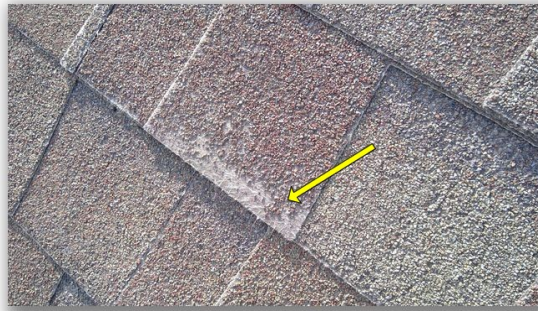
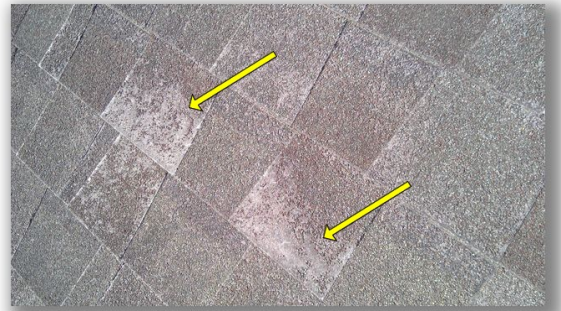
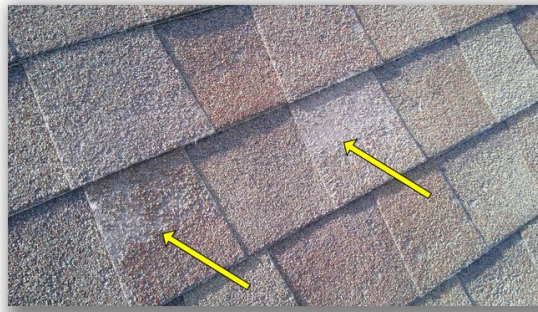
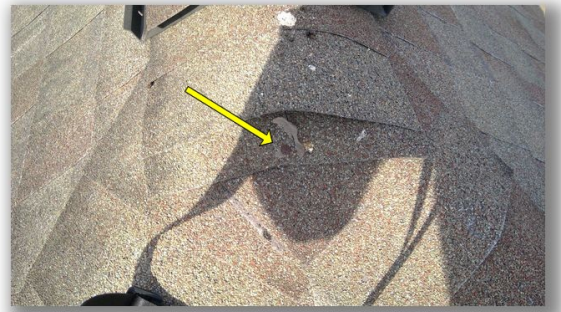
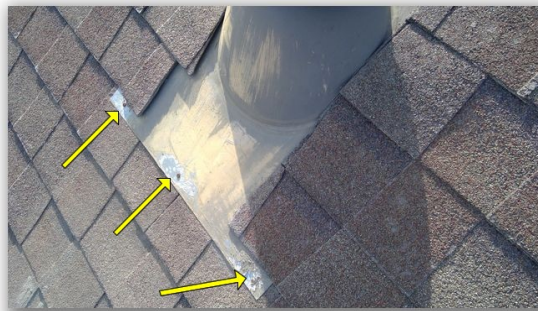
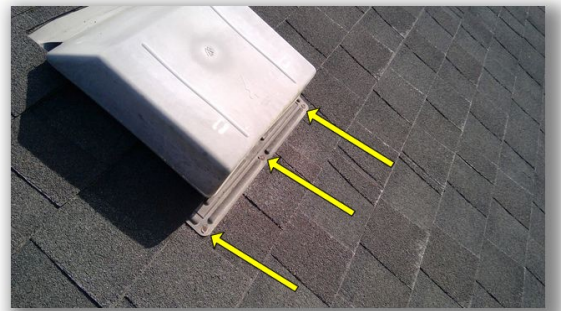
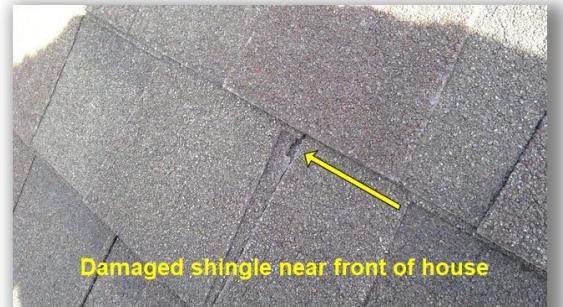
- The composition roofing material has experienced considerable granular loss in various locations throughout the roof.
- 2. Damaged shingles were observed on the front side & right side of the roof structure.
- Exposed fasteners at roof penetrations should be covered to help prevent rust and water intrusion. Recommend en elastomeric caulk.
- **Note:** Roof fasteners (nails and/or staples) were observed to be exposed and should be properly sealed at the ridge caps and flashing areas.

You are strongly encouraged to have a properly certified roofing contractor to physically inspect the roof, prior to the expiration of any time limitations such as option or warranty periods, to fully evaluate the condition of the roofing material. The observation made to support the rendering of this opinion are listed but not limited to the following:

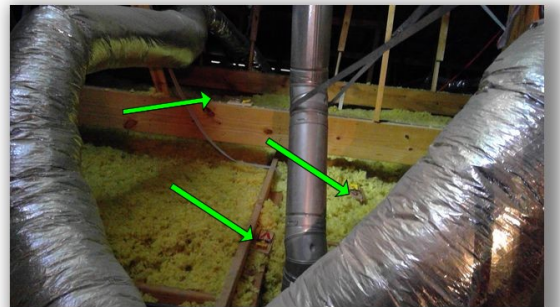
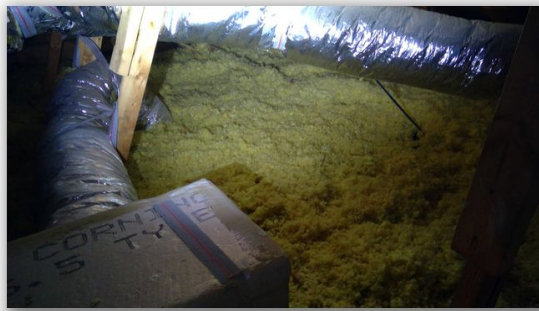
Roof Structure

- **Note:** Visible evidence of rodent activity was observed in the attic area. It is recommended to have a Certified Pest Control Operator further evaluate this condition and make corrections as necessary.

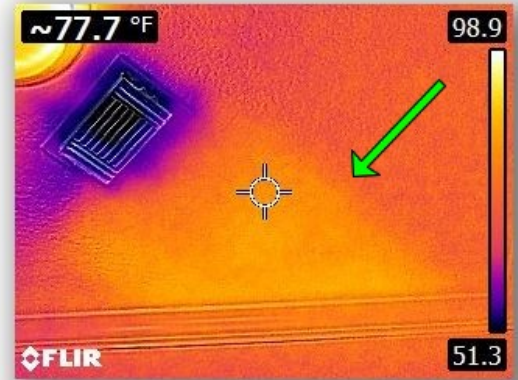
- 3. The attic floor insulation was observed to be missing over the front entrance area area(s).

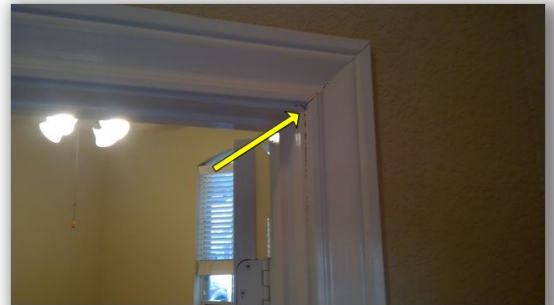
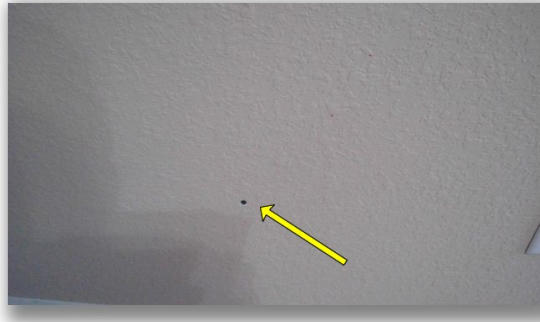
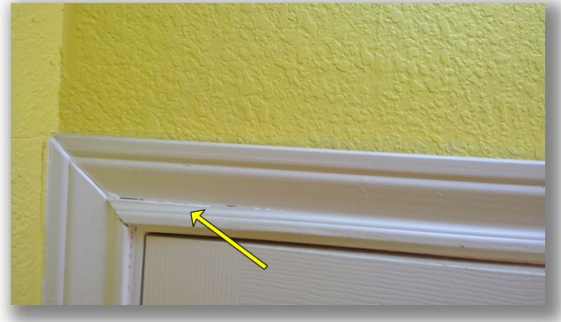
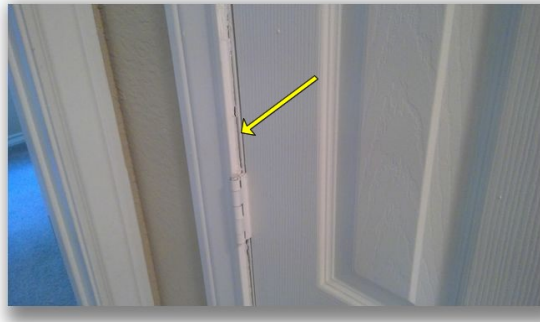
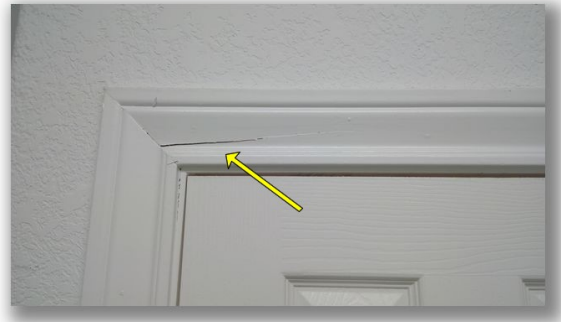
Note: Nail heads were observed to be pushing through the interior finish in one or more locations.

- Observed cracked door trim at various areas of the interior
- Observed area around hall closet door trim in need of caulk improvements

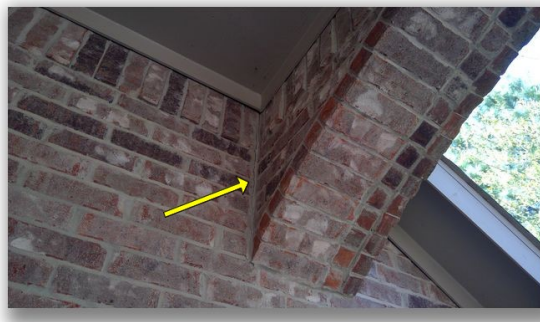
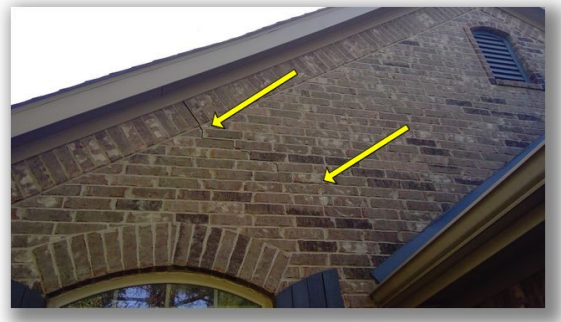
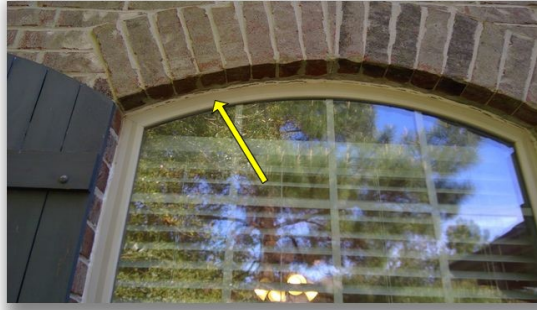
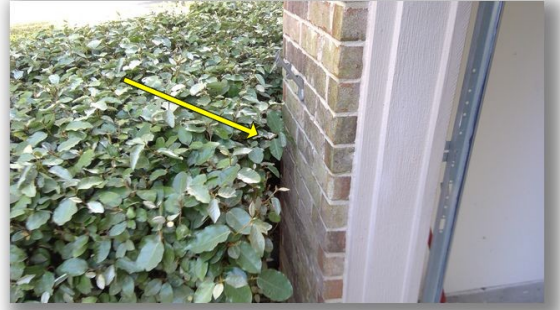
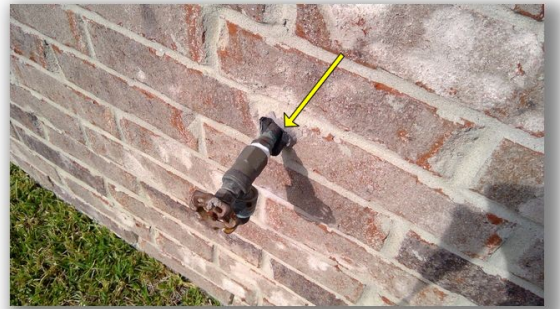
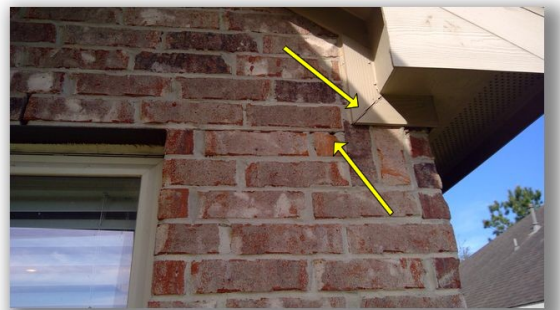
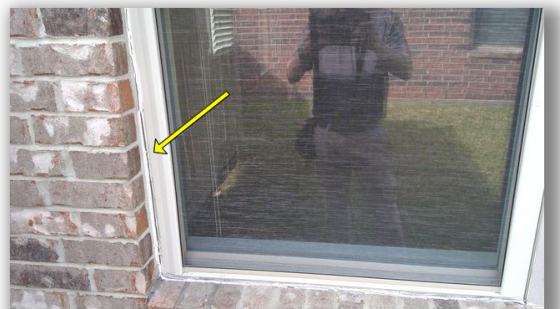
Exterior Walls & Surfaces

- **Note:** Minor mortar and/or brick cracks were observed in the exterior veneer on various locations of the structure. *****One on the front of the house is large and recommended for repair*****

- 4. Caulking improvements are recommended for the area between the exterior veneer and the window frames. It is recommended to use an elastomeric caulking.

- There should be 2" clearance between the siding and roof to prevent water damage
- The area between the exterior cladding / veneer and all of the wall penetrations / openings need to be properly sealed. Areas such as utility connections, downspouts, hose bibbs, lighting fixtures, receptacles etc. It is recommended to use an elastomeric caulking / sealant.

- Recommend mortar over steel lintels *****Rear corner window*****
- Caulking improvements are recommended for the fascia area of veneer at the rear corner of the structure. It is recommended to use an elastomeric caulking.

- Caulking improvements are recommended for the pillar veneer at the back porch area of the structure. It is recommended to use an elastomeric caulking.

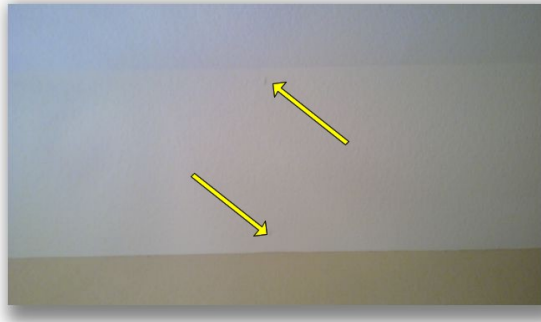
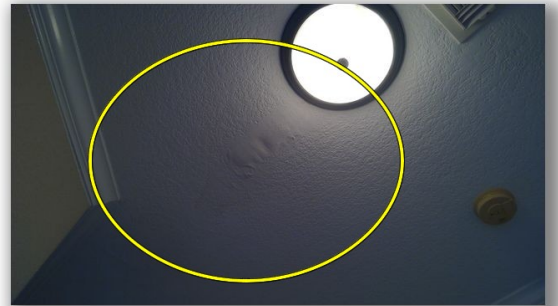
- 5. Water stains were observed on the ceiling finish in the front entry hallway. The cause and remedy should be further evaluated and corrected as necessary.
-

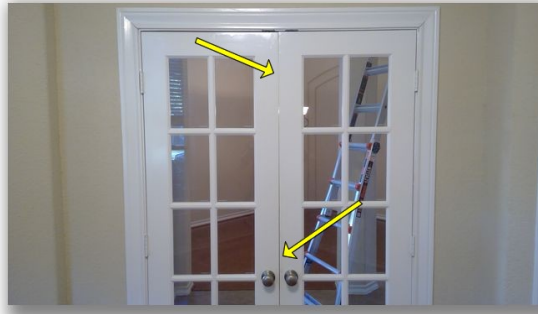
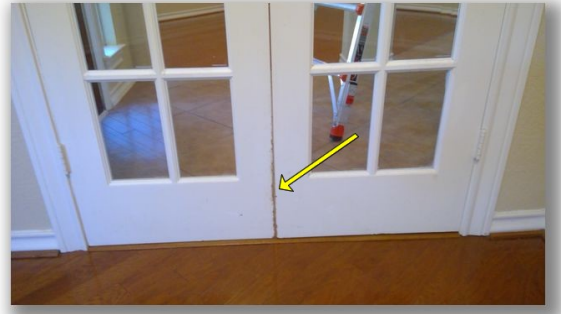
- Study doors were found to be misaligned. Rubbing at the top.
- 6. The door has some surface damage to the study.

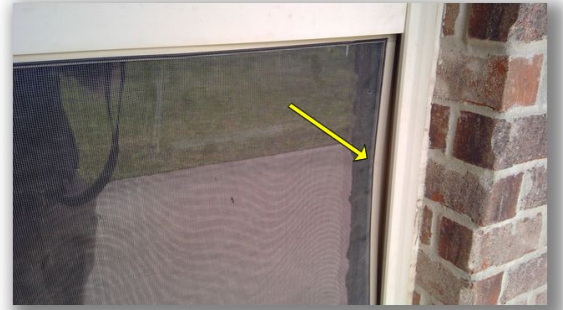
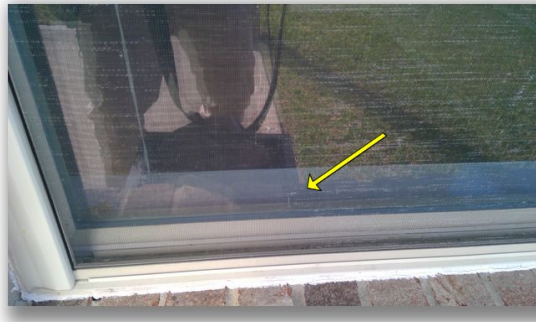
- One or more of the window screens were observed to be damaged. *****Several screens showed damage including the frame and or the actual screen itself*****

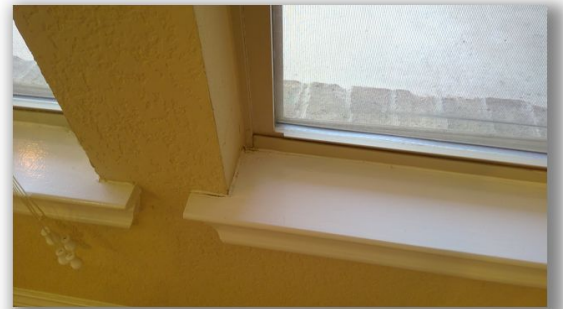
Windows

- 8. The window sill(s) have some deteriorated and/or damaged to various locations.

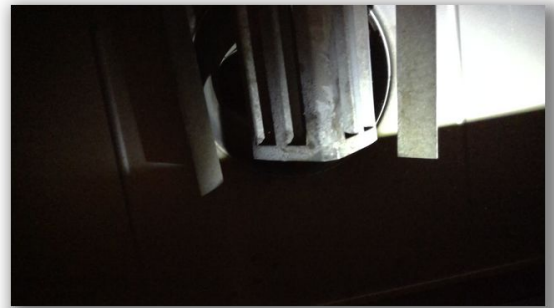
- 9. The gas log assembly appears to be inoperative at the time of this inspection. I was unable to get the gas logs to respond to the pilot assembly / controls. This condition needs to be further evaluated and corrected as necessary.

- When artificial gas logs are installed in a firebox with a damper; the damper should be permanently blocked open with a damper clamp to prevent accidental spillage of carbon monoxide into the living space.

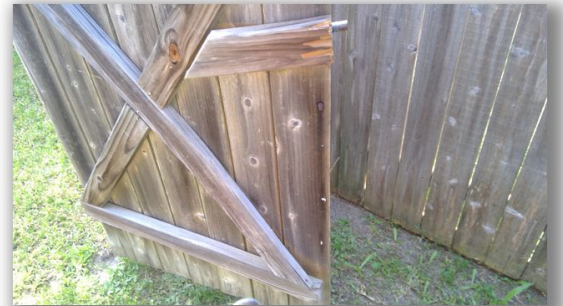
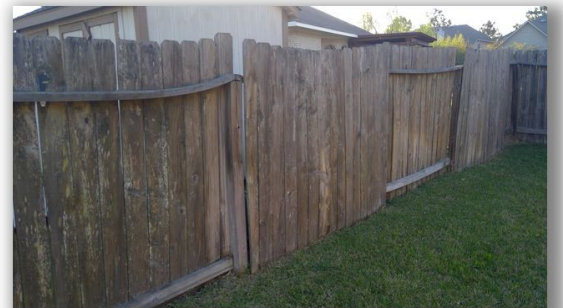
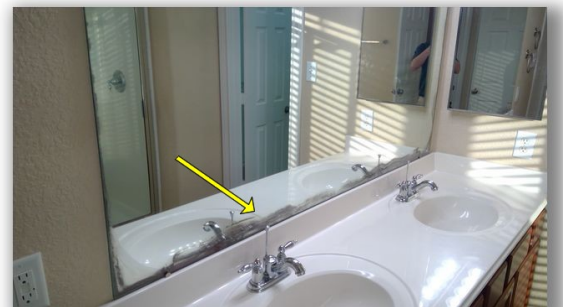
- Observed several fence pickets and gate to be in poor condition
- Observed deteriorated bathroom mirrors

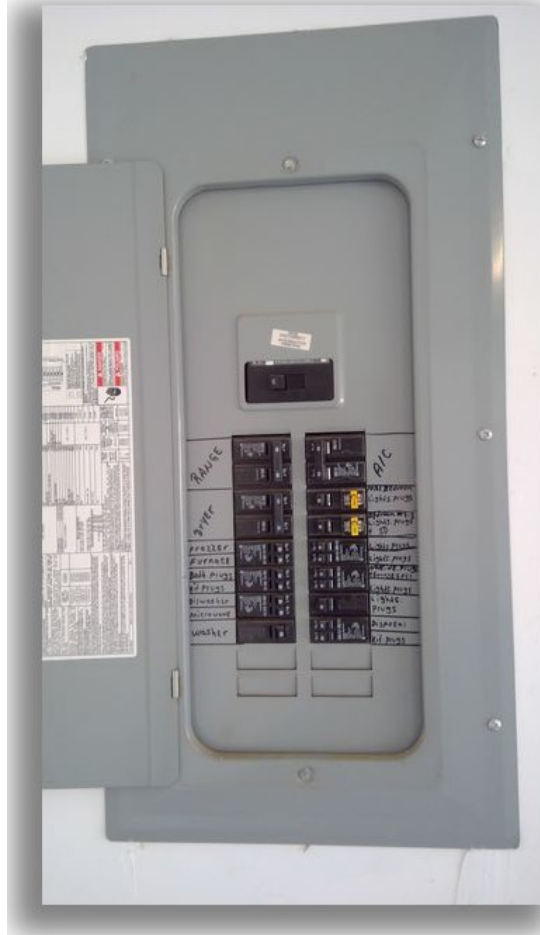
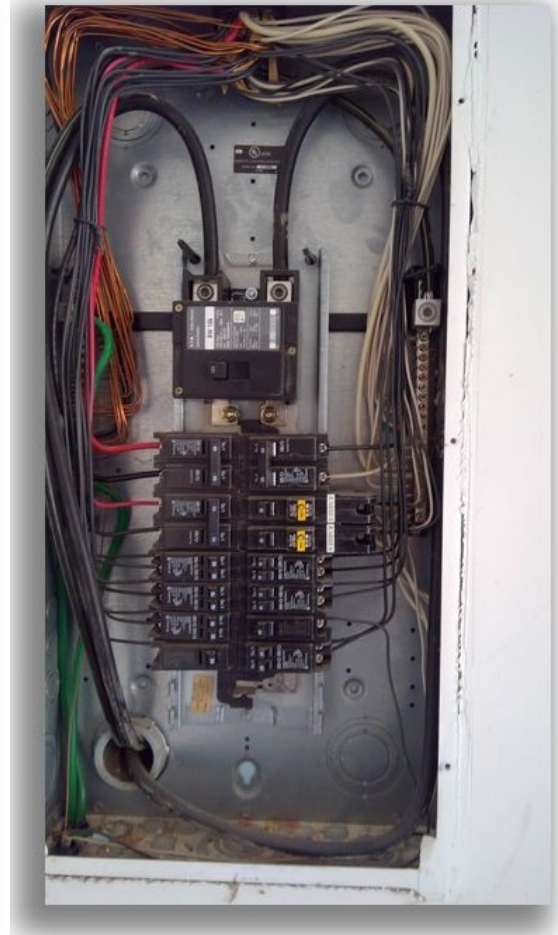
- Not all of the required dwelling unit devices, receptacle and lighting outlets (switches, receptacles and fixtures) are connected to an arc-fault circuit-interrupter (AFCI) circuit device. Under the current National Electrical Code, all of the dwelling units devices, receptacle and lighting outlets (switches, receptacles and fixtures) should be connected to an arc-fault circuit interrupter (AFCI) device.
- One of the AFCI breakers did not trip when tested. This is believed to be due to a faulty AFCI breaker.
- 10. There was no anti-oxidant gel observed on the exposed aluminum conductor terminations.

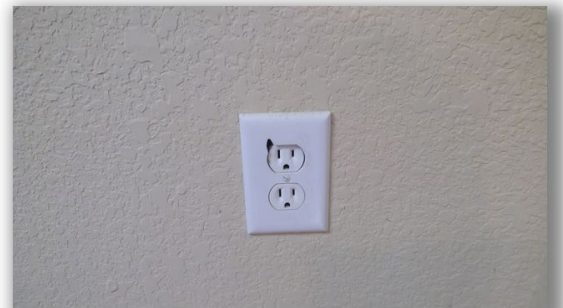
Receptacle Outlets

- Not all of the garage receptacles appear to be connected to a ground fault circuit interrupter (GFCI) device. Under current electrical standards, all of the garage receptacles should have GFCI protection. There New National Electrical (NEC) Code no longer has an exception for “non-appliance dedicated”. *****Sprinkler system dedicated outlet*****
- 11. One or more of the receptacles were observed to be damaged in the kitchen, rear corner bedroom.

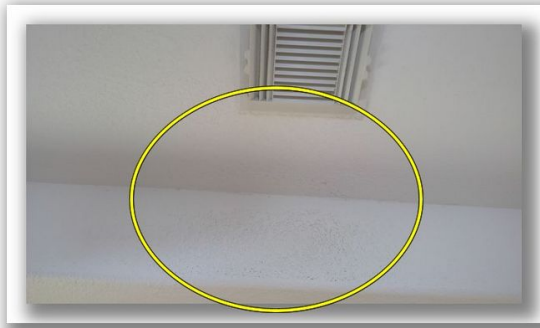
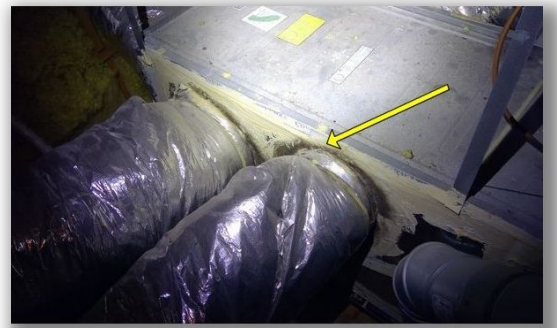
- 16. There is visible dust and/or mildew on the air registers in the master bedroom. The cause and remedy should be further evaluated. It is recommended to have the air registers and duct system cleaned for air quality purposes.
- 17. There was an unknown dark mold like substance observed on the outer surface of the duct work. Evaluation of this substance is beyond the scope of this inspection. If any concerns exist on the type and/or nature of this substance, we recommend further evaluation by a professional in the Air Quality sampling field.

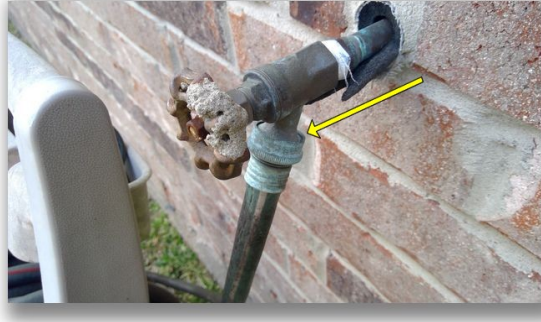
Exterior Faucets/Fixtures

- One or more of the exterior water hose bibbs (faucet) do not have a back-flow or anti-siphon device (Vacuum Breakers) in place.
-

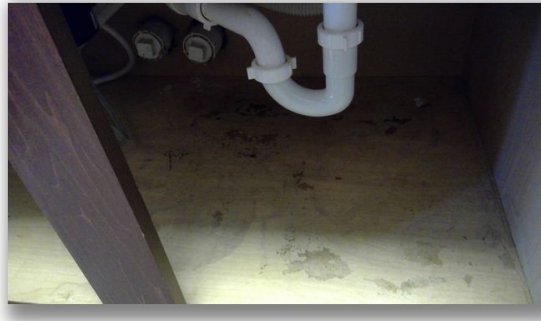
Kitchen Sink

- Observed evidence of previous water leak into the kitchen cabinet area below sink. No active leak was observed at the time of inspection.

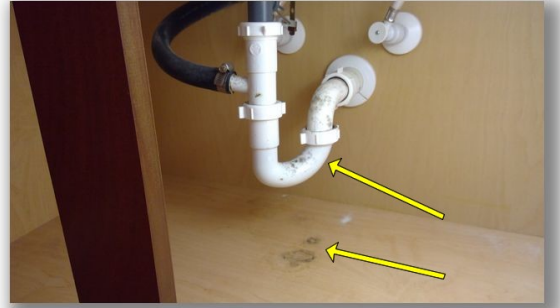
18. *Lavatory / Sink*

- 19. The stopper does not appear to be functioning properly. *****ALL*****
- Evidence of previous water leak into cabinet below bathroom sink
- There was an unknown dark mold like substance observed in cabinetry under the sink. Evaluation of this substance is beyond the scope of this inspection. If any concerns exist on the type and/or nature of this substance, we recommend further evaluation by a professional in the Air Quality sampling field.

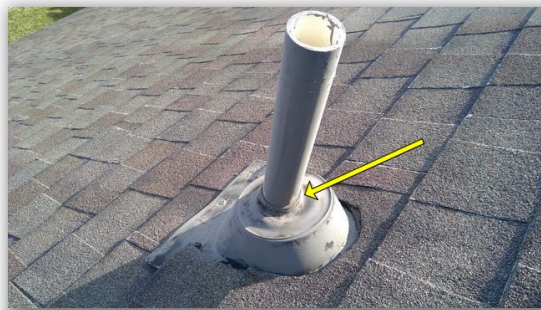
- Recommend re-caulk/seal around plumbing vent stacks with an elastomeric caulk

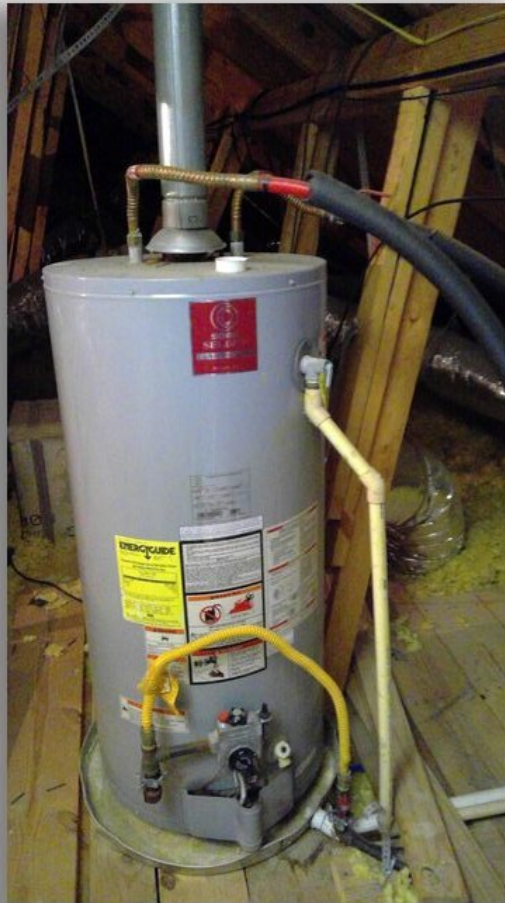
- 26. The vent pipe is not properly mounted at the top of the water heater. This configuration will emit Carbon Monoxide into the heater compartment, which is a known safety hazard.

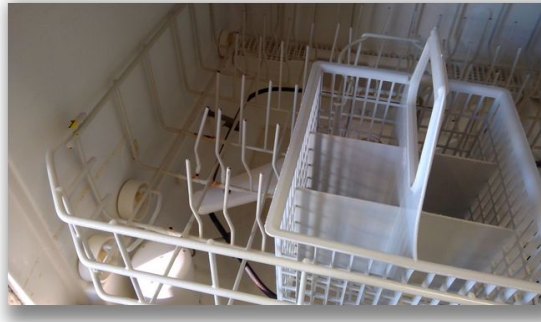
- 27. Some rusting of the dishwasher interior components was observed.

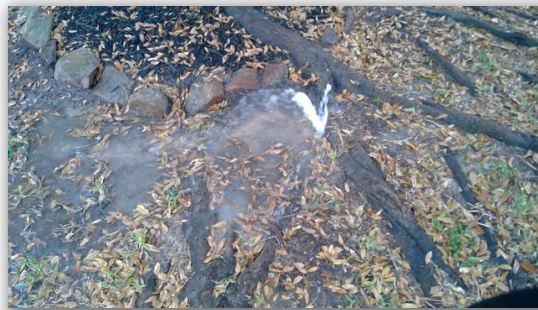
- 28. One or more of the sprinkler heads need to be adjusted so not to disperse water onto concrete flatwork (such as; roadways, sidewalks, porches, patios or driveways) in station(s); **3, 2, 5.**
- 29. One or more of the sprinkler heads were observed to be damaged and/or missing in station(s); **2.**
- 30. The conduit that is protecting the sprinkler system wires is damaged.

The sprinkler system and associated components should be further evaluated and/or serviced by a Licensed Irrigation Technician. The observations made to support the rendering of this opinion are listed but not limited to the following:
