# HOUSTON INSPECTIONS

# PROPERTY INSPECTION REPORT FORM

09/09/2022

306 Fargo Street, Houston, TX 77006

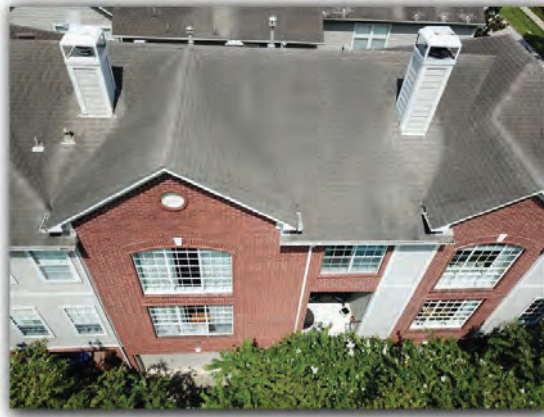
The roof covering appears to be nearing the end of its serviceable life. The roofing shingles have experienced severe loss of aggregate, curling, and cupping. A qualified tradesman should be consulted to evaluate the roof covering to determine if repairs can be performed or if replacement is needed.

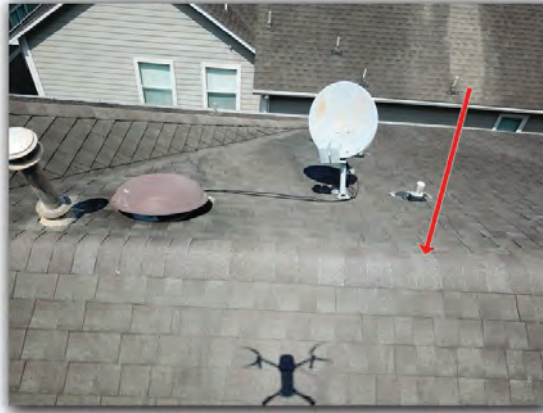
Damaged and / or missing shingles were found during the inspection of the roof covering. Recommend repairs by a qualified tradesman.

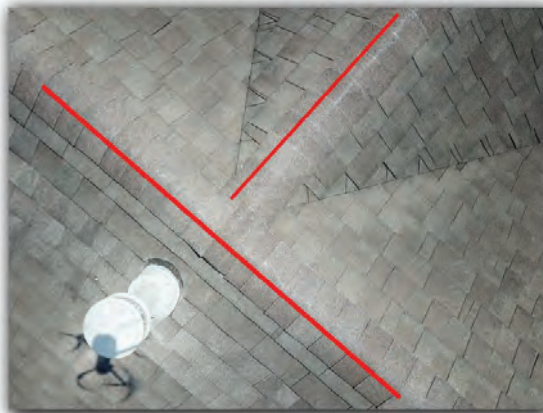
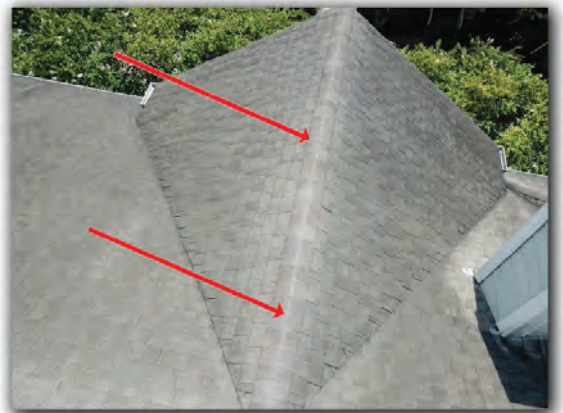
The hip and ridge shingles have reached the end of their serviceable life's as evident by excessive loss of aggregate and damage at many locations. This commonly occurs when these shingles are a different quality than the main body. Recommend contacting a qualified tradesman to evaluate the roof and make the necessary repairs.

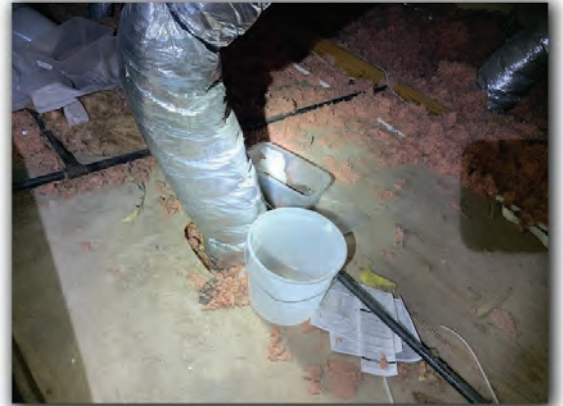
Plastic bins/tubs were found in multiple areas of the attic as indication of potential roof leaks. Patched/repaired shingles were found at portions of the roof covering, potentially to correct the leaks above these areas. Due to these conditions, the wear noted at the roof covering, and the limitations of this inspection, further evaluation and repair by a qualified contractor is recommended.

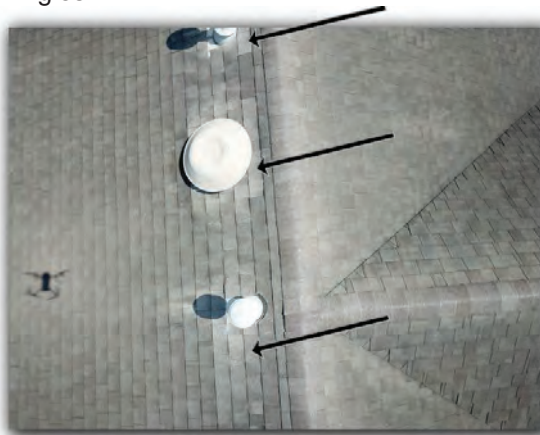
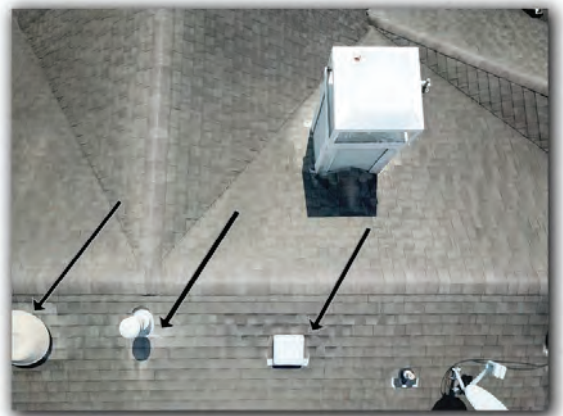
Evidence of roof patching was noted during the inspection as evident by different color and age shingles.

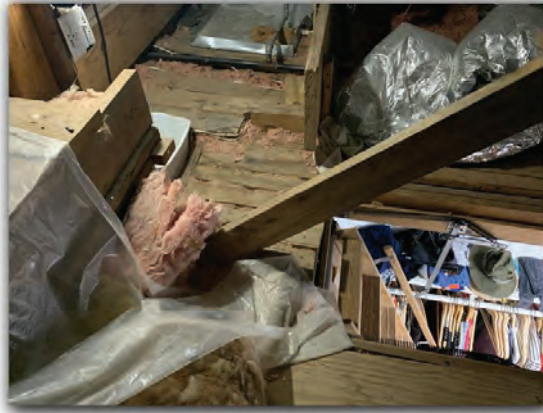
- Attic ladder not installed properly - Safety Hazard for occupants, Recommend securing. The attic ladder has not been installed properly. The stairway should be corrected before future use. This is a safety issue as the ladder could break or come out of the ceiling if not corrected. The ladder should be secured on all four sides with shims and secured using 16D nails or 3" lag screws as directed by the manufacturer.
- Attic ladder is not insulated
- Missing weather-striping at attic door.
- Missing/improper clearance at the attic stairway landing - Safety Hazard

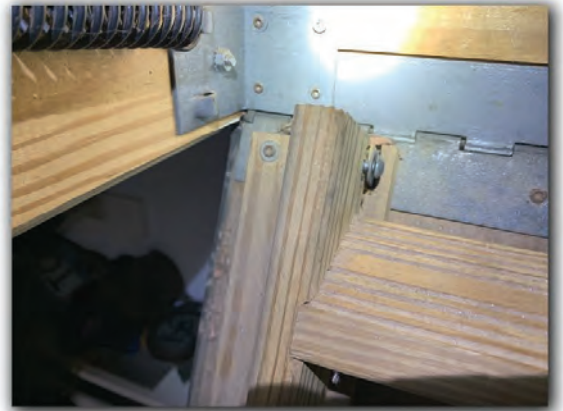
Loose and missing hardware was found at the attic door. This is a safety hazard that should be corrected.

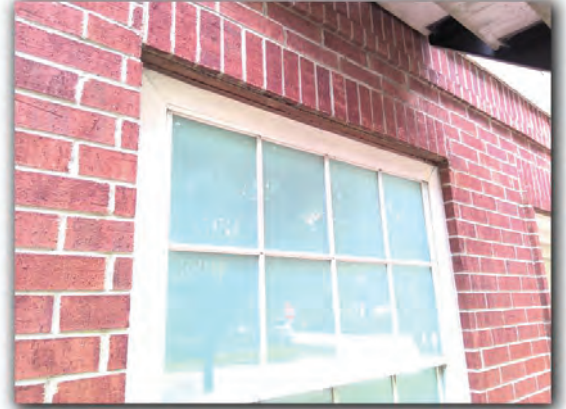
The metal lintels on the exterior of the structure are rusted. Lintels are metal that is installed over openings in the brick veneers (doors, windows, etc). Recommend cleaning and re-painting.

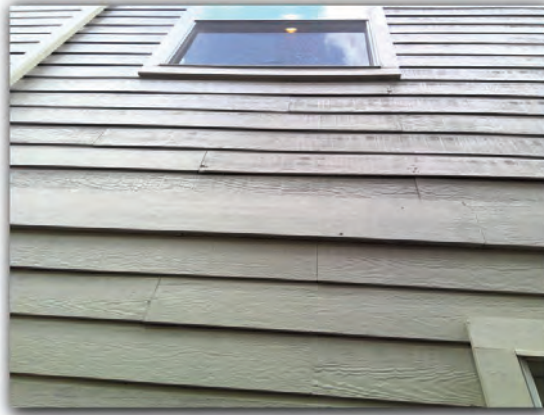
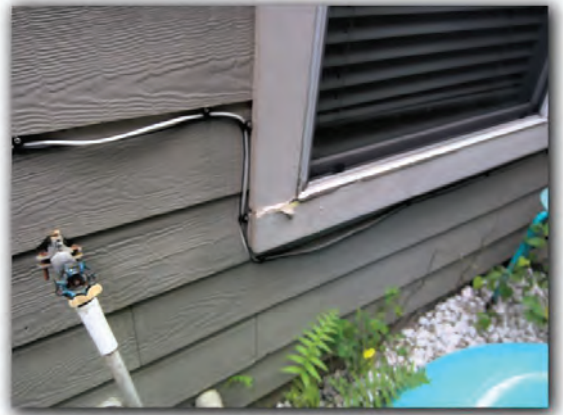
Damaged and / or missing items were found on the exterior of the property. The damage was found at the following locations:

1. Rear exterior door jamb/trim
2. Rear siding
3. Rear window trim

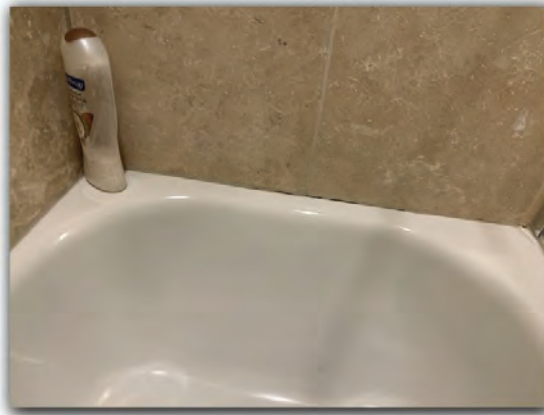
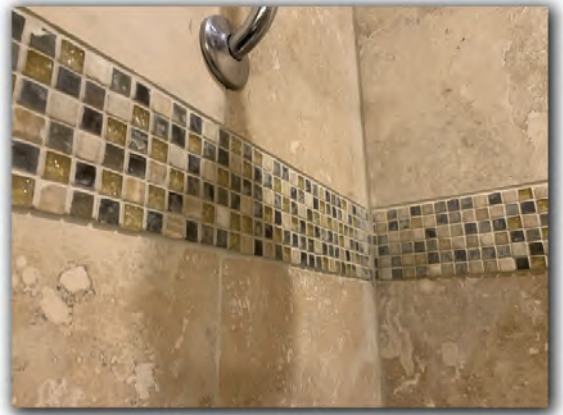
Damaged and missing grout/caulking was noted in the first floor guest bathroom shower/bathtub enclosure.

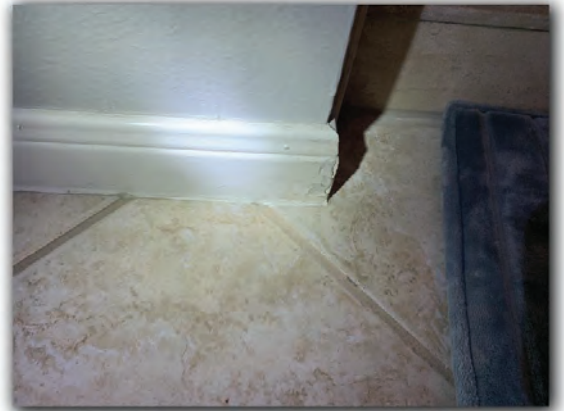
The problems have been possibly caused by one or more of the following: water penetrations, insects, impact, foundation / structural movement, etc. Repairs should include replacement of damaged underlying materials where needed.

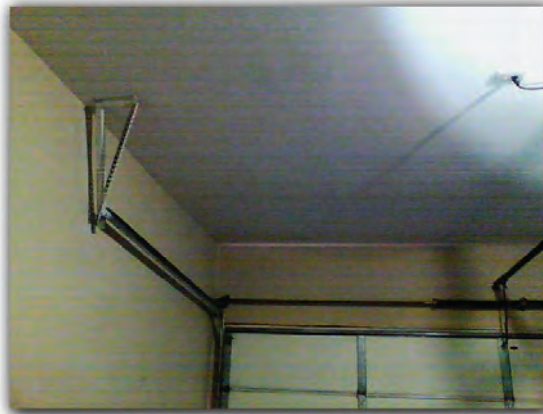
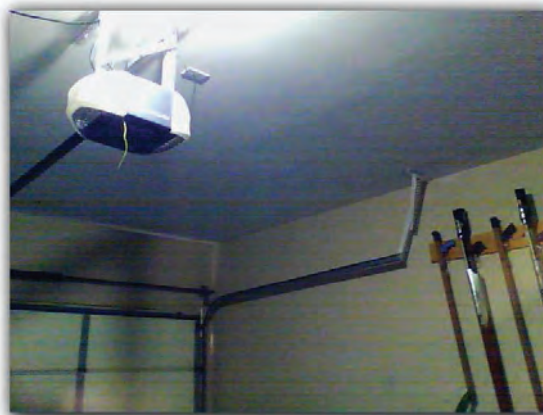
A thermal abnormality was noted in the garage ceiling spanning from one side of the garage ceiling to the other, approximately 8 feet from the front of the house. Elevated moisture content of 19-20% was measured at the left and right portions of this abnormality (As pictured). Drywall cracking/discolorations were found extending from the front to the back of the garage ceiling. Further evaluation of the ceiling and underlying space with repair of the moisture source as well as any underlying damage is recommended.

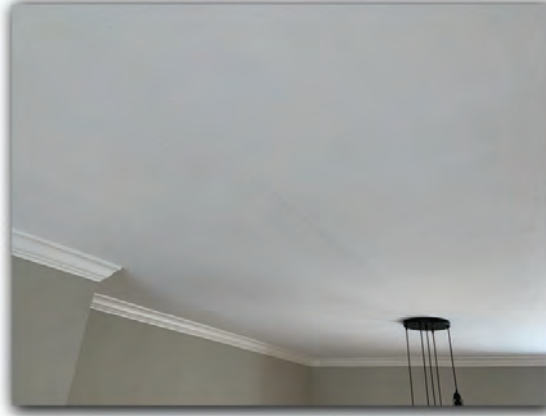
Cracking was noted on the interior ceiling of the property as evidence of settlement.

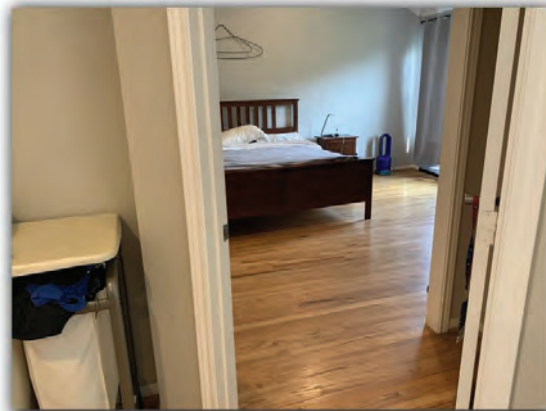
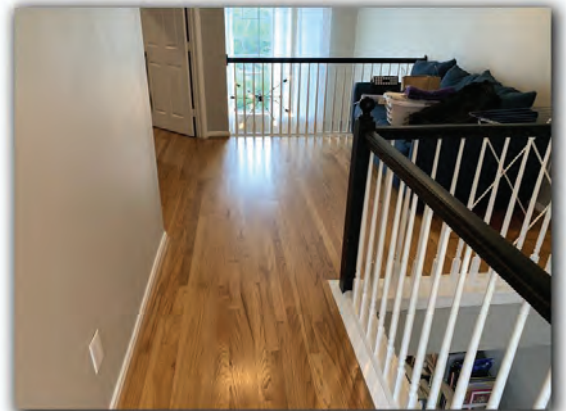
Sloped floors were found on the third floor as evidence of settlement.

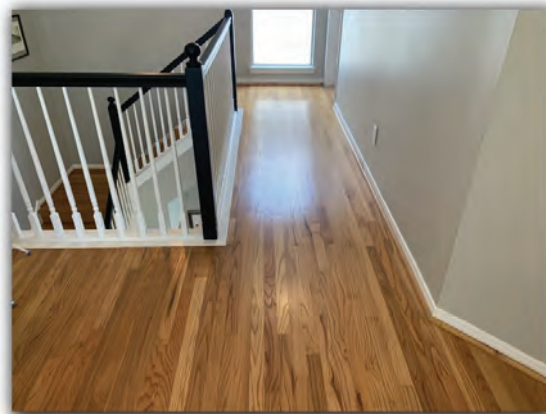
Loose flooring was noted on the third floor as evident by noise when walking. Recommend securing / re-nailing all loose flooring.

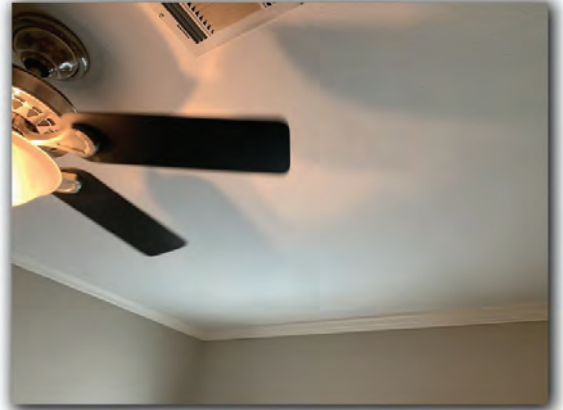
Evidence of patching was found at the first floor guest bedroom ceiling beneath the second floor porch/balcony.

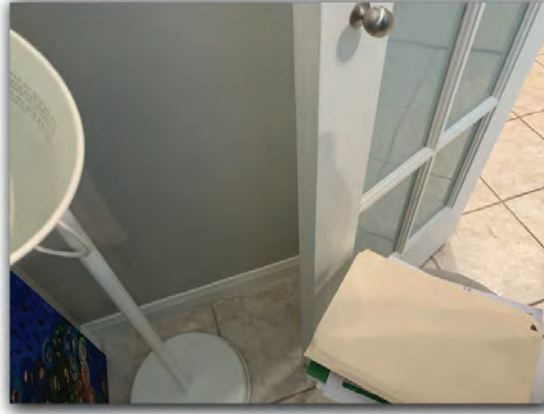
Missing door stops were noted. Recommend the installation of missing door stops.

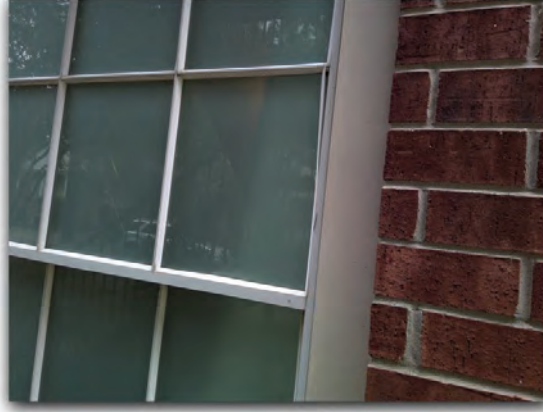
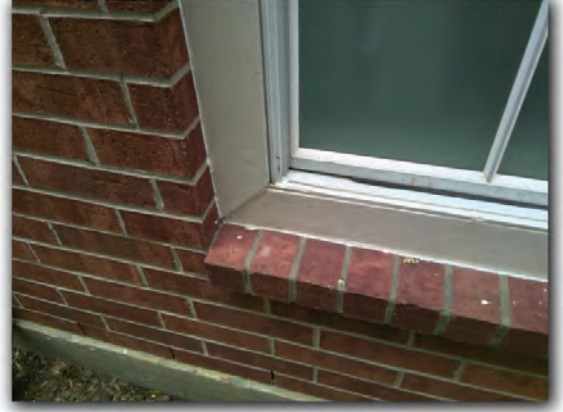
Damaged and / or missing weather stripping was noted at portions of the exterior windows. All weather stripping should be in good condition and installed at all windows.

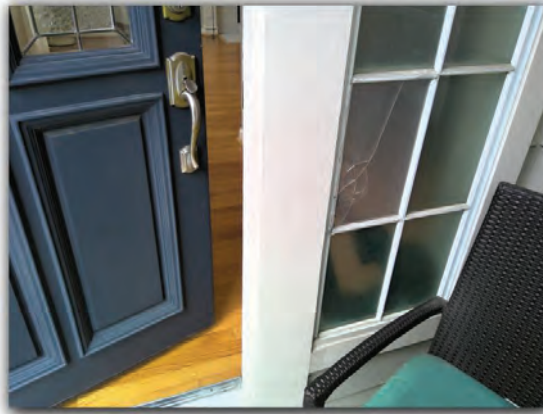
Cracked glass was found right of the front entry door.

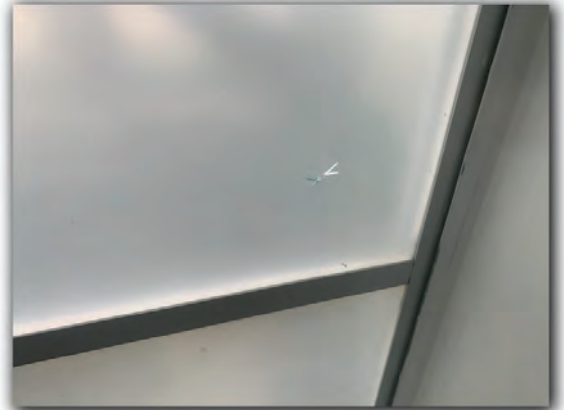
Chipped glass was found in the first floor guest bedroom.

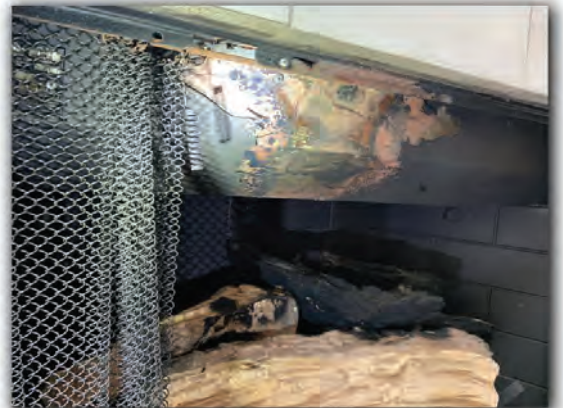
Discolorations and surface damage were found at the firebox/faux logs as indication of improper combustion. Repair/improvement by a qualified contractor is recommended.

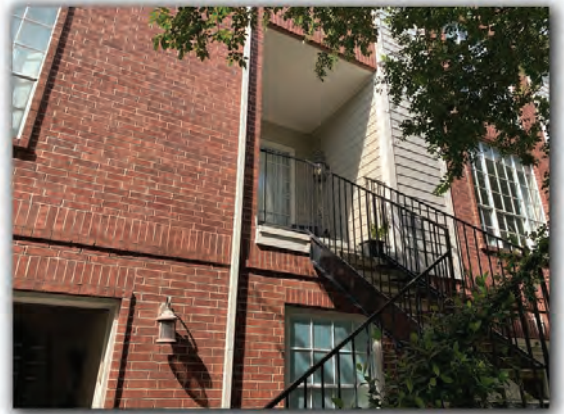
Diverter Flashing Not Visible / Improperly Installed - Further Investigation is Recommended

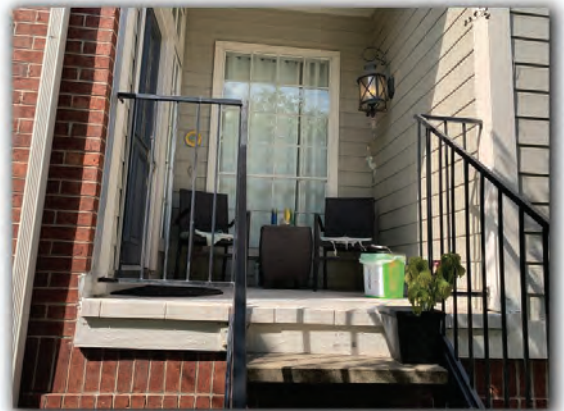
The front balcony flashing and pan are not visible. Previous repair as evidence of previous leaks were noted at the bedroom ceiling beneath this area. Further evaluation for repair/improvement by a qualified contractor is recommended.

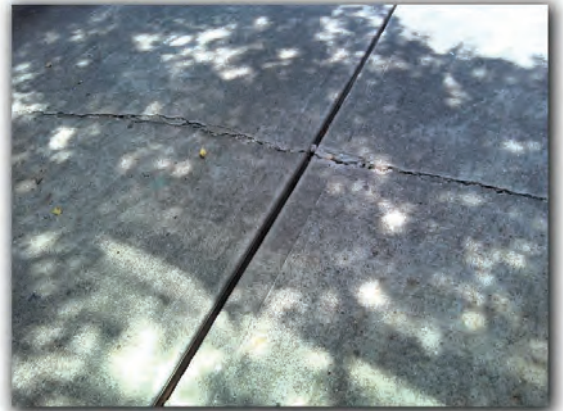
Significant cracks and breaks were found at the driveway.

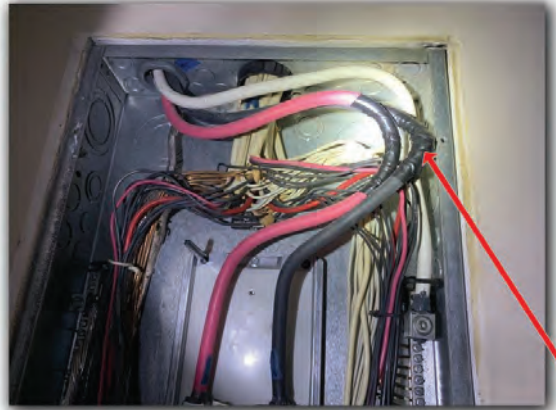
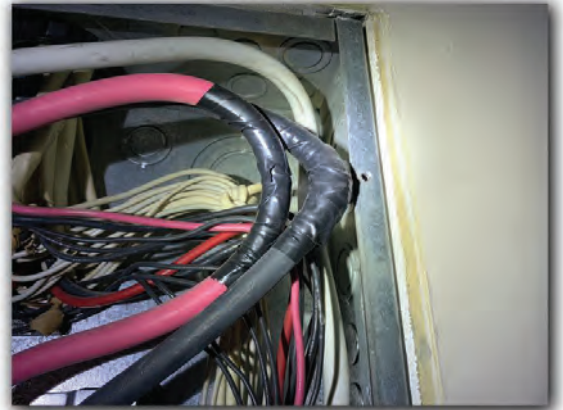
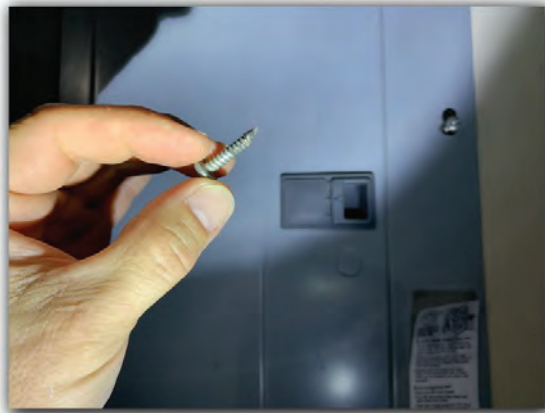
Electrical tape and a sharp bend were found at the upper right conductor of the garage electrical panel as indication of damage. A damaged fastener at this portion of the panel deadfront cover indicates previous arcing/contact with active conductor. Repair of the conductor, separation/clearance from fastener location, and replacement of the deadfront panel fastener by a licensed electrician is recommended.

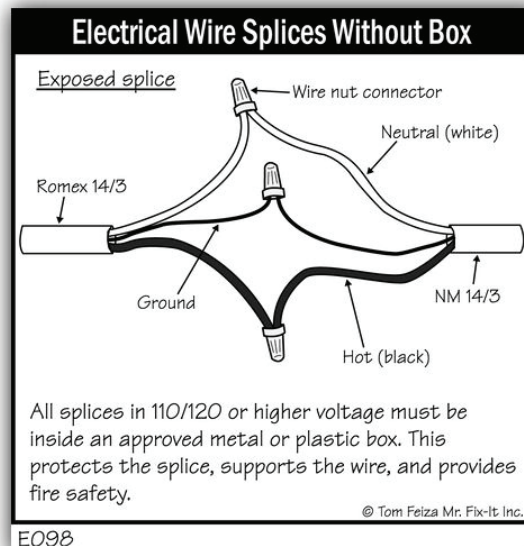
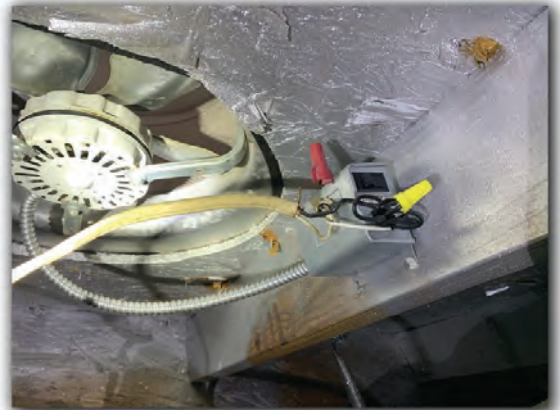
Exposed electrical connections were noted in the attic at the powered fan. Improper electrical connections should be improved. All electrical connections should be made inside junction boxes fitted with cover plates.

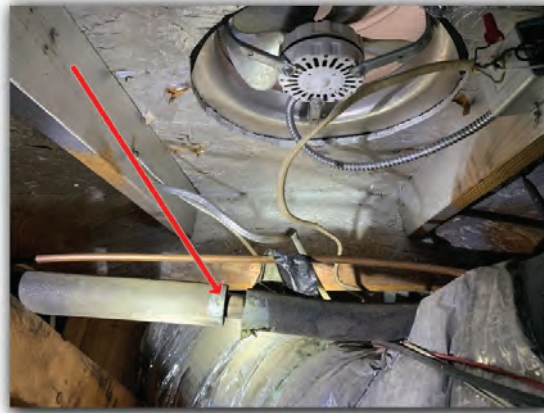
Damaged and missing insulation at the visible portions of the refrigerant lines (Attic beneath the powered fan) should be repaired/replaced.

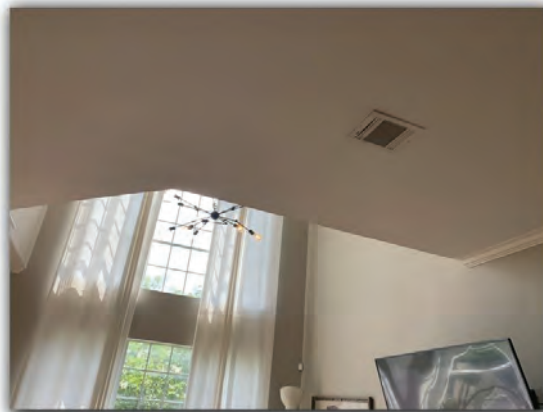
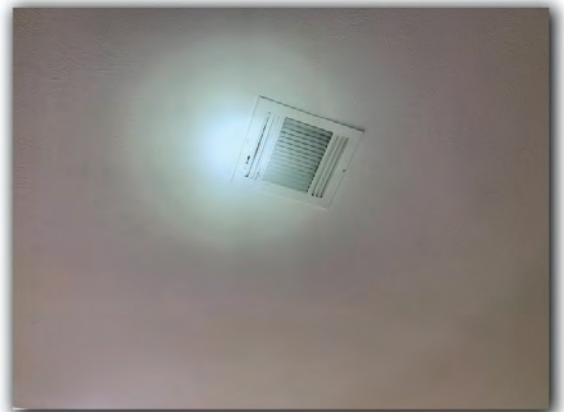
Debris/discoloration was noted at some of the air registers in the living room, laundry room, primary bathroom . Evaluation and repair/improvement by a licensed HVAC contractor is recommended.

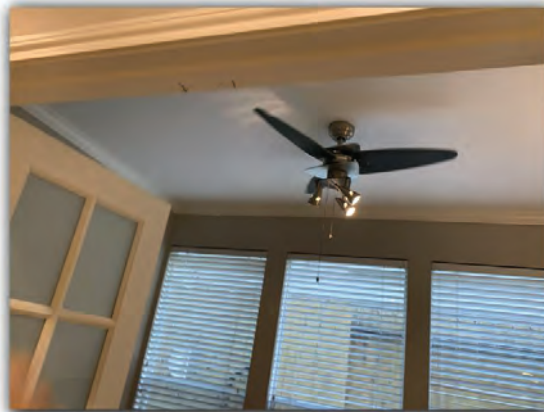
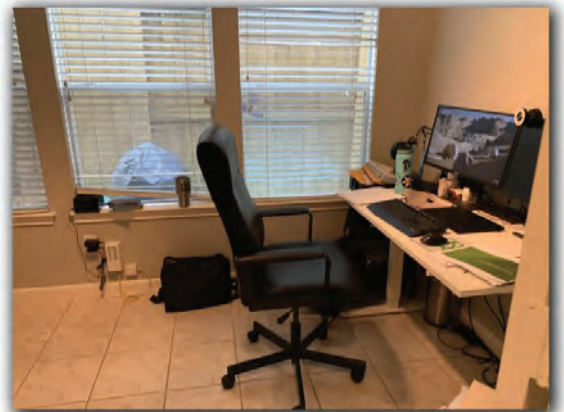
A supply register/duct was not found in the first floor study. Repair/improvement is recommended to ensure proper airflow.

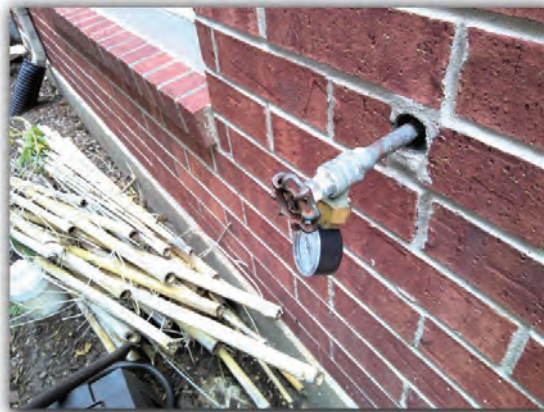
Leaks were found at the hose bib valve stems during operation of the faucets.

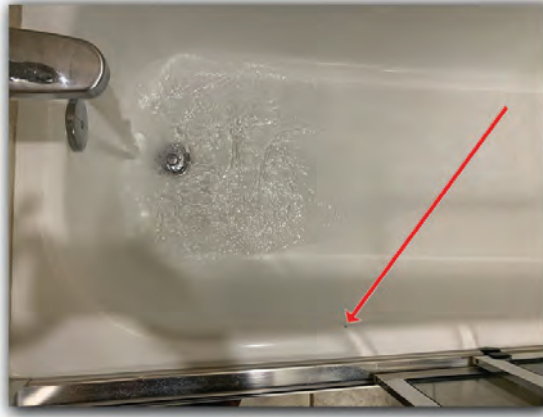
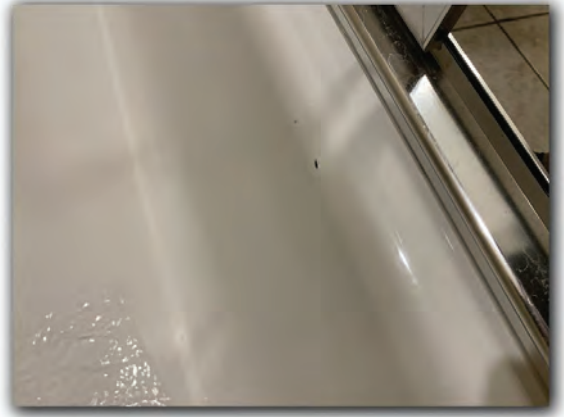
Surface damage was found at the tub. The damage should be repaired to prevent the damage from extending to through the fixture.

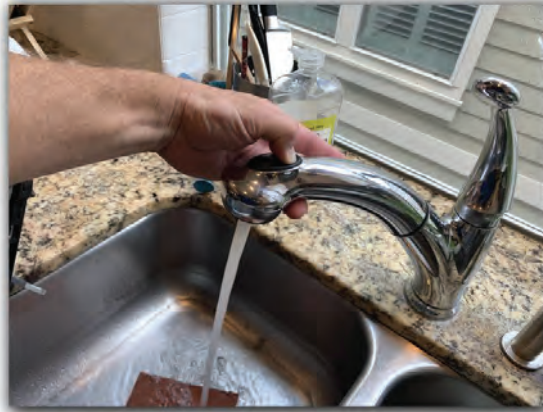
The sink pout does not toggle between spray functions. Repair / improvement is recommended.

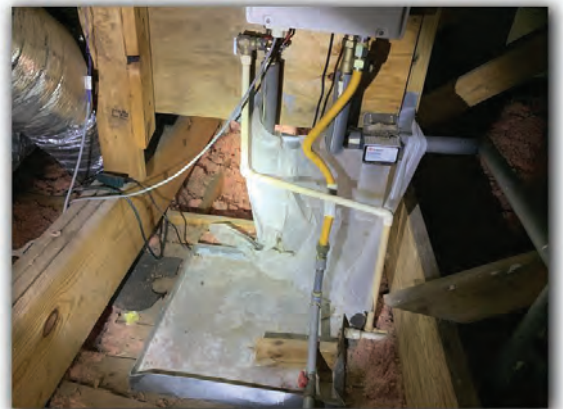
Debris and damage were found at the emergency drain pan. Repair /improvement is recommended.

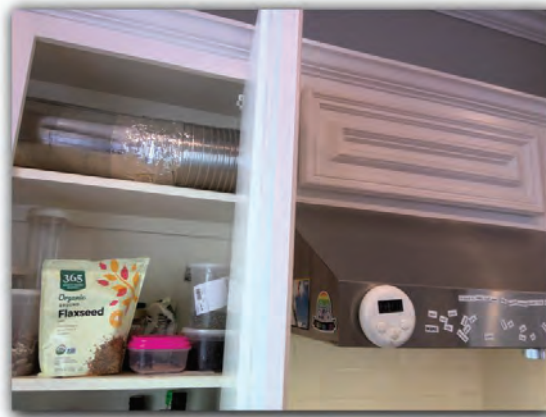
Vent material improper
