SELLER'S DISCLOSURE NOTICE

CONCERNING THE PROPERTY AT 909 Riverside Ct, Friendswood, TX 77546
(Street Address and City)

Style of Home: Single Family, One Story	Age Of Home: 1965	Home Faces: South, SW
Vacant or Occupied: Vacant	Utilities Active: No gas service to water heater, No electrical service to oven/range	Attendees/Personnel Present: Buyer
Weather: Partly Cloudy	Temperature: Over 80	Rain in last 3 days: No
Ground/Soil Condition: Dry, Standing water	Ancillary Services: Wood destroying insect, Pool	Recommended Professionals: Foundation, Structural Engineer, Roofer, Licensed Electrician, Licensed HVAC, Licensed Plumber, Appliance Contractor, Licensed Pest Control, Handyman, Carpenter, Pool, General Contractor, Leak/Water Remediation Contractor

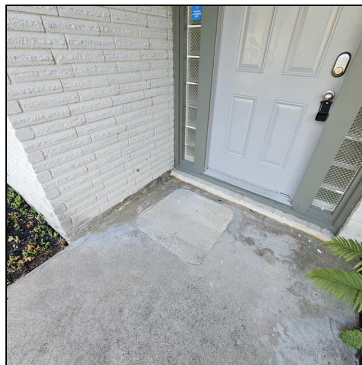
Previous repairs to the foundation have been disclosed and/or were observed. Refer to the seller for any documentation and possible warranties for further information.

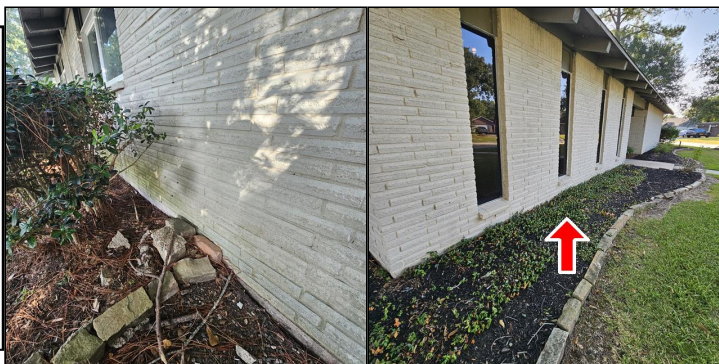
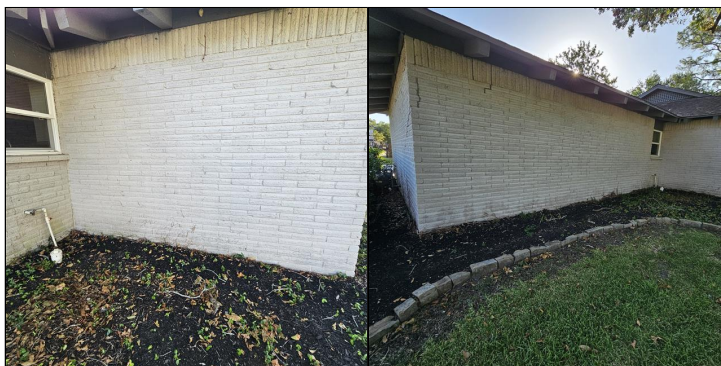
☒ Gutters are recommended where not installed. Water cascading off the roof where gutters are not installed could result in excessive erosion and possibly undermine the foundation.

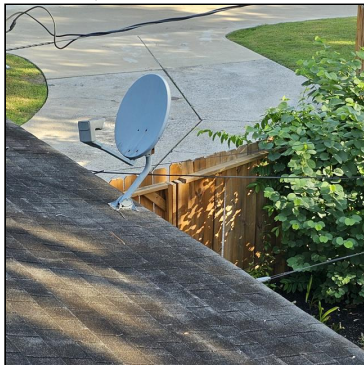
Mounting a satellite dish directly through the roof deck is not recommended. The preferred installation is on side of wall or eaves. In it's current installation, extra sealant is recommended on the fastening bolts.

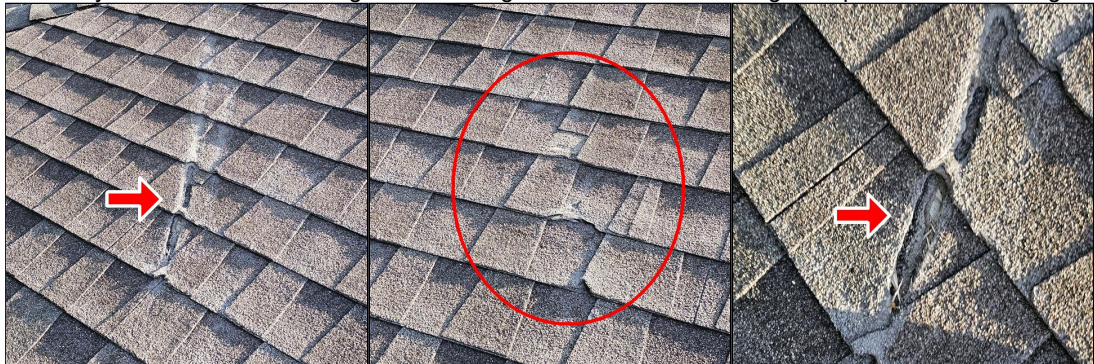
Some worn shingles with granular loss/damage in various areas throughout the roof. A roofer should perform a maintenance check on the covering for needed repairs, patching or replacement of worn shingles. Most notably at front left where shingles are damaged down to the sheathing from previous tree damage.

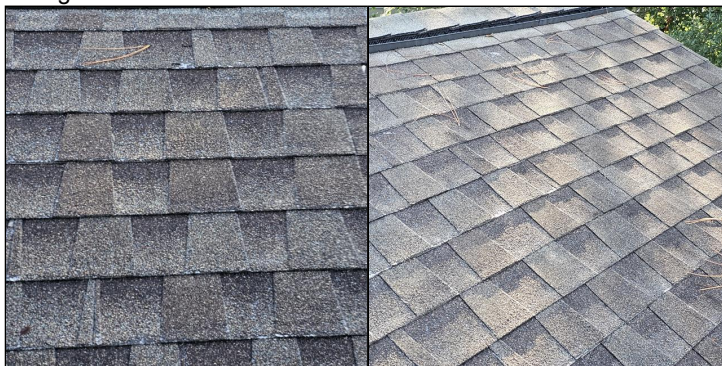
The roof covering is old, and the life of covering has or is near expired. Significant & readily apparent deterioration and/or damage to shingles, tiles, flashing or other roof covering was observed. The covering does need to be replaced. While it could last a year or so, some areas may need patching with tar as leaks develop. Buyer is strongly encouraged to have a properly certified / licensed roofing contractor to physically inspect the roof prior to expiration of any time limitations, such as option or warranty periods, to fully evaluate the condition of the roofing material.

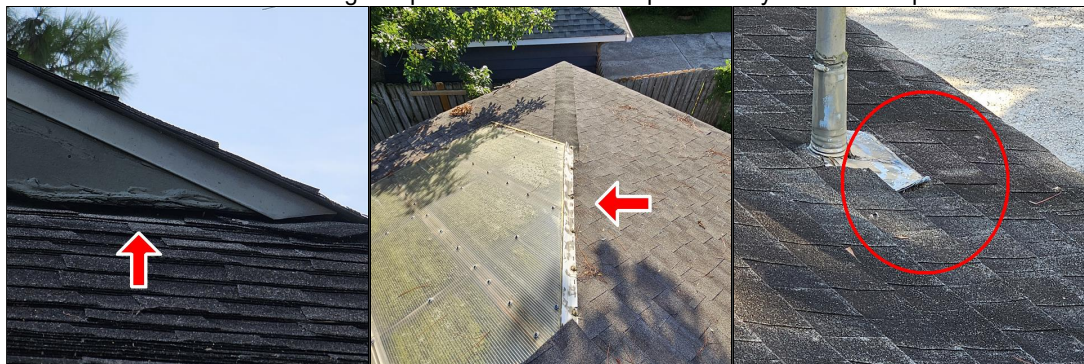
There were vent, counter or step flashings observed to be raised and improperly sealed. A qualified roofer should reseal and seal these roofing components as needed to prevent any future water penetration.

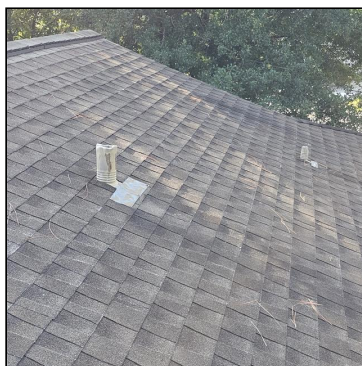
Paint is needed on bare metal flashing, vents or PVC pipes. This will prevent rust and also UV damage to the pipes.

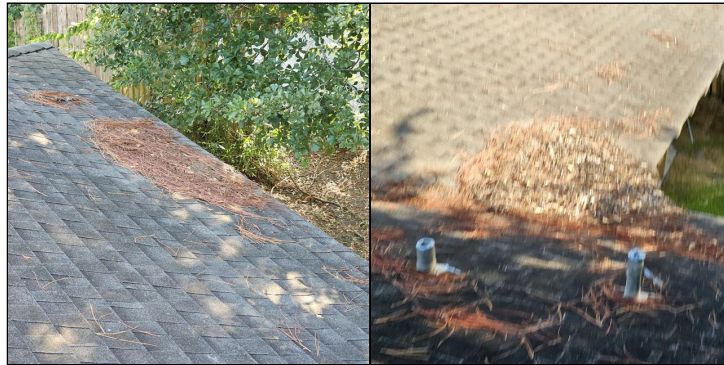
Remove all debris from roof slopes and valleys. Leaf debris may hide possible defects and damage to roofing materials. Debris may also cause water to dam up under shingle tabs.

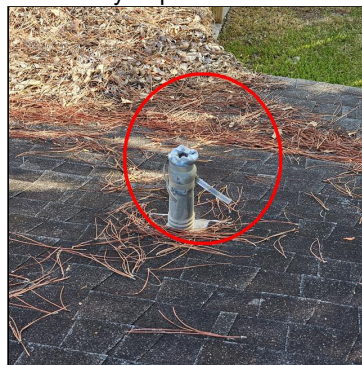
Plumbing vent pipes are improperly flashed (no jack boot, outdated flashing, flanges improperly covered, etc). Proper flashing detail should be installed by a qualified roofer.

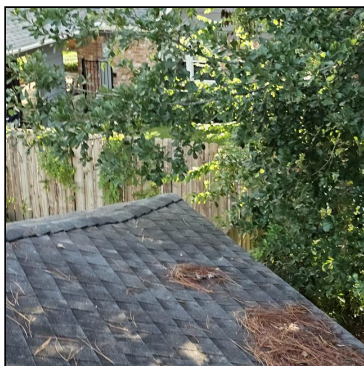
Tree limbs that are in contact with roof or hanging near roof should be trimmed back 3-5' to prevent any damage to the roof covering.

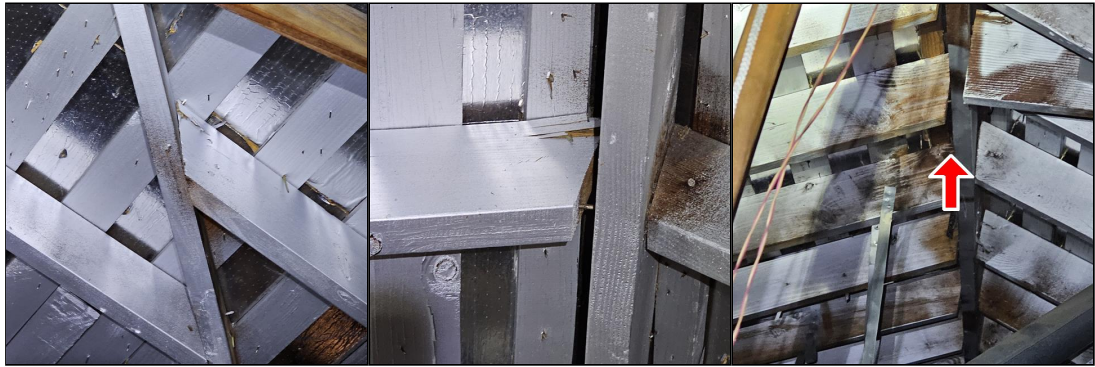
Roof: worn with granule loss/damage in areas. Rafters have separate from ridge beam in some areas, and structural members damaged in various locations. Roof covering pool has notable damage and shifting support members. Refer to inspection report for further information.

Rafters have separated from the ridge beam in areas. At least one vertical support for purlins has become detached. This is typical with settling on older homes, but should be addressed and repaired within near future.

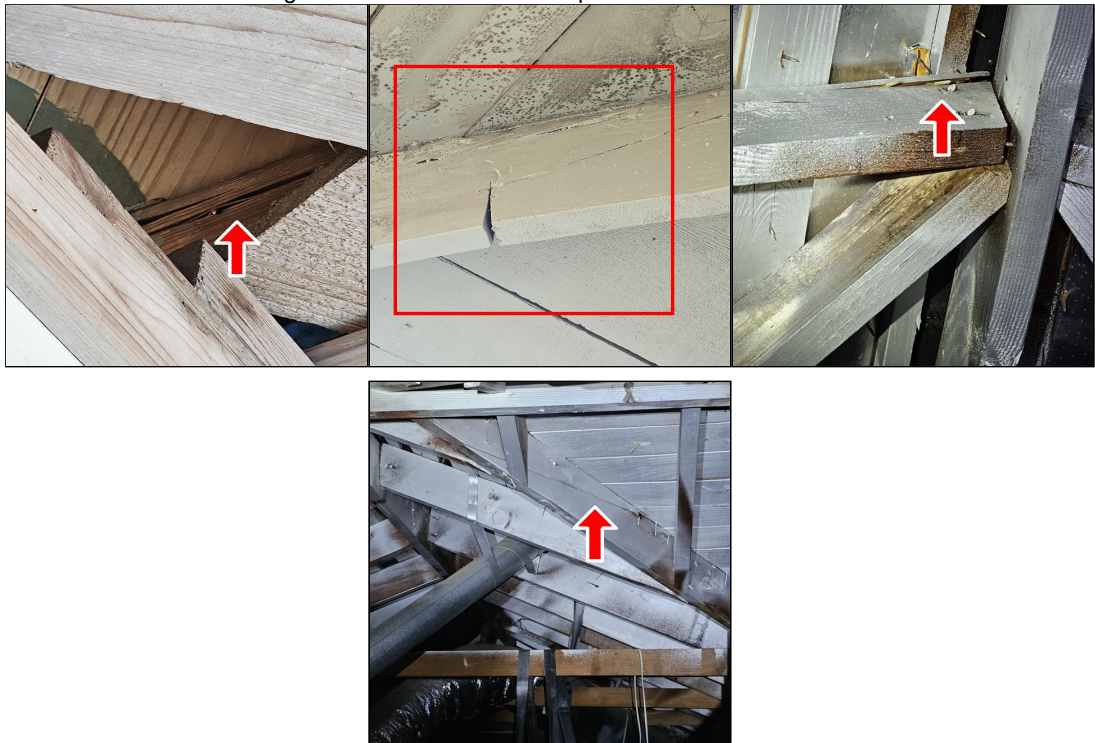
Structural members damaged in various locations. Repair as needed.

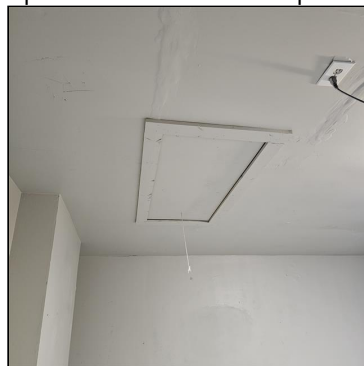
Attic access over garage inaccessible- pull down ladder did not open when operated with normal force.

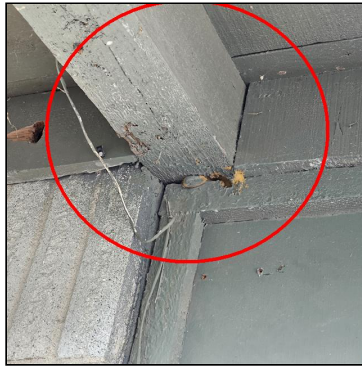
All exterior siding butt & transitional joints that are separated more than 1/8" should be re-sealed (caulk and paint) to prevent moisture incursion.

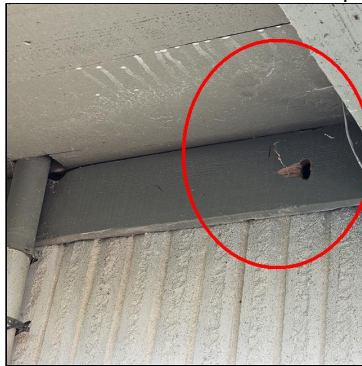
It is recommended that all protrusions through the exterior siding and fixtures mounted on the exterior be sealed in order to prevent moisture incursion. Using a quality exterior caulk type sealant around pipes, wires, light fixtures etc. can prevent moisture related failure of electrical components and siding materials.

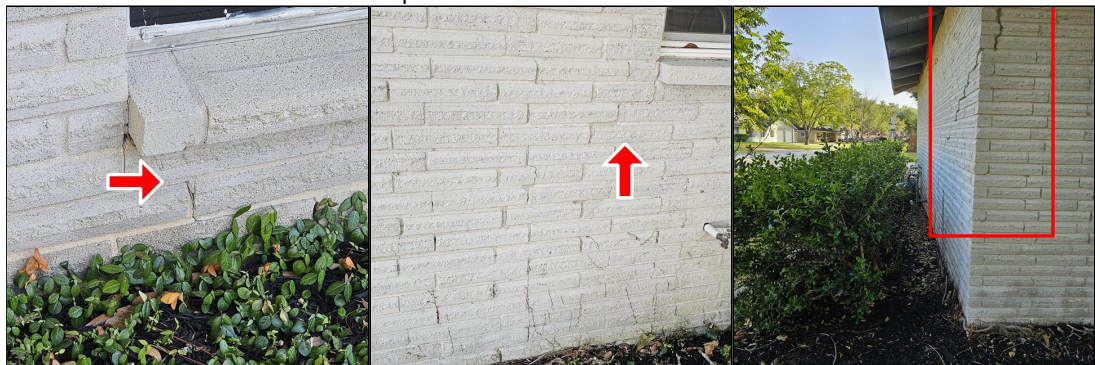
Set cracks in brick, stone and mortar observed in various locations. These cracks should be repaired to prevent moisture intrusion and further expansion.

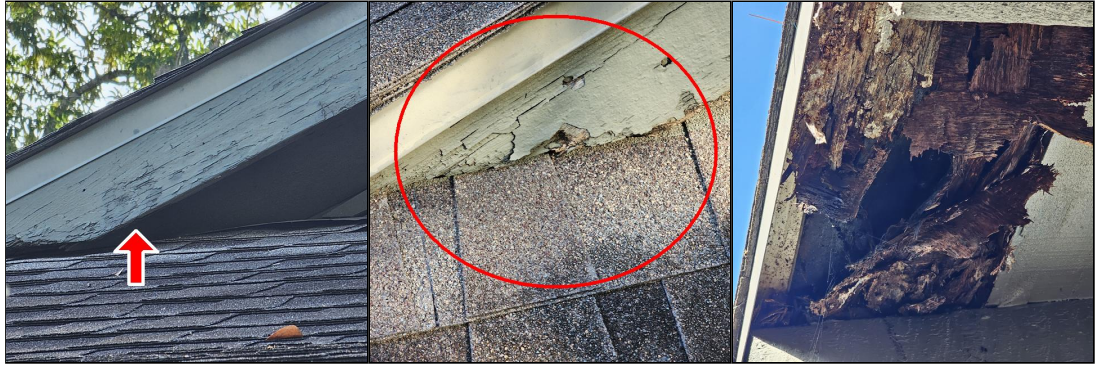
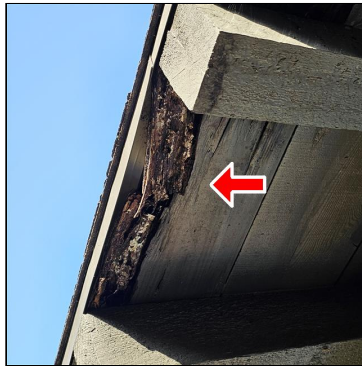
There are areas of the rear of exterior that have sustained varying levels of water (rot) damage and is in need of repair.

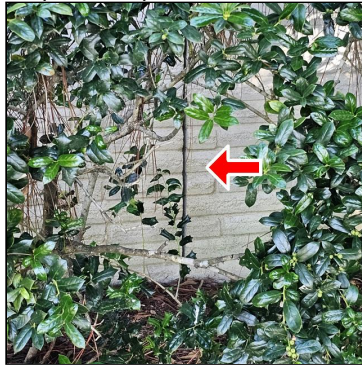
Control joints require added joint compound to prevent water incursion into wall space.

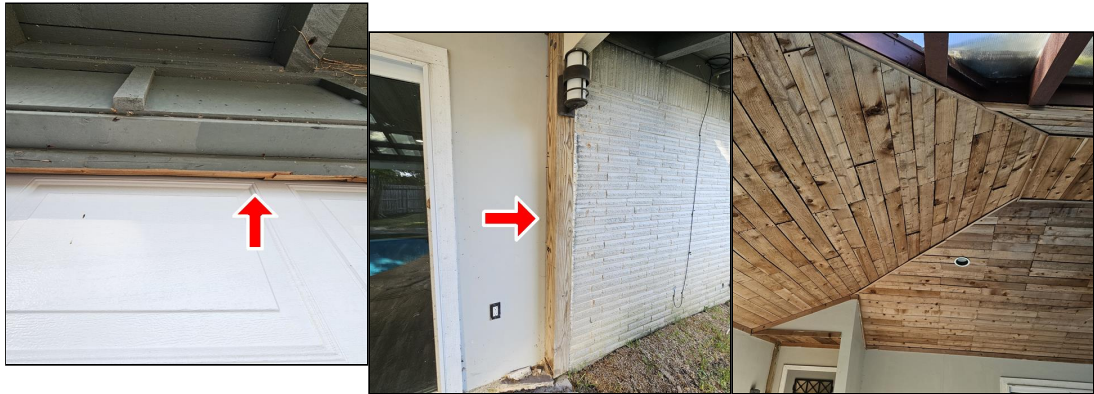
Top of garage door frame.

Seal (paint) all exposed wood surfaces around the exterior of the home to include any bare wood, joints in siding and trim, etc.

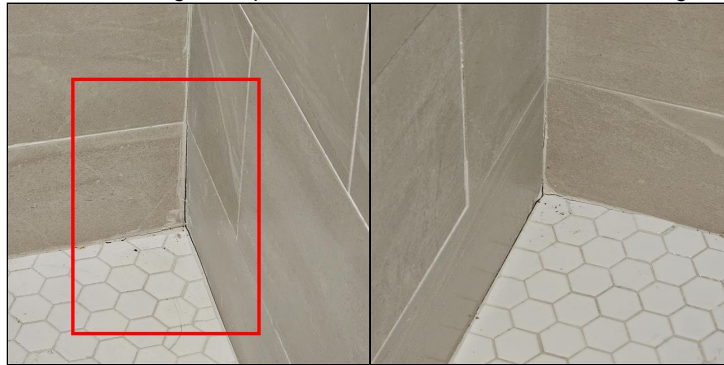
Noted that wall seams and/or fixtures in tub/shower area are not well sealed. Recommend all affected areas are sealed with approved sealant to ensure water spray from enclosure does not infiltrate behind walls over time which could cause future damage and possible health concerns with microbial growth.

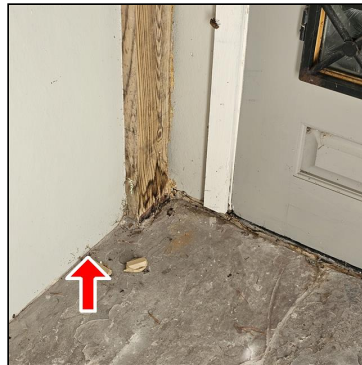
Noted rear wall at pool area does not appear to be properly rated for exterior wall covering with necessary vapor barrier etc.. Repair.

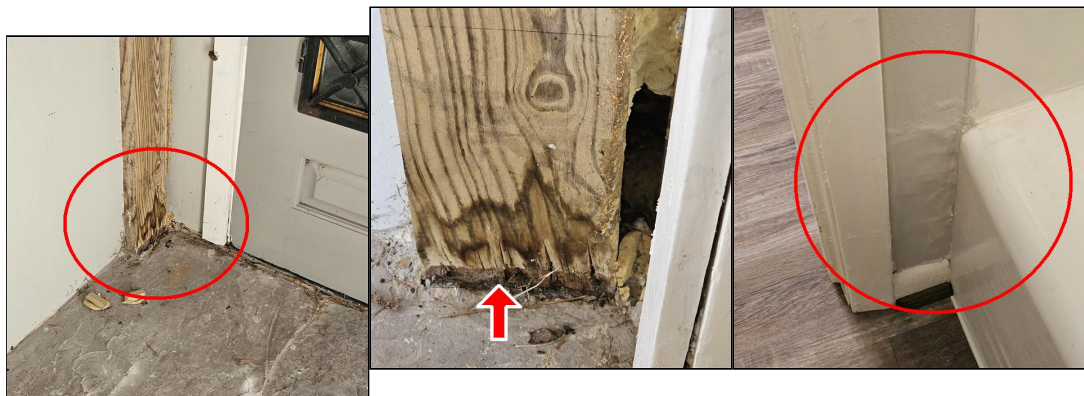
Near rear bathroom exterior door.

There are areas of the interior walls that have sustained varying levels of water damage and is in need of repair. Most notably at bedroom to right of hall bath under window, wall behind toilet in hallway bath, and master bath next to tub.

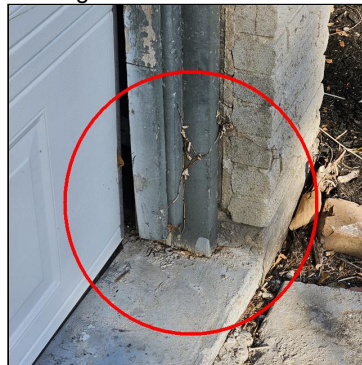
The wood garage door jambs were not undercut at a 45 degree angle. Wood to slab joints should be sealed (caulked) to prevent lower jamb water damage.

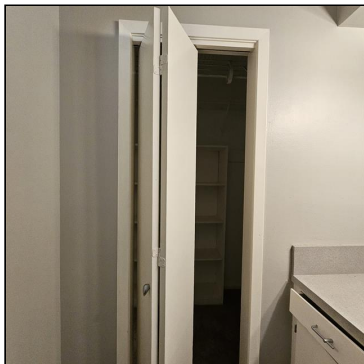
Noted multiple doors that are not aligned to operate as designed, loose hardware, missing hardware, etc. Recommend repairing as needed.

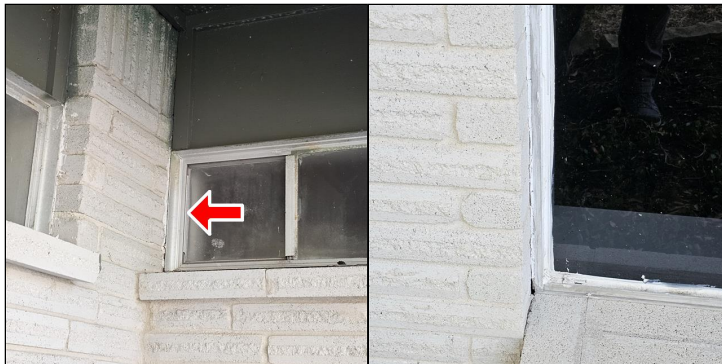
Fresh sealant/caulk applications recommended on exterior window frames at walls. This is an ongoing maintenance item that should be performed on a regular basis to prevent the entry and subsequent damage from water/moisture.

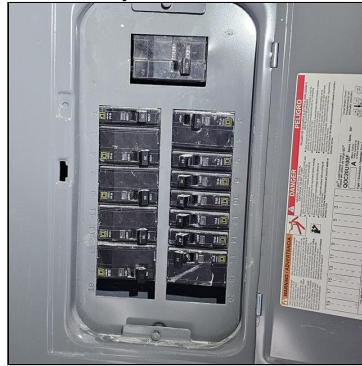
Comments:
All breakers should be properly labeled to identify branch circuits controlled

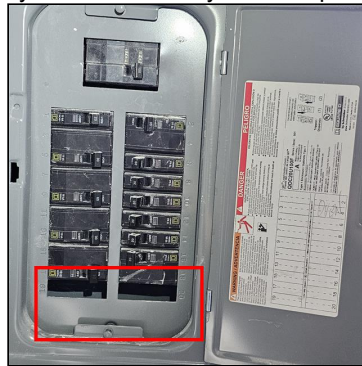
Knockout covers are missing in the main panel. These should be replaced to prevent access to live electrical components, preventing injury. These are easily installed plastic inserts.

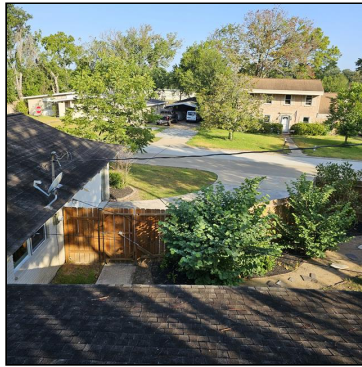
The electrical service conductors clearance (outside) from the ground is less than 10 feet. Line should be raised by a licensed electrician.

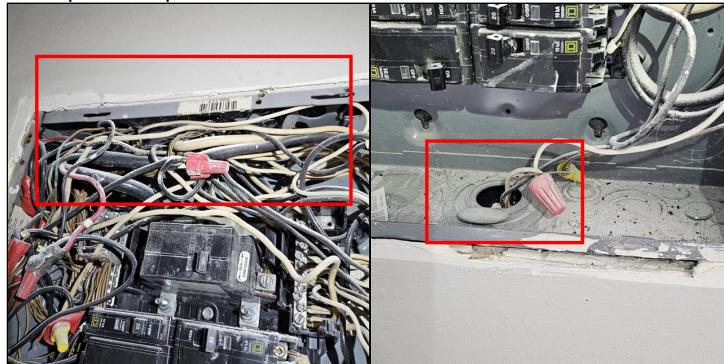
Conductors should enter panels through conduit bushings, and not make contact with panel sheet metal. These are easily installed plastic clip inserts.

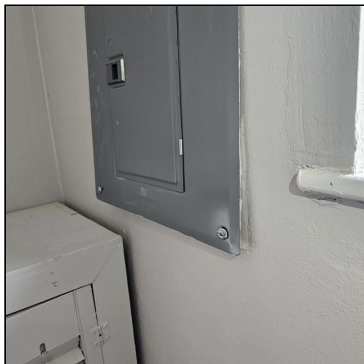
Dead front panel not properly aligned or secured. Repair.

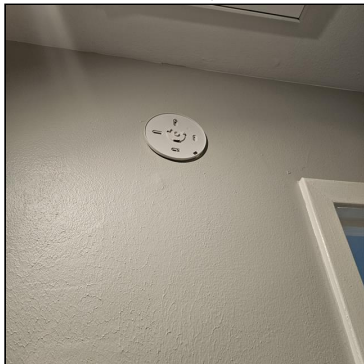
There are no bedroom or hallway smoke detectors installed. Today's standards now require smoke detectors in and directly outside of (hallways) all sleeping areas and on each level for multiple story structures. Additionally today's modern detectors are interconnected, so if one sounds they all sound.

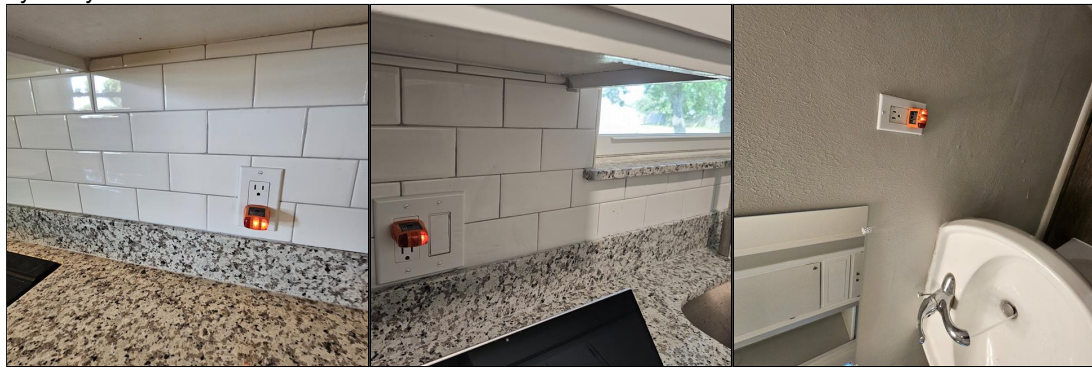
Kitchen counter top and bathroom outlets are not Ground Fault Circuit Interrupt (GFCI) protected as called for by today's standards.

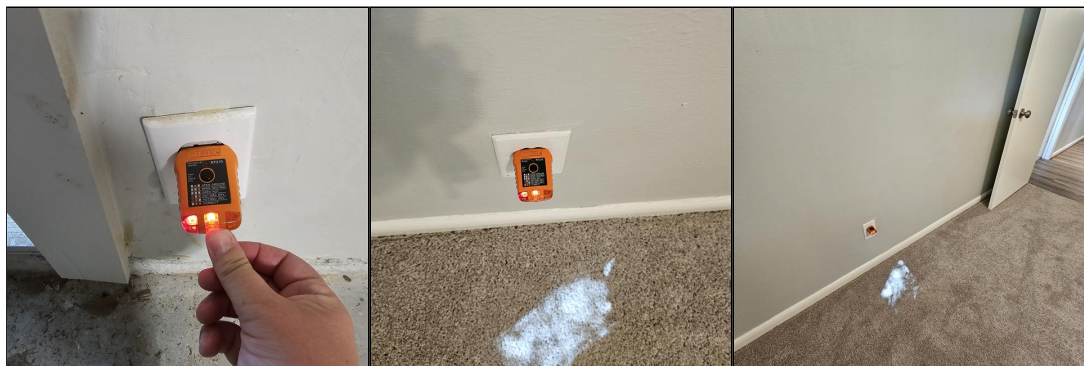
There was a circuit with an open neutral observed in the kitchen (above dishwasher) and in the garage to left of door. The cause should be diagnosed and repaired by a licensed electrician.

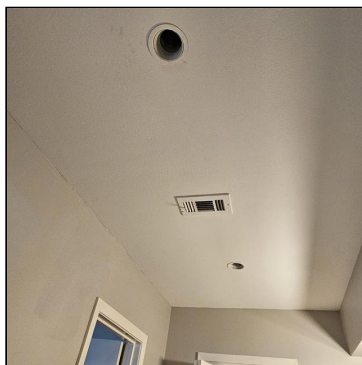
Some lights were not functioning. These are usually just a case of burned out bulbs. Recommend replacing bulbs before closing as needed. If fixtures are still not functioning, then a licensed electrician should diagnose for deficiencies.

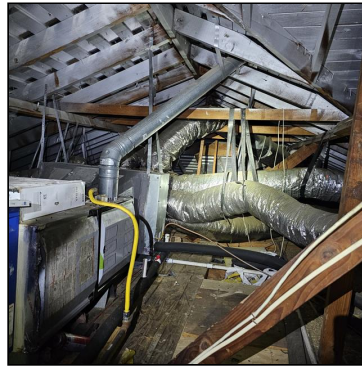
The temperature differentials were off by 5 or more degrees when measured at random vents. This may be corrected by balancing ducts and will provide a more even temperature distribution throughout the house.

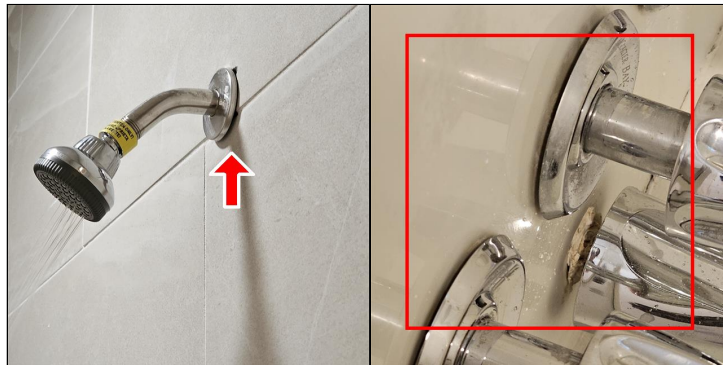
Home has original galvanized supply lines. Lines of this age are known to develop leaks and clogs overtime. Supply problems may not be detectable until they actually fail. Consider updating these supply lines. Consult with licensed plumber for options and pricing.

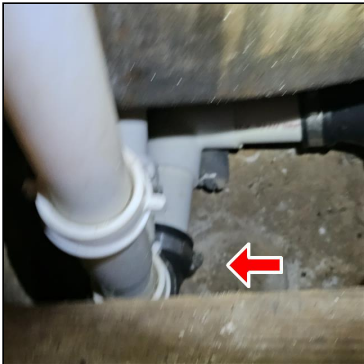
☒ Home has a combination of original galvanized cast iron and some new PVC drains and vents. Iron lines of this age are known to develop leaks and clogs overtime. Drain problems may not be detectable until the home is placed back into normal occupancy use

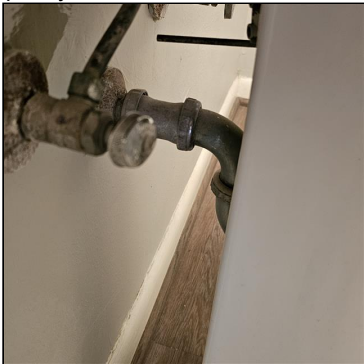
☒ The p-trap on waste line is leaking at the master bath sink. I recommend a qualified licensed plumber repair or correct as needed.

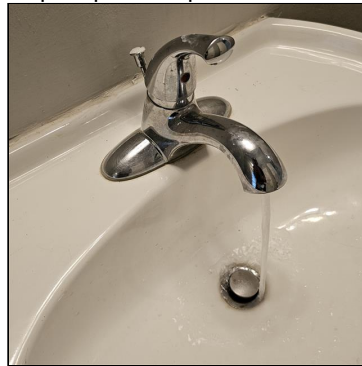
Have all missing/non-functional drain stops repaired/replaced.

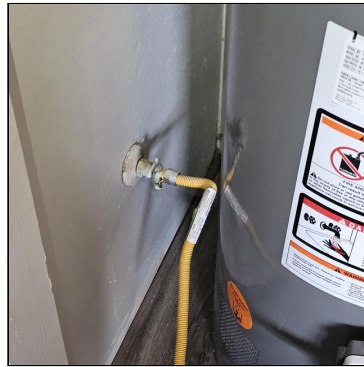
No gas service to unit at time of inspection. Unit could not be operated for inspection. Return inspection recommended after service has resumed.

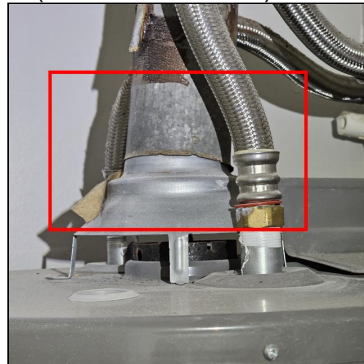
The water heater flue is not secured (sheet metal screwed) to the combustible draft hood.

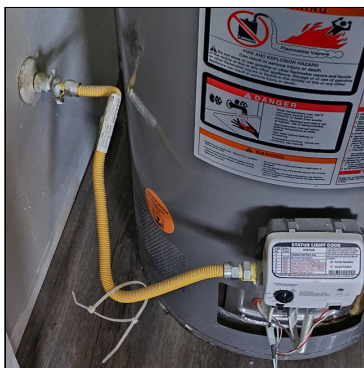
Gas supply to the water heater(s) is missing a sediment trap, or drip leg as called for by current standards (2008).

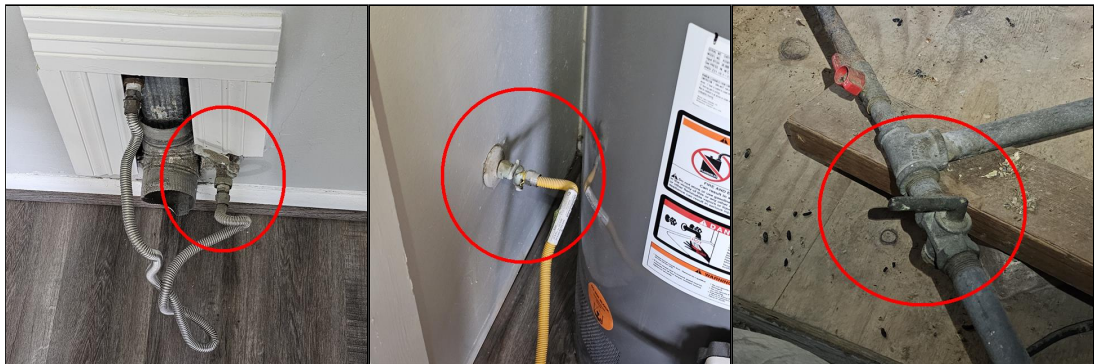
Older "grease pack" gas valves are out of code, and are known to leak over time. These should be replaced.

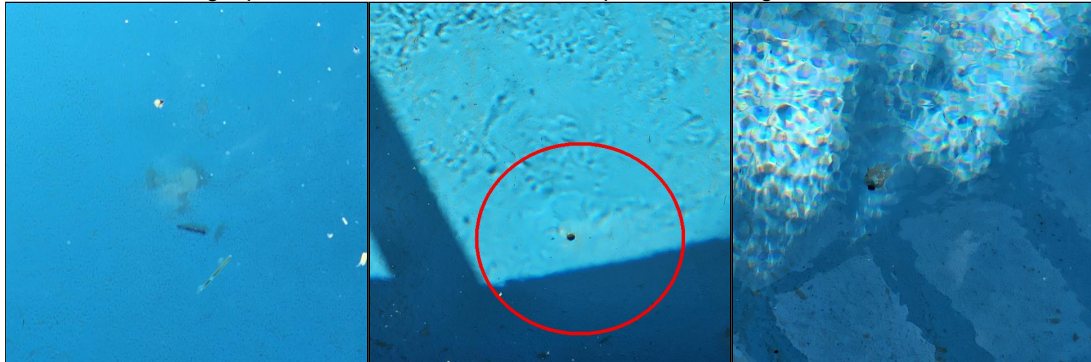
Current safety standards (12/07) require that pool drains be placed at minimum 3ft apart, or on two different planes to prevent a suction hazard (small children). The drains must also have an anti-vortex cover to further prevent injury. This pool did not appear to comply with current standards. More information is available at: <https://www.poolsafely.gov/blog/simple-safety-steps-series-ensure-all-pools-and-spas-have-vgb-compliant-drain-covers-and-teach-your-children-to-stay-away-from-drains/>

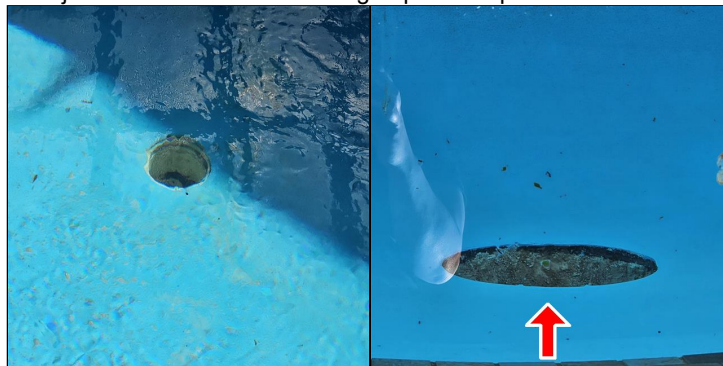
Noted drain, light and jet nozzle covers are missing at pool. Repair
