RedFish Inspections

Property Inspection Report

16118 Arborlea Dr, Friendswood, TX 77546
Inspection prepared for: Del Whittington
Real Estate Agent: Cindy Kipling - Realty Associates

Date of Inspection: 5/4/2022 Time: 2:30 PM - 6:00 PM
Age of Home: 30 years old Size: 2228 sqft
Weather: Mostly Cloudy

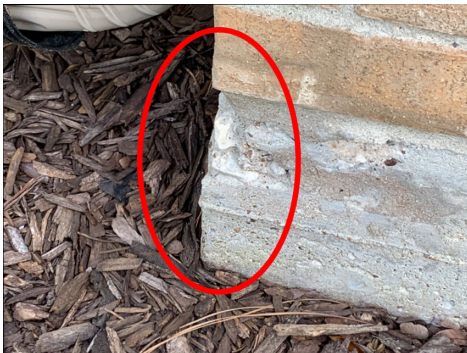
Corner cracks were noted on one or more corners of the foundation. Corner cracks are generally caused by the early removal of form boards and/or improper **flashing** installation between the slab and the brick veneer/stone veneer. No structural defect was noted with this condition. We recommend having these cracks patched/sealed to minimize the opportunity of insect infestation. This was observed on the front, front left, rear left

Front: Corner crack

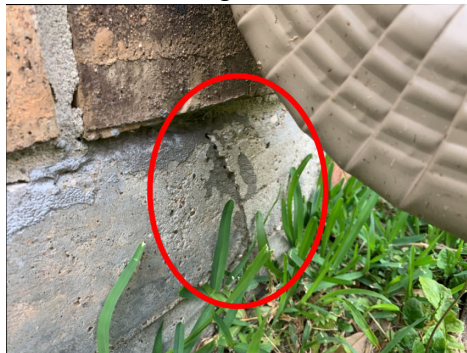
Front: Left: Corner crack

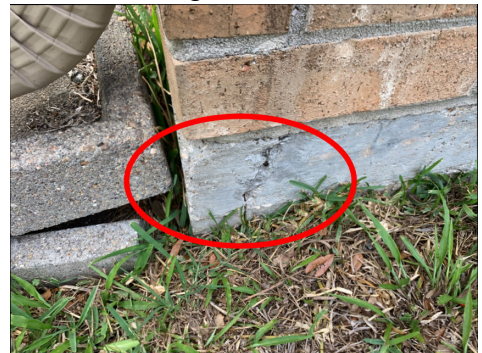
Rear Left: Corner crack

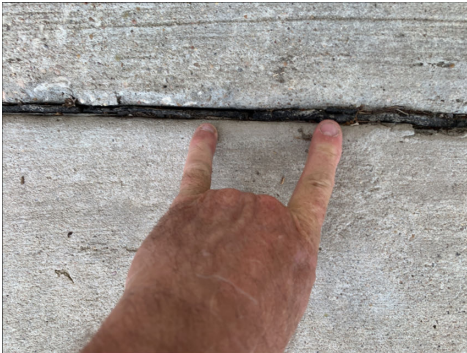
The structure had attaching slabs “expansion joints” between the driveway and the garage/house. This is a location for wood destroying insects (termites) to enter the home. Home owner needs to perform frequent inspections of these areas.

Driveway/walk to foundation: Monitor area for insect activity

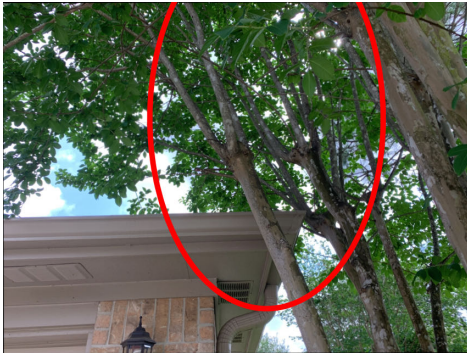
Foliage was noted close to the structure. We recommend trimming all bushes away from structure. Bushes and trees too close to the structure can prevent the wall from drying properly, their roots can affect the foundation, and their branches can damage the structure. This was located on the Right Front, front.

Right Front: Foliage close to structure

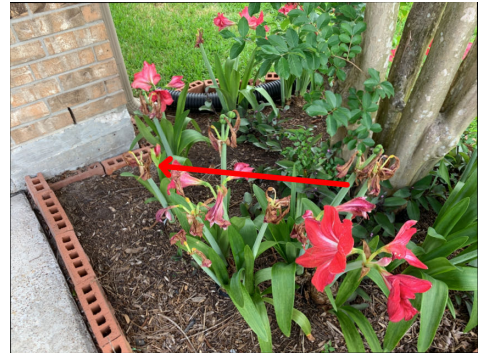
Tree roots adjacent to the structure could have a potential of damaging the foundation. We recommend consulting with a professional, competent and qualified arborist for the best solution to protect the structure as well as the tree. These roots were located on the Right Front.

Right Front: Tree roots adjacent to foundation

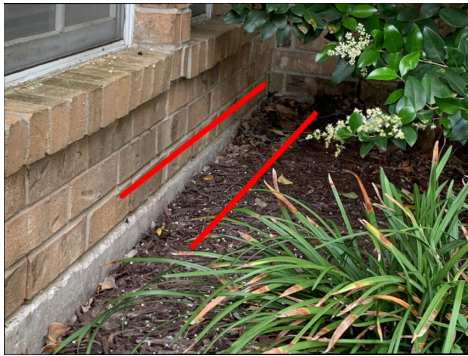
High soil was observed around the structure. We recommend having 4 inches minimum clearance between soil/brick and 6 inches minimum clearance between soil/siding and/or stucco, in order to prevent moisture intrusion/damage, as well as conducive conditions for wood destroying insects and other pests. The high areas were observed on the front.

Front: High soil

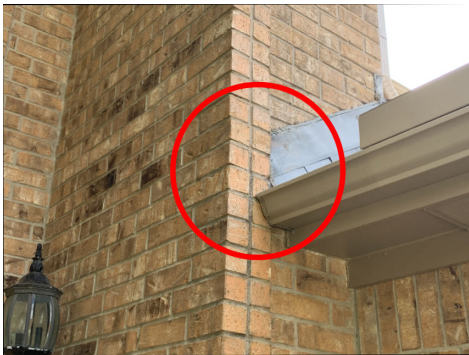
Kickout flashings were missing where the wall continued past the roof. These would help divert water away from the structure and into the gutters. We recommend having these added.

Front: Missing kickout flashing

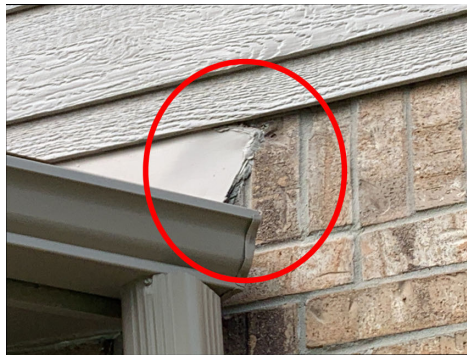
Rear: Missing kickout flashing

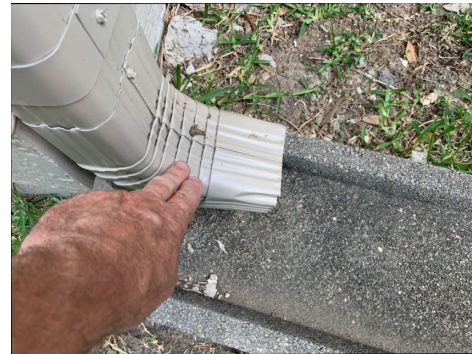
One or more downspouts were discharging too close to the foundation. We recommend having downspouts discharge water at least five (5) feet from the house. Storm water should be encouraged to flow away from the building at the point of discharge.

Downspout extension missing

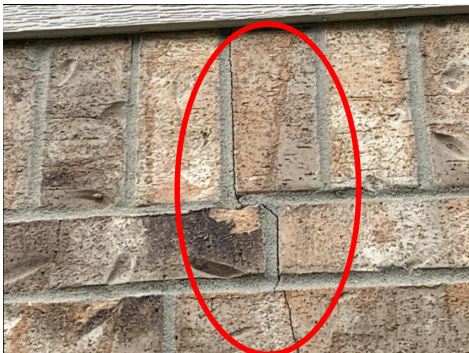
A step crack was observed on the exterior brick veneer. This typically is an indication of structural movement. We recommend patching and monitoring. This was noted on the rear.

Rear: Step crack

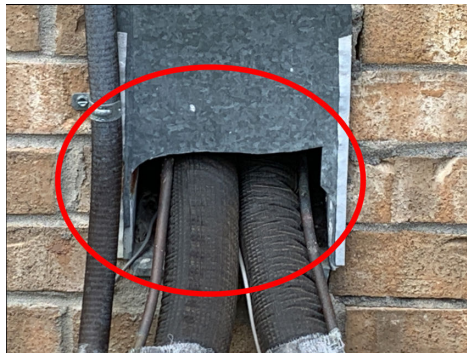
Holes were noted where the air conditioning refrigerant lines and plumbing pipes entered the structure. We recommend sealing the area with foam insulation to prevent pest intrusion. This was located on the left, right.

Left: Hole in wall at AC lines

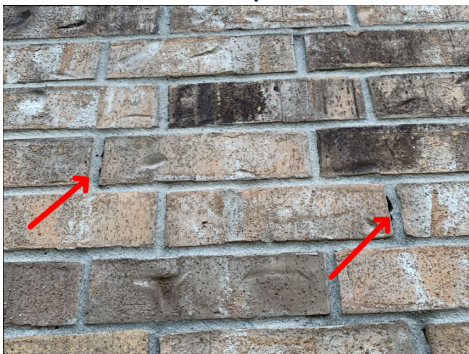
The mortar at the exterior brick veneer was deteriorated. We recommend having this repointed to prevent excess moisture intrusion. This was observed on the left.

Left: Deteriorated mortar

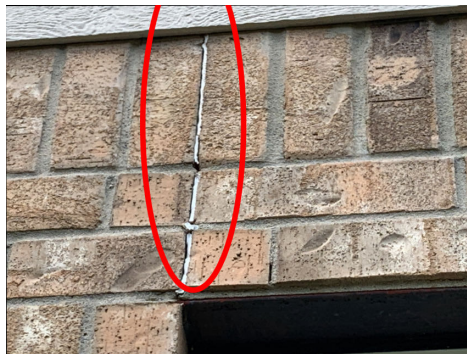
An expansion joint on the exterior brick wall had deteriorated caulk. We recommend re-caulking to prevent excessive moisture and insect intrusion. This was noted on the left.

Left: Caulk deteriorated at expansion joint

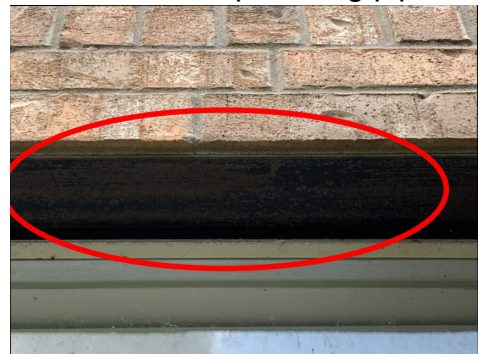
The lintels over the openings (windows/doors) were found to be rusted. These elements support the brick veneer above the openings. We recommend having them (re)ainted to prevent deterioration.

Rear: Rust on lintels

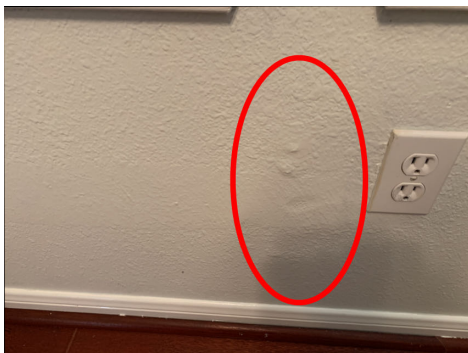
Wall patching was noted. This indicates previous work was performed and we recommend monitoring the area.

Bedroom 1: Patching

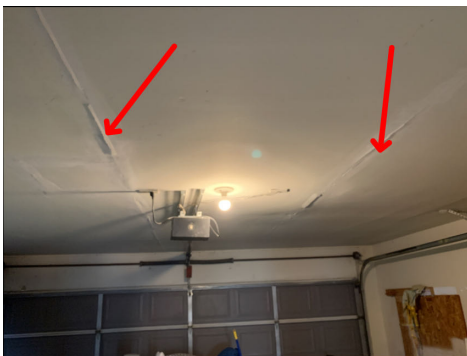
Hairline cracks, which were by nature mainly cosmetic, were noted on the ceiling. We recommend having these caulked and painted.

Garage: Hairline crack

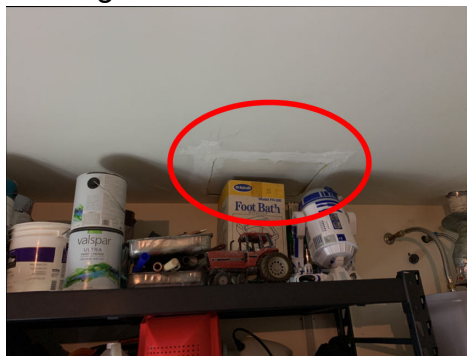
Evidence of patching was detected, which indicates previous work performed. We recommend monitoring.

Garage: Patching

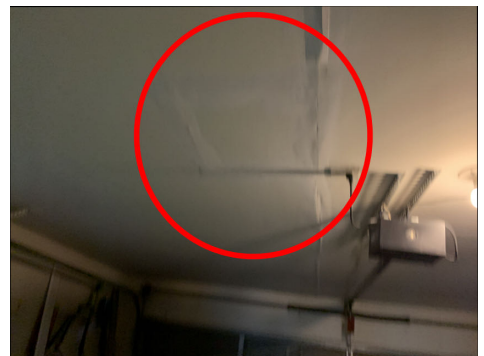
Garage: Patching

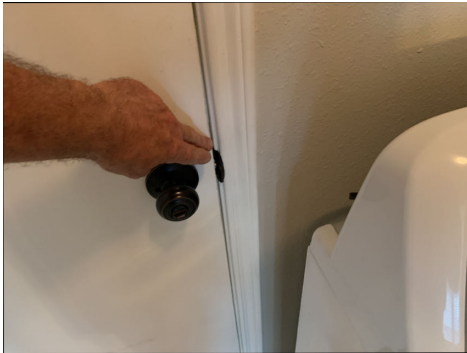
A door in the house would not latch when shut. We recommend having the door and/or hardware adjusted. This was noted in the .

Garage Man Door: Would not latch

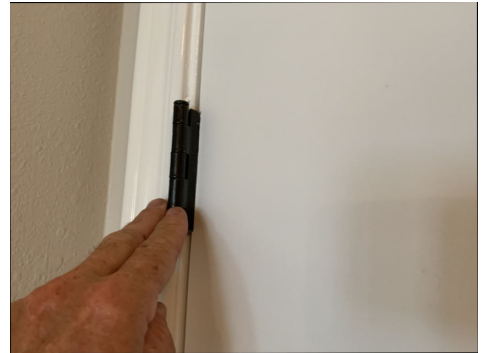
The door between the garage and the interior of the house was not equipped with an auto-closer device. We recommend having one installed to prevent automobile fumes from entering the house.

Garage man door: Auto-close device recommended

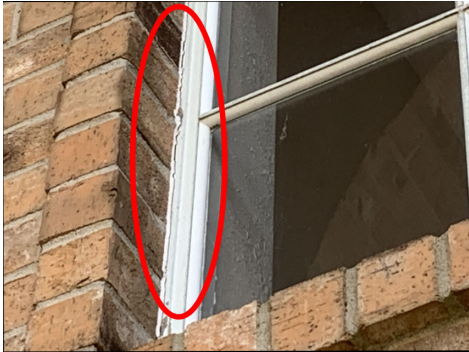
The exterior and interior caulk around the windows was deteriorated. We recommend repair. Exterior caulking is the first energy efficient measure to install. The purpose of exterior caulking is to minimize air flow and moisture through cracks, seams, utility penetrations and openings. Controlling air infiltration is one of the most cost effective measures in modern construction practices, a home that is not sealed will be uncomfortable due to drafts and will use about 30% more heating and cooling energy than a relatively air-tight home. In addition, good caulking and sealing will reduce dust and dirt in the home and prevent damage to structural elements.

Front: Deteriorated caulk

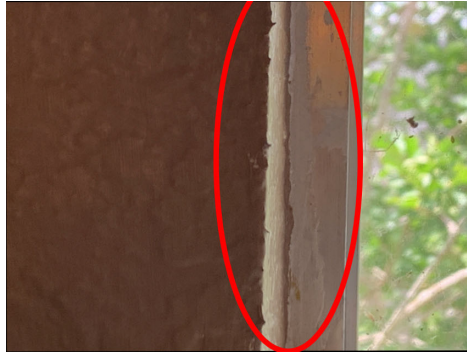
Bathroom 2: Deteriorated caulk

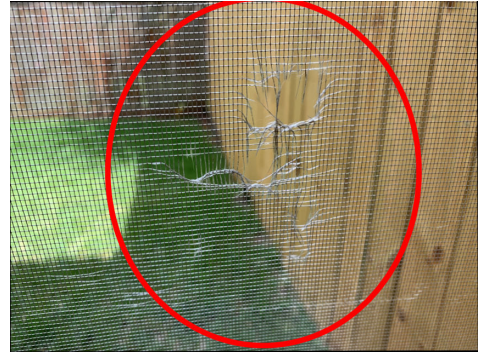
Damaged window screens were found. We recommend having these replaced to prevent insect intrusion. This was observed throughout the house.

Dining Room: Damaged screen

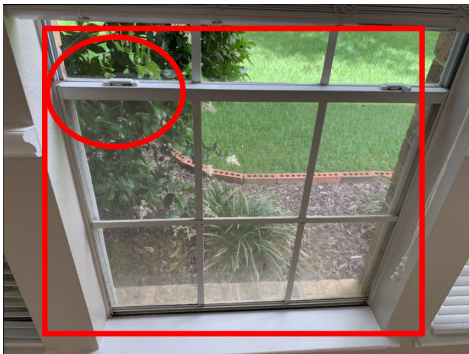
A window was inoperative. We recommend having this repaired/improved to allow proper use as intended as an egress. This was observed in the front room.

A window in the house had a faulty latch. We recommend having this repaired to operate as designed. This was observed in the front room.

Front Room: Inoperative window / faulty latch

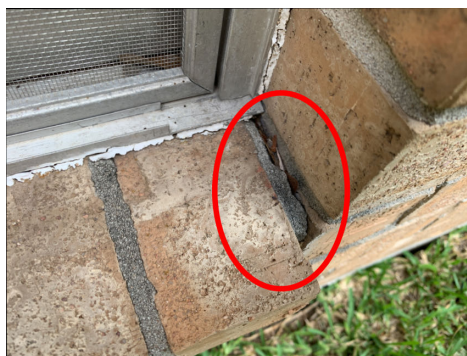
Deteriorated mortar was observed at a window ledge at the time of inspection.

Left: Deteriorated mortar

We recommend having this repointed to avoid moisture intrusion into the structure and help keep the bricks secure. This was observed on the left and rear

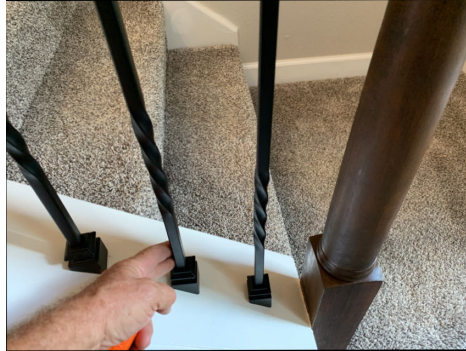
Loose spindle

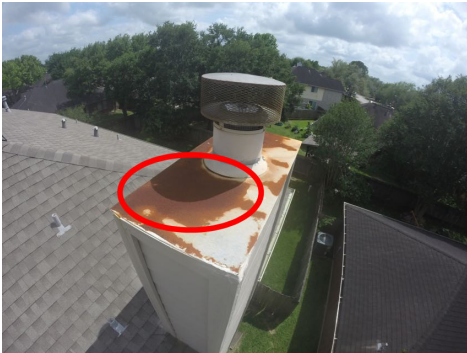
The chimney metal crown was corroded. We recommend having this cleaned, treated and painted to prevent further deterioration.

Crown deteriorated

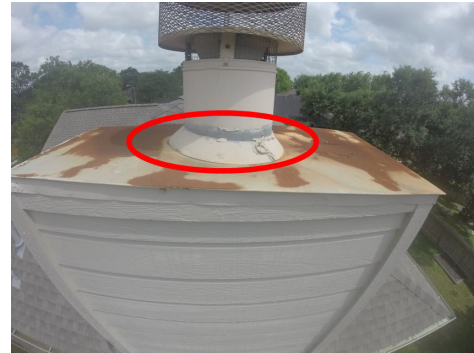
The sealant at many of the flashings and protrusions was deteriorated. This condition is not uncommon as roofing cement and caulk can degrade quickly depending on the amount of sun exposure. Sealants should be inspected and maintained on an annual basis to prevent water intrusion.

Deteriorated sealant

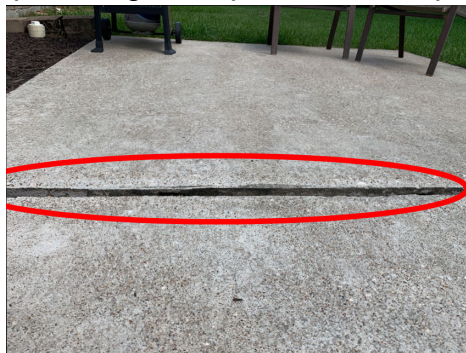
The patio was upheaving. This presented a trip hazard. We recommend repair.

Patio: Upheaving

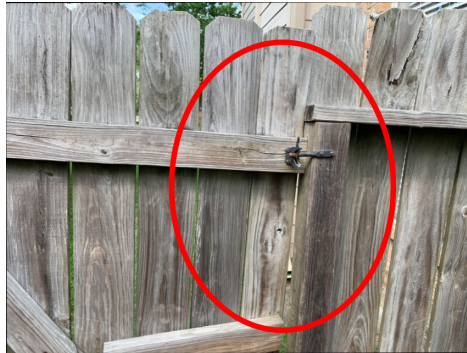
Unable to operate the gate

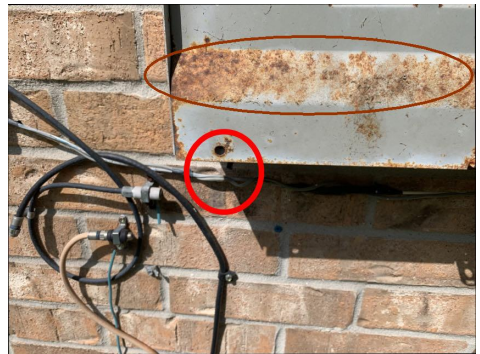
Screw missing and rust on dead front

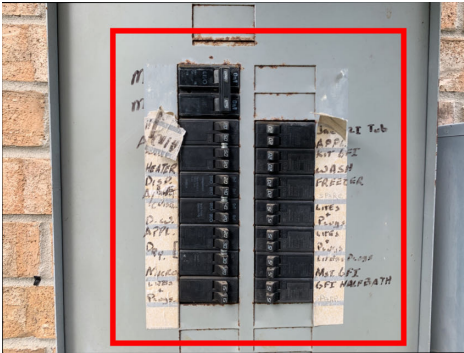
Labels partially missing

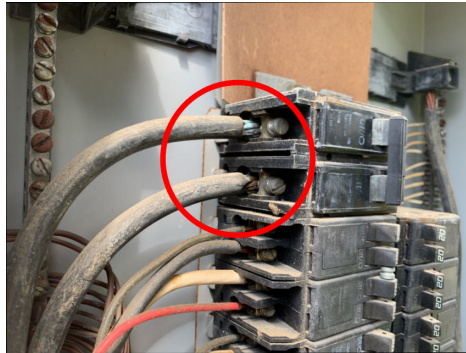
Missing antioxidant paste

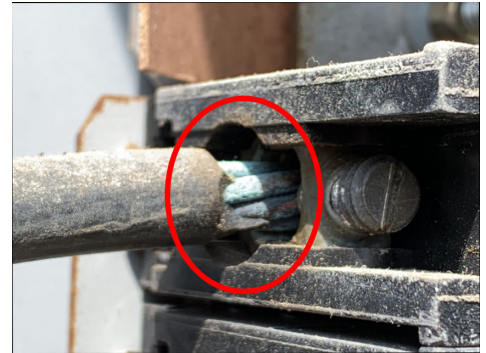
Oxidation on aluminum feeder

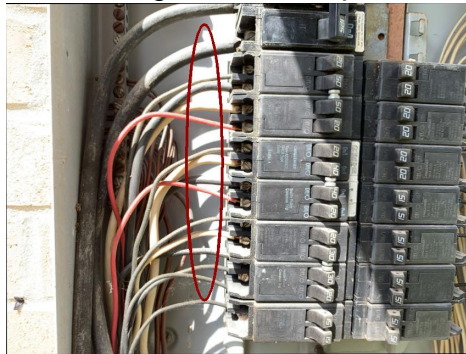
An ungrounded conductor (hot) was improperly identified. We recommend having this permanently re-identified.

Conductor improperly color labeled

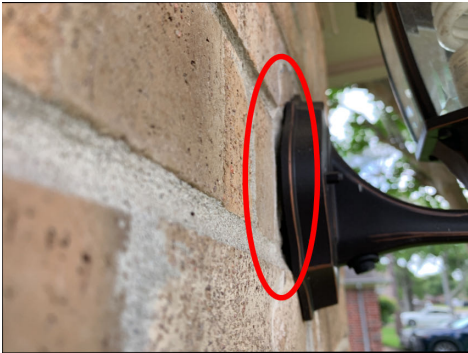
Around House: Caulk missing at fixture to wall connection

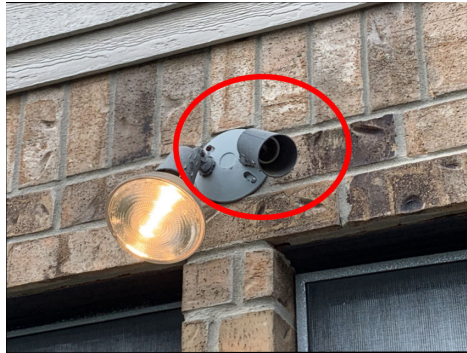
Rear: inoperative light fixture

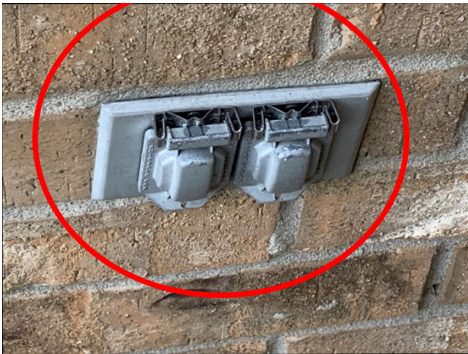
Exterior: Bubble cover recommended

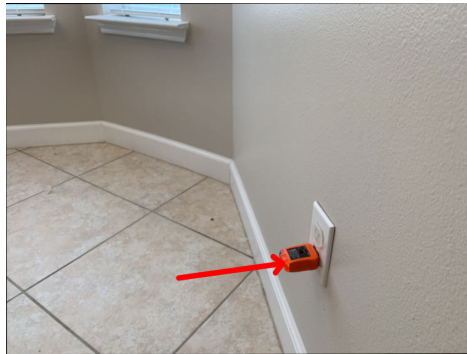
One or more outlets in the home were improperly secured and moved when plugs were inserted. Outlets should be securely installed to prevent fire, shock and/or electrocution hazard. We recommend having these improved. This was observed in the front room, breakfast nook 2nd floor hallway.

Breakfast Nook: Loose outlet

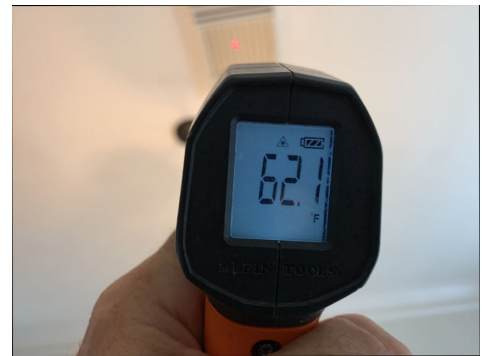
The temperature drop measured at the supply and return registers for the 1st floor unit was lower than considered normal. This usually indicates that servicing is needed. A licensed, professional, competent and qualified HVAC technician should be consulted to further evaluate this condition and the remedies available for correction.

1st floor: vent temperature

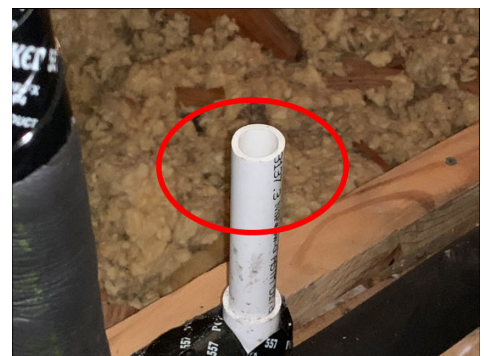
The primary condensate drain line cleanout did not have cap. We recommend adding one to prevent debris from clogging the line.

Unit 1 Cap missing on primary condensate drain line cleanout

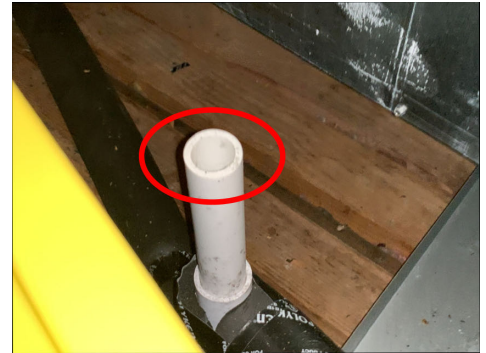
Unit 2 Cap missing on primary condensate drain line cleanout

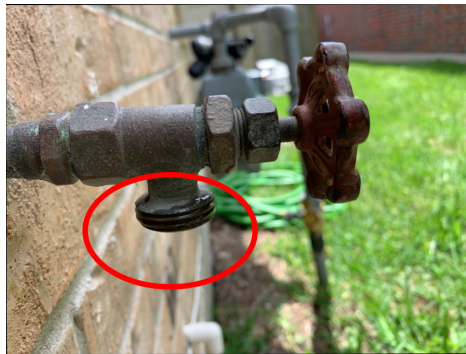
Around house: Back flow preventer recommended

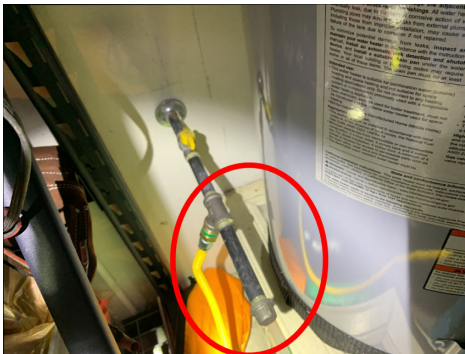
Improper drip leg installation

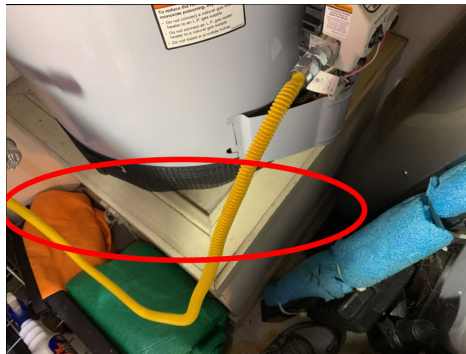
Although the water heater was installed in a location in which leakage of the tank or plumbing connections would cause damage to the structure, no drip pan was installed. We recommend a proper drip pan be installed to prevent possible water damage.

Missing drip pan

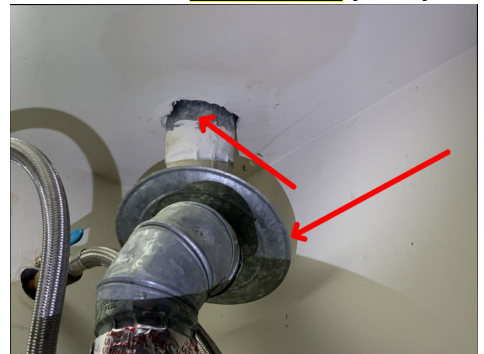
The fire stop at the water heater exhaust flue was found to be loose. We recommend having this properly secured at the ceiling penetration.

Loose fire stop

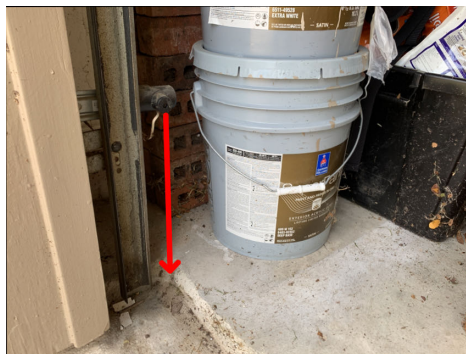
The photo sensor was installed at a height greater than 6 inches. Safety standards designed to protect small children limit the maximum mounting height for garage door photo sensors at 6 inches. We recommend correction by a qualified contractor.

Photo eye sensor more than 6" off ground
