Home Inspection without Pending Sale

Concerning: 959 Grand Jct Dr, Katy, TX 77450

By: Bob Wiesner on Thursday, April 21, 2022

File Number: **TX111516**

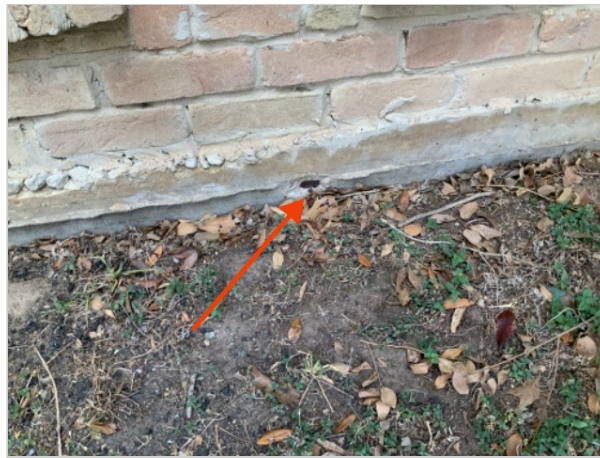
Photo 1

There was exposed rebar on the front exterior wall

Exposed rebar

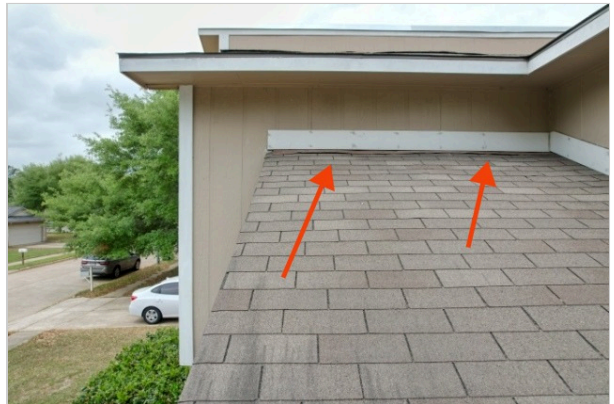
Photo 5

Some of the flashing was raised on the front slope over the front porch, at the wall above the front bedroom, and at the top edge.

Raised flashing

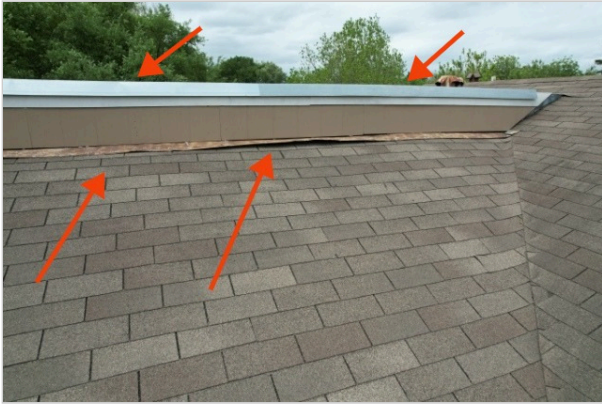
Photo 6

Raised flashing

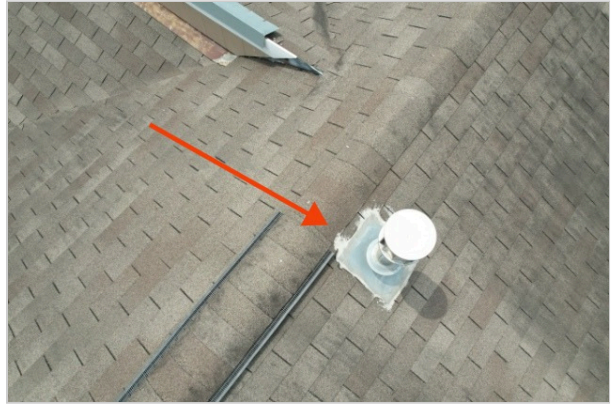
Photo 7

The flashing for the water heater flue was improperly installed (over the shingles instead of wrapping shingles around it).

Improperly installed flashing

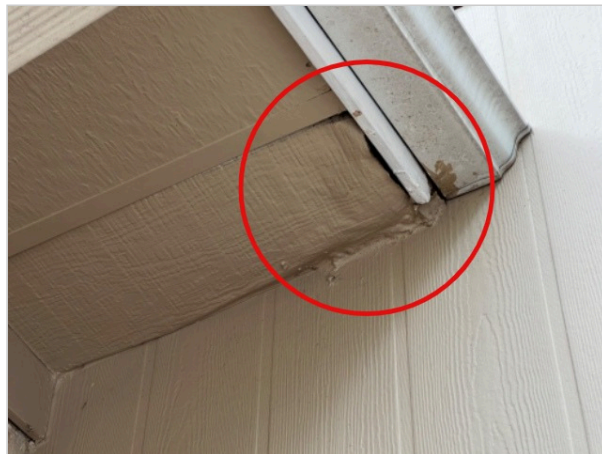
Photo 8

Some of the soffit material on the exterior was damaged / soft.

Damaged wood - above garage

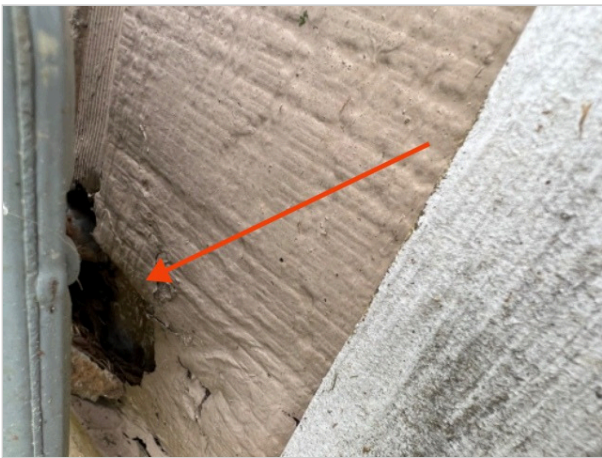
Photo 9

There was a void in the wall behind the gas meter on the rear wall and above one of the exhaust fan terminations.

Void in rear wall

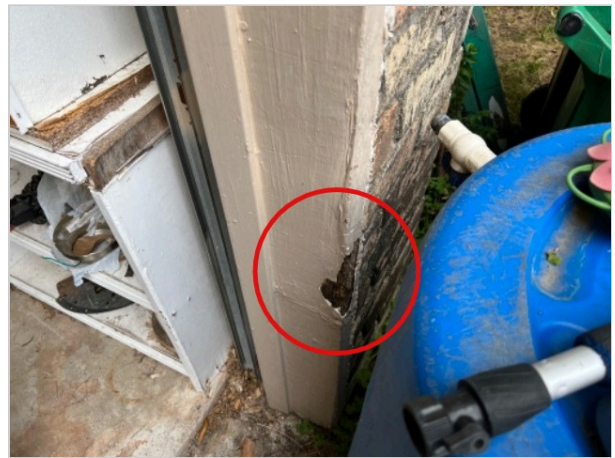
Photo 10

The wood trim on the right side of the overhead garage door was deformed and soft.

Wood damage - overhead garage trim

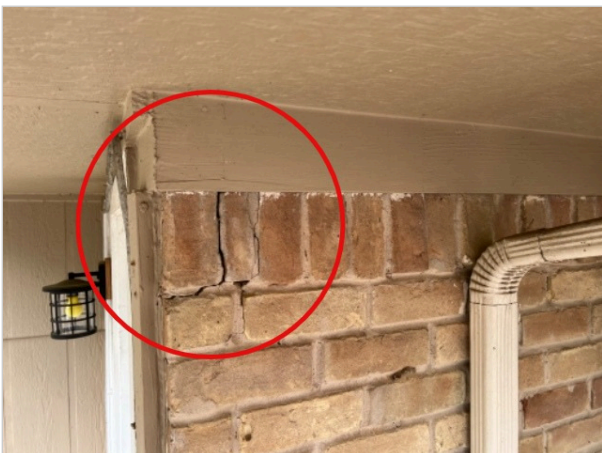
Photo 11

There were several loose bricks that needed re-pointed.

Loose brick - front porch

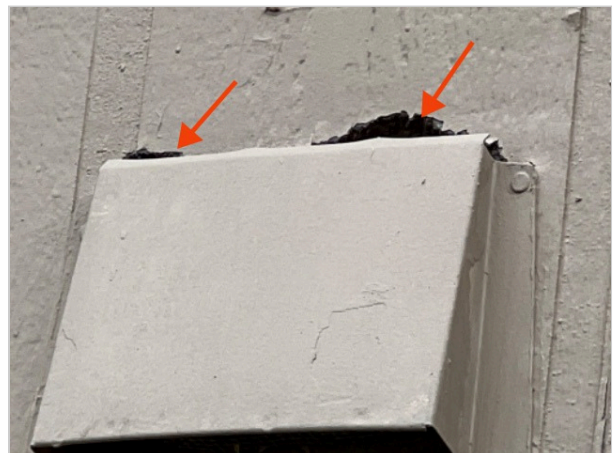
Photo 12

Void in rear wall

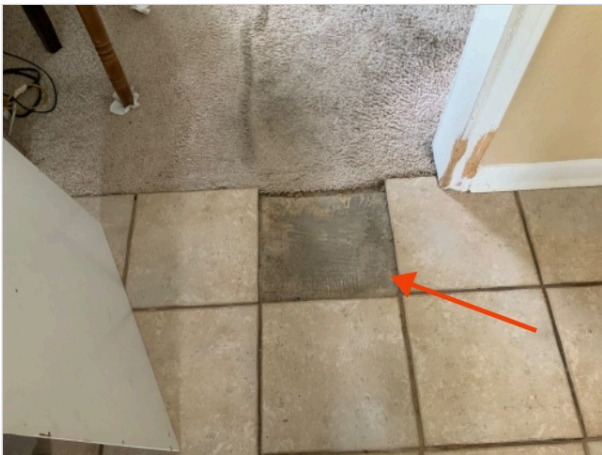
Photo 13

One of the tile pieces in the breakfast room was missing. Also, some tile pieces in the first floor hallway closet were missing.

Tile piece missing from upstairs breakfast / dining room area

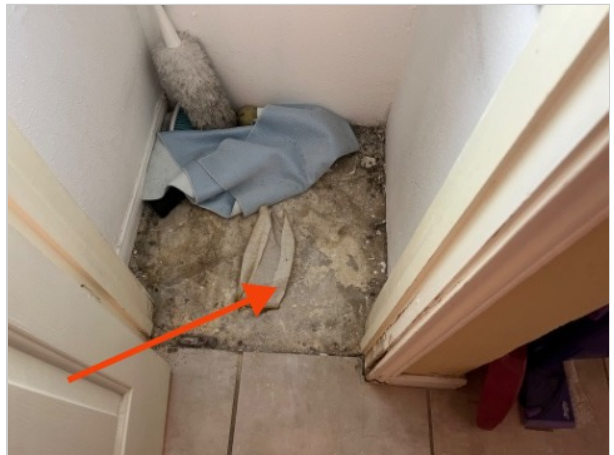
Photo 14

Tile missing from downstairs hallway closet floor

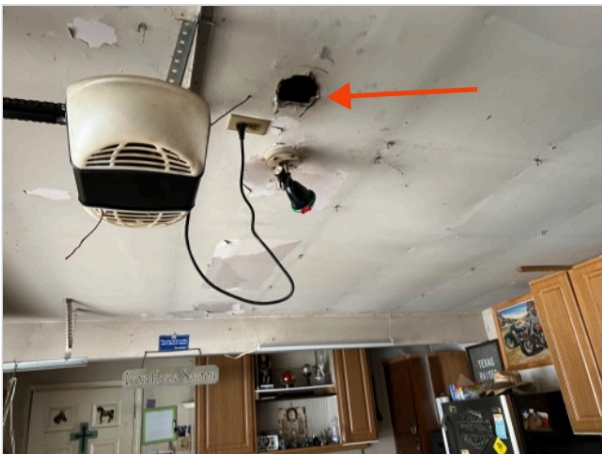
Photo 15

The garage ceiling had voids and appeared to have been peeling. There were no obvious sources of moisture that would cause peeling. However, the voids should be patched. Any attached garage is recommended to be completely finished.

Garage ceiling - void / peeling

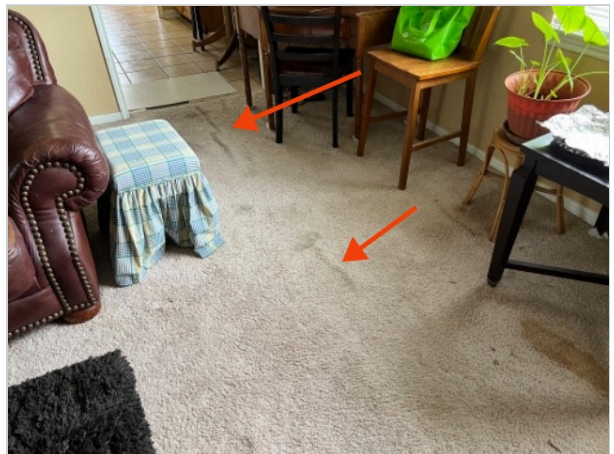
Photo 16

There were ripples in the living room carpet. Ripples are considered a tripping hazard.

Ripples in carpet

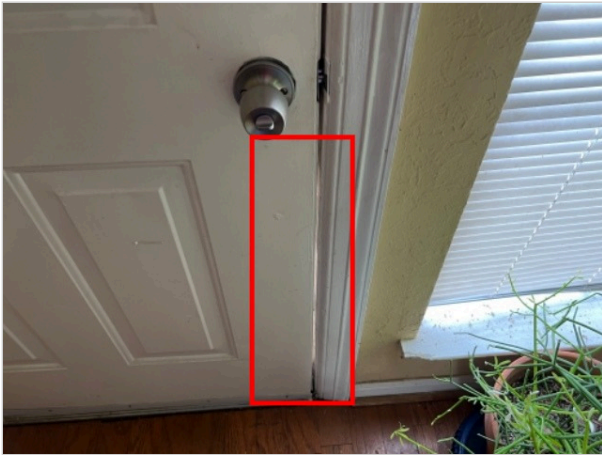
Photo 17

The front entryway door was missing or had damaged weather stripping.

missing weather stripping at front door

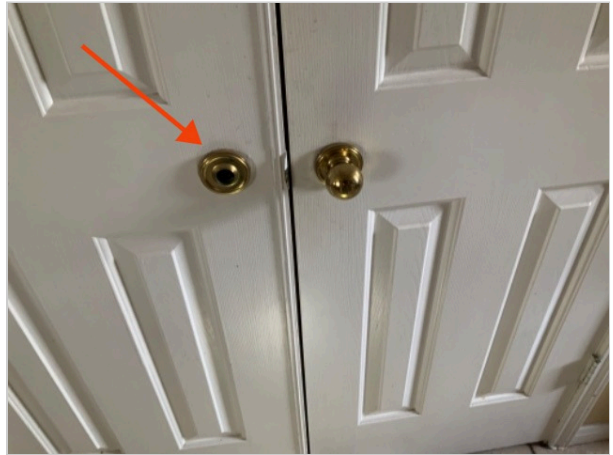
Photo 18

A door knob was missing from the pantry door

Door knob missing - pantry

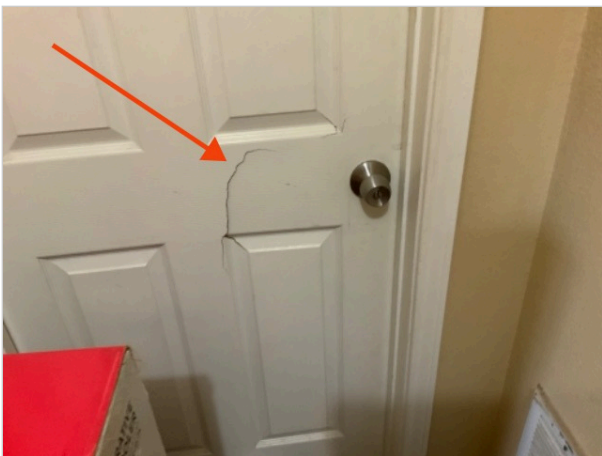
Photo 19

Damaged entryway door

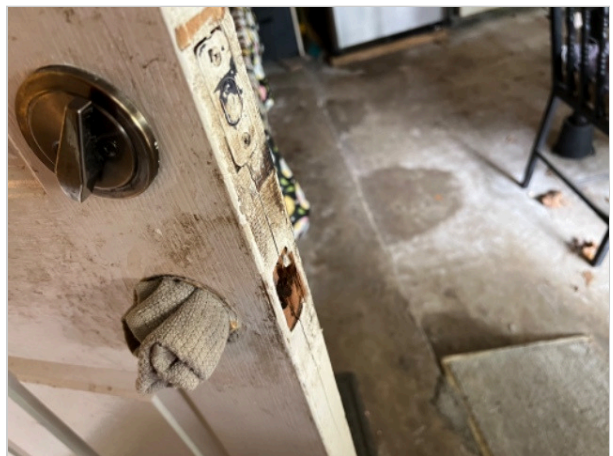
Photo 20

The door from the living area to the garage was damaged, missing a door knob and was not self-closing. As a door that connects living space with an attached garage, the door is recommended to be: protected with a 1 3/8" thick solid wood or honeycomb-core steel door or 20 minute fire rated with a self-closing device (IRC 302.5)

Damaged door from living area to garage

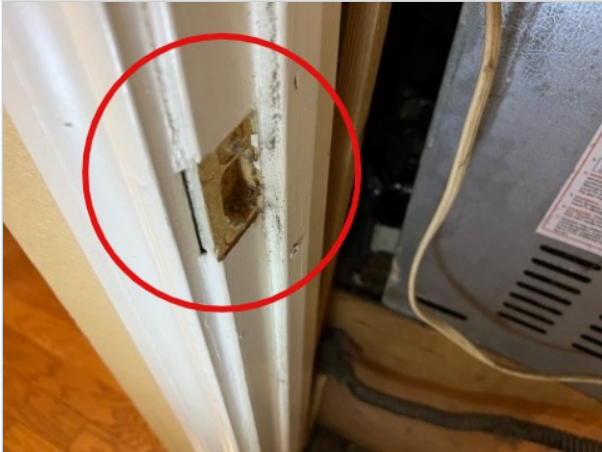
Photo 21

The door to the heater closet had no strike plate.

No strike plate

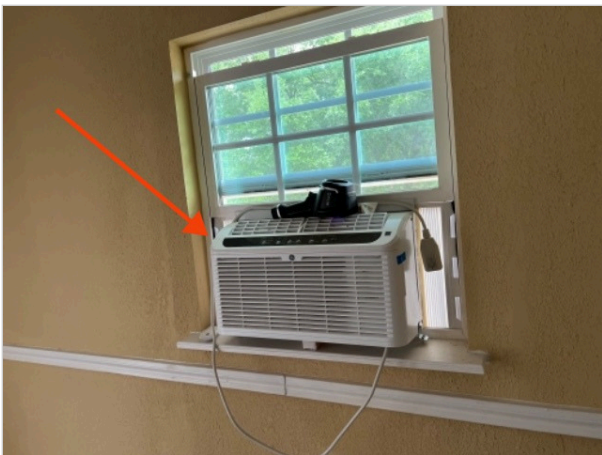
Photo 22

The openable window in the upstairs bedroom was over 44 inches from the floor (emergency egress issue). In addition, the only emergency egress window had an AC window unit installed it.

Only openable window in the upstairs bedroom - AC unit may block egress

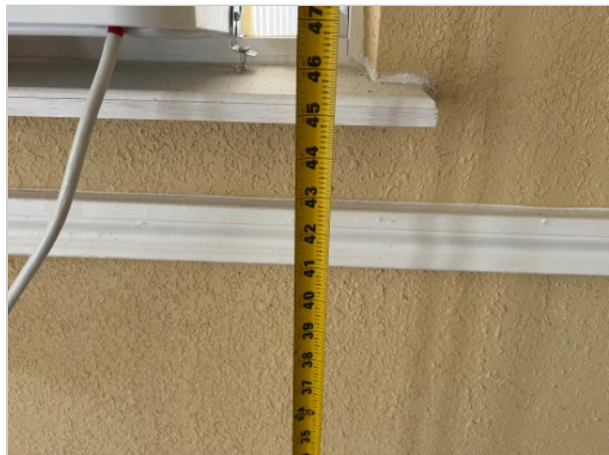
Photo 23

Upstairs bedroom window - Taller than 44" from the floor

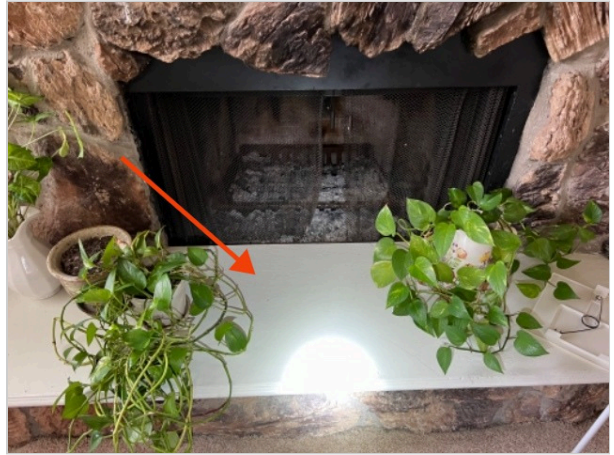
Photo 25

Wooden (combustible) hearth extension

The hearth extension was wooden (combustible). It's recommended that it be removed and replaced with a non-combustible material such as brick or stone.

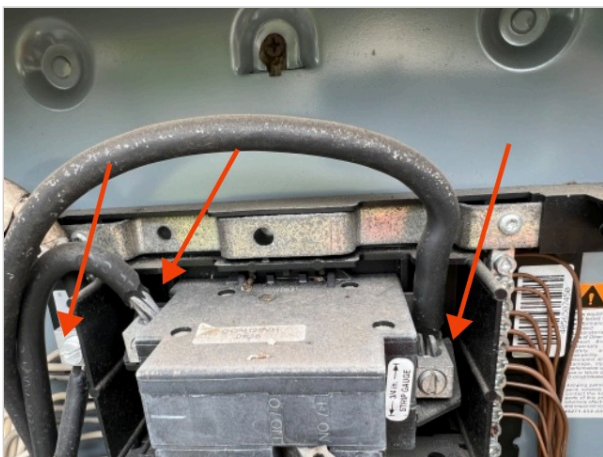
Photo 29

The aluminum service entrance wire ends did not have an anti-oxidant where they connect to the main breaker and the neutral bus.

No antioxidant

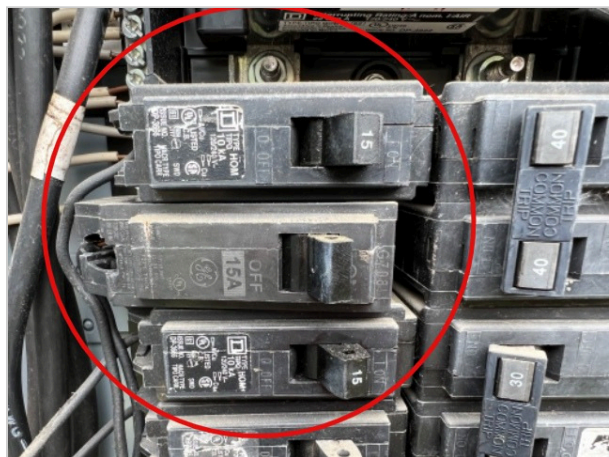
Photo 30

There was a GE circuit breaker in the Square D electrical panel. Circuit breakers made by other manufacturers may not be compatible with another brand panel. We were unable to verify whether or not those breakers were approved for that electrical panel.

GE circuit breaker in Square D box - did not seem to be sitting properly

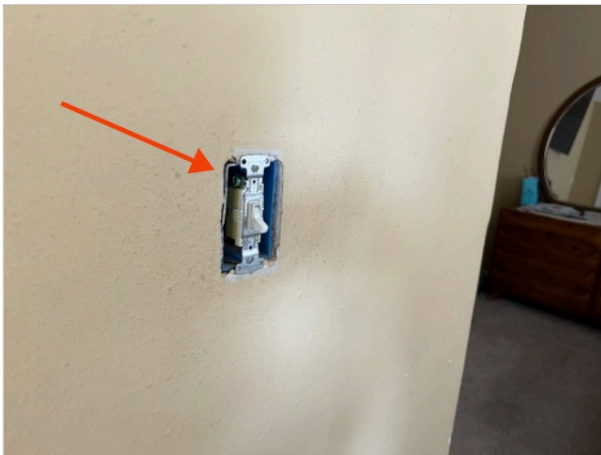
Photo 31

A face plate was missing on the switch and the rear first floor bedroom.

No face plate

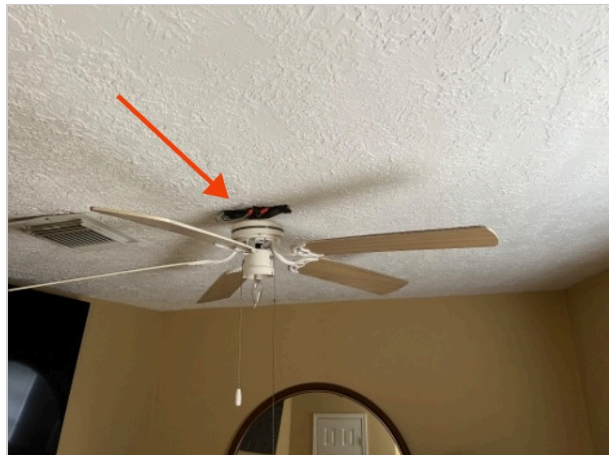
Photo 32

The ceiling fan in the rear first floor bedroom was partially detached from the ceiling.

Partially detached fan & open splices not properly covered

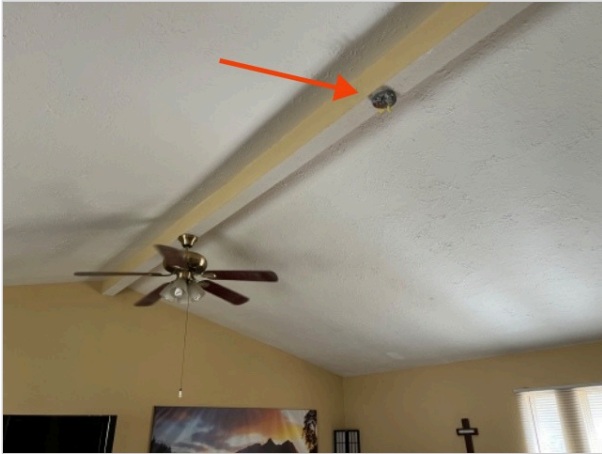
Photo 33

There was an open junction box on the living room ceiling with no fixture / cover.

Electrical junction box without a fixture or cover

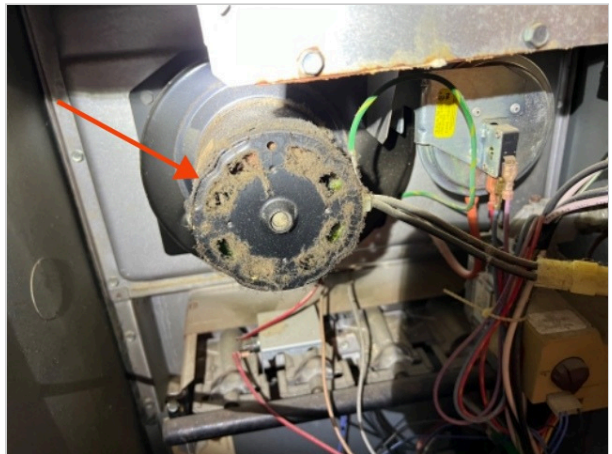
Photo 35

Dirty fan motor

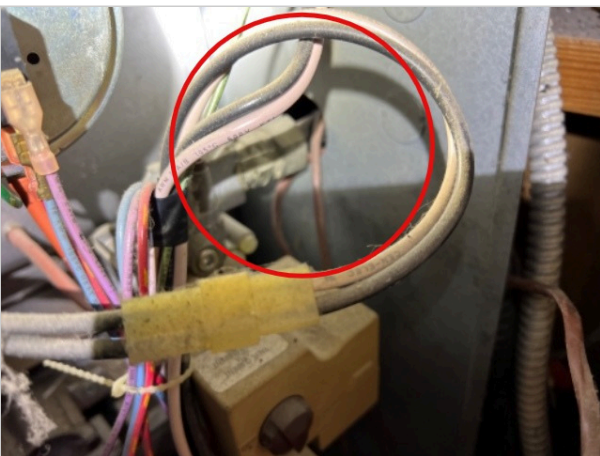
Photo 36

The unit was functioning properly at the time of the inspection.
There is an improper connection at the heater. 1) the flex appliance hose went through the housing, 2) there was no sediment trap for the gas line at the heater.
The components in the cabinet were dusty / dirty.

Flex line through housing

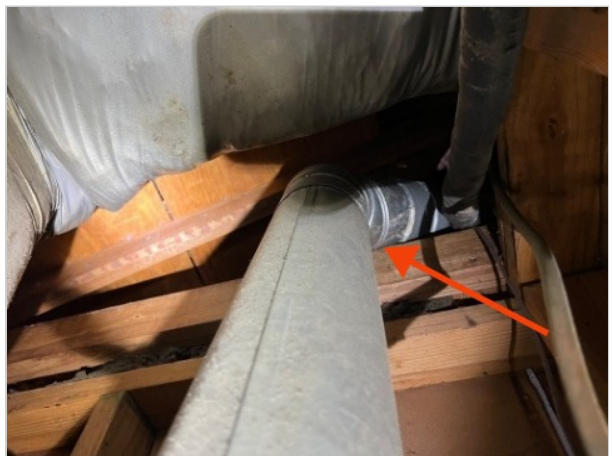
Photo 37

The heater flue appeared to be close to or in touch with combustibles. The heater flue should be at least one inch away from any wood (framing or decking) or other combustible material.

Flue in contact with combustibles

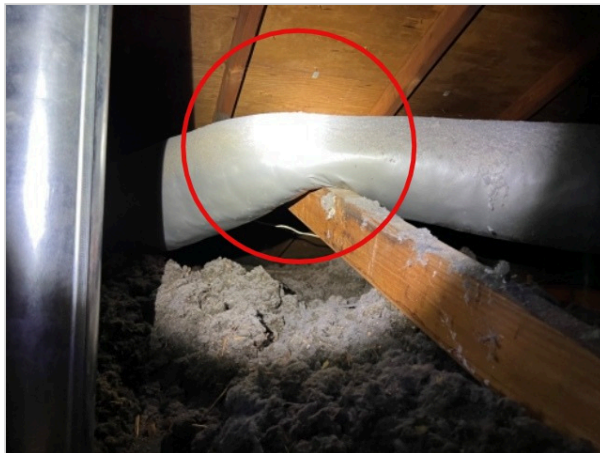
Photo 41

There were ducts in the attic bent in such a way as to reduce air flow through them.

Duct in attic with restricted airway

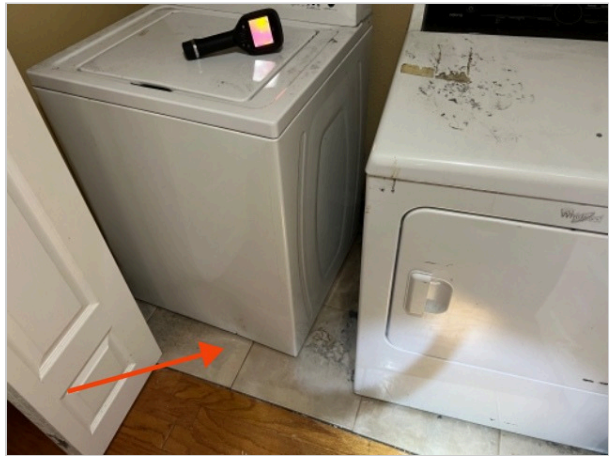
Photo 45

There was no pan under the washing machine on the second floor laundry area. In addition we could not confirm the presence of a floor drain.

No pan under washing machine

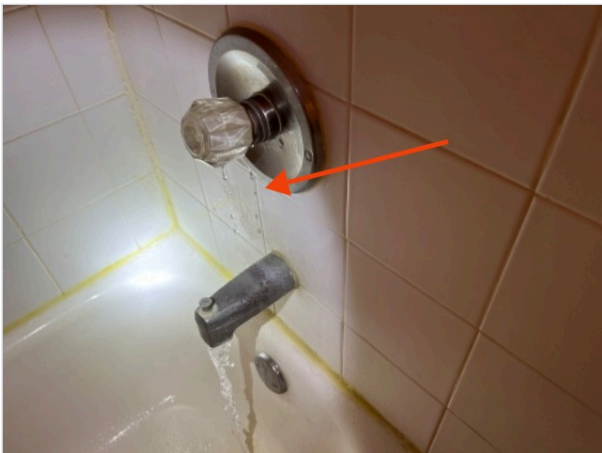
Photo 46

The control knob in the second-floor bathroom bathtub was leaking.

Leak

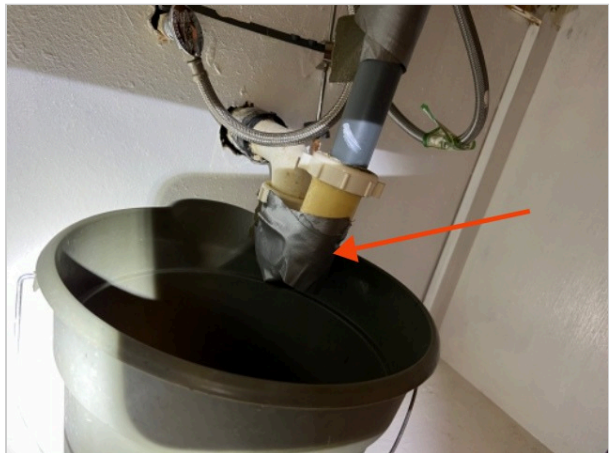
Photo 47

There was a bucket under the downstairs bathroom sink with duct tape around it (should be repaired properly).

Improper repair

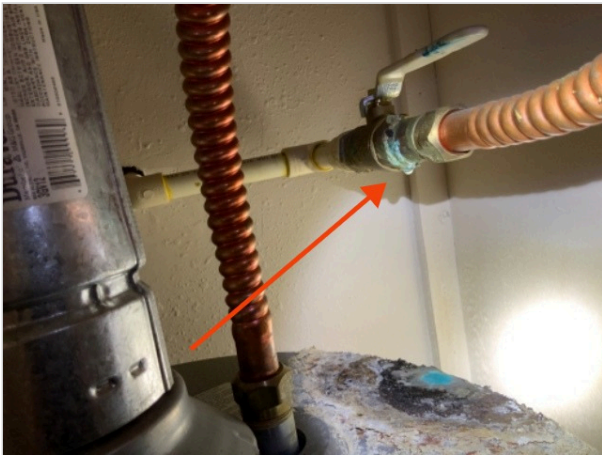
Photo 48

There was a leak at the cold water valve.

Leak at cold water valve

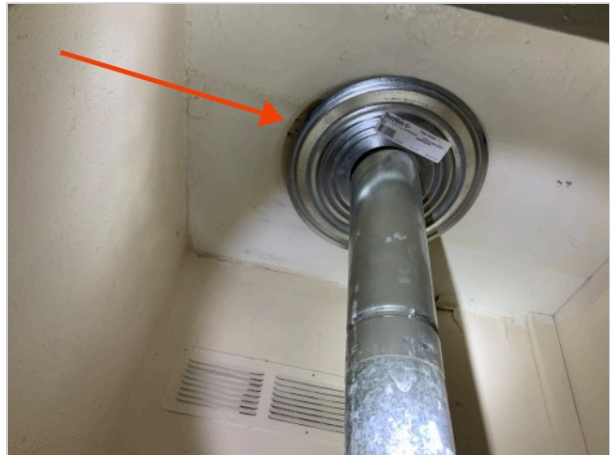
Photo 49

The flue pipe fire stopper is partially detached from the ceiling.

Flue pipe fire stop partially detached from ceiling

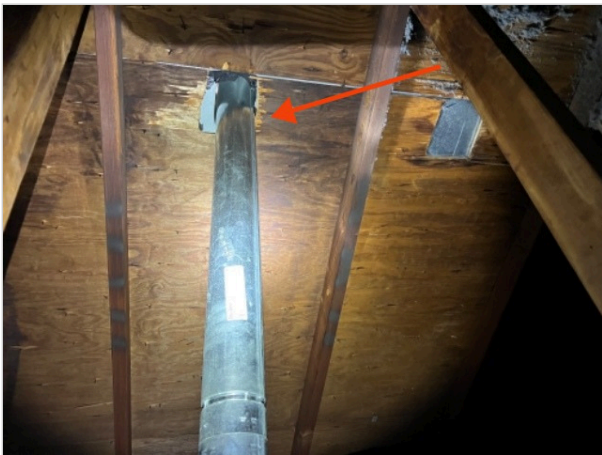
Photo 50

The flue pipe was in contact with or within 1" of the roof decking (combustible).

Flue pipe within 1" of combustibles

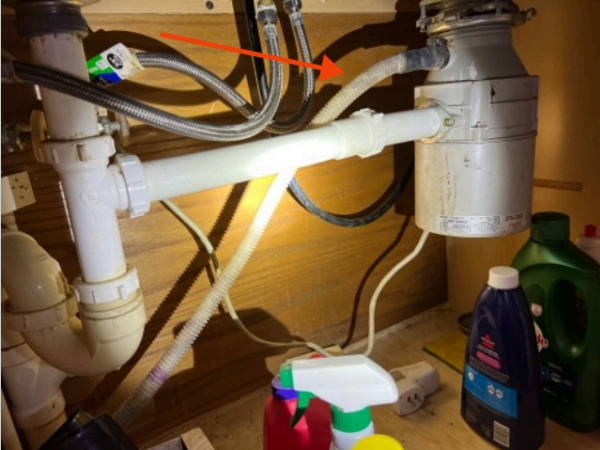
Photo 52

The drain line was not properly looped

Improper dishwasher drain line loop

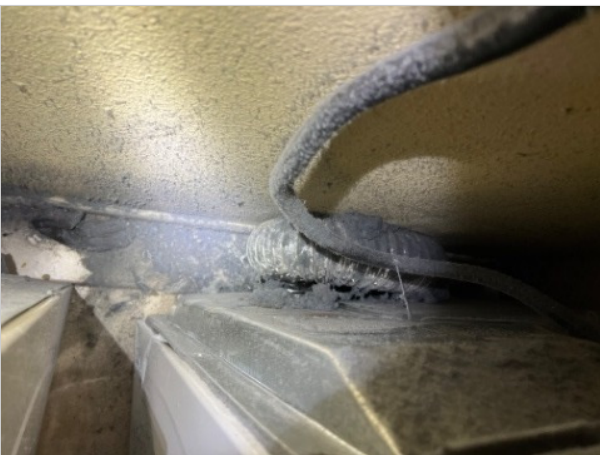
Photo 56

Lint behind dryer

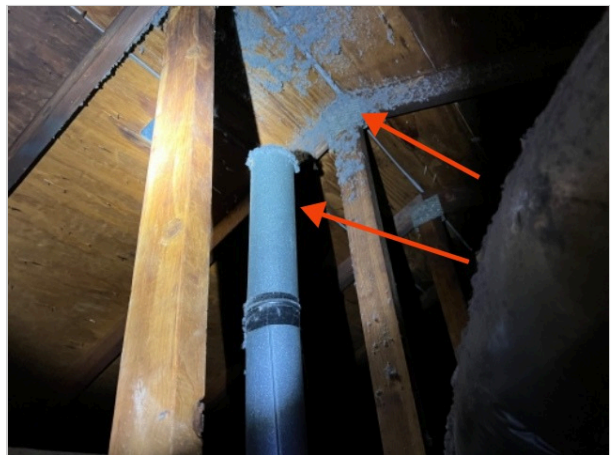
Photo 57

The dryer vent did not appear to be connected to the dryer appropriately. Also, the vent terminated in the attic and was ejecting lint into the attic and onto the attic roof decking. (Potential fire hazard)

Dryer vent termination in attic / lint on combustible decking
