# Your Inspection Report

12128 Ostermeyer Road  
Galveston, TX 77554

**INSPECTION DATE:**  
Tuesday, November 15, 2022

**PREPARED BY:**  
Charles Lehnhoff, 23070

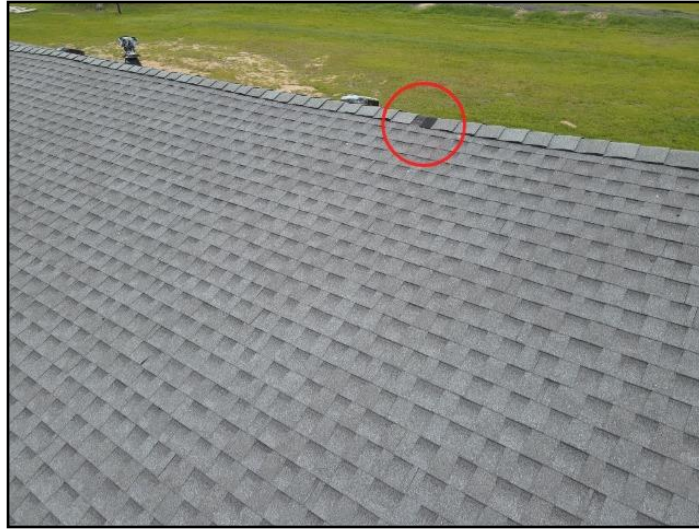
3. Missing, loose or torn

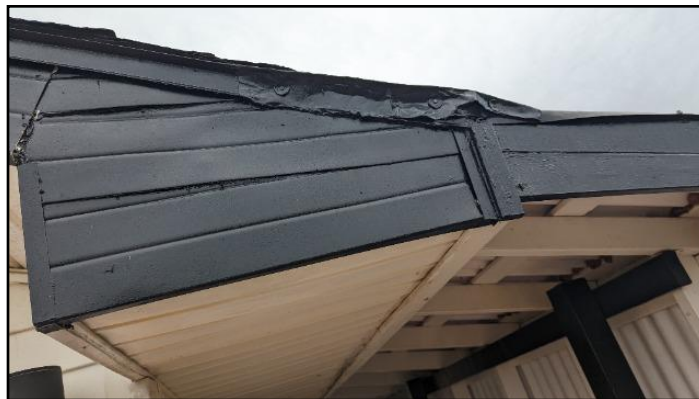
3. Condition: • [Leak](#)

Implication(s): Chance of water damage to structure, finishes and contents

Location: Rear Roof

4. Leak

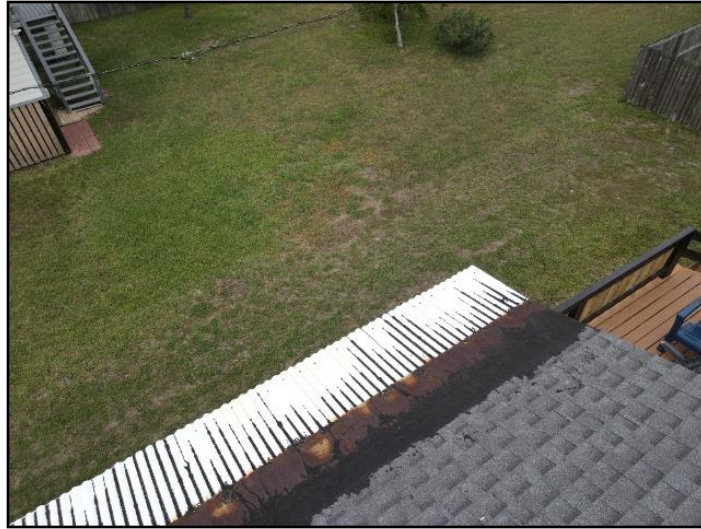
5. *Rust*

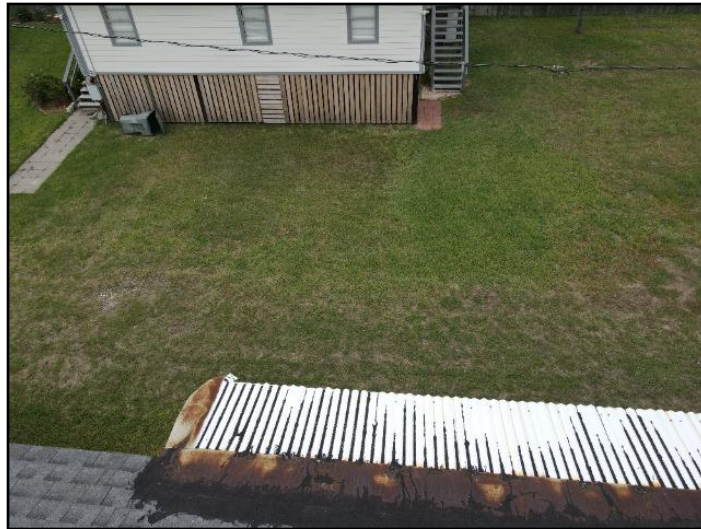
5. **Condition:** • [Damage, punctures, tears, bent metal](#)

**Implication(s):** Chance of water damage to structure, finishes and contents

**Location:** Left Side Roof

6. *Damage, punctures, tears, bent metal*

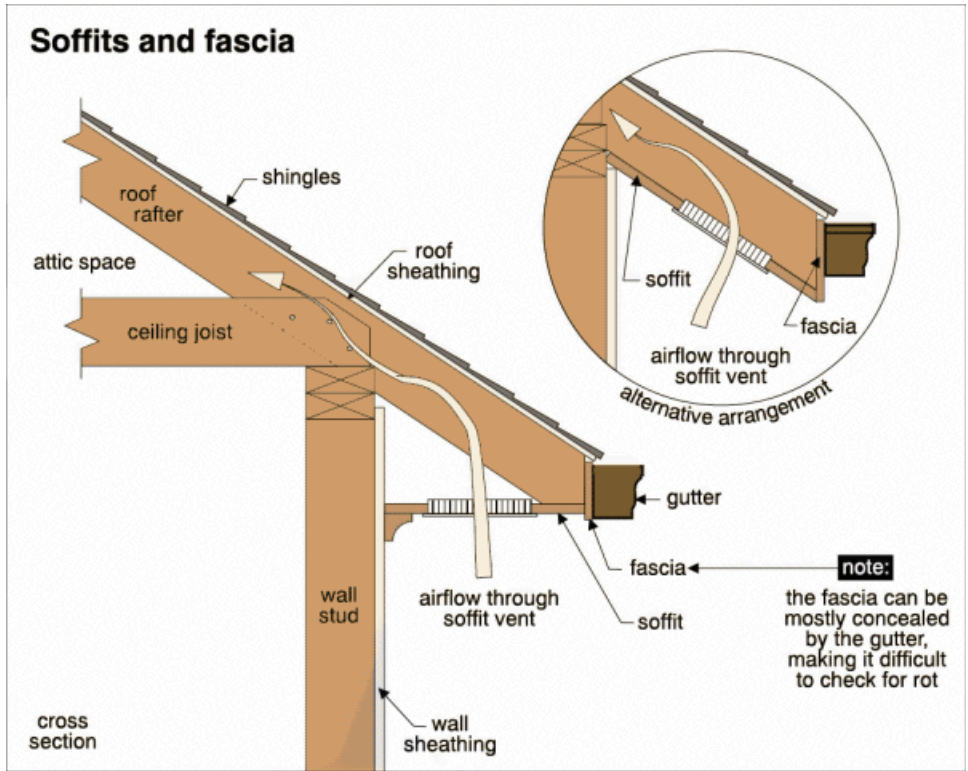
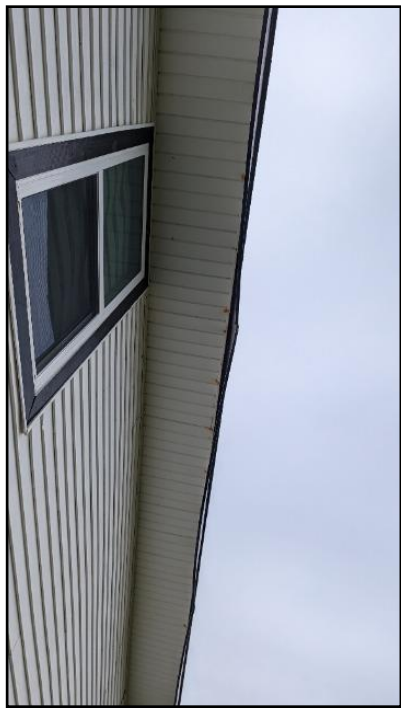
8. Vents - ineffective / missing

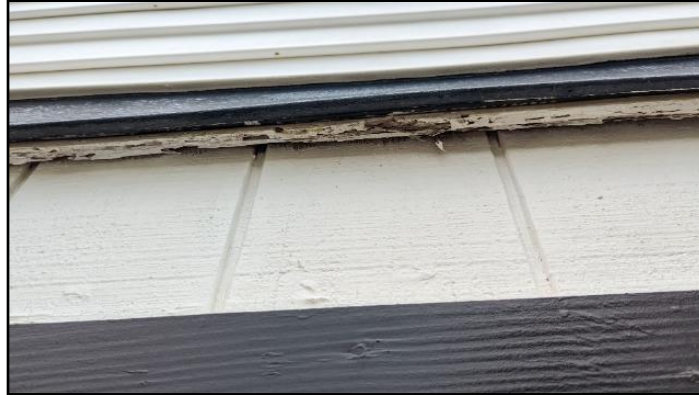
**Implication(s):** Chance of water damage to structure, finishes and contents

**Location:** Various Throughout Exterior

**9.** *Flashings incomplete or ineffective*

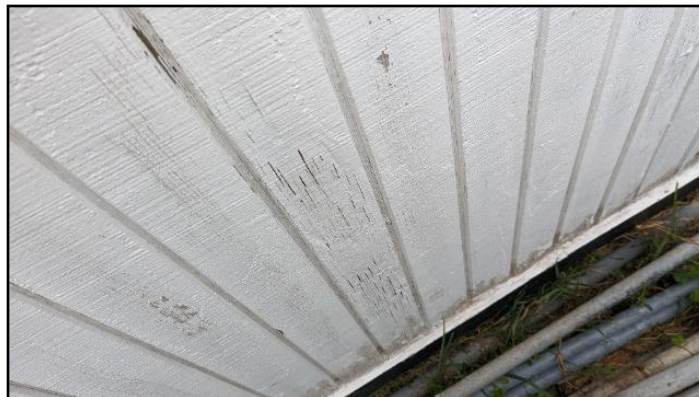
**Implication(s):** Shortened life expectancy of material

**Location:** Throughout Exterior Wall

**10.** *Paint or stain - needed*

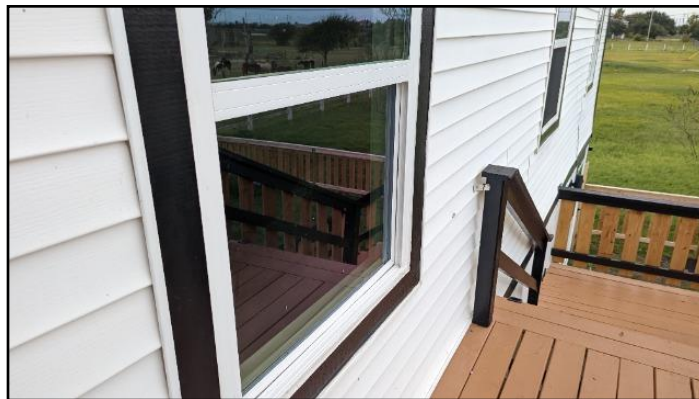
Implication(s): Increased heating and cooling costs | Reduced comfort

Location: Various

12. Missing

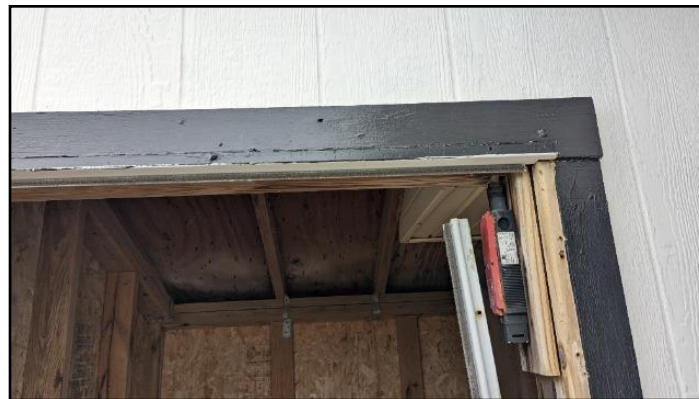
Implication(s): Chance of damage to finishes and structure | Material deterioration

Location: Front Left Side Second Floor Porch

14. Rot or insect damage

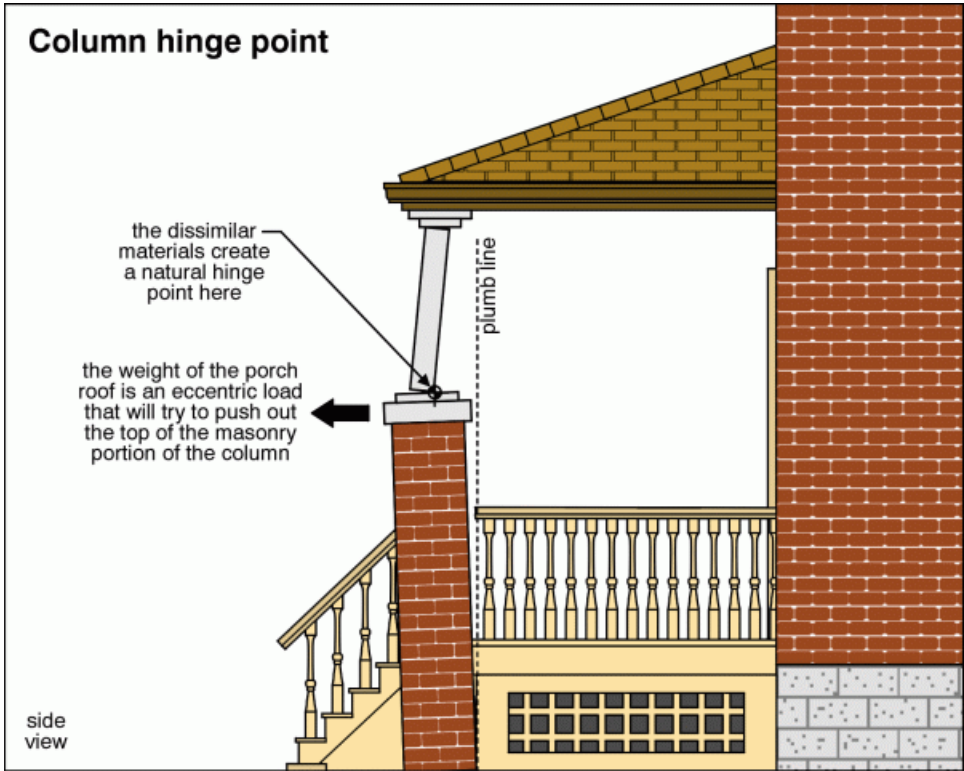
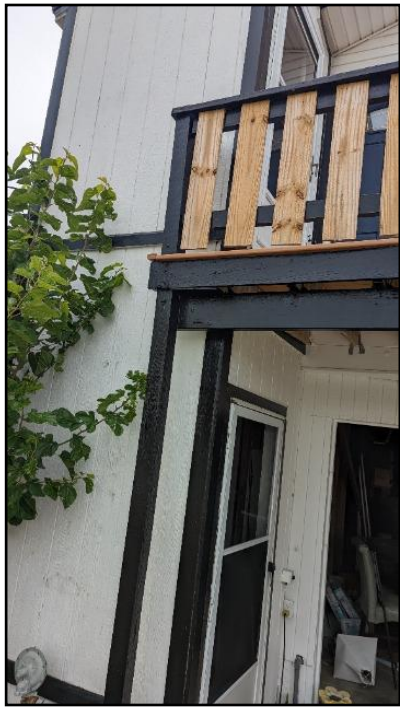
16. Leaning

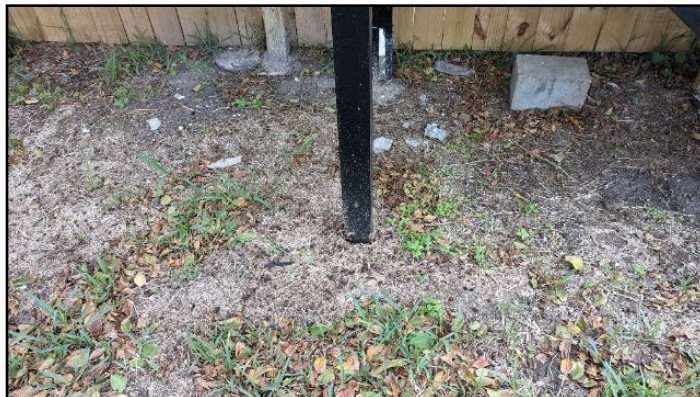
**Implication(s):** Weakened structure | Chance of movement | Rot | Insect damage

**Location:** Various Rear Deck

17. Wood/soil contact

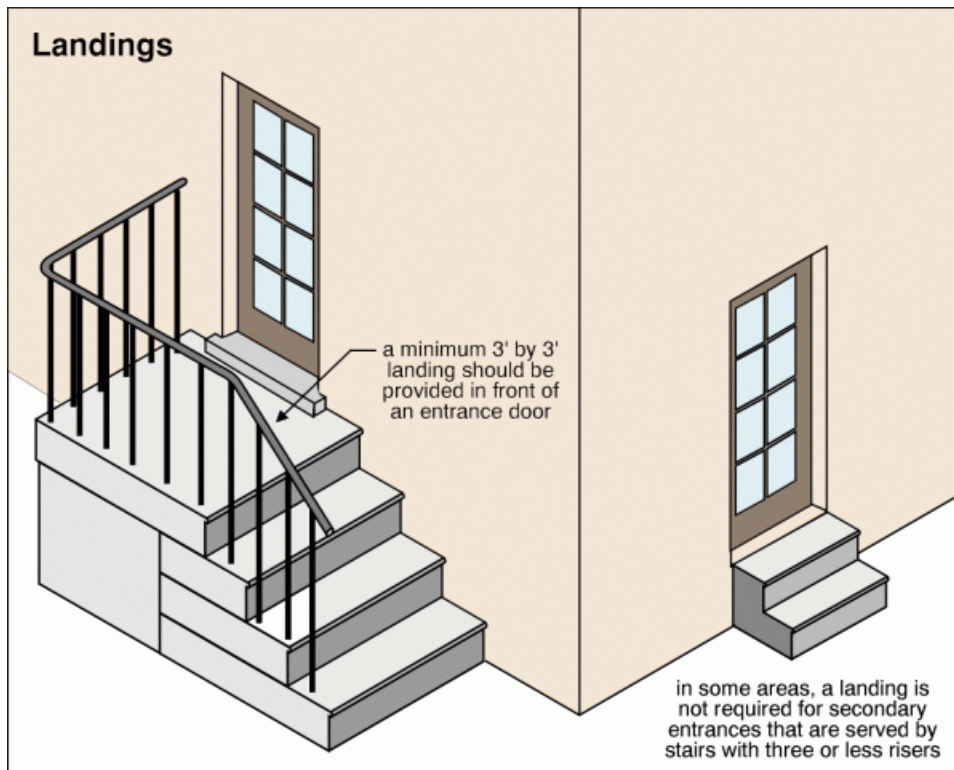
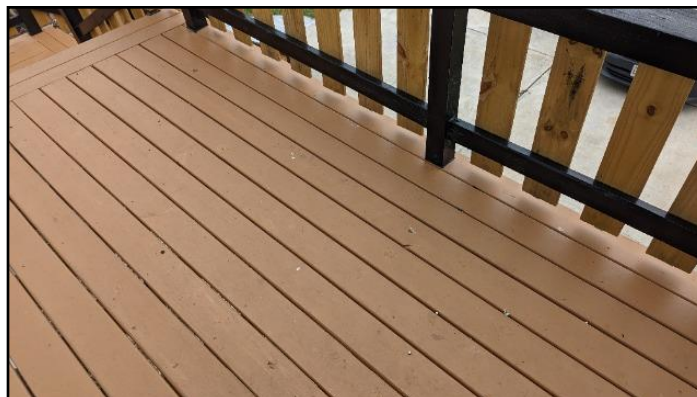
**Implication(s):** Trip or fall hazard

**Location:** Front Second Floor Deck

20. Steps slope

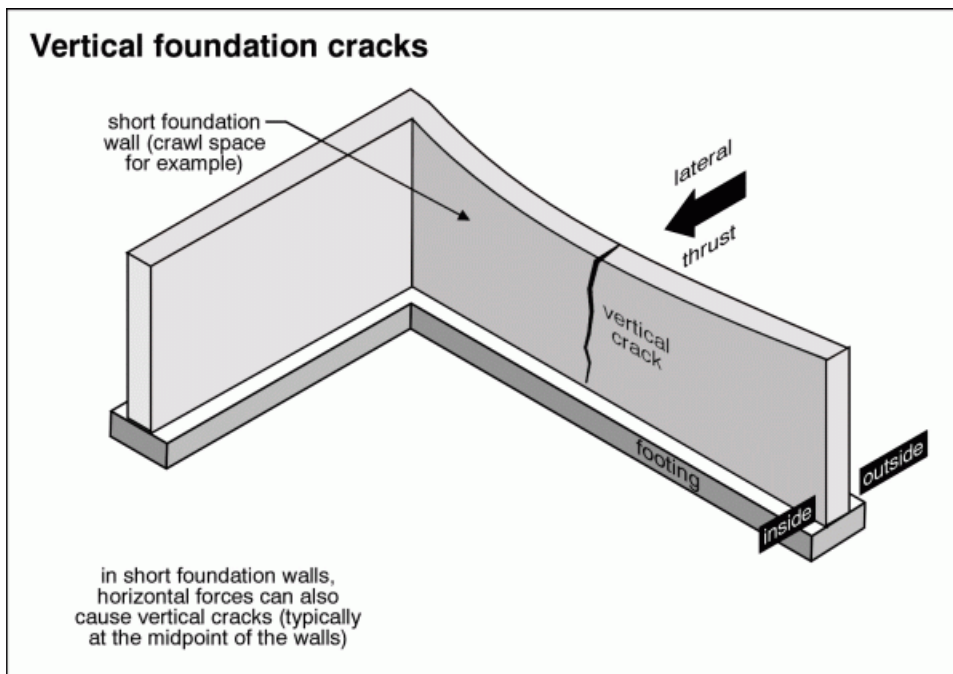
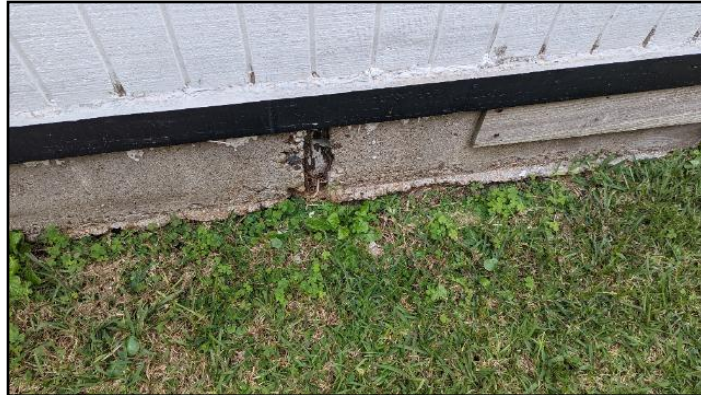
**Implication(s):** Chance of water damage to structure, finishes and contents | Weakened structure

**Location:** Right Side Exterior

25. Cracked

- Recommendations\Overview: **Key Note: Some beams and columns appear to be sagging and shifting. The foundation is indicated to be moved by wavy floors, self-closing doors, racked doors, bowing walls, etc. Some footings appear to be cracked. Further evaluation of the foundation is recommended by a structural engineer prior to close.**

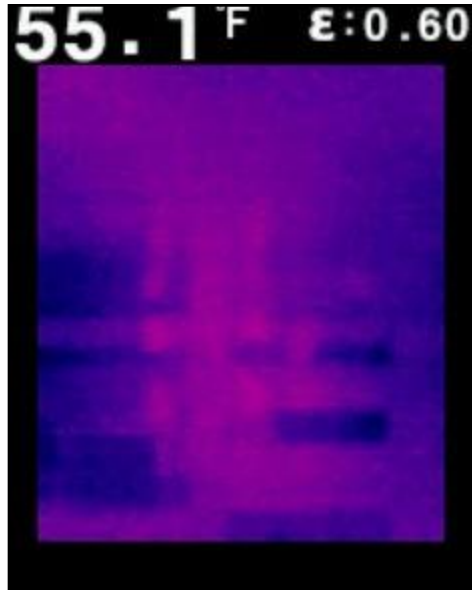
**33. Sub Panel Laundry Room**

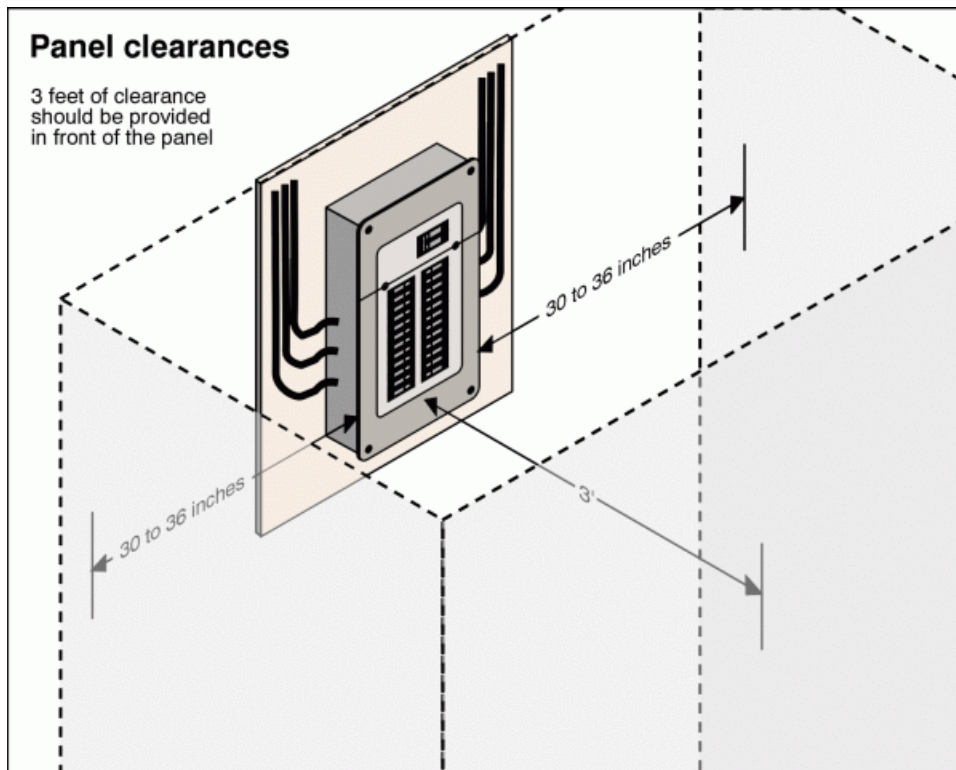
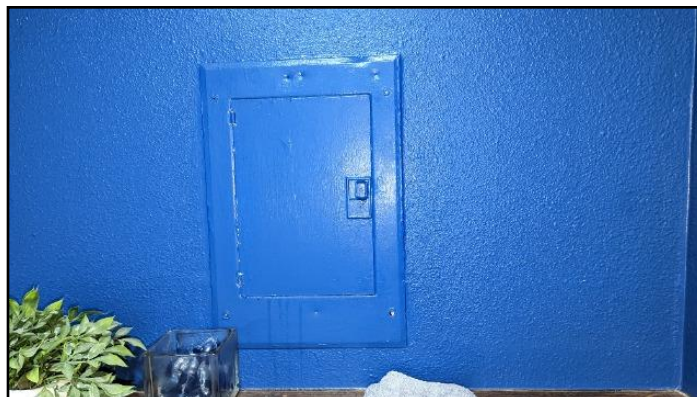
**Implication(s):** Difficult to service

**Location:** Laundry Area

35. Poor access

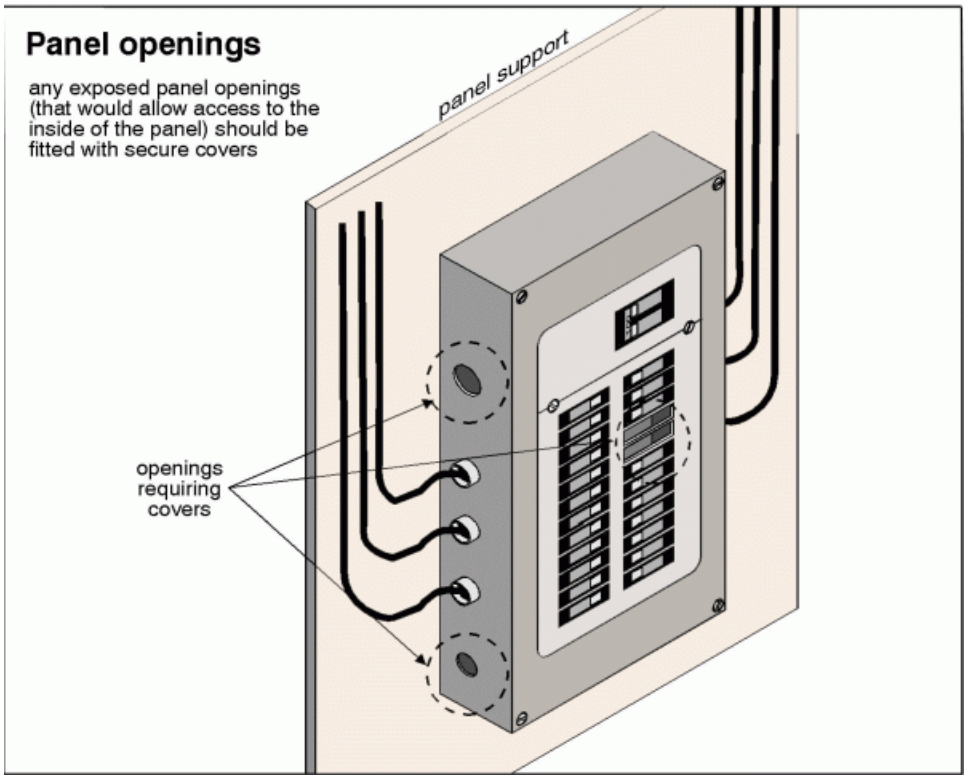
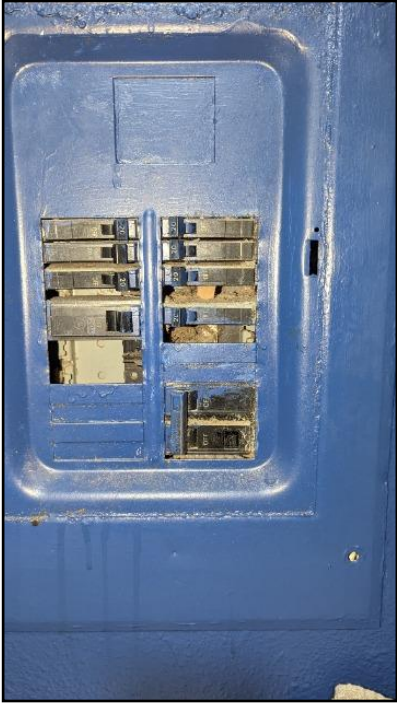
**36. Condition:** • [Openings in panel](#)

**Implication(s):** Electric shock | Fire hazard

**Location:** Laundry Area

36. Openings in panel

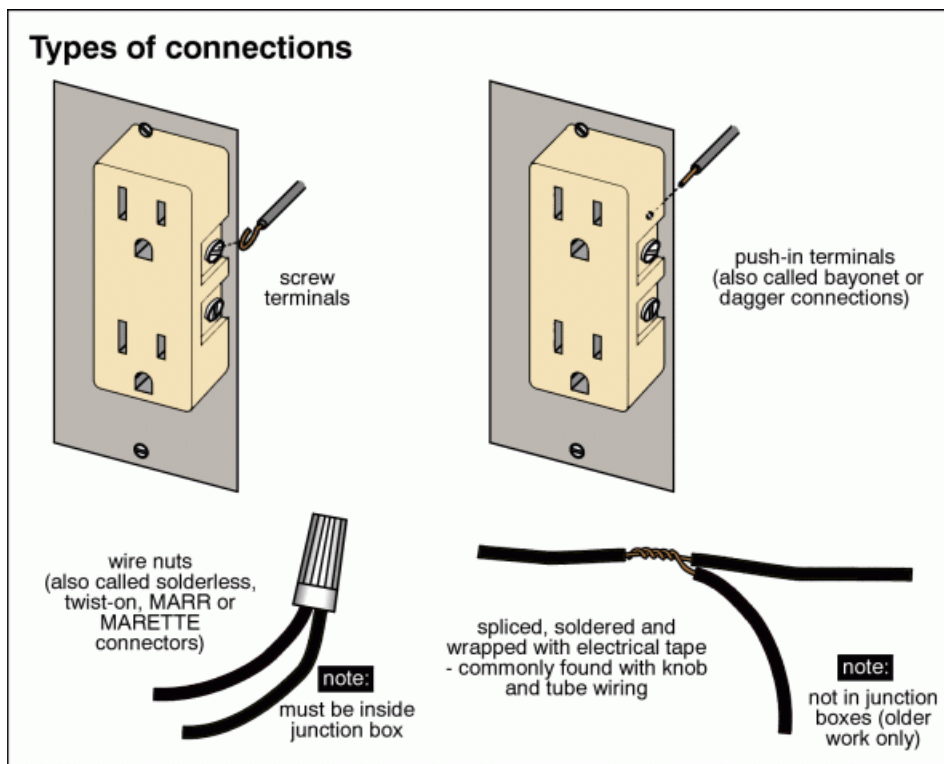
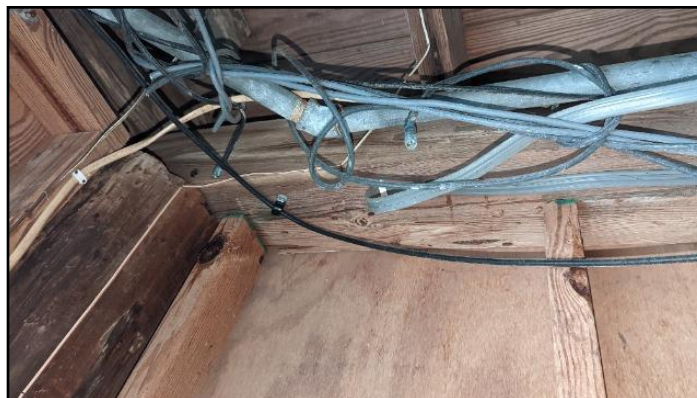
**Implication(s):** Electric shock | Fire hazard | Interruption of electrical service

**Location:** Various Throughout Garage

**37. Loose connections**

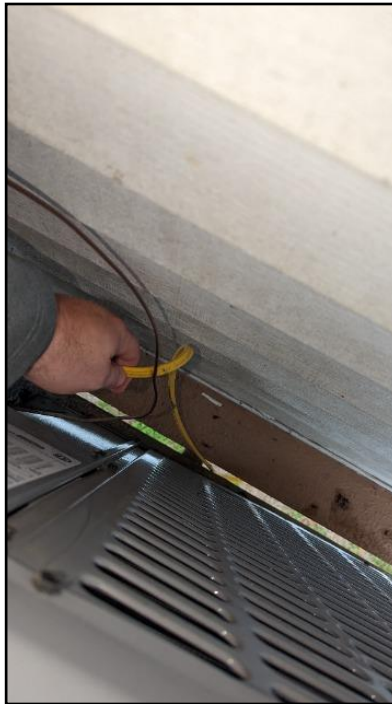
39. *Not suitable for use*

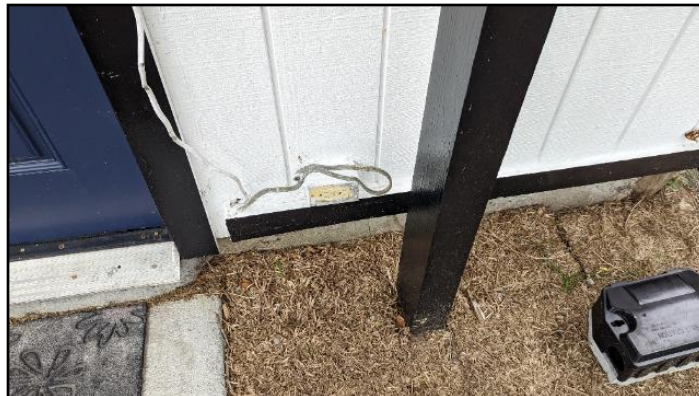
42. **Condition:** • [Wires too close to grade](#)

**Implication(s):** Damage to wire | Electric shock

**Location:** Various Throughout Exterior

40. *Wires too close to grade*

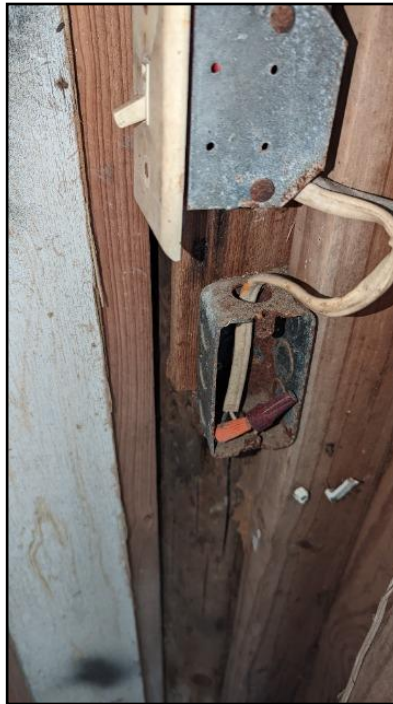
41. Cover loose or missing

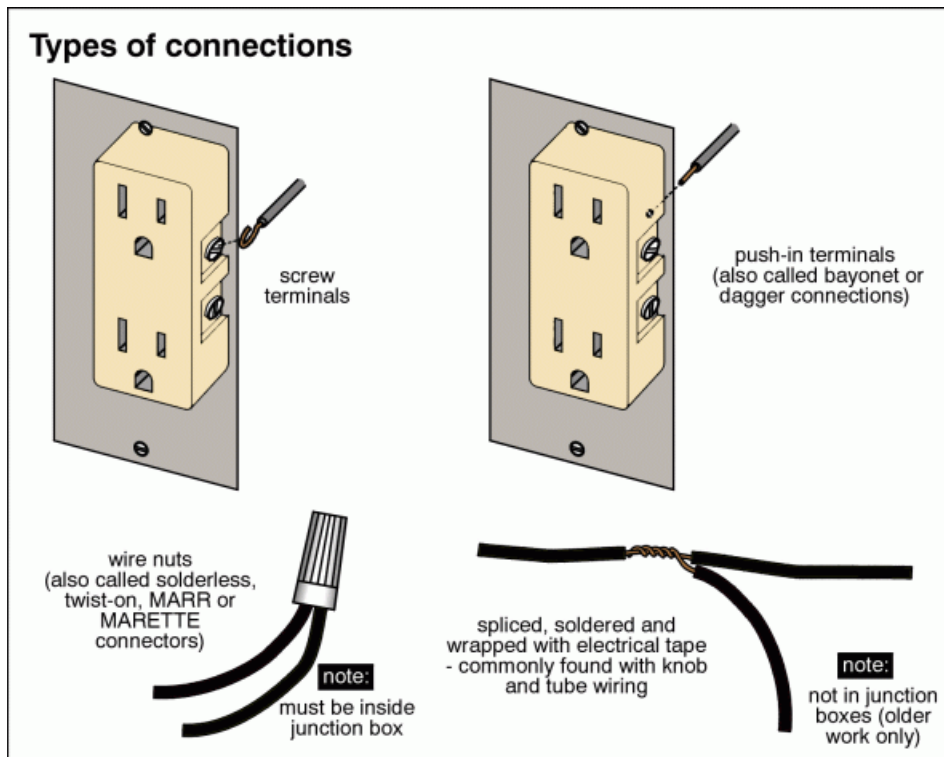
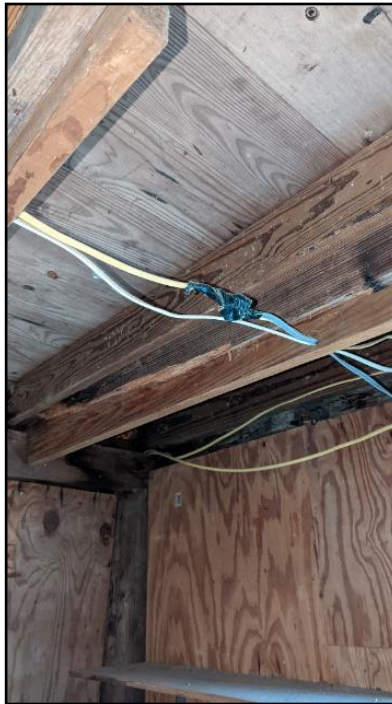
44. Condition: • [Missing](#)

Implication(s): Electric shock | Fire hazard

Location: Various Middle Garage

42. Missing

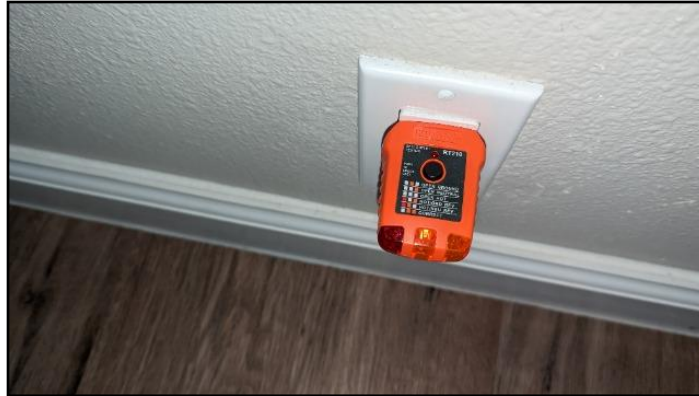
**Implication(s):** Electric shock

**Location:** Throughout

*44. Ground needed for 3-slot outlet*

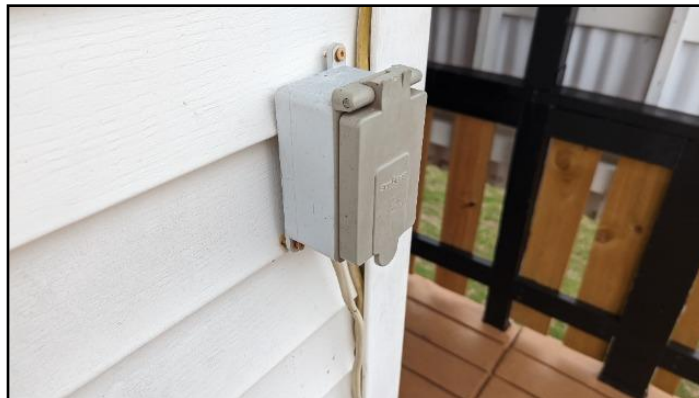
**47. Condition:** • Not suitable for outdoor (exterior) use

**Implication(s):** Shock hazard or interruption of electrical service

**Location:** Various Throughout

*45. Not suitable for outdoor (exterior) use*

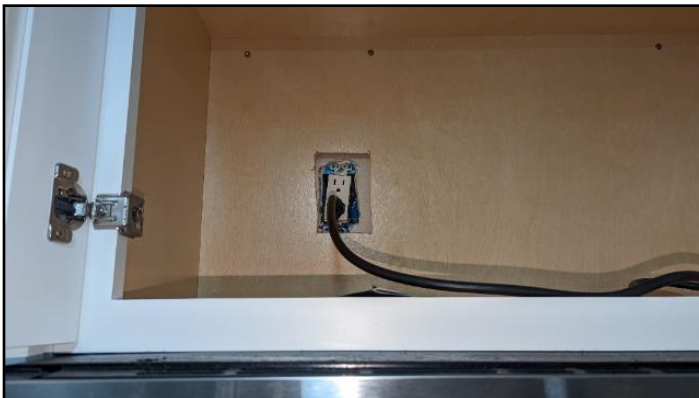
Implication(s): Electric shock

Location: Middle Second Floor Kitchen

47. Missing

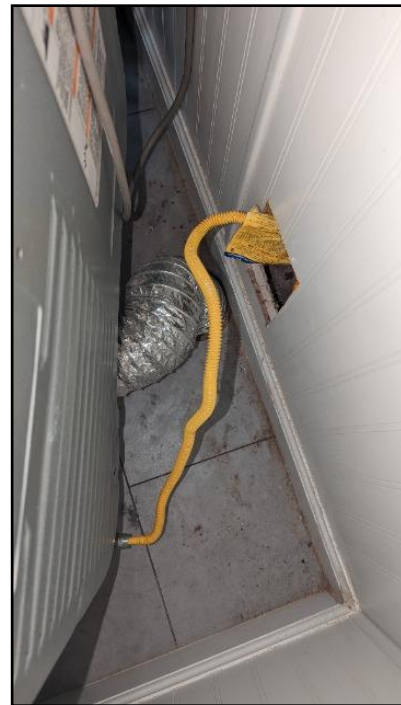
48. Missing

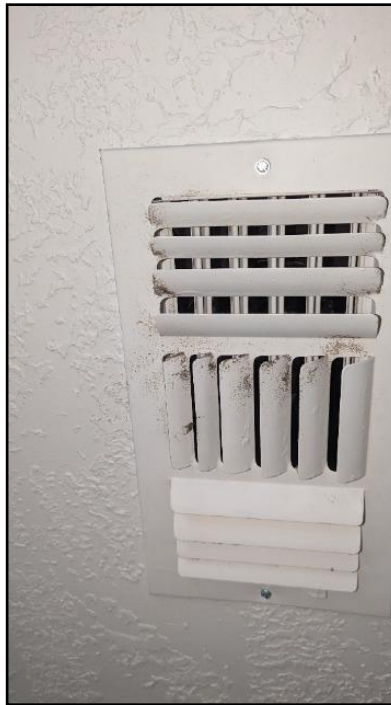
Implication(s): Increased cooling costs | Reduced comfort

Location: Various

53. Dirty

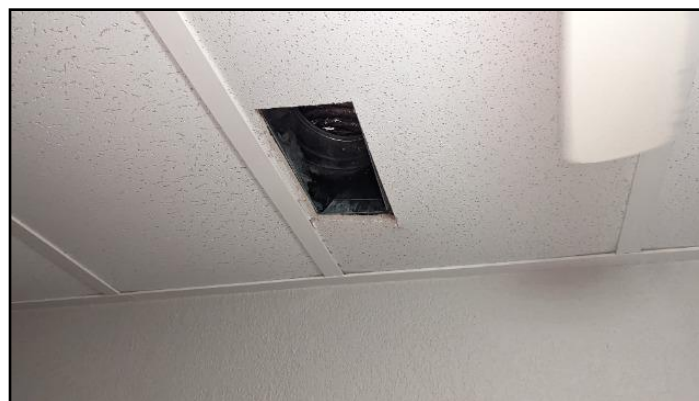
51. Condition: • [Disconnected or leaking](#)

Implication(s): Increased cooling costs | Reduced comfort

Location: First Floor Middle Bedroom

54. Disconnected or leaking

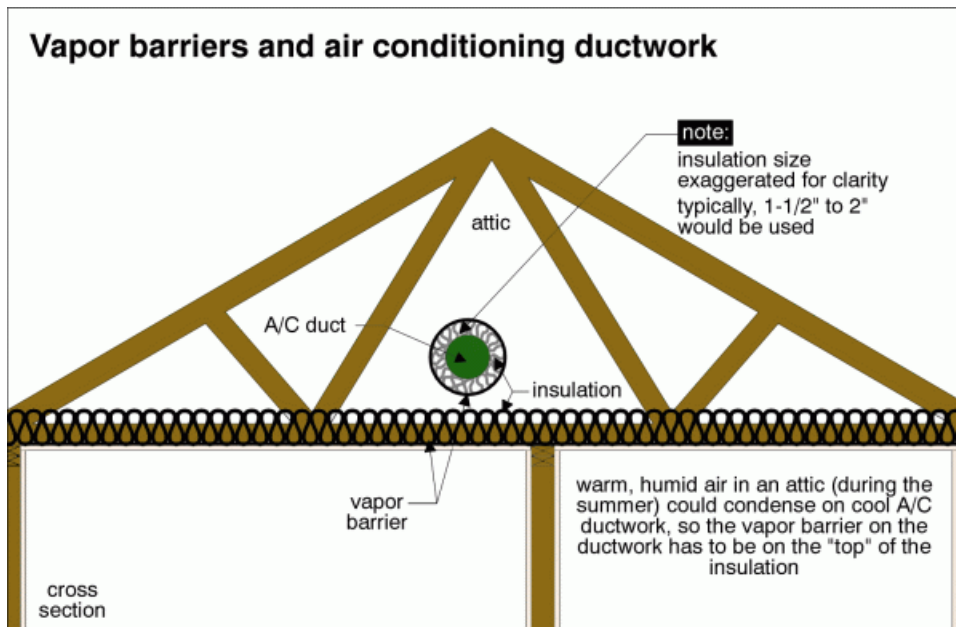
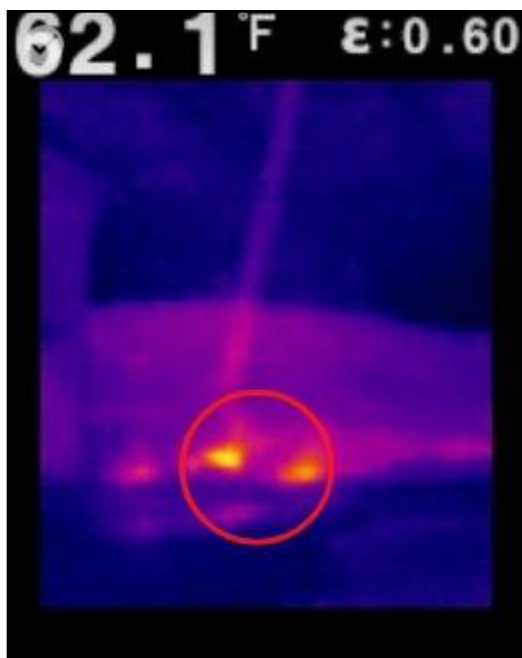
**Implication(s):** Chance of condensation damage to finishes and/or structure | Increased cooling costs | Reduced comfort

**Location:** Left Middle Attic

56. Damage

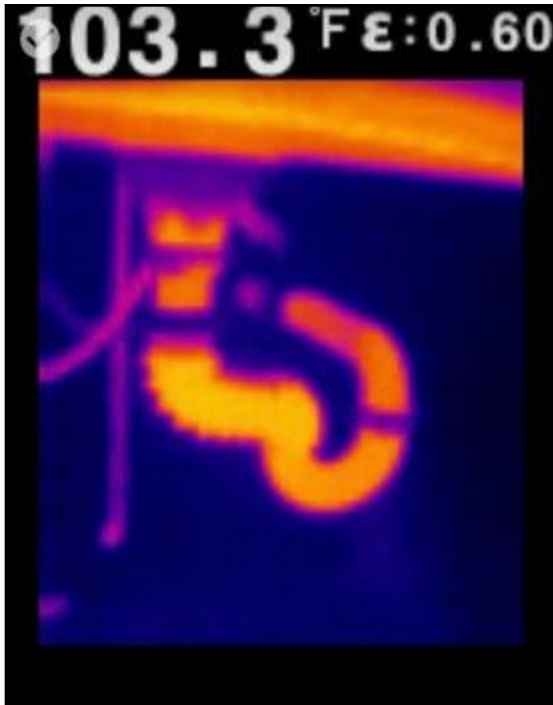
67. Master Bathroom Trap

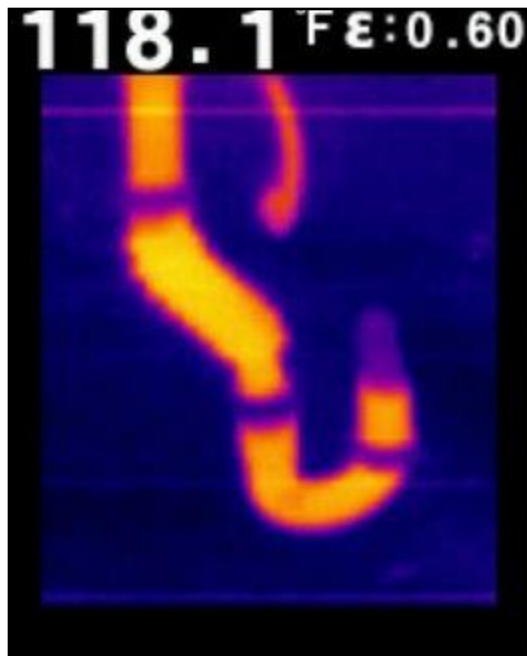
72. First Floor Hallway Bathroom Trap

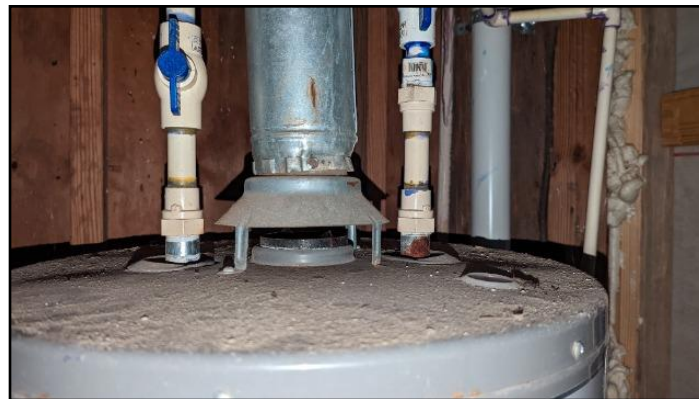
Implication(s): Water Damage | Fire Damage

Location: Garage

74. PVC against inlets

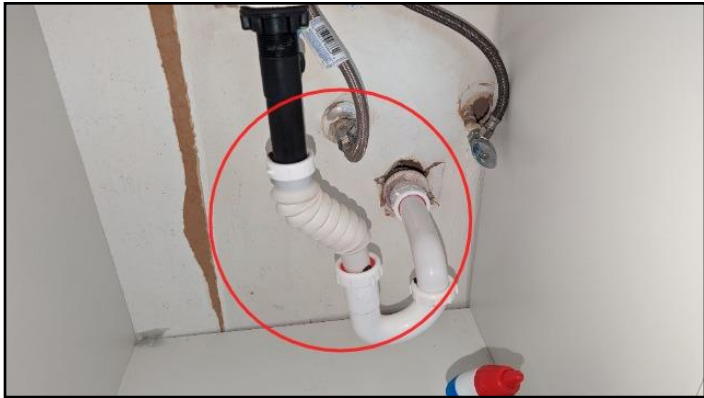
Location: Various Kitchen Bathroom

75. Nonstandard shape or material

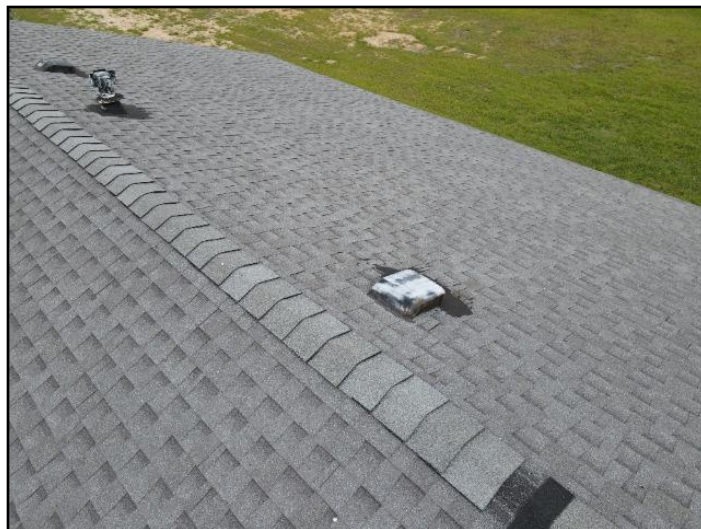
Implication(s): Sewer gases entering the building

Location: Throughout Roof

77. Missing

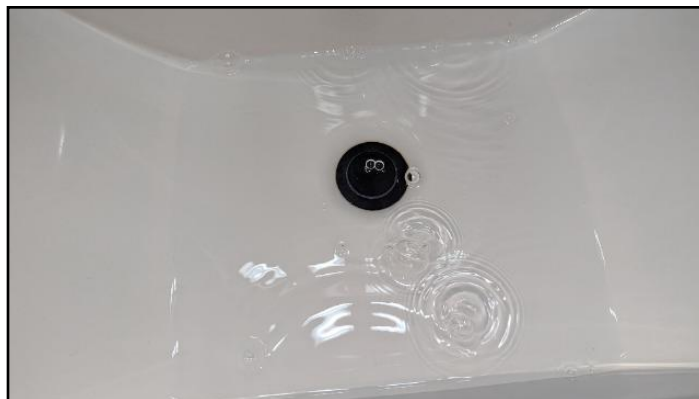
Implication(s): Chance of water damage to structure, finishes and contents

Location: Second Floor Master Bathroom

79. Slow drains

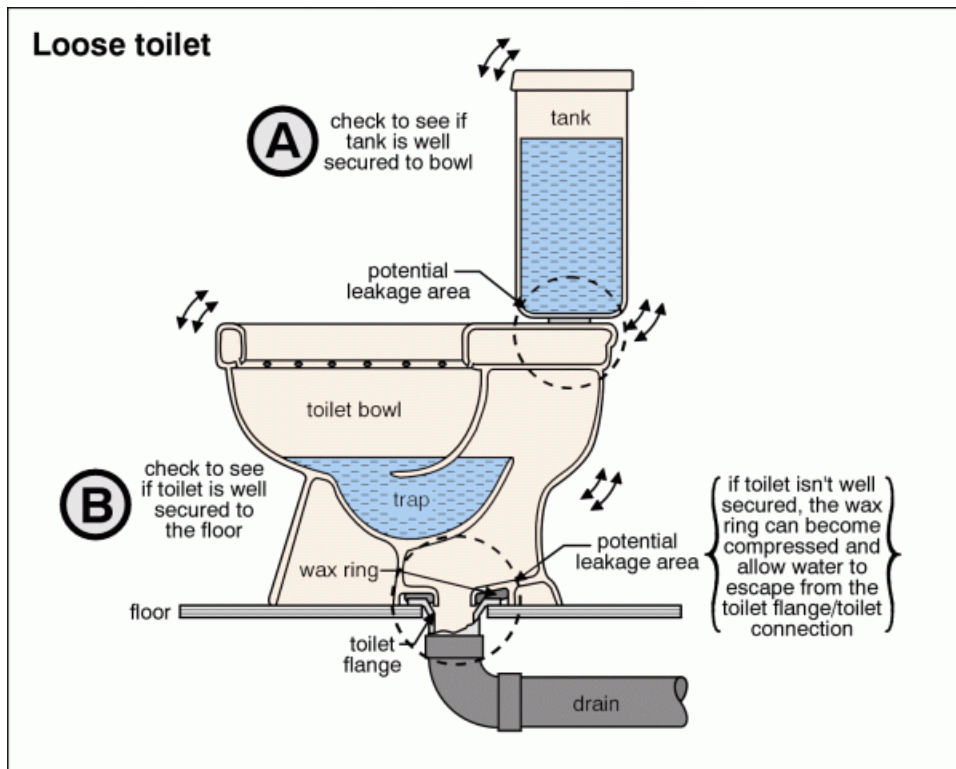
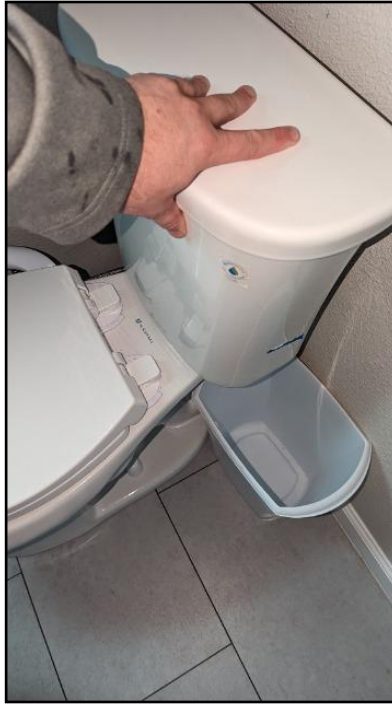
**Implication(s):** Chance of water damage to structure, finishes and contents | Sewage entering the building | Possible hidden damage

**Location:** Second Floor Master Bathroom

81. Loose

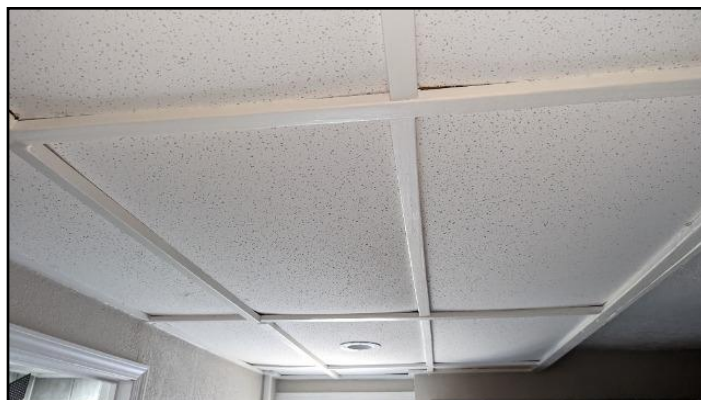
Implication(s): Damage or physical injury due to falling materials

Location: Throughout First Floor

88. Loose

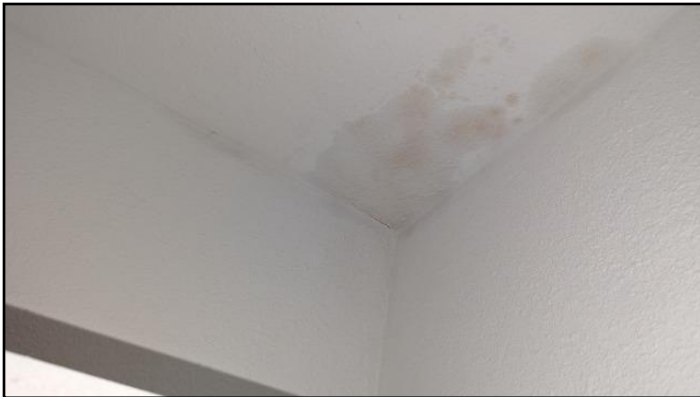
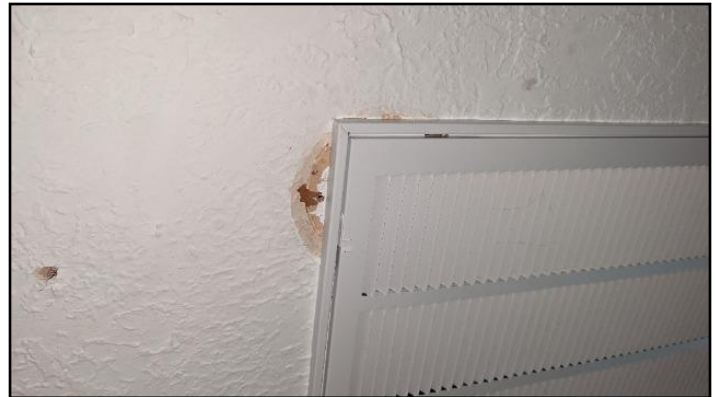
72. Condition: • Water stains

Location: Front Middle Bedroom & Hallway

89. Water stains

90. Water stains

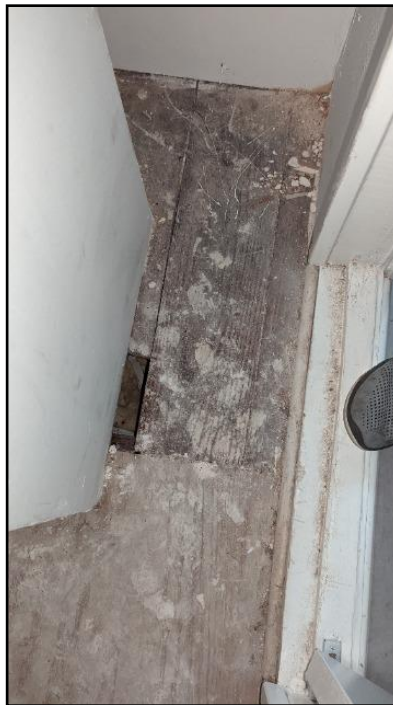
Implication(s): Chance of damage to contents, finishes and/or structure | Physical injury

Location: Second Floor Master Bathroom Closet

91. Missing

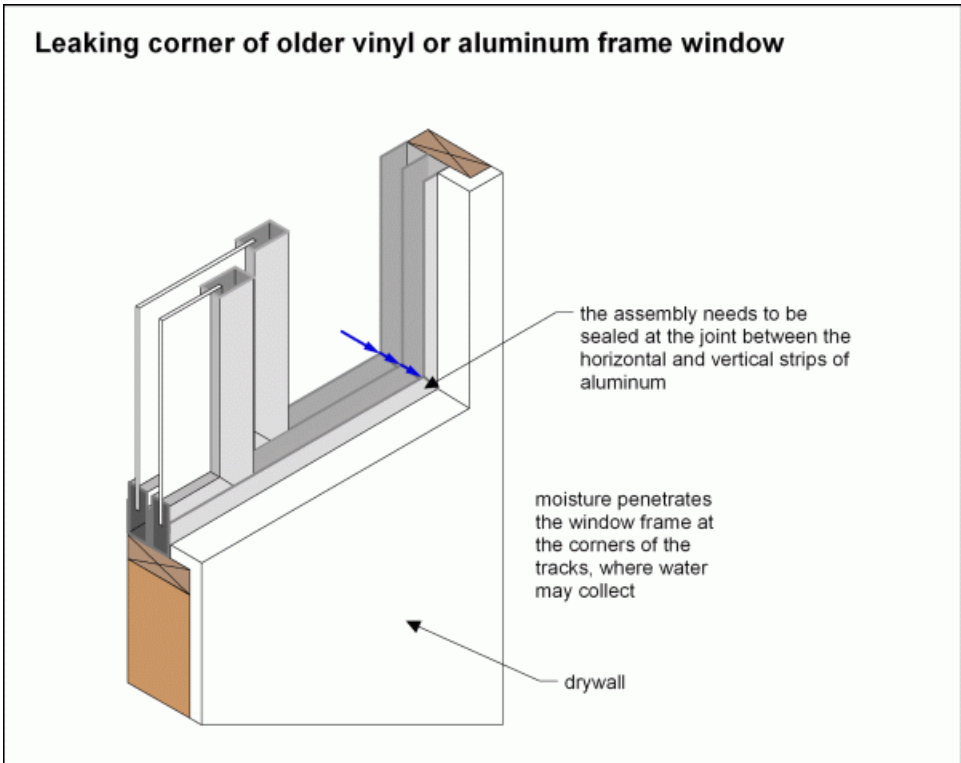
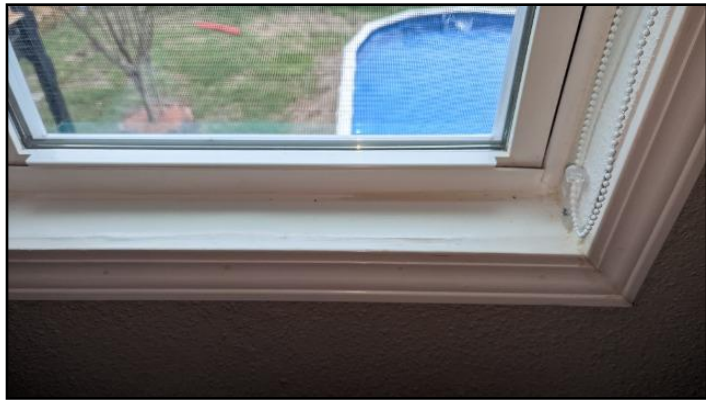
93. Water leaks

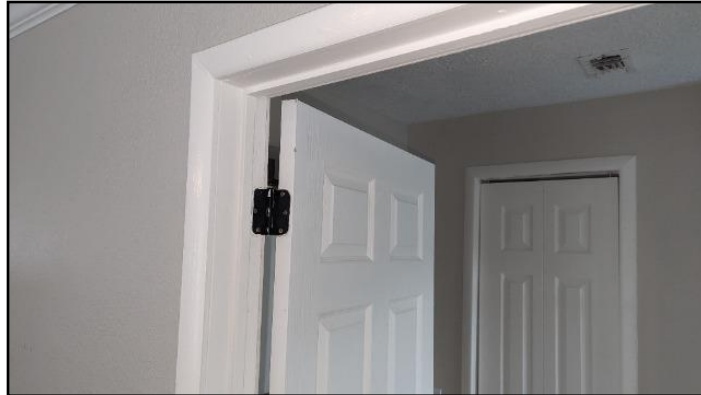
94. *Damage*

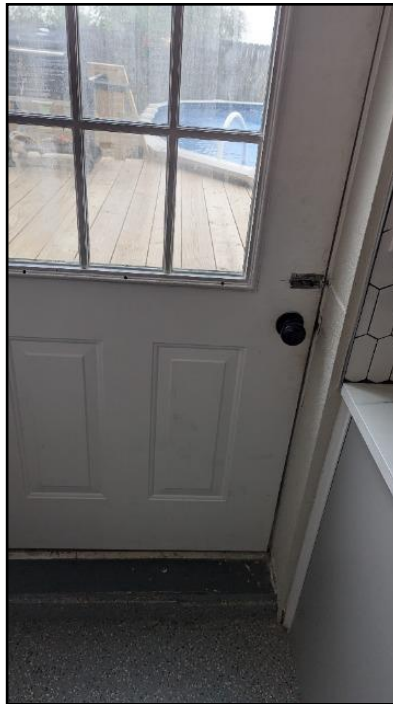
77. **Condition:** • [Inoperable](#)

**Implication(s):** Reduced operability

**Location:** Rear First Floor Kitchen

95. *Inoperable*

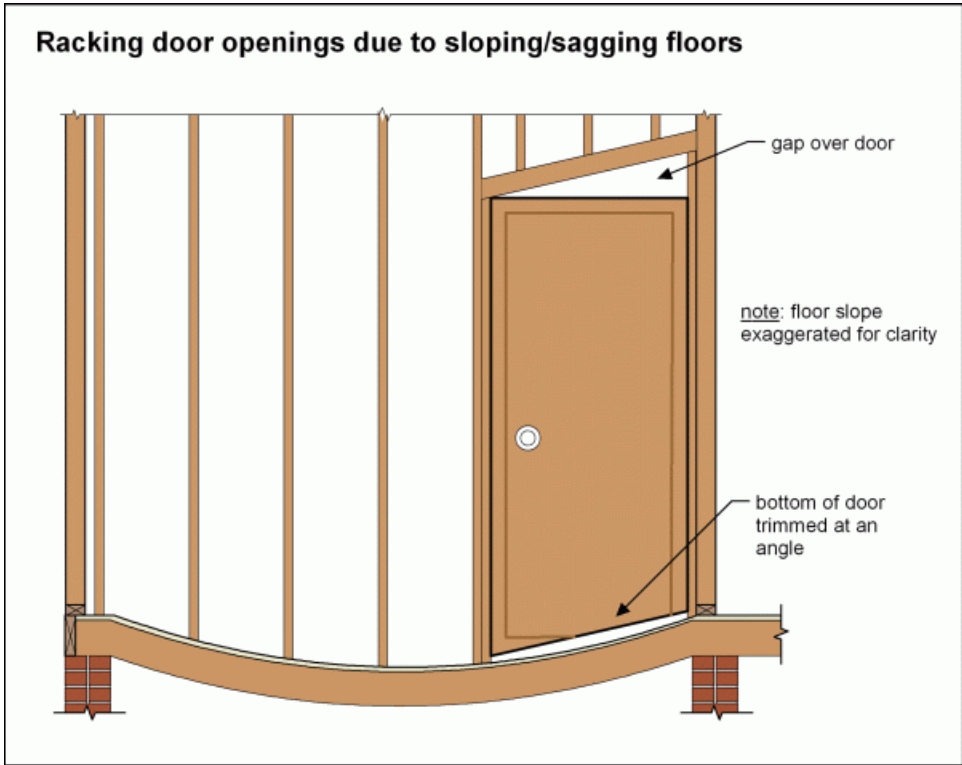
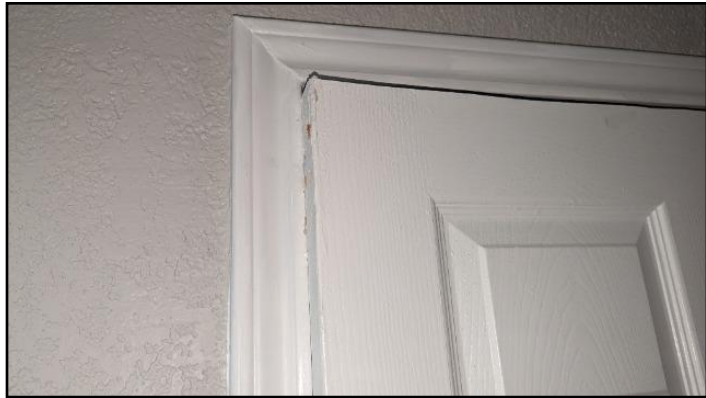
78. **Condition:** • [Racked/out-of-square](#)

**Location:** Second Floor Master Bathroom

96. Racked/out-of-square

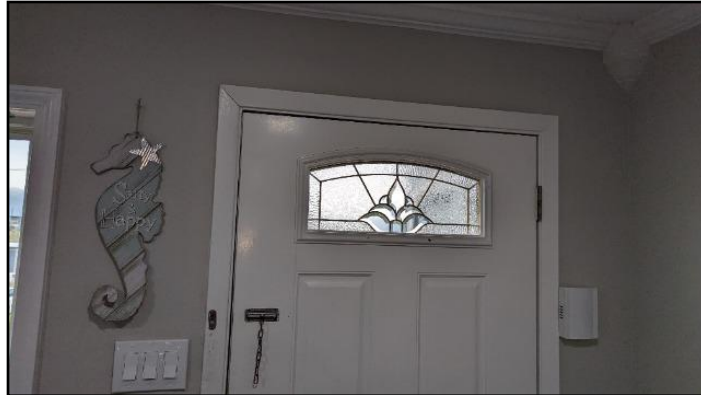
97. Loose or poor fit

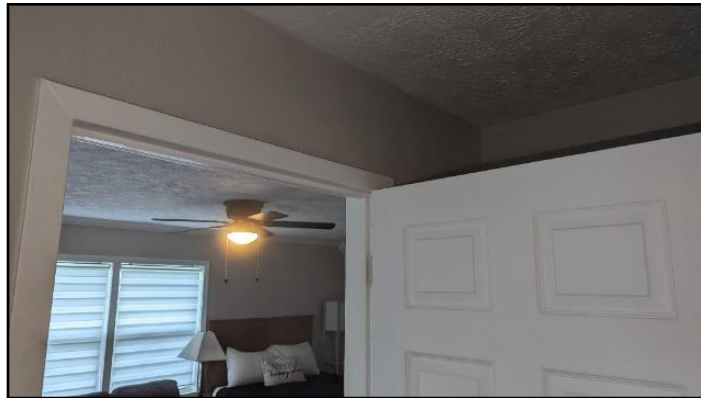
80. Condition: • [Swings open or closed by itself](#)

Implication(s): Physical injury

Location: Various Throughout

98. Swings open or closed by itself
