# Your Inspection Report

12128 Ostermeyer Road  
Galveston, TX 77554

**INSPECTION DATE:**  
Tuesday, November 15, 2022

**PREPARED BY:**  
Charles Lehnhoff, 23070

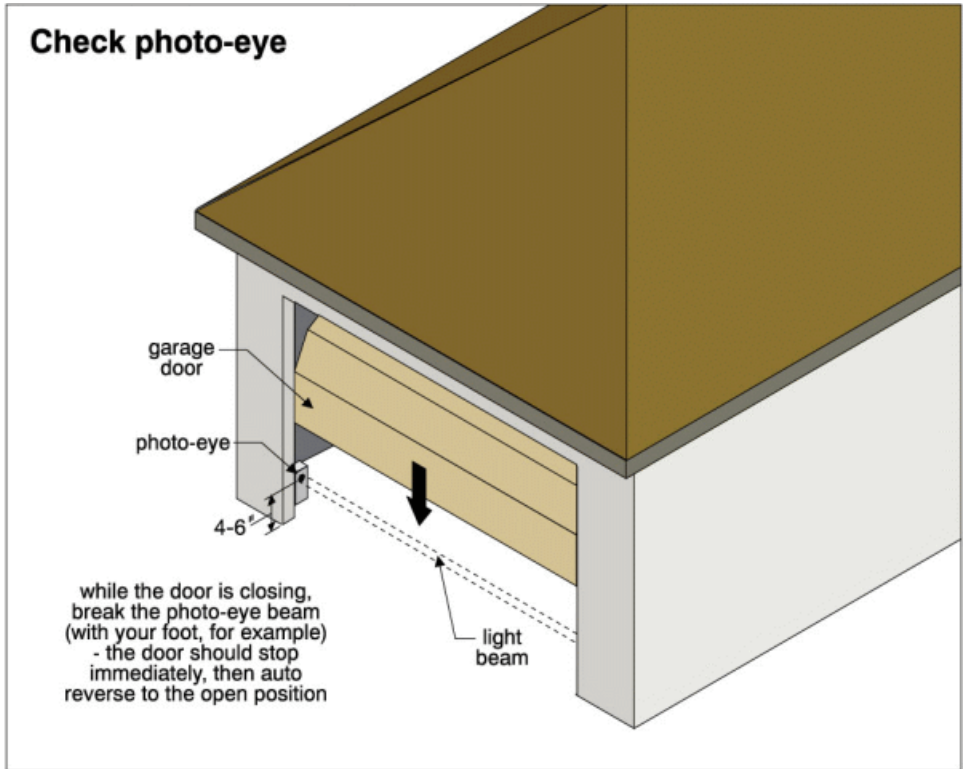
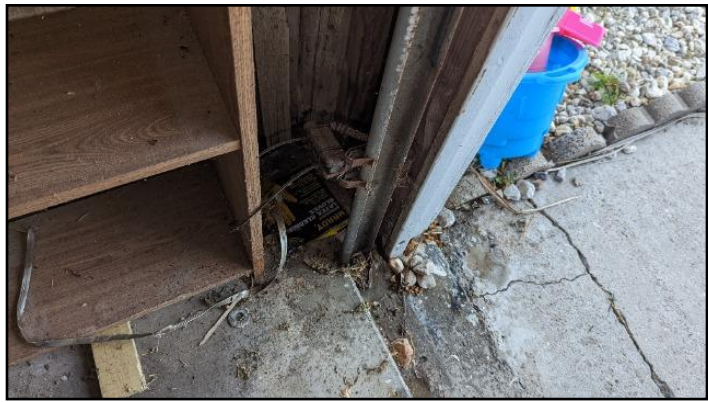
Implication(s): Physical injury

Location: Garage

101. Sensors damaged

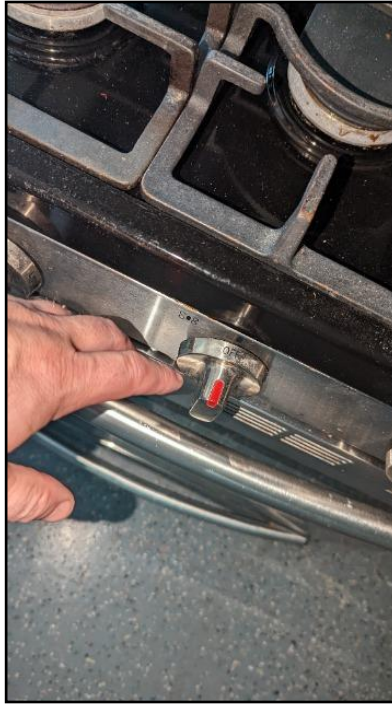
**84. Condition:** • Inoperative knobs  
**Implication(s):** Reduced operability  
**Location:** Middle First Floor Kitchen

102. Inoperative knobs

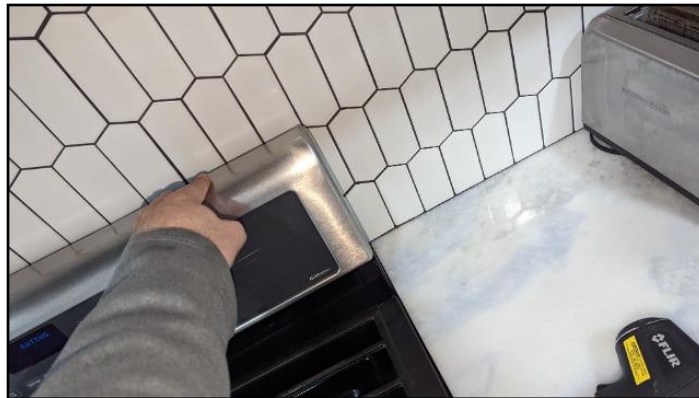
**85. Condition:** • Anti-tipping device missing  
**Implication(s):** Physical injury  
**Location:** Various Kitchen

103. Anti-tipping device missing

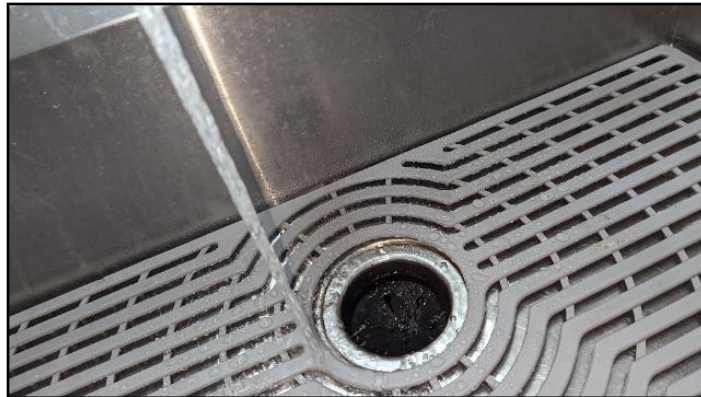
**86. Condition:** • Vibration  
**Implication(s):** Damage to equipment  
**Location:** Kitchen

104. *Vibration*

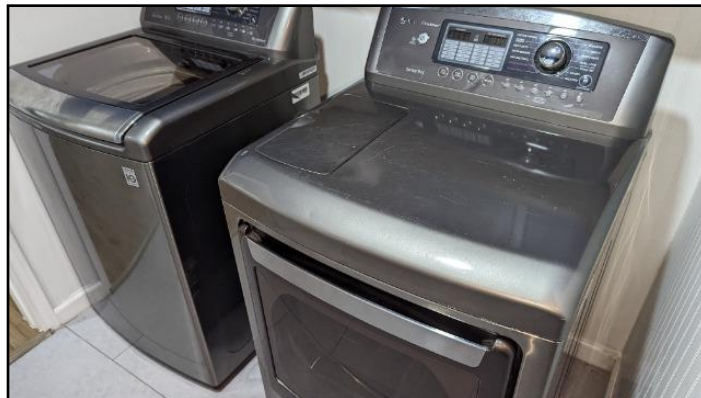
**Implication(s):** Chance of water damage to structure, finishes and contents

**Location:** Laundry Area

105. *Drip pan missing*

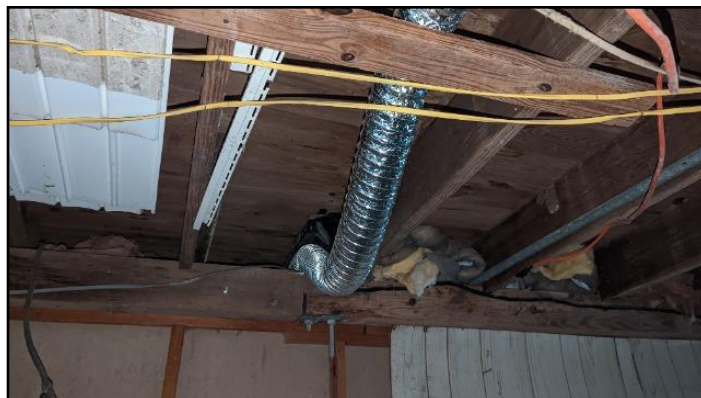
**Implication(s):** Equipment ineffective | Fire hazard

**Location:** Middle Garage

106. *Dryer vent material not smooth wall*
