RE: Foundation Inspection
Job #18223

The residence inspected was located at 5510 Ashmere Lane in Spring, Texas.

This was a foundation inspection, based on physical observation. The following are the results obtained from the visual structural evaluation. This residence is a thirty eight year, one and one half story, single family wood frame dwelling with a brick veneer wood siding. The structure has a poured concrete slab foundation.

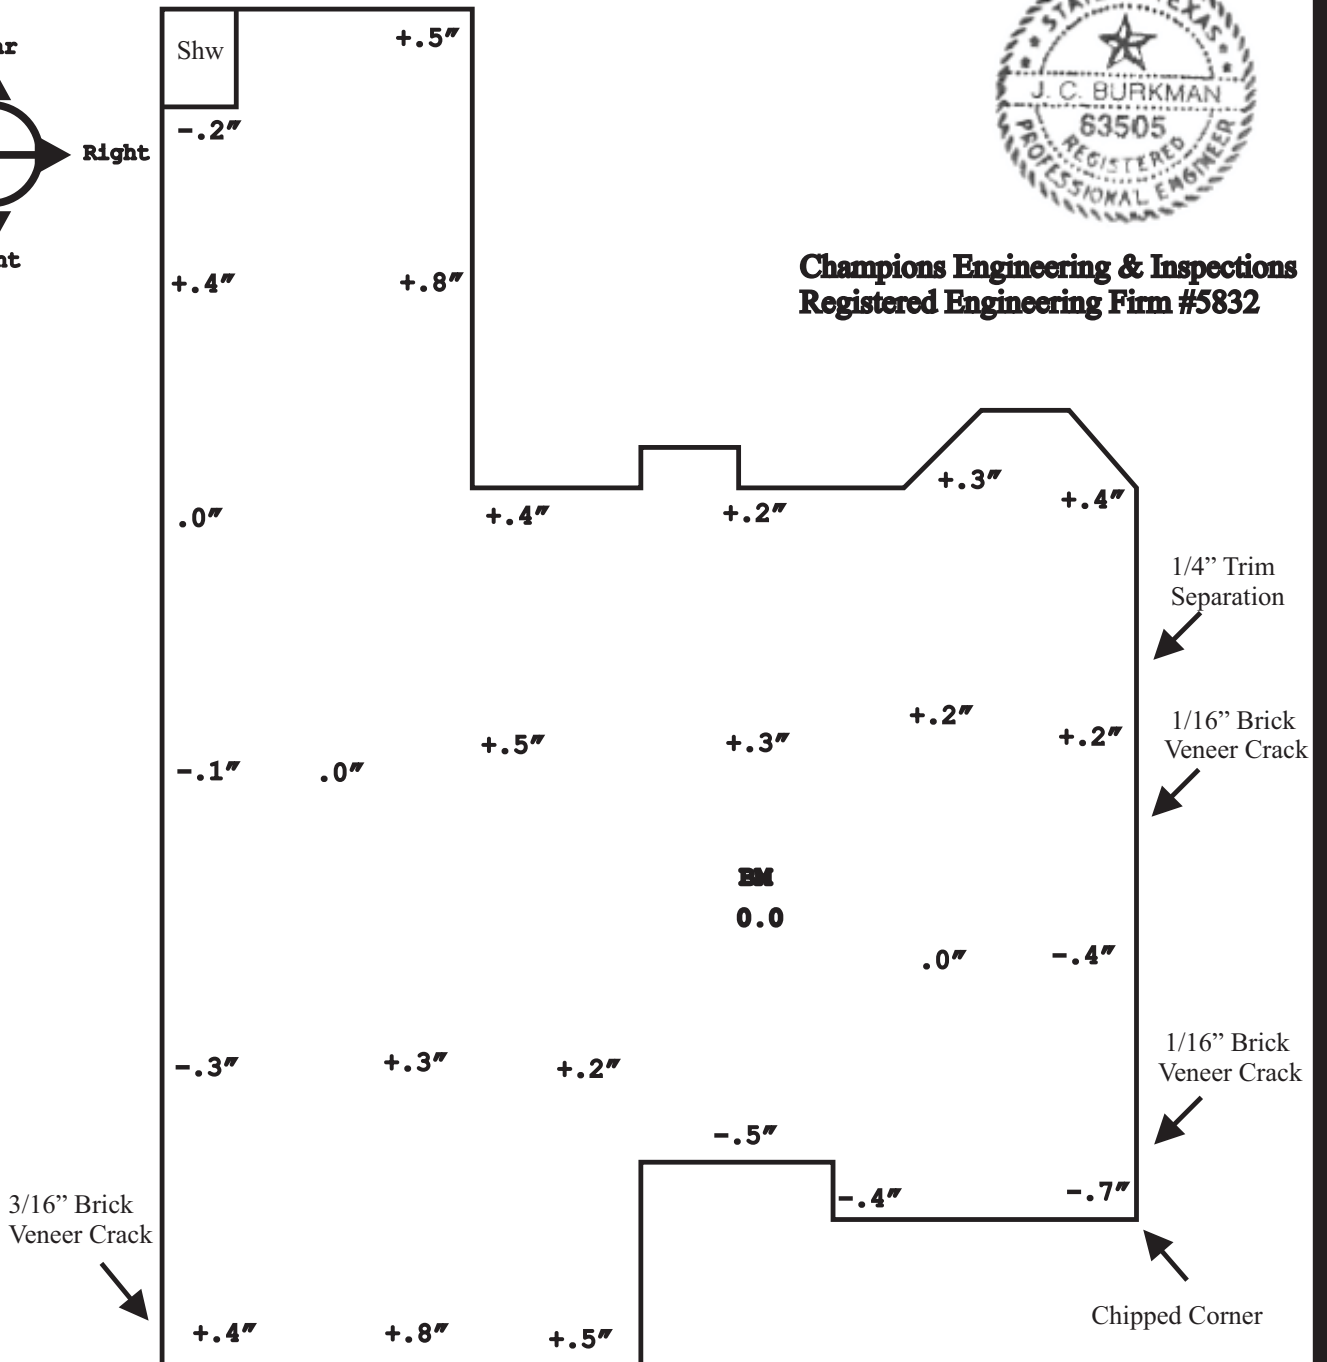
The slab elevations were measured using an electronic manometer level measuring the surface of the floor coverings. Minor deviations were observed, but they were not consistent to indicate a significant problem. The locations of the measurements are noted on floor plan attached.
