Property Inspection Report

**Shane and Ashley Morris
1805 Autumn Pond Circle
Alvin, TX 77511
Midtown Park
Key Map 695M**

Monday, August 31, 2020

PROPERTY INSPECTION REPORT

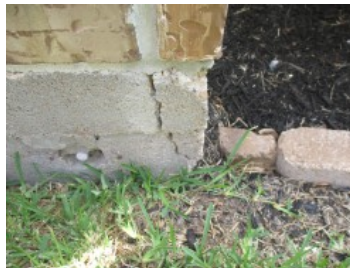
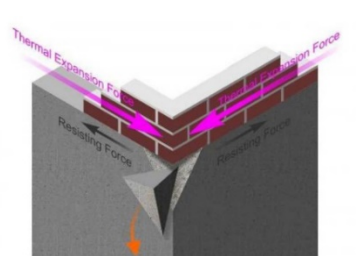
Maintenance: Spalling found within 12" of the foundation's corners may occur because of bonds between the brick and brick ledge and differential thermal movement. Spalling was noted at self-evident corners. This damage did not appear structurally significant and was not in need of repair at the time of this inspection.

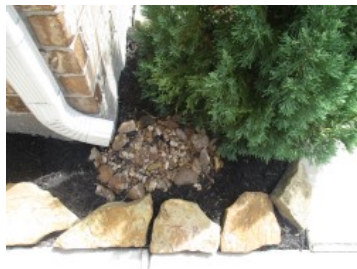
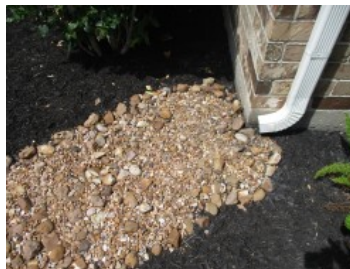
There were downspouts in the gutter system which directed water less than 5ft away from the slab. This may cause erosion at the foundation and allow undesirable movement.

Maintenance: Gutters and downspouts were installed at some eaves of this structure. I recommend, however, that as a structural improvement, gutters be installed on all horizontal fascia and that the downspouts direct water at least 5' away from the structure. This will improve drainage and reduce erosion and ponding which adversely affect foundations, driveways, and sidewalks.

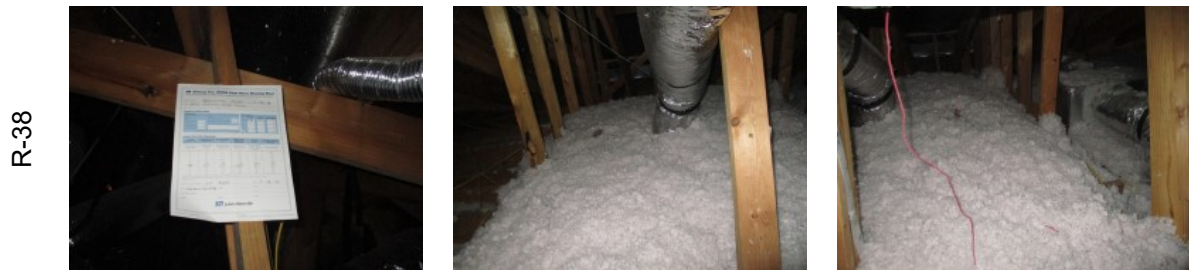
Information: The stairway door did not have a retainer installed to prevent loose fill insulation from spilling into the living space when the attic access is opened. A wood framed, or equivalent baffle or retainer is required to be provided when loose fill insulation is installed, the purpose of which is to prevent the loose fill insulation from spilling into the living space when the attic access is opened, and to provide a permanent means of maintaining the installed R-value of the loose fill insulation. *Note that, in my experience, the retainer poses a greater threat to personal safety than justified by the energy savings; it makes entering and leaving the attic space complicated.*

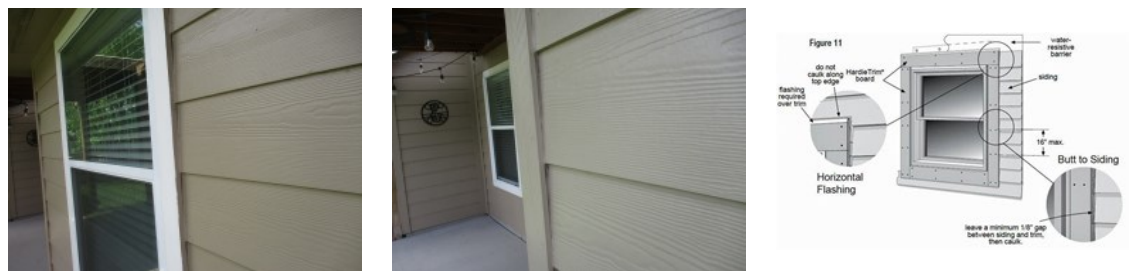
Information: The cementitious siding was installed beneath, rather than butting to, the trim. While this is not the recommended method of installation, the manufacturer accepts this within this zone (HZ10). *Manufacturer's Installation Instructions - Technical Bulletin.* No recommendation.

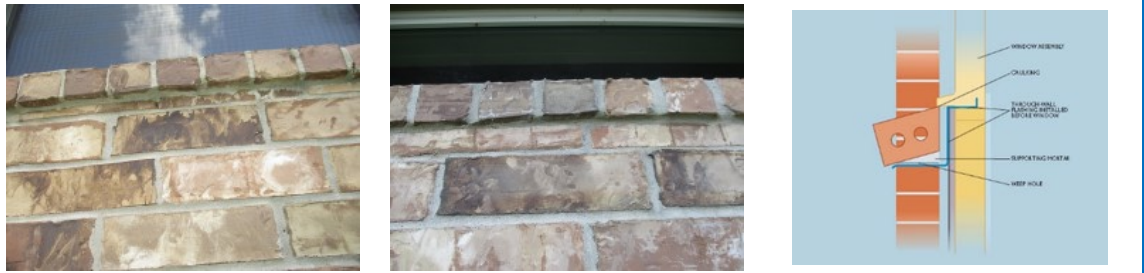
Information: No flashing or weep holes were observed beneath the brick rowlock-type sills beneath the windows set into masonry walls. While technically incorrect, this method used here is the most common method of installing the rowlock. No recommendation.

Information: The brick rowlock-type sills had a slope less than 15° from horizontal. Brick Industry America (BIA) recommends a minimum slope of 15 degrees (Technical Note 36, "Brick Masonry Details: Sills and Soffits") intended to prevent water from standing on the sill. The rowlock did slope away from the wall and there was no visible evidence of water penetration. There were no adverse and material conditions observed at the time of this inspection. No recommendation.

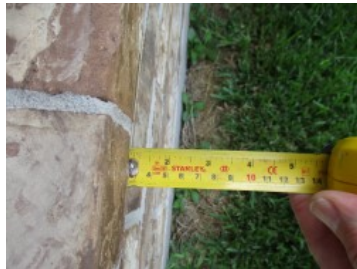
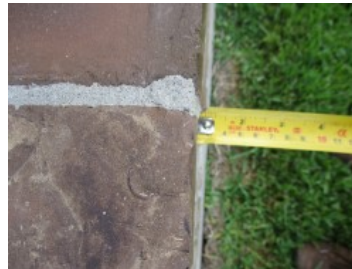
Information: The masonry rowlock-type sills had a shallow overhang. Brick Industry Association (BIA) recommends that the masonry overhand by a minimum of 1 1/2 inches. (Technical Note 36, "Brick Masonry Details: Sills and Soffits"). There was no visible evidence of water penetration at the time of this inspection. We make no recommendation for repair. No recommendation.

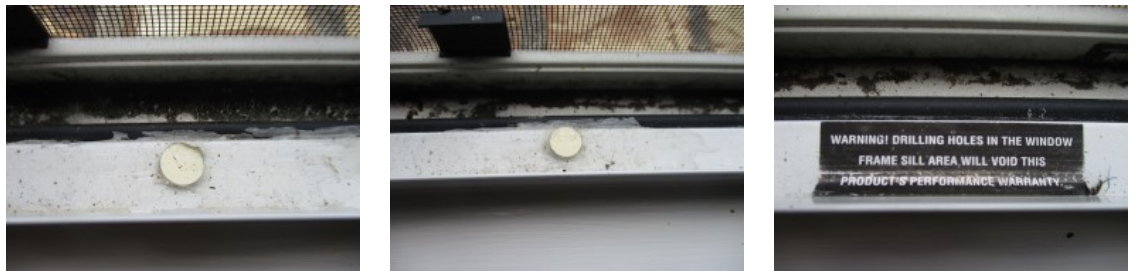
Maintenance: Windowsills had been drilled for the installation of alarm contacts. Manufacturers of most window frames specifically prohibit drilling holes in the windowsill for installation of alarm contacts. We were not able to determine whether there was any hidden latent damage caused by this condition. I recommend that each of the contacts be caulked as a preventative measure against moisture damage.

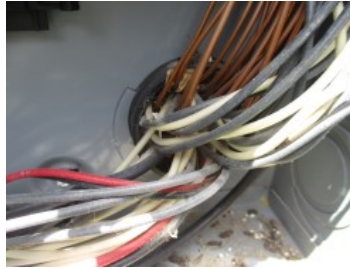
Information: Branch conductors filled more than 75% of a raceway and individual conductors were not secured to the panel cabinet. Such constriction of conductors may generate excessive heat and de-rate the amperage of the cables. Each cable is to be secured to the panel box. While not technically correct, this method of installation is used on virtually all exterior-mounted cabinets and many cabinets installed within stud cavities on inside walls.

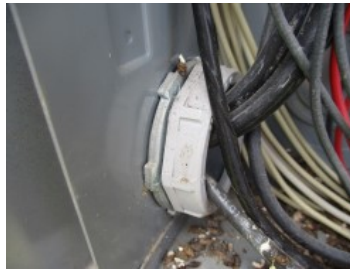
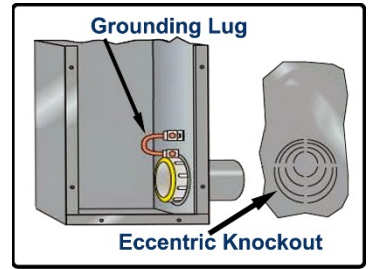
The raceway was not bonded to the electrical grounding system. Short Sections of Raceway. Isolated sections of metal raceway or cable armor, where required to be grounded, shall be connected to an equipment grounding conductor.

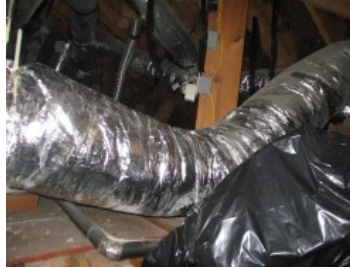
Portions of the duct within the attic space were not supported. The duct should be supported every 4ft with 1 1/2" straps to hold it relatively level to improve air flow and minimize the accumulation of condensate.

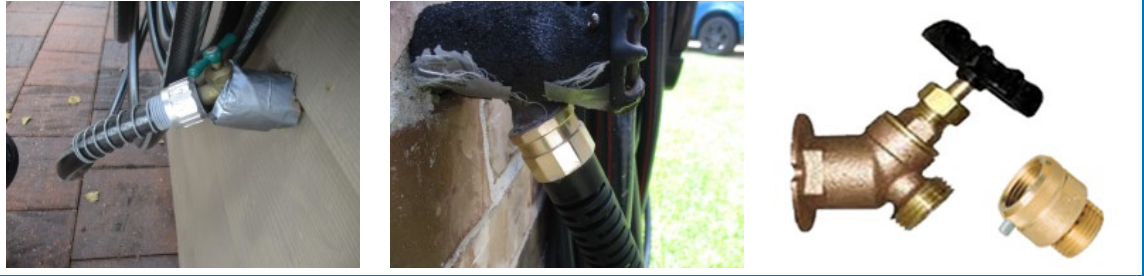
Vacuum breakers were missing from one or more hose bibs. Sill cocks, hose bibs, wall hydrants and other openings with a hose connection shall be protected by an atmospheric-type or pressure-type vacuum breaker or a permanently attached hose connection vacuum breaker for protection of the potable water supply.

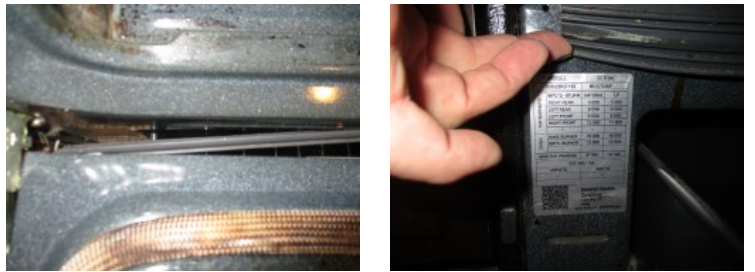
Gasket at the bottom of the Range door was not fully attached. Recommend repair.

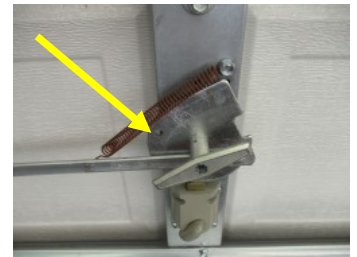
The door lock, or locks, was not disabled on overhead doors with operators present. Locks, on garage doors controlled by a garage door opener, should be disabled or removed. Attempting to open a locked door may result in damage to the door, or the unit may be pulled from its mounting causing property damage or personal injury.

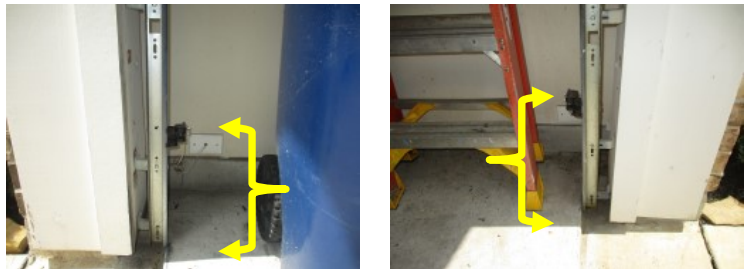
The sensors (electric eyes) were improperly installed on one, or more, overhead doors; they were more than 6" above ground level. These sensors, in conjunction with the auto-reverse feature, are protection against personal injury to small children and animals. These sensors should be set to a height of no more than 6" above ground level for personal safety.
