PROPERTY INSPECTION REPORT

Date of Inspection: 9/26/2022

Joseph Killion <i>Name of Client</i>	9/26/2022 <i>Date of Inspection</i>
3349 Jan Ct Katy, TX 77493 <i>Address of Inspected Property</i>	
Syed Waqif (Aj) <i>Name of Inspector</i>	TREC # 22011 <i>TREC License #</i>
<i>Name of Sponsor (if applicable)</i>	<i>TREC License #</i>

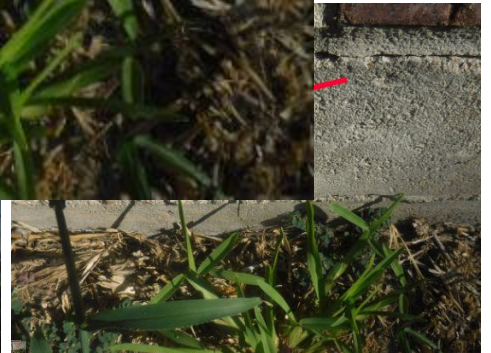
Spalling on the south side

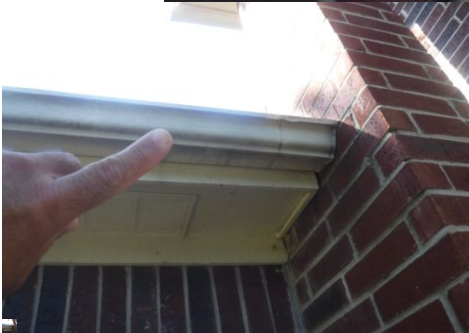
Congested rain gutters/needs cleaning/leaning gutters

• The congested roof drains should be cleared and maintained free of debris.

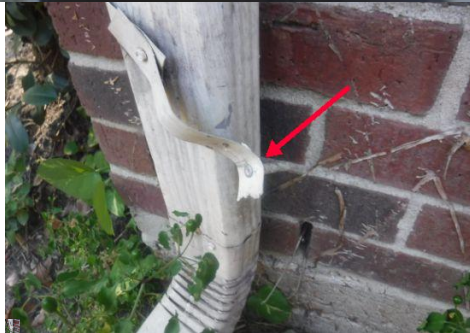
Damaged gutters

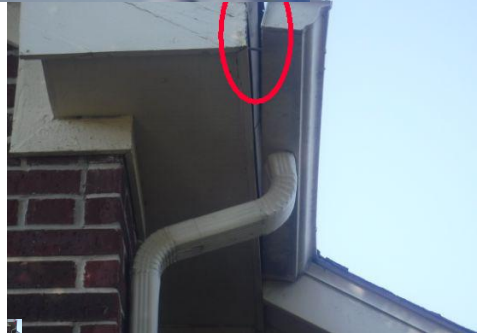
Damaged/leaning gutters

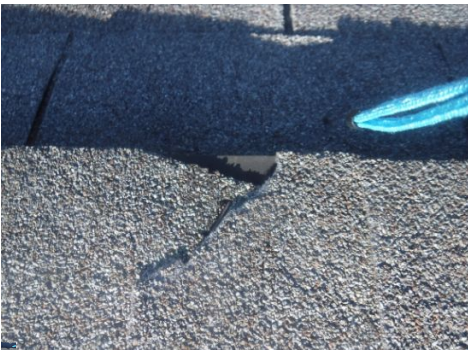
Damaged shingles

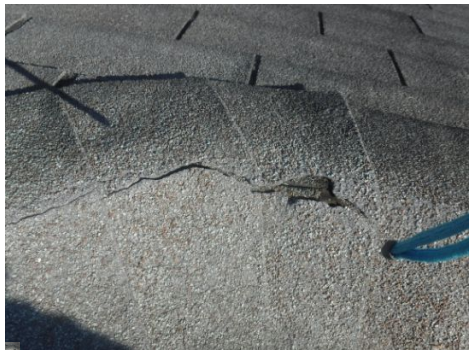
Damaged shingles

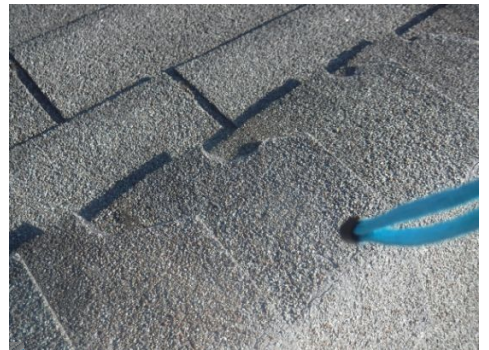
Damaged shingles

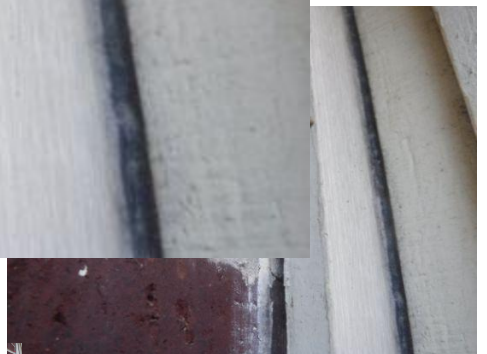
Exterior wall movement crack/opening

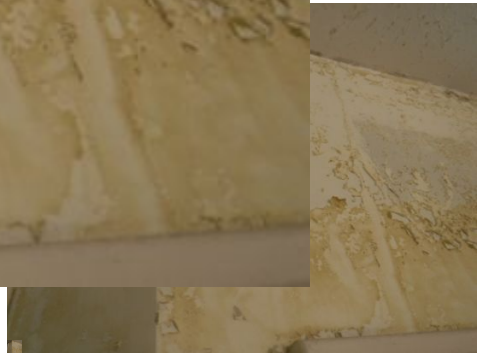
Damaged wall

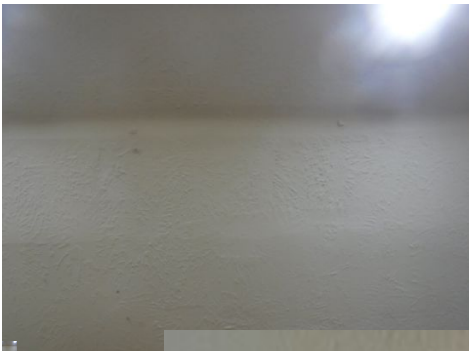
Nail pop

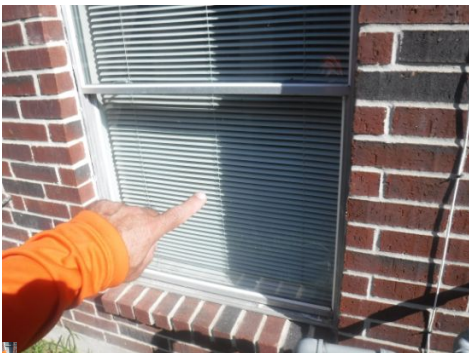
Missing screen

- Replace window screens where missing. The owner/builder should be consulted regarding any screens that may be in storage. Refer to the picture below.

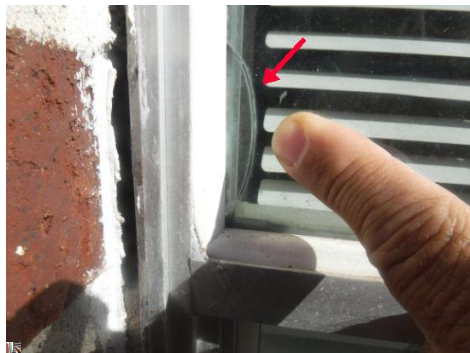
Damaged window

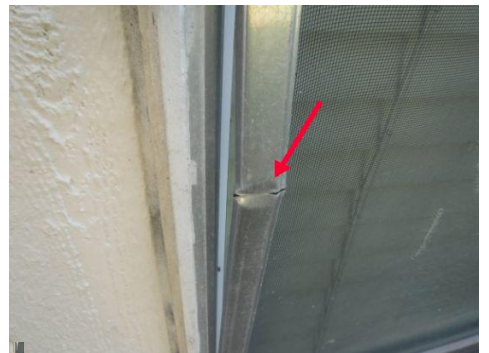
Damaged screens

The damaged screens were found on the window should be repaired or replaced. Refer to the picture below.

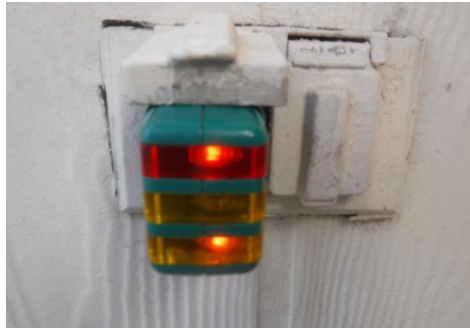
Living room wall is hot and has ineffective grounding

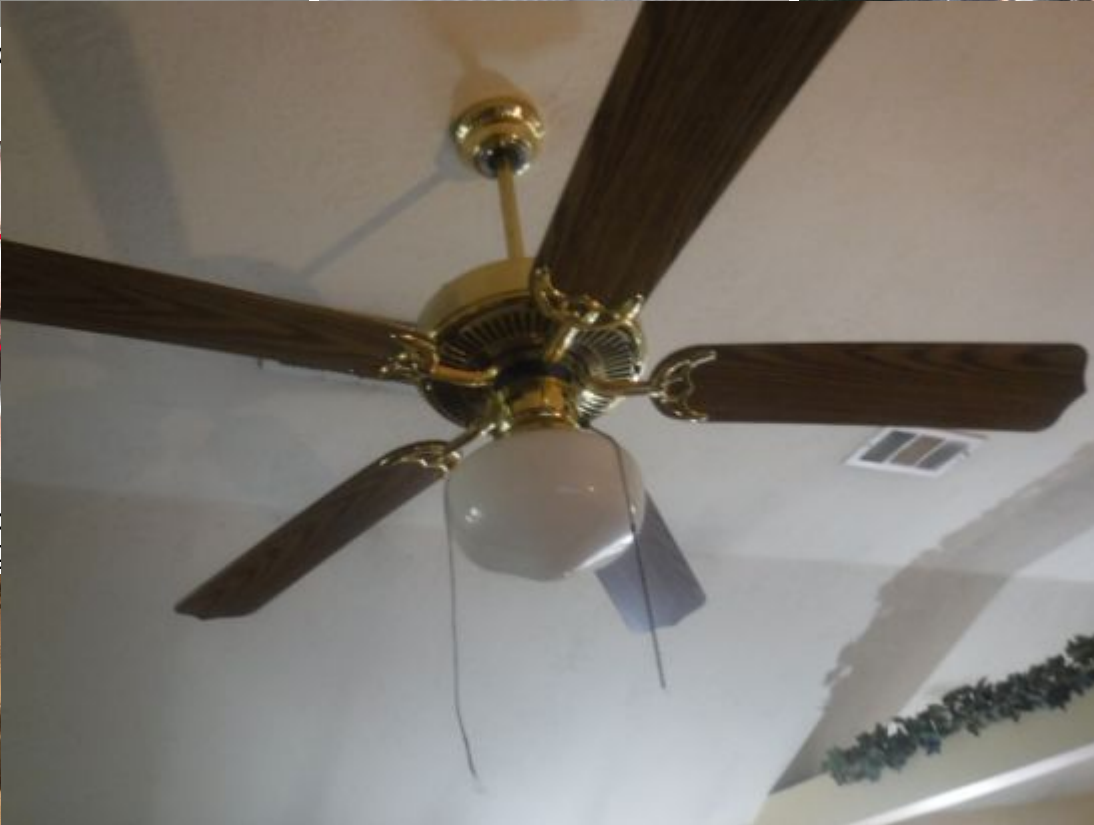
Inoperative ceiling fan in the living room

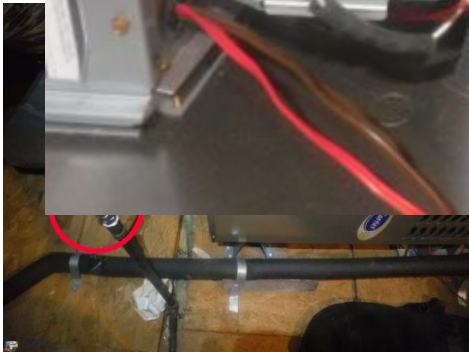
Missing sediment T trap

Page 20 Item: A	Heating Equipment	<ul style="list-style-type: none"> • Missing gas sediment trap " T " at the connection. Recommend contacting a certified plumber to fix the issue according to the current code.
Page 21 Item: C	Duct Systems, Chases, and Vents	<ul style="list-style-type: none"> • Vent cover needs cleaning. Refer to the picture.

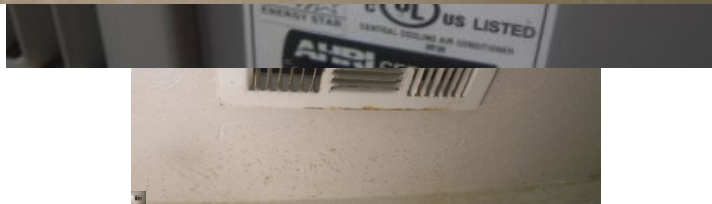
Rust on the AC vent in the master

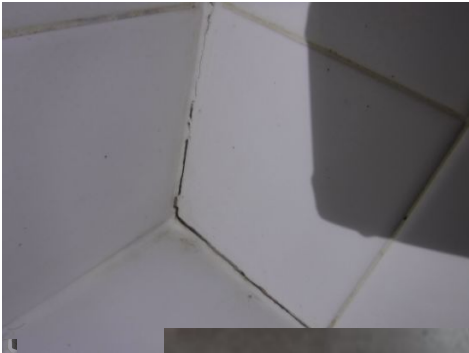
Missing or damaged grout/needs

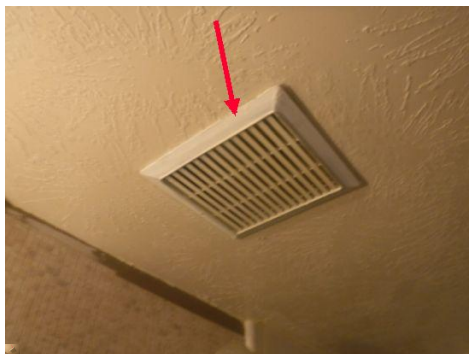
• The bathroom exhaust fan exhibits excessive vibration when running. This condition should be repaired.

Fan is vibrating
