Inspection Report

Property Address:
8643 Vista Hills Dr
Richmond TX 77407

PROPERTY INSPECTION REPORT

Xuan Tien Le - TREC License # 23885 9/21/2022

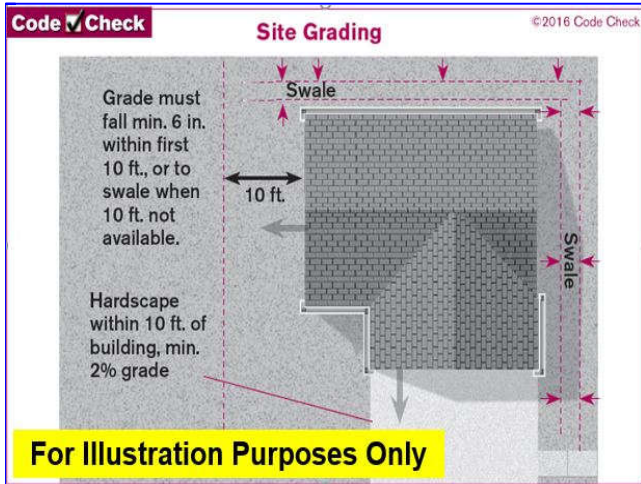
B. Item 1(Picture) Grading

(1) General grade improvements are needed to prevent ponding/standing water. Proper drainage is needed to help prevent water from standing and/or ponding next to the foundation. Corrective measures may be needed if the water stands within 10-feet of the foundation for more than 24-hours. Grading improvements are needed to direct run off water away from the structure. Any area where the ground or grade does not slope away from the structure is to be considered an area of improper drainage. The recommended slope away from the foundation is 6 inches per 10 feet.

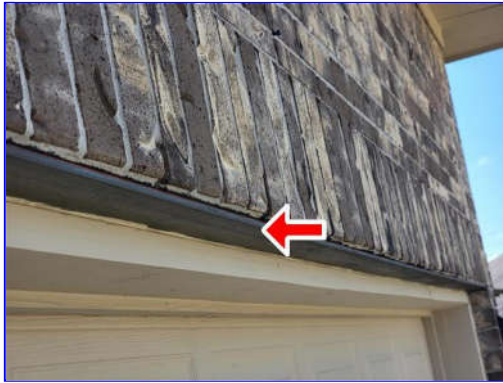
E. Item 4(Picture)

(3) Mortar separation was observed in Front of the house. Depending on the degree of deterioration, repairs may be needed. In the event repairs are needed, a qualified, verified mason should be consulted regarding proper repairs.

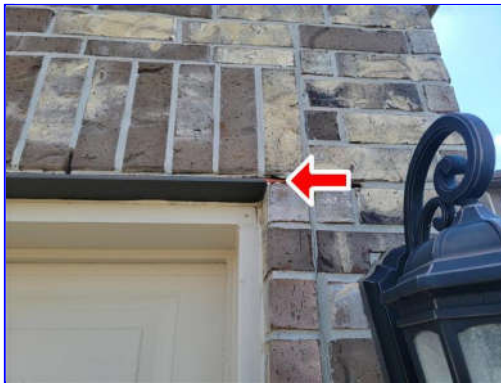
E. Item 8(Picture)

(4) Caulking trim and windows in some locations, was observed to need improvement. Make improvements as needed.

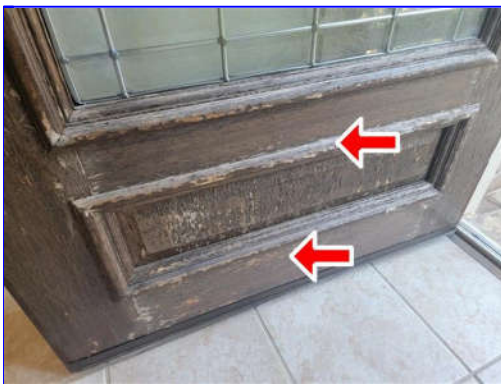
G. Item 1(Picture)

The exterior door(s) at the front of home was/were observed to have the following defect(s): finish is damaged. Repair or replacement is needed.

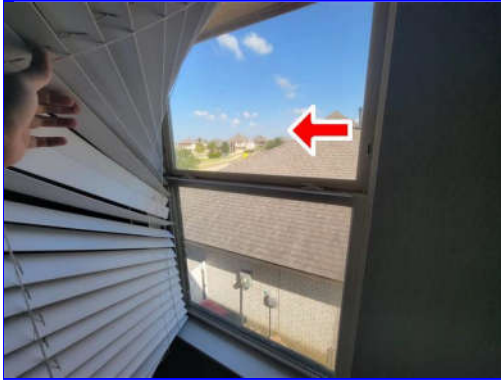
H. Item 1(Picture)

One window at Rear Left bedroom is/are fogged suggesting the seals have failed. A qualified, verified window specialist should be consulted regarding this condition.

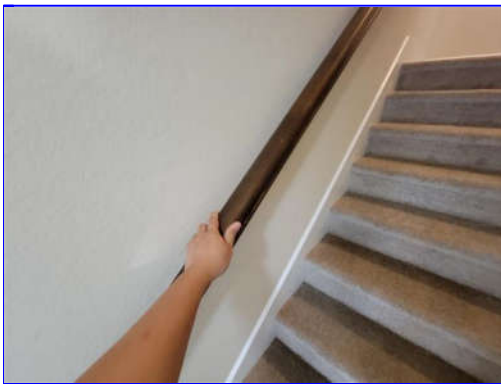
I. Item 1(Picture)

The stair handrail(s) is/are loose and is/are a potential safety concern. Repairs should be made to prevent potential injuries. The design strength of a handrail should resist a 200-pound concentrated load applied at any point in any direction along the handrail or the top of the guard.

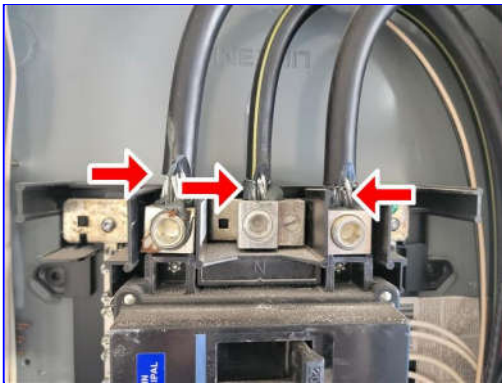
A. Item 4(Picture)

(3) The aluminum feeder wires are not coated with anti-oxidant paste to prevent corrosion.

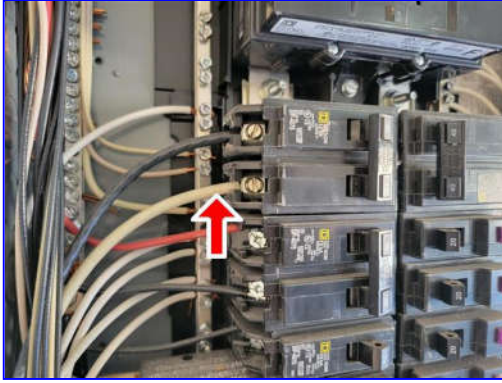
A. Item 5(Picture)

(4) Cables at breakers are white, an improper color code for these cables.

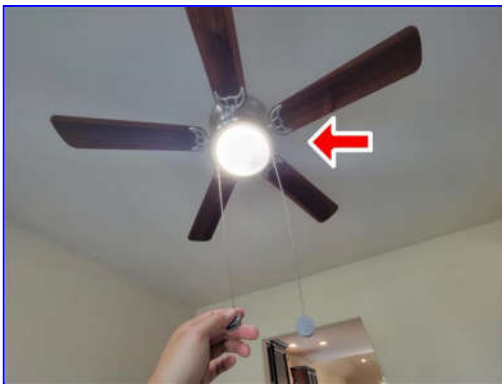
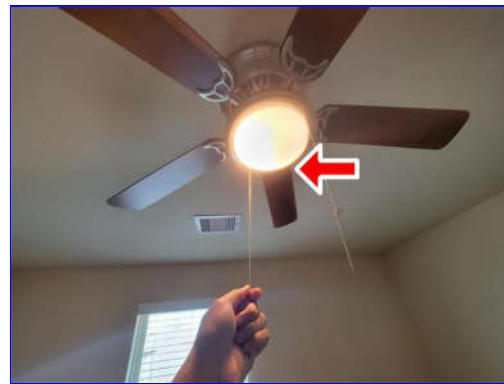
(3) Ceiling fan in various locations was/were observed to have the following defect(s): is not properly balanced and is inoperative using the available controls.

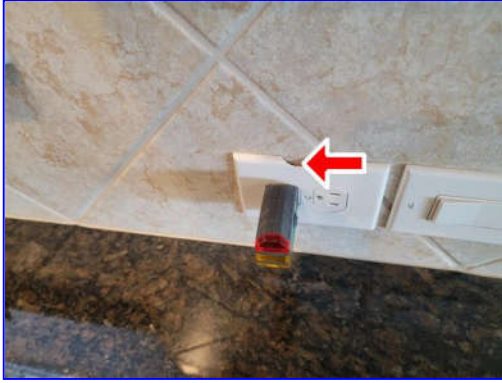
B. Item 3(Picture)

(4) At least one receptacle(s) in kitchen area was/were observed to have the following defect(s): have damaged cover plates. Damaged or missing cover plates should be replaced.

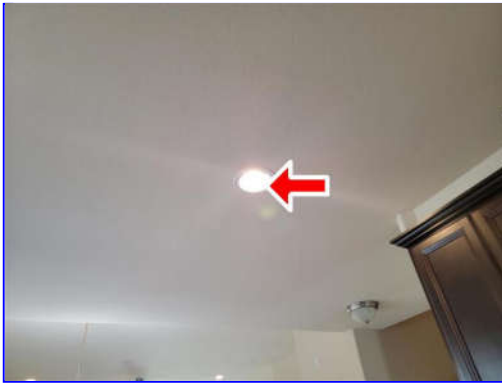
B. Item 4(Picture)

(5) Light in Kitchen area was observed flickering when in operation. Recommend a qualified professional evaluate and repair.

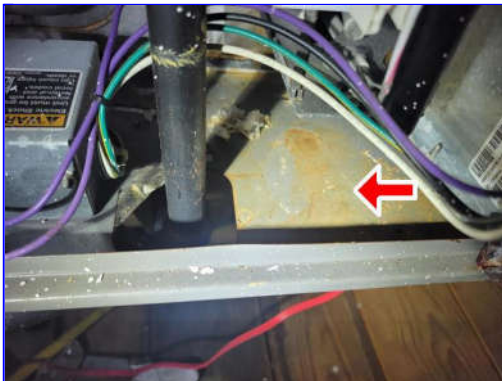
A. Item 3(Picture)

(3) There were areas of rust present at the heater cabinet. Recommend further investigation.

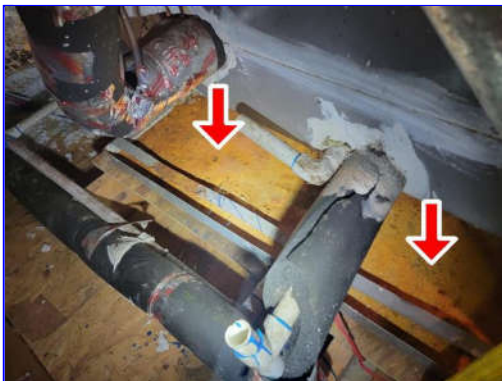
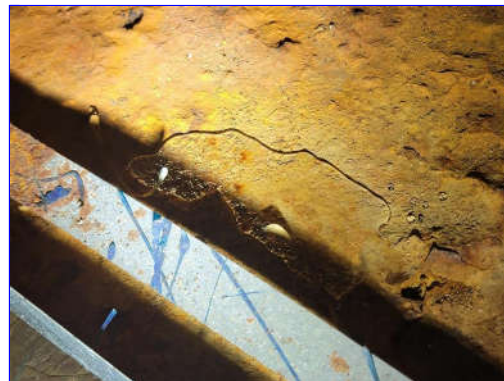
(5) Safety pan at the air conditioning evaporator coil in the attic is corroded. Replacement is necessary to prevent potential damage surrounding surfaces if the safety pan fails.

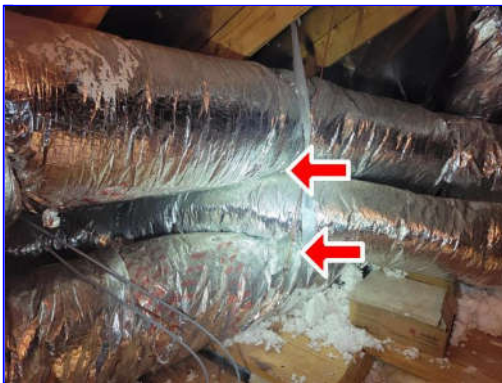
C. Item 3(Picture)

(2) Ductwork was observed to be in contact with other ductwork. Typically ductwork should be separated to prevent condensation between ducts. Condensation can lead to excess moisture in the attic space. This can lead to potential problem, i.e. wet insulation and conducive conditions that can lead to organic microbial growth.

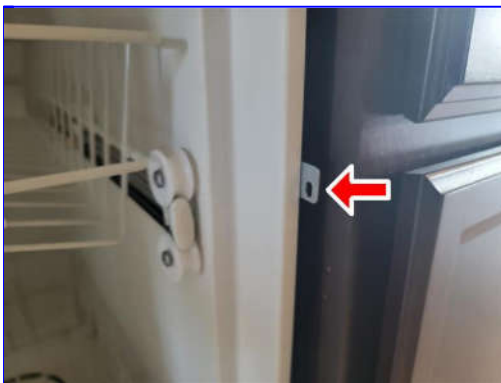
A. Item 4(Picture)

(2) The dishwasher was found to be inoperable using the normal controls at the time of inspection. This condition should be further investigated by a qualified appliance professional.

(3) The dishwasher was observed to be improperly installed in the cabinet opening. The unit was observed to be loose in the opening and should be secured with proper length screws to the underside of the cabinet.

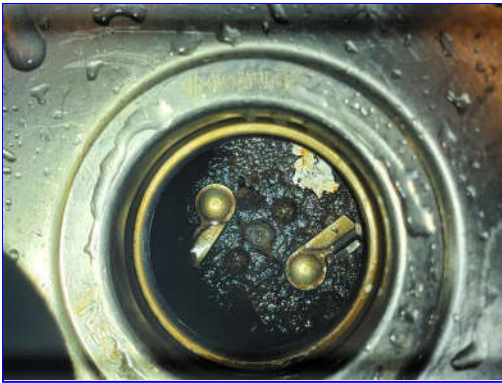
B. Item 3(Picture)

(2) The food waste disposer was inoperative at the time of the inspection. Furthermore, food disposal was observed to have the following defect(s): rusted inside at the blades. An appliance specialist is recommended to evaluate and estimate repairs.

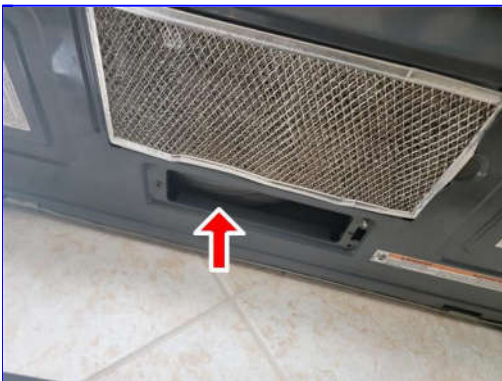
C. Item 4(Picture)

(2) The bulb for the range hood was observed to be inoperative. I recommend repair or replacement as needed.

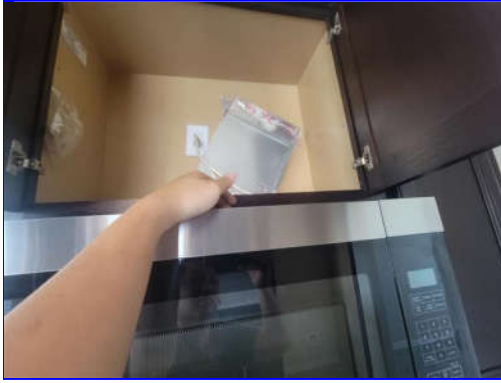
C. Item 5(Picture)

(3) The range hood vent was observed to have the following defect(s): not properly installed and is venting into the interior of the home/cabinet space. The range hood vent should be sealed where needed.
