PROPERTY INSPECTION REPORT

22430 Smokey Hill Dr. , Katy, TX 77450
Inspection prepared for: Matt Messer
Real Estate Agent: Open House - Open House

Date of Inspection: 10/8/2022 Time: 8:30 AM
Age of Home: 1977 Size: 1,812
Weather: Clear 75 Degs F
Structure Type: Structure is a wood framed structure
on a concrete slab foundation.

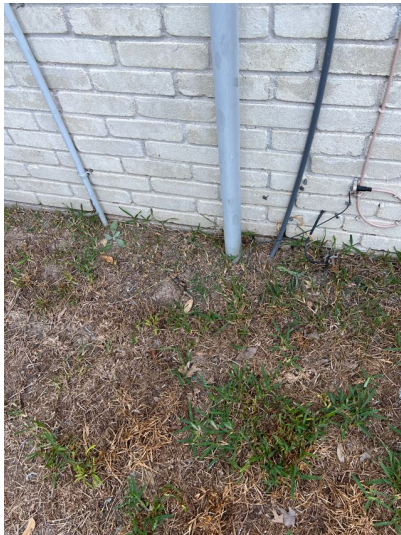
Soil elevation that is at the height of brick weep holes and higher or at bottom of siding or higher is a conducive condition for termites to gain entrance to wall structure. It's like a welcome mat.

- The soil was noted to be too high on foundation in one or more locations.

High soil, back side of house.

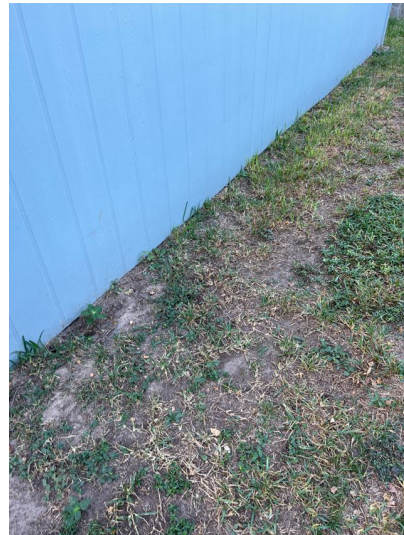
High soil, back side of garage

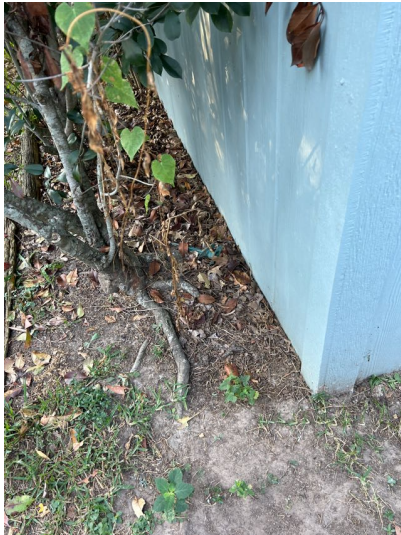
High soil right side of garage

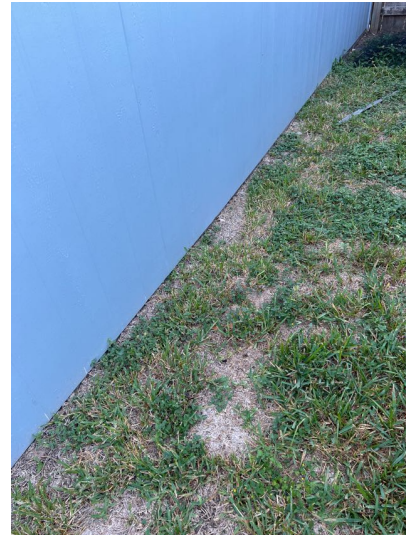
High soil left side of garage .

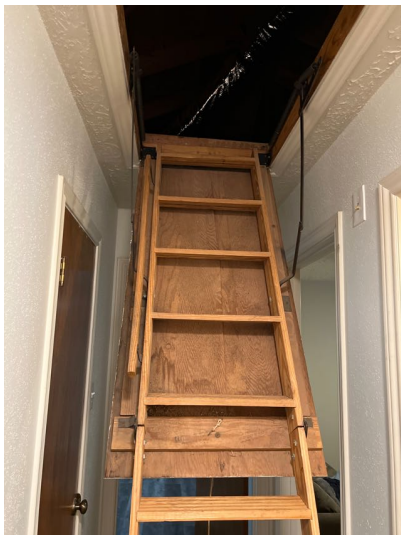
- The attic structure was observed to be conventionally framed with rafters, purlins and collar ties
- **There is no insulation installed on the attic access cover as required by current standards.**

Attic access missing insulation.

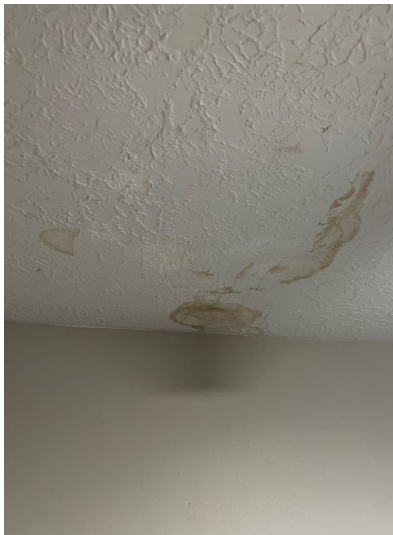
- Moisture stains were noted ceiling. The cause and remedy should be further evaluated and corrected as needed.

Moisture stain on ceiling.

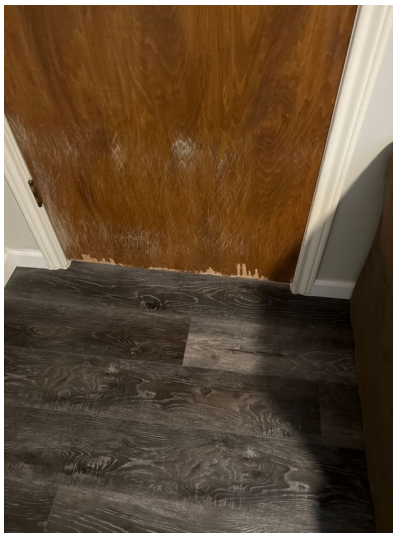
- One or more interior doors noted with damage.

Damaged bedroom door

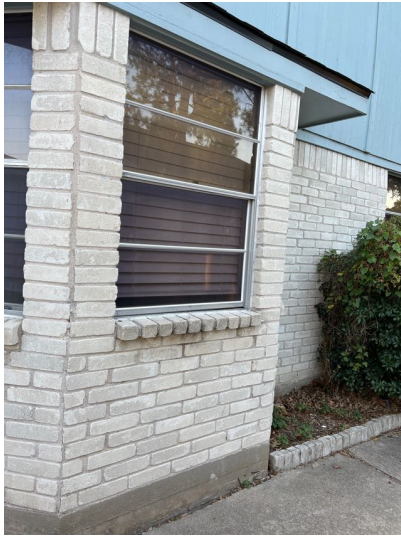
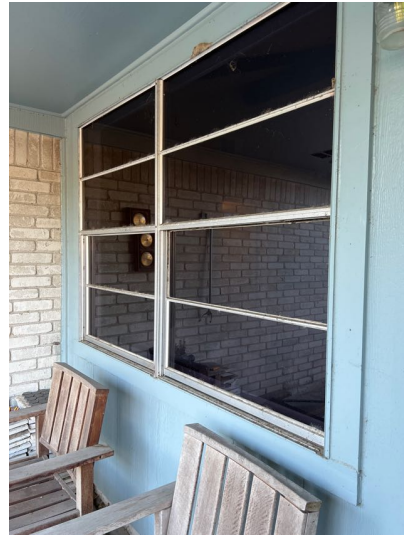
- One or more of the window screens were observed to be damaged and/or missing. Screens are mentioned in this part of the report as they are a specific item in the T.R.E.C. Guidelines. Screens that are torn enough to allow insect infestation should be repaired or replaced. All windows that have channels for screens should have them installed.

Windows missing screens.

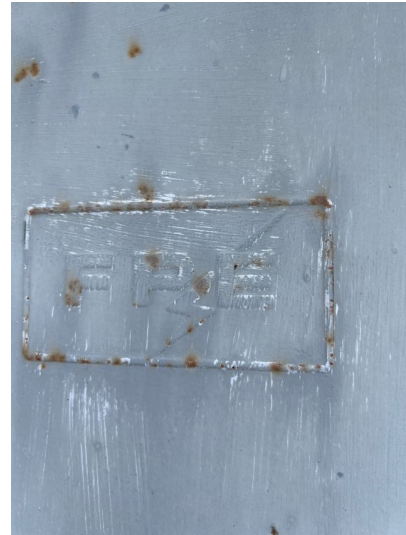
- Service entrance wiring is underground
- The aluminum service conductors in electrical panel missing anti-oxidant grease.
- One or more of the electrical panels were observed to be Federal Pacific Panels. These panels are obsolete, known to be hazardous and should be replaced. FPE electric panels' circuit breakers fail to trip when they should (when there's a short circuit or circuit overload). This problem has lead to thousands of fires across the United States. There are also many reports that FPE circuits in the off position still send power to the circuit. This can cause electrocution when working on a circuit you believe to be off.
- Having a licensed and reputable electrical contractor correct issues noted in this report and, while on site, check for any other electrical related issues is recommended.

*Electrical service panel brand name.
Federal pacific*

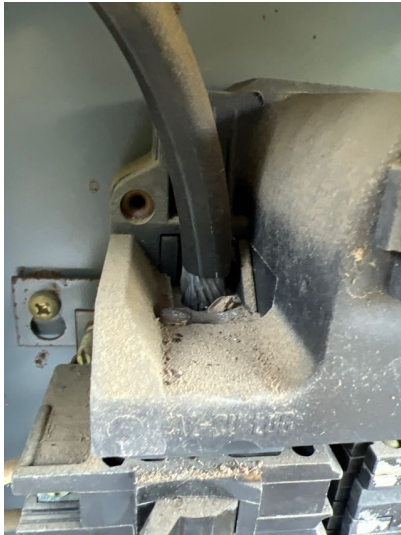
Aluminum service conductors missing anti-oxident grease.

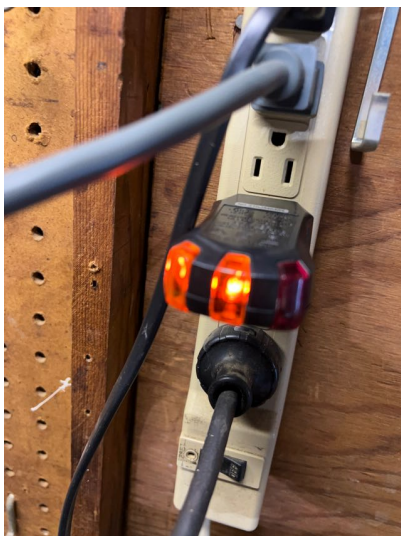
Garage electrical receptacle not GFCI protected.

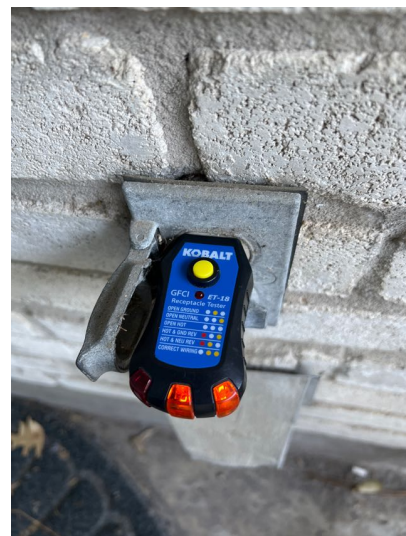
Exterior electrical receptacle not GFCI protected.

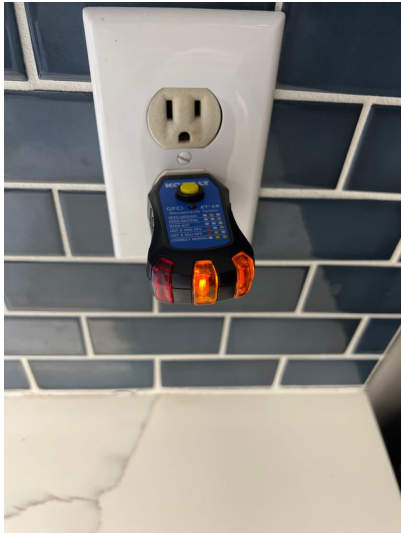
Kitchen electrical receptacle not GFCI protected.

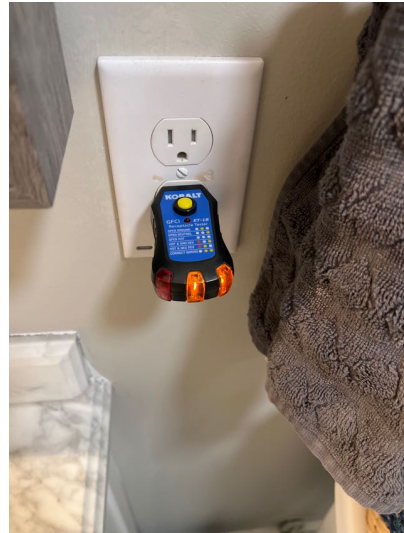
Bathroom electrical receptacle not GFCI protected.

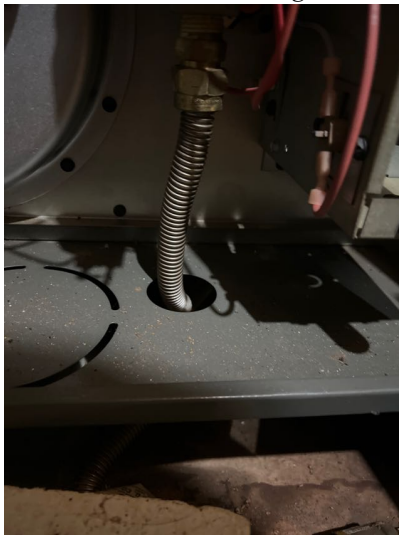
- The flexible gas appliance connector has been installed through furnace cabinet. This is a safety concern.

Gas connector has been installed through furnace cabinet.

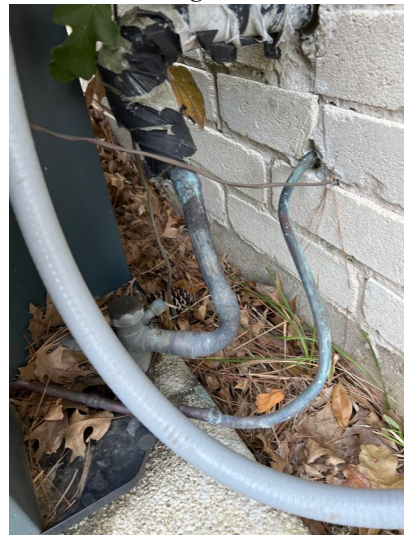
Damaged insulation on freon line at AC condensing unit.

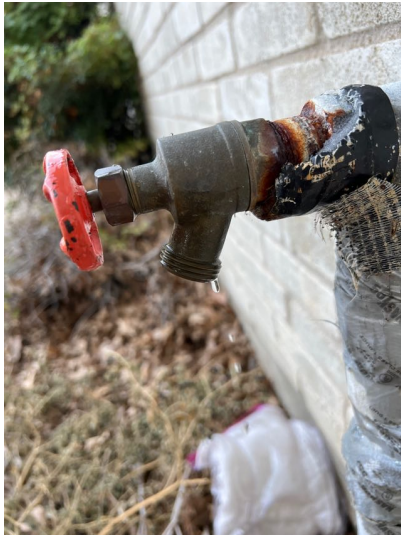
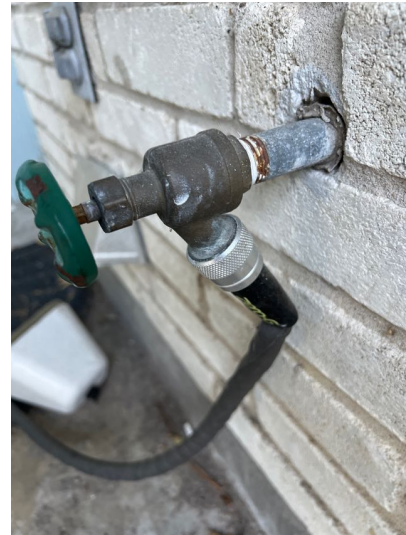
Hosebib missing anti-siphon device.

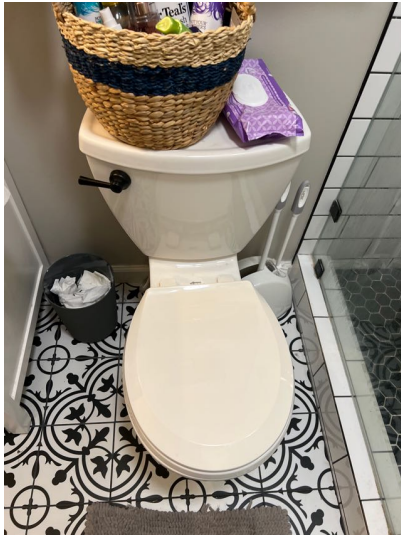
- One or more toilets noted loose where attached to floor.

Master bathroom toilet loose where attached to floor

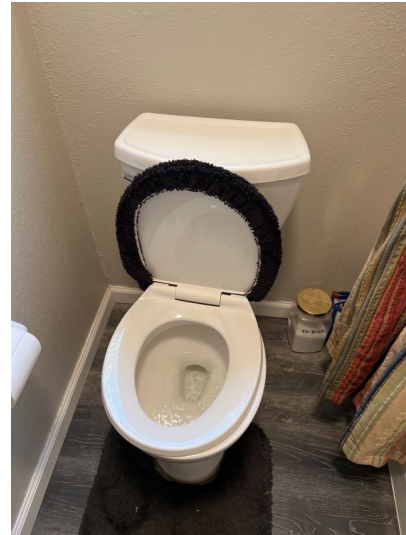
Hall bathroom toilet loose where attached to floor

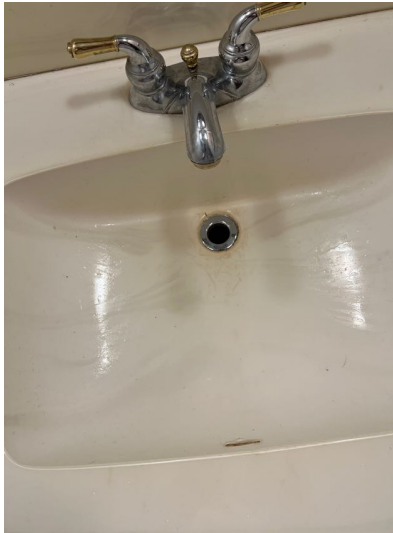
- Type of Drain Piping Material: Unknown
- Drain stoppers were either damaged, or non-functional at one or more sinks in the home

Hall bathroom vanity noted with missing drain stop

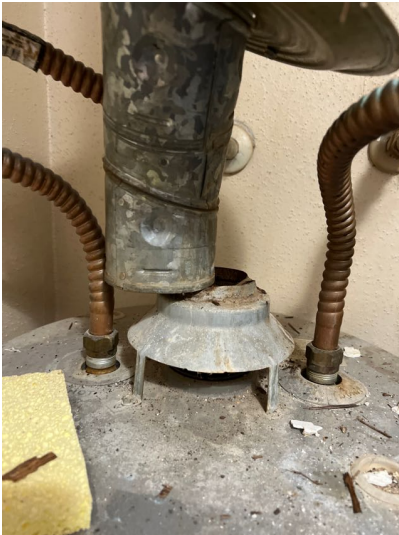
Improper flue pipe venting was noted and further evaluation is recommended

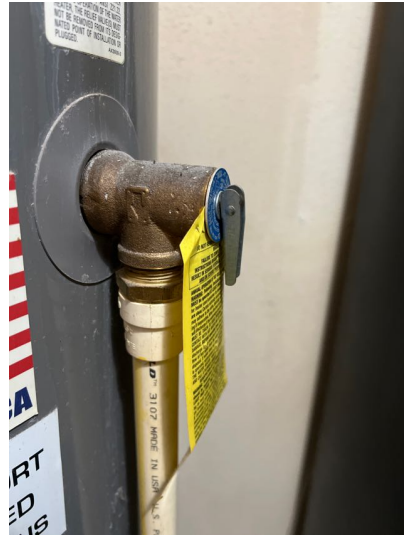
Water heater temperature and pressure relief valve is damaged.

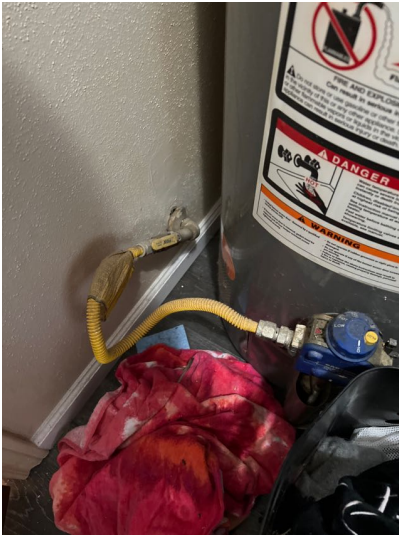
Water heater gas piping missing sediment trap.

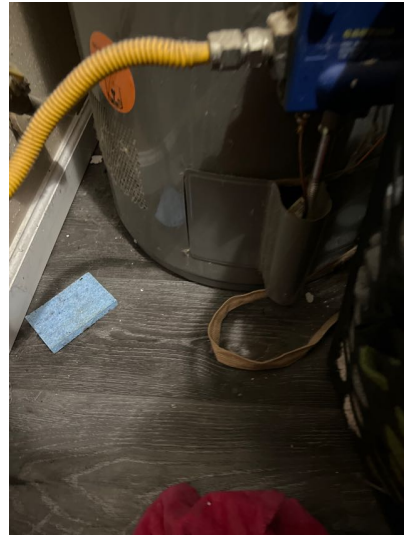
- The water heater is missing a drain pan and discharge piping to the exterior. A drain pan under the tank is designed to prevent or minimize damage from a water leak.

Water heater missing required drain pan and discharge piping.

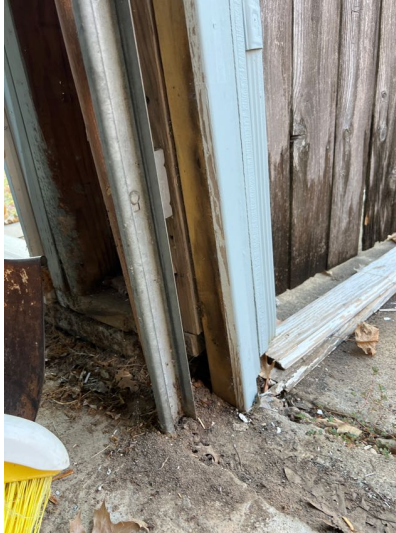
- The garage door did NOT automatically reverse when tested.
- The garage door opener auto reverse sensors were missing at time of inspection.

The garage door opener auto reverse sensors were missing at time of inspection.
