Property Inspection Report

5602 Bending Crest CT, Sugarland, TX 77479 Inspection prepared for: Kalpesh Mehta Real Estate Agent: -

Date of Inspection: 9/9/2019 Time: 10:00 AM Age of Home: 2019 Size: 3158 Weather: Clear 95° Order ID: 302.

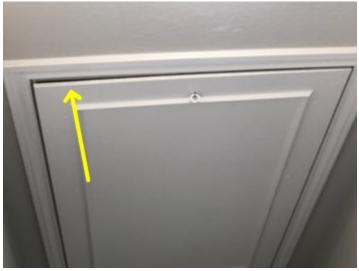
The drop-down attic access door above the second-floor hallway area does not appear to adequately/fully shut. Adjust/repair as needed in order to completely shut as intended.

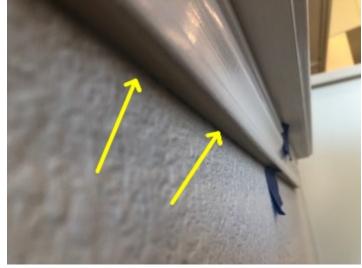
Caulk/seal underneath the windowsill apron/wall joints that are void at breakfast area, and throughout the house where needed as marked with blue tape.

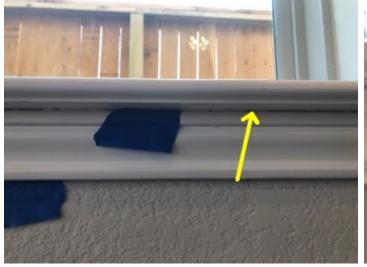
Caulk/seal below the windowsill/apron joint that is void NE of the breakfast area, and East of dining room.

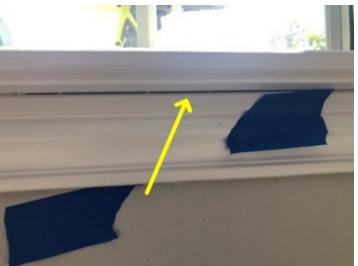
Caulk below windowsill/appron joint that is void North of dining room

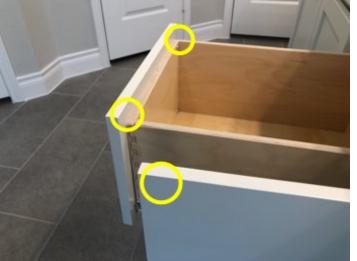
Install missing rubber bumpers to all cabinet doors and drawers at kitchen and bathroom areas.

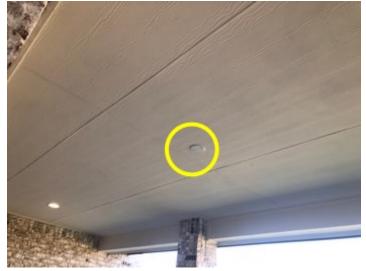
Install missing electrical fixture to the junction box at ceiling above the covered patio at bat of the house.

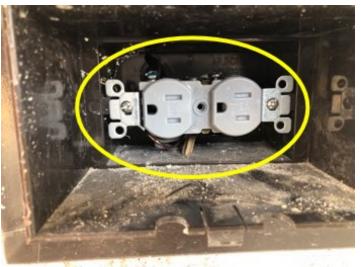
Install missing cover plate to the outdoor receptacle at covered patio at back of the house for proper safety.

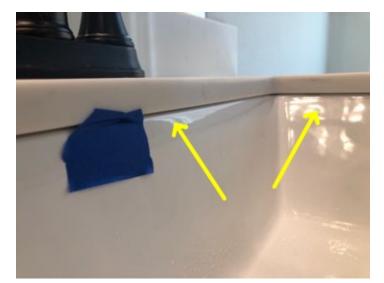
Appears to be missing caulking around the master Scratch marks observed to the bathtub basins at bathroom lavatory sinks/quartz countertop joints. Scratch marks observed to the bathtub basins at both second-floor hallway bathrooms. Recoat the tubs as needed.
