**122 Vine Mint Drive
Montgomery TX 77316**

Client(s): Gryparis
Inspection Date: 2/23/2020
Inspector: Murray Campbell , TREC #22455

Concerning: 122 Vine Mint Drive, Montgomery, TX 77316

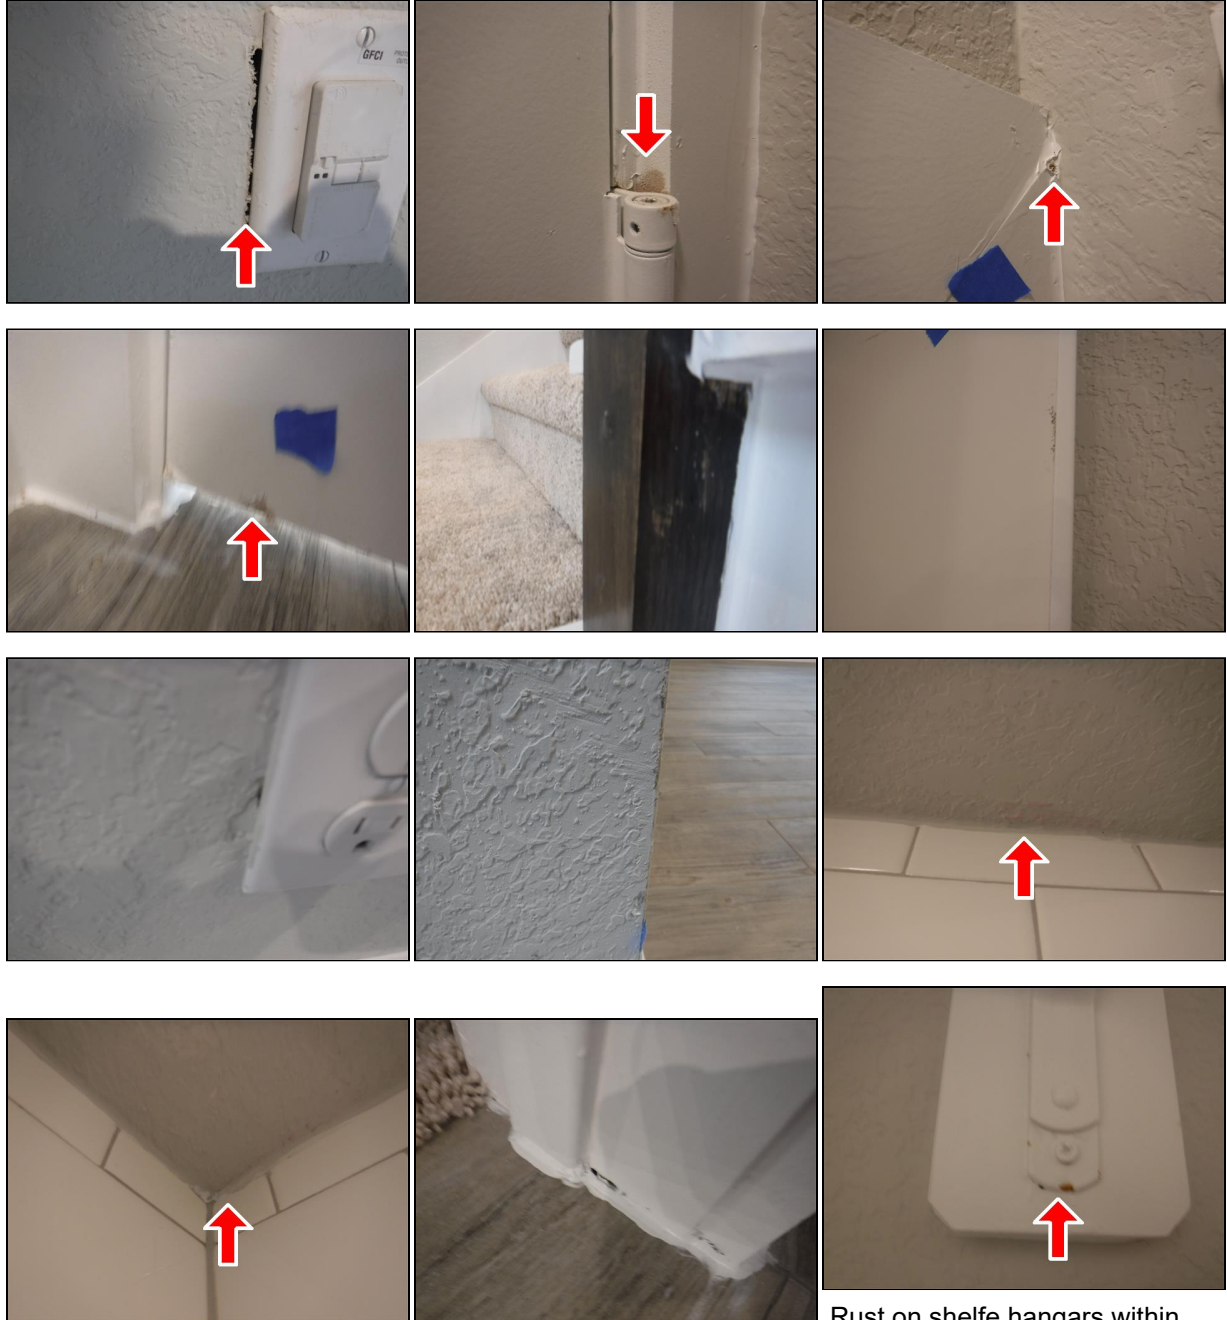
Rust on shelf hangers within master bedroom.

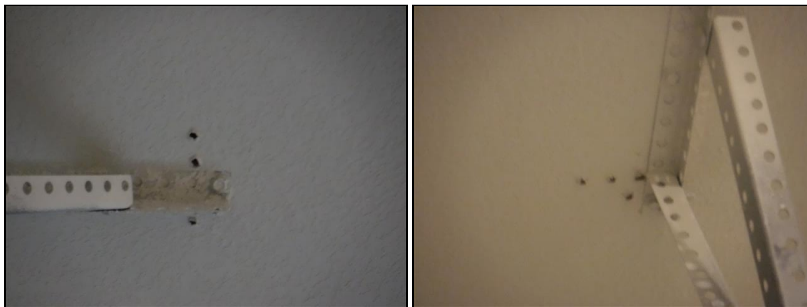
Transition missing upper guest bathroom.

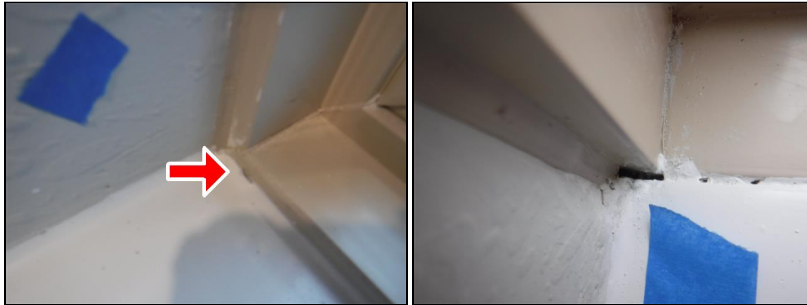
Noted several window sills at interior of home with deteriorated caulking at various sides of window frames. Deteriorated caulking at area can potentially subject framing under and behind window sill to future moisture collection concerns. Recommend having all window sills affected re-sealed with caulking. Important to check all 4 sides of window frames for deteriorated caulking concerns.

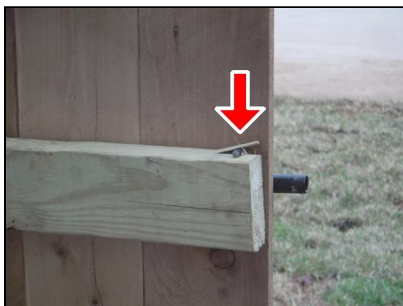
Exposed fastener at right side gate.

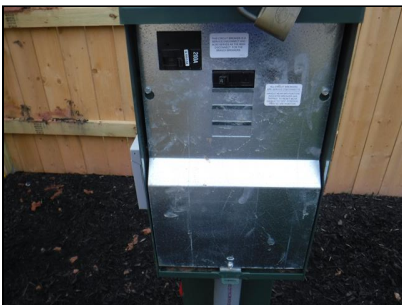
Missing dead front on main panel. Replace as needed.

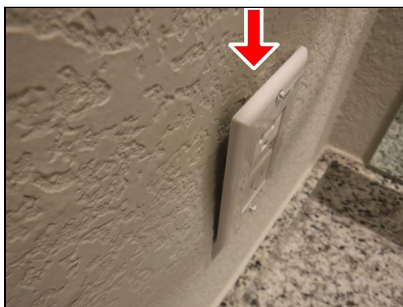
☒ Replace missing cover plates on various outlets and switches. Prevent access to live components that can cause injury or electrocution.

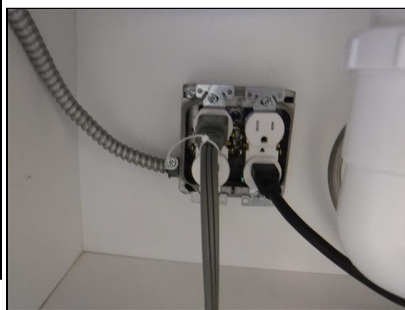
This cover plate within guest bathroom is not attached.

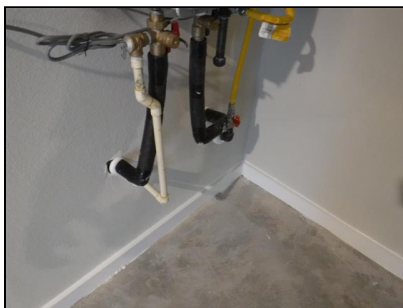
The water heater abuts to an interior wall and there is no emergency leak catch pan installed. Today's standards now require a catch pan that is plumbed to the exterior in locations where tank leaks could cause interior water penetration.

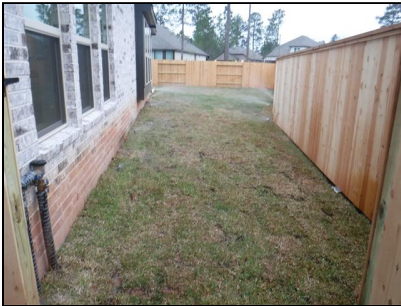
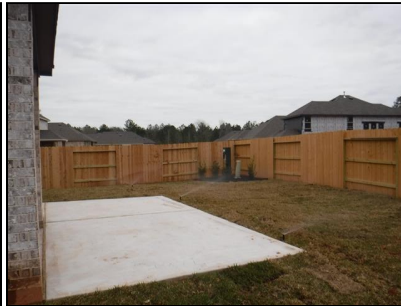
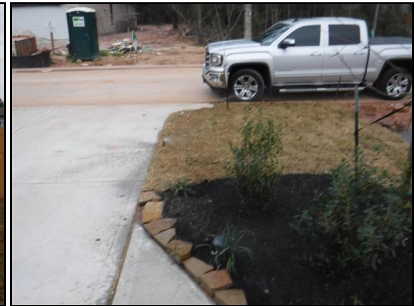
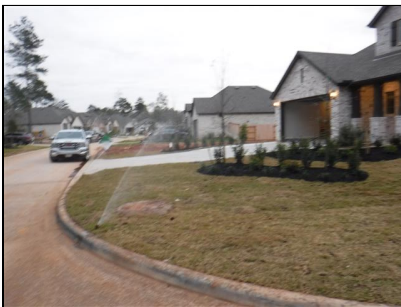
There is a damaged sprinkler head at front left side and stations #4 and #5 did not operate (facing front). The system is in need of further review and repair by a licensed irrigator.

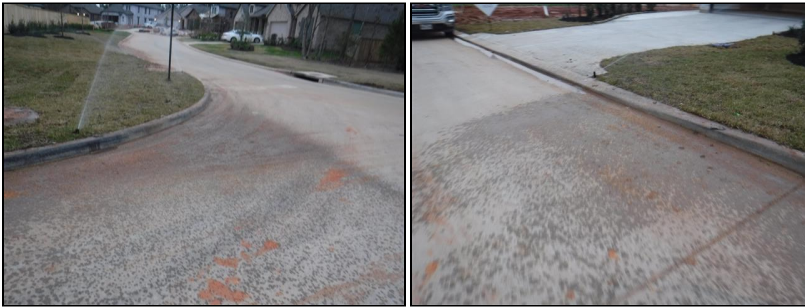
The sprinklers over sprayed into the street. This could result in a fine within certain municipalities. Adjustment or redirection is recommended.
