## PROPERTY INSPECTION REPORT

Report # 23003

Concerning: 2225 River Valley Dr Columbia Lakes, TX 77486  
(Address or Other Identification of Inspected Property)

By: Kenny Boulton January 9, 2023  
TREC Professional Inspector Lic.# 698 (Date)

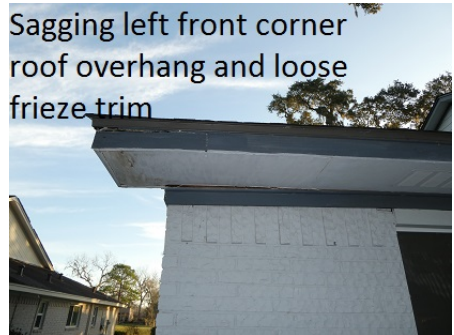
Sagging was noted in the breakfast room left front corner roof overhang with rot roof decking and loose frieze trim. Repairs are needed.

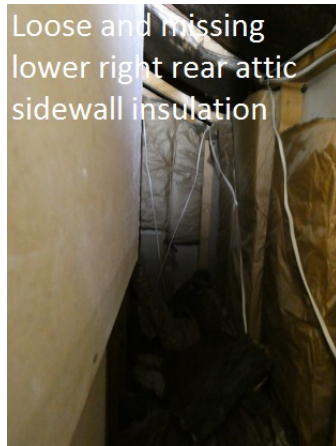
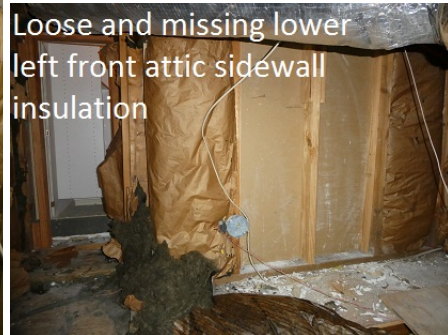
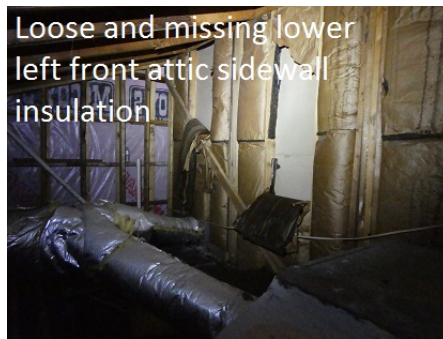
Missing insulation on the upper sidewalls in both lower attics should be replaced.

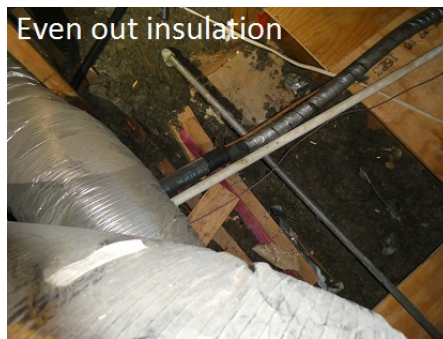
Pulled back insulation in the lower left front attic should be evened out.

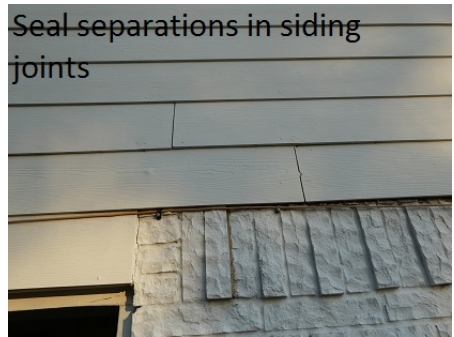
Cracking was noted in the brick veneer below the kitchen window opening.

Separations in the siding joints should be sealed.

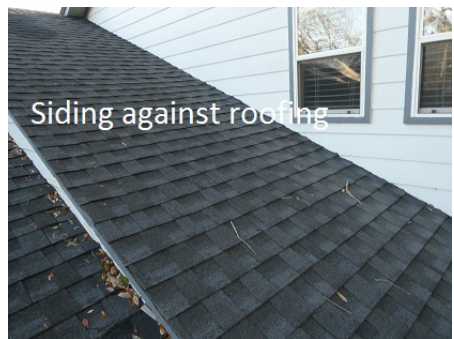
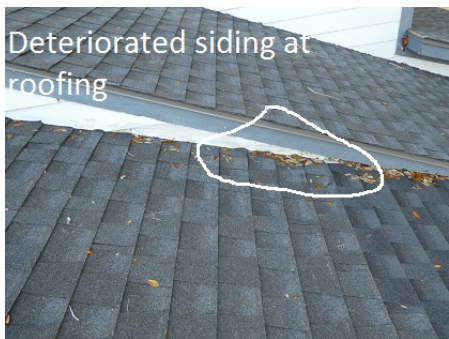
The siding manufacturer recommends a minimum siding clearance of one inch from the roofing to prevent moisture deterioration in the siding as seen in the lower edges of the siding above the breakfast room.

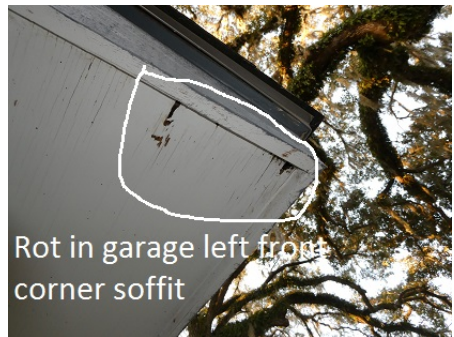
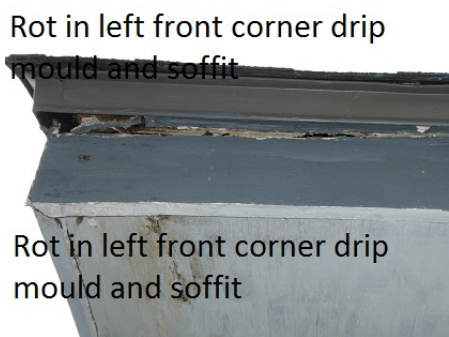
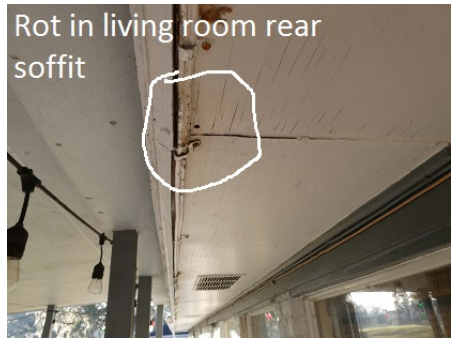
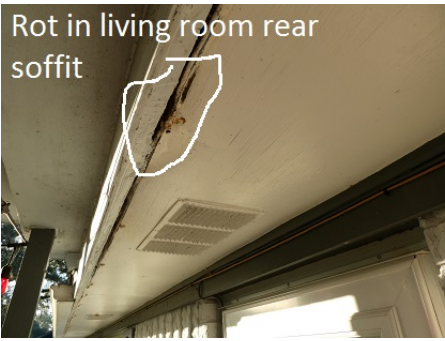
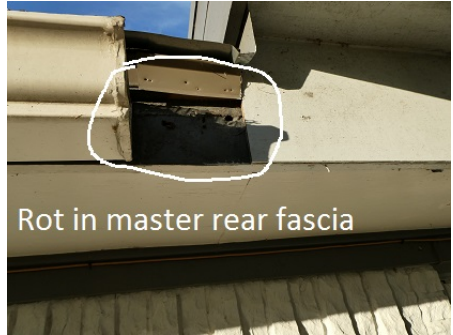
Rot was found in the following locations:

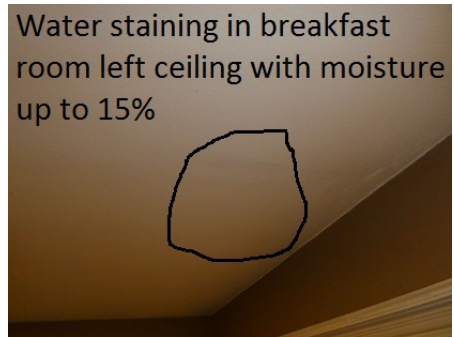
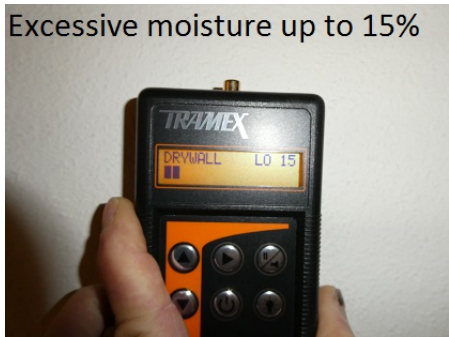
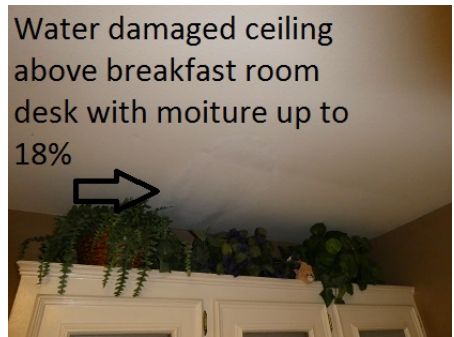
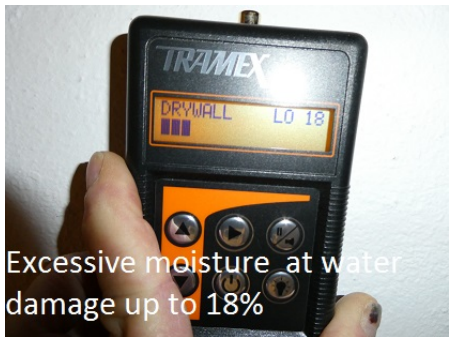
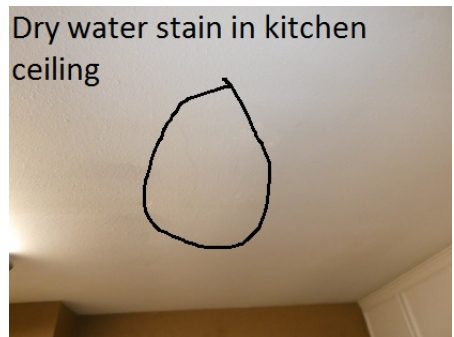
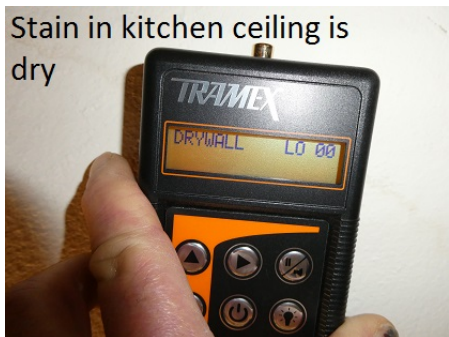
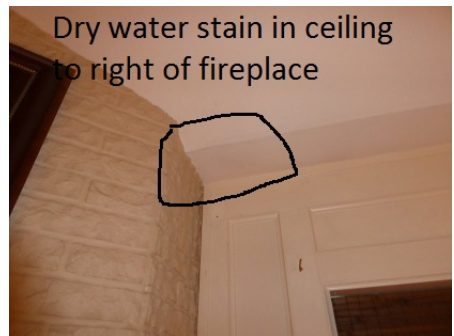
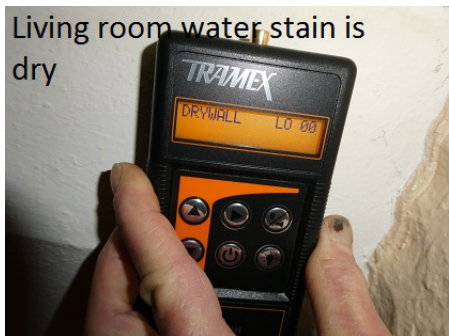
Water damage was noted in the breakfast room ceiling above the desk with water staining in the breakfast room left ceiling, kitchen ceiling and living room ceiling to the right of the fireplace. These areas were tested with a Tramex MRH III moisture meter and found excessive moisture in the breakfast room up to 18% above the deck and up to 15% in the left ceiling. The kitchen and living room stains were dry. No readily apparent source was found for the moisture in the attic above the breakfast room. The sellers should be consulted as to any

previous leaks. This area should also be investigated further to determine the source for the elevated moisture levels.

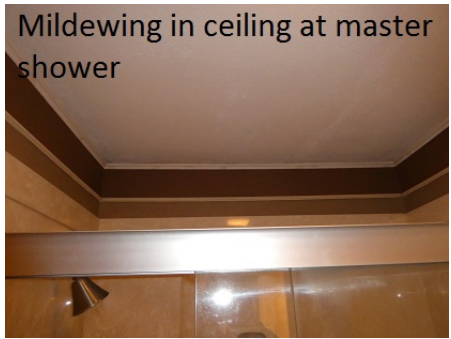
Mildewing was noted in the master shower area ceiling. This usually caused by showering without using the exhaust fan.

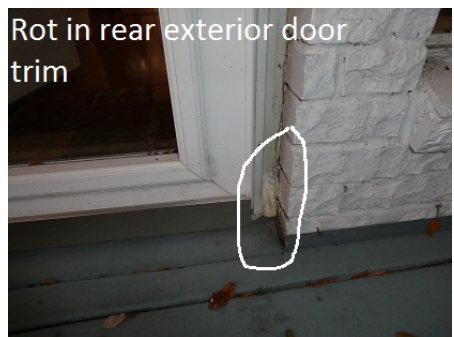
Rot was found in the rear exterior door trim.

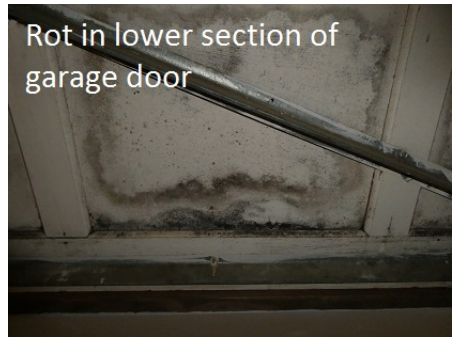
Rot and water damage was found in the bottom panels of the garage door.

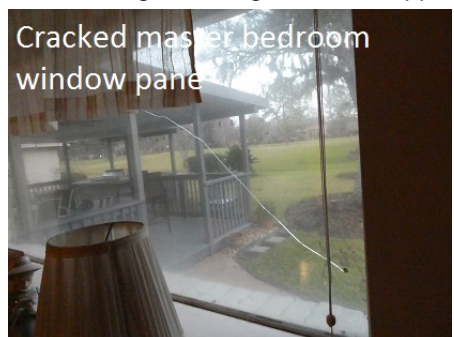
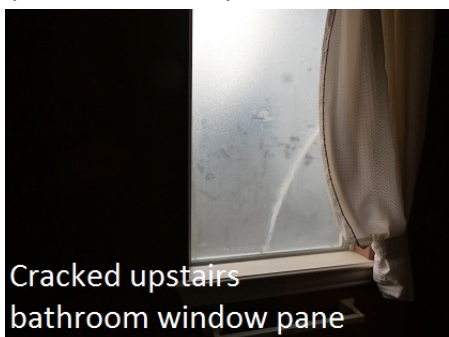
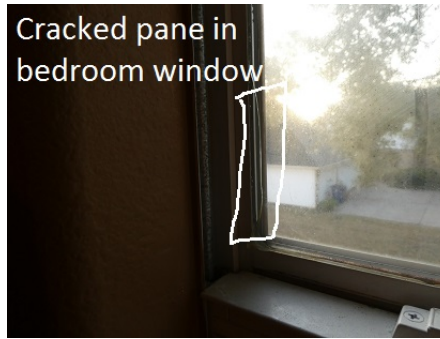
The cracked glass panes in the master bedroom, upstairs bathroom and right bedroom right wall right window upper pane should be replaced.

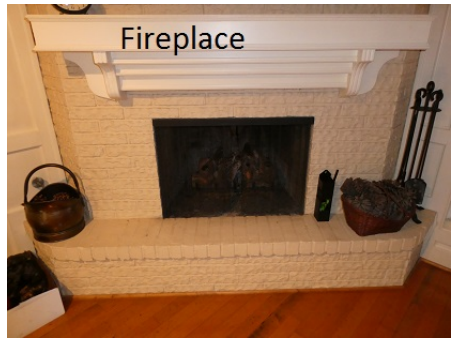
The 11 ¼" wide hearth outside the fireplace is not large enough to reduce the risk of fire, should hot embers manage to escape from the fireplace. Hearth extensions shall extend at least 16 inches in front of the fireplace opening.

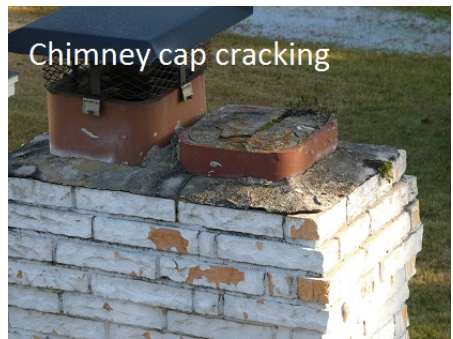
The cracking in the mortar cap of the masonry chimney should be sealed.

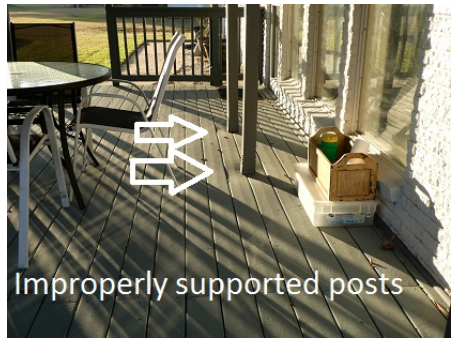
The two middle support posts at the house for the deck roof structure are installed on the middle span of the deck boards causing sag in the deck boards. Ideally, a footing should be installed properly supporting the posts and therefore the roof structure.

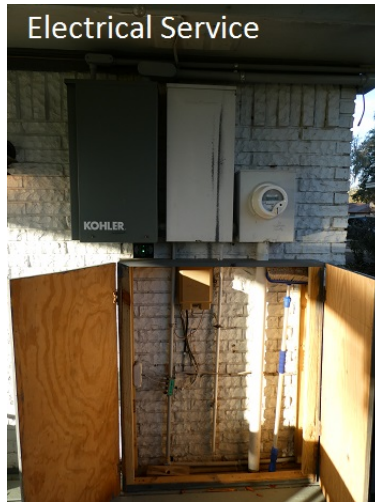
The ground wire to ground rod connection should be visible and accessible.

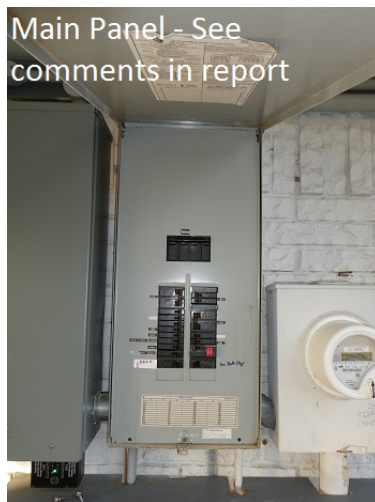
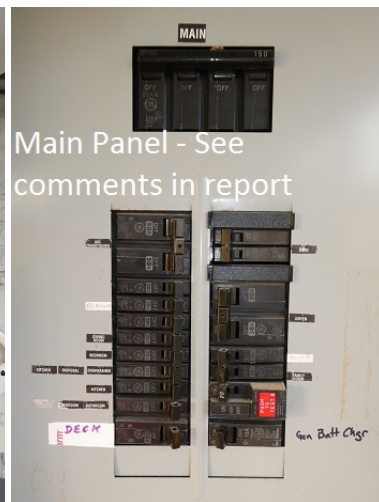
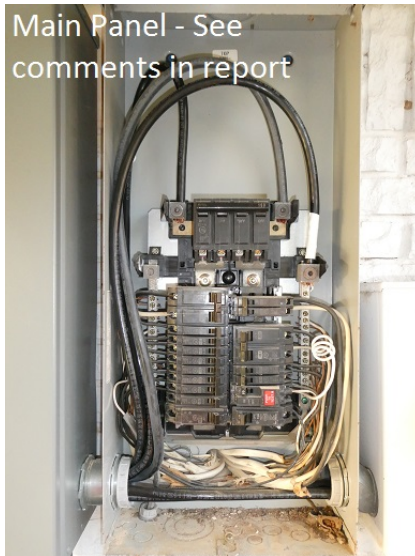
MAIN PANEL

All circuits should be properly identified. White wires used as line or hot wires should be identified as such by wrapping the wires with black or red electrical tape or marking the wires with marker at the breakers.

Cable clamps (sometimes referred to as bushings or grommets) are required where wiring passes into the main distribution panel. Cable clamps serve to protect the wiring from the metal edges of the panel openings.

The ground and neutral wires are improperly combined on the ground and neutral bus terminals and should be separated with isolated ground and neutral bus terminal connections.

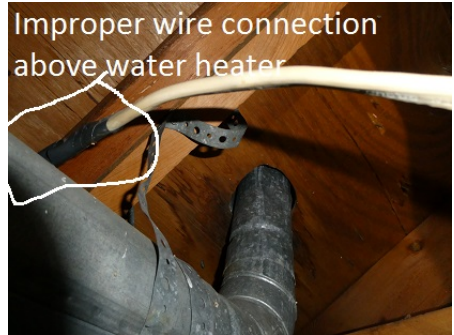
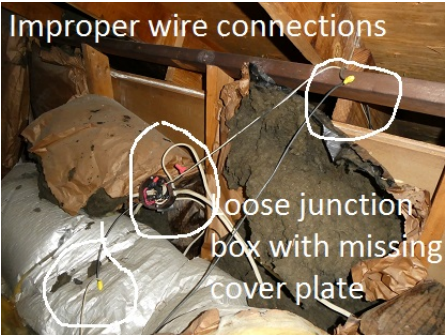
Improper electrical connections at and above the upper attic junction box and above the water heater should be improved. All electrical connections should be made inside junction boxes fitted with cover plates.

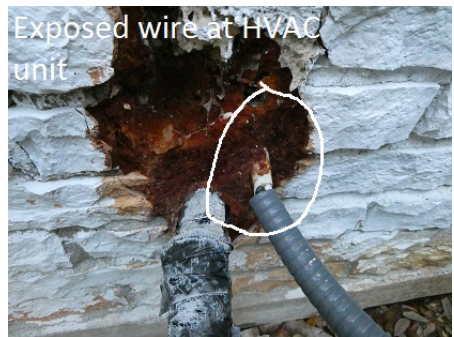
Exposed at the left exterior wall for the outdoor unit of the central air conditioning system should be installed in conduit.

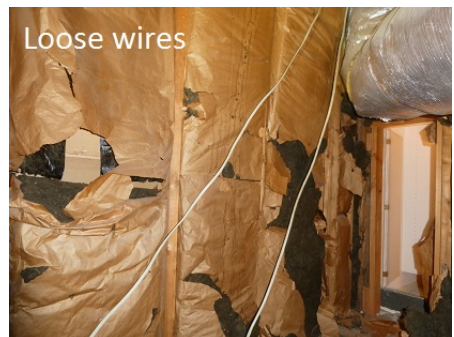
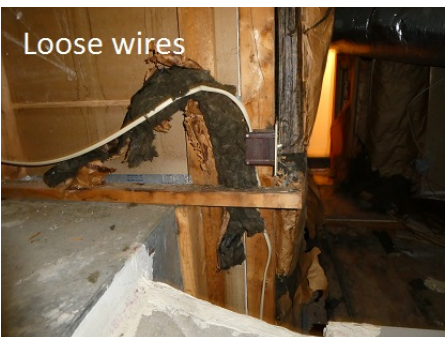
Loose wiring in the lower left and upper attics should be secured within 12 inches of the boxes with no wire suspended more than 54 inches without support.

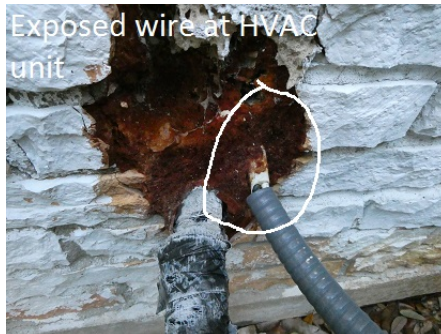
The exposed wiring at the exterior wall for the outdoor unit of the central air conditioning unit should be installed in conduit.

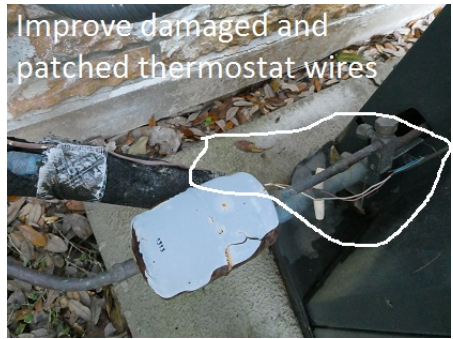
The damaged and patched thermostat wire at the outdoor unit of the central air conditioning unit should be repaired and protected from damage.

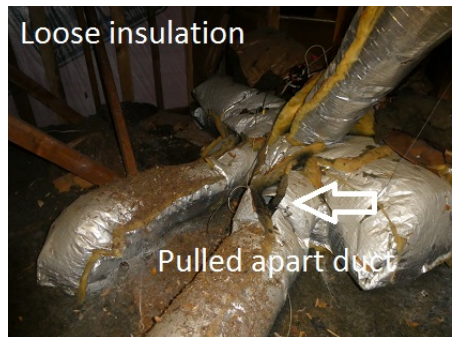
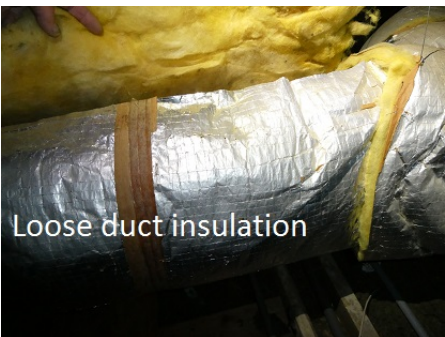
The rigid ductwork is in less than ideal condition requires repairs at various places in the upper and lower left attics. The pulled apart duct in the upper attic should be reconnected with loose insulation at various places on the rigid ducts properly secured on the vent pipes.

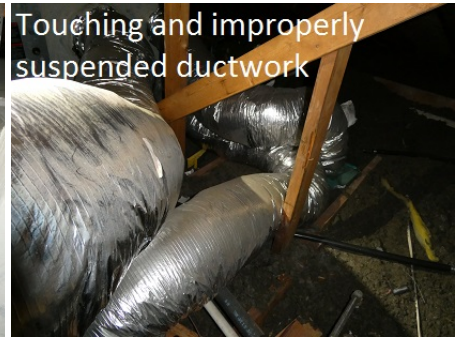
The touching and improperly suspended flexible ducts at the plenum should be suspended so the ducts do not touch. This can create a moisture/condensation issue between the two ducts. Isolation insulation should be installed between

touching ducts or the ducts should be separated by re-configuration of the current ductwork suspension. The ducts should also be suspended every 4' – 5' with no more than 1/2" of sag per foot.

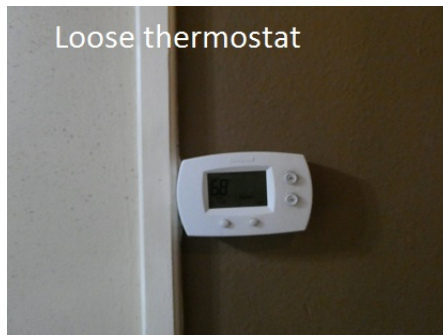
The loose thermostat should be secured to the wall.

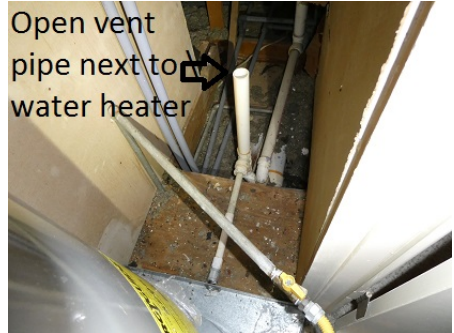
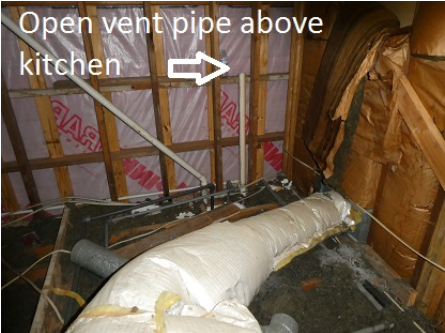
The open vent lines in the left lower attic to the right of the water heater and in the right lower attic above the kitchen sink should be properly vented through the roof with a roof jack.

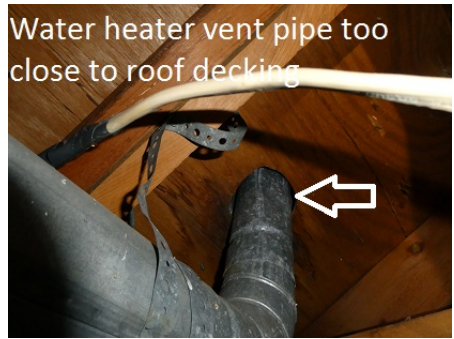
The water heater vent pipe should have a minimum clearance of one inch from combustible roof decking materials.

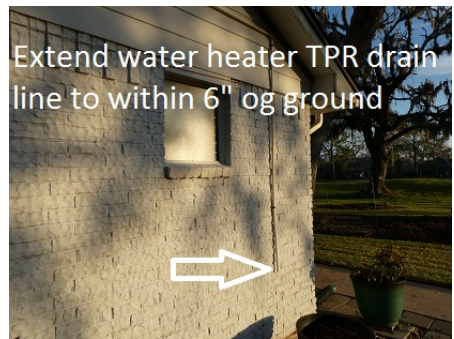
The drain line for the water heater Temperature and Pressure Relief (TPR) Valve should terminate within 6 inches of the ground instead of on the upper right rear sidewall.

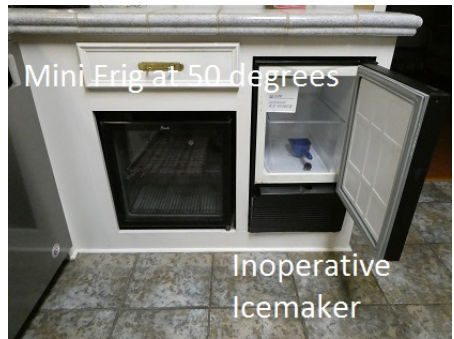
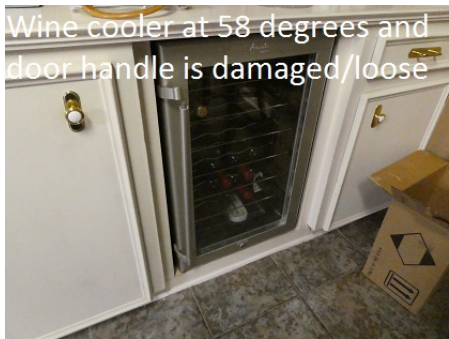
The inoperative icemaker should be repaired or replaced as necessary.  
 The mini frig temperature at 50° at the time of the inspection.  
 The loose wine cooler handle should be repaired.  
 The wine cooler was at 58° at the time of the inspection.  
 The refrigerator, washer and dryer were not a part of the inspection.

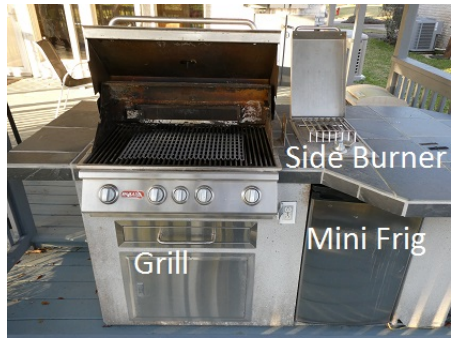
The refrigerator was unplugged and was not tested at the time of the inspection. The inoperative gas grill control knobs for the rear infrared burner and right grill burner should be repaired or replaced as necessary.
