17225 Termini-San Luis Pass Rd  
Galveston, TX 77554  
Biju Oommen

## PROPERTY INSPECTION REPORT

**By:** Scott Osborne, Lic #20555 08/28/2020  
(Name and License Number of Inspector) (Date)

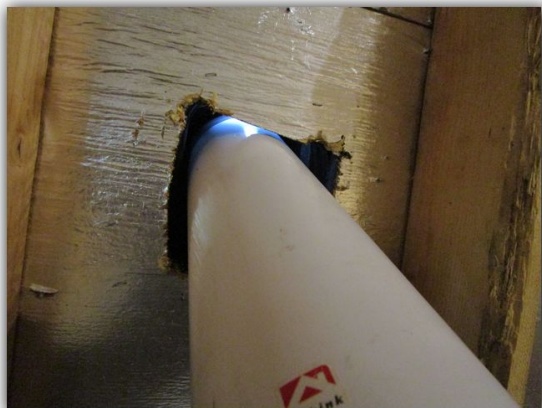
**There is daylight coming through the attic where the vent pipes penetrate the roof / attic. This is indicative that the roof jacks are not fully weather sealed and may be a water penetration point.**

**I recommend the roof be evaluated by a qualified roofing contractor. Any exposed openings are potential moisture or pest penetration points and should be sealed.**

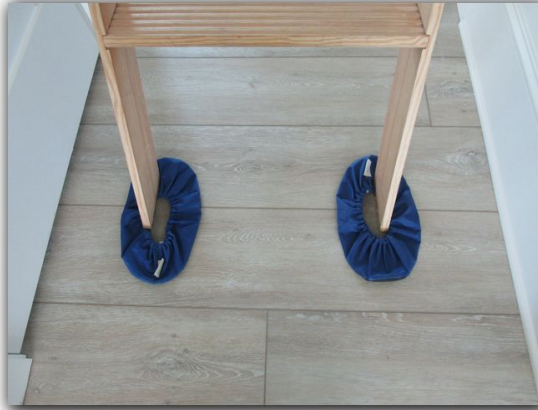
There are missing fasteners in the brackets at the top of the attic ladder where the ladder attaches to the framing at the right bracket.

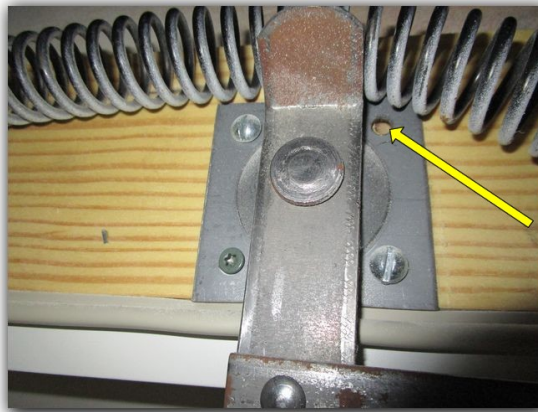
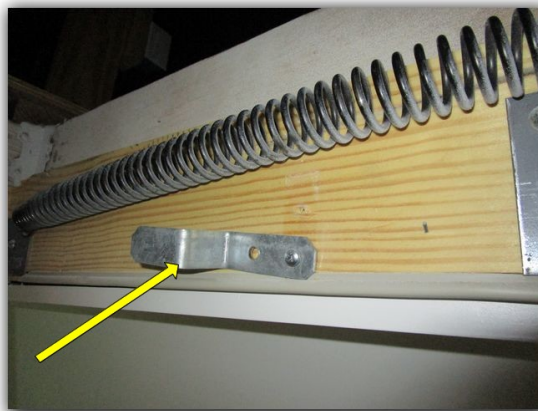
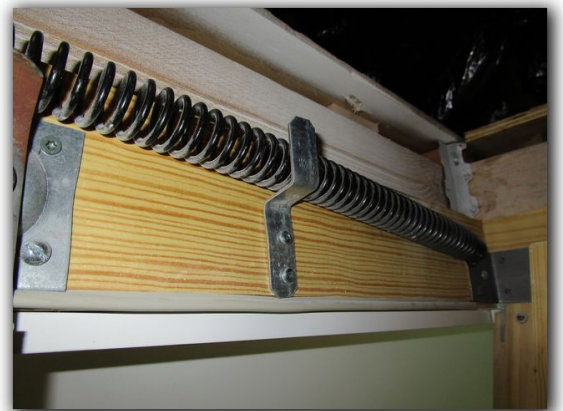
The right bracket for the ladder spring is missing a fastener and is not installed properly.

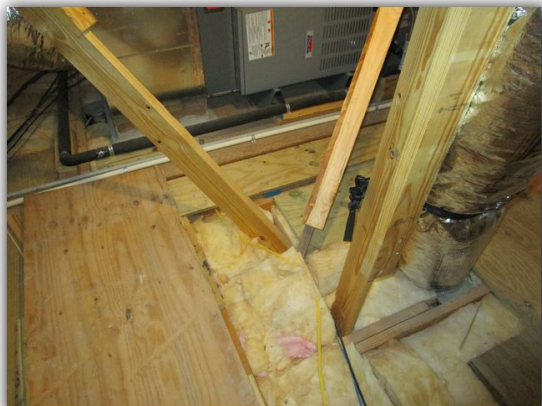
There is a required minimum 24" wide, unobstructed walkway to all attic equipment. The walkway is obstructed / inadequate, creating a potential trip hazard, at the HVAC equipment that serves the lower living area.

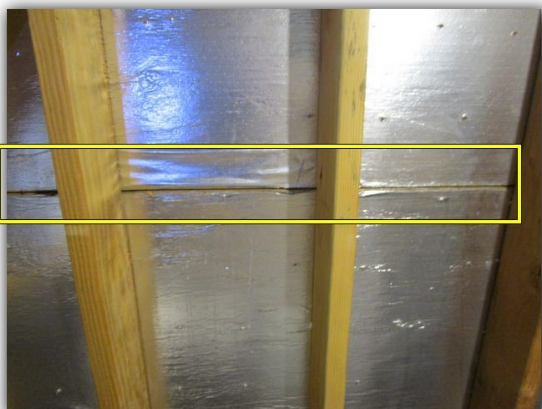
There are no "H" clips between the roof decking.

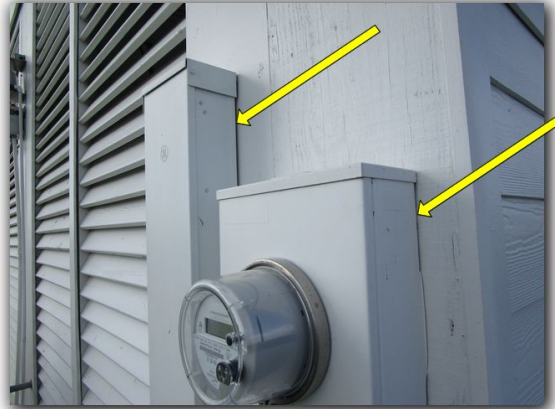
The exterior light fixtures are not properly sealed or secured to the wall. This is a potential moisture penetration point.  
The electric meter and service panels are not properly weather sealed on the exterior wall.

**All wall penetrations and exposed openings should be sealed to help prevent pest and moisture penetration into the wall cavity including areas such as electrical outlets, exterior light fixtures, window and door frames, and water and gas supply lines.**

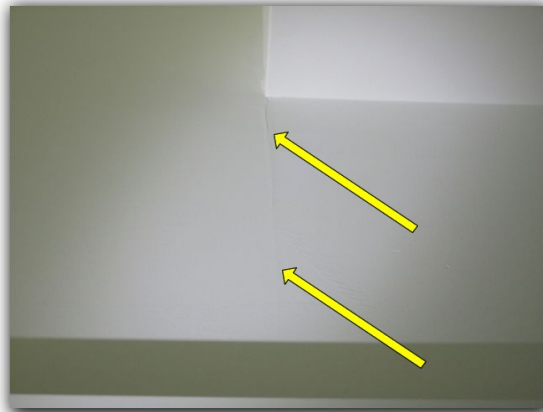
There is a hairline crack on the wall in the upstairs hall above the hall closet door.

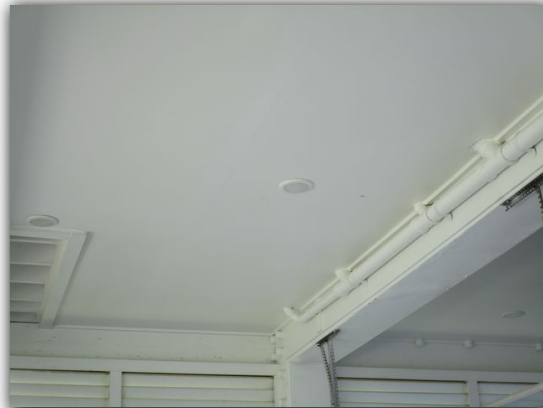
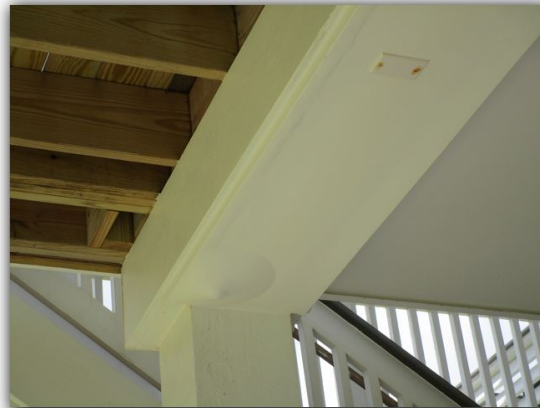
There is moisture damage to the ceiling area in the open space below the home (the parking area, open area, and where the stairs are located). There was a water overflow in the downstairs private bathroom in this area. See the Plumbing section for more information. NOTE: I recommend further evaluation of the areas of the ceiling that have moisture stains as there may be hidden damage or microbial growth that is not visible at the time of the inspection.

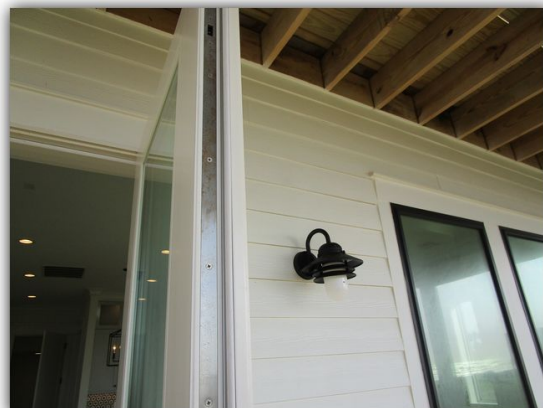
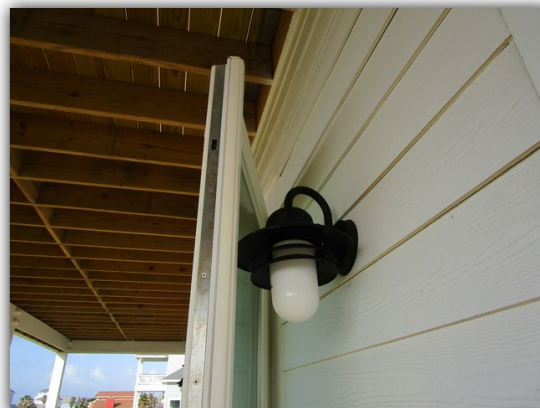
The front entry door opens outward and is subject to the wind catching the door and forcing it open rapidly. There is a light fixture behind the door that may be damaged in this type of event. I recommend consulting with a qualified contractor or the builder to determine the best solution to help protect the door from swinging open unexpectedly and the light fixture behind the door.

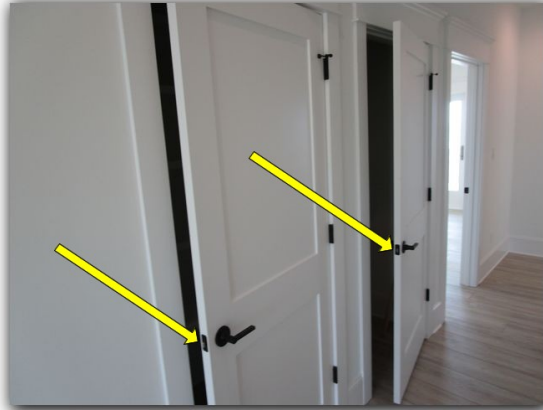
There are doors that do not latch properly at more than one location around the home, including the upstairs hall closet doors.

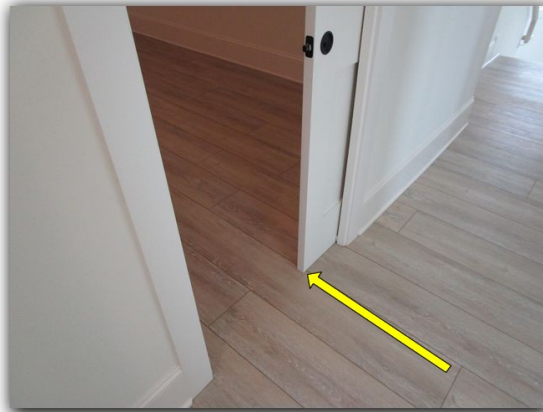
The pocket door at the "game room" (the door leading to the hallway) rubs against the floor when opening / closing.

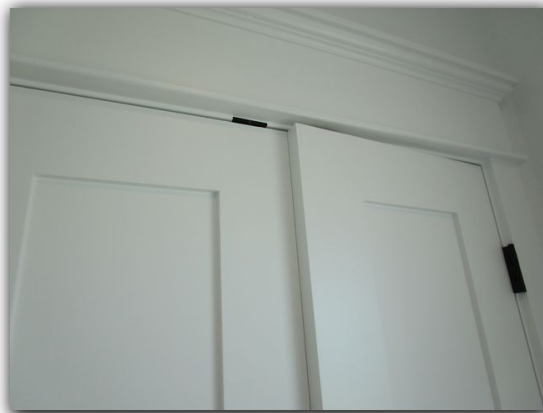
The rear right bedroom closet doors are not square in the frame and rub in the middle when opened / closed.

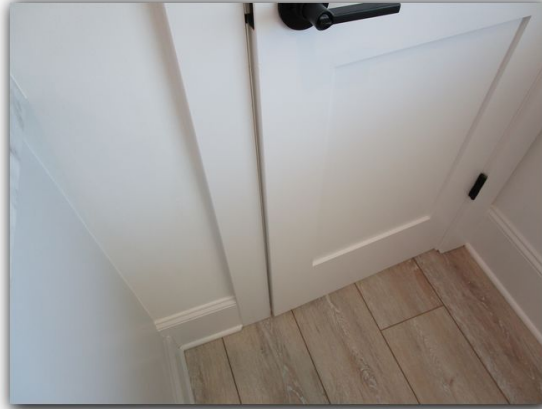
The rear right private bathroom door is not square in the frame and rubs in the jamb.

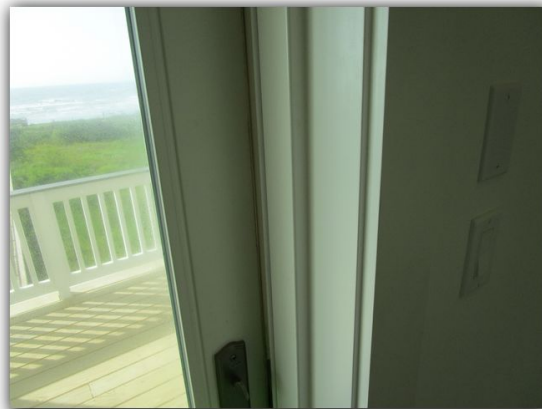
The rear right bedroom balcony (exterior door) is not square in the frame and rubs in the jamb.

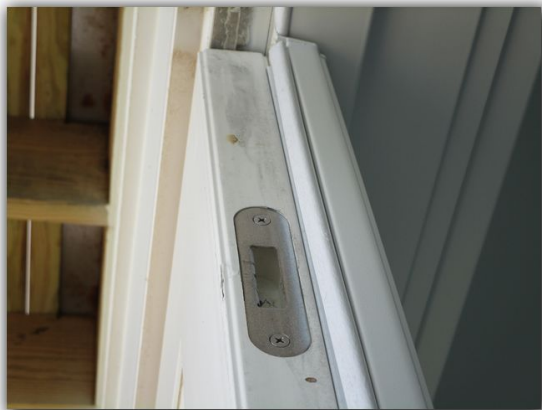
The front entry door is not square in the frame. The slide bolts are missing at the left door, and the door is very hard to lock.

NOTE: The doors may require adjustment by a qualified door contractor.

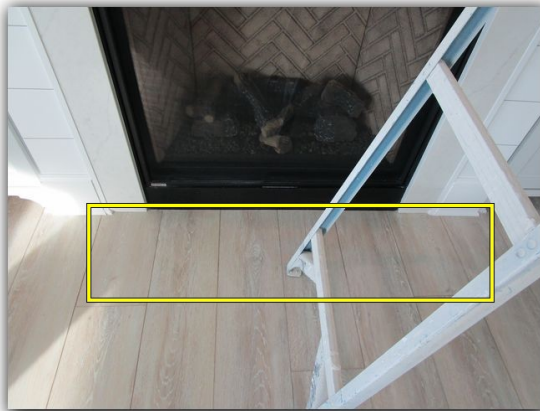
The fireplace is required to have a non combustibile hearth extension that is separate and distinct from the surrounding flooring. The area in front of the fireplace does not meet this requirement.

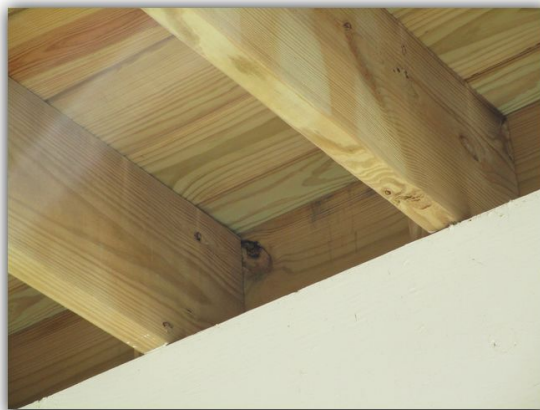
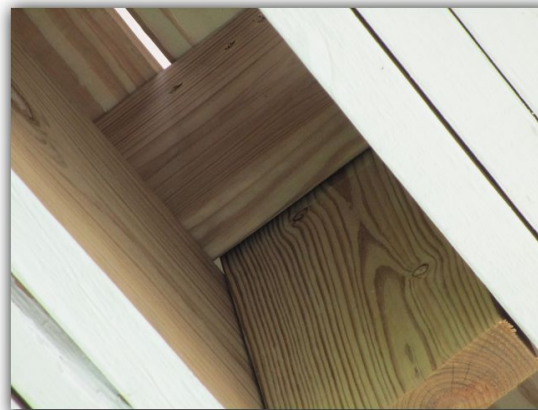
**Note: Structural load capabilities were not inspected  
There are no joist hangers on the joists for the rear balconies.**

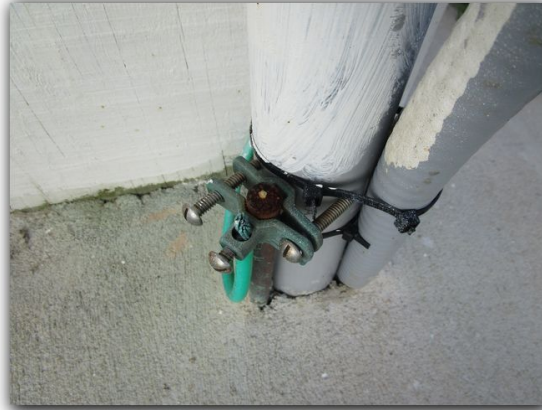
The wrong clamp has been used to secure the ground wire to the ground rod. The clamp should be an acorn style clamp.

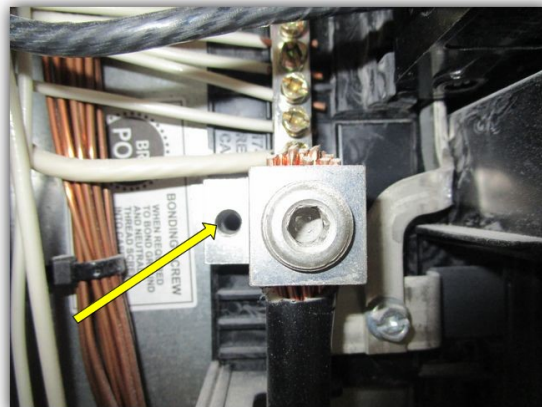
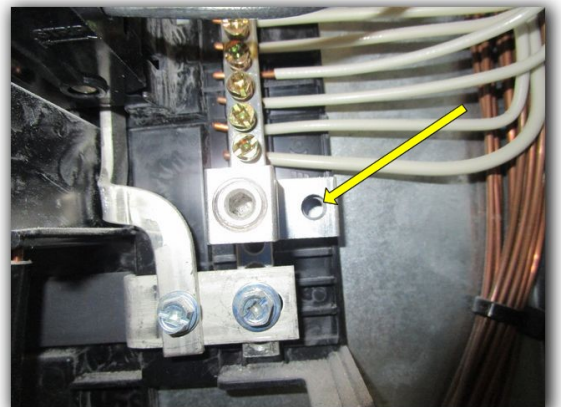
There is no bonding screw in the sub panel in the pantry.

I recommend a complete review by a licensed electrician to review and repair any and all deficiencies.

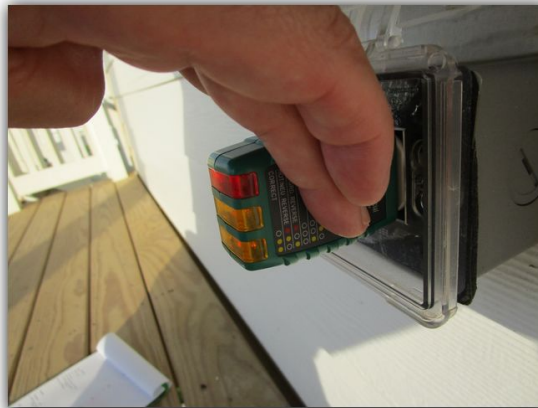
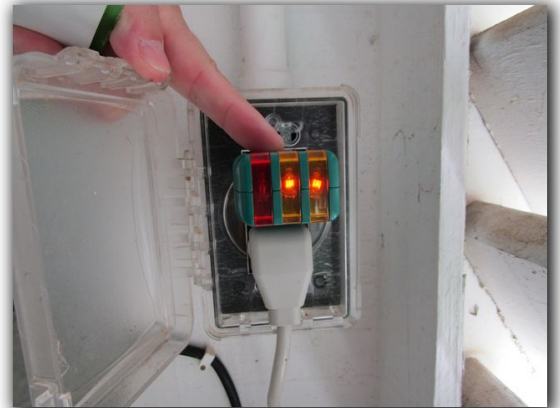
There are outlets that are not GFCI protected, as is currently required, including in the exterior outlets.

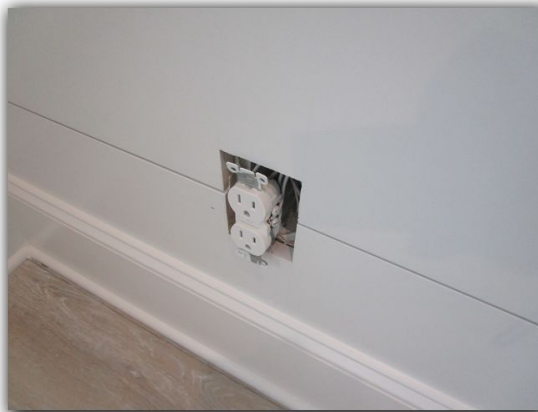
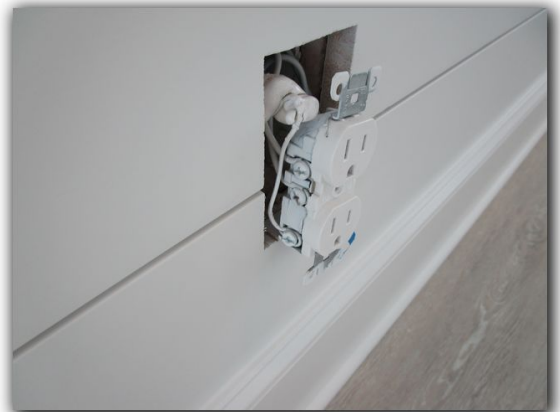
There are missing outlet covers in the main living area at multiple locations, with loose outlets in this area.

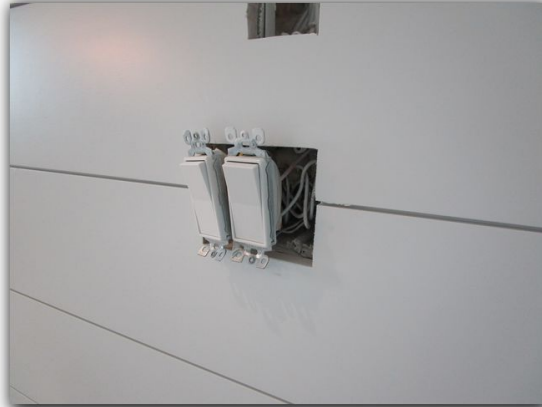
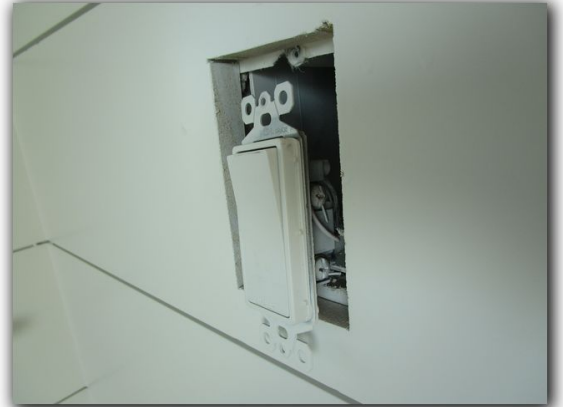
There are loose switches and missing switch plate covers throughout the main living area.

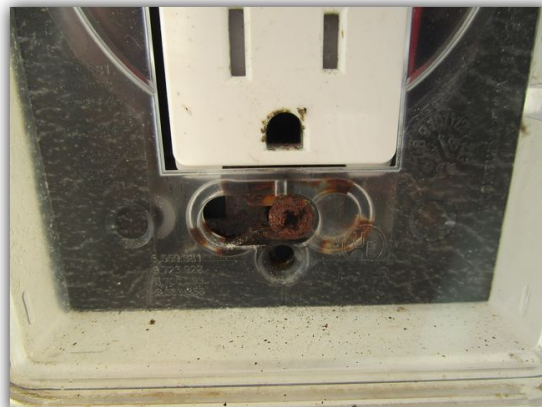
There is rust on the fasteners on the exterior outlets and light switches (at the covers / fasteners).

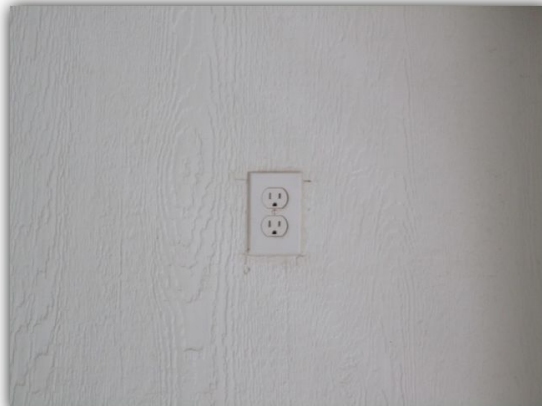
There are outlets in the garage area that are not properly weather sealed / covered.

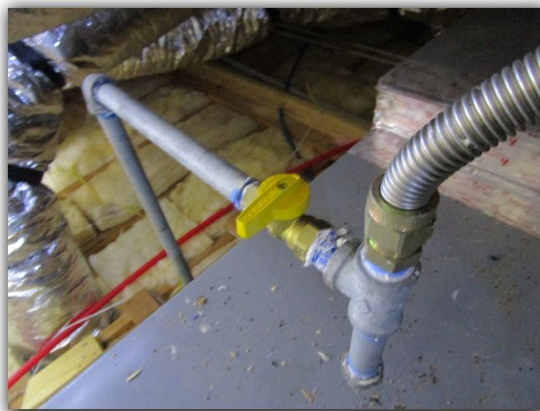
The gas supply was shut off to the unit at the time of the inspection. I did not turn on the gas as I do not know why it was shut off. I recommend having the builder or a licensed HVAC contractor restore the gas supply and test the unit.

I recommend a complete review of the entire HVAC system by a qualified HVAC technician.

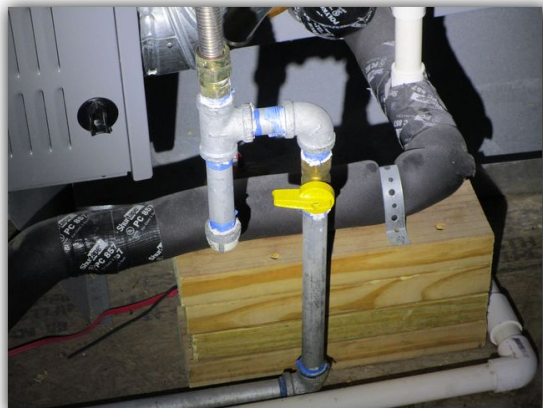
The gas supply was shut off to the unit at the time of the inspection. I did not turn on the gas as I do not know why it was shut off. I recommend having the builder or a licensed HVAC contractor restore the gas supply and test the unit.

I recommend a complete review of the entire HVAC system by a qualified HVAC technician.

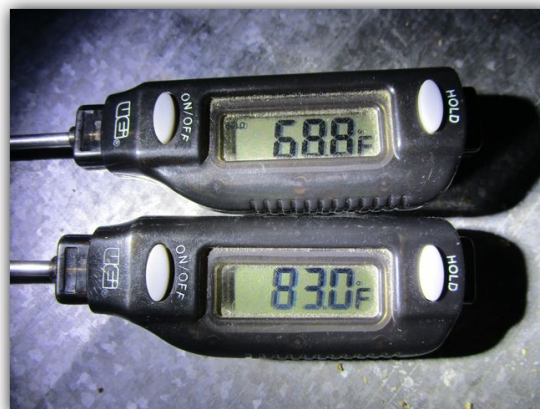
The condenser unit took a long time to turn on. When on, the condenser unit motor made a vibrating noise.

**The unit is not cooling adequately.  
I recommend a complete review of the entire HVAC system by a qualified HVAC technician prior to closing.**

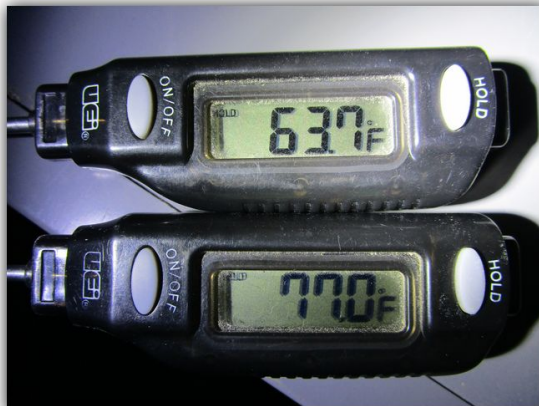
The temperature differential between the supply and return registers should be at least 15 degrees. The unit did not produce a temperature differential that meets this minimum requirement. This could be symptomatic of other issues inside the system. The system is not cooling adequately.

I recommend a complete review of the entire HVAC system by a qualified HVAC technician prior to closing.

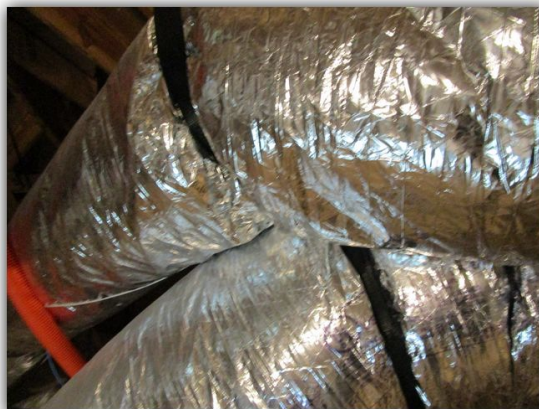
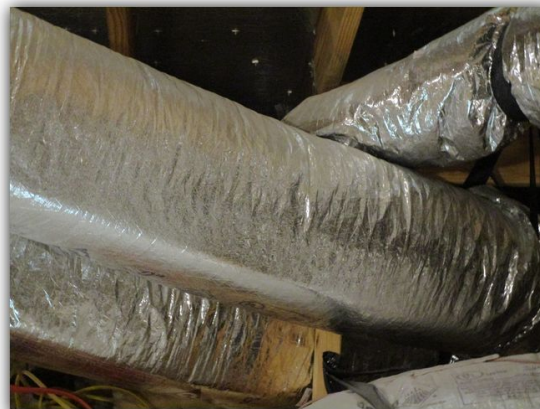
There are A/C ducts in the attic in direct contact with one another. The ducts are not separated by a non cellulose material. The contact can cause condensation which can then drip into the attic space.

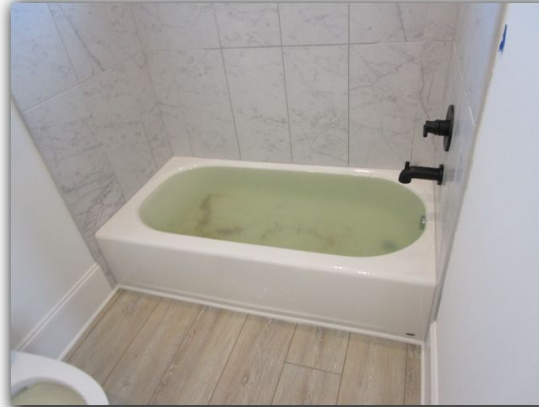
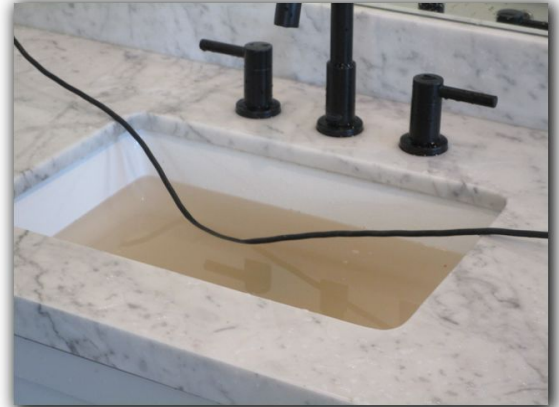
The tub, sink, and toilet drains are clogged. The tub overflowed into the bathroom / bedroom floor. The floor was dried and cleaned. Water drained into the sub floor and onto the open space below the home in the open area, creating stains on the "ceiling" spaces.

I recommend having a licensed plumber review and repair the deficiencies.

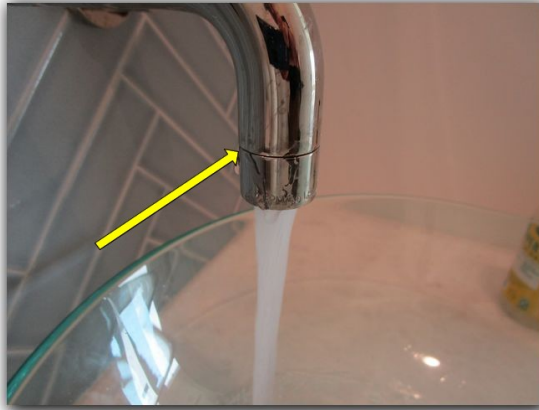
**There is a leak at the sink faucet (at the end of the faucet).**

**I recommend having a licensed plumber review and repair the deficiencies.**

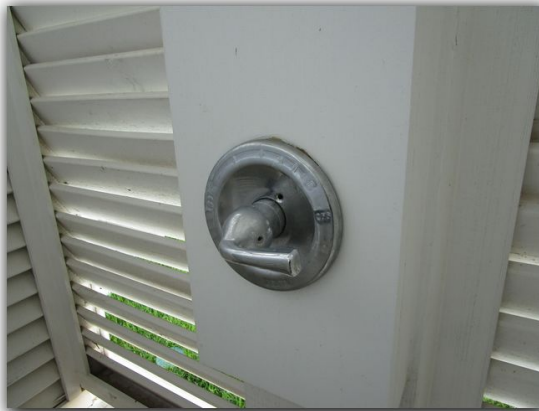
**The outdoor shower control / handle (the fixture) is loose, and there is rust / corrosion on the fixtures.**

**NOTE: I recommend a complete review of the plumbing system, including scoping the underground lines for any damage, leaks or other deficiencies by a licensed plumber. I recommend having a licensed plumber review and repair the deficiencies.**

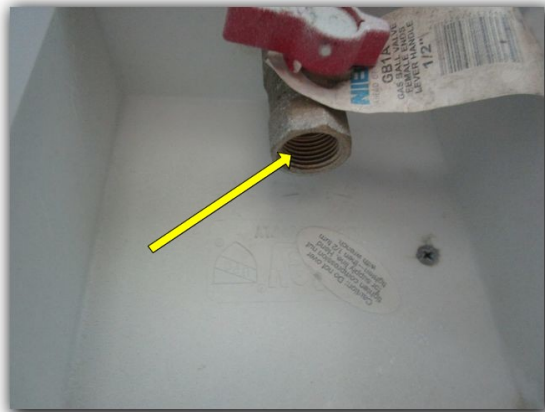
**There is a gas supply line that is not properly capped.**

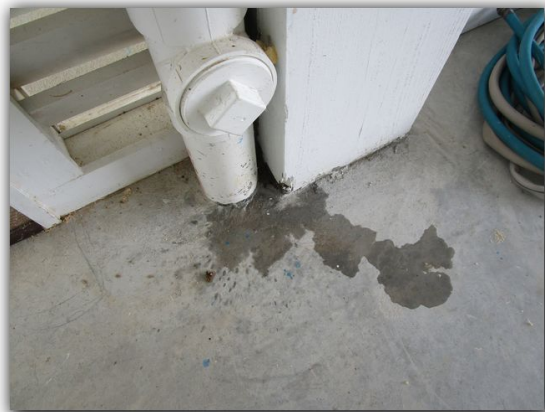
**There was a leak at the drain cap in the garage area as well as along the drain above the garage / open area below the home.**

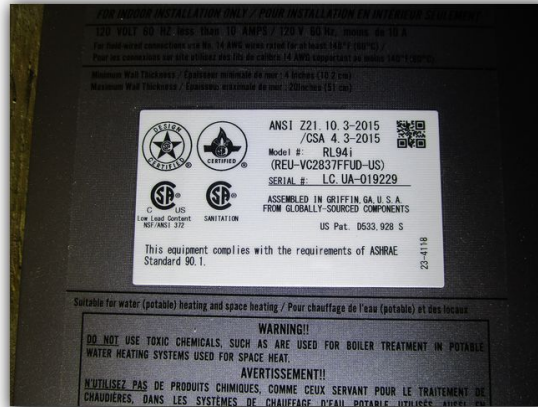
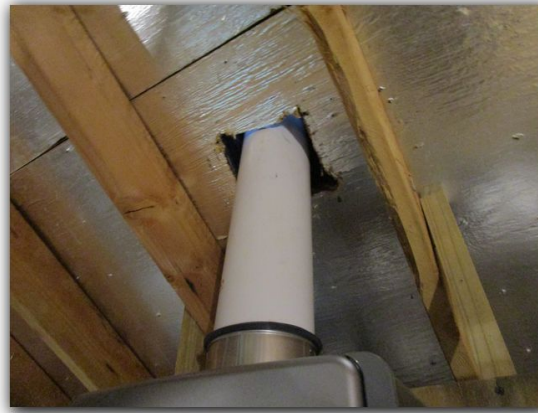
**NOTE: The TPR (temperature and pressure relief valve) was not operationally checked at the time of the inspection. If the water heater is not maintained annually, the valve may not seat properly when it is operated, which causes the valve to leak. It is best to replace a TPR valve every 3 years to prevent it from getting clogged with mineral deposits. It is also recommended to open / close the valve at least twice per year as a form of maintenance. The vent pipe is not properly strapped at the roof penetration.**

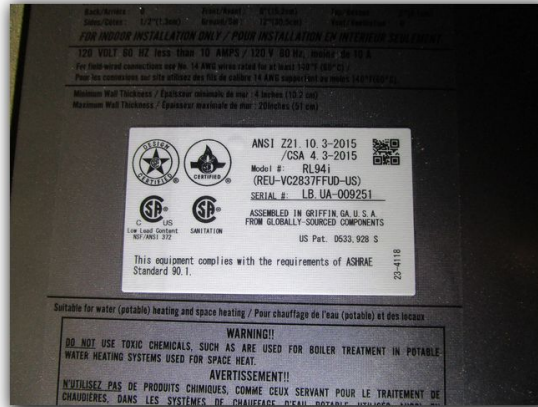
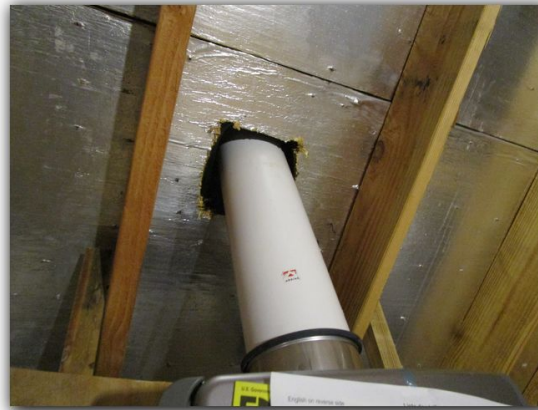
**NOTE: The TPR (temperature and pressure relief valve) was not operationally checked at the time of the inspection. If the water heater is not maintained annually, the valve may not seat properly when it is operated, which causes the valve to leak. It is best to replace a TPR valve every 3 years to prevent it from getting clogged with mineral deposits. It is also recommended to open / close the valve at least twice per year as a form of maintenance. The vent pipe is not properly strapped at the roof penetration.**

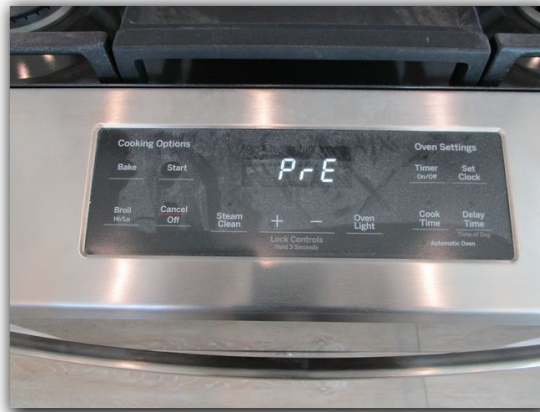
**The unit did not properly engage, and did not move past the "PRE" stage. I recommend having the oven reviewed by a qualified contractor.**

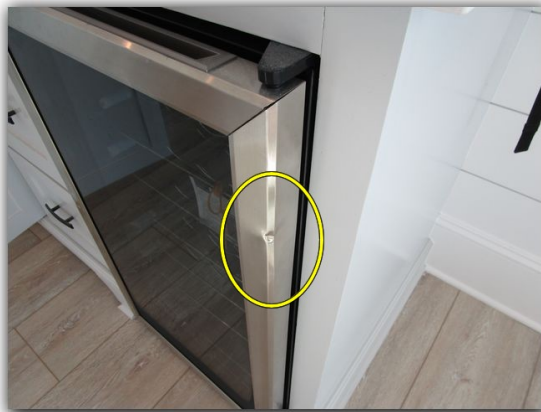
The wine refrigerator was not inspected. However, during the inspection, I observed damage to the door of the unit.

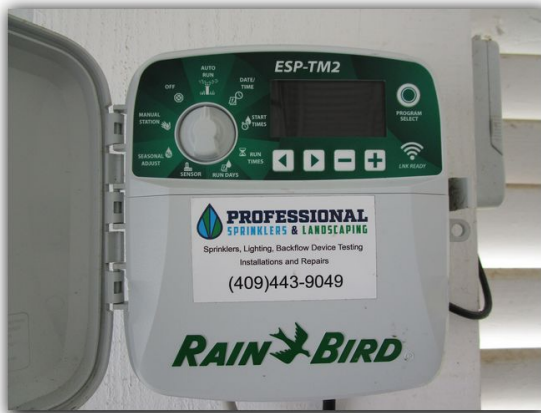
**NOTE:** The sprinkler system was not inspected for underground leaks or coverage. There was power to the control unit, but the display would not turn on. The selector switch was not able to be turned / manipulated. I was not able to test the irrigation system.

I recommend having the system reviewed by a qualified irrigation specialist.
