Vested Property Inspection

Address 2626 Hollyhall Unit# 1003 Houston Tx 77054

Inspection Report

Date: 7/28/2019	Time: 08:30 AM	Report ID: 2626-072819
Property: 2626 Hollyhall Unit# 1003 Houston Tx 77054	Customer: Mrs. Jeanie Amuta	Real Estate Professional:

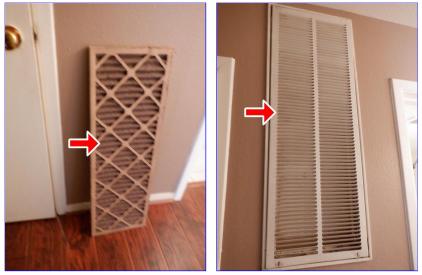
Dirty air filter

(3) The disposable filter is clogged and dirty. Recommend filter to be replace by a qualified technician.

Missing air filter

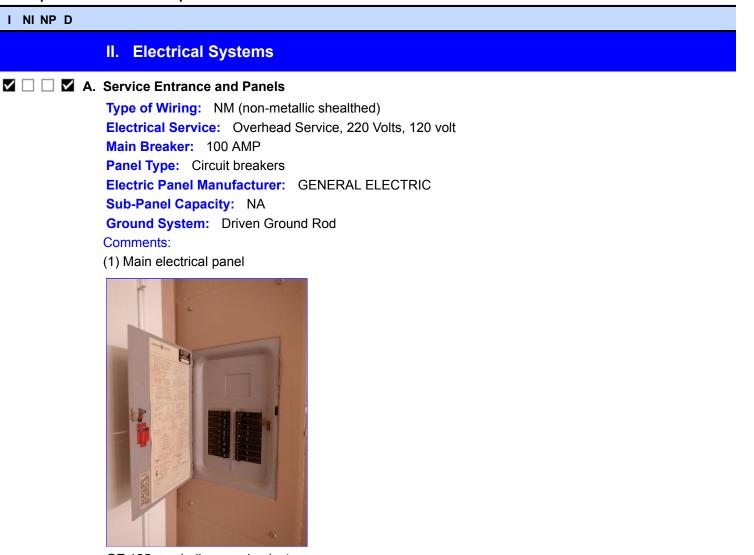
GE,125amp,hallway main elect panel

O (2) The aluminum service wire should be coated with anti-oxidation grease where they are stripped back to be connected to the main or branch circuit breakers. Have a qualified electrical technician to evaluates and repair all conductor wires as necessary.

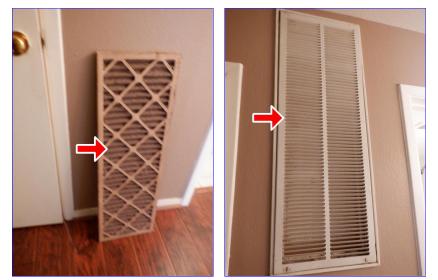
Dirty air filter

(3) The disposable filter is clogged and dirty. Recommend filter to be replace by a qualified technician.

Missing air filter
