## MECHANICAL INSPECTION

1634A Park St  
Houston, TX 77019

# PROPERTY INSPECTION REPORT

Concerning: 1634A Park St, Houston, TX 77019

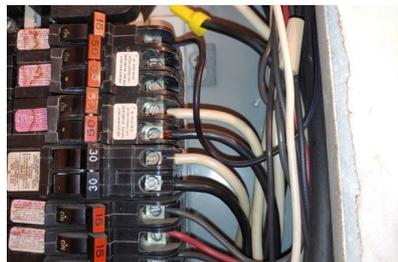
We observed one or more white wires that were used as a power wires, and were connected to a circuit breaker. Typically, the white wires are the grounded/neutral conductors, and if they are used as a power conductor, they must be permanently marked or wrapped with black or red tape to identify them as a “hot” ungrounded conductor.

**Obtain Cost Estimate**

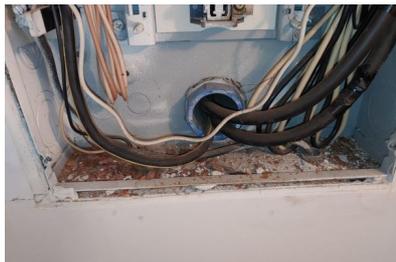
**3: Breaker Panel - Foreign material**

Foreign material was observed in the panel box, which can be a safety hazard, and it is recommended that the panel be cleaned

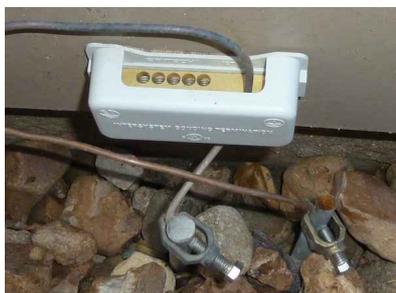
A low voltage grounding block for the low voltage service was not installed at the grounding rod. A grounding block may need to be installed for low voltage network service, such as phone and cable.

**Obtain cost estimate**

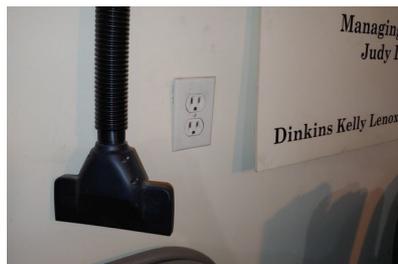
Garage

An outlet was loose on the wall and needs to be secured.

**Obtain Cost Estimate**

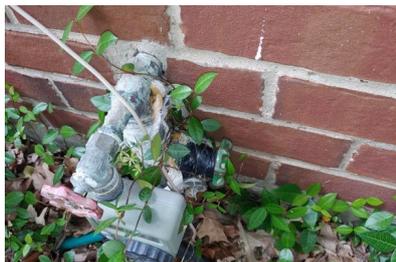
Front of house

The shut-off valve for the main inlet water line was located at the exterior of the house.

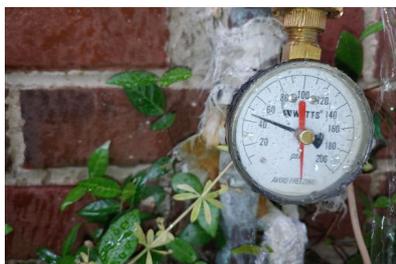
The static water pressure to the house at the time of the inspection was measured with a pressure gauge at the hose bibb nearest the shut off valve, and the static pressure was observed to be 46 PSI.

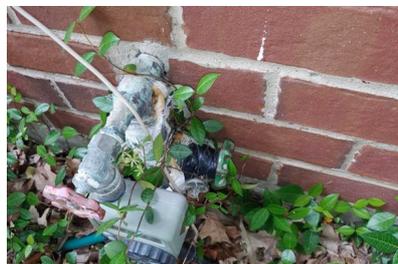
**3: Hose Bibb - Leaking at valve stem**

A leak was observed at a hose bibb around the valve stem.

**Obtain Cost Estimate**

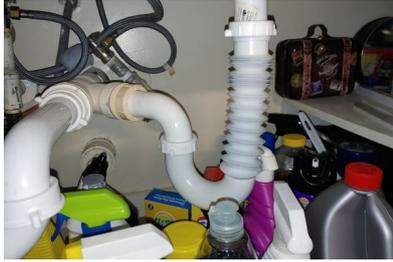
**4: Bellows Drain Piping**

should be given to replacing the Bellows piping.

**Obtain Cost Estimate**

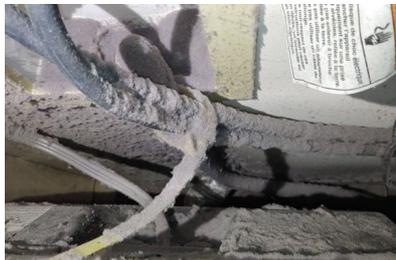
The flexible dryer vent duct was disconnected from the back of the dryer and needs to be resecured to the dryer.

**Obtain Cost Estimate**
