## STRUCTURAL INSPECTION

1634A Park St  
Houston, TX 77019

APRIL 15, 2021

REF: CONDITION OF PROPERTY SURVEY

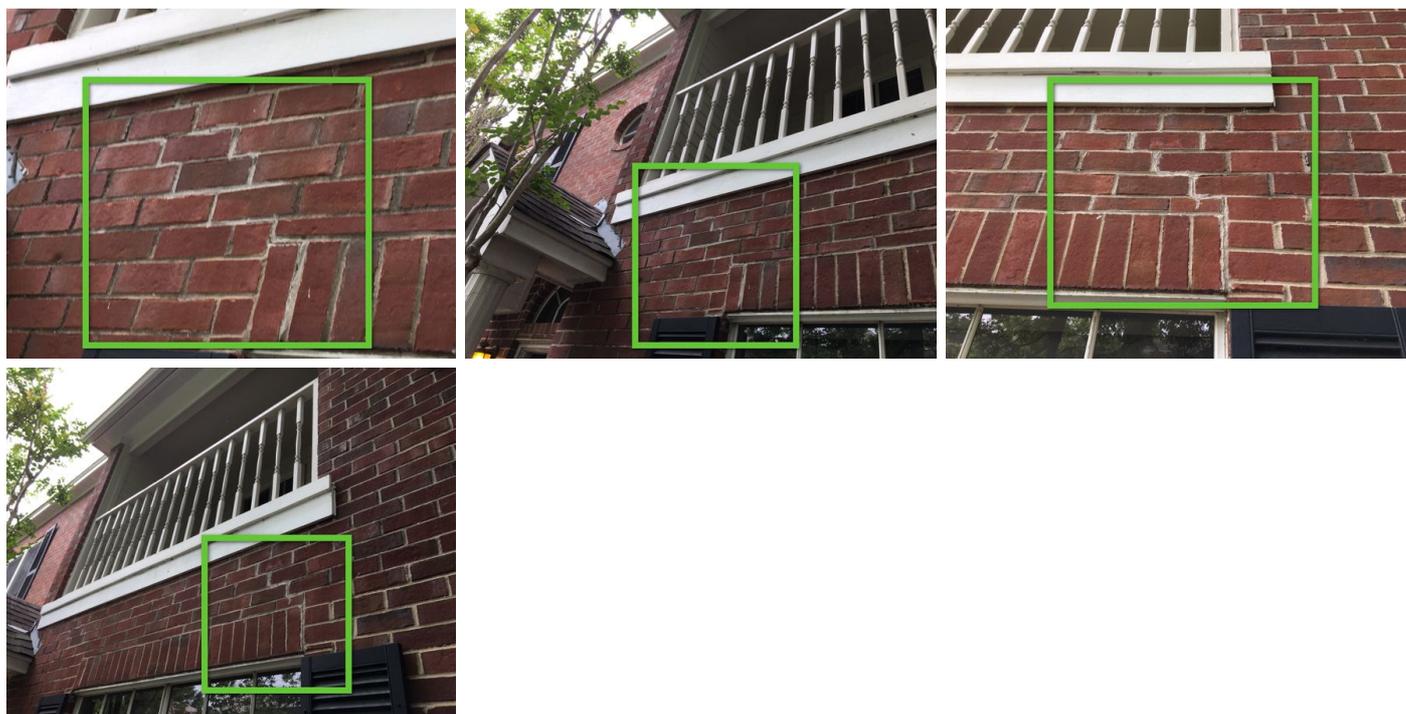
#### Differential Movement: Veneer - Cracks/Patches

Cracks and/or patches were observed in the exterior veneer at the time of the inspection, including at the above locations.

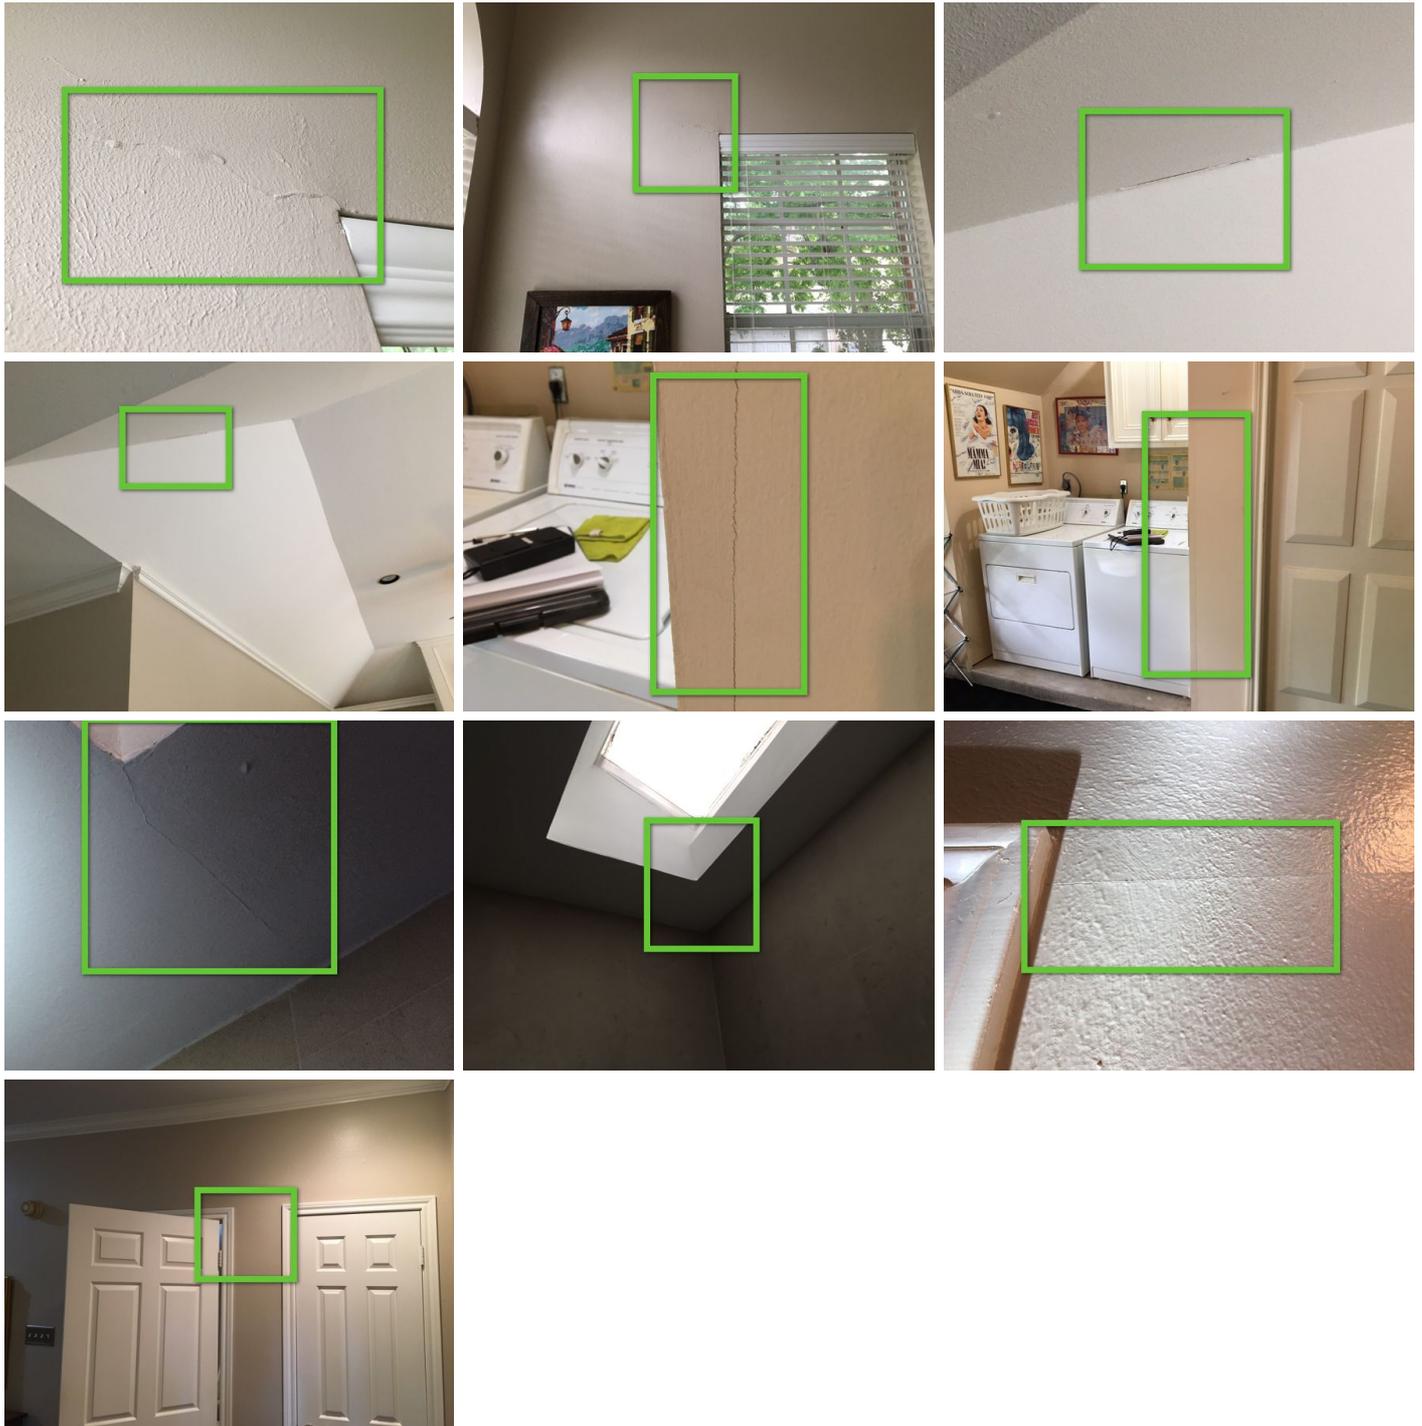
#### Differential Movement: Sheetrock Cracks/Patches/Compression ridges

Master bedroom, master bathroom, living room, garage, and the stairs.

Sheetrock cracks, patches, and/or compression ridges were observed in the house during the inspection, including at the above locations.

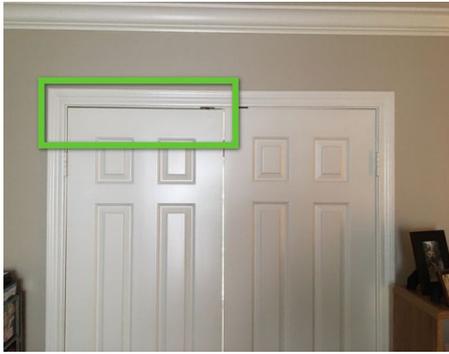
Second-floor bedroom

Door frames that were out of square, leaving a triangular separation between the door and the door frame at the top of the door were observed where a separation was visible at the top of the door.

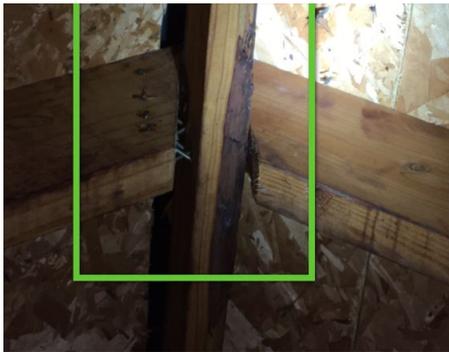
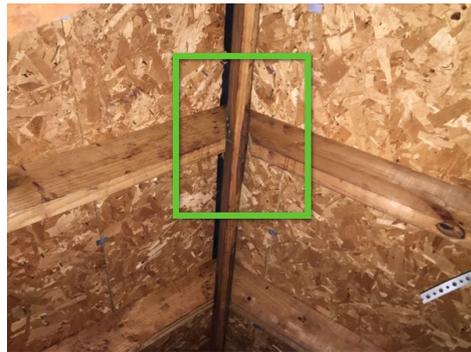
### Separation of Materials: Rafter separation

One or more rafters were observed to be separated from the ridge beam in the attic, which can be an evidence of movement.

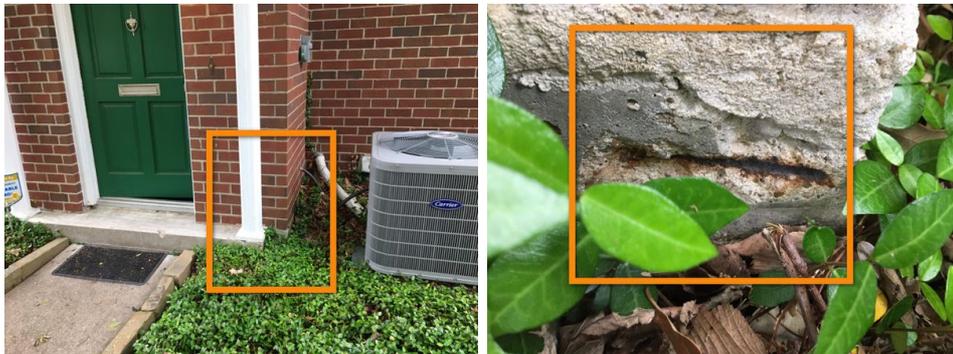
**FOUNDATION - SPALLED**

The face of the foundation concrete was spalled, and the reinforcing steel used in the construction of the foundation was observed to be exposed. The rust should be removed from the rebar, and the rebar grouted to prevent further deterioration.

Contact a qualified professional.

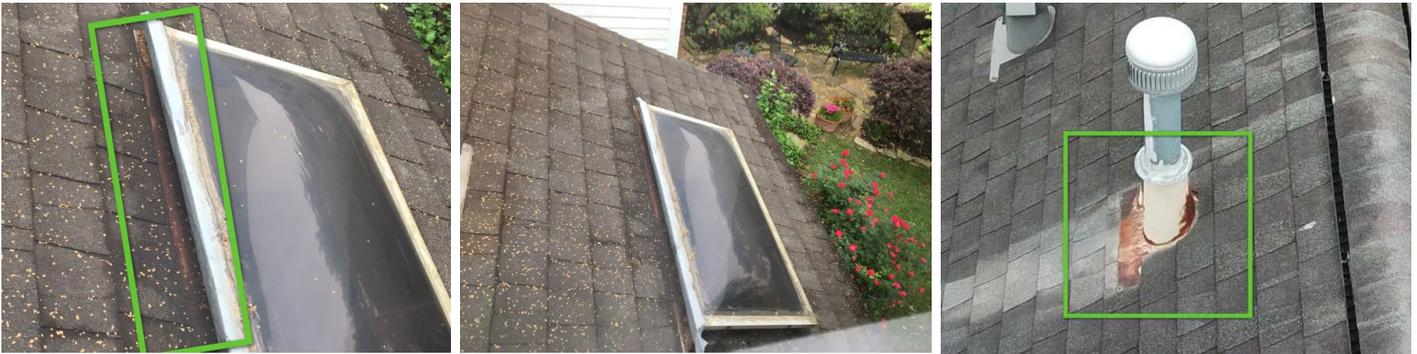
### Wear and Deterioration: Composition - Advanced

Discolored, Aggregate Missing, Rusted Roof Jack, Rusted flashing

The composition roof surface was showing evidences of advanced deterioration of the roof surface as described above and shown below.

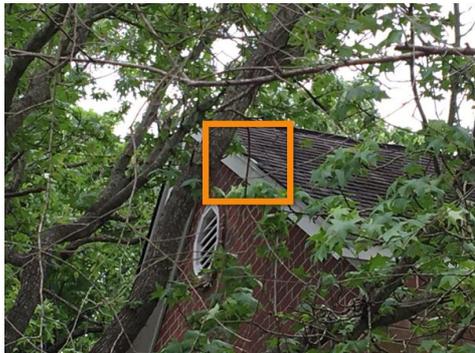
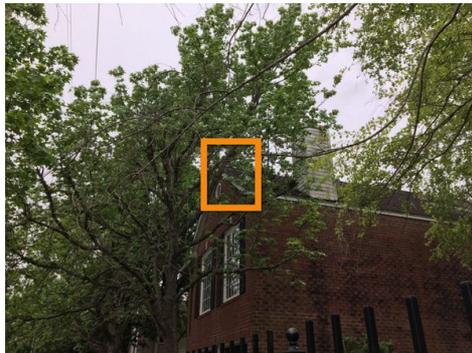
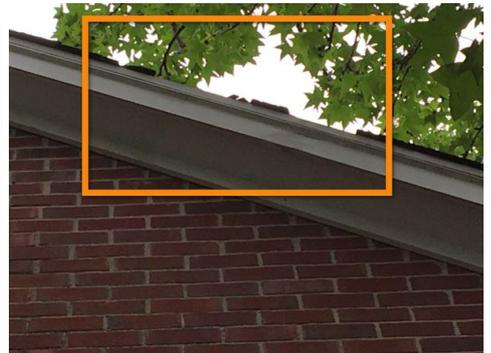
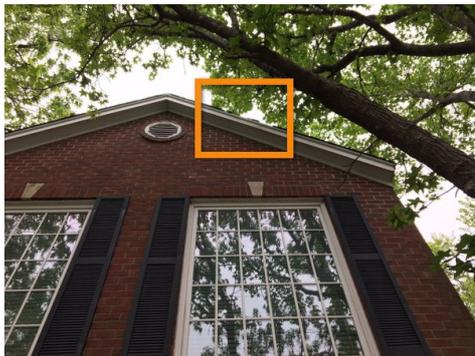
### DAMAGED SHINGLES

Some damage to shingles were notified that north east corner of the house. The damaged shingles need to be replaced.

Contact a qualified professional.

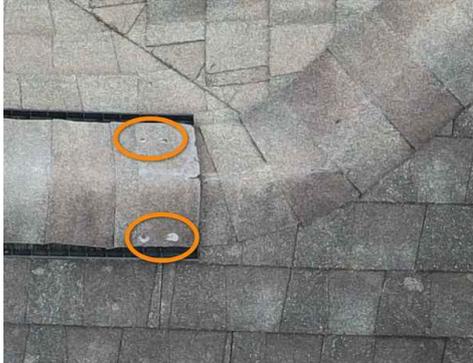
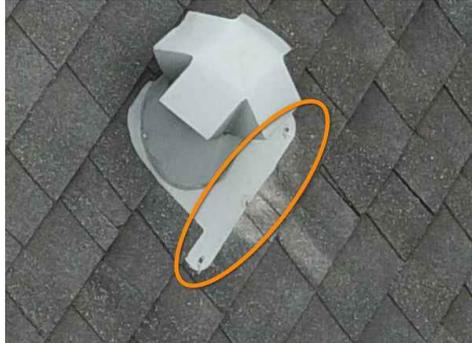
**DETERIORATED SEALANTS**

We observed sealants that were cracked/separated/missing and repair is needed.

Contact a qualified professional.

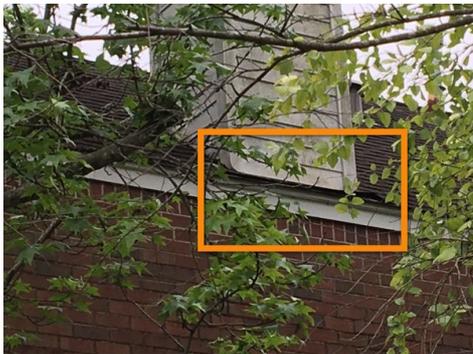
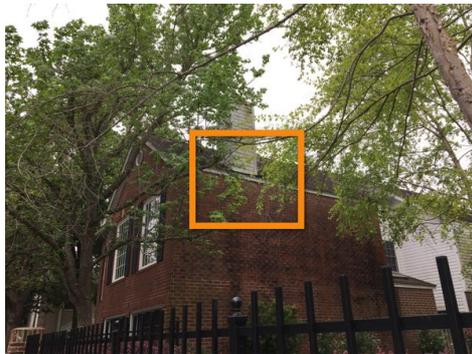
**FLASHING/COUNTER FLASHING**

We observed one or more conditions with the roof flashing as pointed out above. Have a roofing contractor provide a cost estimate to make all needed repairs

Contact a qualified professional.

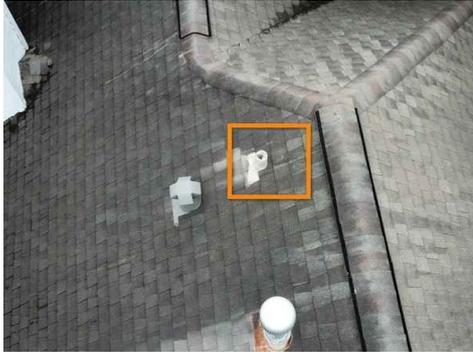
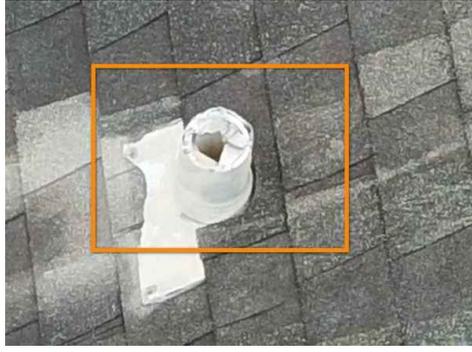
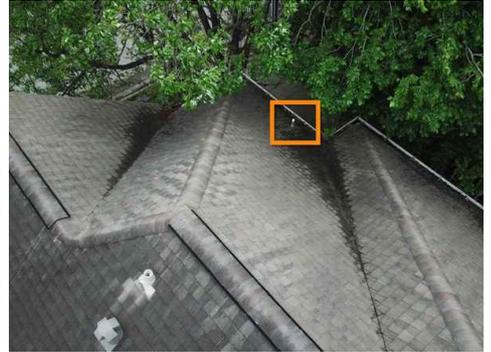
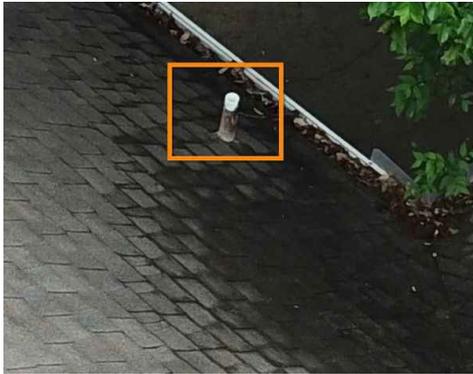
**ROOF JACKS**

Lead - Squirrel Damage

The roof jacks at the plumbing vent pipes were observed to have the conditions as described above. Further investigation with a roofing contractor is recommended to make all needed repairs.

Contact a qualified professional.

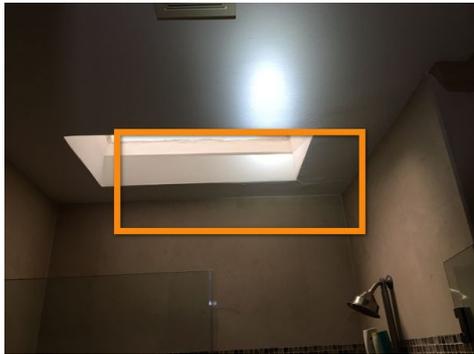
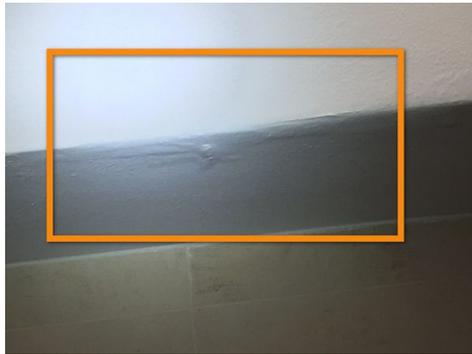
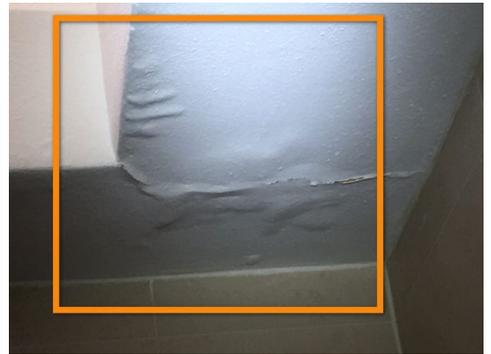
**OBSERVED ON CEILING**

After observing the interior of the structure, evidences of roof leaks were visible, where the ceiling was water damaged. It is recommended that a roofing contractor be contacted to find the source of the leaks, and to make any needed repairs.

Contact a qualified professional.

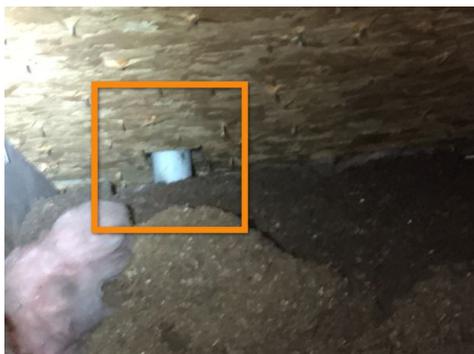
Sewer vent at the northwest corner of the attic

**ATTIC ROOF DECKING AND/OR FRAMING MEMBERS**

After observing the interior of the structure, evidences of roof leaks were visible in the attic, where the roof decking and/or roof framing members were water stained. It is recommended that a roofing contractor be contacted to find the source of the leaks, and to make any needed repairs.

Contact a qualified professional.

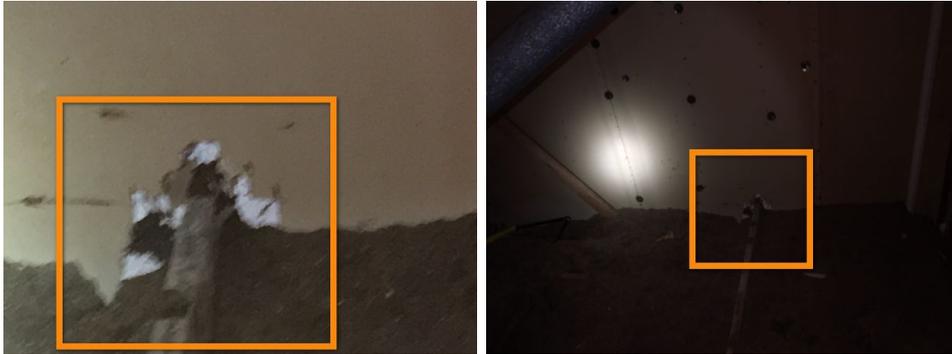
**REPAIR - FIRESTOP - SHEETROCK, REPAIR**

The sheetrock on the wall that separated the units at the ends of the attic has holes and did not provide a continuous surface. This condition can be a fire hazard, and the sheetrock should be repaired.

Contact a qualified professional.

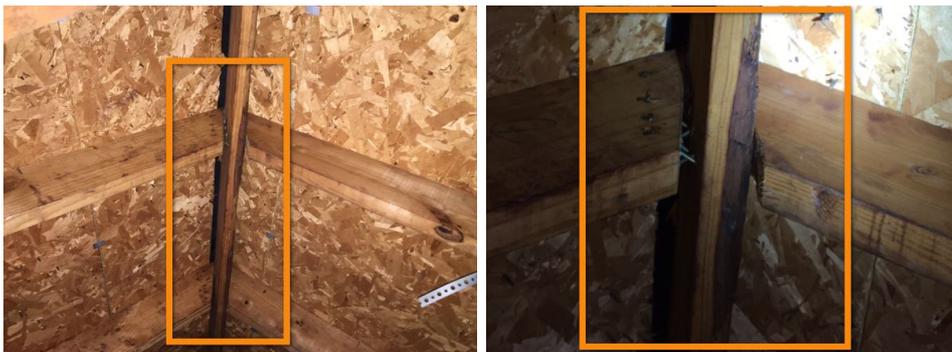
**RAFTER NOT FLUSH ON RIDGE BEAM**

We observed rafters that were separated at the top of the rafter, where the rafter meets the top ridge beam. Rafters should be flush against the ridge beam, and it is recommended that 3 foot make-up pieces be "sistered" onto the rafters, so that the make-up pieces are flush against the ridge. This will allow the rafters to bear against the ridge beam for the entire length of the miter cut on the rafter.

Contact a qualified professional.

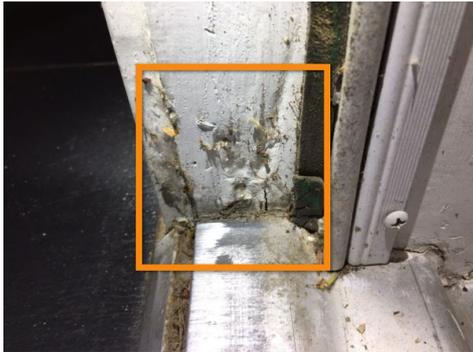
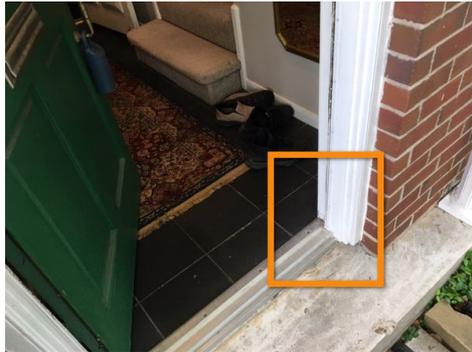
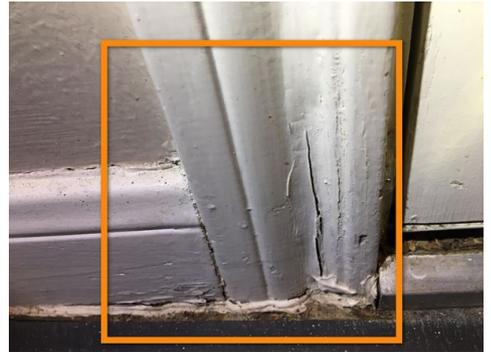
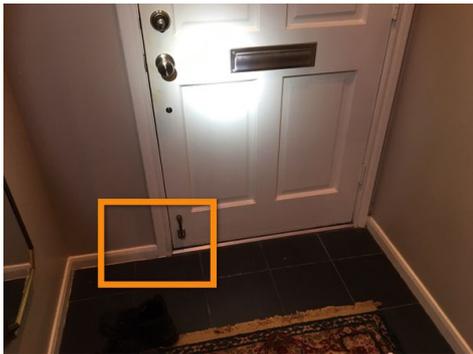
**WATER STAINS/WATER DAMAGE**

Evidences of water penetration to the interior of the structure were observed, including water damaged materials. The source of the water penetration appears to be related to a lack of proper sealant at the exterior joints of the door. Further investigation is recommended with service companies to determine the source(s) of the water penetration along with any secondary damages, and also to provide a cost estimate for any needed repairs.

Contact a qualified professional.

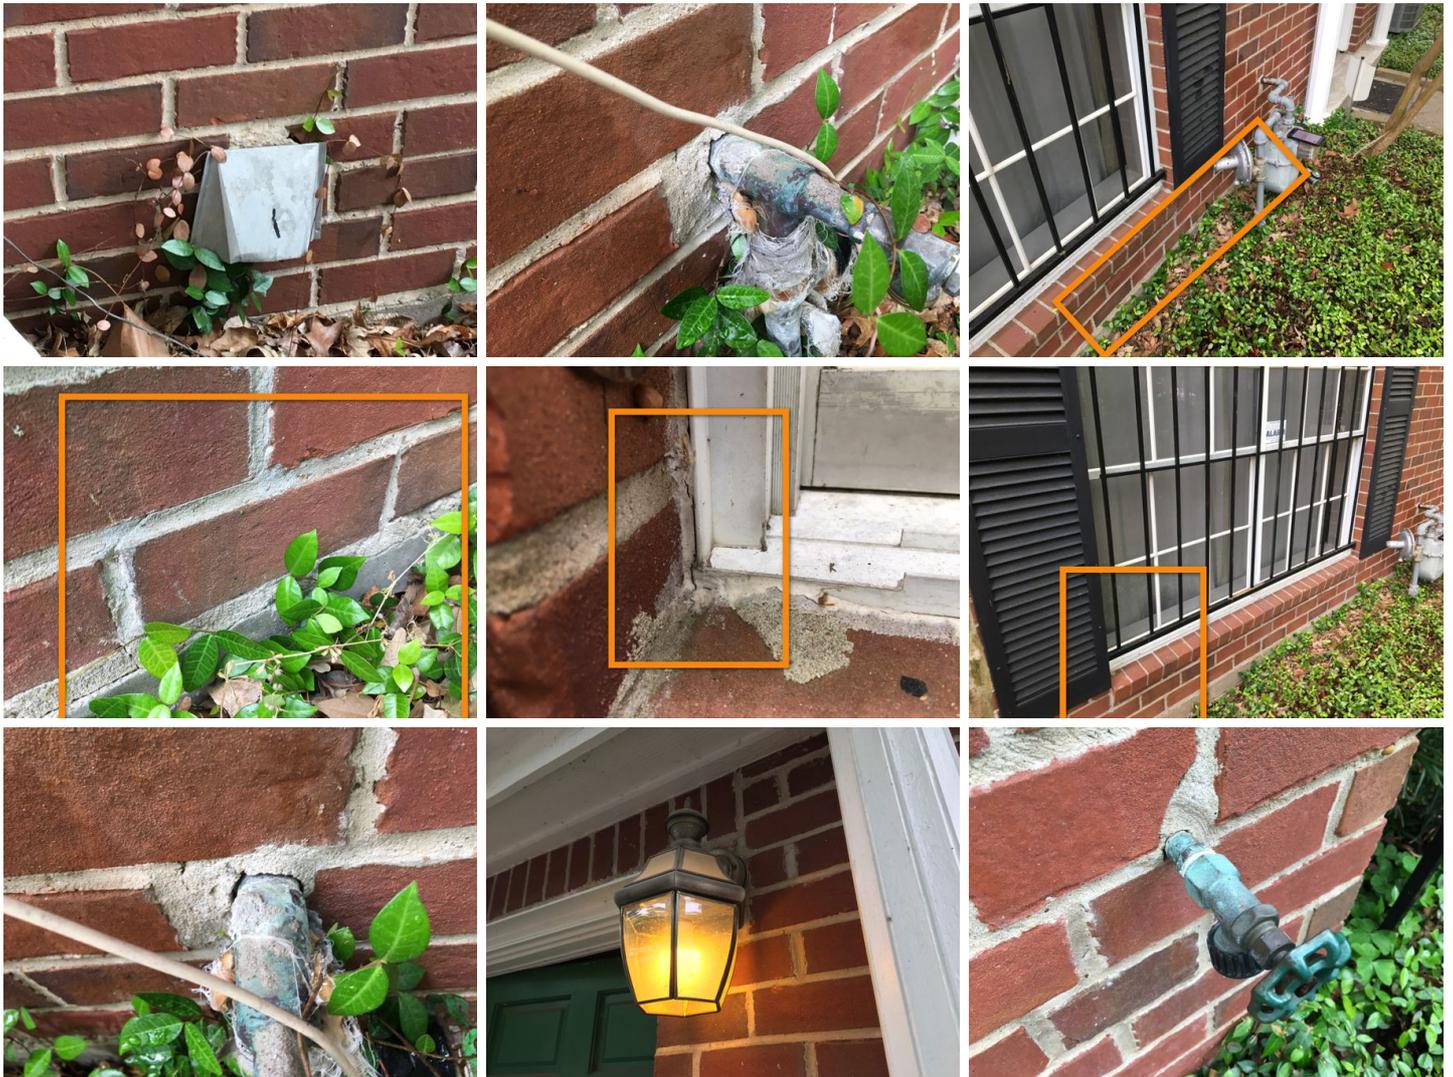
Deteriorated Sealants, Light Fixtures, Piping, Hose Bibb, Sealants deteriorated/missing, Caulking Cracked/Missing, Window sealants, Vent Caps

A substantial vulnerability to water penetration was observed at penetrations/openings through the exterior building envelope, and it is recommended that all penetrations/openings be sealed against water penetration. Typical examples on a structure may include light fixtures, air conditioning refrigerant lines, water piping, gas piping, vent caps, windows, doors, expansion joints, etc. Below is a representative sample of locations and/or photographs showing some, but not necessarily all, locations where there is a vulnerability to water penetration. Have a contractor provide a cost estimate to seal all vulnerable areas on the exterior building envelope against water penetration and/or open up any clogged weepholes in the veneer.

Contact a qualified professional.

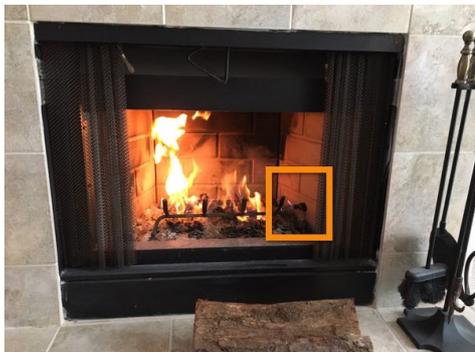
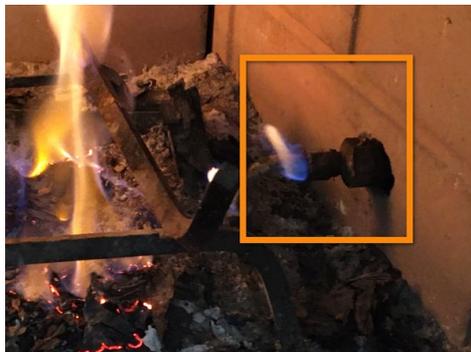
**GAS LEAK**

The gas line was leaking at the connection. It is recommended to provide the needed repairs.

Contact a qualified professional.

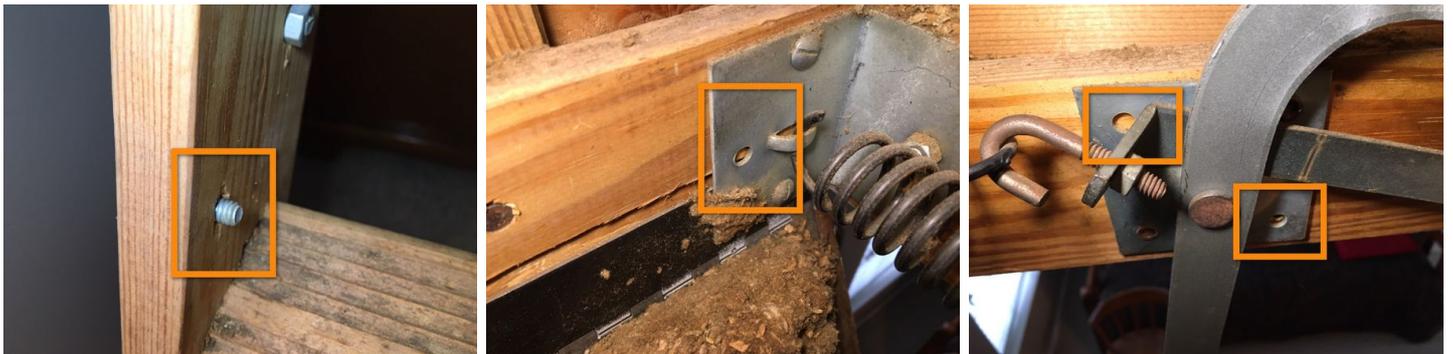
### LADDER ATTACHMENT IMPROPER

Nails missing in spring arm pivot, Nails missing in corner brackets, Missing nuts/bolts

The stair assembly was not properly installed or secured to the framing members, and repair is needed for safety purposes. The condition(s) can be a safety hazard, and repair is needed, as an improperly installed stair assembly can possibly collapse.

Contact a qualified professional.

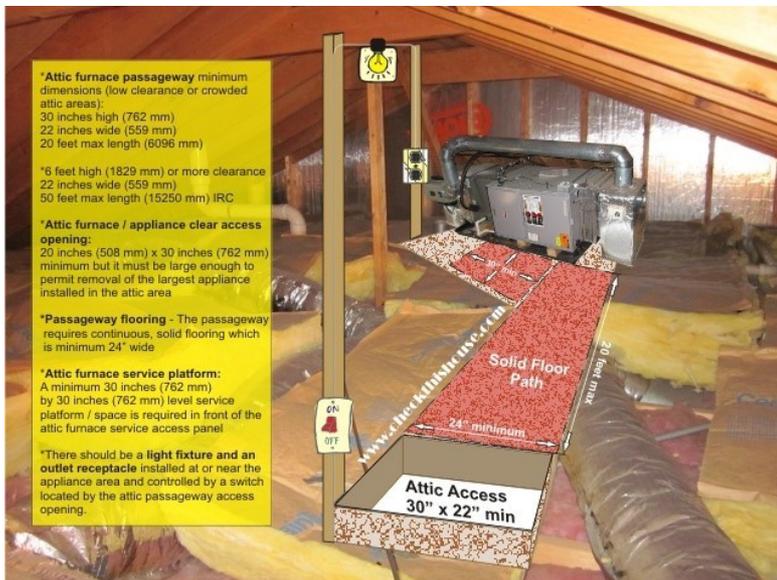
**INADEQUATE WALKWAY DECKING**

Contact a qualified professional.

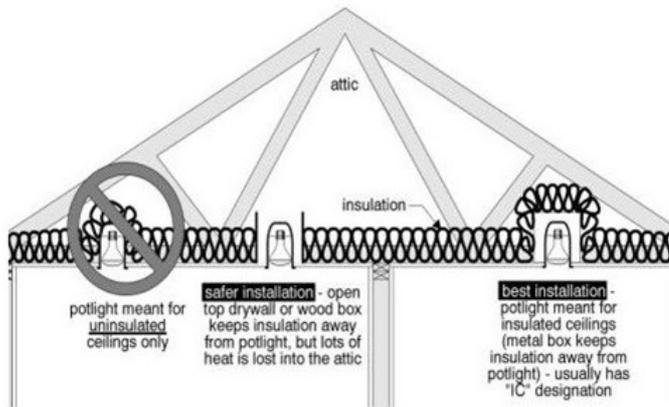
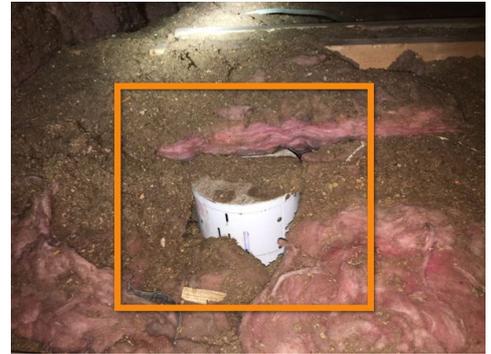
**CONTACT WITH RECESSED LIGHTS**

The insulation was in contact with the recessed lights, which can be a fire hazard and shorten the life of the light bulbs. It is recommended that the insulation be pulled back to provide a three inch air space.

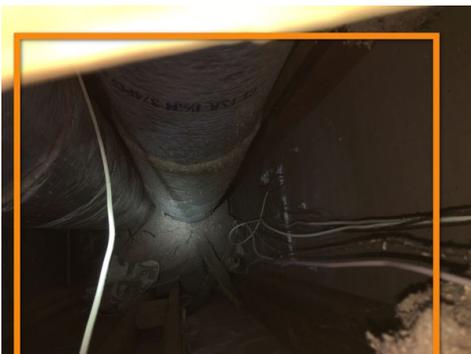
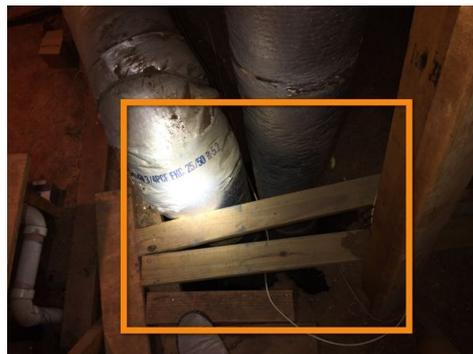
**INSULATION LOOSE/MISSING - WALLS**

The insulation in the attic was loose/missing at some of the vertical walls, and needs to be repaired.

Contact a qualified professional.

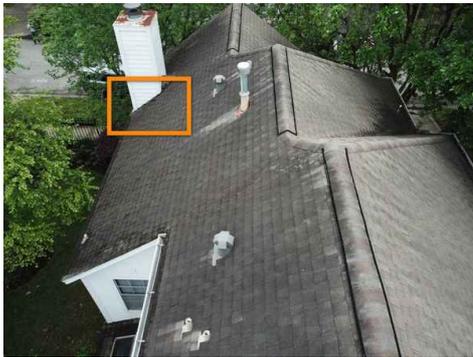
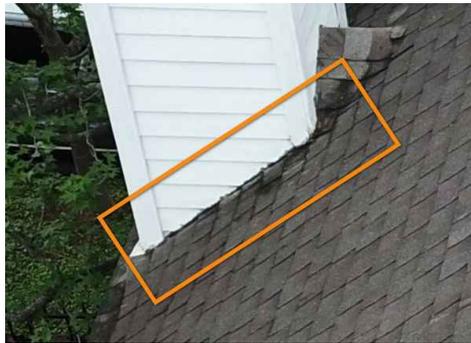
#### **DAMAGED AT BOTTOM**

The siding was observed to be damaged at the bottom where it meets the roof and needs to be repaired.

Contact a qualified professional.

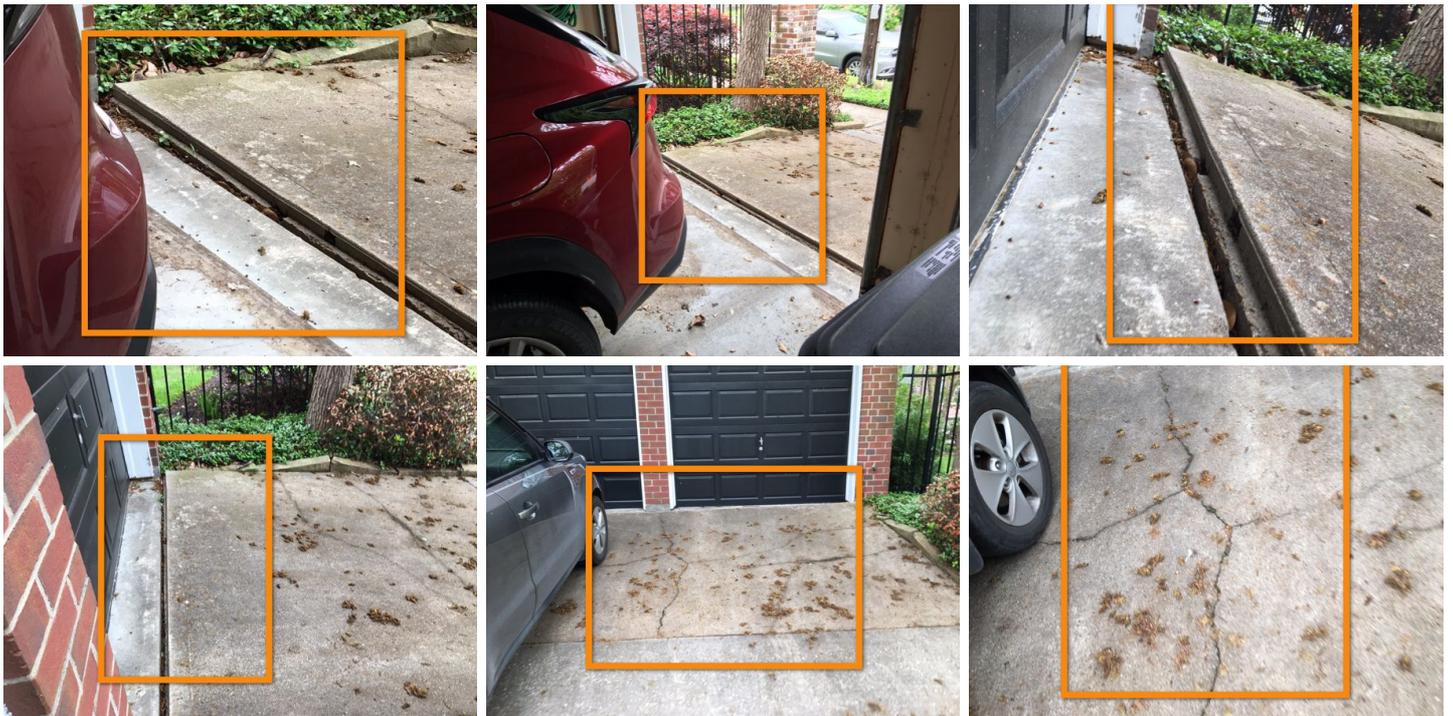
### DRIVEWAY REPAIR

The driveway concrete was cracked and uneven. The damaged portion presents a tripping hazard. It is recommended that a contractor be contacted to provide a cost estimate to make the needed repairs.

Contact a qualified professional.

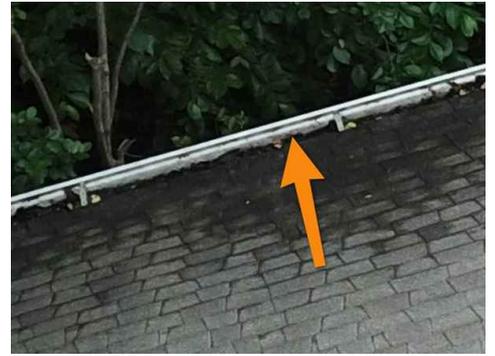
The gutters were observed to have debris in them and are in need of cleaning.

Contact a qualified professional.

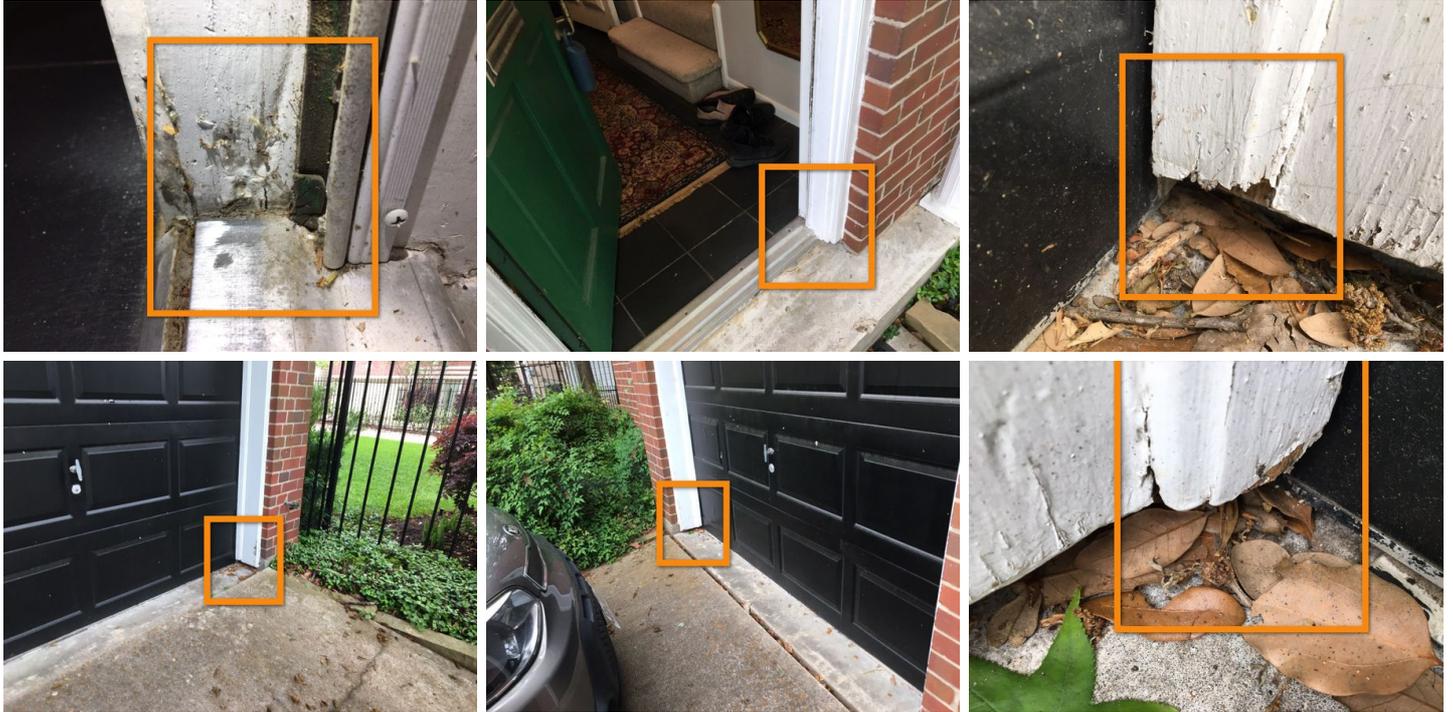
**WOOD ROT**

Wood rot was observed and needs to be replaced. Have a contractor provide a cost estimate to determine the entire scope of the wood rot, and provide a cost estimate to replace all rotted wood in the house.

Contact a qualified professional.

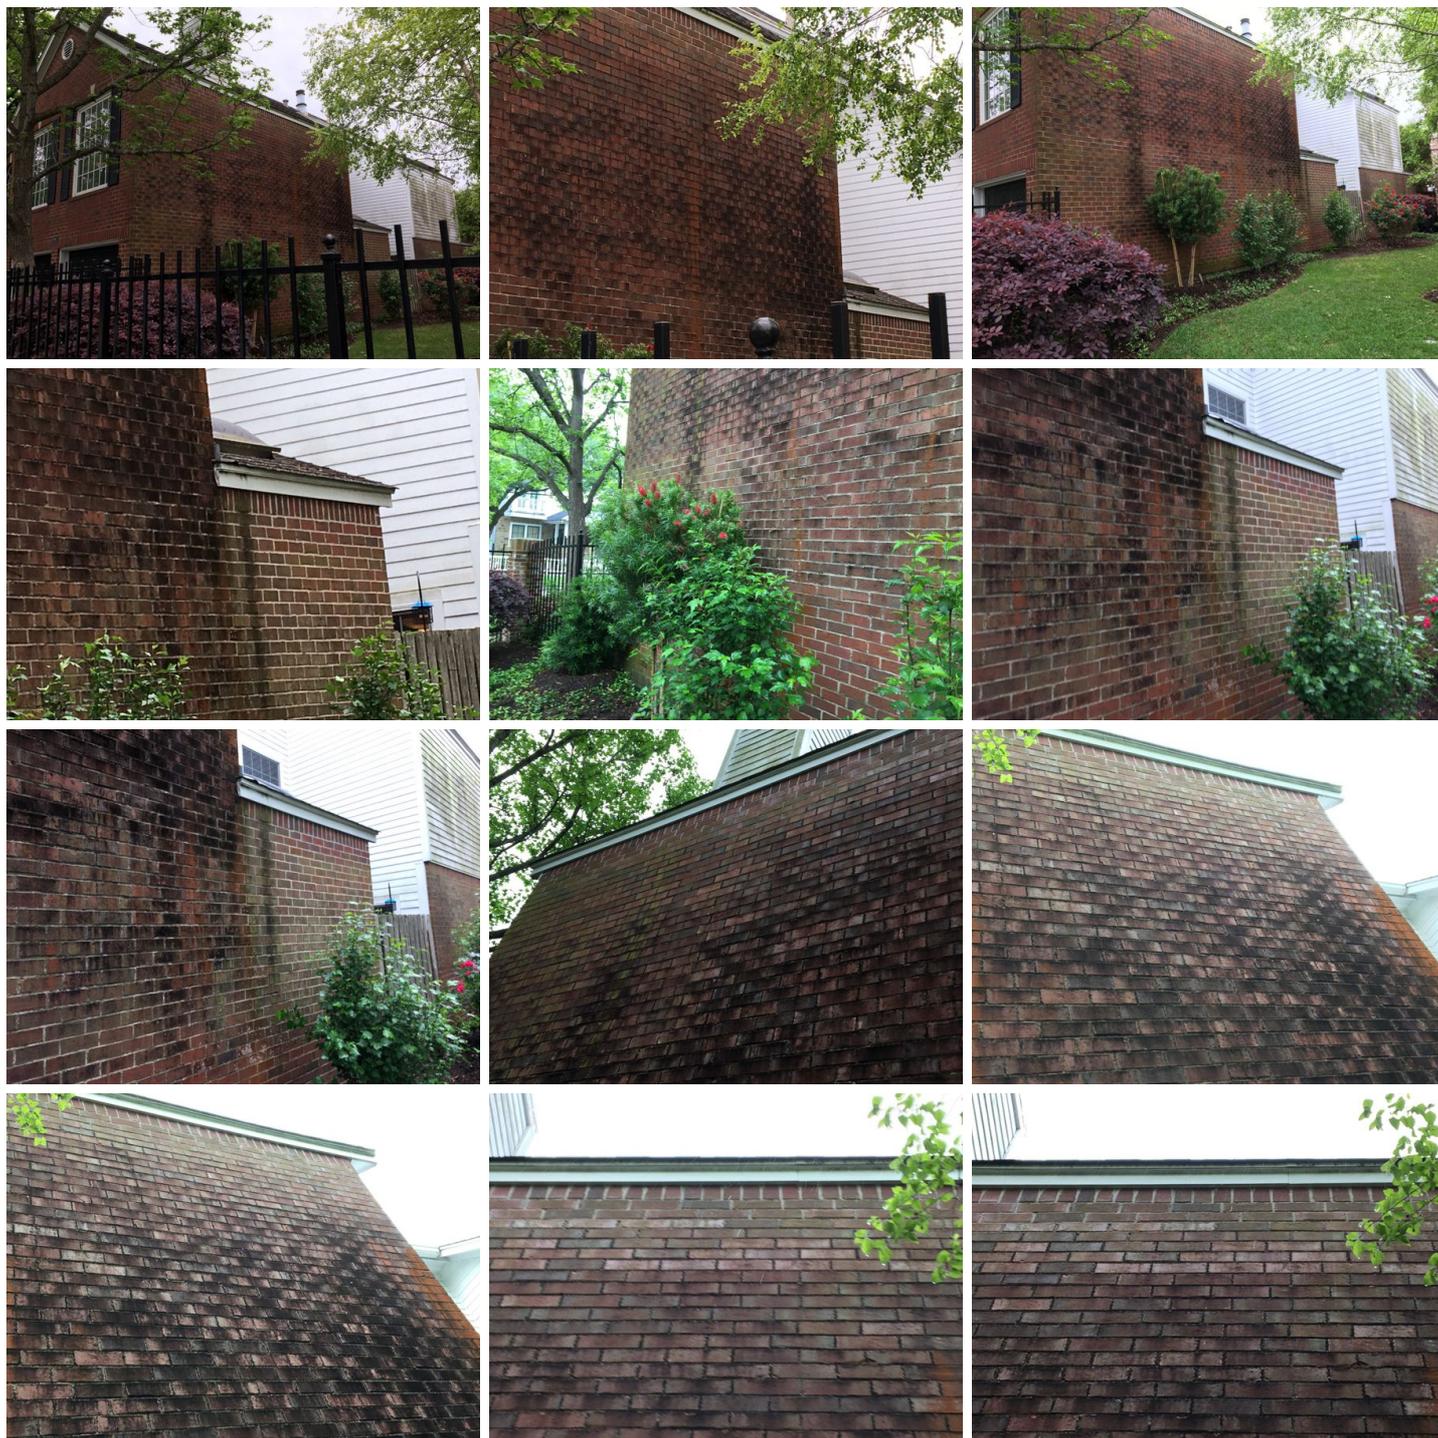
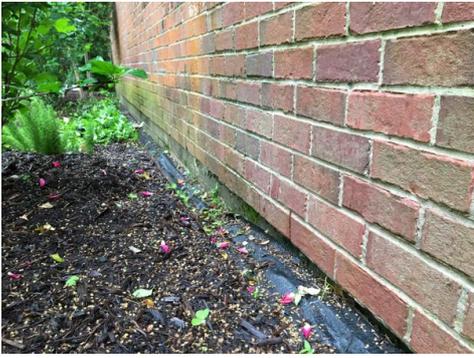
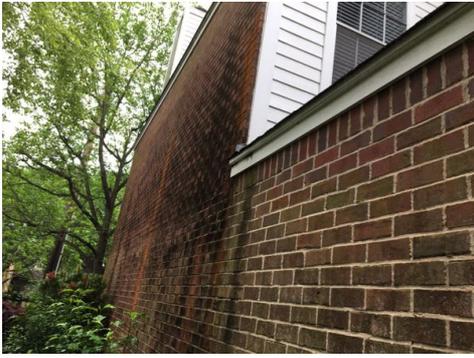
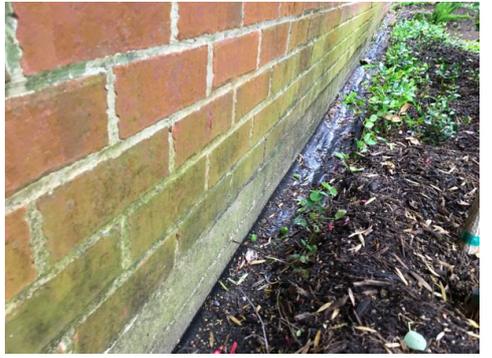
**BACK WALL OF THE HOUSE**

The rear wall of the house was covered with mildew, especially close to the master bathroom area. While mildew growth on exterior brick is not unusual, certain conditions could allow this to occur. In the case of the back of this house, the roof line finish is flush with the wall without an overhang to allow the runoff water of the roof to drop off the roof away from the house wall. Also, there are big trees near this area and areas with lots of shade have the tendency of holding moisture for longer periods, allowing mildew to thrive. This condition does not appeared to be allowing water into the house since we checked the interior of the wall with a moisture meter, and no higher than normal moisture readings were obtained. Also. no stains or water damage were visible at the interior behind this wall.

It is recommended to install gutters at the rear of the house to minimize this condition. It is also recommended to clean the brick wall by power washing and treating the wall with one of the available treatments for mildew to avoid the fast growth of mildew. Contact a contractor to provide the repairs.

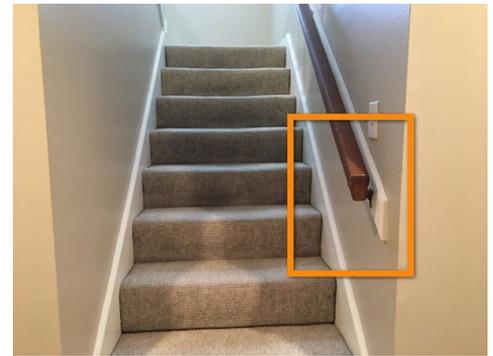
The handrails for the stairway were not constructed according to the current building code standards, which is expected given the age of the house. Therefore, the ends of the handrails do not terminate into the wall, which could allow loose clothing or a purse or bag to catch on the open end, causing tripping and/or falling down the stairs.
