Property Inspection Report

2005 39th St, Galveston, TX, 77550

Inspection Date: 10/26/2022

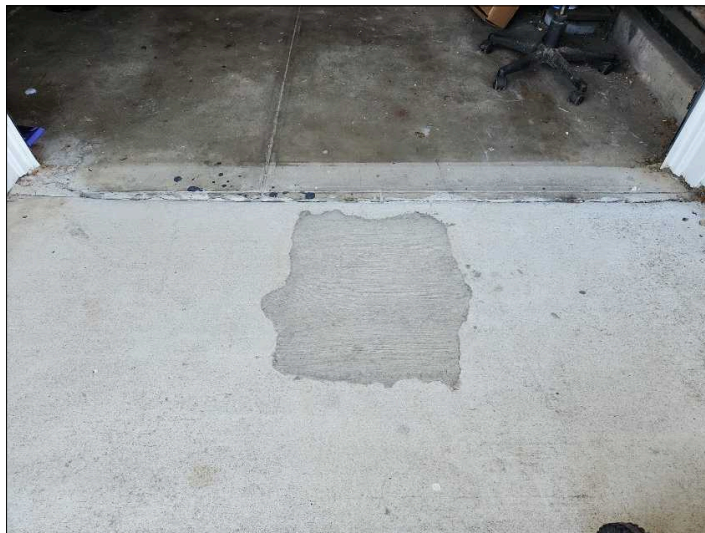
A.1. -There are indications of previous foundation repair. We recommend you refer to the structural engineer's report if available for further information of repairs, warranty and proper maintenance of the foundation. There is often a transferable warranty after work has been completed, recommend contacting the homeowner for more information.

- There are indications of previous foundation repair. We recommend you refer to the structural engineer's report if available for further information of repairs, warranty and proper maintenance of the foundation. There is often a transferable warranty after work has been completed, recommend contacting the homeowner for more information.

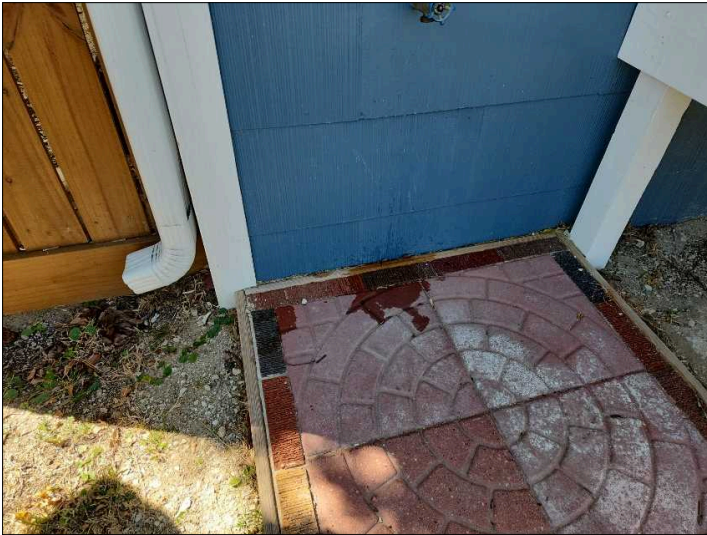
B.1. -The soil or concrete is too high or footing is too low which does not allow proper exposure of the slab. This can cause conducive conditions to Wood Destroying Insects or water penetration usually if there is improper slope. Mainly at - front, left side

- The soil or concrete is too high or footing is too low which does not allow proper exposure of the slab. This can cause conducive conditions to Wood Destroying Insects or water penetration usually if there is improper slope. Mainly at - front

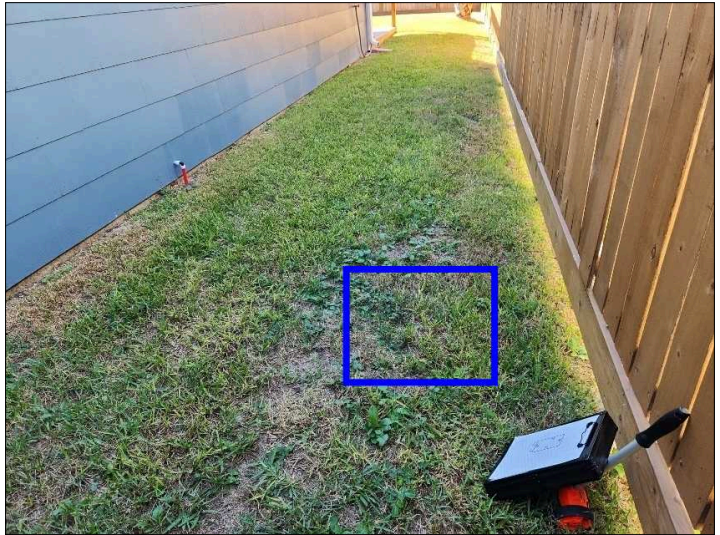
B.2. -Fill dirt is needed along the foundation or in the yard. Mainly at - right side

- Fill dirt is needed along the foundation or in the yard. Mainly at - right side

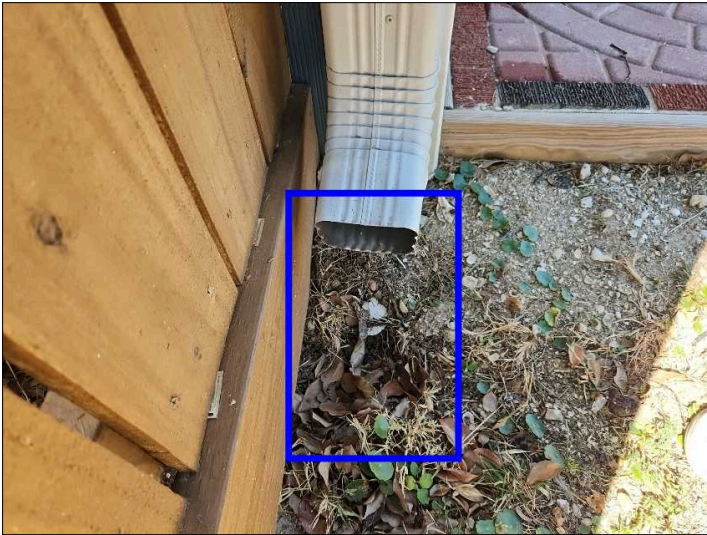
C.3. -Splash blocks or downspout extensions should be installed to direct water away from foundation.

- Splash blocks or downspout extensions should be installed to direct water away from foundation.

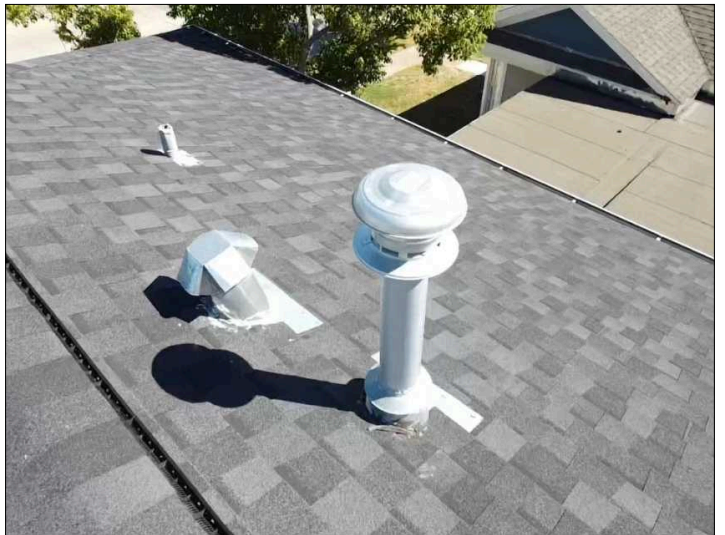
C.2. -One or more of the vents and or flashing is unpainted, recommend painting all unpainted vents and flashing to help prevent damage due to UV rays or rust.

- One or more of the vents and or flashing is unpainted, recommend painting all unpainted vents and flashing to help prevent damage due to UV rays or rust.

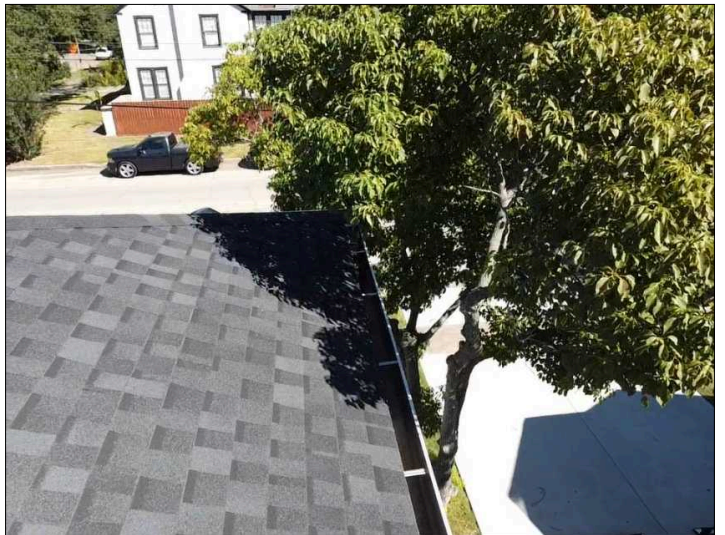
C.1. -Tree limbs should be kept trimmed at least 5' from roof to help prevent damage to the roof during windy conditions.

- Tree limbs should be kept trimmed at least 5' from roof to help prevent damage to the roof during windy conditions.

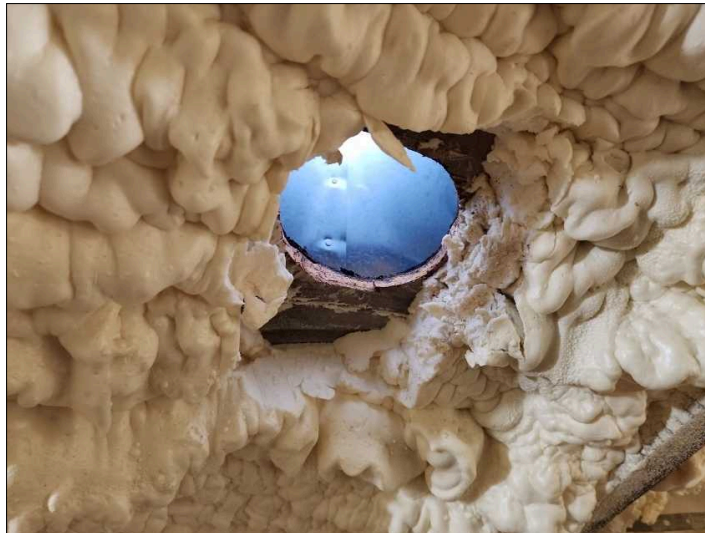
D.1. Unused vent. Recommend sealing to help retain proper insulation.

Unused vent. Recommend sealing to help retain proper insulation.

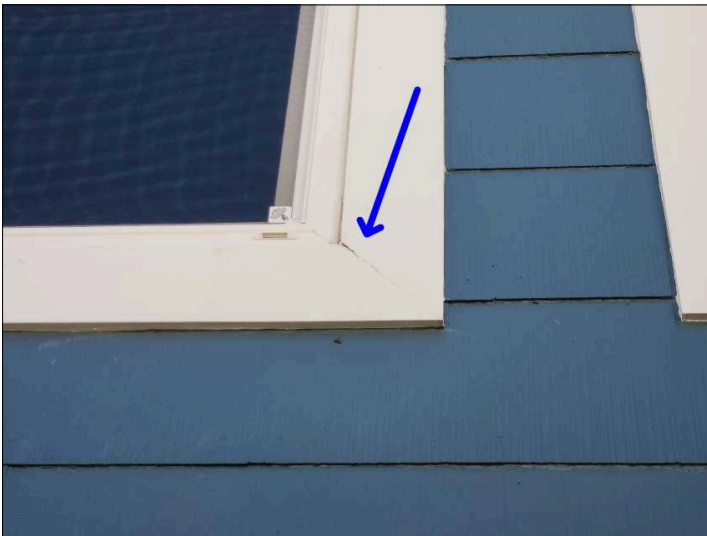
E.2. -Recommend sealing trim to help prevent water penetration. Mainly at - right side, rear

- Recommend sealing trim to help prevent water penetration. Mainly at - right side

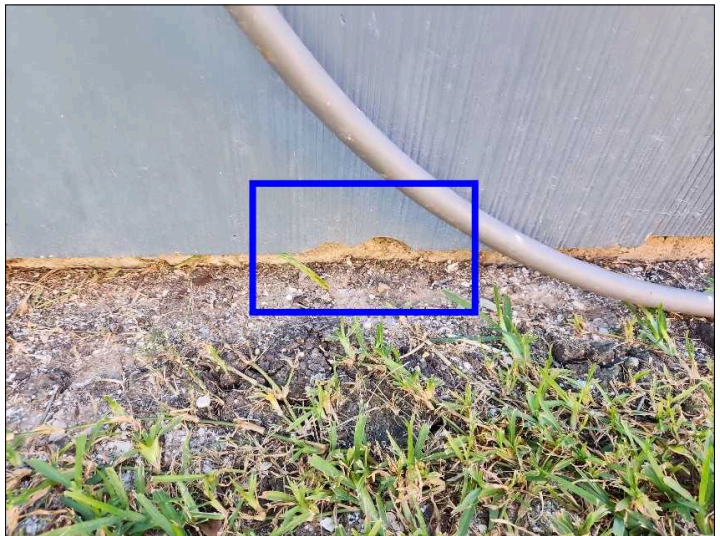
E.4. -There is some damage to the exterior siding, recommend repair or replacement to help prevent water penetration. Unable to determine the condition of the underlying materials. Mainly at - right side

- There is some damage to the exterior siding, recommend repair or replacement to help prevent water penetration. Unable to determine the condition of the underlying materials. Mainly at - right side

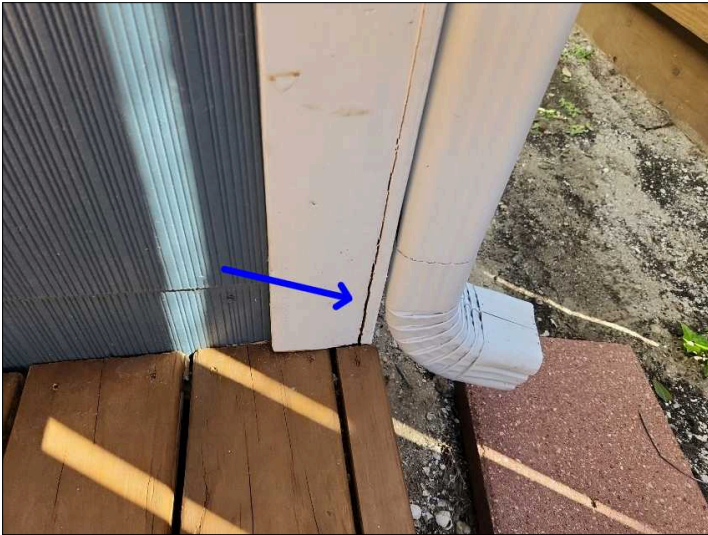
- Recommend sealing trim to help prevent water penetration. Mainly at - rear

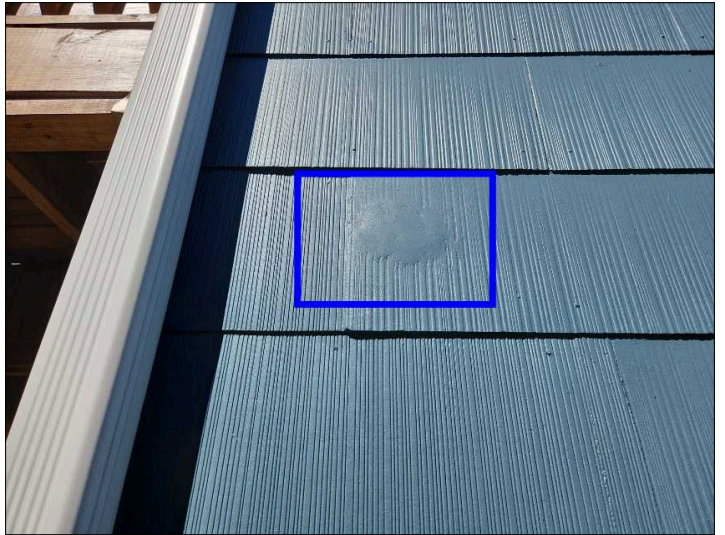
E.5. -The are signs of previous repairs in the siding. Unable to determine condition of underlying materials. Mainly at - left side

- There are signs of previous repairs in the siding. Unable to determine condition of underlying materials. Mainly at - left side

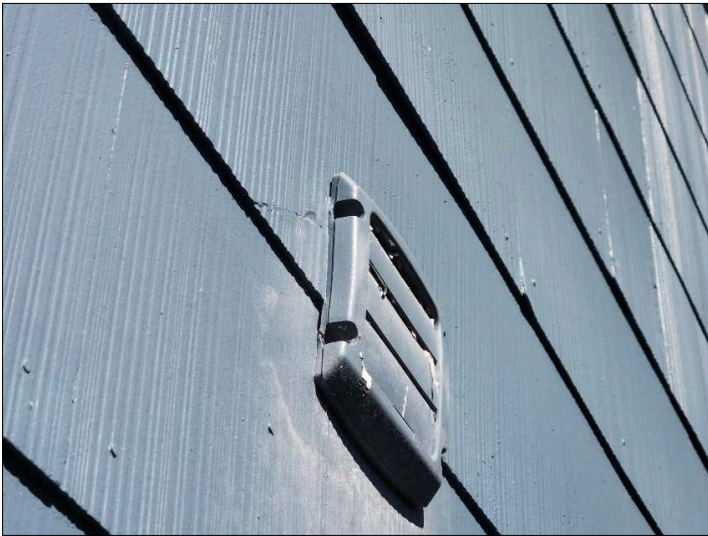
- Seal all vents at wall connection to help prevent water penetration into walls. It is a good idea to leave a small opening at the bottom to allow any water penetrating to escape.

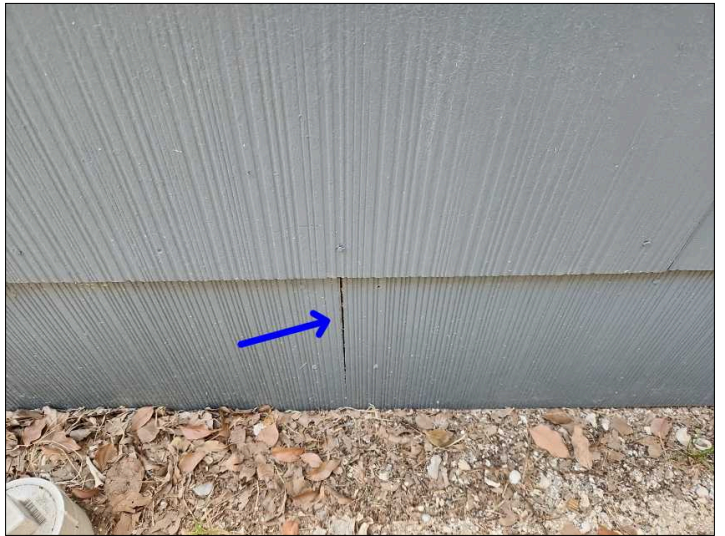
E.3. -There are gaps at the joints in the siding in various locations due to shrinking and expansion of siding materials, recommend sealing all open joints in the siding to help prevent water penetration.

- There are gaps at the joints in the siding in various locations due to shrinking and expansion of siding materials, recommend sealing all open joints in the siding to help prevent water penetration.

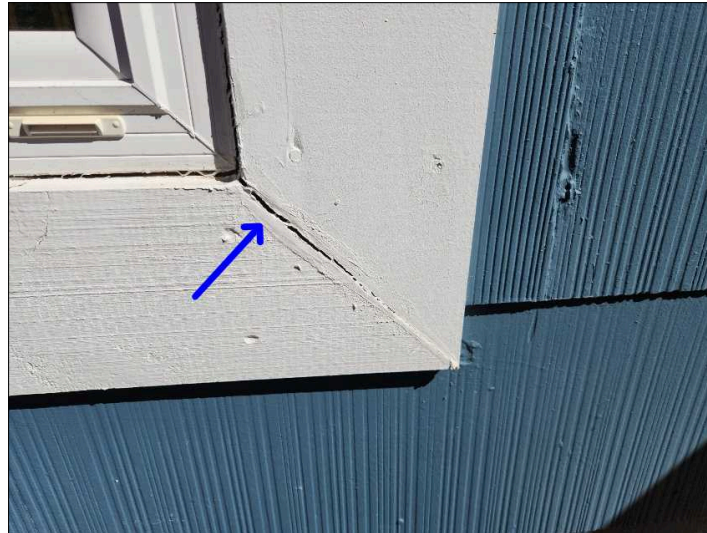
- Recommend sealing trim to help prevent water penetration. Mainly at - rear

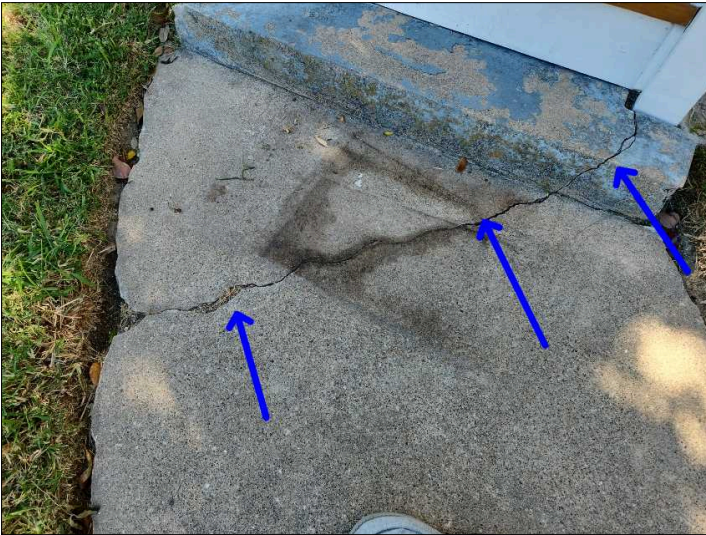
F.1. -Cracks were noted in the pavement. These are cosmetic in nature at this time. Recommend sealing to help prevent further deterioration. Mainly at - front walk

- Cracks were noted in the pavement. These are cosmetic in nature at this time. Recommend sealing to help prevent further deterioration. Mainly at - front walk

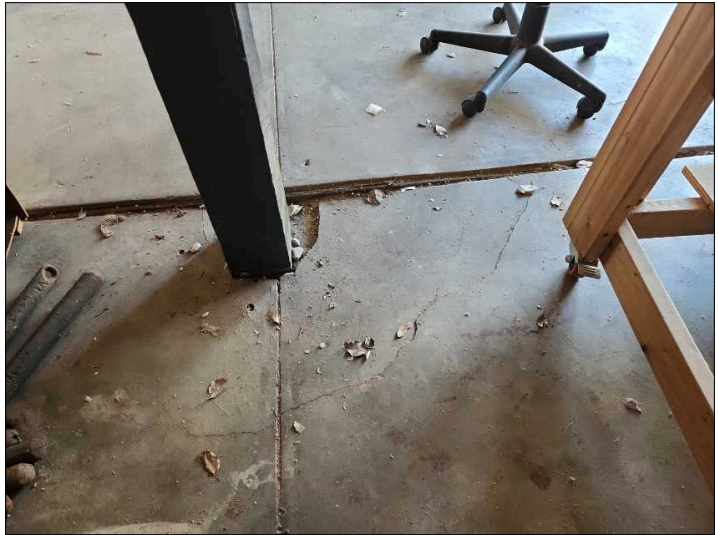
F.2. -Uneven pavement was noted, recommend repairs to help prevent tripping. Mainly at - garage

- Uneven pavement was noted, recommend repairs to help prevent tripping. Mainly at - garage

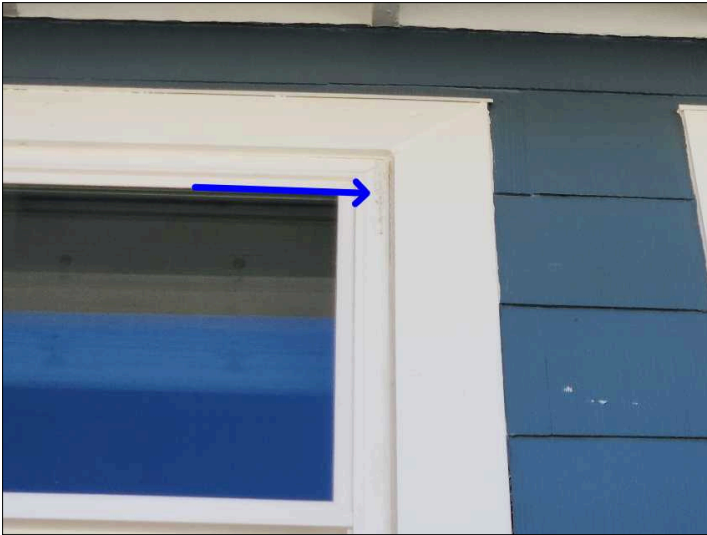
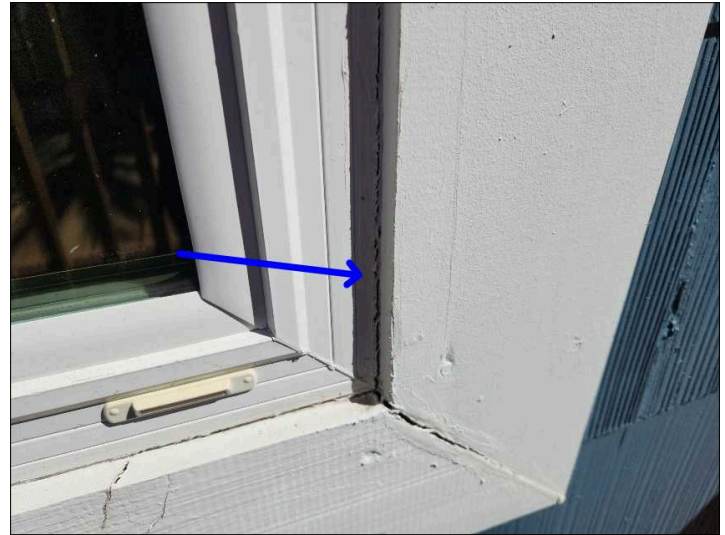
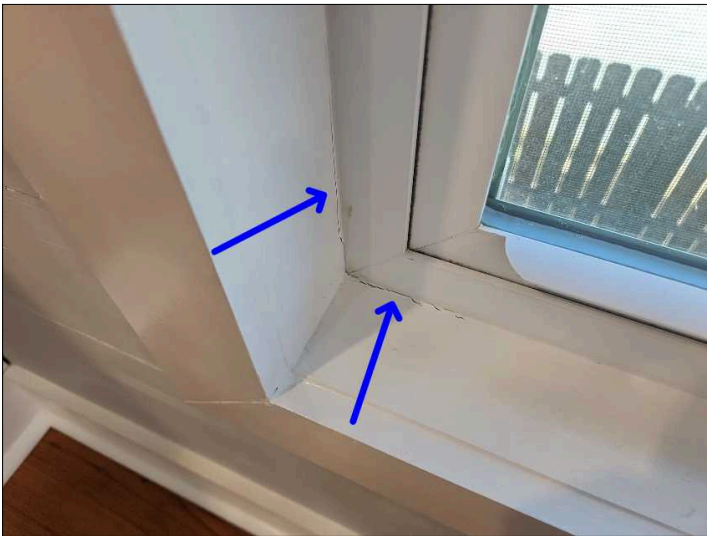
H.1. -Sealant is needed around various windows between the window framing and exterior brickwork or trim to help prevent water penetration, recommend checking all windows for proper sealant.

- Sealant is needed around various windows between the window framing and exterior brickwork or trim to help prevent water penetration, recommend checking all windows for proper sealant.

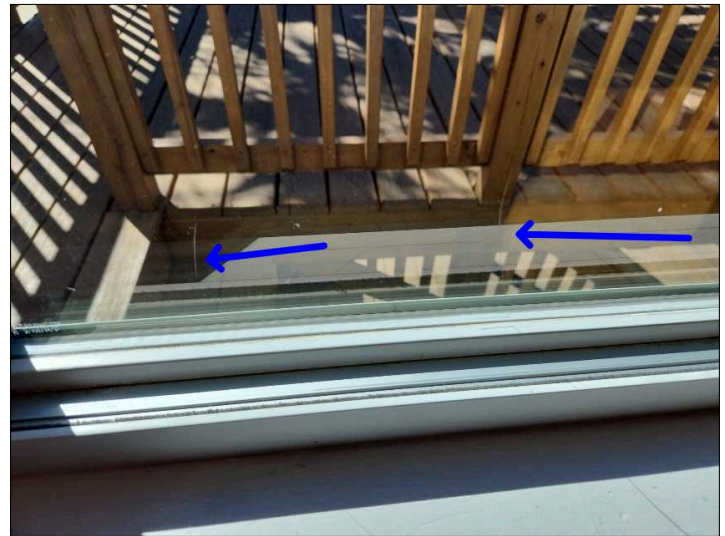
H.2. A scratch was noted in a window pane. Mainly at - rear bedroom

A scratch was noted in a window pane. Mainly at - rear bedroom

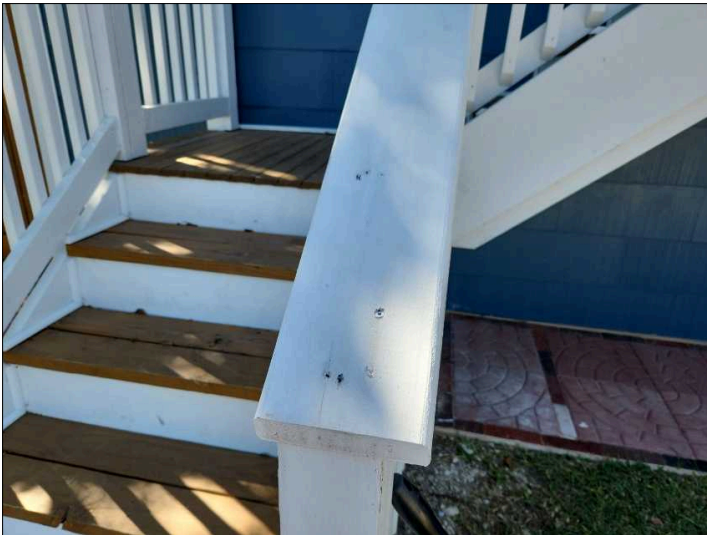
I.2. -There was no graspable rail on the staircase.

- There was no graspable rail on the staircase.

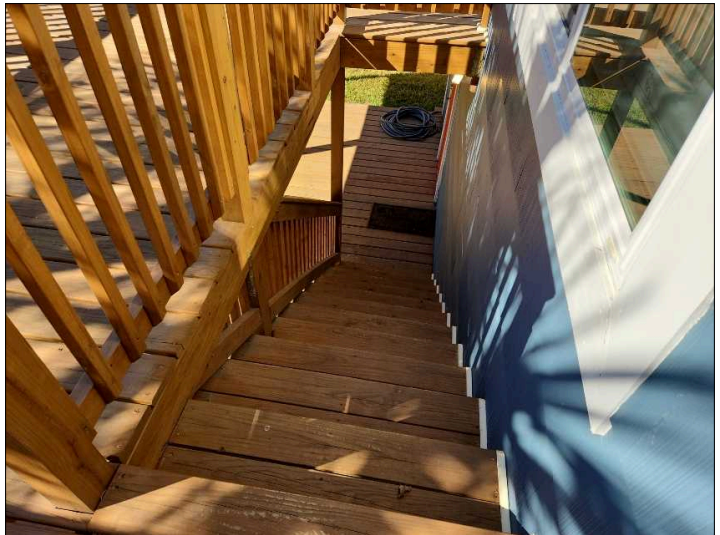
I.1. -The stair hand rails are not continuous from top to bottom of stairway as recommended at the time of construction.

-The stair hand rails are not continuous from top to bottom of stairway as recommended at the time of construction.

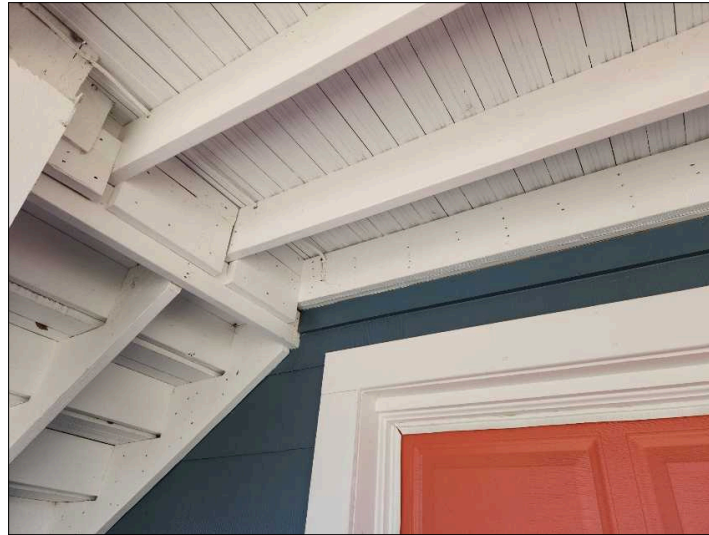
K.1. -Joist hangers are missing on the patio cover joist.

- Joist hangers are missing on the patio cover joist.

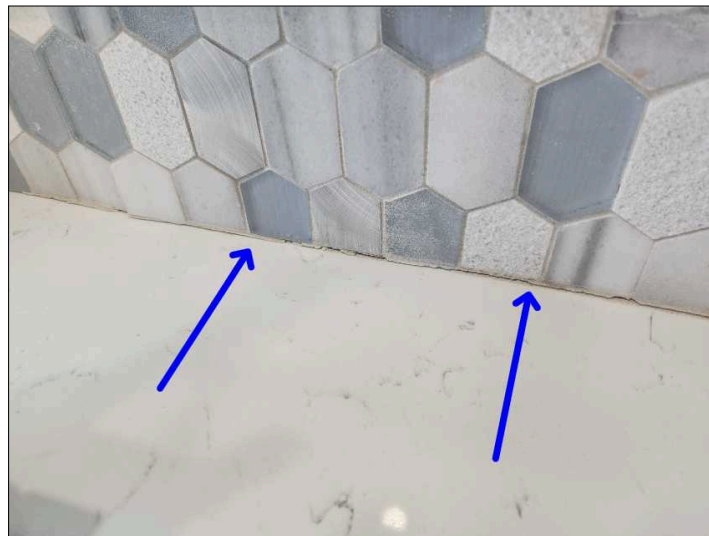
L.1. - Seal countertop at wall connection. Mainly at - kitchen

- Seal countertop at wall connection. Mainly at - kitchen

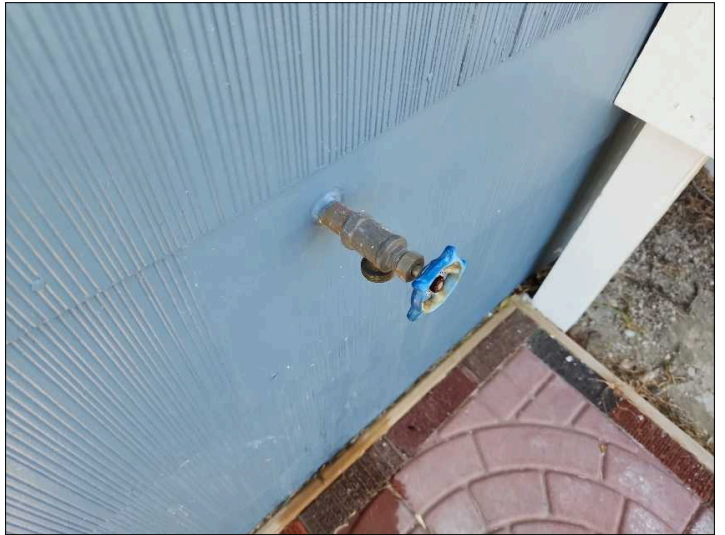
A.3. -Recommend adding or replacing insulation to exterior faucets to help prevent freezing.

- Recommend adding or replacing insulation to exterior faucets to help prevent freezing.

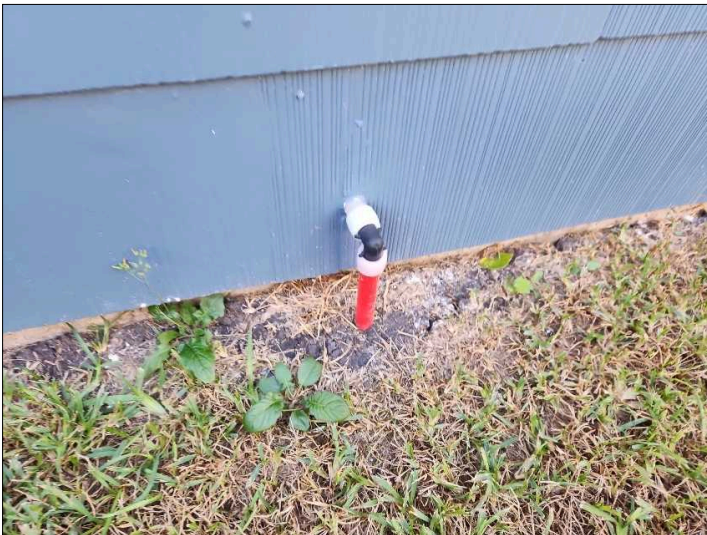
- PEX pipe material should not be used outdoors unless buried or otherwise protected. PEX piping will deteriorate in the prolonged presence of ultraviolet rays, so it should not be used outdoors if there is a chance that it will be exposed to sunlight for any duration.

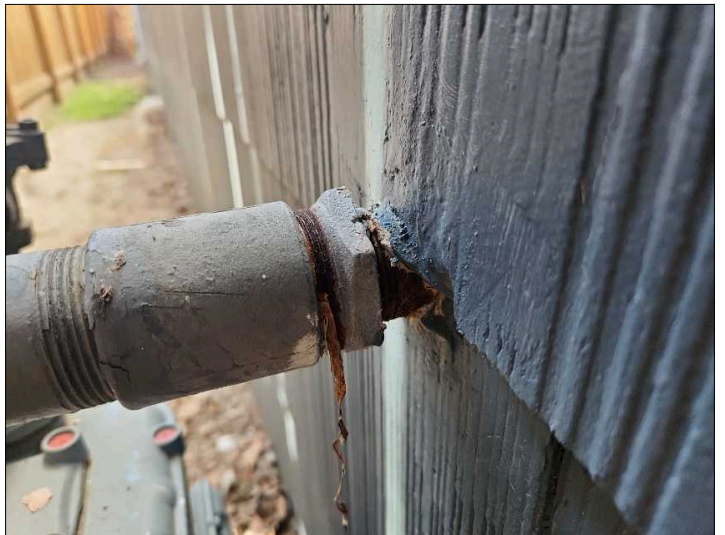
- Paint pipe at gas meter to help prevent premature deterioration.

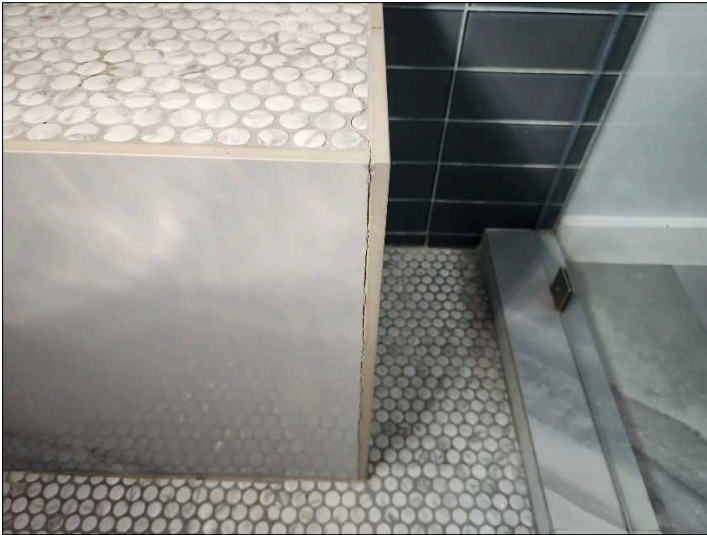
- Recommend sealing the shower surround to help prevent water penetration to underlying materials. Mainly at - hall bath

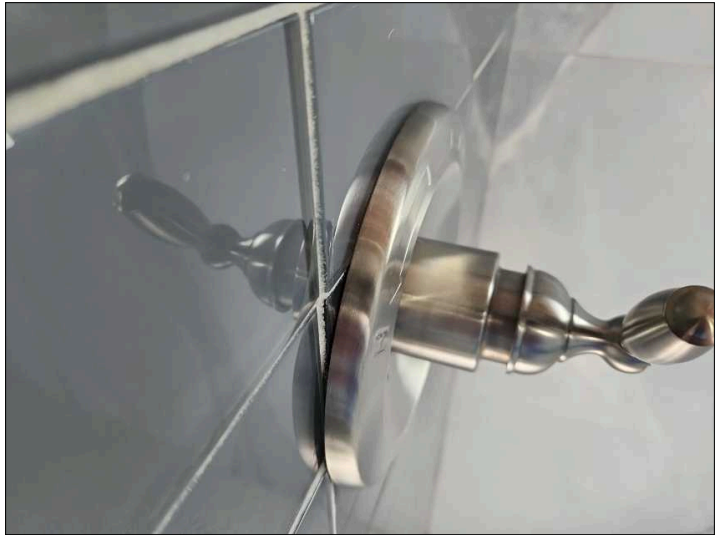
- All tub shower faucets and spouts should be sealed to help prevent water penetration behind the fixture.

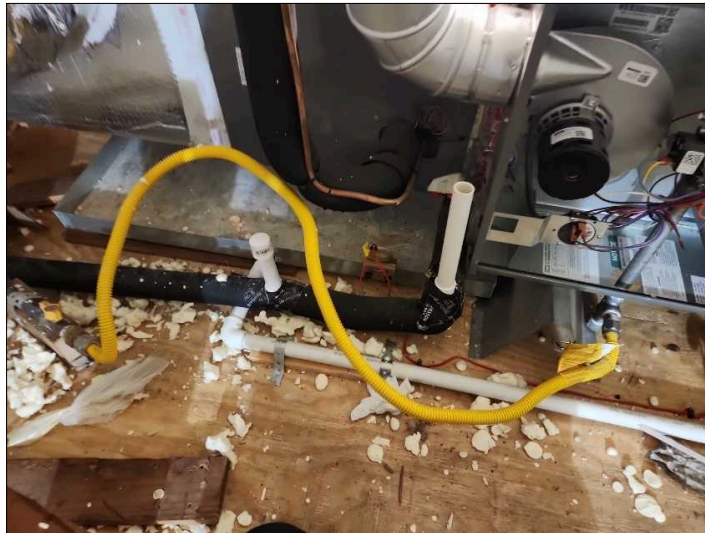
- Gas flex line exceeds proper length. Mainly at - furnace

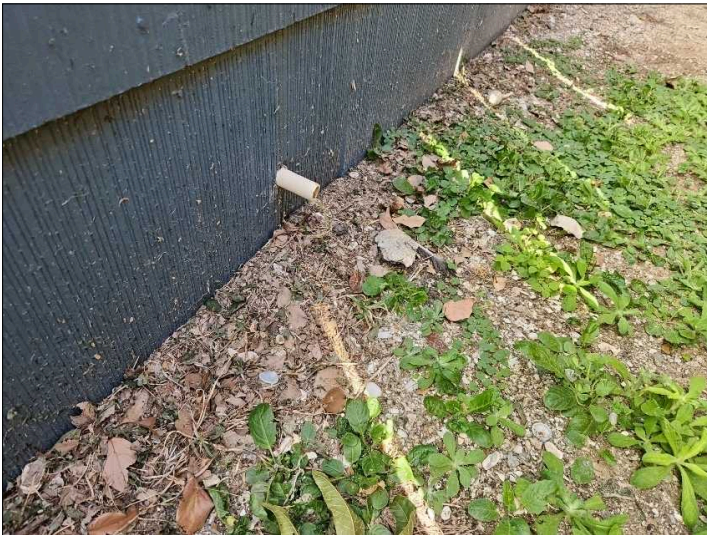
C.3. -The water heater pan drain or T&P (Pop-Off) valve drain line does not have a properly installed 90 elbow to safely direct the high-pressure discharge from the valve where it exits the exterior.

- The water heater pan drain or T&P (Pop-Off) valve drain line does not have a properly installed 90 elbow to safely direct the high-pressure discharge from the valve where it exits the exterior.

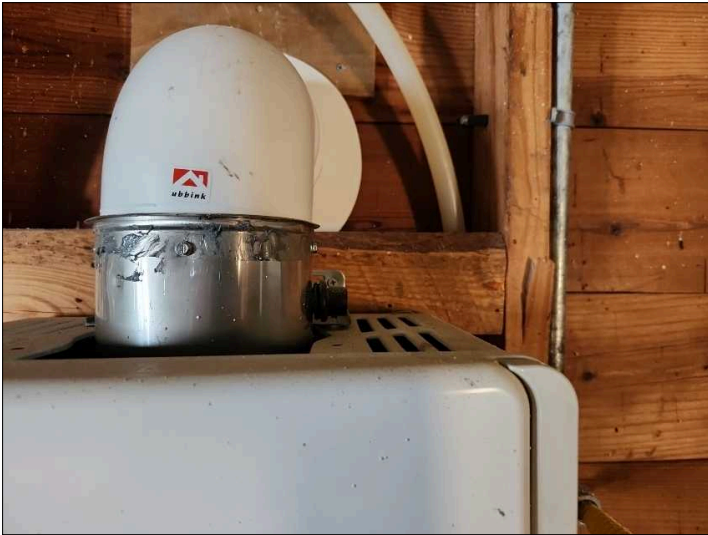
C.4. - The condensation drain line is missing from the vent of the water heater. Recommend adding drain line to help prevent condensation from draining back in to unit.

- The condensation drain line is missing from the vent of the water heater. Recommend adding drain line to help prevent condensation from draining back in to unit.

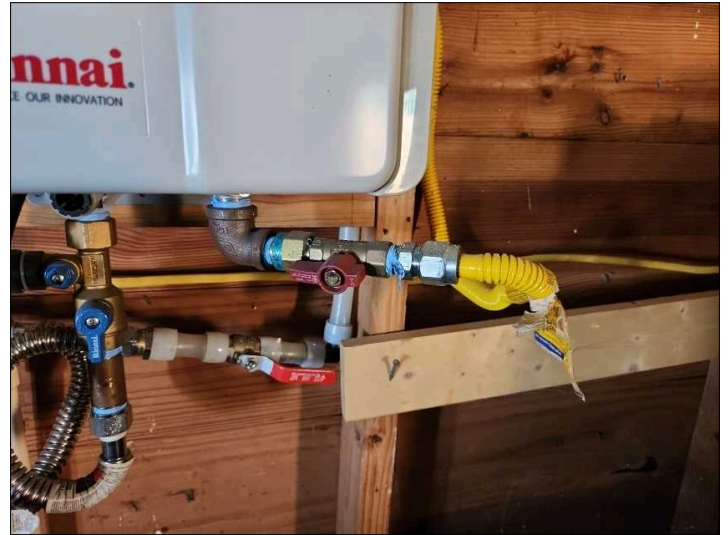
- No drip leg or sediment trap for gas line on water heater. This helps prevent trash from clogging jets.

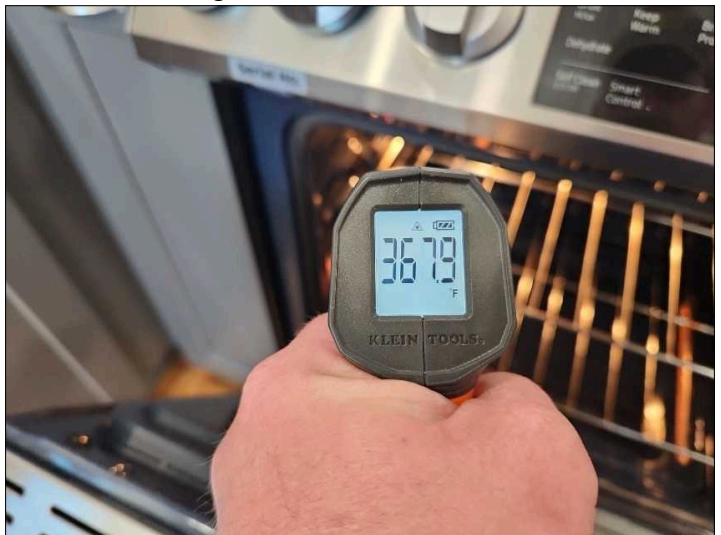
D.2. -Oven Thermostat to Temperature Reading: 350F / 365-370F

-Oven Thermostat to Temperature Reading: 350F / 365-370F

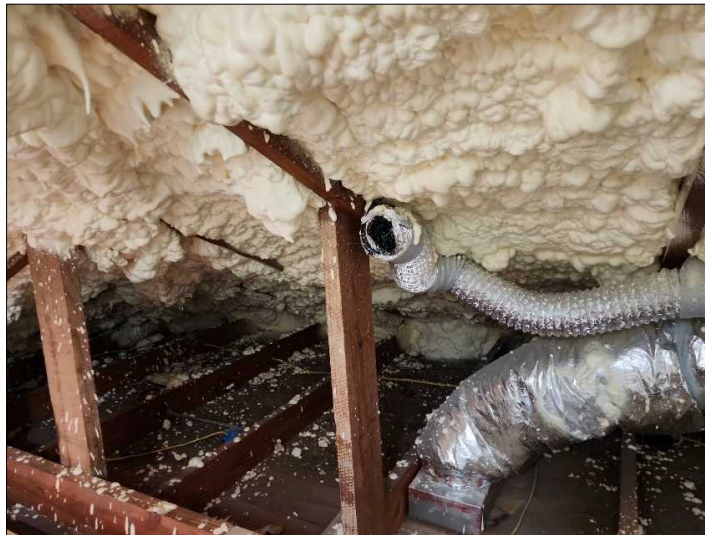
F.1. -Bath or laundry exhaust vents terminate in attic, recommend all exhaust vents terminate to the exterior.

- Bath or laundry exhaust vents terminate in attic, recommend all exhaust vents terminate to the exterior.
