FOUNDATION INSPECTION

3806 Knollcrest Dr
Montgomery, TX 77356

JUNE 4, 2022

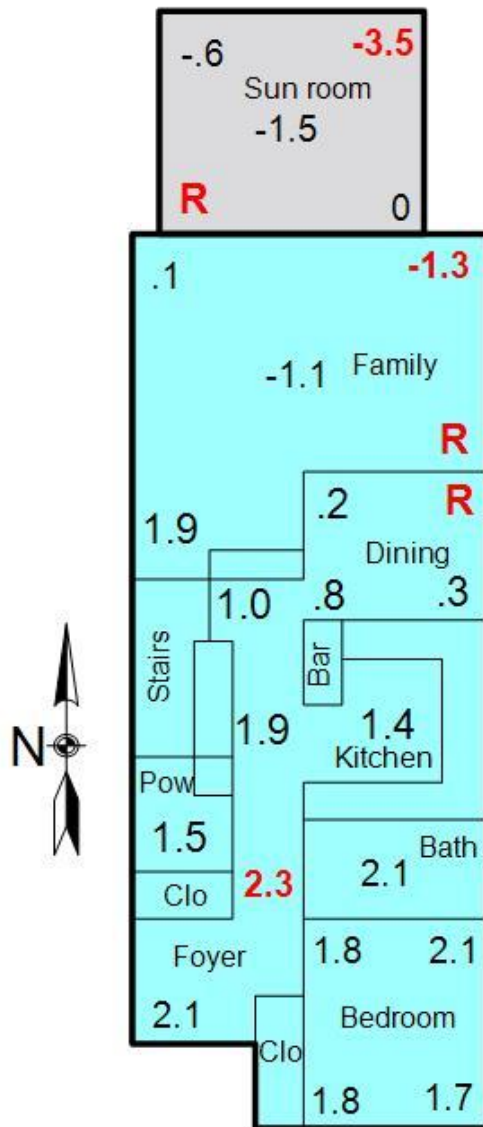
Elevation Readings 3806 Knollcrest Drive

The floors were checked with an electronic level, and were observed to be sloping towards the rear of the house. The difference in elevation between the high point and low point was 3.6 inches. The high point was located at the hallway near the foyer, and the low point was located at the rear of the family room. The unlevelness takes place over a horizontal distance of approximately 40-50 feet.

The sun room was sloping 3.5 inches in approximately 15 feet. It is pointed out that the sun room is a separate foundation that appeared to be added at some point.

Due to the more than acceptable amount of movement of the foundation of this structure, it is our opinion that releveling of the foundation is needed at the house and the sunroom. It is recommended that at least three foundation repair contractors be contacted in order that they may make their own assessment of the scope and cost of the work needed to bring this foundation back to an acceptable degree of levelness.

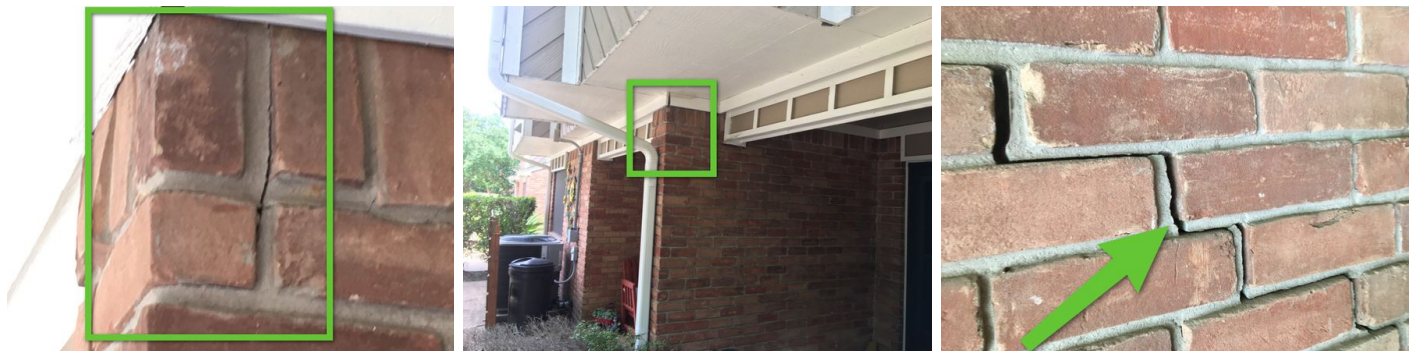
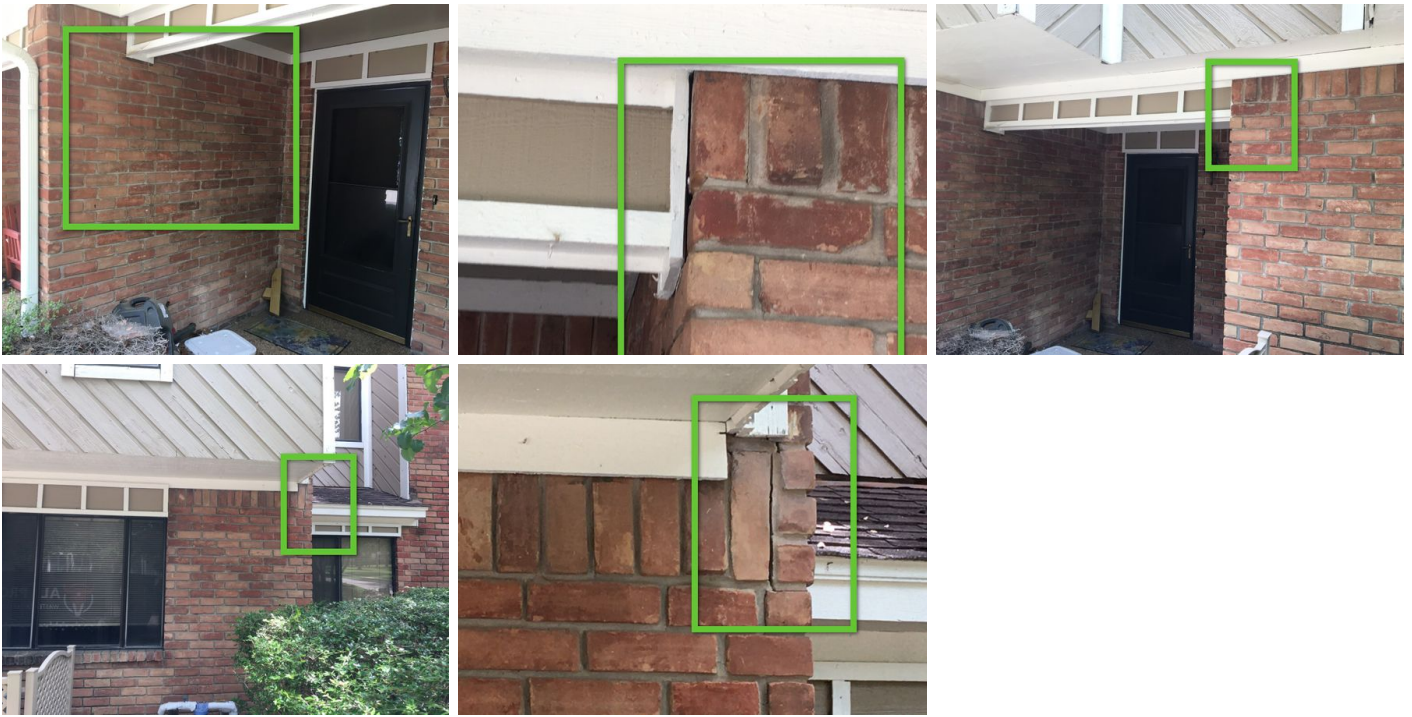
Differential Movement: Veneer - Cracks/Patches

Cracks and/or patches were observed in the exterior veneer at the time of the inspection, including at the locations shown in the photos.

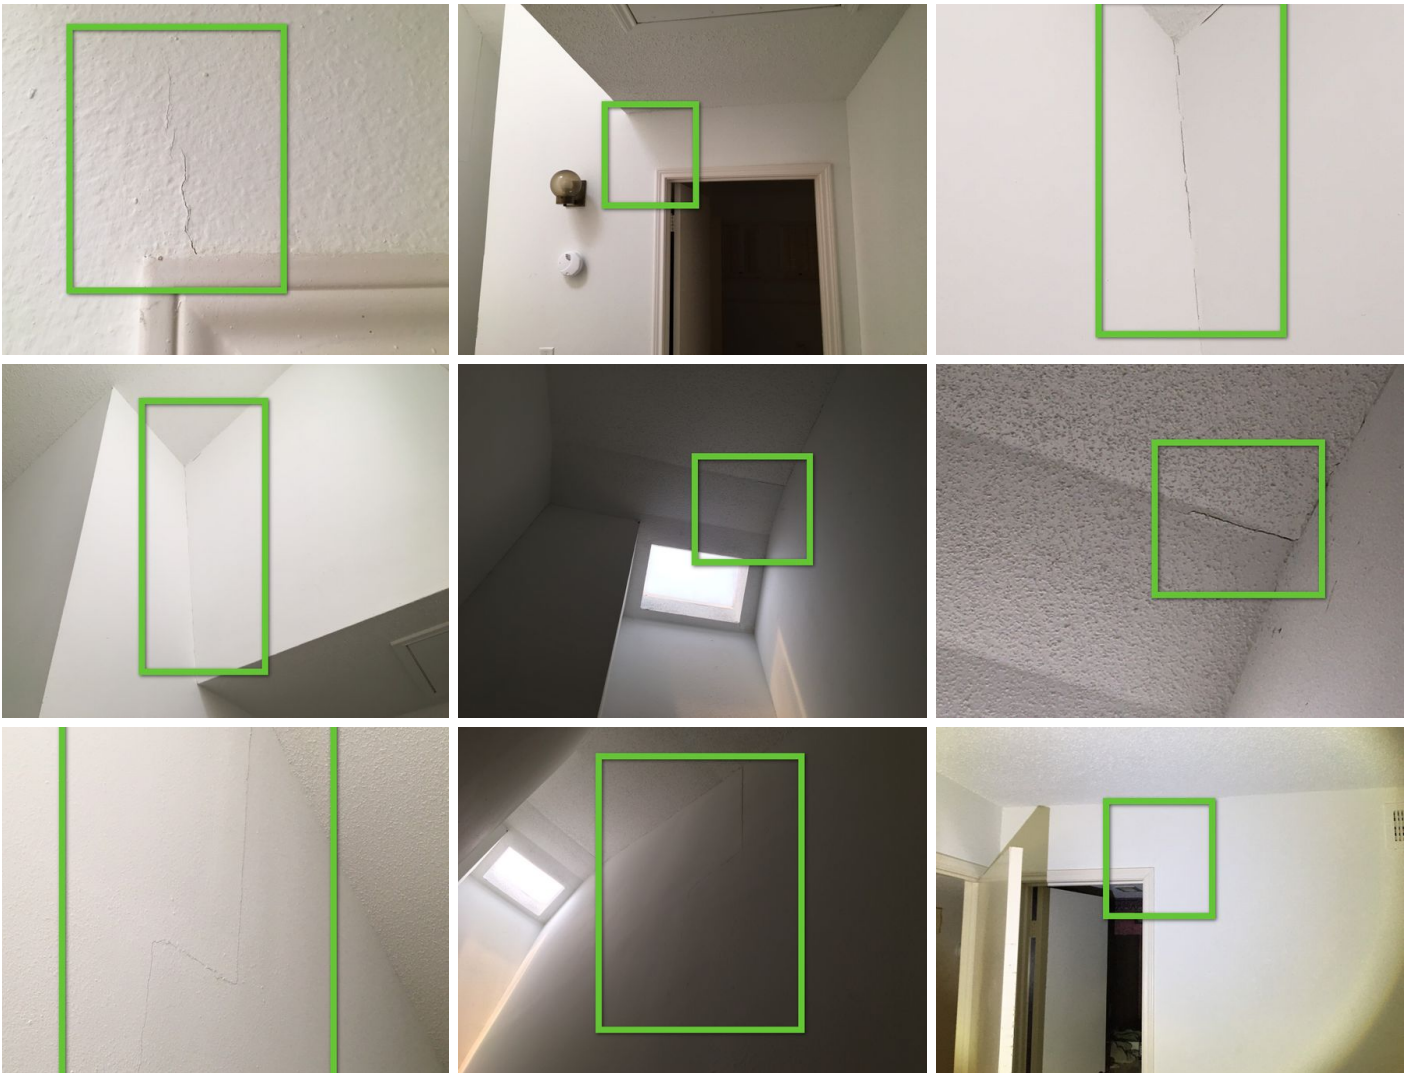
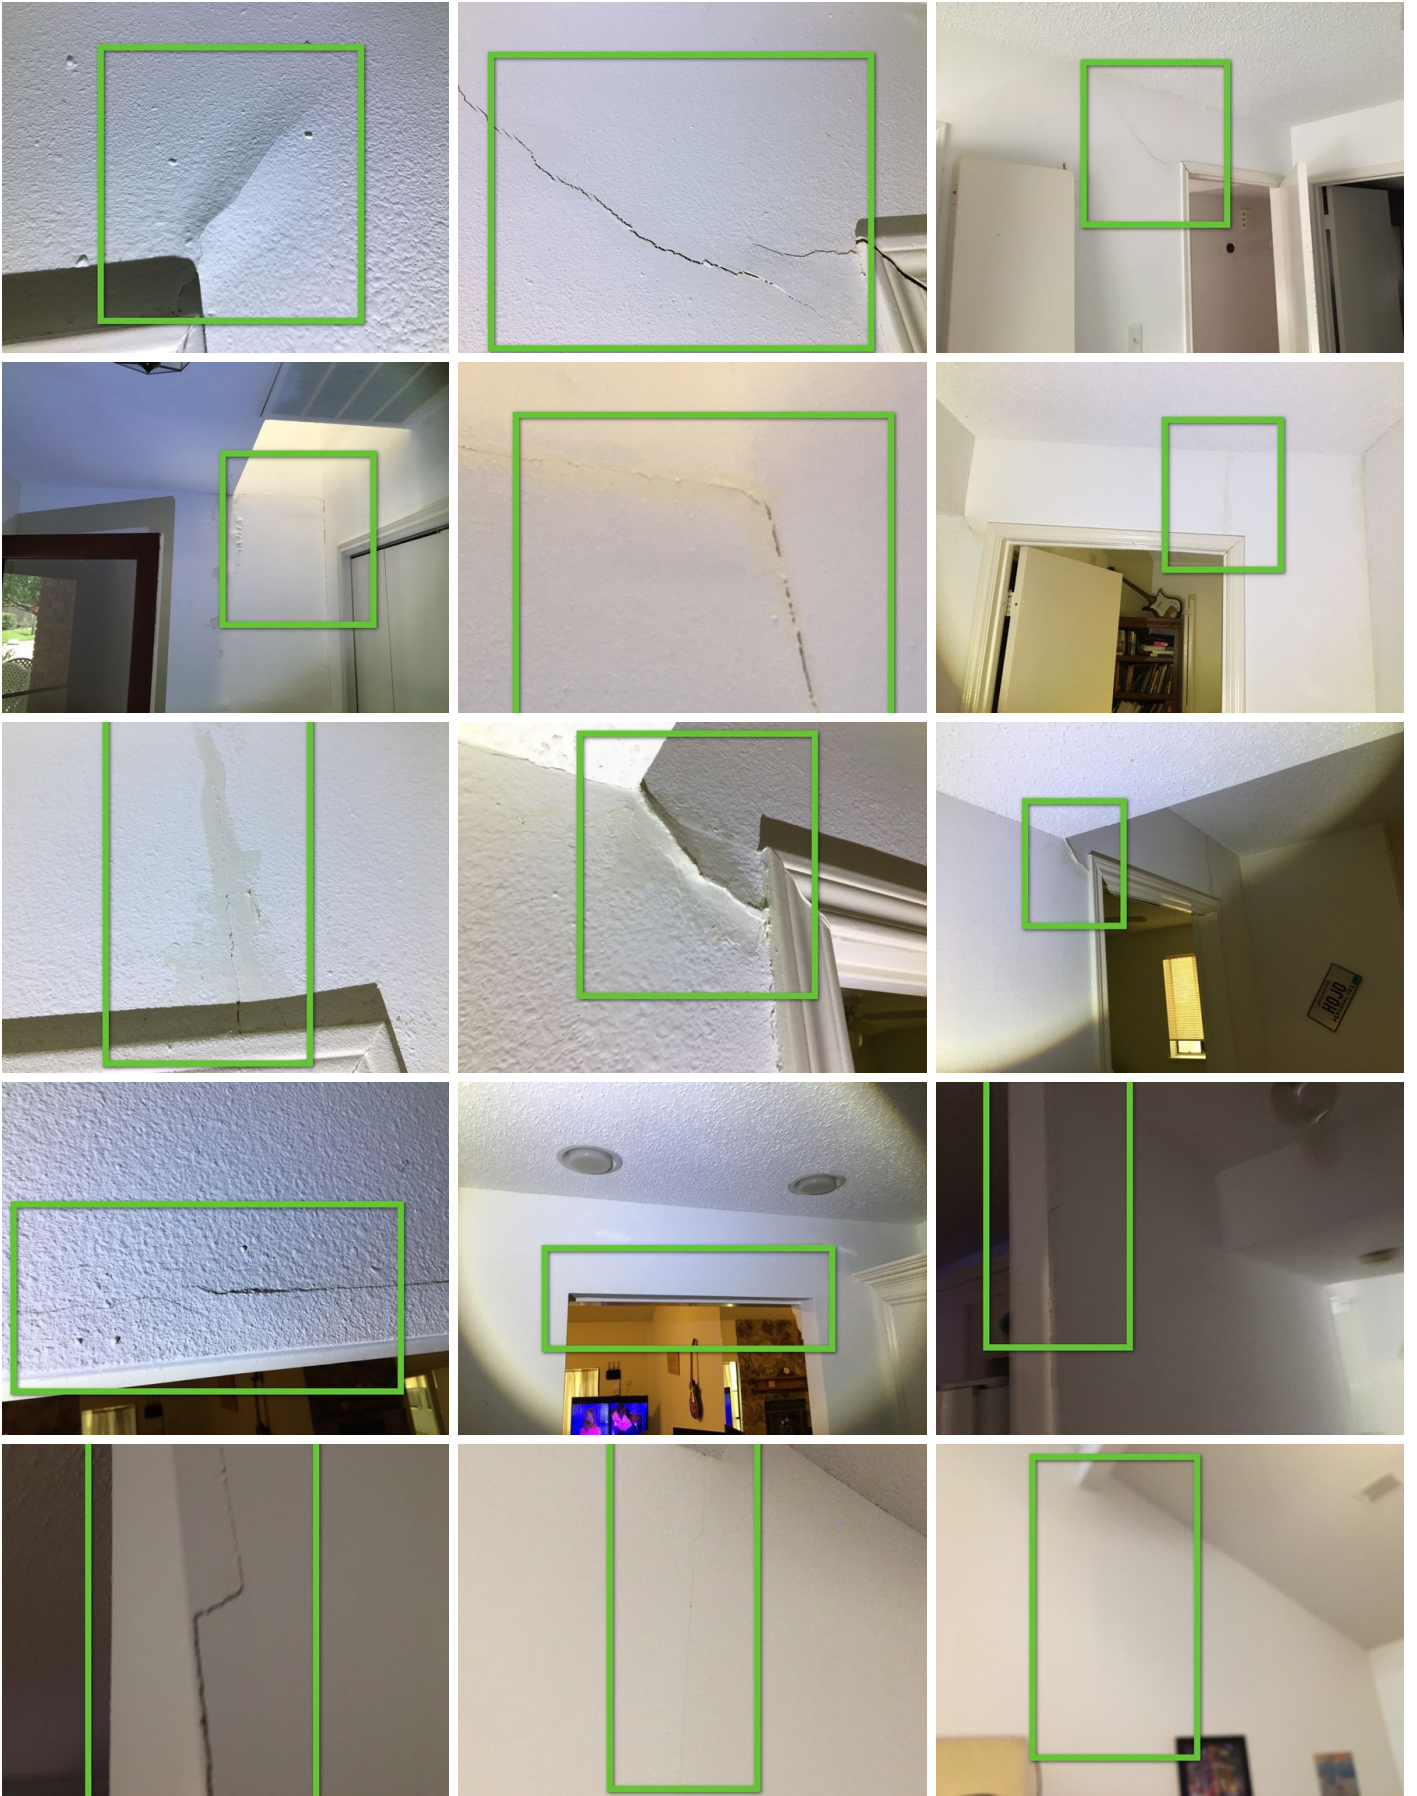
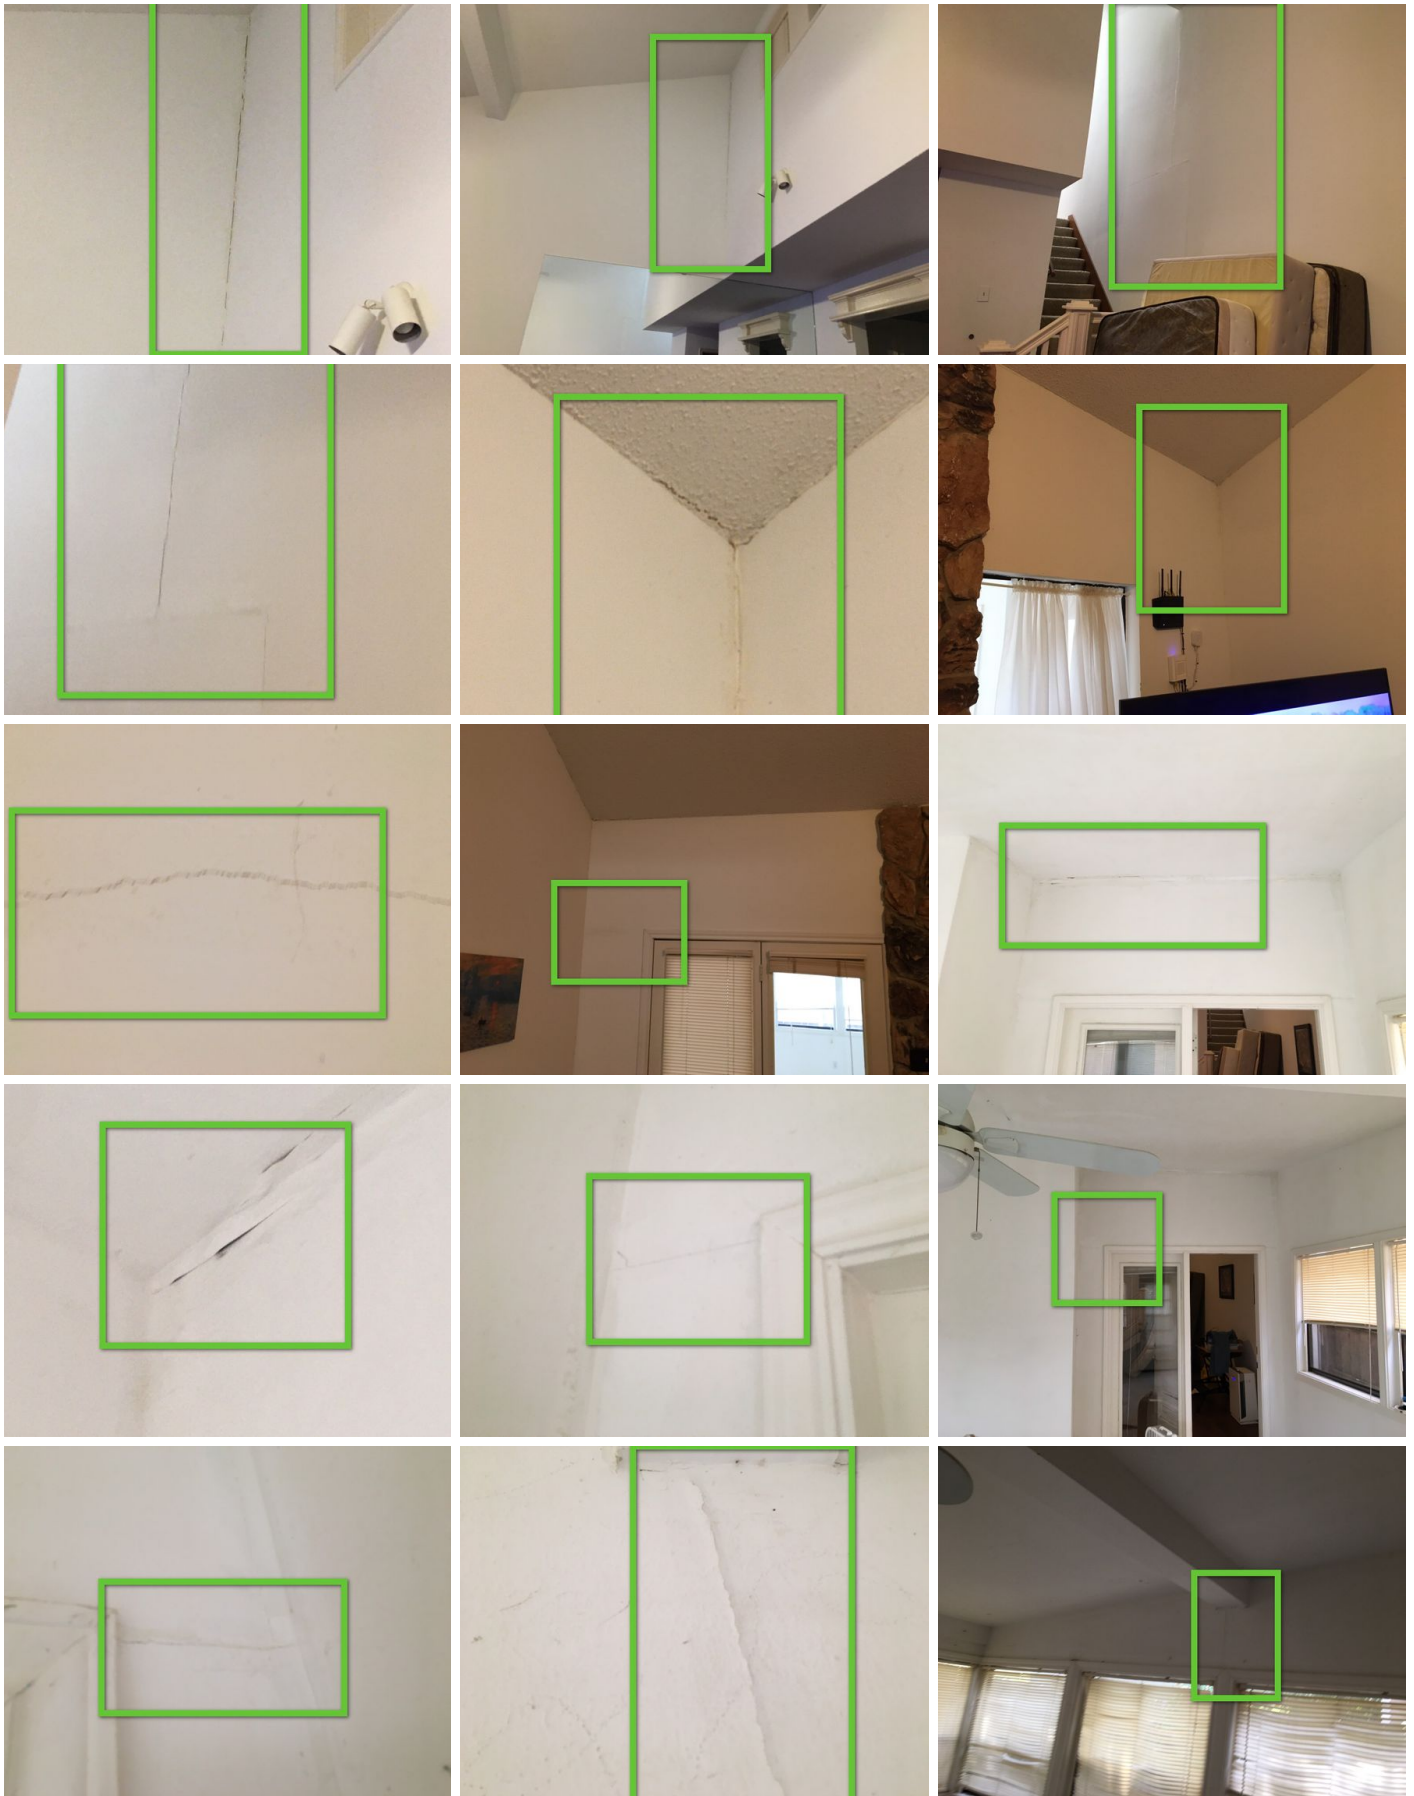
Differential Movement: Sheetrock Cracks/Patches/Compression ridges

Family room, first floor hallway, kitchen, foyer, front bedroom, second floor front bedroom, and the second floor hallway
Sheetrock cracks, patches, and/or compression ridges were observed in the house during the inspection, including at the above locations.

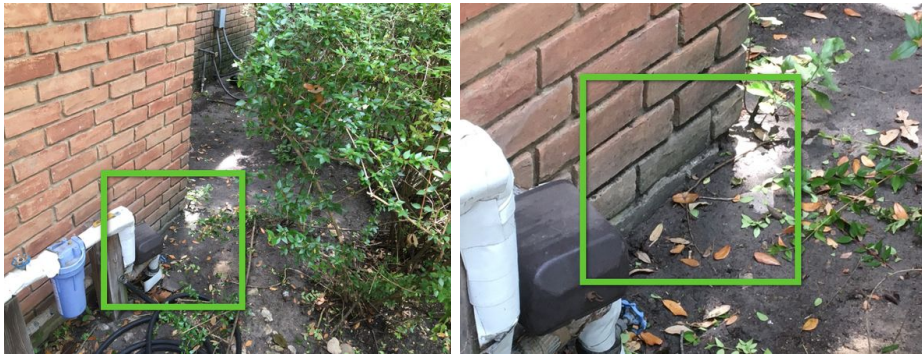
Differential Movement: Slab Not visible - High Soil

It is pointed out that a portion of the foundation concrete could not be viewed due to soil that was graded near or above the top of the foundation and/or heavy foliage growing against the house. The soil and/or foliage should be removed, and 3-4 inches of foundation concrete exposed.

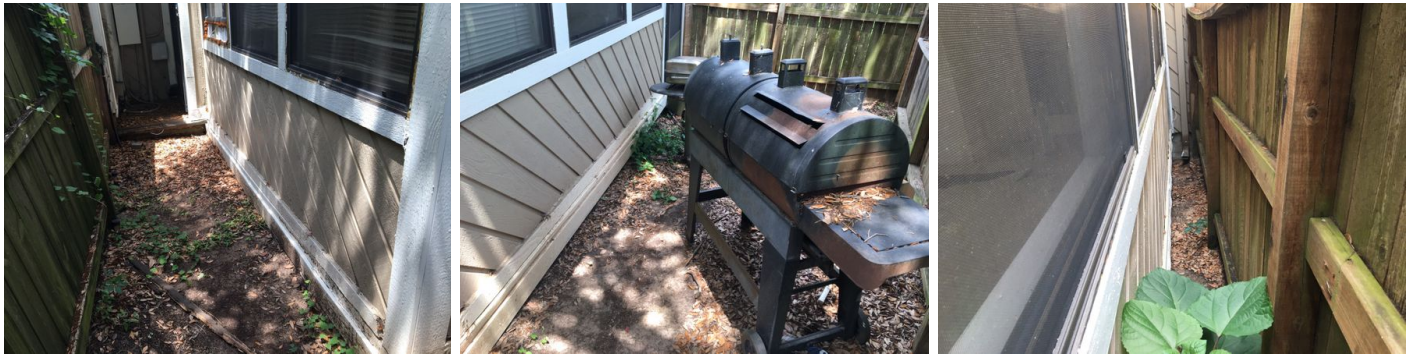
Differential Movement: Slab not Visible - Patio

It is pointed out that a portion of the foundation concrete could not be viewed due to the sun room that adjoined the foundation.

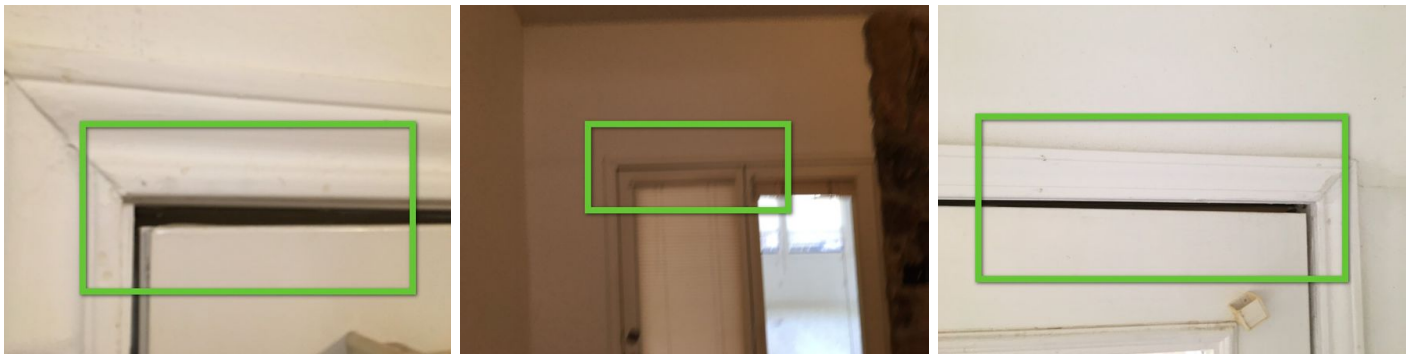
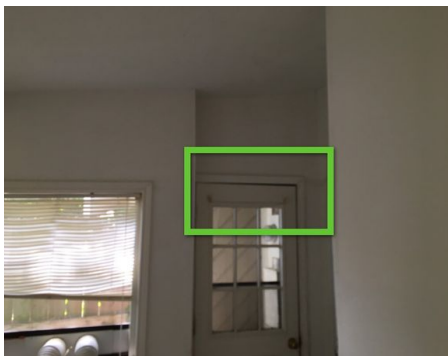
Separation of Materials: Door triangles at top

Family back door, sunroom east patio door, second floor south bedroom, on the second floor south bathroom.

Door frames that were out of square, leaving a triangular separation between the door and the door frame at the top of the door were observed.

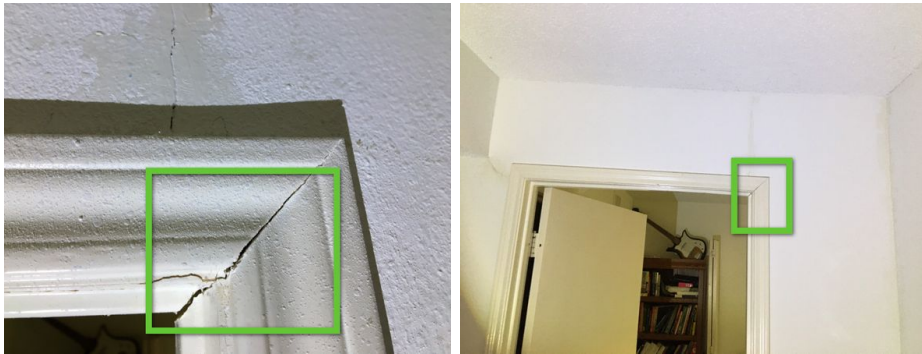
Separation of Materials: Door trim separation

We observed door trim that had separations at the trim joints at some locations.

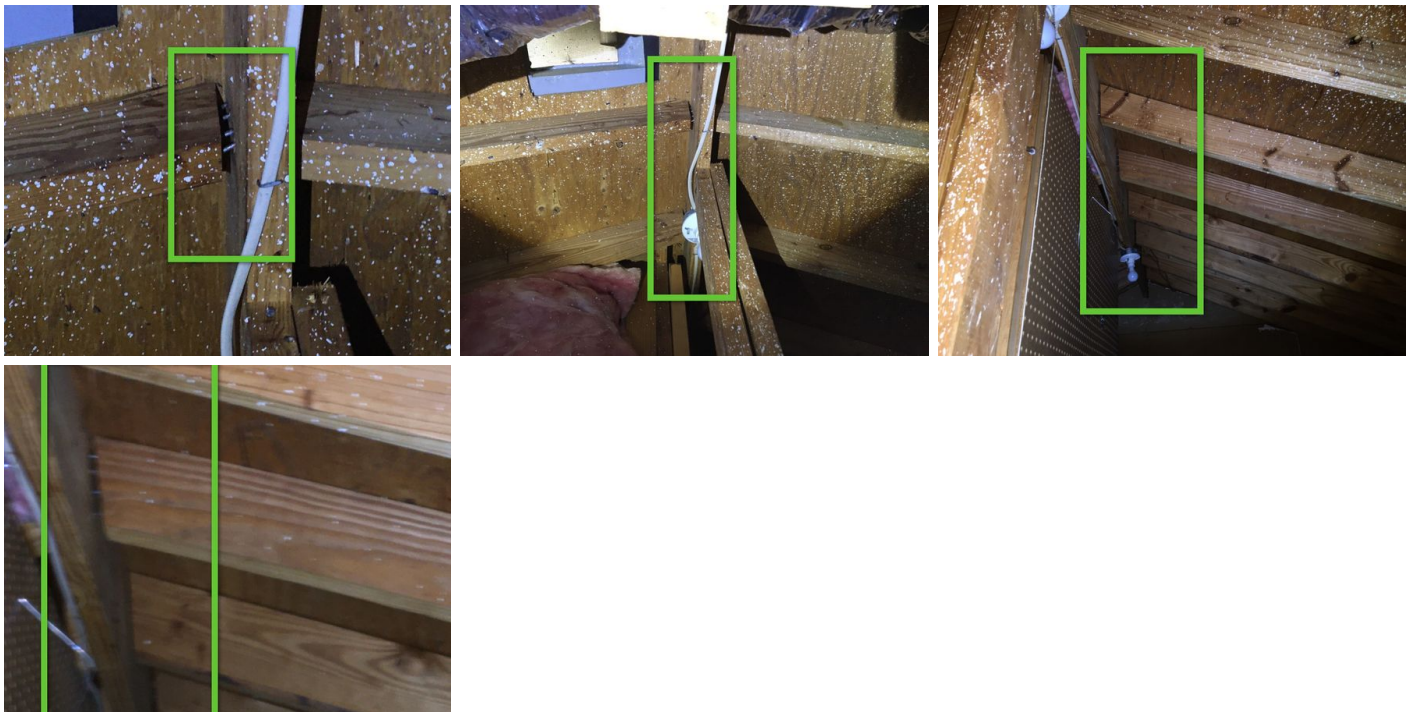
Separation of Materials: Rafter separation

Several rafters were observed to be separated from the ridge beam in the attic, which can be an evidence of movement.

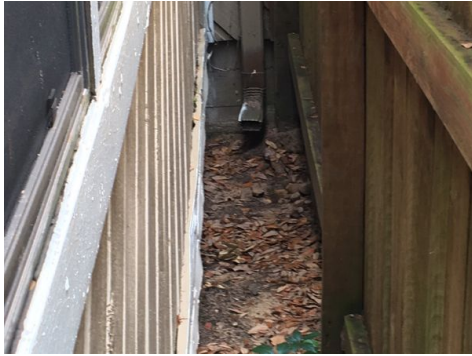
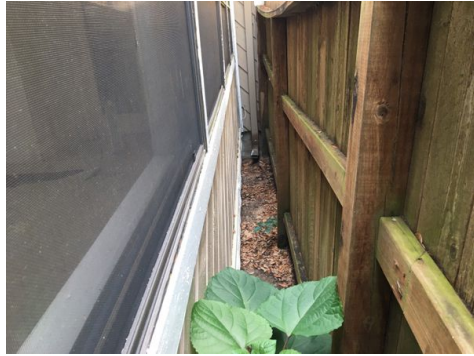
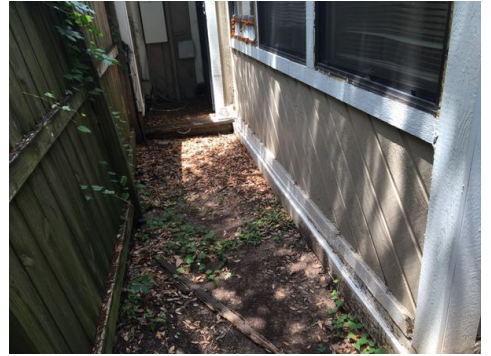
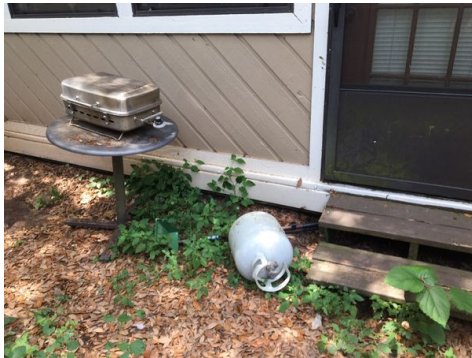
GRADING POOR

REAR PATIO AND UNDER THE CRAWLSPACE AREA AT THE SUN ROOM.

The perimeter drainage was observed to be poor at some areas where the lot is not sloped away from the house (6 inch drop in the first 10 feet) and water will pond. Poor drainage conditions near the foundation can contribute to foundation movement. It is recommended that a company specializing in drainage solutions be contacted to provide a recommended solution, along with a cost estimate to provide proper drainage.

Contact a qualified landscaping contractor
