Property Inspection Report

3616 1/2 Avenue M, Galveston, TX 77550
Inspection prepared for: Victor Orellana
Date of Inspection: 4/28/2023 Time: 9:00 AM
Age of Home: 1975 Size: 1544
Weather: Sunny 78 Degrees
Property Vacant

Inspector: Travis Morrow
TREC 22042
P.O. Box 6816, Katy, TX 77491
Phone: 2817796431
Email: travis@morrowinspections.com
www.morrowinspections.com

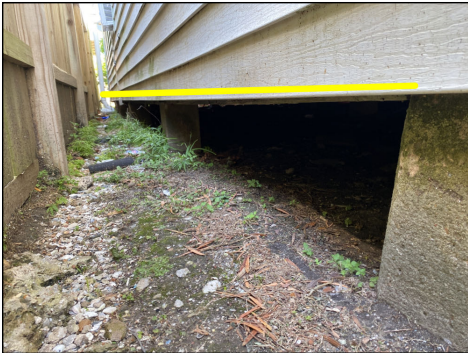
Open crawl space left side of home.

A.2. Access to the crawlspace should be improved to prevent vermin activity. Recommend installing screen mesh to help prevent pest intrusion into crawlspace. (left/rear of home)

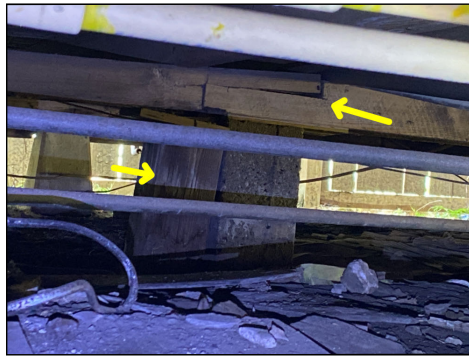
A.8. Pier(s) observed to be deteriorated/damaged at the time of inspection. Recommend consulting a qualified contractor for repair.

Leaning piers/damaged beams.

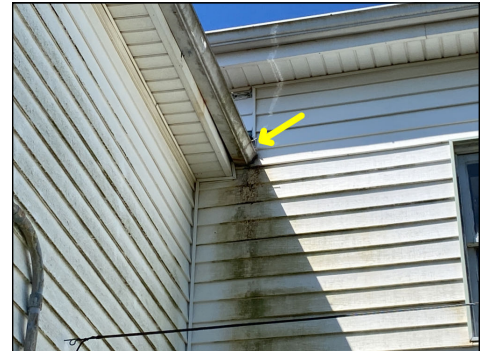
B.6. Damaged or loose gutters and/or downspouts were observed. Recommend repairing.

Loose gutter/spill out evidence rear of home.

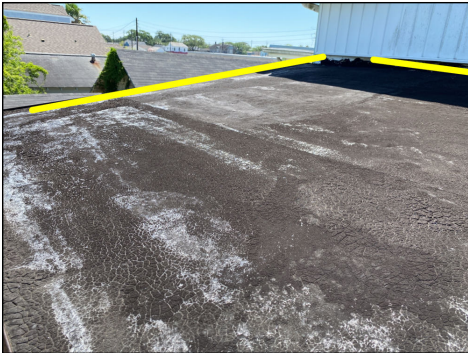
C.4. Roof appears to be at the end of its serviceable life, and replacement may be the only long term solution. This opinion is based upon the following conditions observed at the time of inspection. A qualified roofer should be engaged.

-low sloped rolled roofing/hot moped deterioration/exposed fiberglass backing/etc.

Roofing deterioration.

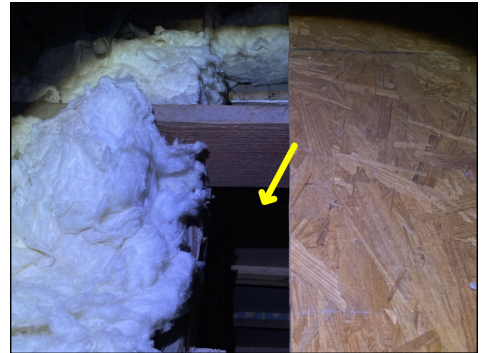
D.4. Current standards require fire blocking to be provided to cut off all concealed draft openings (both vertical and horizontal) and to form an effective fire barrier between stories and between a top story and the roof space. Typical areas where insufficient fire blocking is found exist where ductwork passes through the attic floor, garage breezeways, HVAC closets, garage ceiling penetrations, and around the chimney flue. Improvements to these and any other areas are recommended (i.e. seal w/ plywood, fire code drywall or sheet metal, etc.).

Missing fire blocking.

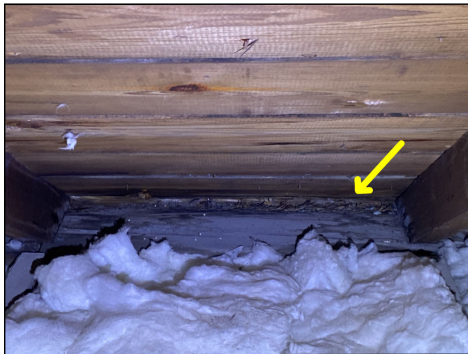
D.11. Rot/deterioration of roof deck, or framing member(s) observed (indication of current/previous moisture intrusion). Replacement of rotted/deteriorated area(s) is recommended, and a qualified contractor should be engaged.

Rot/deterioration of attic framing.

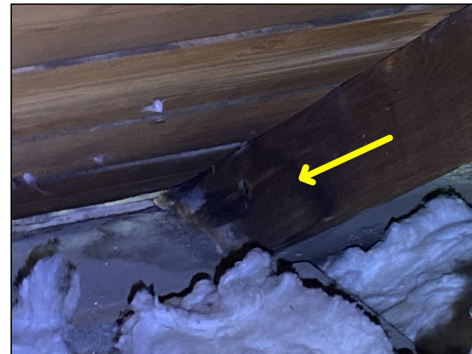
D.7. Staining was observed on the roof deck and/or framing members, indicating leakage has occurred. The cause should be determined and repairs undertaken as necessary.

D.9. Inspector observed what appears to be organic like growth. Recommend further evaluation and repair protocol prepared by a licensed and qualified hygienist.

Prior leakage/organic like growth.

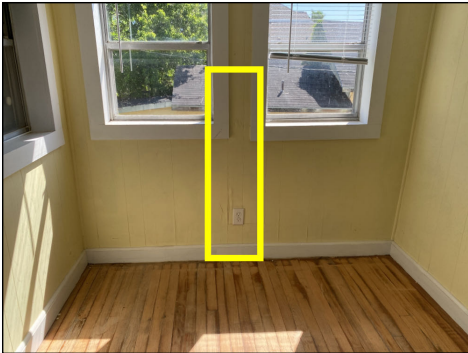
Prior leakage evidence laundry room.

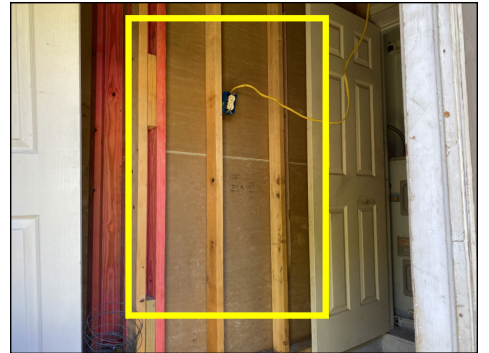
E.5. Missing vertical wall insulation should be replaced. (exterior closet)

Missing wall insulation exterior closet.

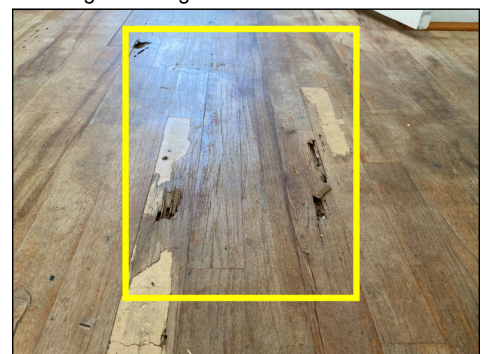
Flooring deterioration second floor living room.

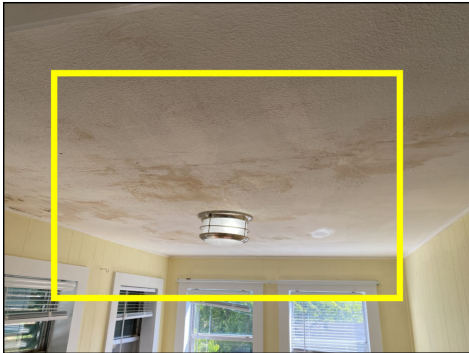
Organic like growth laundry room.

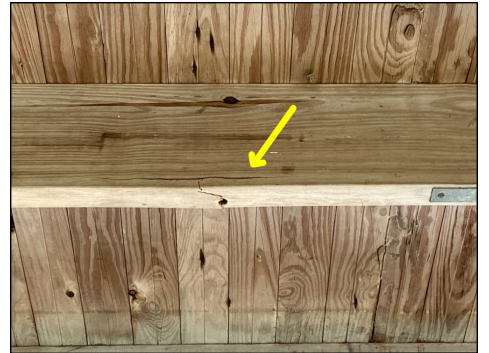
Damaged joist below laundry room.

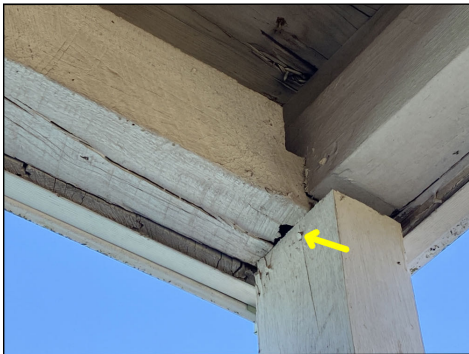
Rot/deterioration laundry room floor structure.

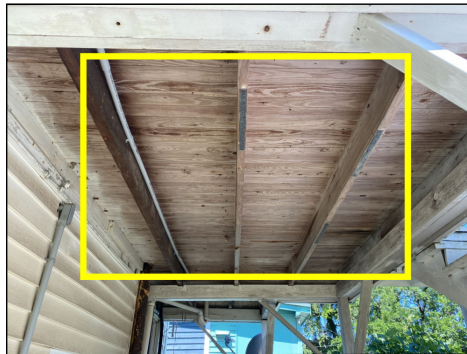
No floor insulation below laundry room.

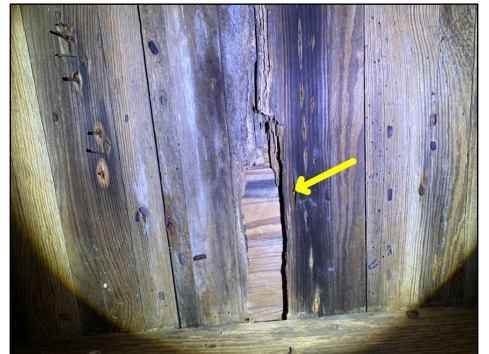
Rot/deterioration of subfloor first floor.

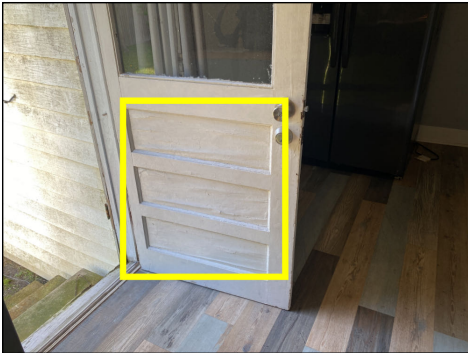
Deterioration first floor kitchen exterior door.

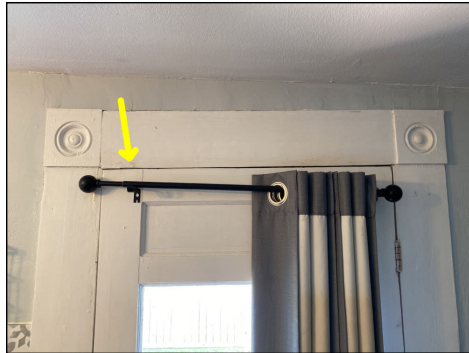
Door is not square within frame first floor exterior door.

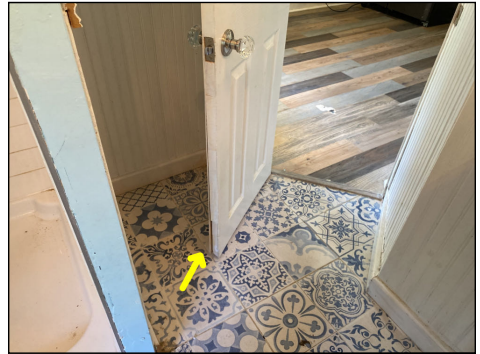
Damaged door first floor bathroom/kitchen.

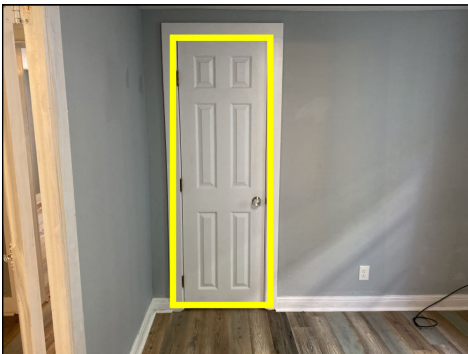
Door will not latch rear first floor bedroom closet.

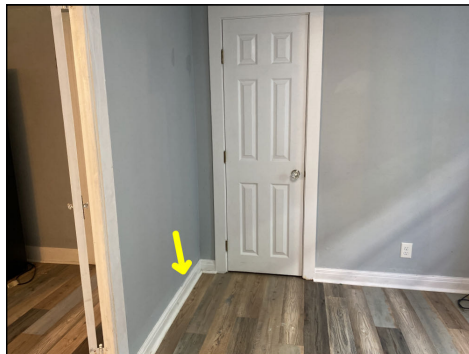
Missing doorstop example.

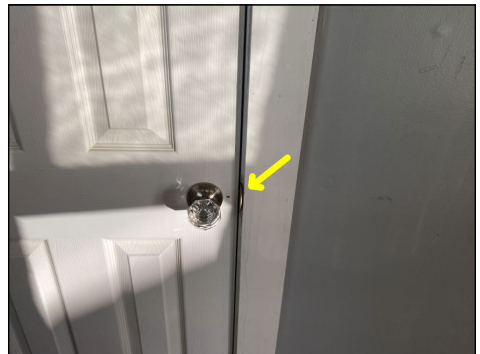
Damaged hardware first floor living room (latch will not turn).

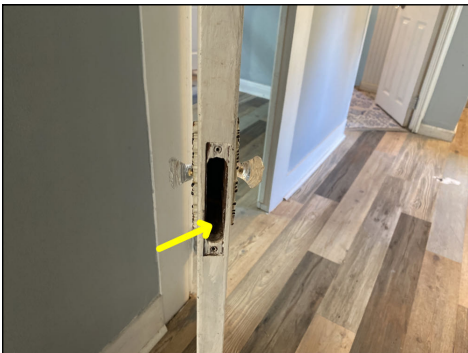
Missing hardware rear first floor bedroom door.

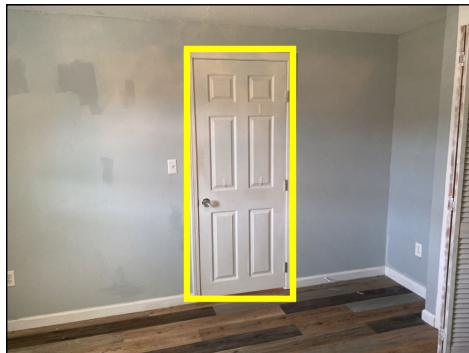
Door sticks front first floor bedroom.

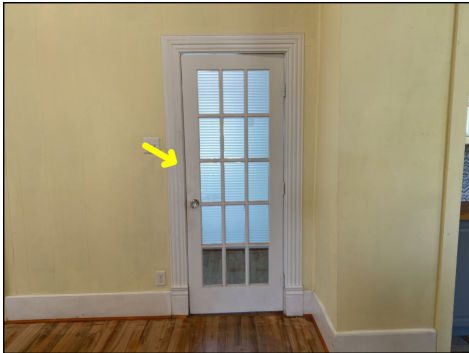
Door sticks second floor bathroom.

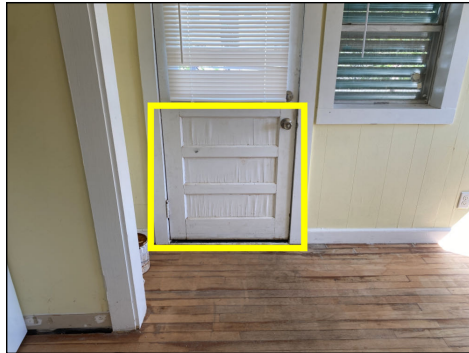
Deterioration, weatherstripping, door sticks laundry room exterior door.

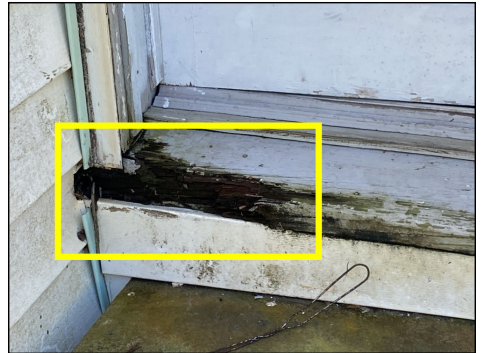
Rot/deterioration first floor kitchen exterior door.

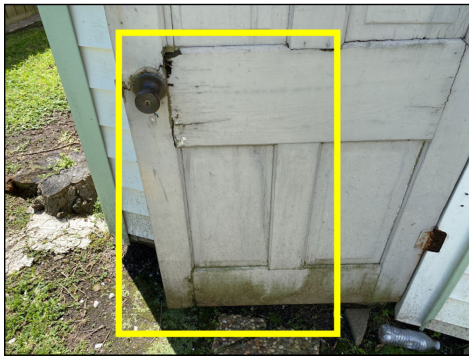
Rot/deterioration exterior closet door.

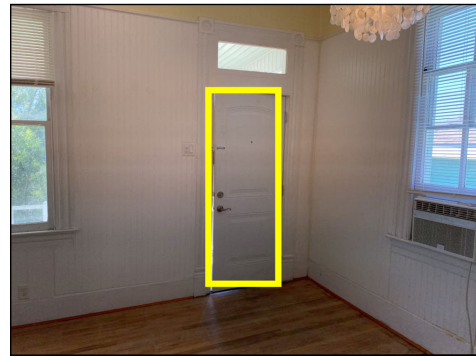
Door sticks second floor front.

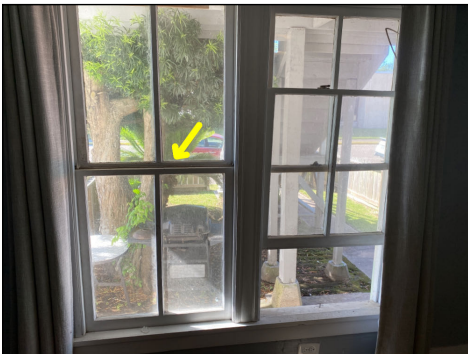
Missing window latch first floor bedroom.

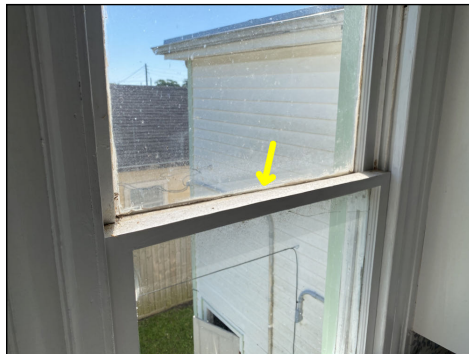
Missing window latch second floor kitchen.

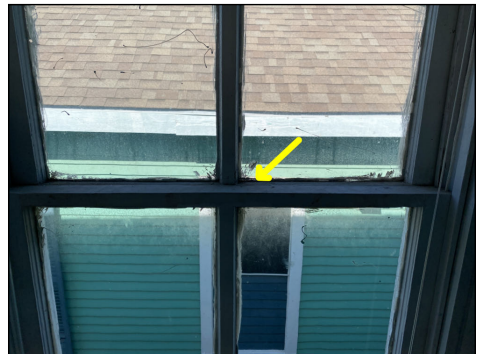
Missing window latches second floor bathroom.

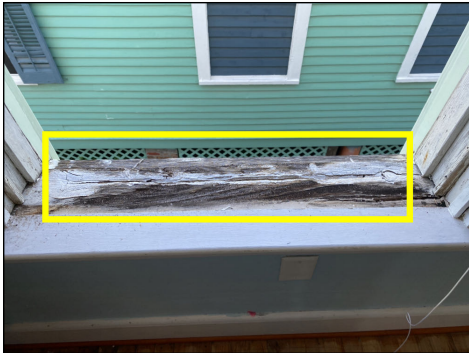
Rot/deterioration window trim second floor.

H.8. Rotted or deteriorated window trim should be repaired.

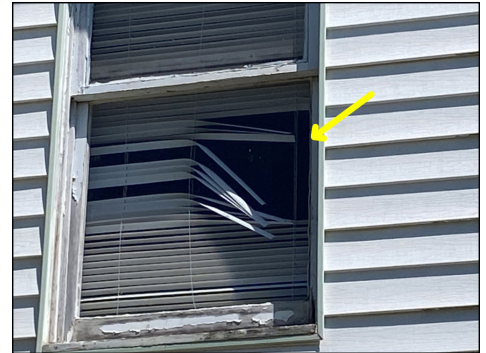
Damaged blinds example.

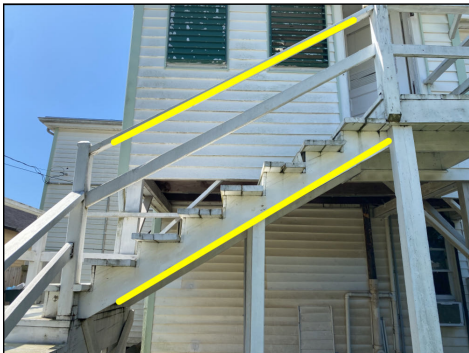
Stair baluster spacing.

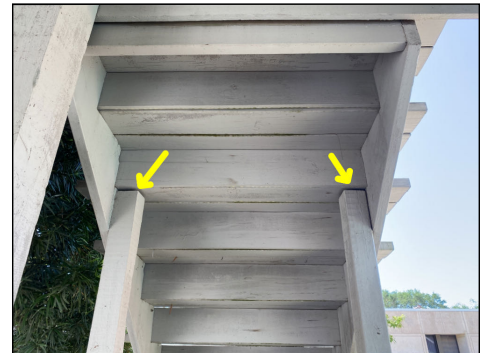
Front stairs not bearing on posts.

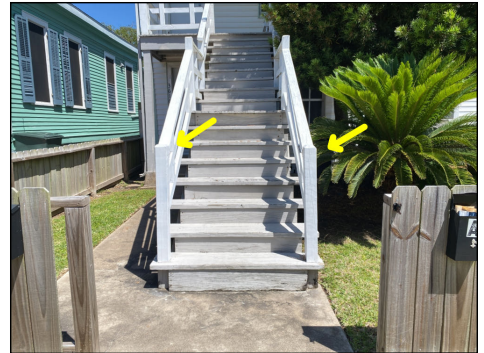
Loose railings front exterior stairs.

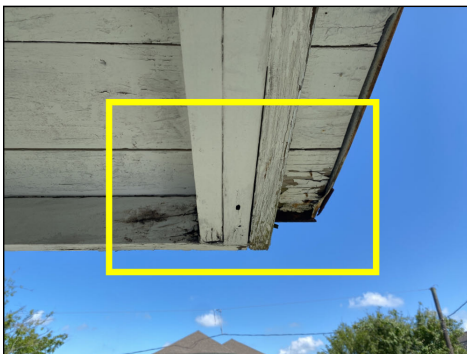
K.2. Rot/deterioration observed at patio/door overhangs. A qualified contractor should be engaged for further review/repair. (laundry room exterior, first floor kitchen exterior)

Rot/deterioration laundry room exterior patio overhang.

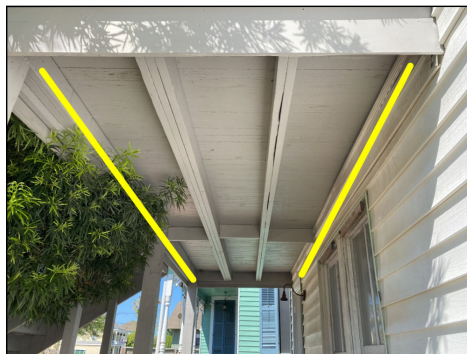
K.3. The deck/patio/porch framing did not appear to follow current construction standards. A qualified contractor should be engaged for further review/repair. (no joist hangers/structural strapping/bearing on nails/etc.)

No joist hangers/questionable framing front deck.

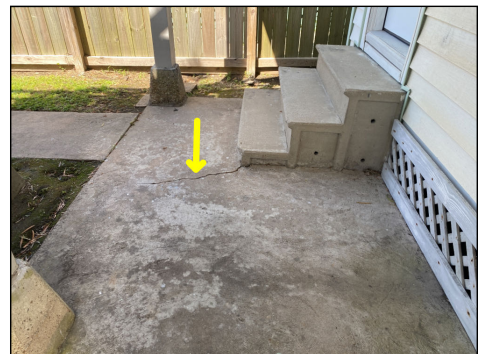
Entryway cracks.

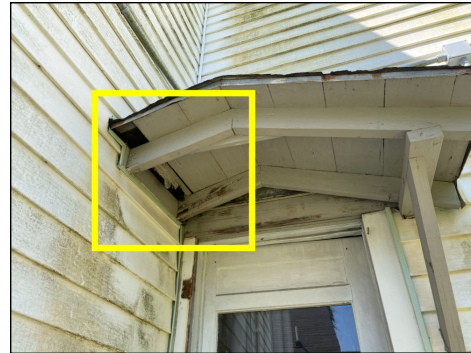
Rot/deterioration first floor kitchen exterior door patio cover.

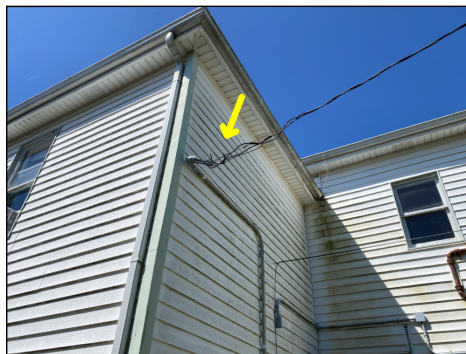
Improper drip loop/weather head.

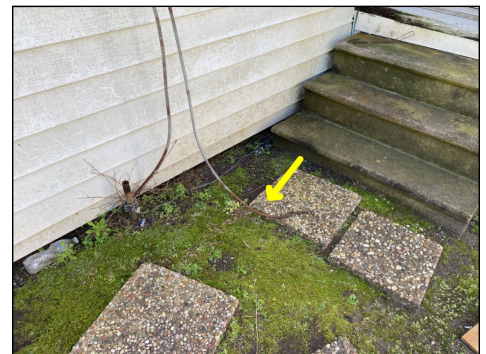
Ground wire not connected at rod.

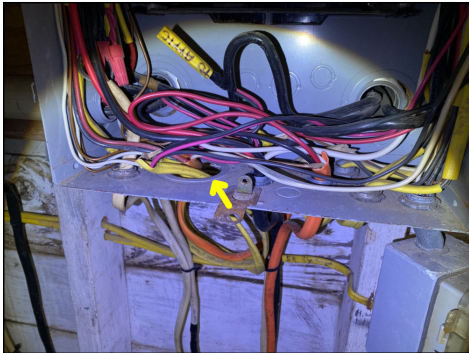
Missing grommet distribution panel

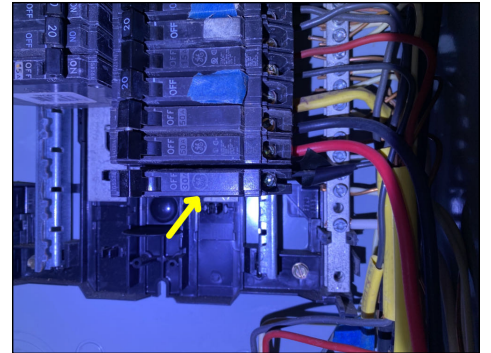
30-amp breaker 12-gauge wire distribution panel.

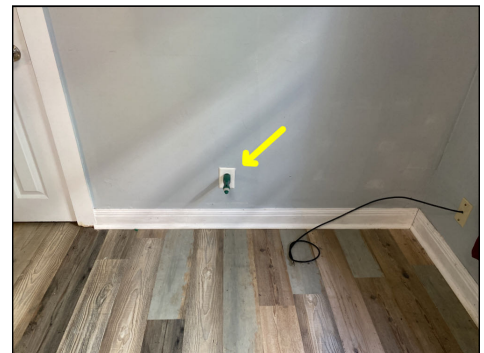
No power to outlet rear first floor bedroom.

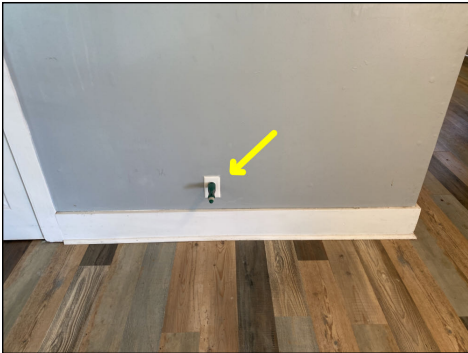
No power to outlet first floor living room.

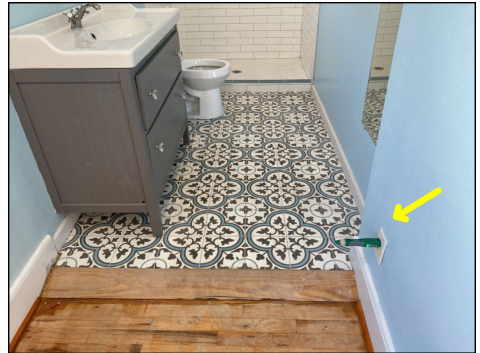
Missing gfci protection second floor bathroom.

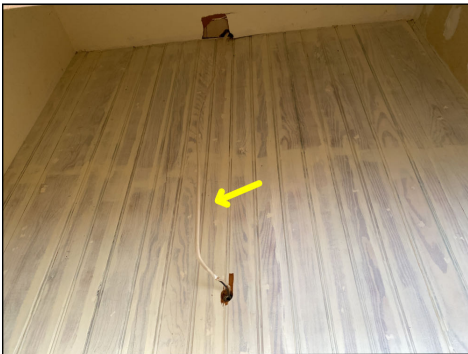
Wiring exposed on interior second floor living room closet.

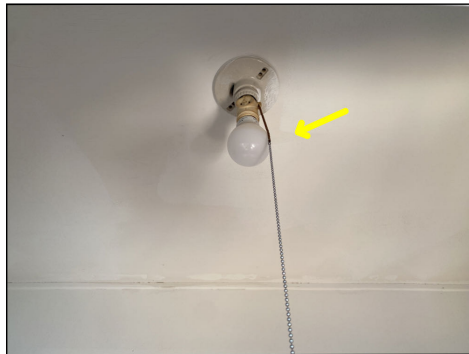
Missing protective light globe second floor bedroom closet.

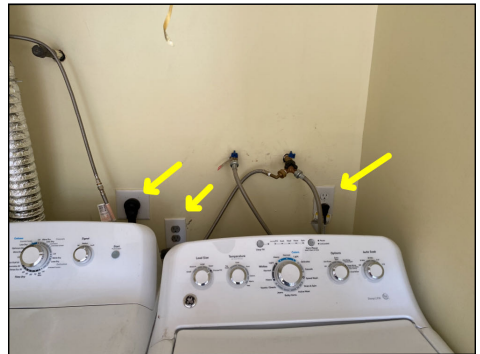
No gfci protection laundry room.

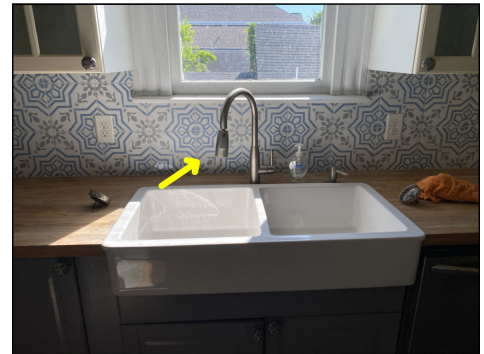
Faucet leak (slow drip) second floor kitchen sink.

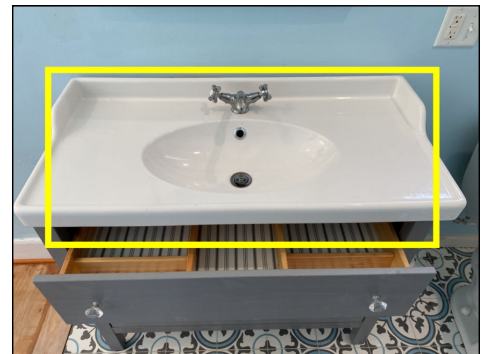
Sink/vanity not secured second floor bathroom.

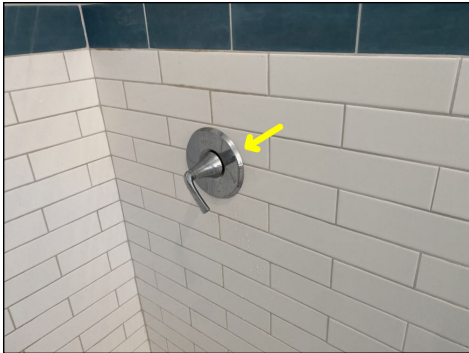
Hot/cold reversed second floor bathroom shower stall.

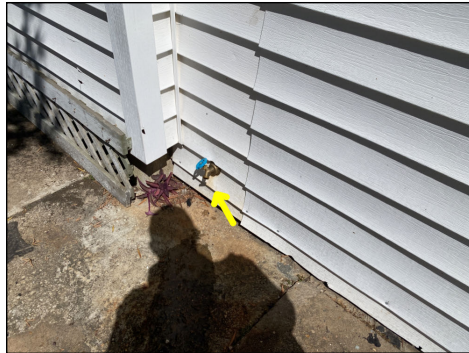
Missing anti backflow devices exterior hose bibs.

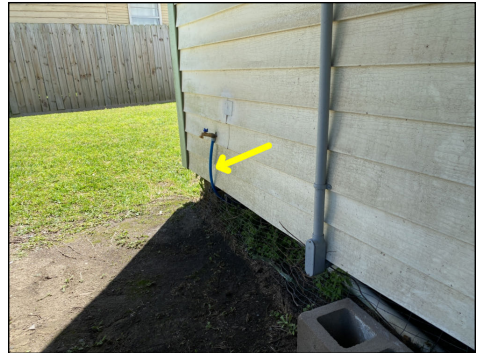
Exterior PEX piping not protected from freeze/UV deterioration.

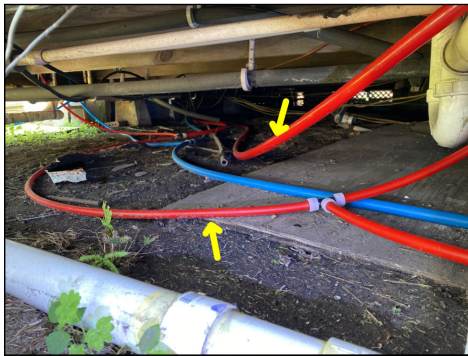
PEX piping not secured as required.

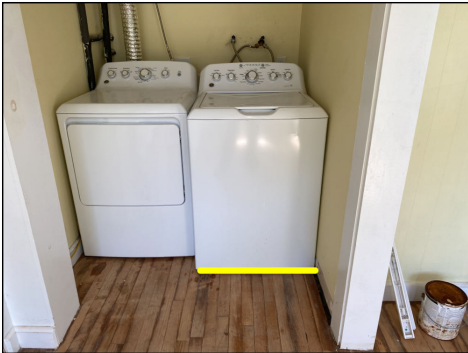
No laundry drain pan.

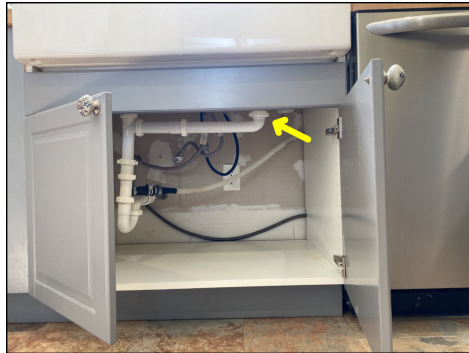
Drain leaks second floor kitchen sink.

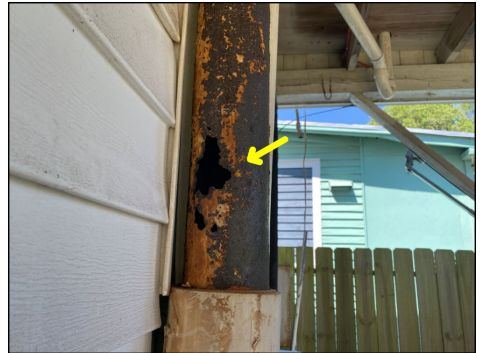
Corrosion/deterioration of drain piping rear of home.

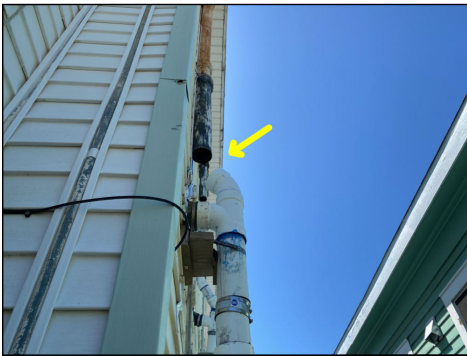
Drain piping voids rear of home.

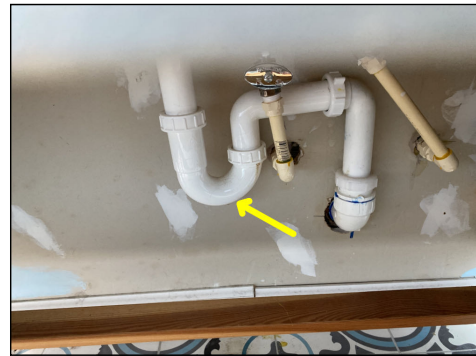
Drain leak second floor bathroom sink.

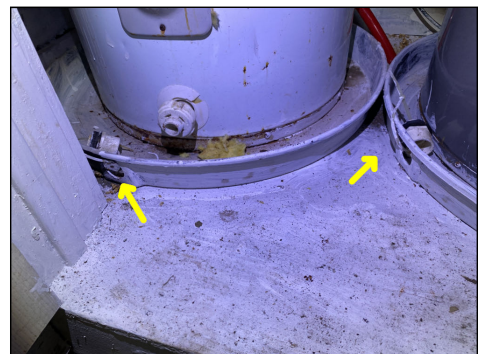
No drain pan drain lines.

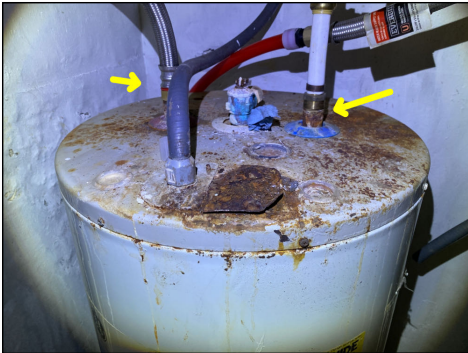
Corrosion/deterioration GE unit/fitting corrosion/leakage.

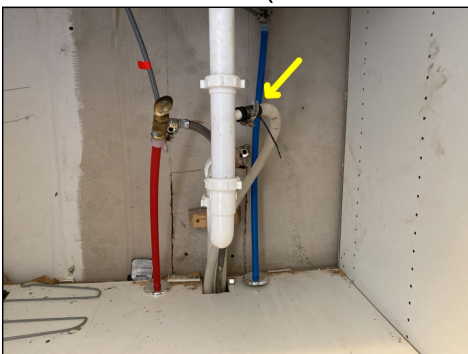
A.1. No air gap is present/observable. Recommend raising drain line above bottom of kitchen sink or install counter mount air gap device to help prevent back flow contamination. (first floor kitchen)

Missing drain air gap/high loop first floor kitchen.

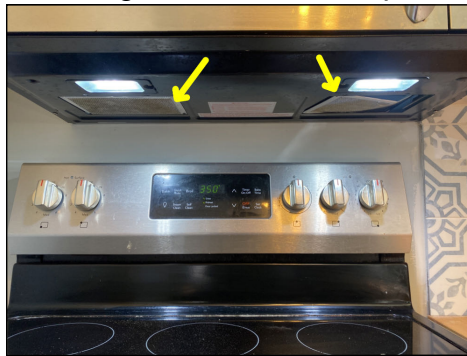
C.1. Unit/filters are dirty and requires cleaning.

Dirty filters first floor kitchen unit.

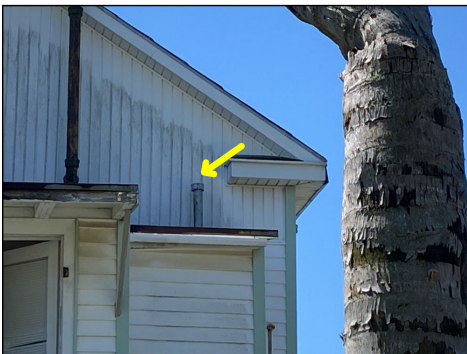
H.1. Roof mounted dryer vent terminations should terminate into dryer specific roof terminations that have backdraft prevention devices. Recommend consulting a qualified contractor for repair.

Dryer vent termination.
