Inspection Report

LOCATED AT:
21434 W Park Tree Lane E
Katy, TX 77450

INSPECTED ON:
Monday, April 17, 2023

Inspector
Justin Vincent #24206
A Plus Inspections Of Texas

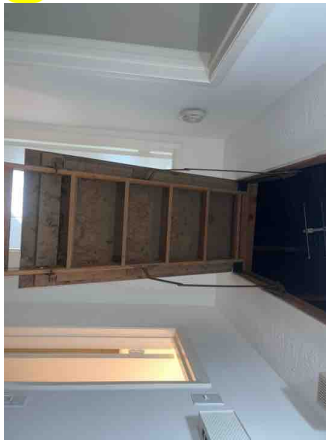
REP The attic stairway did not have insulation or weather stripping, which could be installed.

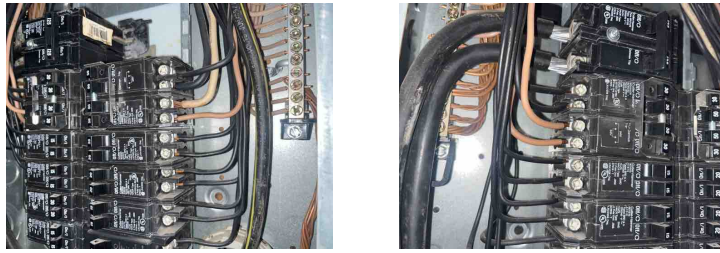
SAFT White wires were connected to some of the breakers and disconnects. They should be marked at both ends with red or black electrical tape, to indicate they are carrying a positive current.

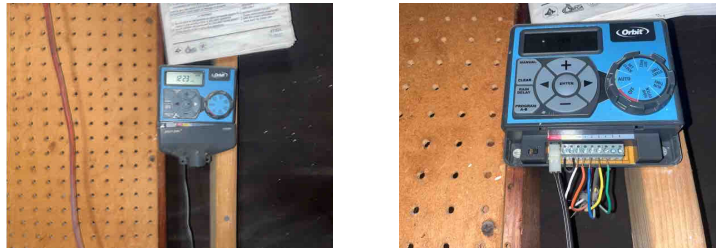
View of the sprinkler system controller

REP The sprinkler system did not have a diagram present and sprinkler system controller did not have markings indicating what each zone was used for. These should be present.
