SUMMARY
 96 Bayou Vista Dr, Hitchcock, TX
 77563
 Mike Holland
 March 22, 2022

Home Insp.

Arthur Guzman
 Certified Professional Inspector
 TREC#23407
 Fort Bend Inspections
 832-250-0135
 info@fortbendinspections.com

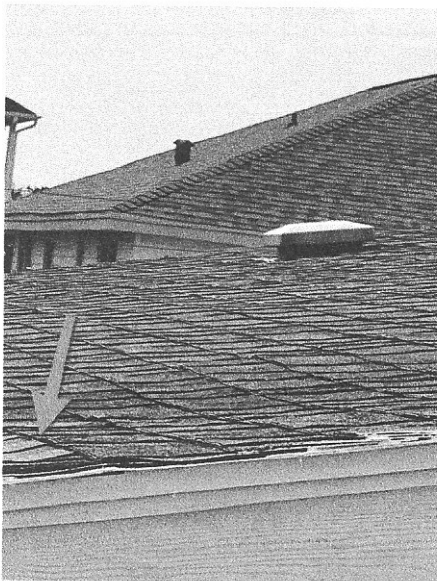
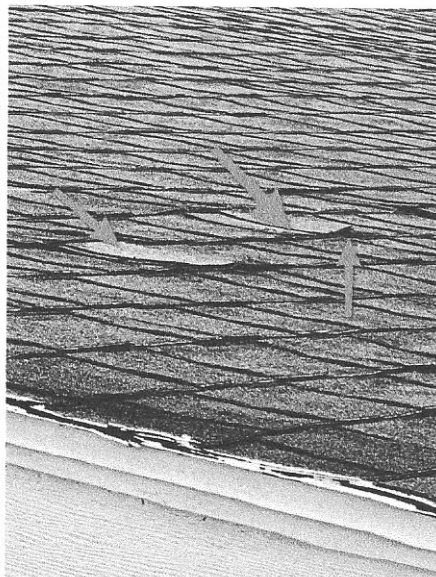
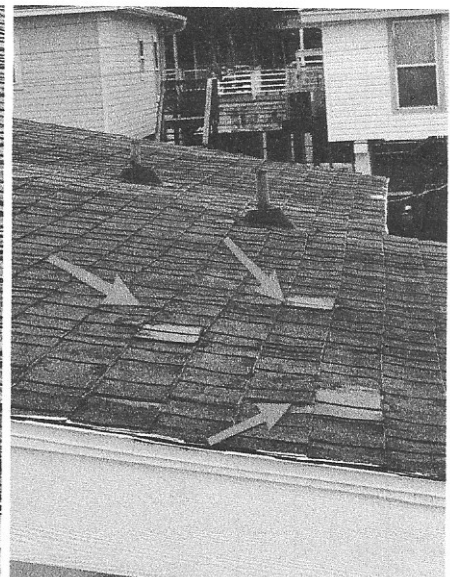
2.3.2 C. Roof Covering Materials

ROOF AT END OF ITS LIFE

Roof shingles appear to be near end of life.

Your roof is at least 20 years old; while many shingles today are produced for durability, many factors can accelerate the aging of shingles.

Contact a qualified professional.

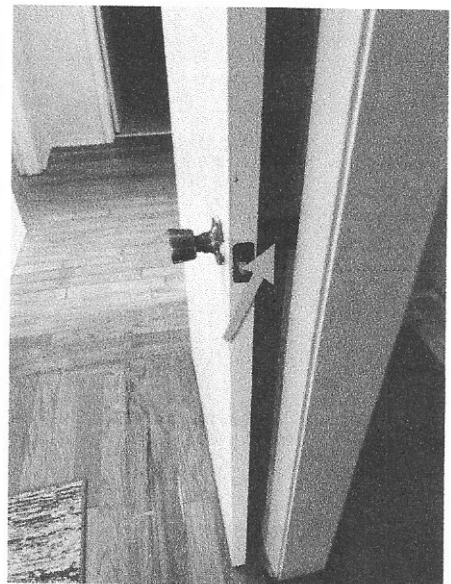
2.7.1 G. Doors (Interior and Exterior)

MISSING DOOR STOPS

Observe missing doorstops in one or more areas around home

In the pink room

Contact a qualified professional.

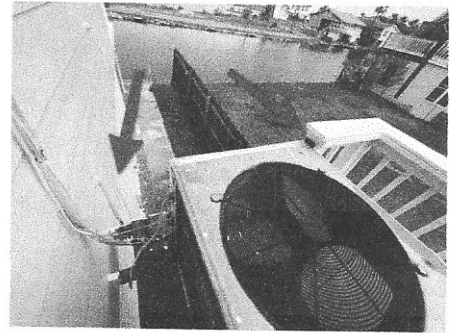
2.11.1 K. Porches, Balconies, Decks, and Carports

NO RAIL GUARD

recommend adding A handrail to prevent someone from falling over while working on the AC unit

Contact a qualified professional.

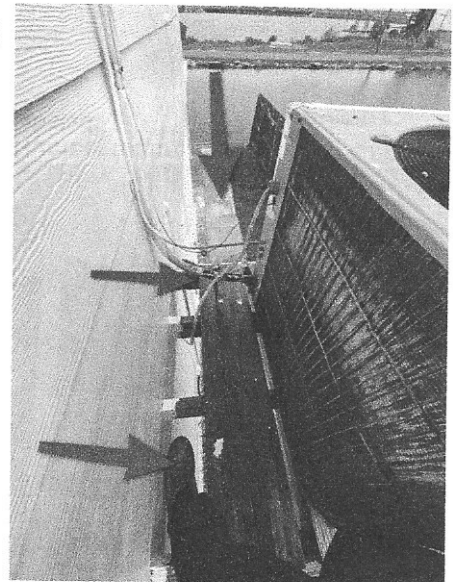
2.11.2 K. Porches, Balconies, Decks, and Carports

ADD DECKING

observed missing decking big enough for an adults foot to slide through this is not good when working on the AC unit. A person can fall and trip over the edge there needs to be a board to prevent injury

Contact a qualified professional.

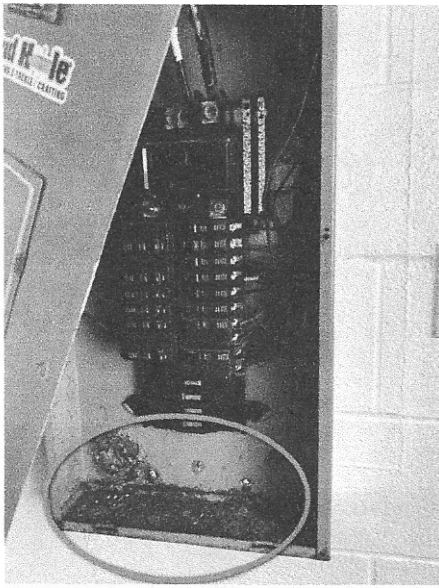
3.1.1 A. Service Entrance and Panels

FRAYED SHEATHING

Wires on service entrance are damaged or frayed. Recommend contacting your electric utility company or a qualified electrician to evaluate and repair.

Contact a qualified electrical contractor.

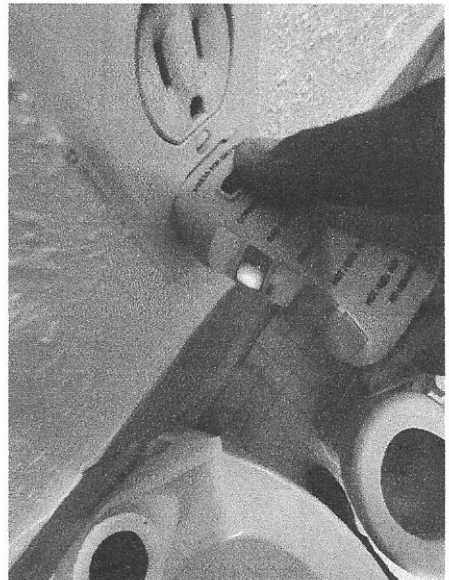
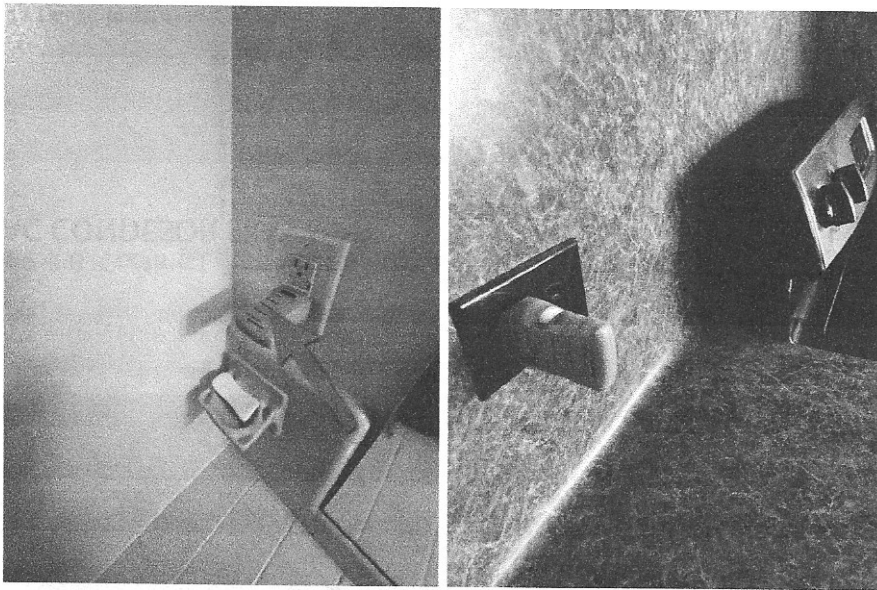
3.2.2 B. Branch Circuits, Connected Devices, and Fixtures

NO GFCI PROTECTION

No GFCI protection present in the following locations:

1st floor BATHROOM

Recommend licensed electrician upgrade by installing ground fault receptacles in all locations.

Recommendation
Contact a qualified electrical contractor.

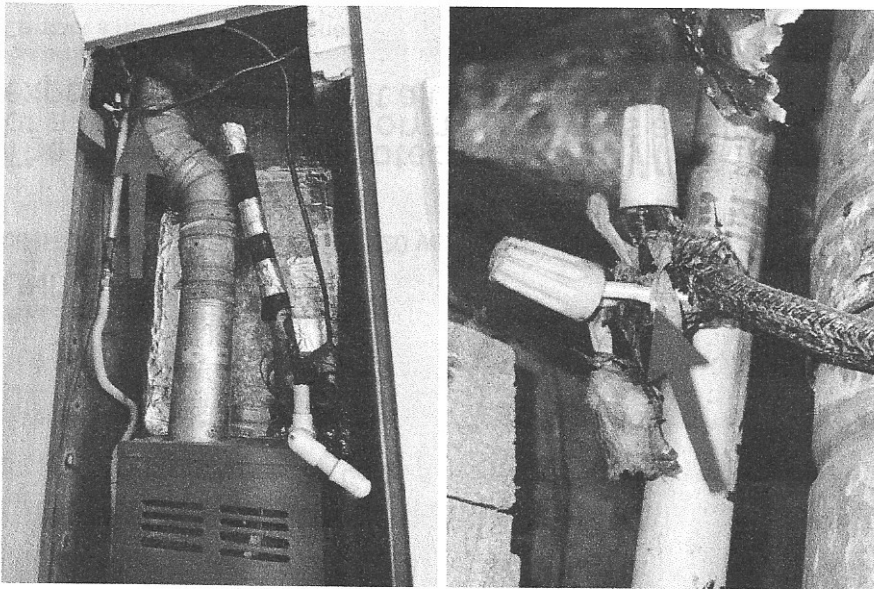
3.2.4 B. Branch Circuits, Connected Devices, and Fixtures

CLOTH WIRING

Cloth wiring is an outdated type of electrical wiring which uses cloth instead of plastic to insulate and protect electrical conductors and they lack the safety features of modern wiring installations, like grounding. They also do not typically provide enough power for modern needs – which can result in a dangerous over-stressing of the electrical system, which could lead to a fire.

Contact a qualified professional.

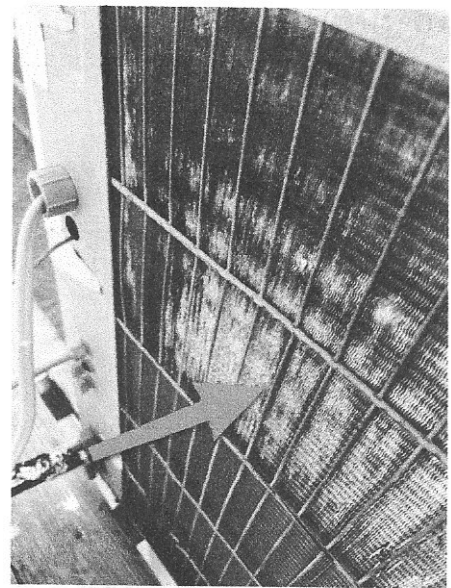
4.2.1 B. Cooling Equipment

INSULATION MISSING OR DAMAGED

IMPROVEMENT RECOMMENDED: The insulation around the condensers suction line (refrigerant line) was in poor condition. The insulation should be kept in good condition. The suction line should be kept well insulated to prevent leaks from condensation and energy loss. This is a minor repair that should be done by a qualified person.

Recommendation
Contact a qualified HVAC professional.

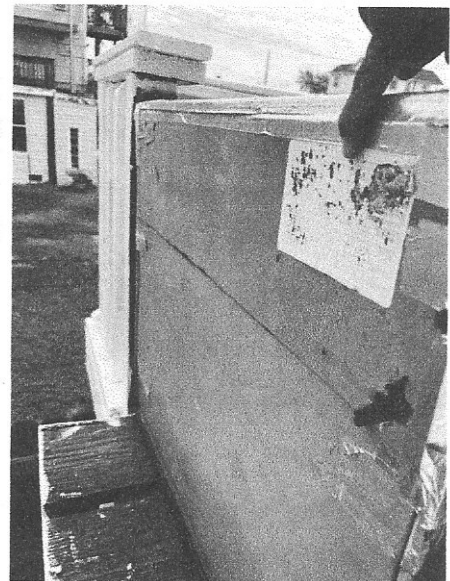
4.2.4 B. Cooling Equipment

NO LABEL

Could not determine information for the AC compressor or condenser exterior of the building. The label is too faded to read

Recommendation
Contact a qualified professional.

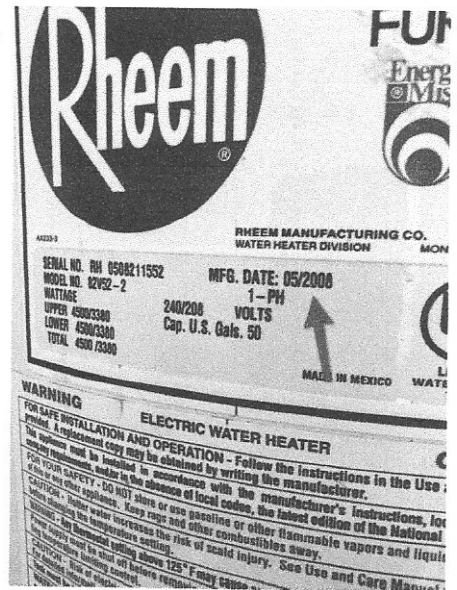
5.3.2 C. Water Heating Equipment
WATER HEATERS AT END OF LIFE

Based on the manufacturer's suggested service life, the life expectancy of a water heater is about 8 to 12 years. That varies with the location and design of the unit, quality of installation, maintenance schedule and water quality.

Recommendation
 Contact a qualified professional.
