Home by Home Professional Home Inspections

Inspection Report

918 Sycamore Ridge Lane, Houston, TX 77073
Houston TX 77073

PROPERTY INSPECTION REPORT

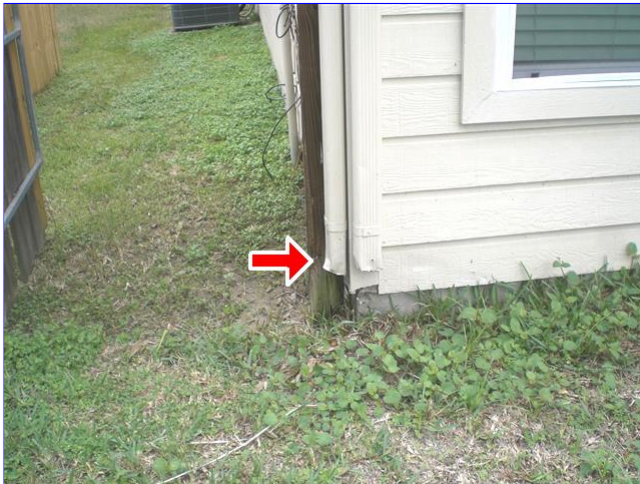
B. Item 1(Picture)

(1) Recommend installing gutters on the parts of the home that do not have them. Gutters will divert the water away from the walls and the foundation. Too much water around the foundation will cause the clay soils to expand and this will cause up lift on the foundation.

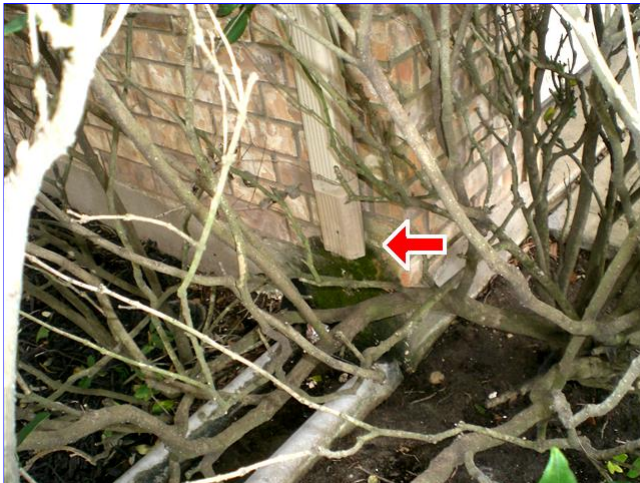
B. Item 2(Picture)

(2) The elbows for the downspouts at the front and right rear of the home were missing.

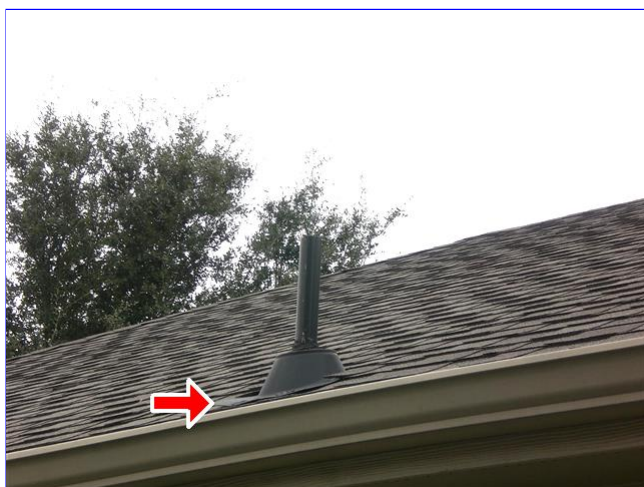
C. Item 1(Picture)

(2) The roof flashing for the roof jack/plumbing vent at the left of the home had pulled up (possible water penetration).

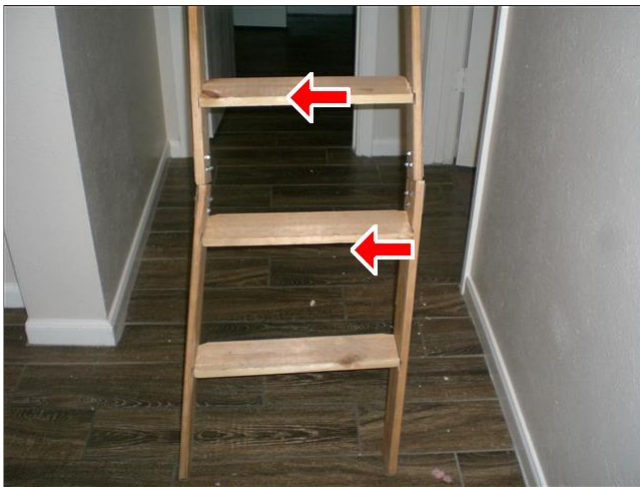
D. Item 2(Picture)

(3) The attic stairs were old and wobbly. (Safety hazard).

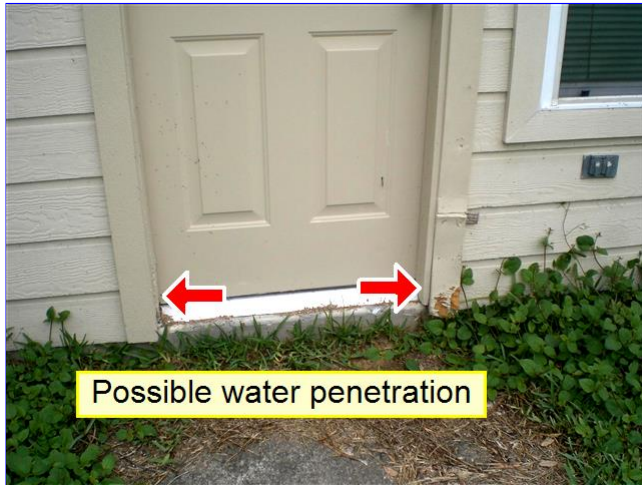
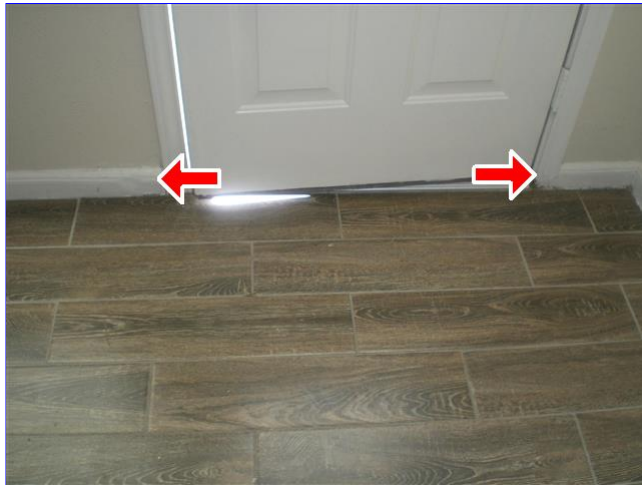
(2) Wood rot was present at the bottom of the garage/back porch door frames.

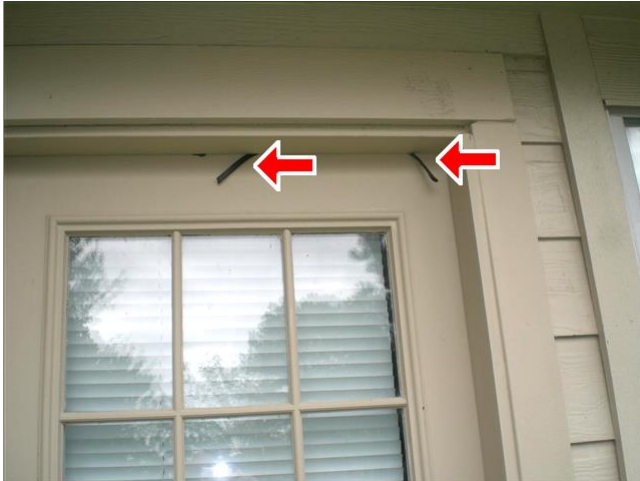
G. Item 3(Picture)

(3) Weather stripping was missing/damaged for the back porch door, this will allow conditioned air to escape to the exterior of the home.

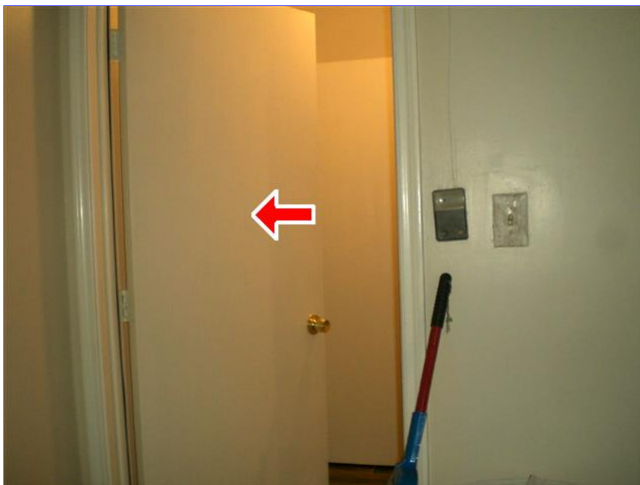
G. Item 4(Picture)

(4) Self closing door hinges are required for attached garage doors. The door did not close by itself. Also a carbon monoxide detector is required to be installed preferably near the garage door (safety hazard).

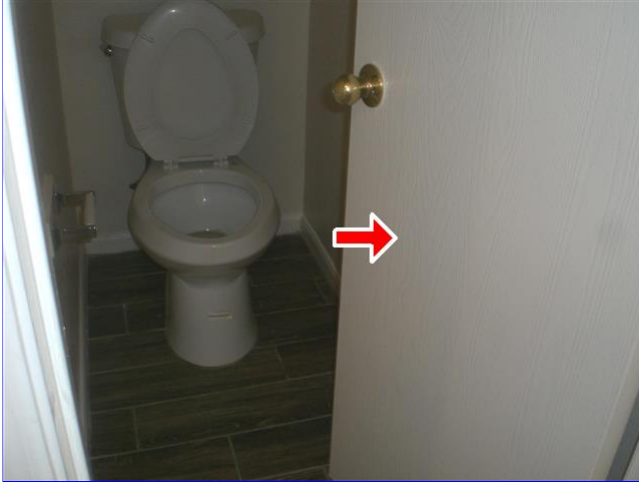
G. Item 5(Picture)

(5) The master bathroom toilet room door opened to the inside. This door should open to the outside for emergency reasons.

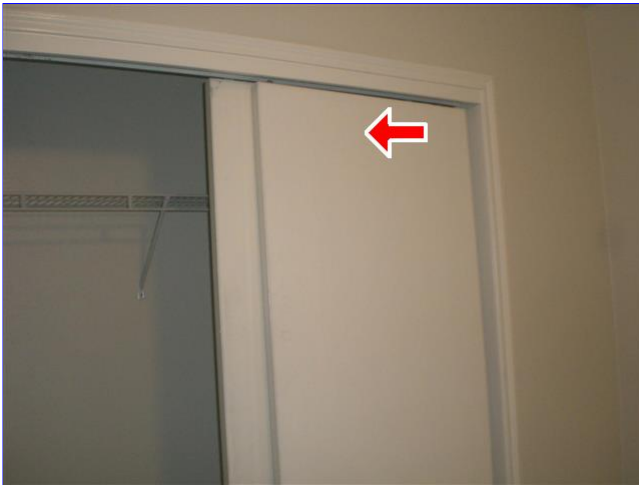
G. Item 6(Picture)

(6) The right rear bedroom closet doors were not installed.

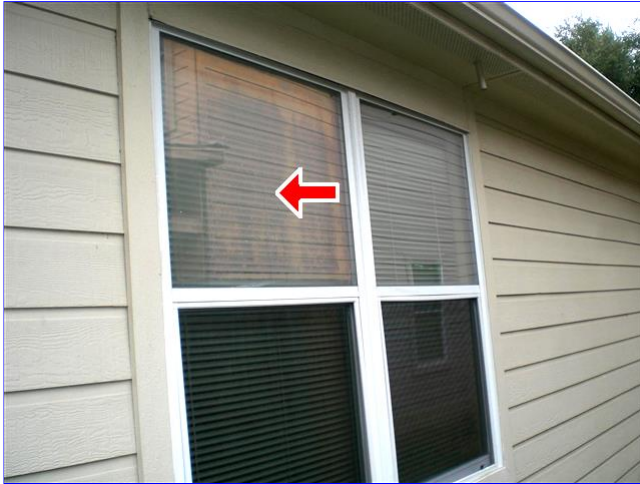
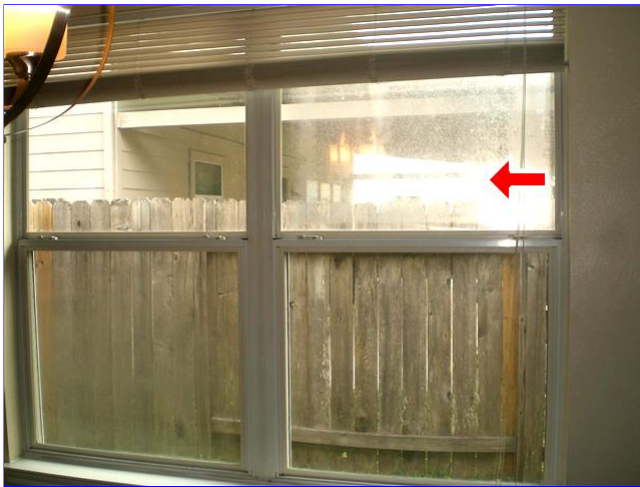
What appeared to be fog and dirt was present in between the double glass panes for the living room window (broken seal??).

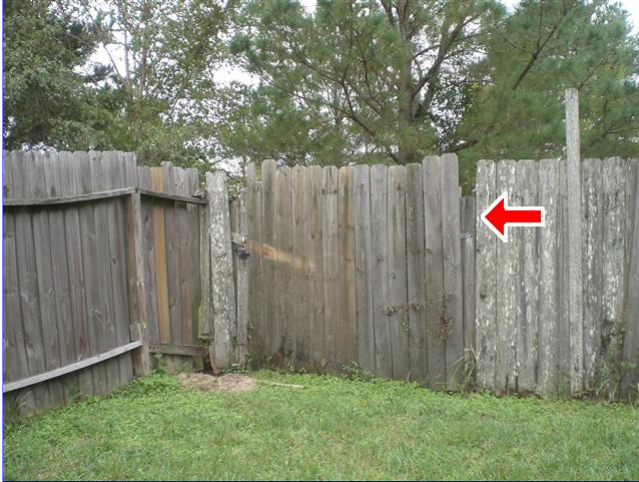
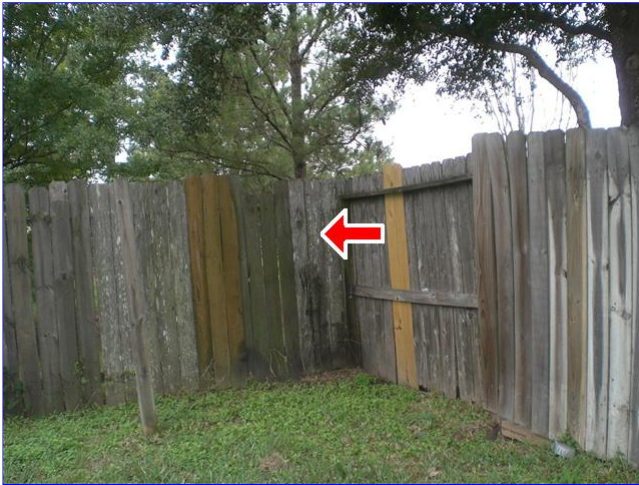
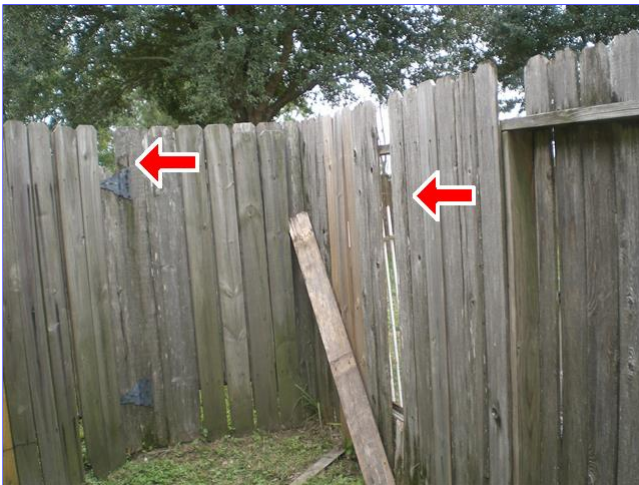
Although the fence was not part of the home inspections, we noticed sections of the fence were damaged.

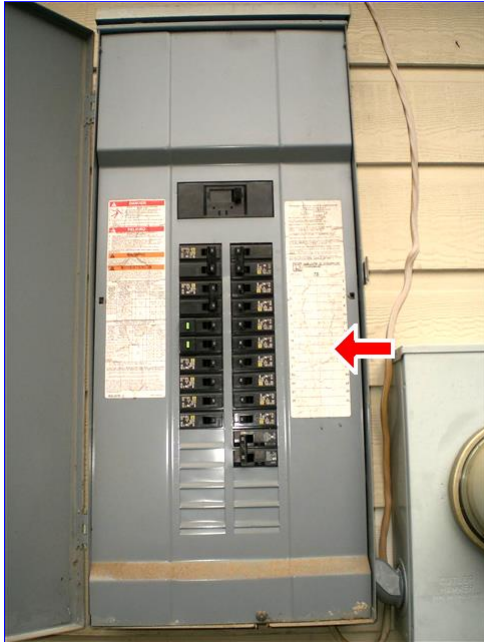
A. Item 3(Picture)

- (3) Electric main panel was not properly marked. All circuits should be clearly marked so that they can be shut down in an emergency.

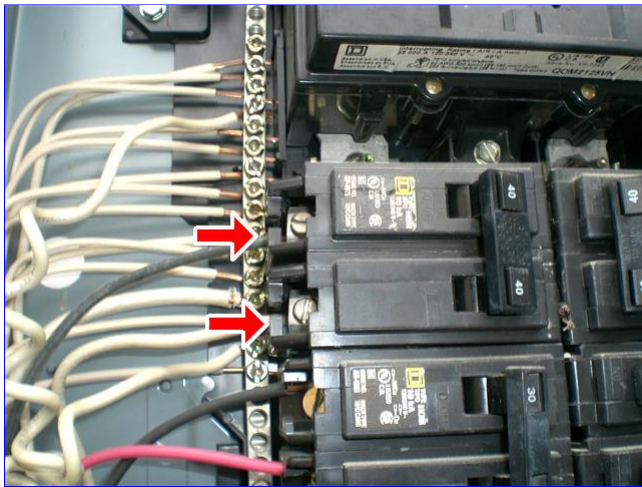
A. Item 4(Picture)

(4) The wires going to the 40 amp breaker appeared to be undersized. This will cause the circuit to remain live if a problem exists (Fire hazard).

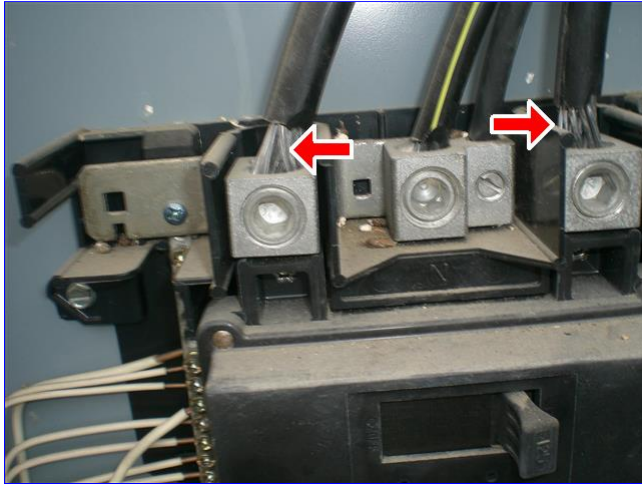
A. Item 5(Picture)

(5) Anti-oxidant compound did not appear to be present on the main service connectors. The Texas Real Estate Commission (TREC) recommends that Anti-oxidant compound be applied to all aluminum wires in the main panel.

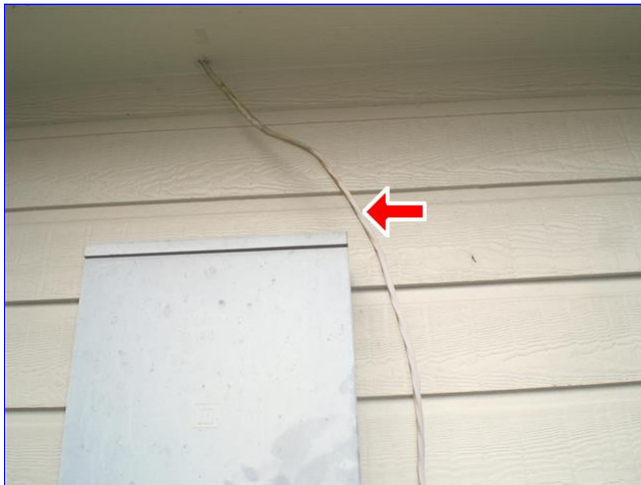
B. Item 1(Picture)

(1) Exterior electrical wiring needed to be protected in conduit.

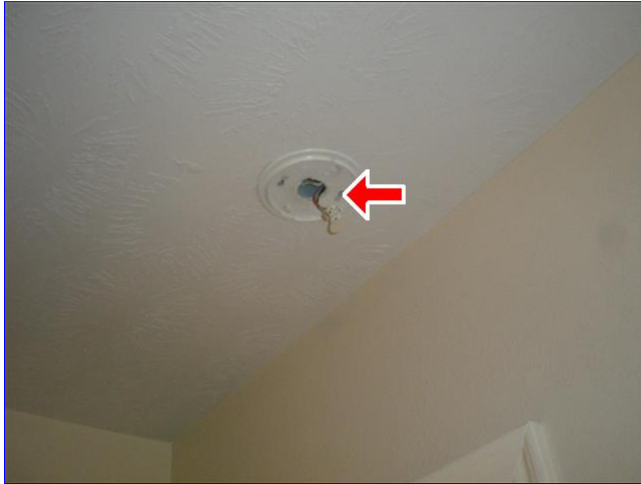
B. Item 2(Picture)

(2) Smoke alarms were not in all the recommended areas. A minimum of 1 for each floor and 1 for each sleeping area should be installed.

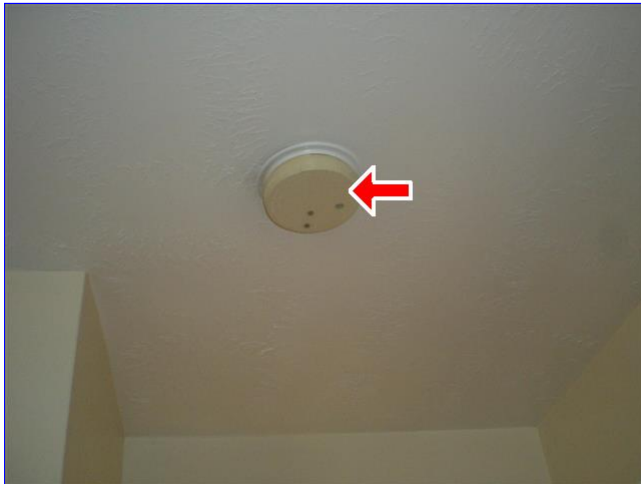
B. Item 3(Picture)

(3) The smoke alarm in the home appeared to be old. Recommend replacing smoke alarms that are over 10 years old. This will help to insure that the alarms sound when needed. A minimum of 1 for each floor should be installed, and 1 for each bedroom and living area recommended.

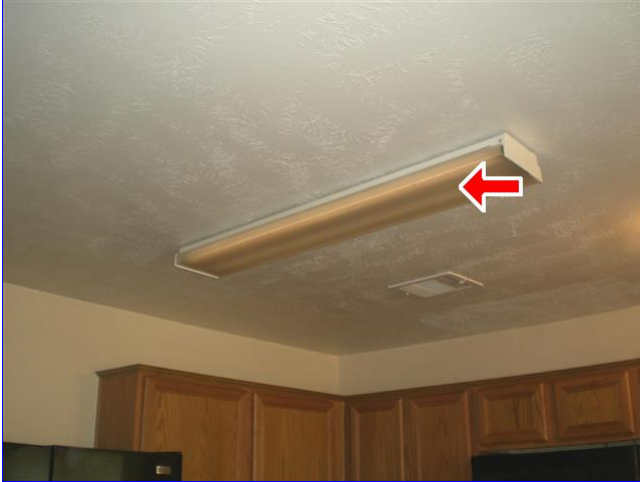
B. Item 4(Picture)

(4) The kitchen ceiling light was damaged.

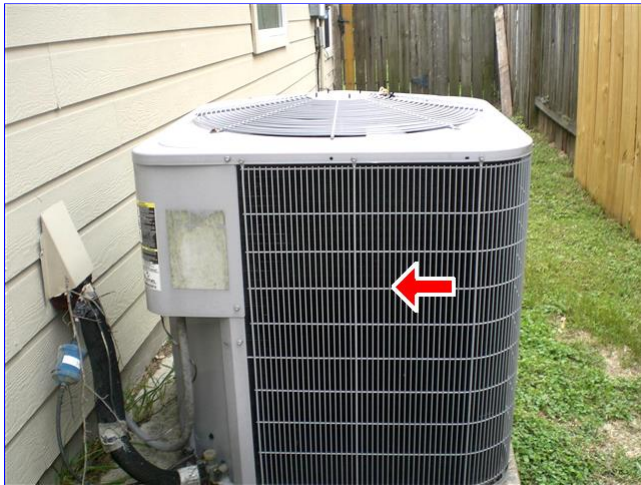
B. Item 1(Picture)

(2) The AC unit appeared to be 10 years old.

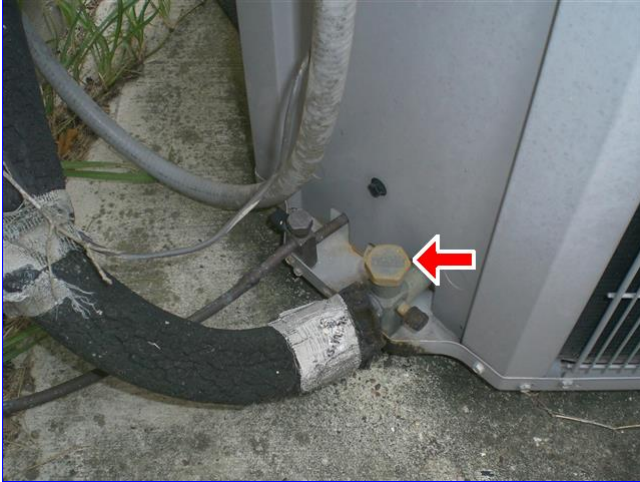
B. Item 2(Picture)

(3) Locking caps are required for the HVAC refrigerant ports.

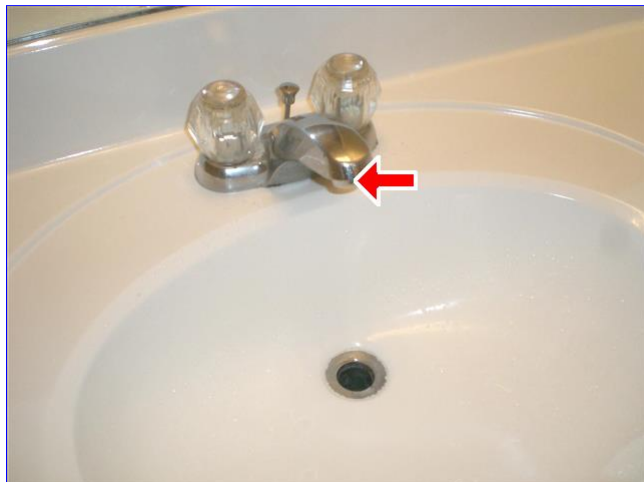
A. Item 1(Picture)

(2) What appeared to be the hallway bath sink faucet aerator was damaged/missing.

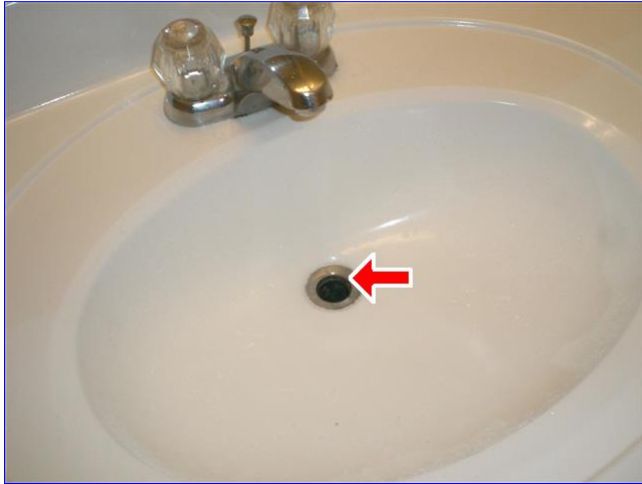
B. Item 1(Picture)

The baths sink drain stoppers were missing.

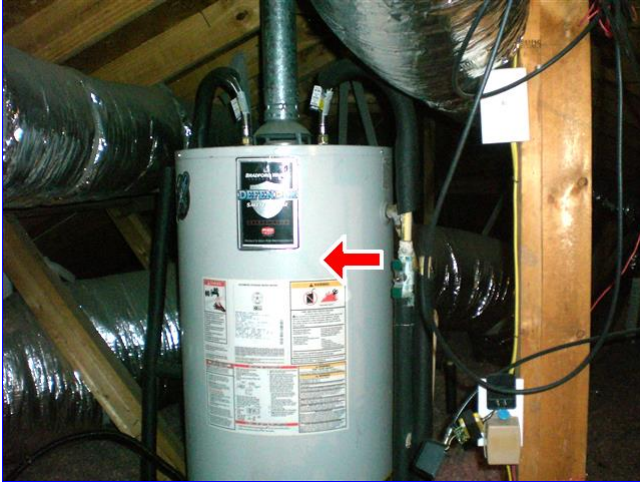
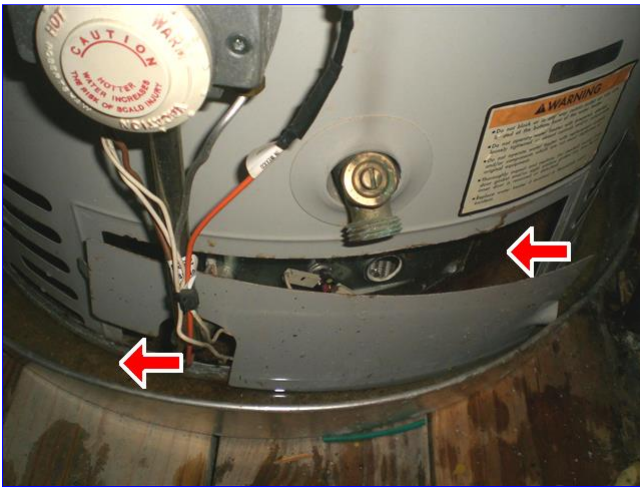
The water heater unit appeared to be old and deteriorated, leaking and did not work at the time of the inspection. Recommend replacing.

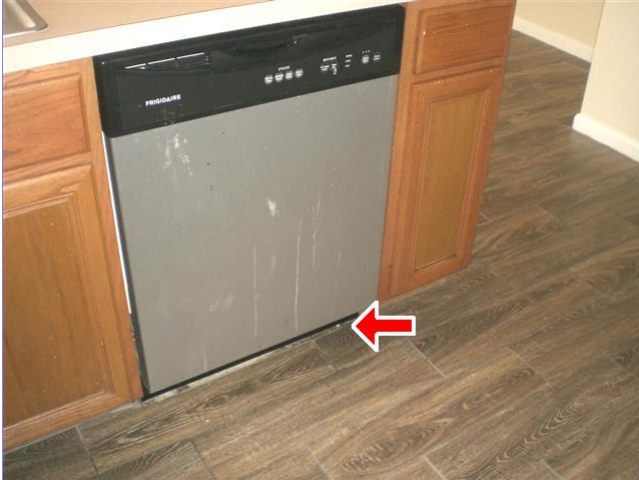
A. Item 1(Picture)

(1) The dishwasher was leaking at the time of the inspection.

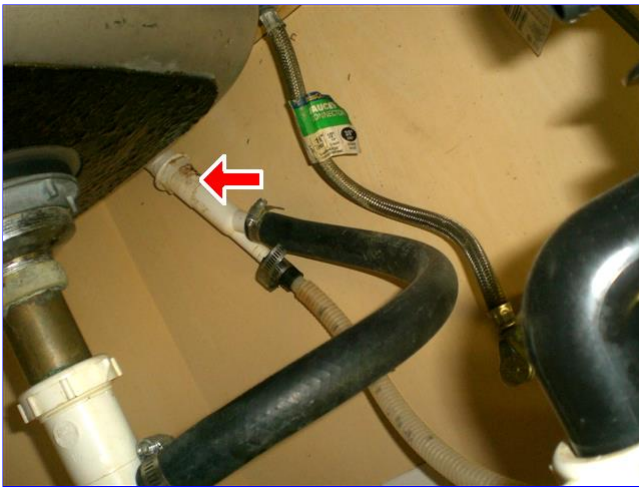
A. Item 2(Picture)

(2) Dishwasher drain air gap was installed under the kitchen sink. This air gap should be installed on top of the kitchen sink.

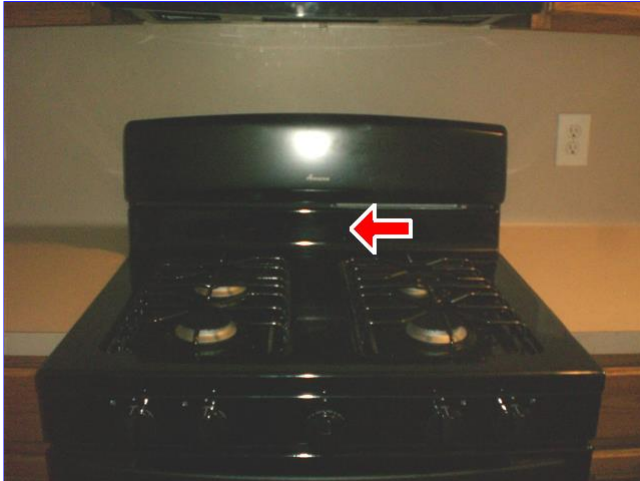
D. Item 1(Picture)

There is no anti-tip device installed to keep the stove from tipping over when children climb on or weight is placed on the oven door. I recommend that one be installed for safety. See the warning label on the oven door. While this is an important safety issue (see http://www.consumerfed.org/pdfs/Stove_Tip_Press_Release040507.pdf), it is simply fixed by installing the anti-tip device. They typically only cost a few dollars at a local appliance parts or hardware store or may still be present with the owner's manual of this stove.

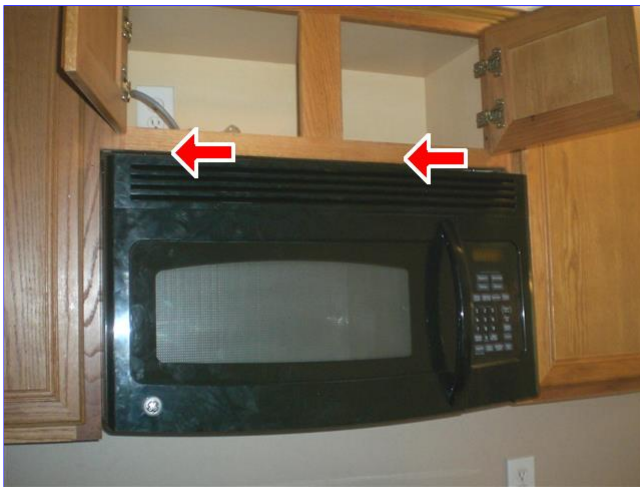
E. Item 1(Picture)

The microwave was not properly secured (detaching).

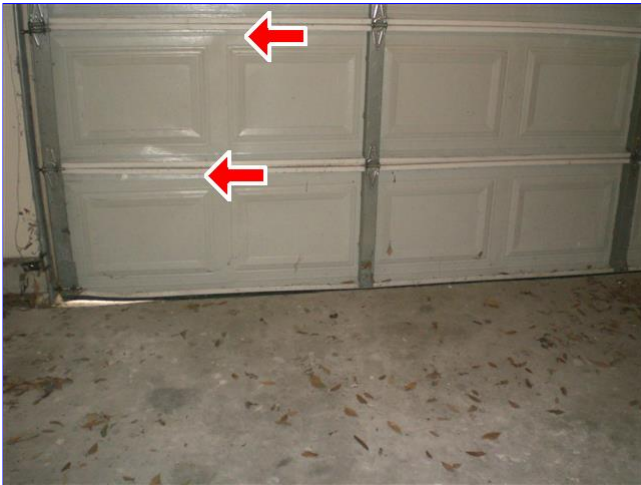
H. Item 2(Picture)

(2) Sections of the garage door appeared to be damaged.
