FIG Services LLC d/b/a FOX INSPECTION GROUP
Property Inspection Report #200507AD-21515 Pebble Pine Court
8616 Daffodil St. Houston, TX 77063
(Office) 713.723-3330 (Email) office@foxinspectiongroup.com

PROPERTY INSPECTION REPORT

Concerning: 21515 Pebble Pine Court, Cypress, TX 77433
(Address of Inspected Property)

By: Arash Dinyarian, TREC: PI 22735 05/07/2020
(Name and License Number of Inspector) (Date)

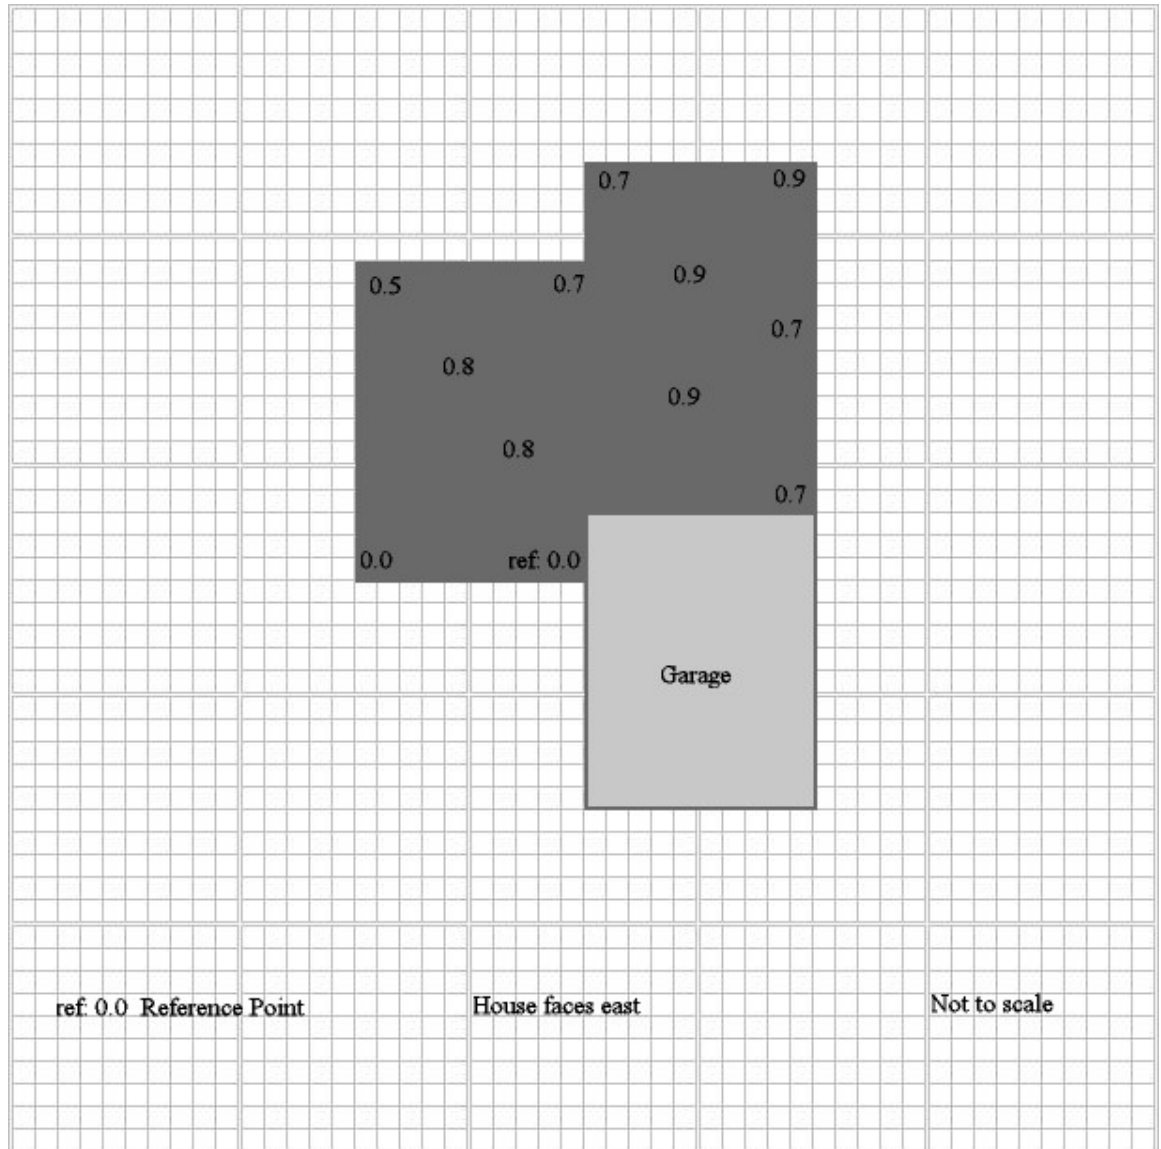
A foundation elevation survey was conducted during the inspection. The floorplan below represents data gathered using a Zip Level or similar instrument and adjusting for floor covering height differences. i.e. differences between tile, carpet and wood flooring(except step down to garage). Measurements are listed to the nearest 1/10th of an inch. Greatest variance was 0.9".

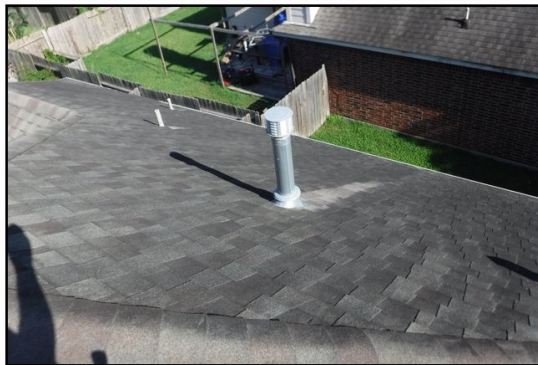
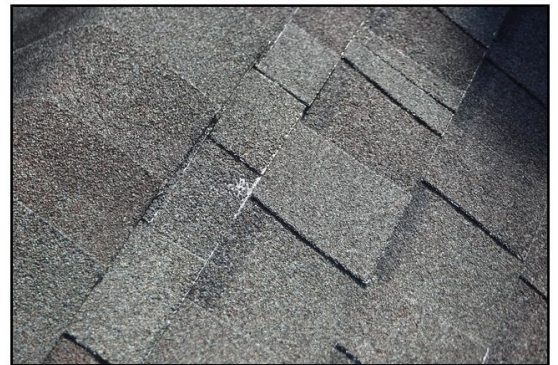
Older roof. Observed Brittle, cracked, curled ends, and/or excessive granular loss of shingles.

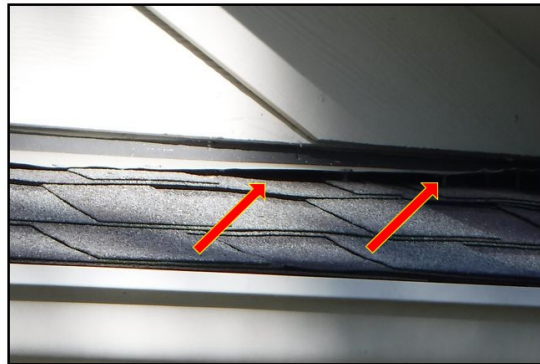
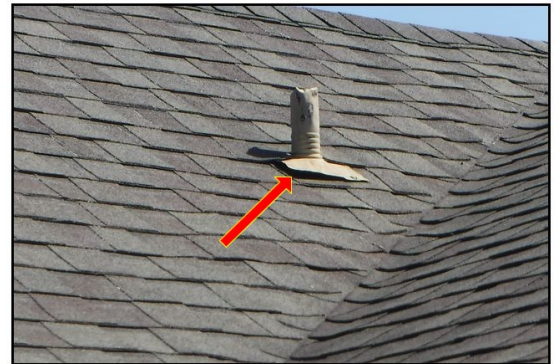
The lower side of flashing is not sealed down, wind-driven rains can cause water penetration.

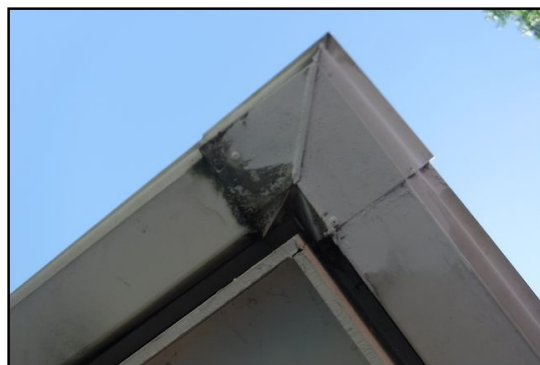
Observed water stains on fascia board on the backside of rain gutters; indication water is running down the backside of rain gutter which leads to wood rot.

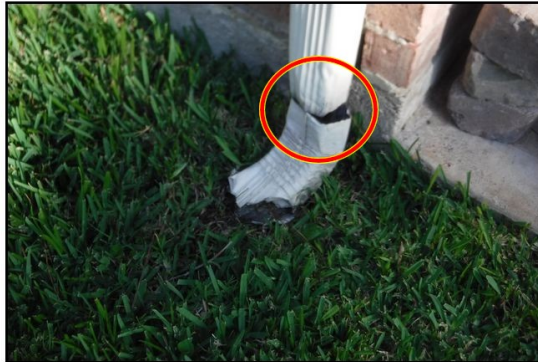
The elbow needs to be secure at one or more locations.

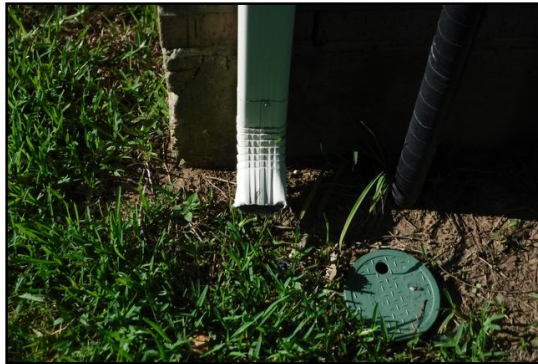
Downspouts need splash blocks at bottoms to prevent soil erosion.

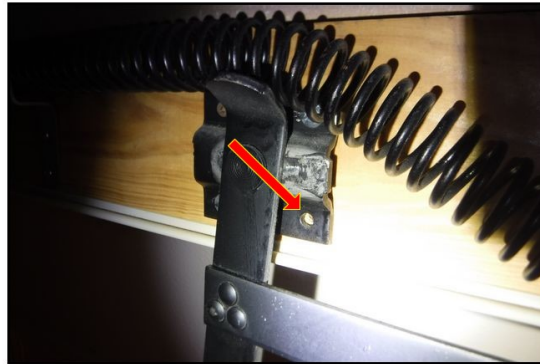
Not installed per manufacturer's installation instructions. Missing securing nails/lag bolts in holes of metal pivot points and corner braces.

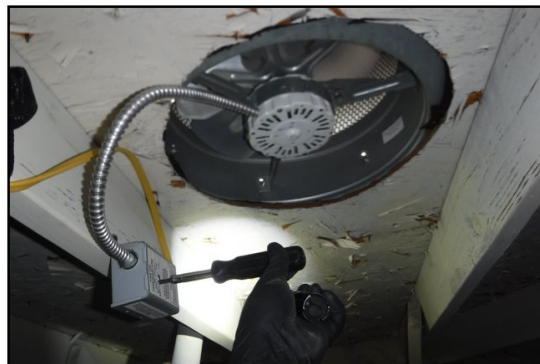
Attic power fan is not operational, appears motor windings are burned out.

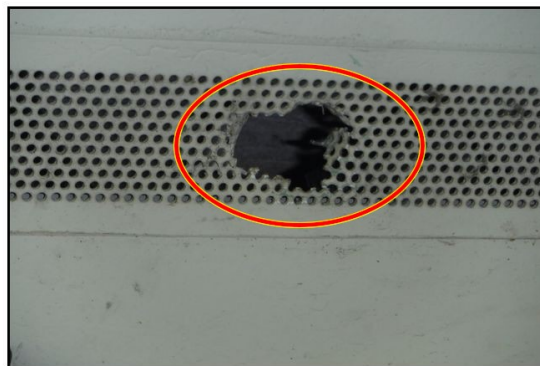
Potential rodent entry; from damage of soffit screen.

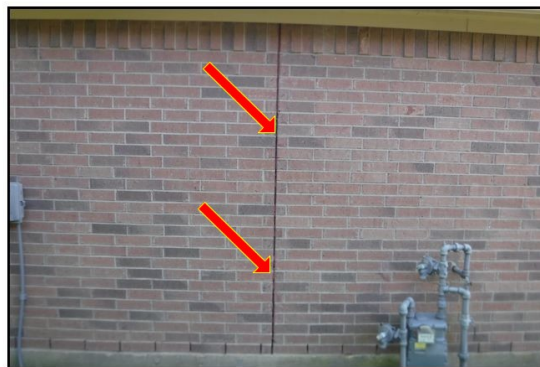
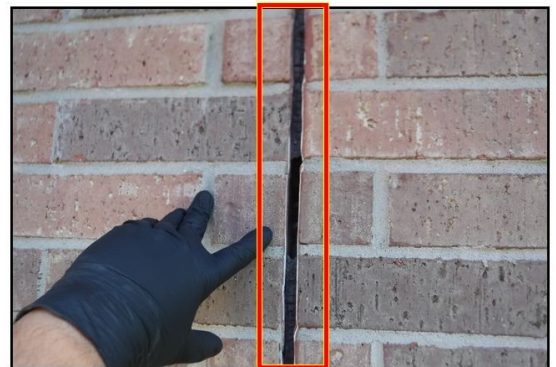
Expansion joint(s) and / or inside corners in brick veneer need caulking. Ensure any mortar present in the expansion joint is first removed before sealing.

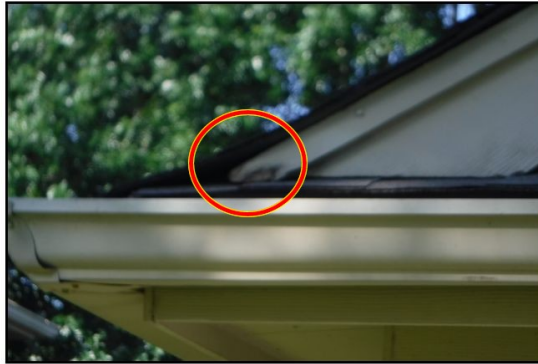
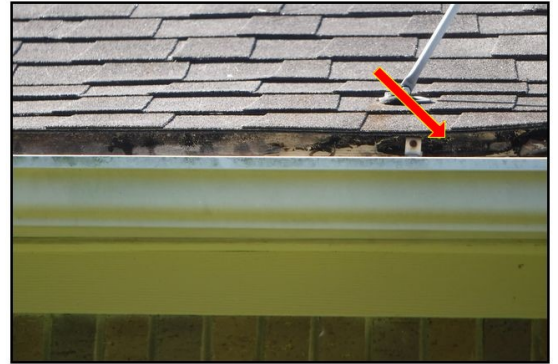
Wood rot / damages observed on areas of house/garage.

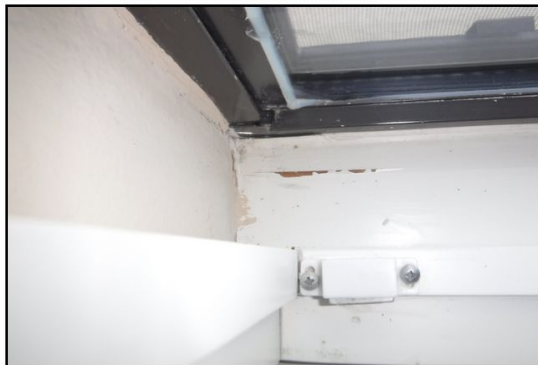
Water stains/damage to the interior of one or more window jambs. Moisture meter indicated that the stains were not active (wet) at the time of inspection.

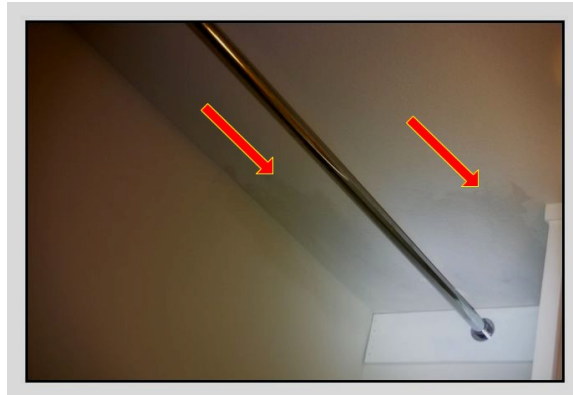
Cosmetic cracks and/or previously repaired cracks in sheetrock observed in the ceiling; master bathroom closet.

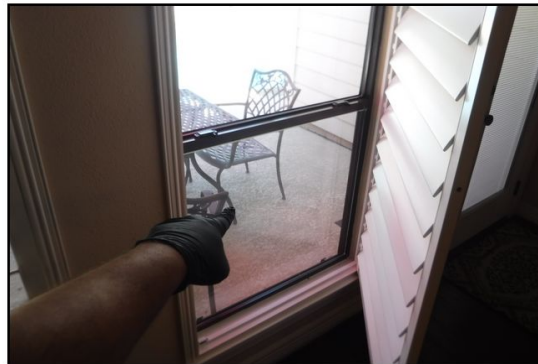
Observed one or more windows that were not operational, including, but not limited to living room.

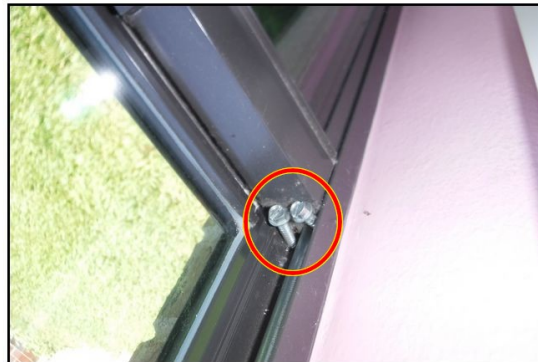
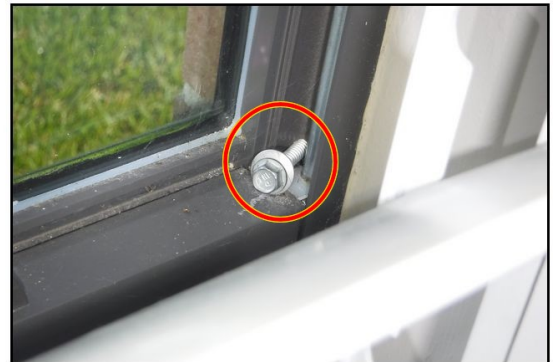
Several windows were observed to be screwed and/or locked shut. Windows in a bedroom that do not open are a recognized fire/safety hazard, including, but not limited to guest bedrooms.

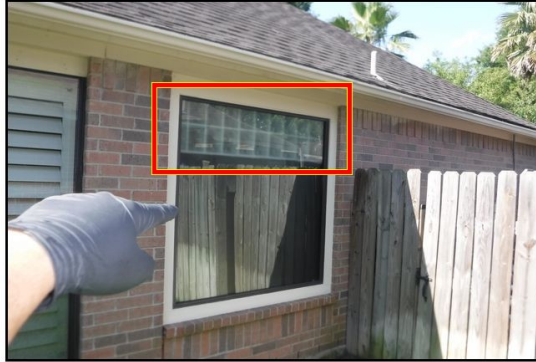
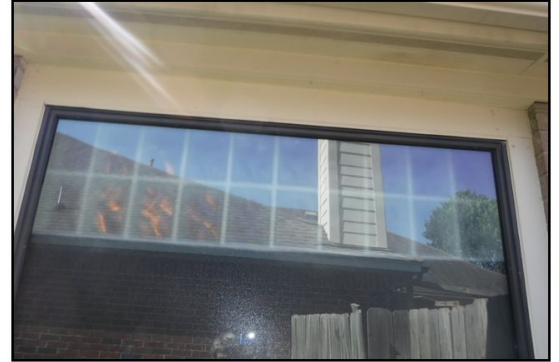
2/3 of window observed to be covered with master bathroom shower wall. (Only 1/3 observed to be visible from inside master bathroom).

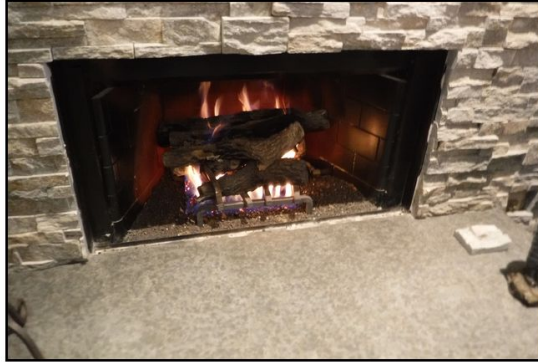
Soot build up on Faux logs indicates improper combustion - air/fuel mixture. Recommend service to clean soot and adjust the air/fuel mix to reduce/eliminate soot production.

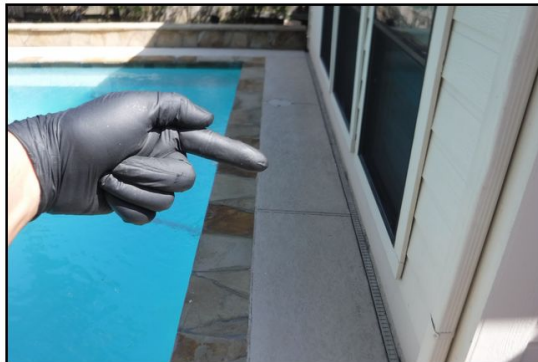
The exterior patio improperly slopes towards the house. This condition tends to encourage water penetration during heavy rains.

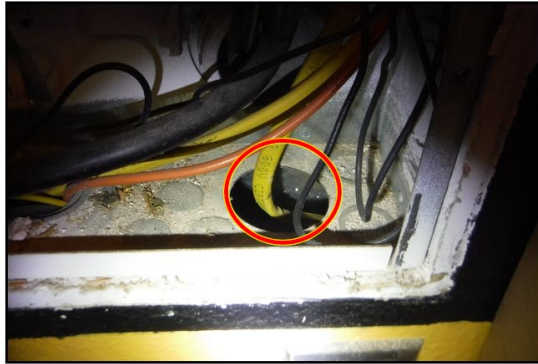
A protective bushing is not present around the electrical wire as it passes through a metal box.

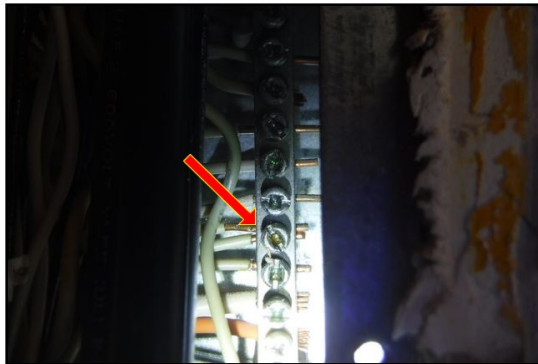
Observed two or more neutral conductors under one screw lug on the neutral bus.
Current industry standards and National Electric Code permit one neutral conductor per screw lug.

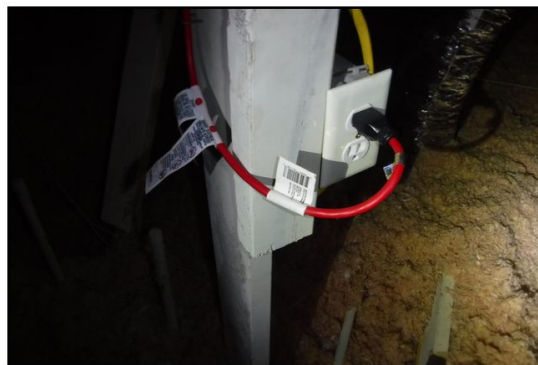
Lamp cord and/or extension cord wiring used improperly as permanent wiring; attic.

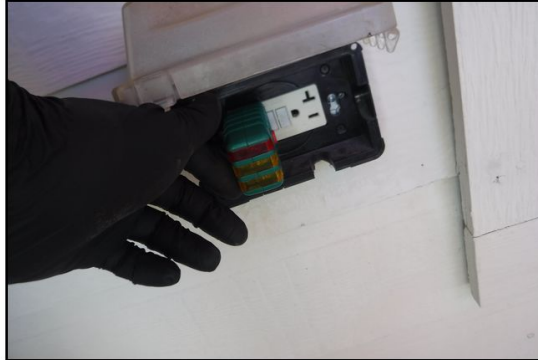
Multiple GFCI outlets, wired on the same circuit could require re-setting multiple outlets before power is restored. Recommend consulting a qualified electrician as to methods/necessity of repair.

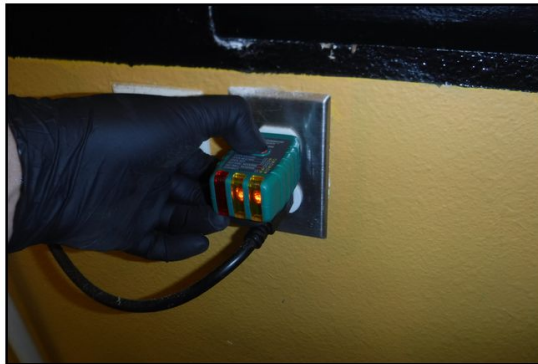
Did not observe GFCI protection of all outlets in required locations, including but not limited to the location marked below. This condition is a recognized safety hazard and needs repair.

Not all exterior locations

Not all in garage

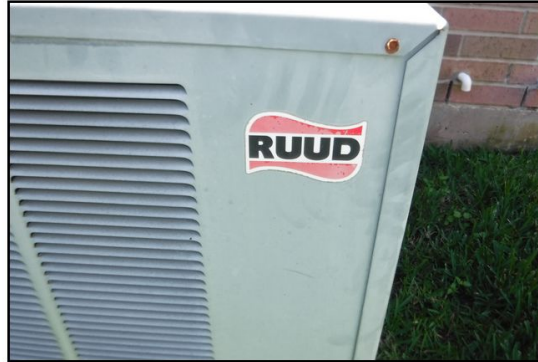
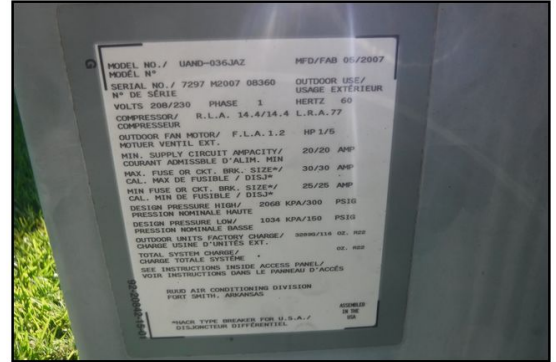
Manufactured in: 2007

Older unit, Cooling properly at the time of inspection.

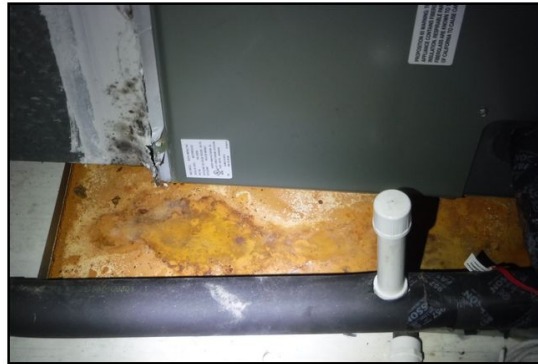
Secondary drain pan is very rusted, recommend replacement. Secondary drain pan is rusted; indication coil (or previous coil) has a history of leaking/dripping condensation into the pan.

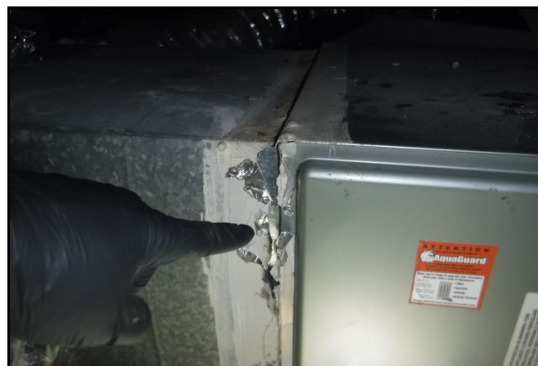
Excessive air loss around transition/coil/heater/plenum and/or damaged/loose ducts.

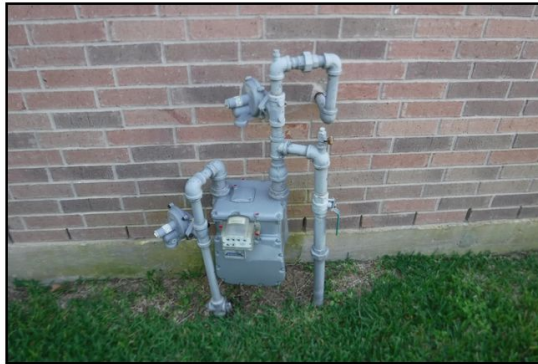
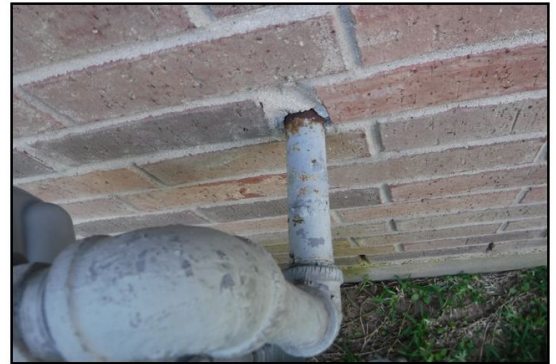
Exposed exterior gas piping not protected from corrosion as required per IRC 2603.3

Unable to determine if above ground gas lines are properly bonded as required by 2006 IRC/G2411.1 (310). Recommend further evaluation by qualified contractor.

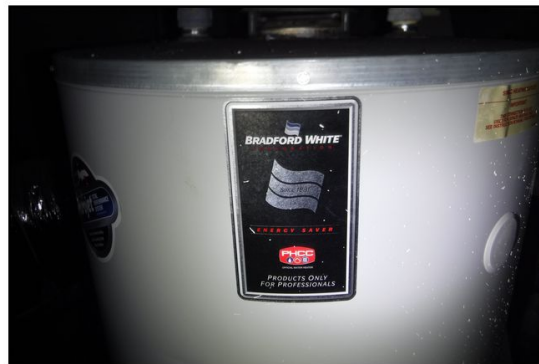
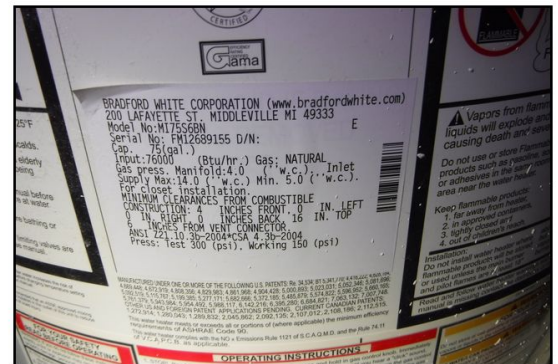
Manufactured in: 2009

The unit has exceeded its normal serviceable life; budget for repair or replacement.

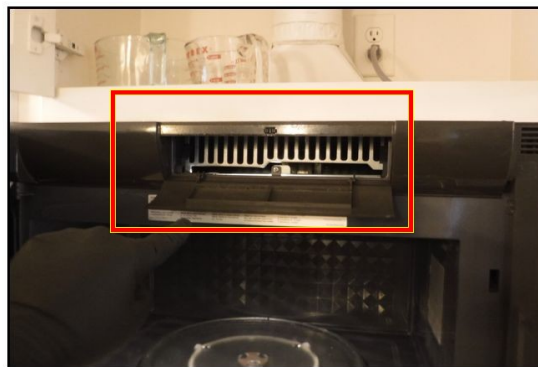
Push door/panel of the main door observed to be broken.

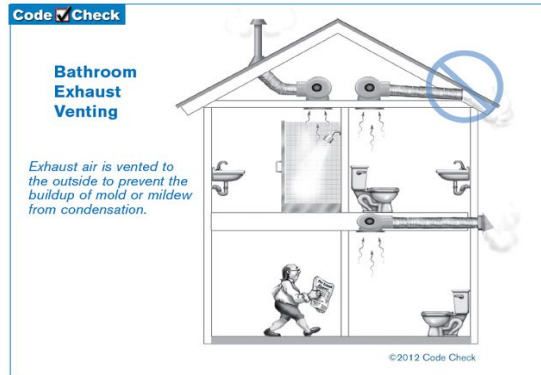
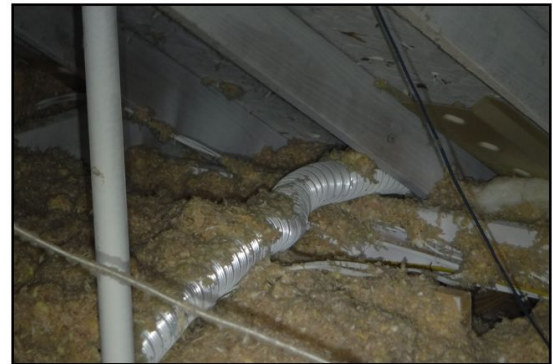
Exhaust improperly vents to the soffit, ducting should vent to the exterior.

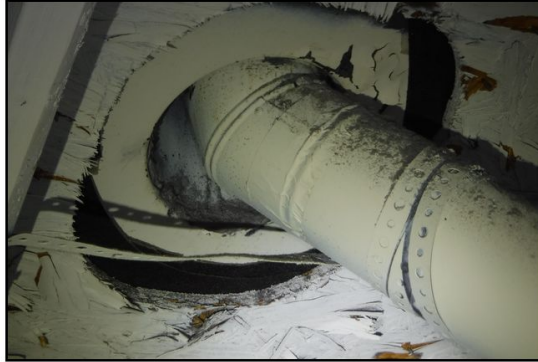
Dryer vent contains lint buildup. Recommend cleaning dryer vent and/or resecure the vent to reduce drying time and risk of fire hazard.
