# NationSpec Home Inspection

32314 Hamilton Crest Dr, Brookshire, TX 77423

Inspection prepared for: Lindsay Clark

Date of Inspection: 1/17/2022 Time: 1:30 PM

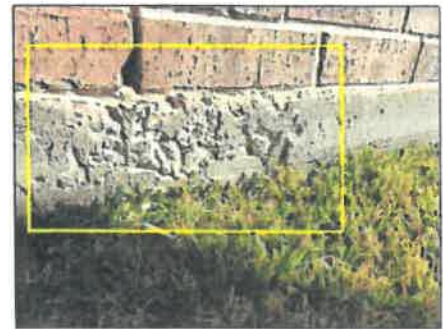
A.3. Recommend sealing all honeycombing or extrusions using an approved material with an epoxy bonding agent. These areas can corrode and create gaps inside the foundation wall where moisture and insects can potentially enter.

*Left side, honeycombing*

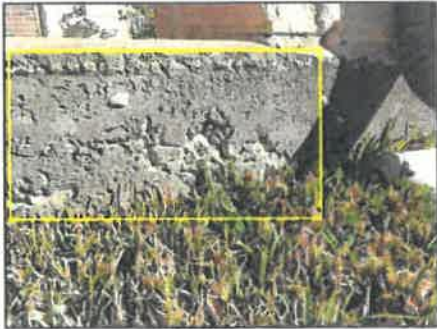
*Left side, detail*

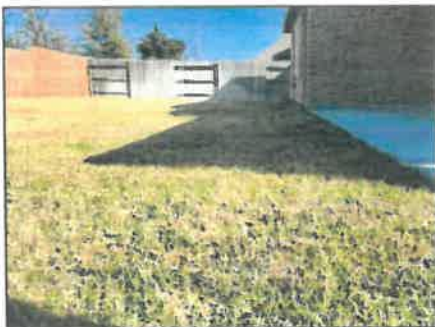
*Rear, swale observed*

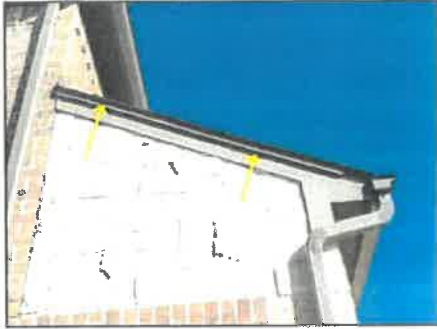
C.5. Missing drip edge. This could be considered an as built condition but is still deficient as of the IRC for 2012. Informational: IRC R905.2.8.5; A drip edge shall be provided at eaves and rake edges of shingle roofs. Adjacent segments of drip edge shall be overlapped not less than 2 inches. Drip edges shall extend not less than 1/4 inch below the roof sheathing and extend up back onto the roof deck not less than 2 inches. Drip edges shall be mechanically fastened to the roof deck at not more than 12 inches on center with fasteners (1, 2) as specified in Section R905.2.5 [roofing nails with minimum 12-gauge shank and 3/8-inch-diameter head]. Underlayment shall be installed over the drip edge along the eaves and under the drip edge along the rakes.

*Left side rake, no drip edge flashing observed*

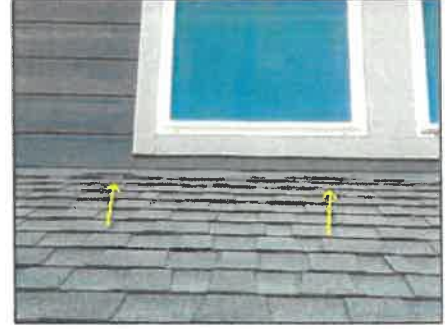
C.6. Upper gutter(s) drain onto the lower roof covering(s). Informational: Gutters that drain onto roof coverings can cause aggregate loss due to waterflow. One or more manufacturers don't warranty shingles at these locations.

*Some gutter downspouts terminate onto roof covering, may cause granule loss*

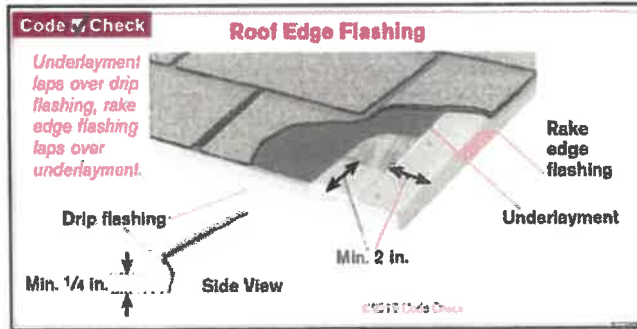
Front rakes, no drip edge flashing

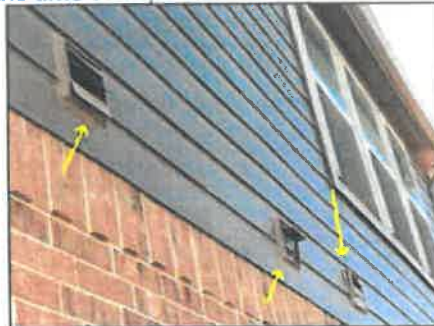
*Right side, vent covers need to be repaired and/or re-secured*

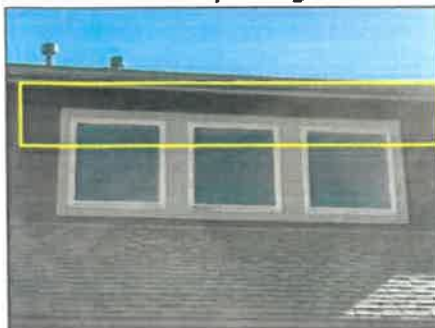
E.1. Missing Z flashing above windows. Informational: IRC requires approved corrosion resistant flashing applied on the exterior wall envelope in such a manner as to prevent the entry of water into the wall cavity or penetration of water to the building structural framing components. The flashing shall extend to the surface of the exterior wall finish and be installed to prohibit water from re-entering the exterior wall envelope. Approved flashings shall be installed at the top of exterior doors and windows, the intersection of chimneys with frame or stucco walls, under the ends of masonry, wood or metal copings and sills, continuously above all projecting trim, at exterior porches, decks or stairs attached to the wall of wood frame construction and at wall and roof intersections.

Rear, no Z-flashing observed about windows

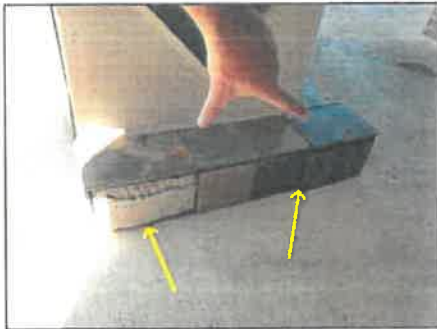
E.13. Outdoor grill structure was observed to have cracks and loose/missing tiles

*Outdoor grill structure, loose / missing tiles*

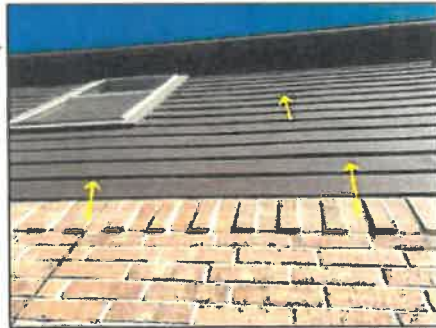
E.12. The brick ledges slope away from the dwelling less than 15°. Informational: Per Brick Industry Association. Correction of this detail is not possible without removal of the brick ledges. Flashing detail wasn't observed below the windows. Informational: IRC Figure R703.8

*Left side, brick window sill sloped 7°*

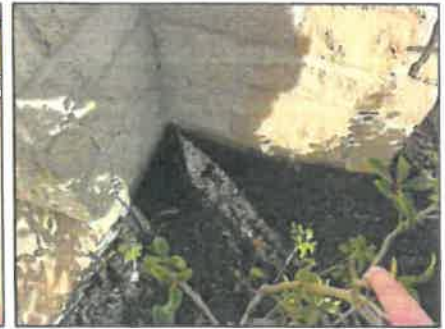
E.8. There were no weepholes observed in the lower course of the masonry veneer in one or more areas of the structure. Under current building standards; there should be open weepholes not less than (3/16") in diameter on the lower course of the masonry wall and spaced no more than (33") apart to drain excess water from the interior of the wall voids.

*Front column, missing weep holes*

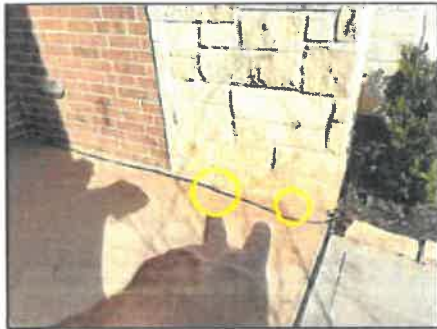
Front porch, stone missing weep holes

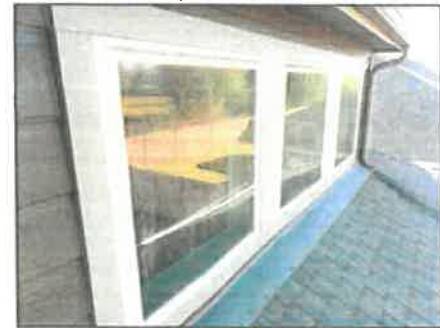
E.15. Algae or fungal growth observed on exterior cladding. Recommend having exterior of house pressure washed

Rear upper, funagl growth observed on exterior of structure should be pressure washed

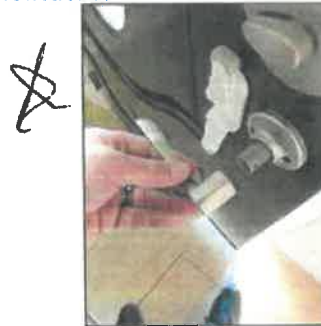
G.2. Exterior doors at one or more locations were observed to need proper weatherstripping and/or bottom sweep

Door to garage, damaged bottom sweep and no self closing device

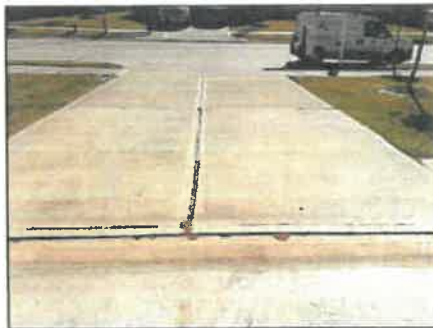
Driveway

K.3. Some minor damage was observed to finished concrete surfaces and/or edges. Recommend repair

Driveway, minor damage to edge recommend repair

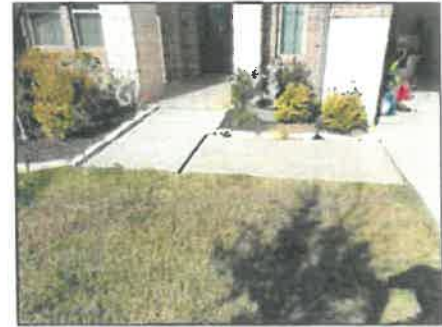
Front walkway

K.1. Cracks were observed in the driveway and sidewalk. Recommend fill and monitor

Sidewalk, crack recommend fill and monitor

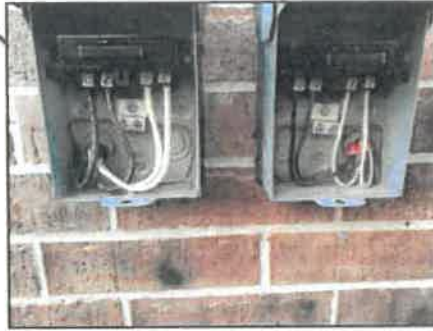
*White conductors not marked as hot in condenser disconnect boxes*

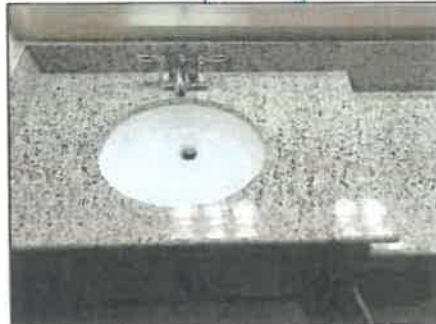
Primary bathroom, sink slow to drain

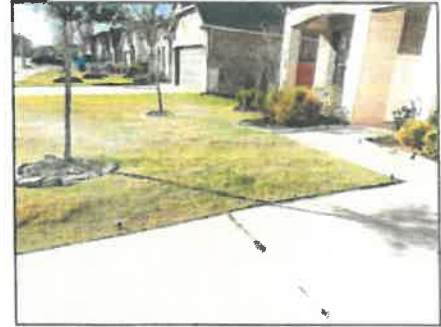
*Zone 2, grass overgrowth sprinkler heads did not fully pop up*
