Gerard J. Duhan, P.E., #59832
Engineered Foundation Solutions, #F-12259
281-788-7393 gerard@texashomeengineer.com

ENGINEERING OPINION
INVESTIGATION OF CONDITIONS
RESIDENCE AT 1039 LAKELAND CIRCLE, ROSHARON, TEXAS, 77583
Date of Inspection: November 30, 2021
Date of Report: December 5, 2021

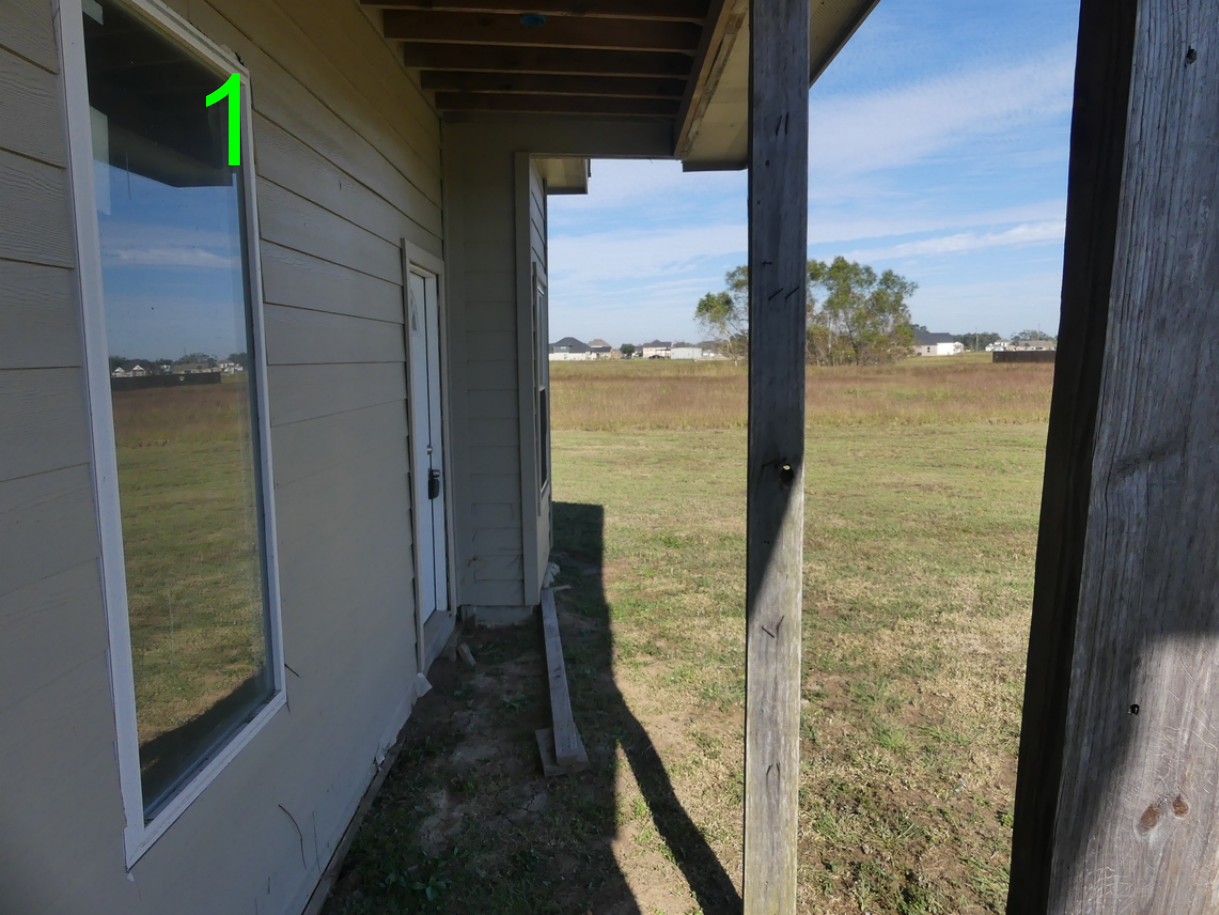
2

The front and back porch are covered by roofs with no concrete for the porch deck and no foundation support for the covers, see photos 1, 2, and 3. **Concrete decks will have to be installed, doweled into the existing foundation, with 12"x12" grade beams, and 4x6 posts sitting on the deck surface on bases to support the cover.**

Some of the wood forms to create the foundation have not been removed, see photos 2, 3, 4, 6, and 7. **Remove the foundation forms.**
