Inspection Report

Property Address:
3505 PECOS
BRYAN TX 77801

TUCKER INSPECTIONS LLC

Date: 11/22/2022	Time:	Report ID:
Property: 3505 PECOS BRYAN TX 77801	Customer: KAI COTHRAN	Real Estate Professional: Monica Martinez

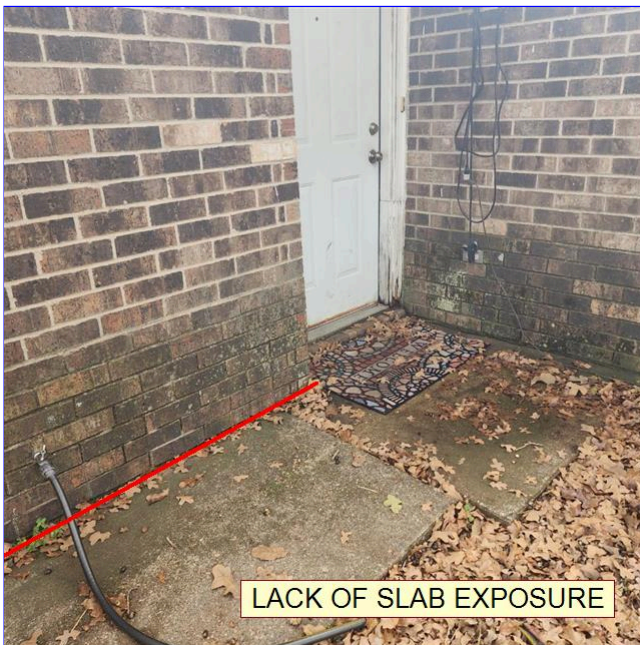
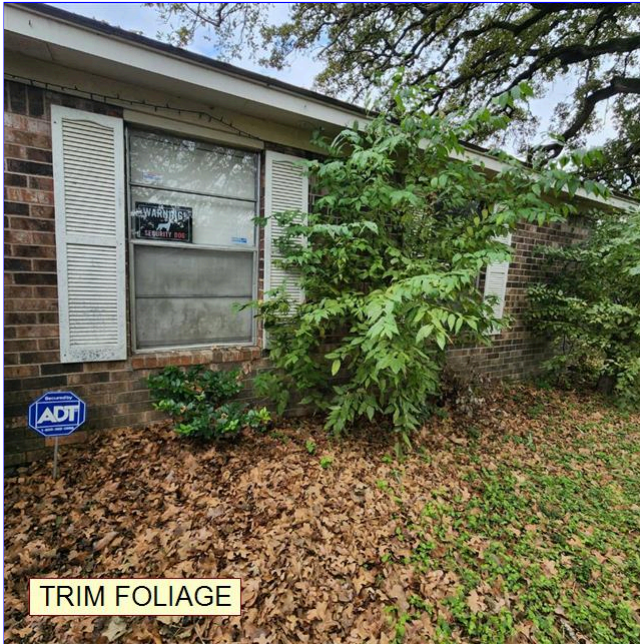
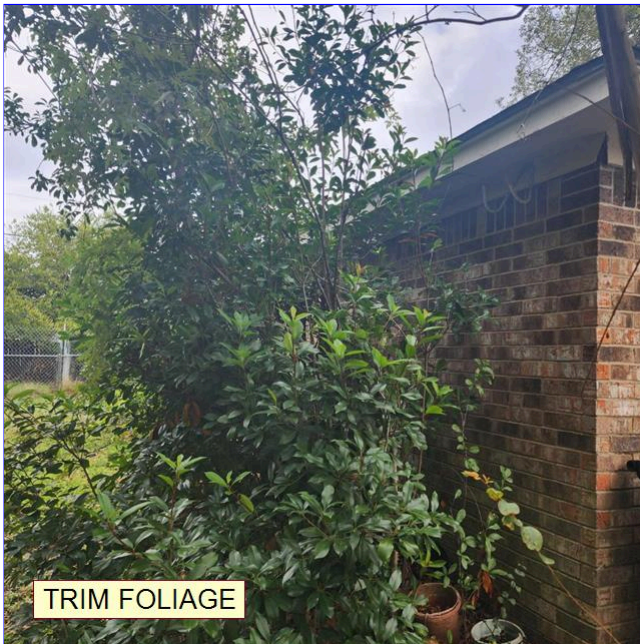
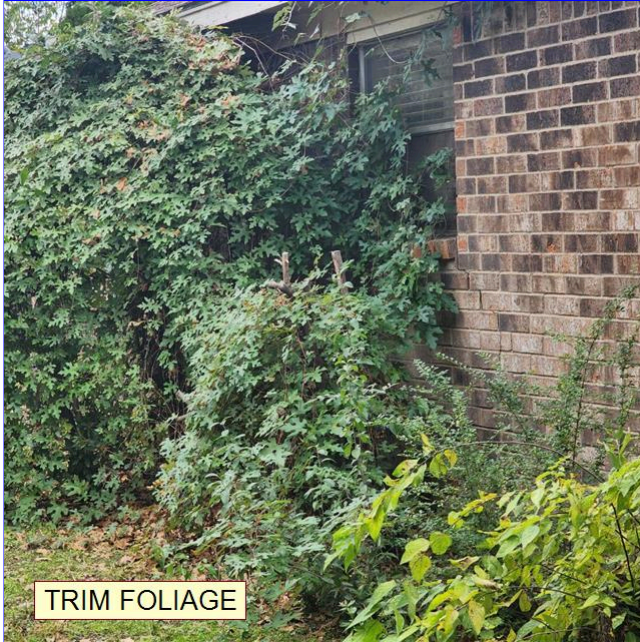
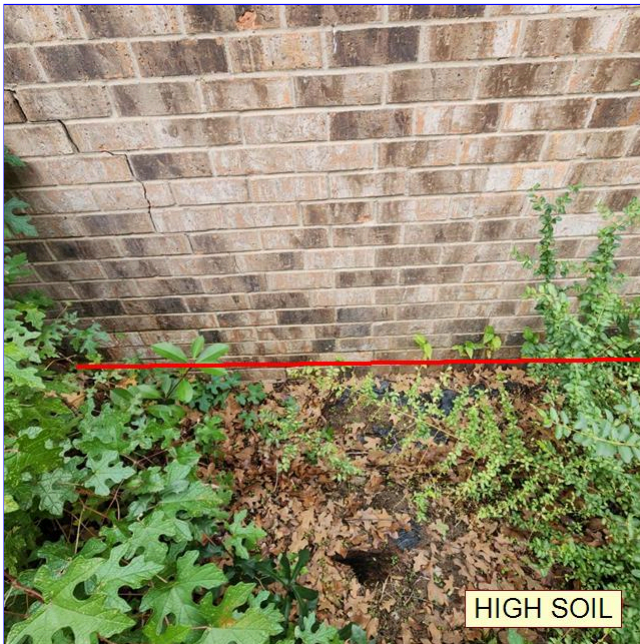
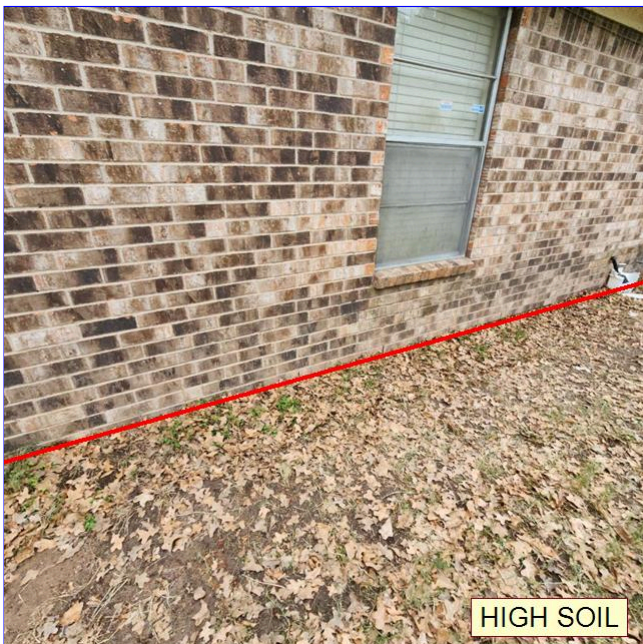
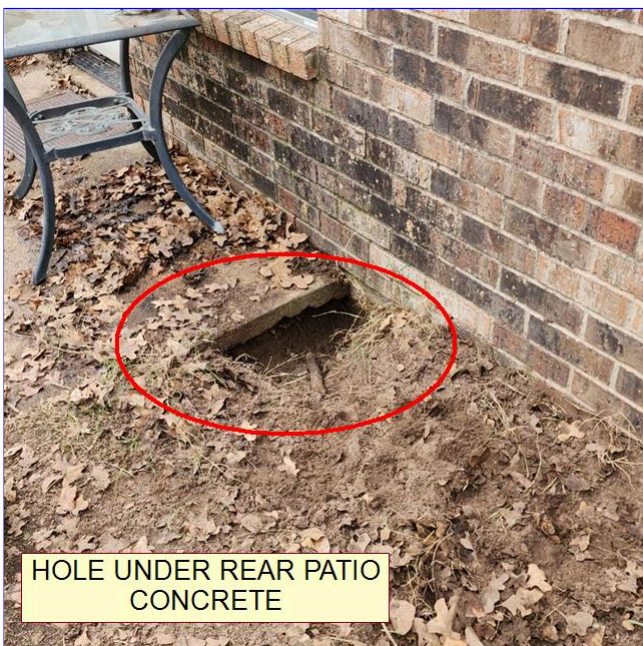
The soil is high along several areas of the foundation. The front walkway concrete is high along the foundation. It is recommended that at least three to four inches of slab is visible above the height of the grass, concrete or flower beds. Lack of slab exposure can lead to water and insect problems.

The foliage needs to be trimmed away from the structure.

There is a hole dug under the rear patio concrete. This can allow for soil erosion near the foundation. Recommend filling this area.

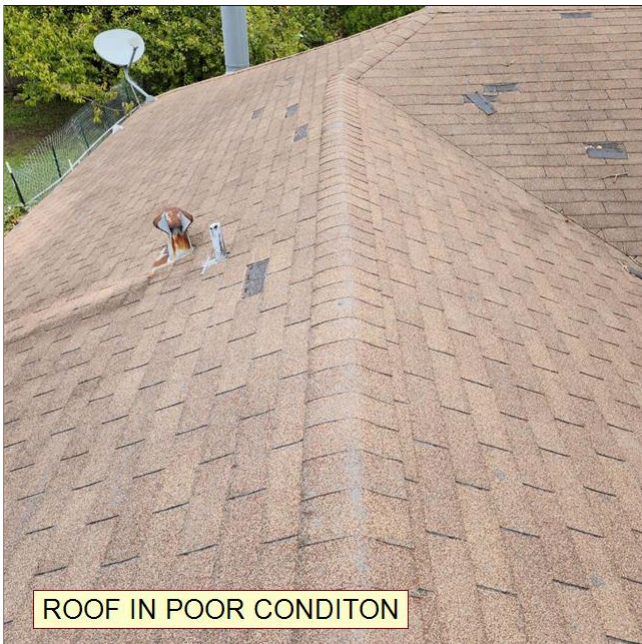
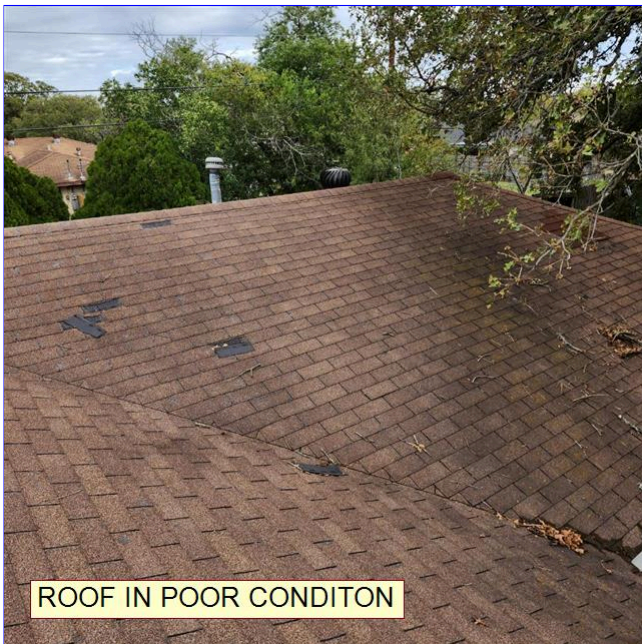
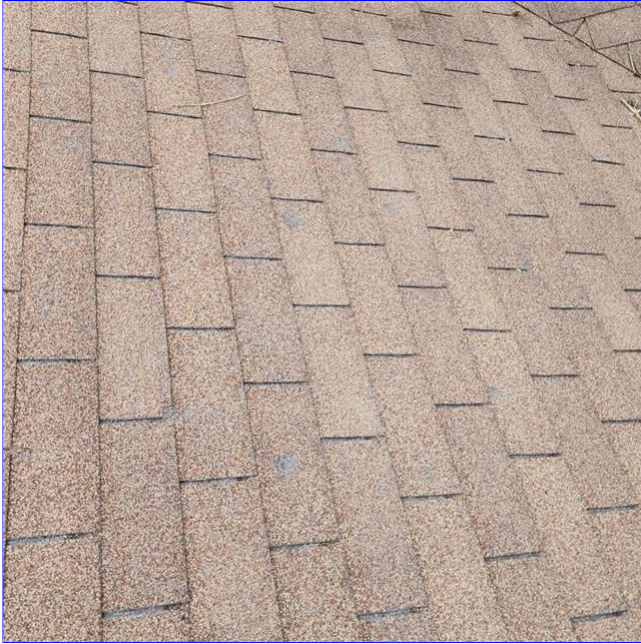
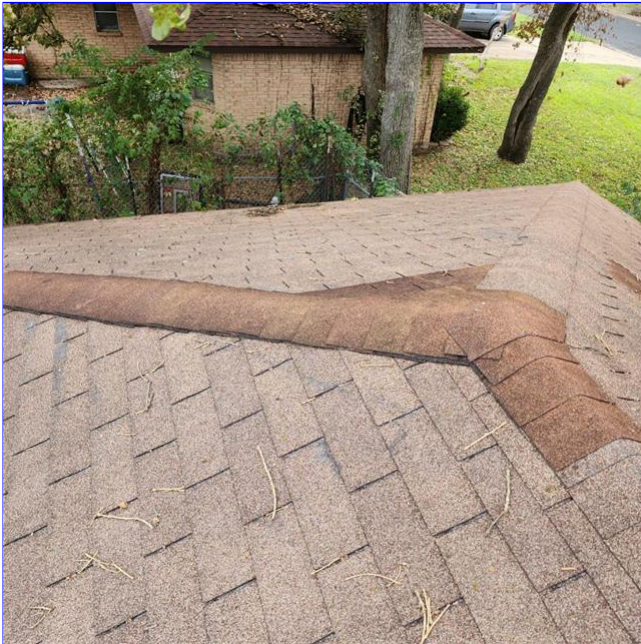
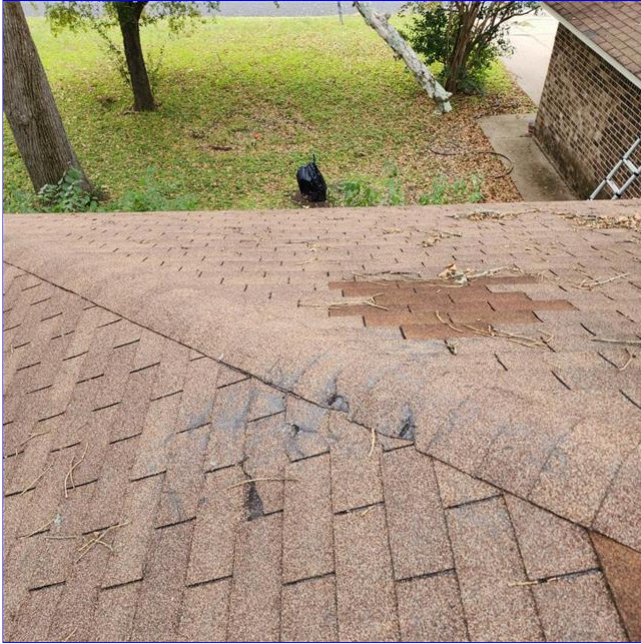
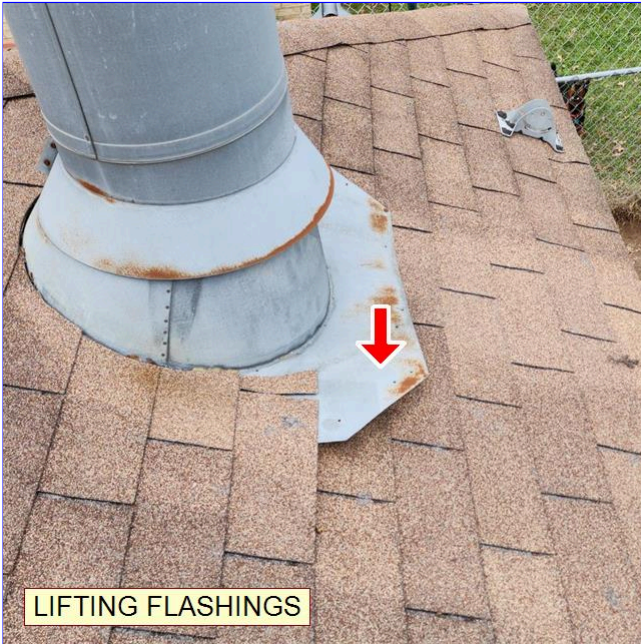
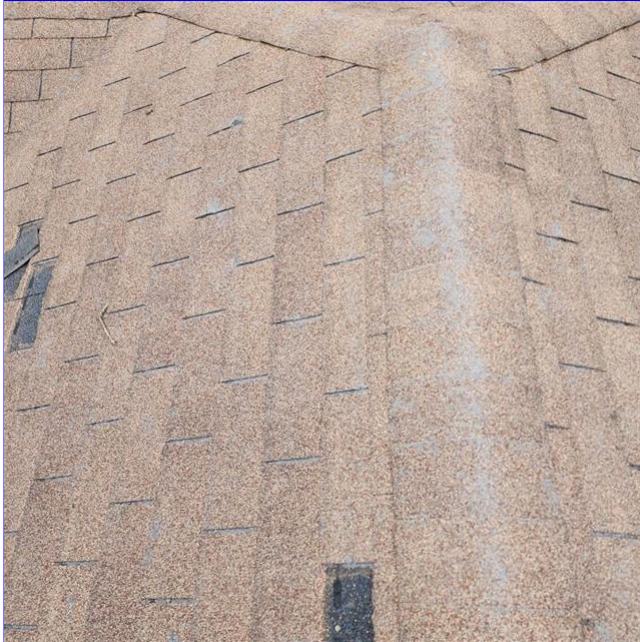
This is a composition roof that is at the end of its life. There are signs of weather damage in several areas. There missing, torn and worn shingles along the roof. Recommend replacement.

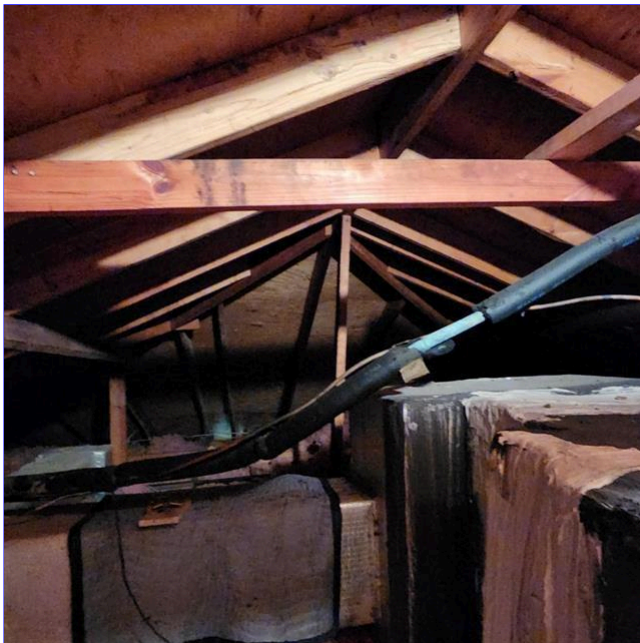
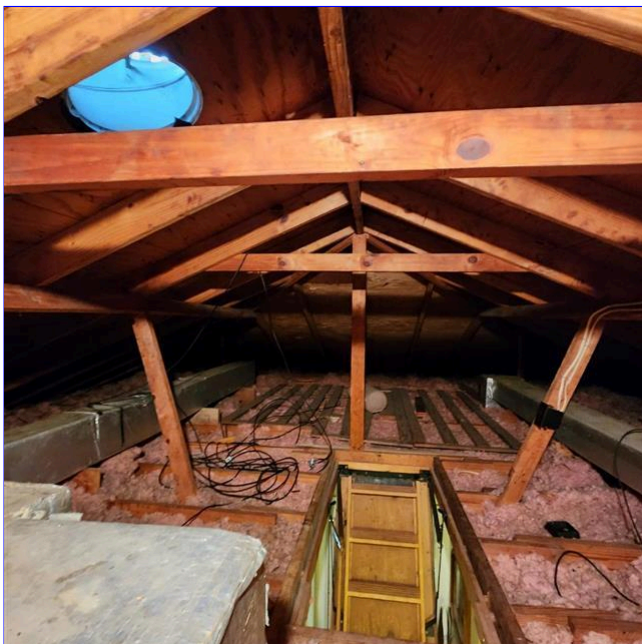
The attic framing in this home is typical for the era of its construction. It lacks enough bracing to meet current building standards. However, the framing still appears to be performing as intended with only signs of minor rafter deflection.

The insulation in the attic does not meet the current building standard of R30 value.

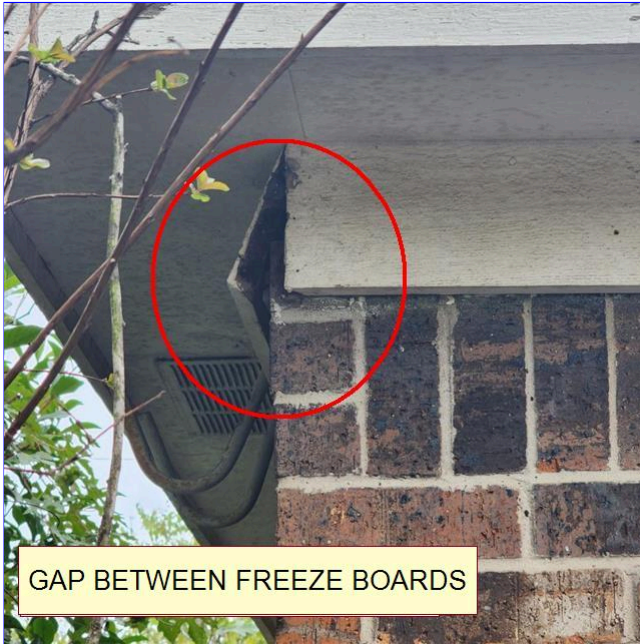
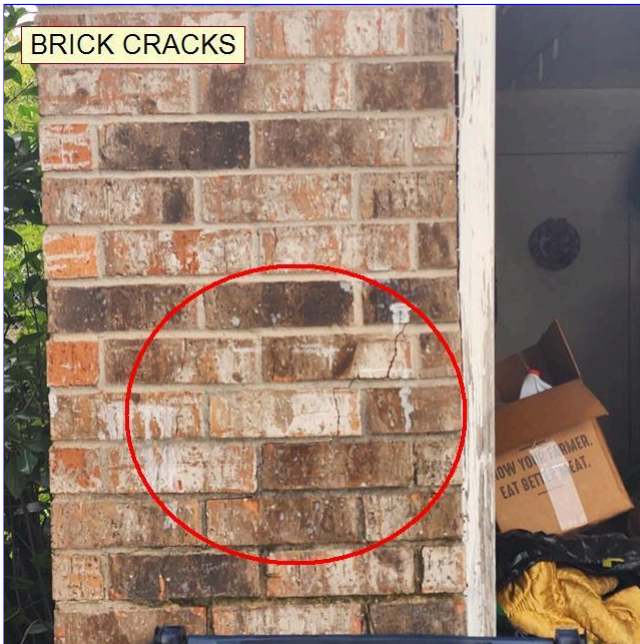
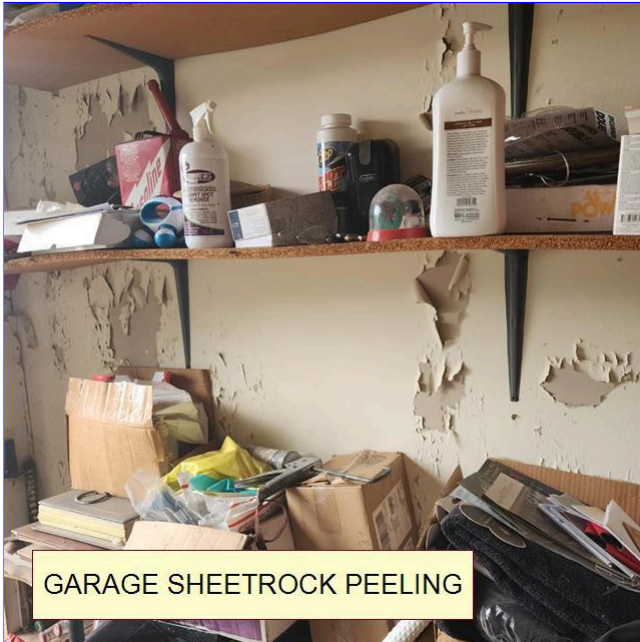
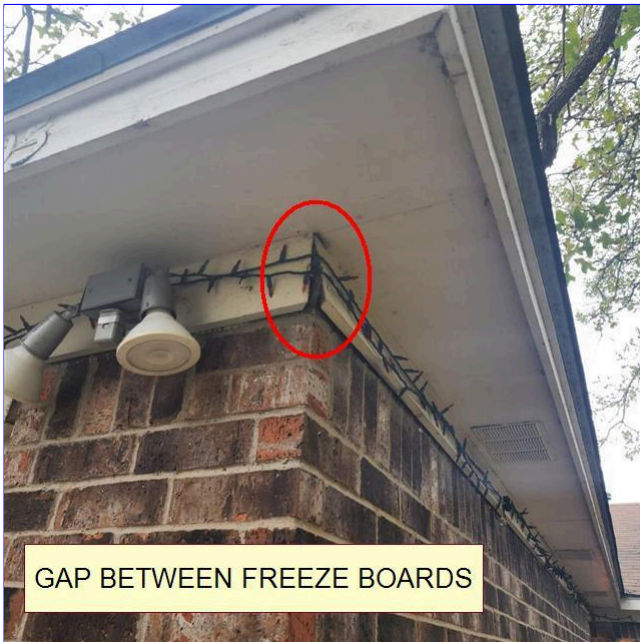
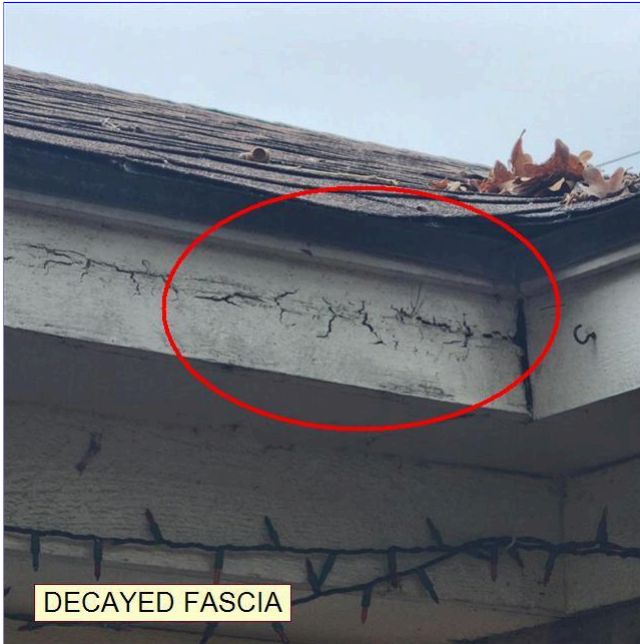
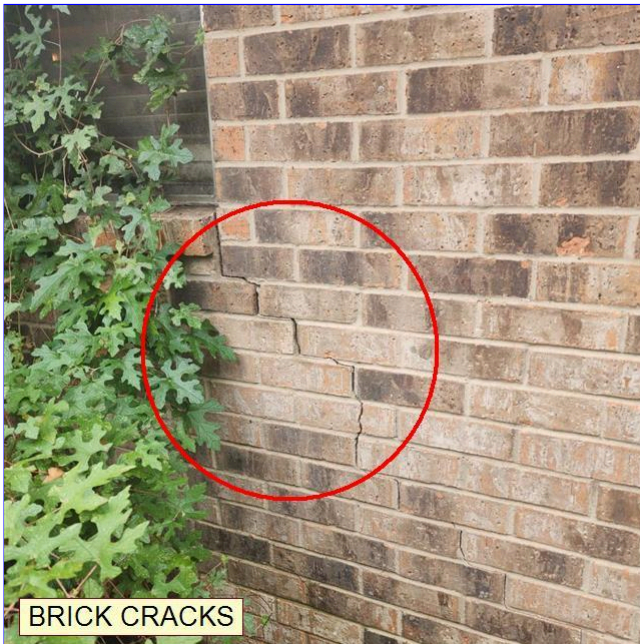
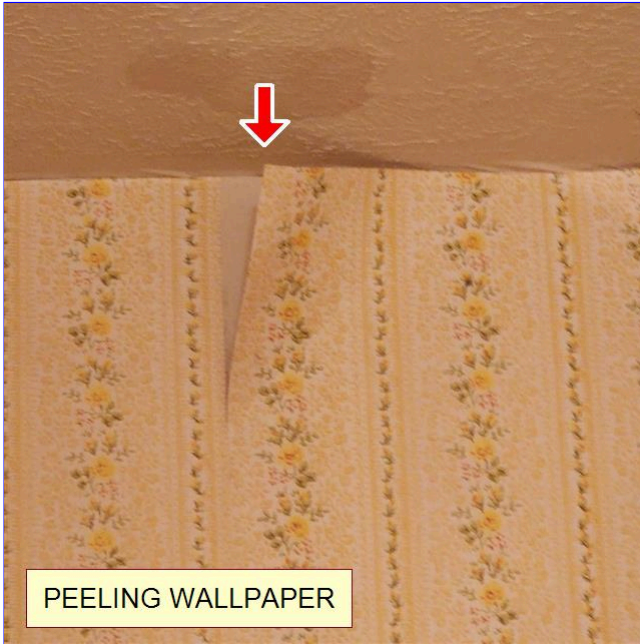
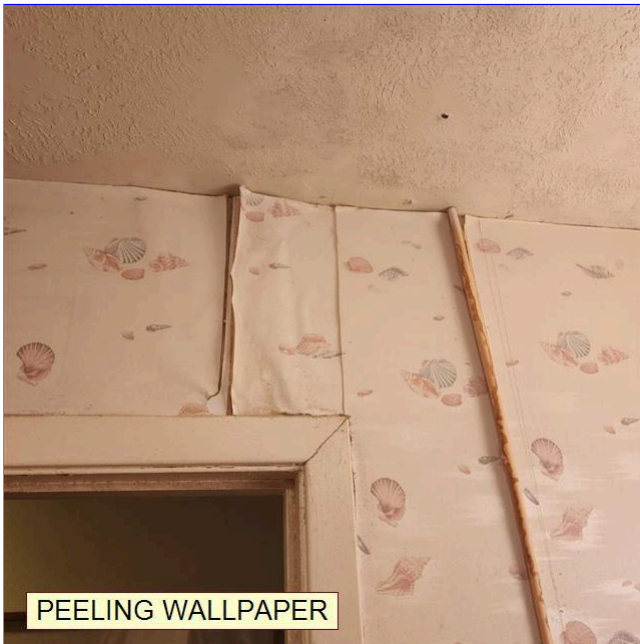
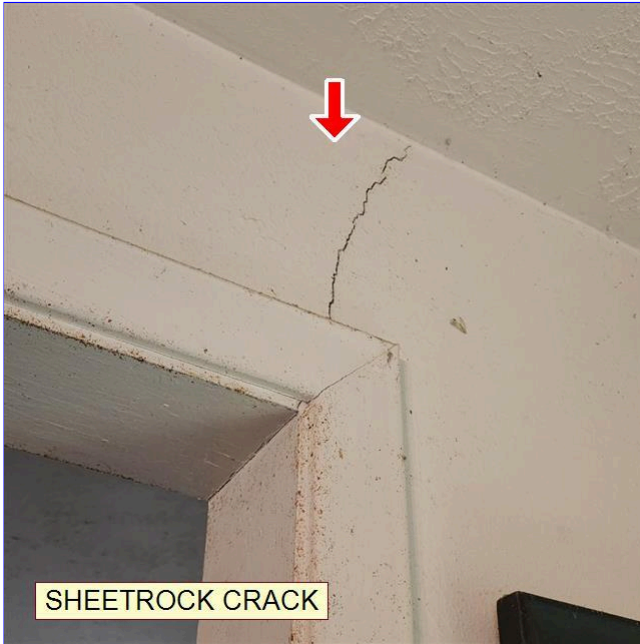
The gaps in the fascia, soffit, and siding should be sealed to prevent moisture from entering.

There are gaps between the corner freeze boards due to the foundation movement.

Brick cracks were noted in multiple areas around the exterior of the home.

The walls / sheetrock throughout the home are in overall poor condition. Cracks, peeling wallpaper, peeling sheetrock, and other cosmetic deficiencies were noted.

One of the front fascia boards is decayed.

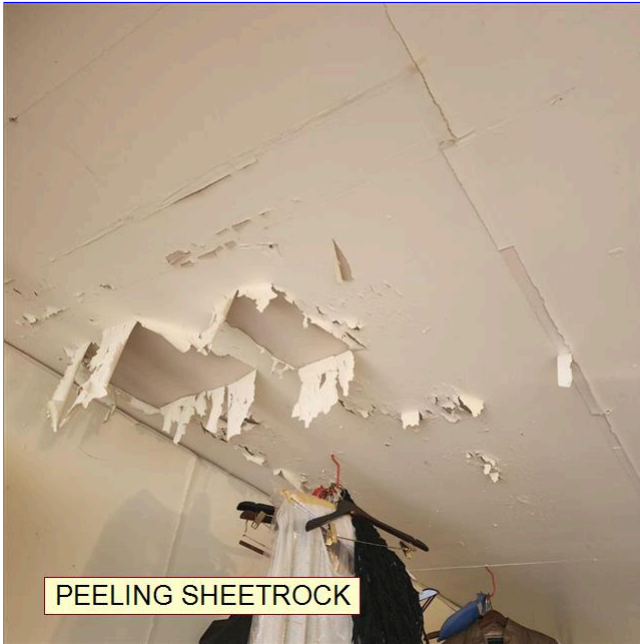
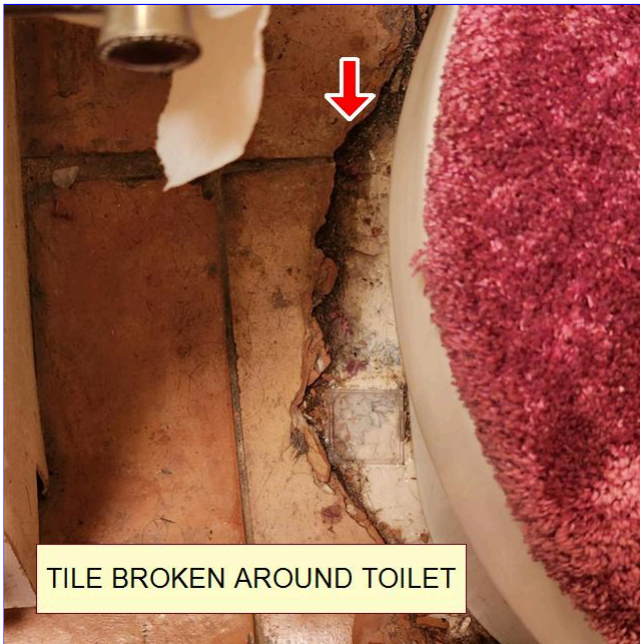
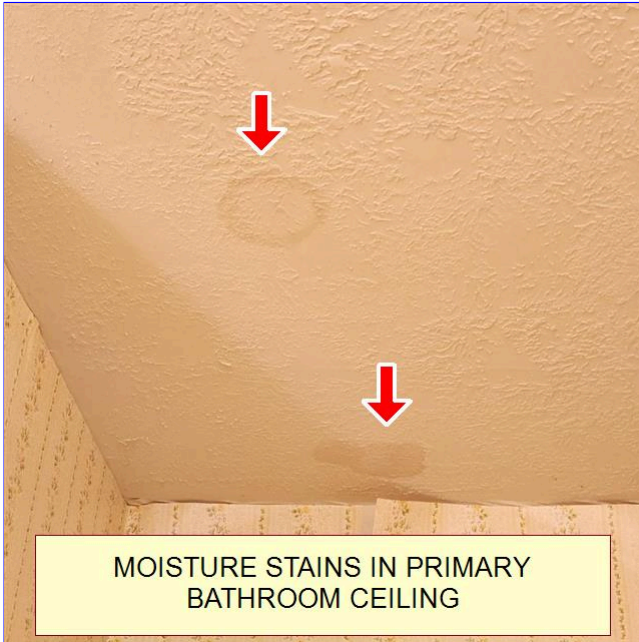
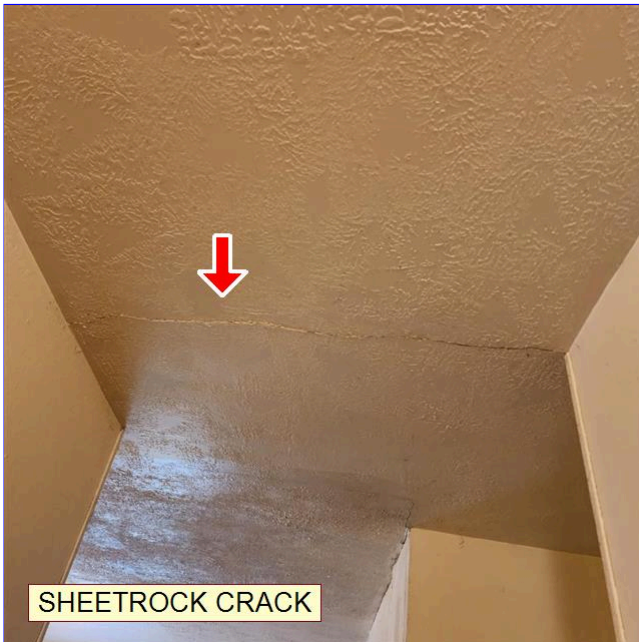
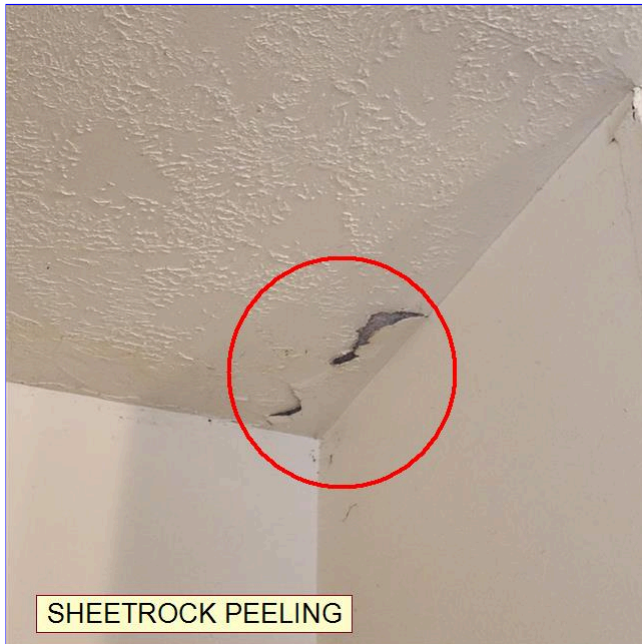
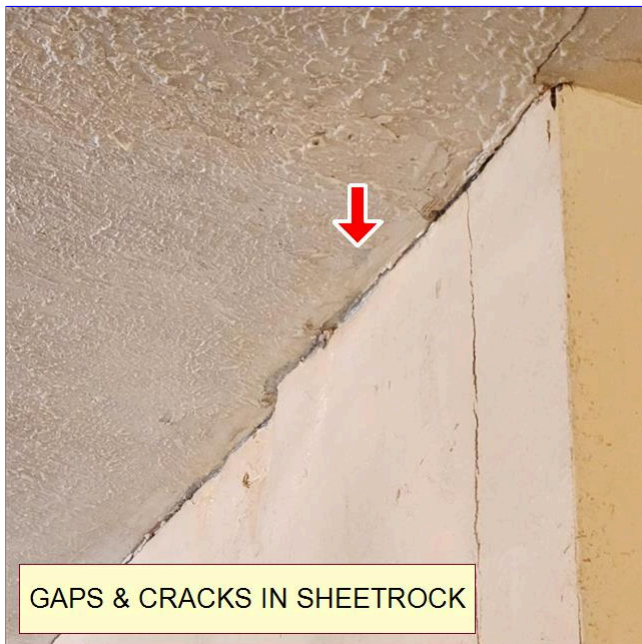
The garage ceiling sheetrock is peeling in several areas and is in poor condition.

There are moisture stains in the primary bathroom ceiling.

The tile around the primary bathroom toilet has been broken & chipped out.

The ceiling sheetrock throughout the home are in overall poor condition. Cracks, peeling sheetrock, and other cosmetic defects were noted.

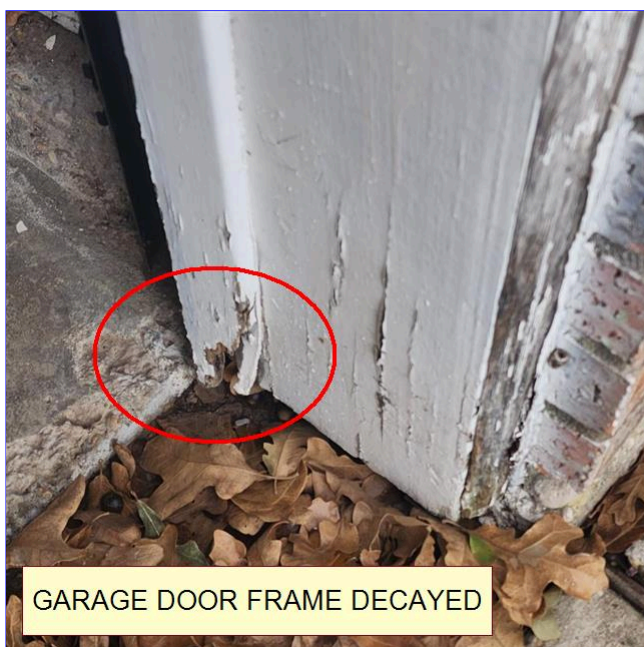
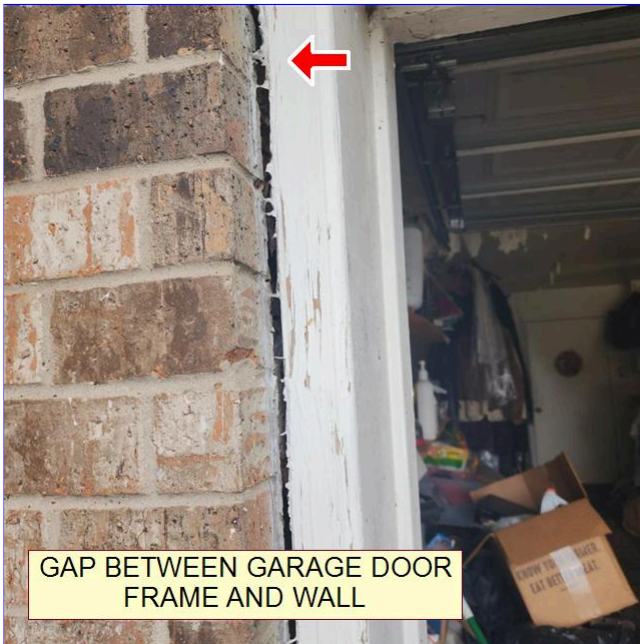
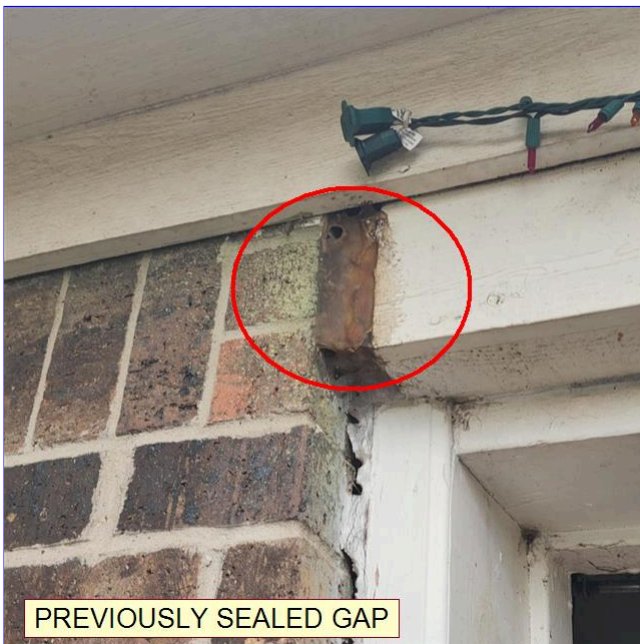
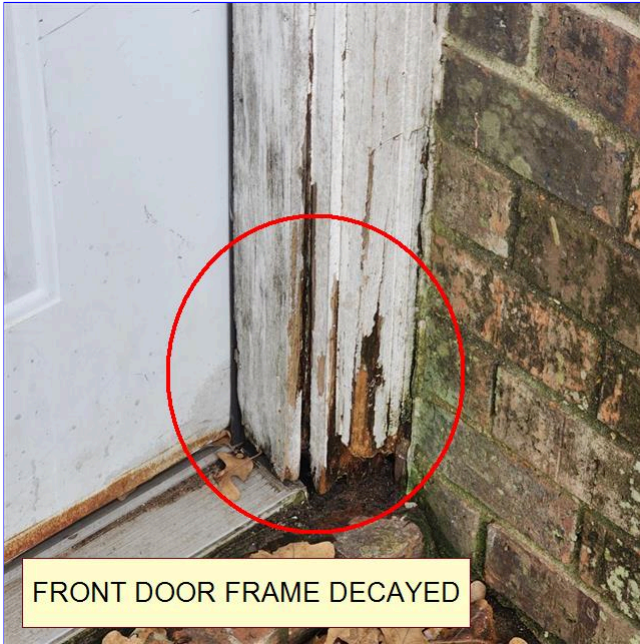
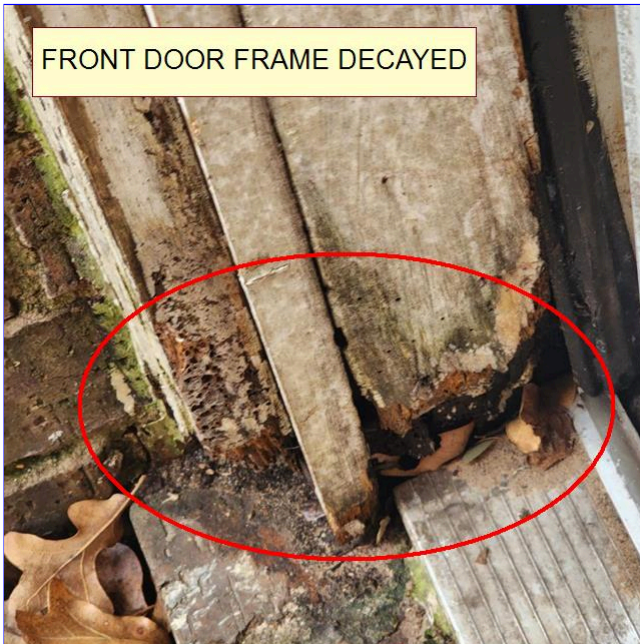
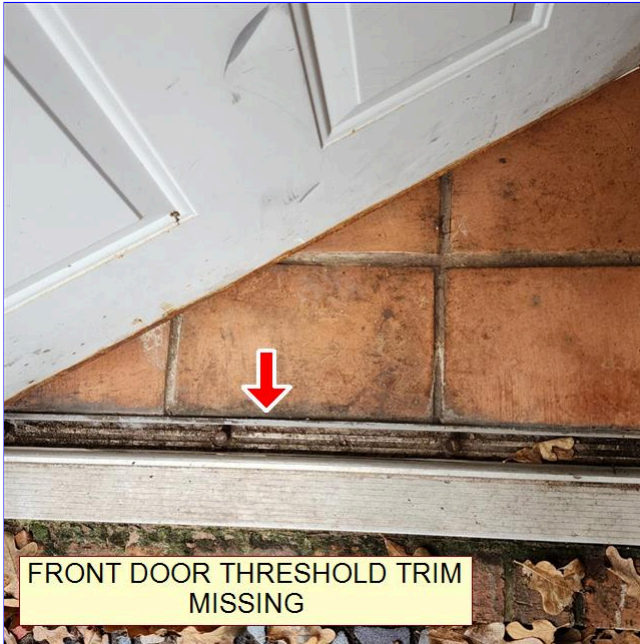
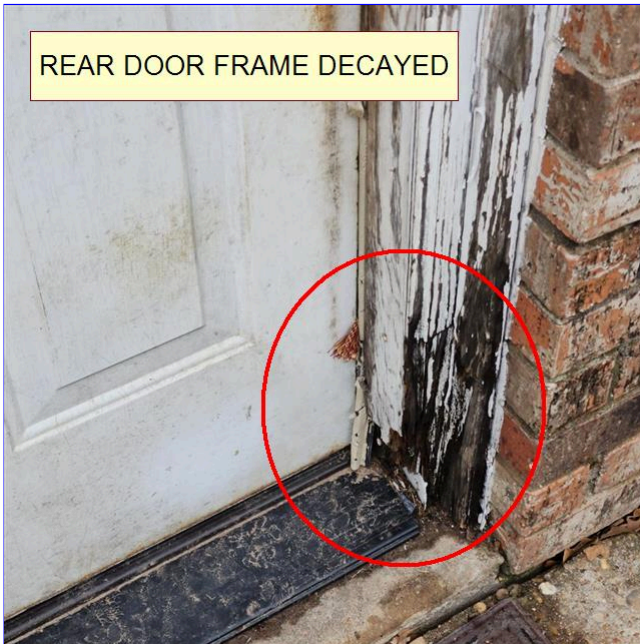
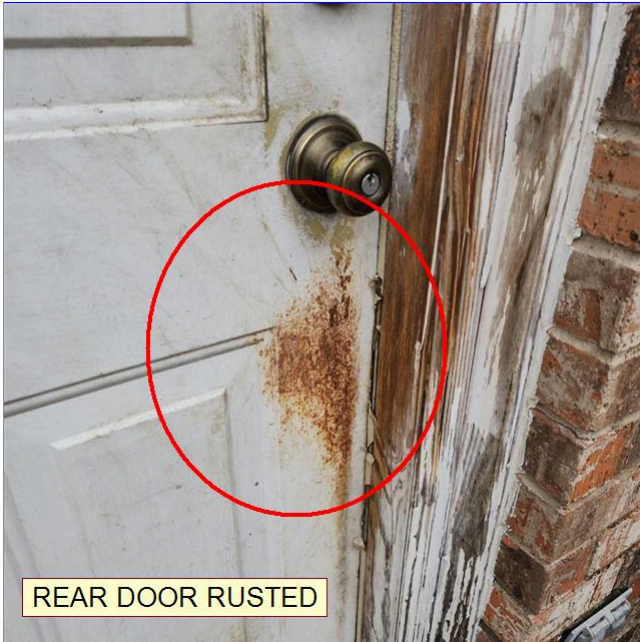
The garage door frame is decayed at the base of the right side.

There are large gaps between the garage door frame and brick that should be sealed.

The front door frame is decayed at the base on both sides.

The front door threshold plastic center trim is missing.

The garage occupant door does not have self closing hinges installed. This would not meet current building standards.

The occupant door from inside garage to inside the home is not a fire rated door. This means that should a fire occur in garage, the occupant door does not afford protection until fireman arrive. This door should be replaced with a fire rated door.

The front door drags on the tile when opened and closed.

The rear exterior door is rusted.

The rear door weather stripping is damaged.

The rear door frame is decayed at the base on both sides.

The garage occupant door frame does not have weather stripping installed.

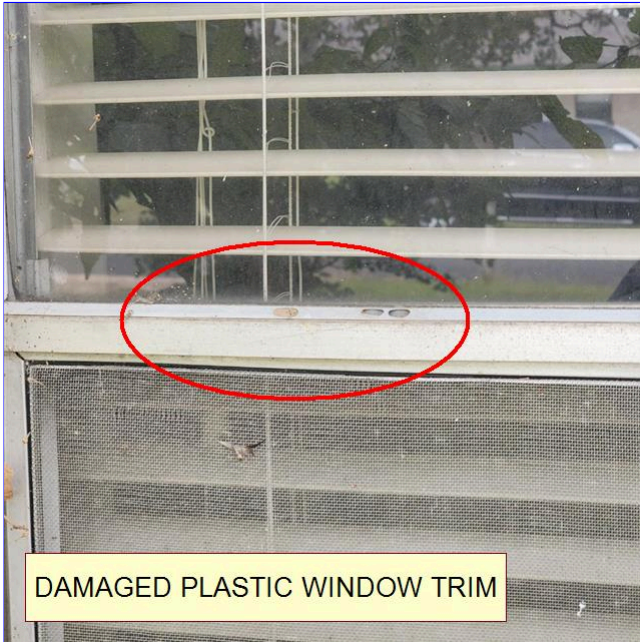
I. Item 1(Picture)

Screens: 4 damaged

Several of the windows had chipping exterior plastic window trim.

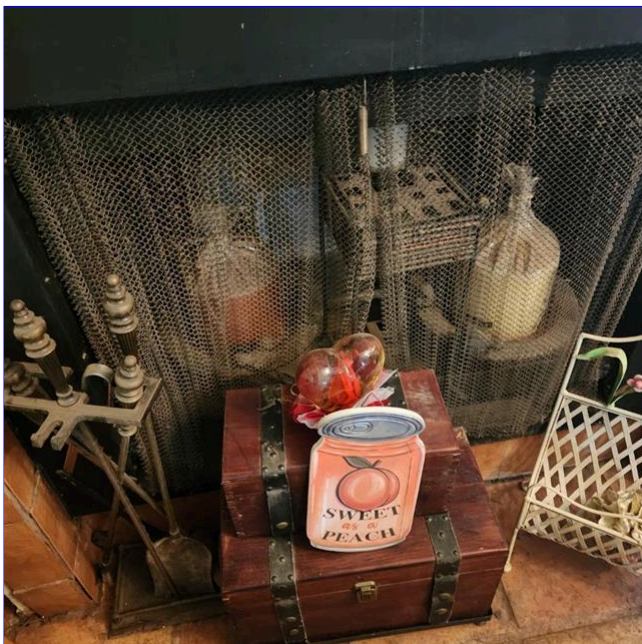
J. Item 1(Picture)

The fireplace and chimney need to be cleaned.

Note: The chimney was filled with items at the time of inspection.

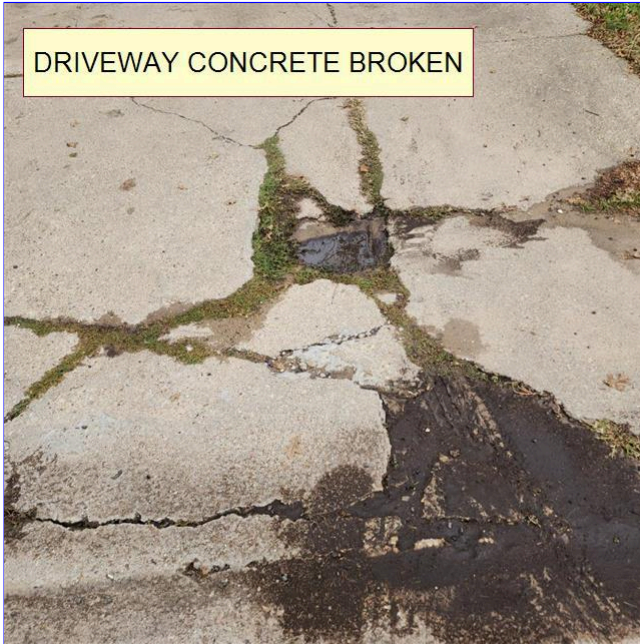
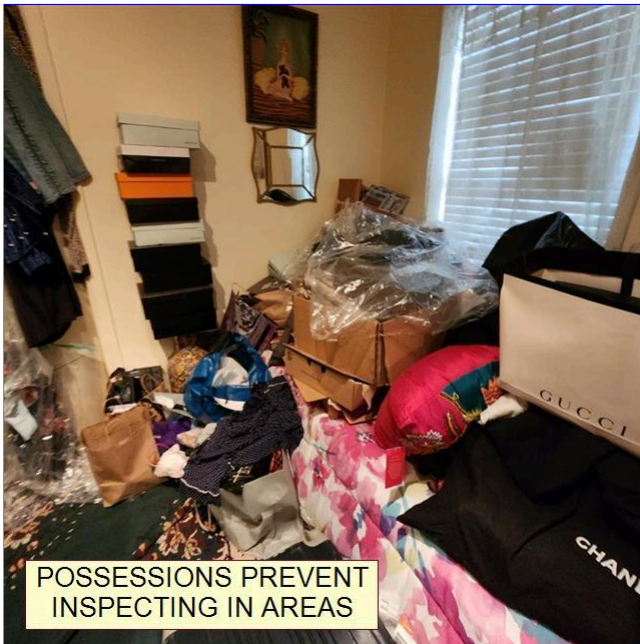
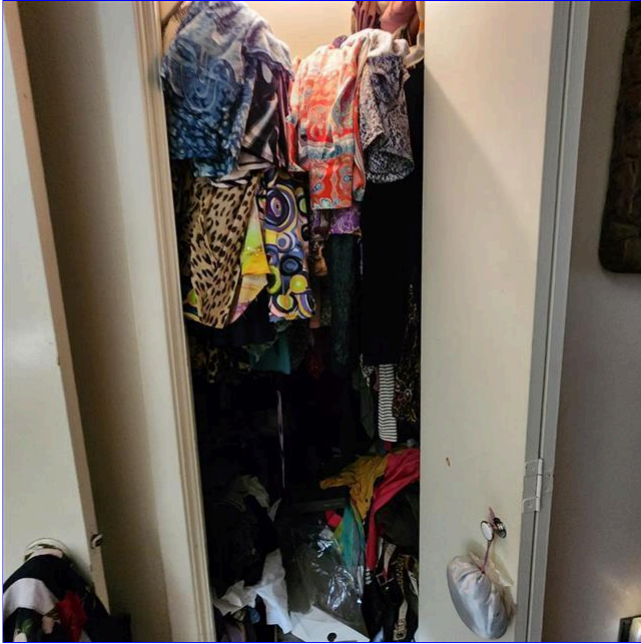
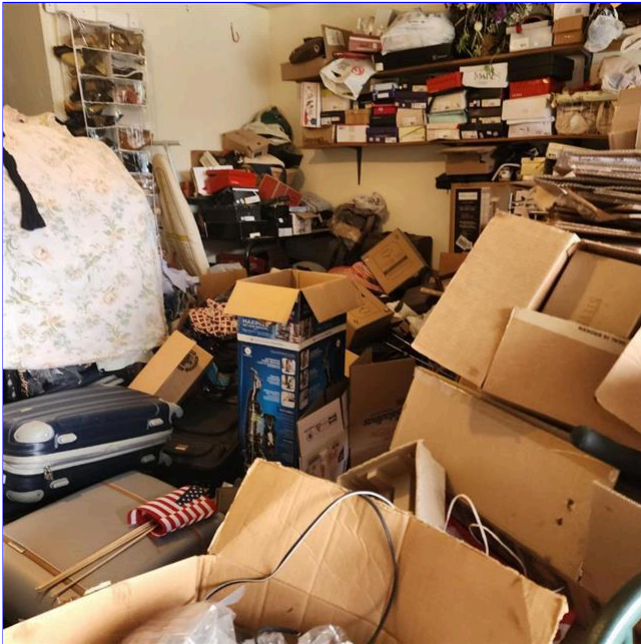
The rear fence is in poor condition and leaning in several areas.

The driveway concrete is cracked / broken in several areas.

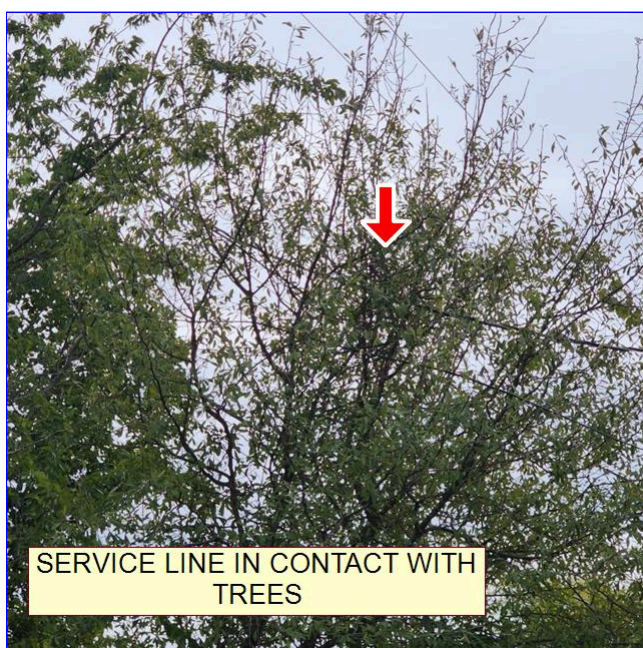
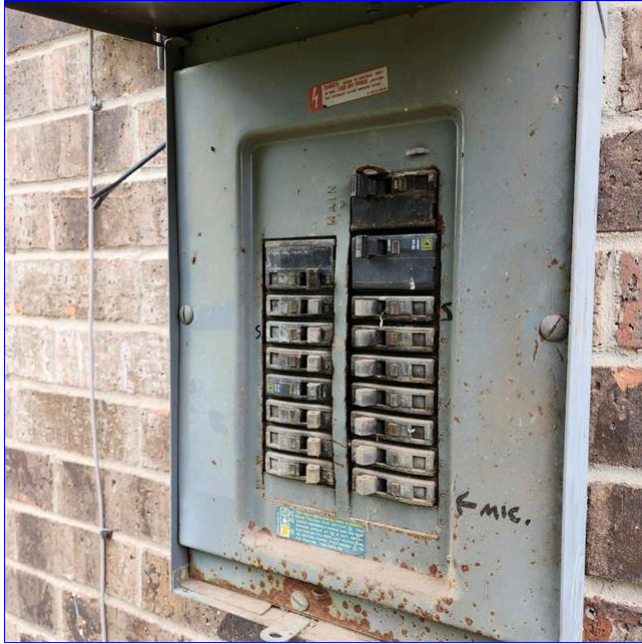
The breakers in the panel were not labeled as to which circuit they protect. *This would not meet current building standards.*

The incoming service line is in contact with tree branches.
