Inspection Report

Property Address:
3505 PECOS
BRYAN TX 77801

TUCKER INSPECTIONS LLC

Date: 11/22/2022	Time:	Report ID:
Property: 3505 PECOS BRYAN TX 77801	Customer: KAI COTHRAN	Real Estate Professional: Monica Martinez

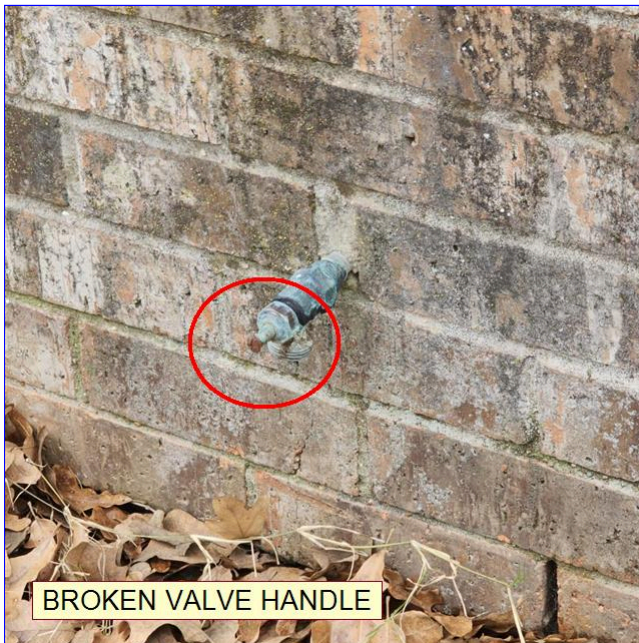
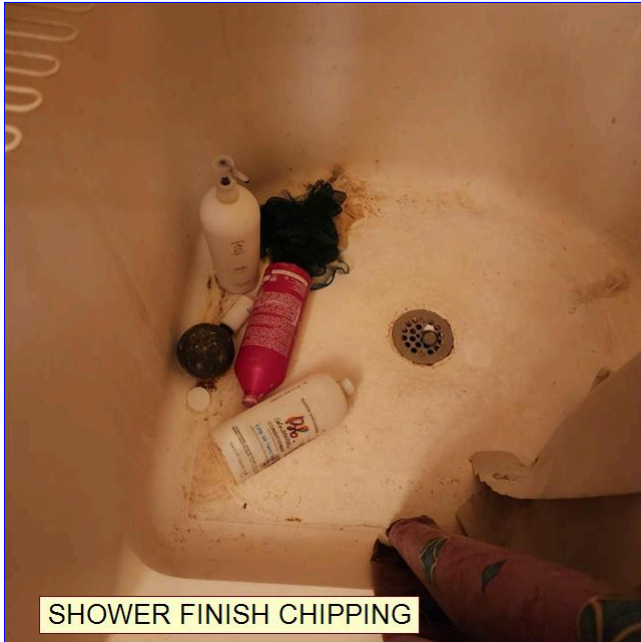
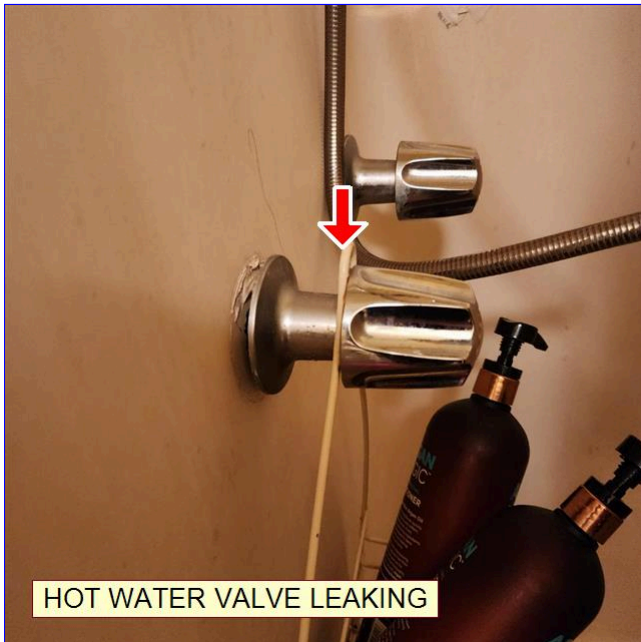
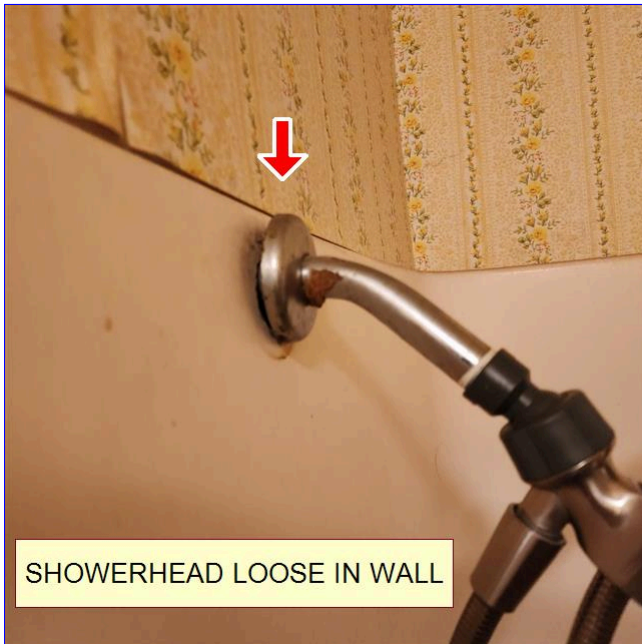
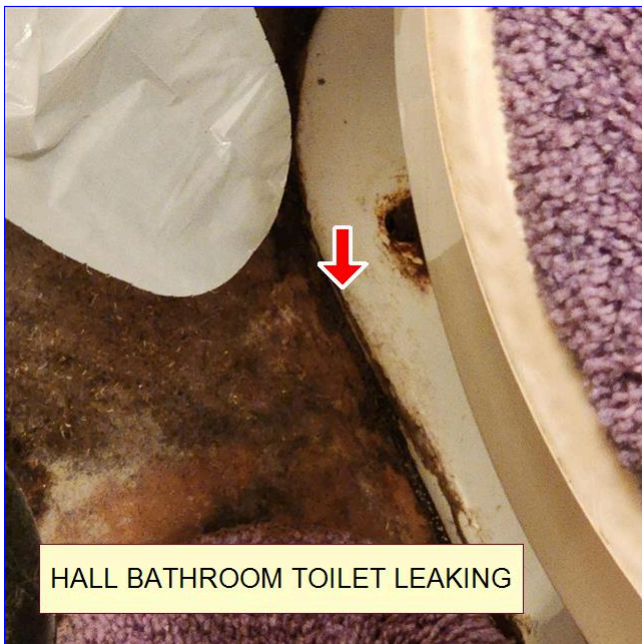
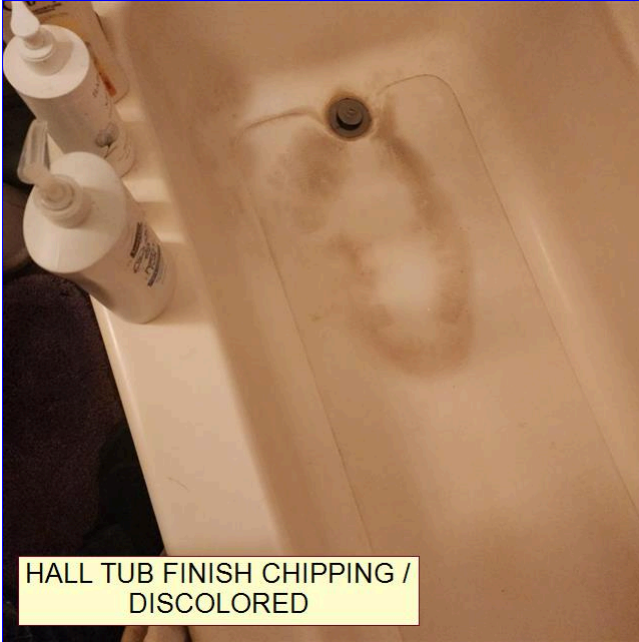
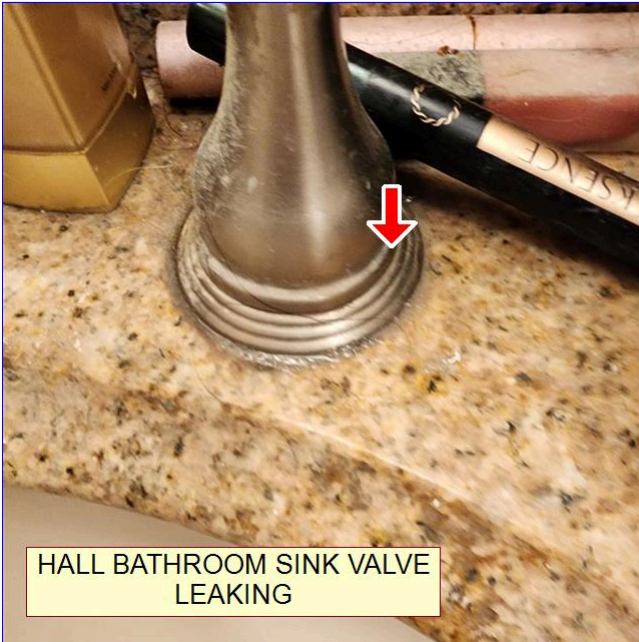
There were missing back flow preventer on the exterior hose bibs.

The rear exterior hose bib valve handle is broken.

The primary bathroom shower finish is chipping.

The primary bathroom shower hot water valve is leaking

The primary bathroom showerhead is loose in the wall.

The hall bathroom toilet is leaking at the base.

The hall bathroom tub finish is chipping and rusted around the drain.

The hall bathroom sink is leaking at the cold water valve stem.

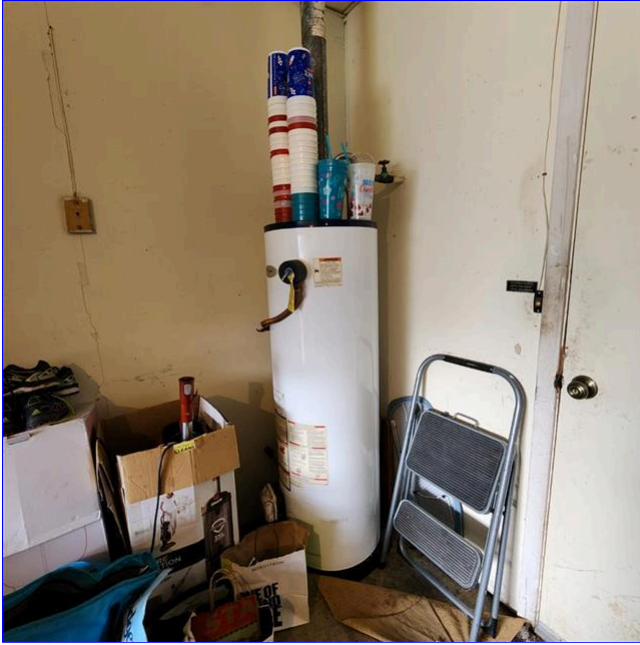
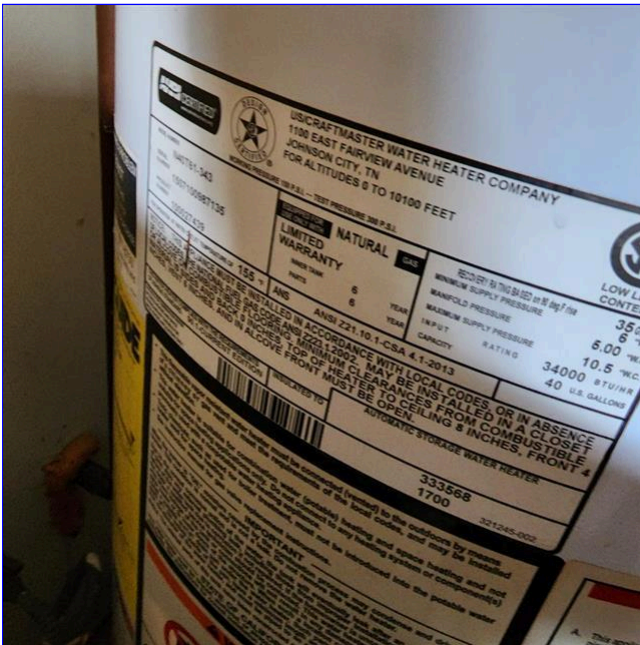
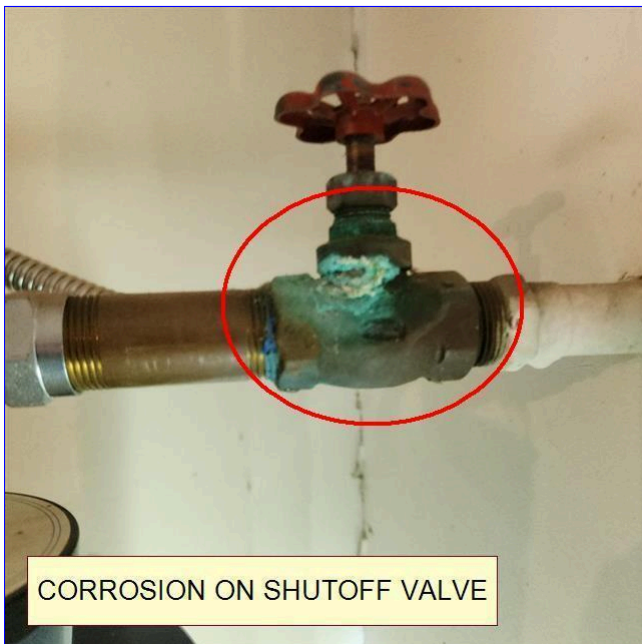
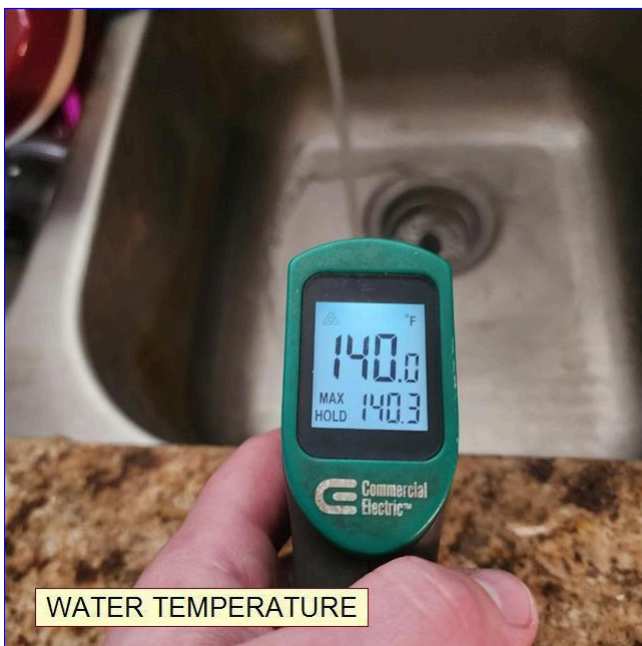
There was no pan under the unit. The pan should have a drainline attached running to the exterior. *This*

The unit was not raised 18" off the floor.

Corrosion was noted on the water shutoff valve. No active leaks were found at the time of inspection.

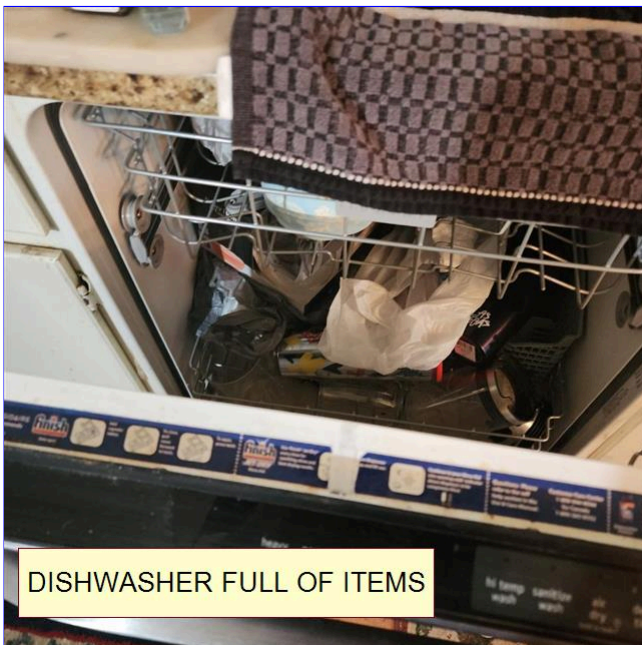
A. Item 1(Picture)

The dishwasher was filled with possessions and was not able to be function tested at the time of inspection.

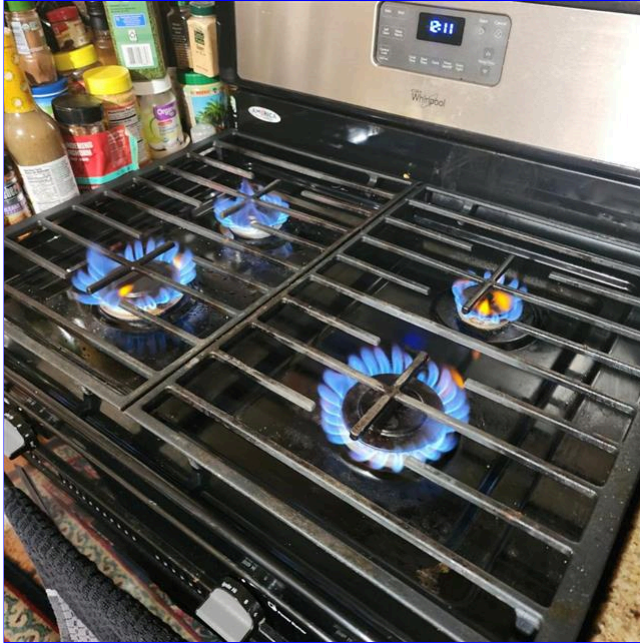
D. Item 1(Picture)

This is a stand alone range. There was not an anti tip brace in stalled. *This is a safety hazard.*

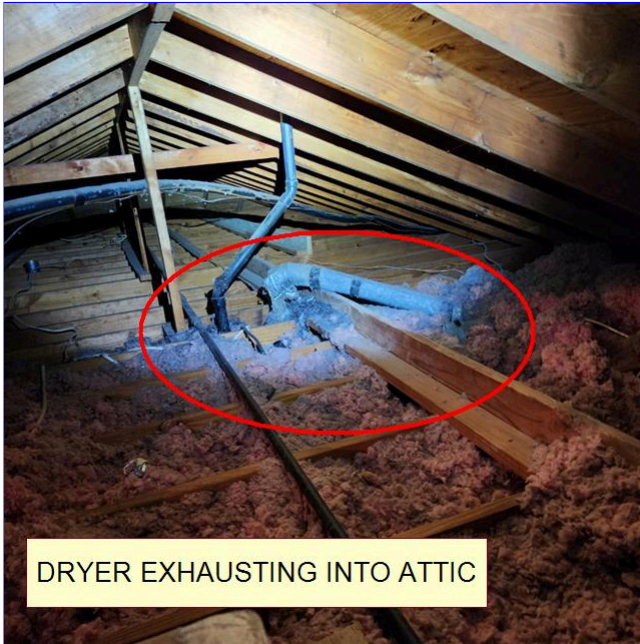
H. Item 1(Picture)

The dryer exhaust is currently vented into the attic. The vent pipe should extend through the roof decking to the exterior of the home.

The dryer exhaust vent pipe needs to be cleaned.
