Mechanical Serviceability Inspection

3505 Pecos Bryan, TX, 77801

Report Created on November 22, 2022 10:04 PM

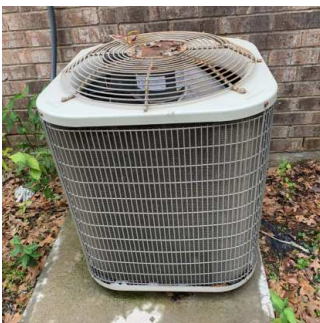
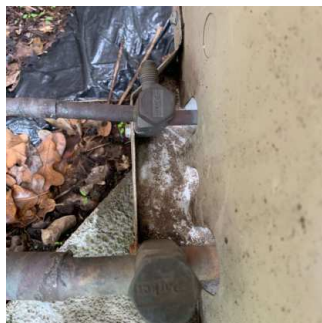
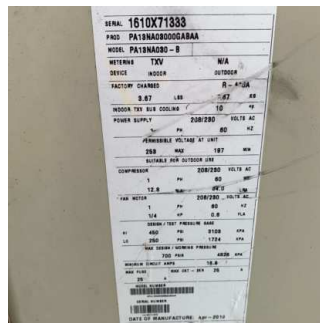
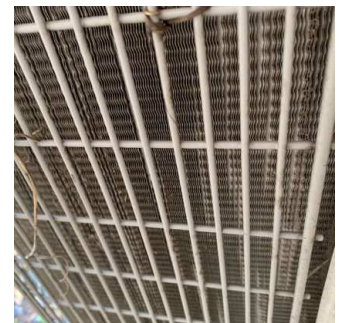
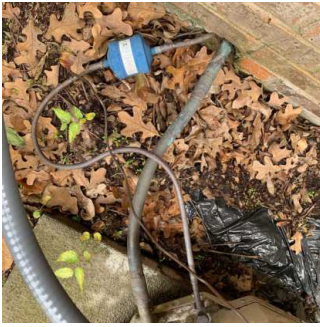
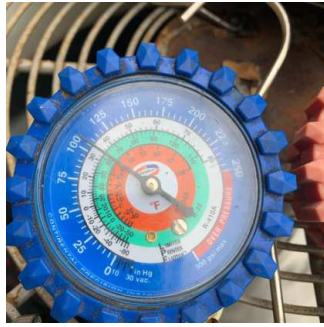
Items	Good	Fair	Clean	Dirty	Damaged	Notes
Condenser		✓		✓		2010 Payne 2.5 Ton R-410A Clean condenser coils and electrical section, secure low voltage and install locking valve caps. Insulate Copper.

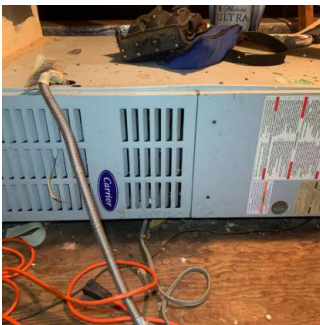
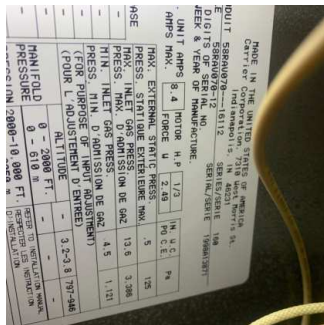
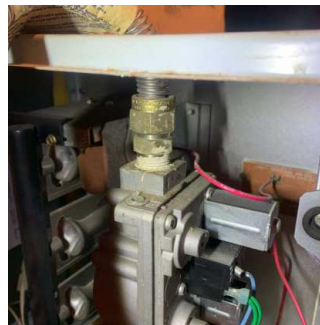
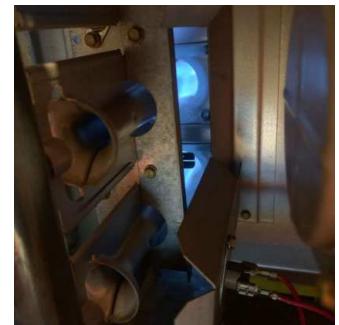
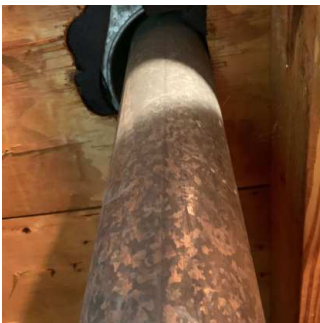
Items	Good	Fail	Clean	Dirty	Damaged	Notes
Furnace		✓		✓		1998 Payne Furnace in operational condition, need to seal flue pipe and install CO detector. Install solid gas pipe. Seal transition. Need 1" flue clearance.

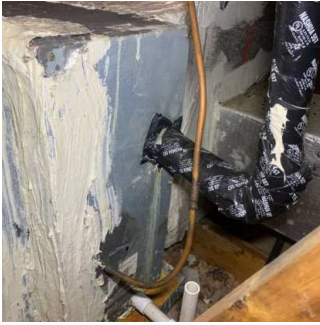
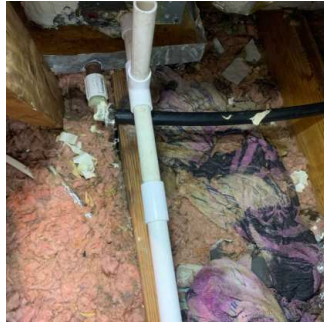
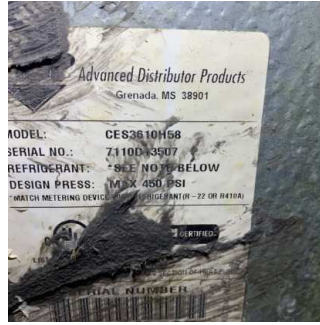
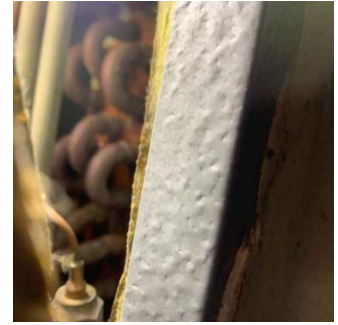
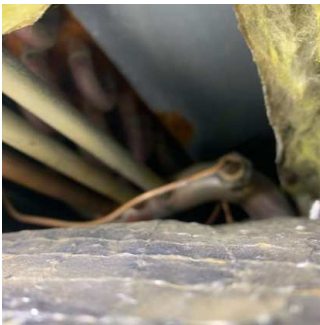
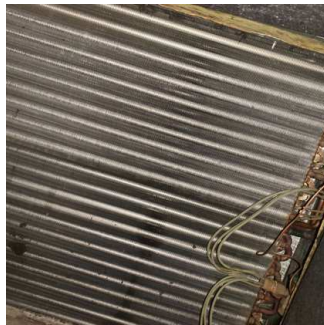
Items	Good	Fair	Clean	Dirty	Damaged	Notes
Evaporator Coil		✓		✓		2010 ADP Evaporator Coil is rusted, but has no detectable leaks, need to have coil cleaned, drain cleaned, and insulated. Install safety switch.

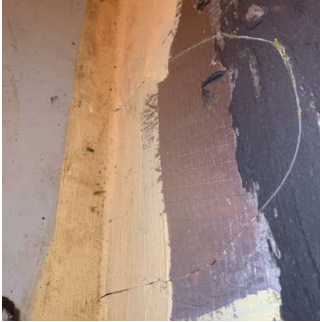
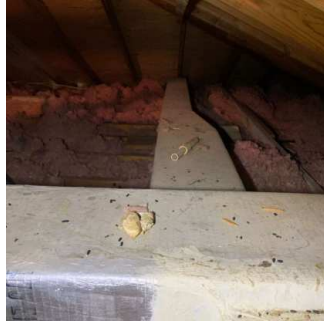
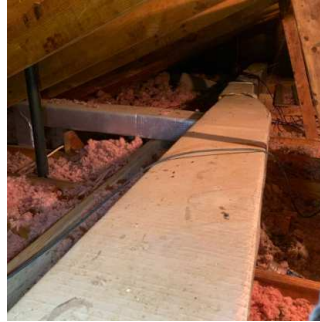
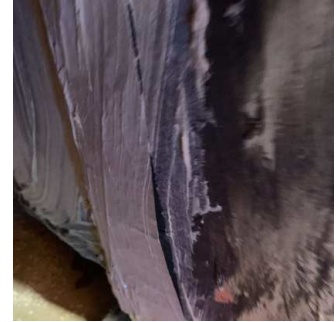
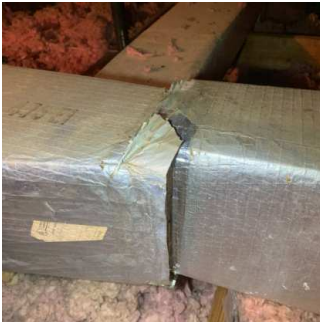
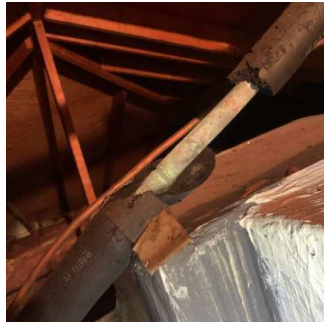
Items	Good	Fair	Clean	Dirty	Damaged	Notes
Misc.						Seal ductwork in 1 spot. Repair damaged duct in 1 area. Insulate copper. Clean and repair dryer vent.
