# PROPERTY INSPECTION REPORT

Concerning: 2215 Briarstead Drive , Houston, TX 77057  
(Address or Other Identification of Inspected Property)

By: Bob Avery Lic.#: TREC #20559 MAT #1059 04/15/2021  
(Name and License Number of Inspector) (Date)

DATE OF INSPECTION: 04/15/2021

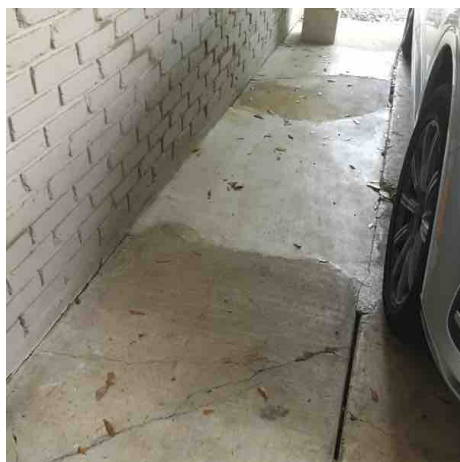
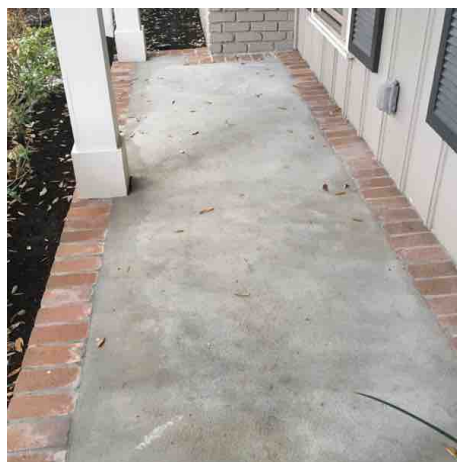
- Previous slab repairs noted. Recommend client investigate with seller as to repairing company, and if the warranty is transferable and request a current status by the repairing company to see if there has been any change since the repair. If so, make repairs. If no such warranty exists we recommend a licensed structural engineer to further evaluate the current status of the foundation.

Slab appears to not be providing adequate support at this time. See comments in walls, ceilings and floors to support this opinion.

Recommend a structural engineer be consulted to understand the extent of the issue and the repairs needed to correct.

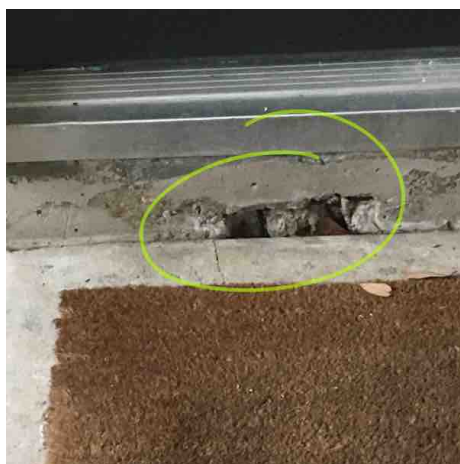
- Gap in foundation wall should be filled and sealed. At car port

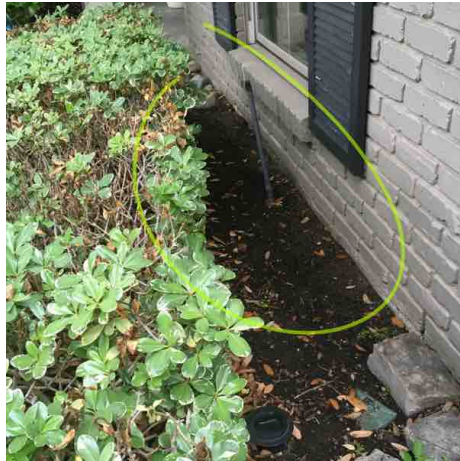
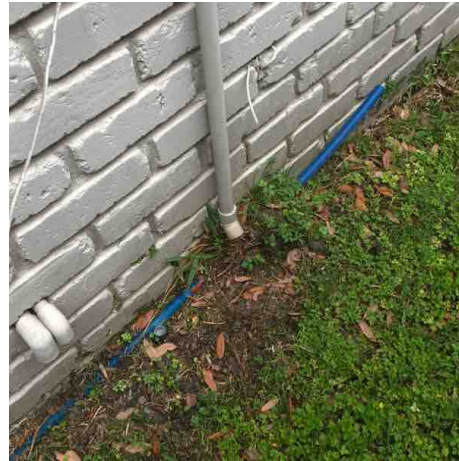
- **Soil grade is level with or above brick weep holes; this is conducive to pest and moisture intrusions. Recommend lowering soil grade height to expose approximately 4 inches or more between the brick or siding veneer and final soil height, then regrade surrounding soil levels in a manner that will move moisture away from foundation areas in a positive manner. Recommend WDI inspection. Throughout**

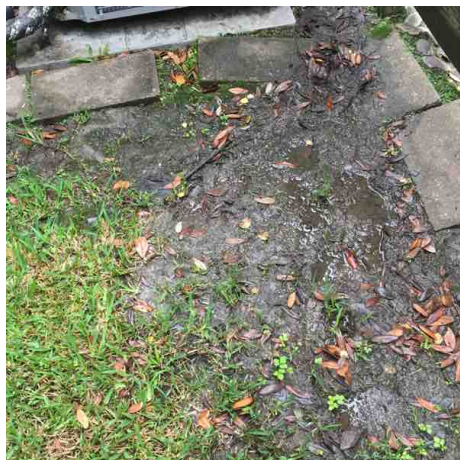
- **Standing water was observed. Lot drainage and guttering should be addressed in alleviating this problem. (Right Exterior)**

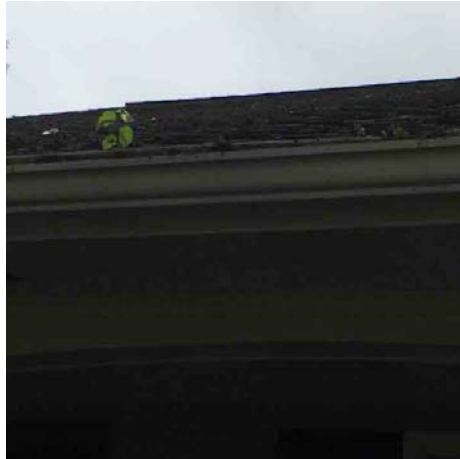
- **Gutters contain debris. Recommend removal of debris and cleaning of gutters and downspouts. A regular routine maintenance program should be established in the future to prevent build-up of debris.**

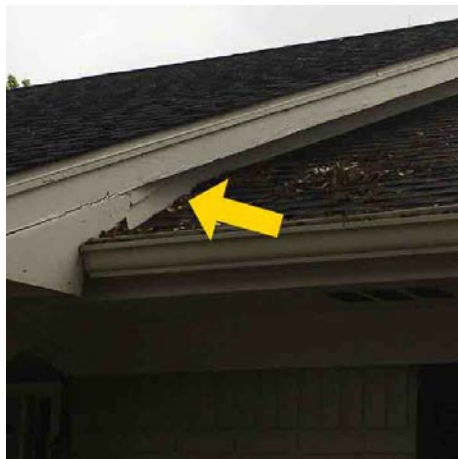
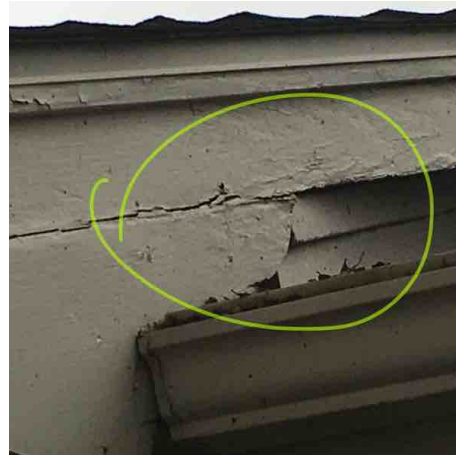
- Construction of roof/pitch did not allow for safe access to roof covering, roof was visually observed on the ground with binoculars (30 or 40 zoom cameras are also used) and / or by ladder at edge of roof surface, some areas could not be visually observed.
- **Wood decay observed at several locations of the fascia and/or soffit**

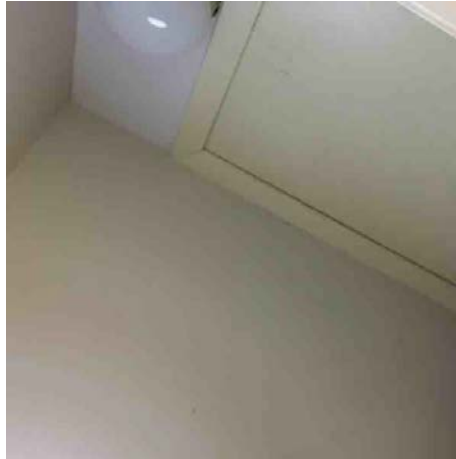
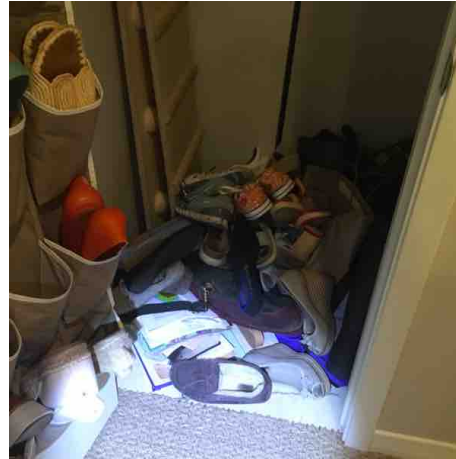
- Hatch to access attic in addition is not accessible

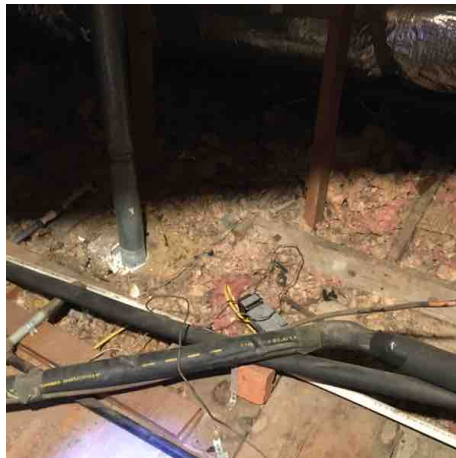
- Recommend adding/replacing-missing insulation in areas as necessary to promote better overall efficiency and reduce energy costs.

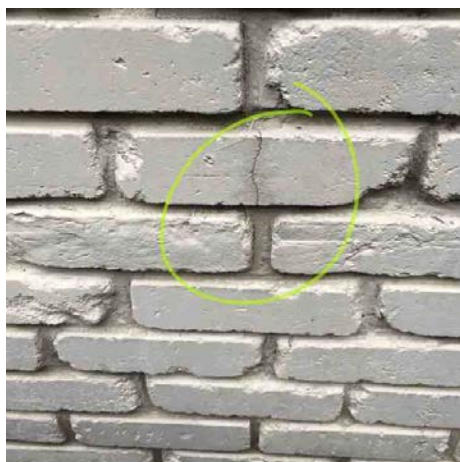
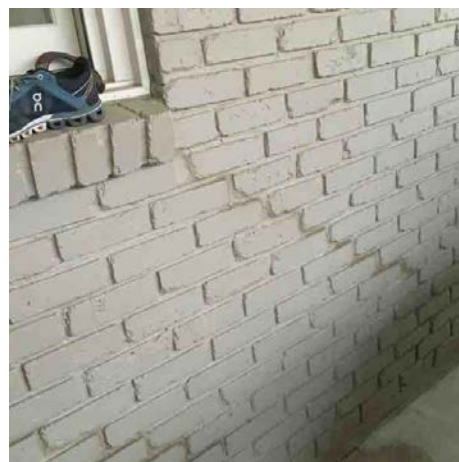
- **Settlement crack noted on exterior right wall. Normal for a home of this age. See foundation section**

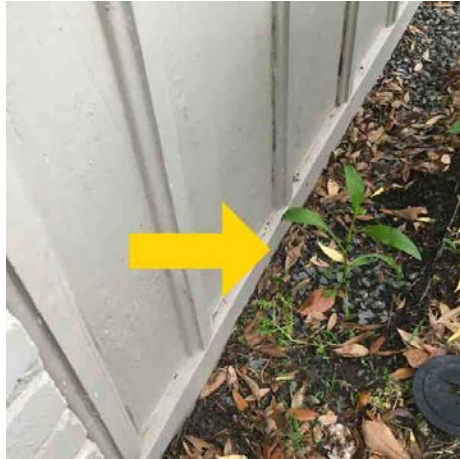
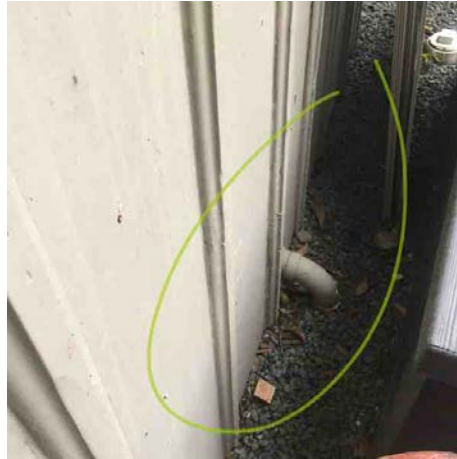
- Siding is in direct contact with ground which can cause decay and creates a pathway for wood destroying insects. Recommend regrading to allow for 4" to 6" of the slab to show. Throughout

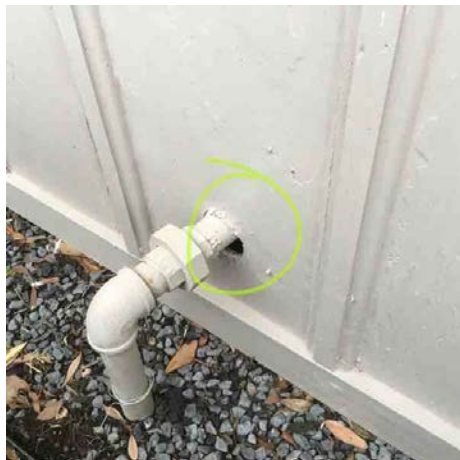
- All exterior wall penetrations should be sealed with a high quality exterior caulking material to help prevent moisture from penetrating. (Back Exterior)

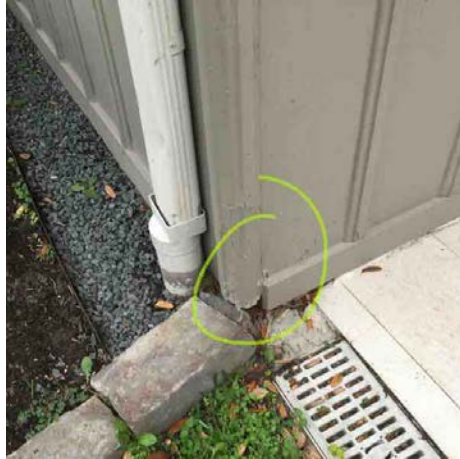
- Decay observed at several locations around perimeter of residence. Recommend further review by a qualified siding contractor to perform a thorough evaluation of all exterior siding and make repairs as needed. (Back Exterior)

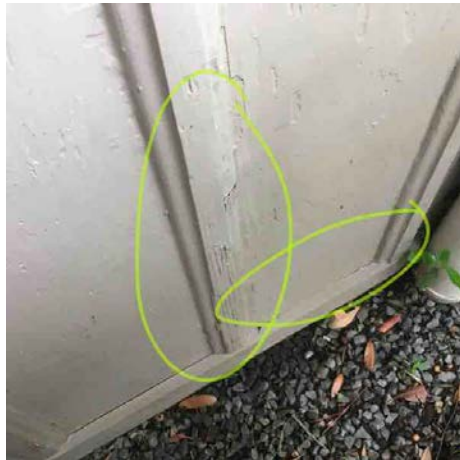
- Recommend all areas of decayed wood be repaired/replaced to promote good weather seal and reduce moisture penetration. (Back Exterior)

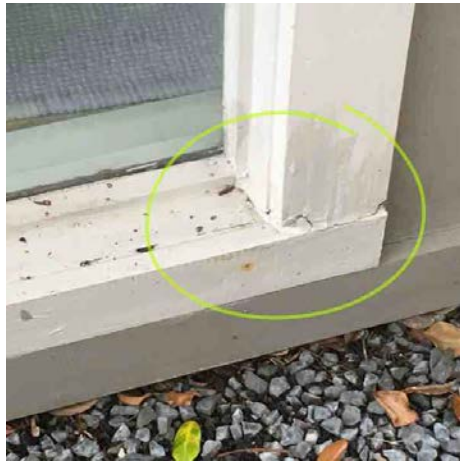
- Recommend all areas of decayed wood be repaired/replaced to promote good weather seal and reduce moisture penetration. **(Back Exterior)**

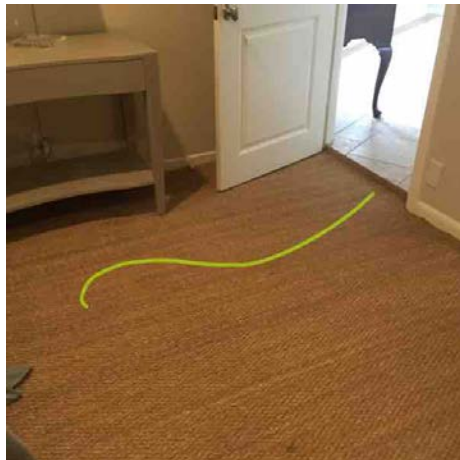
- Floors are uneven in master.

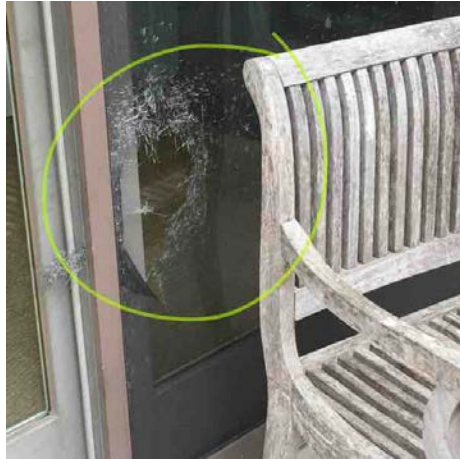
- Sliding Screen door is damaged.

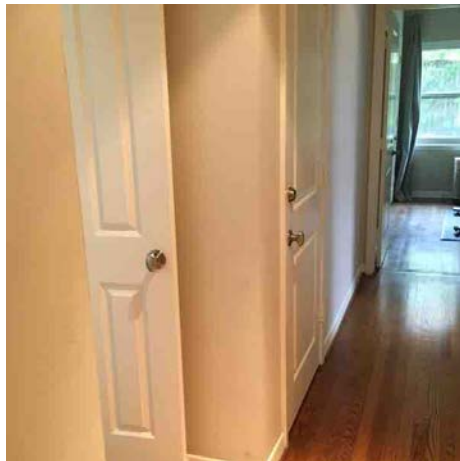
- Closet door is locked. No access

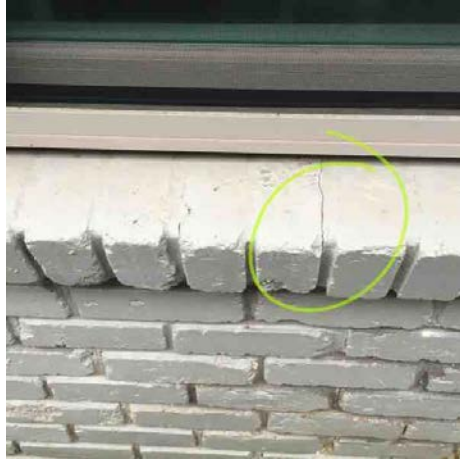
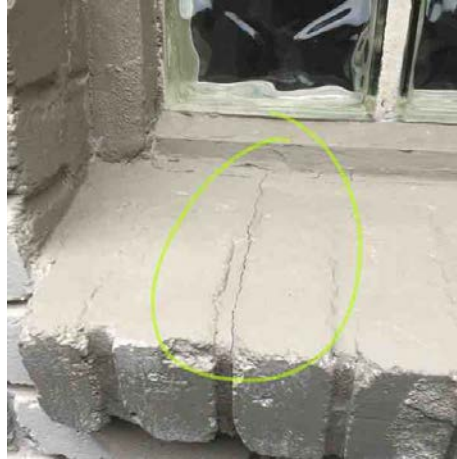
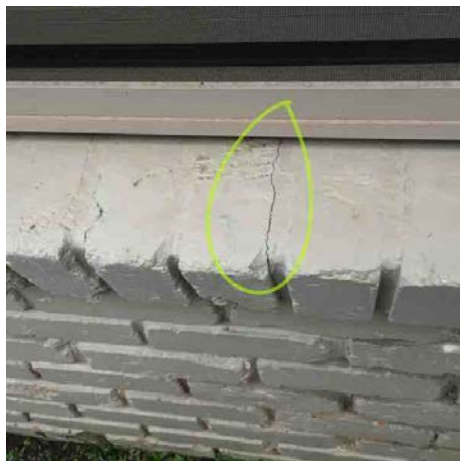
- **Several cracks noted on the exterior window ledges. Recommend sealing.**

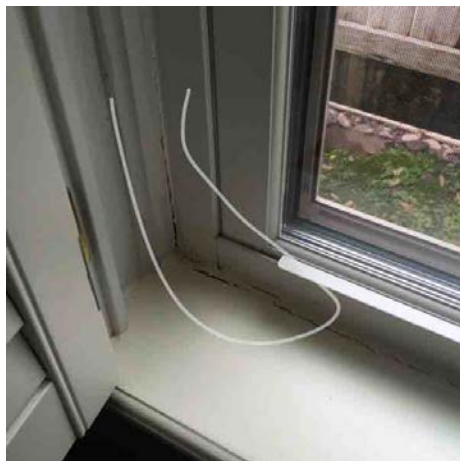
- **Sills show signs of minor decay require maintenance. Nursery**

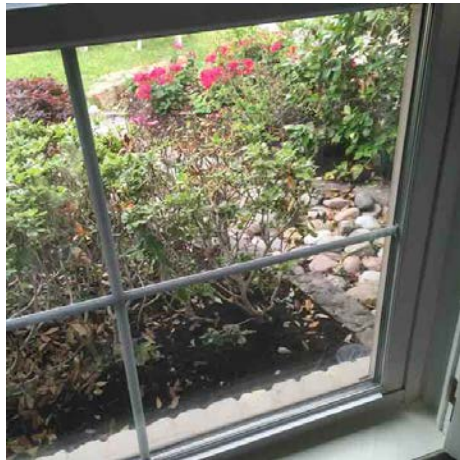
- Some window screens missing or damaged.

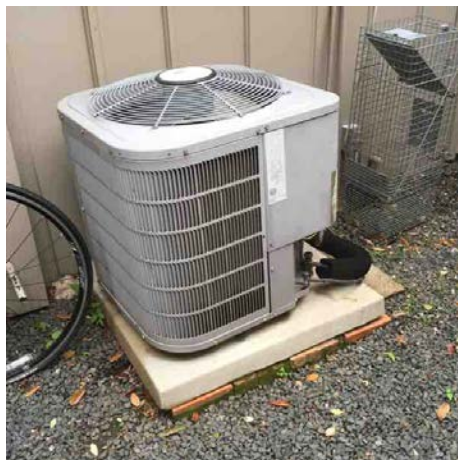
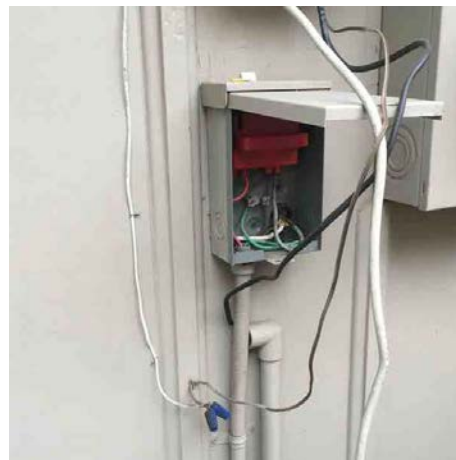
- Exterior condensing unit is out of level, recommend having unit leveled to promote best overall operation and function.

**A/c Disconnect box is missing interior cover**

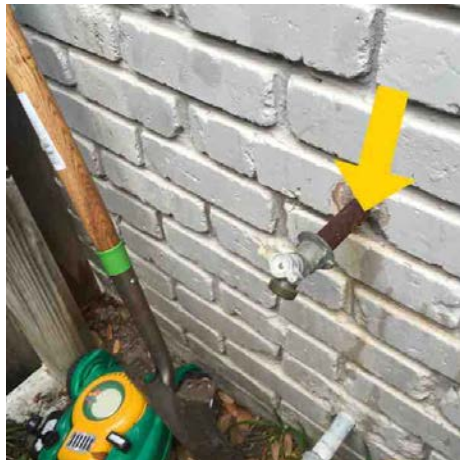
- Piping to exterior faucet is rusted. Recommend licensed plumber evaluate

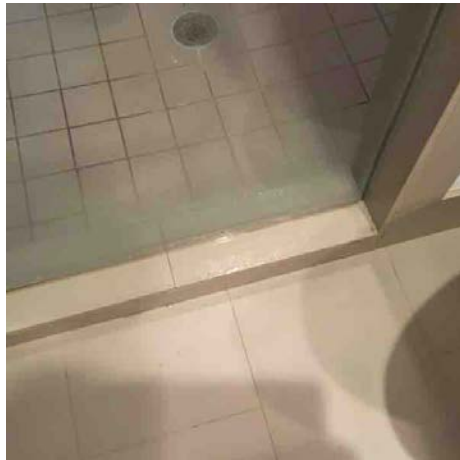
- Bath shower at back Right: door strip allows water to escape

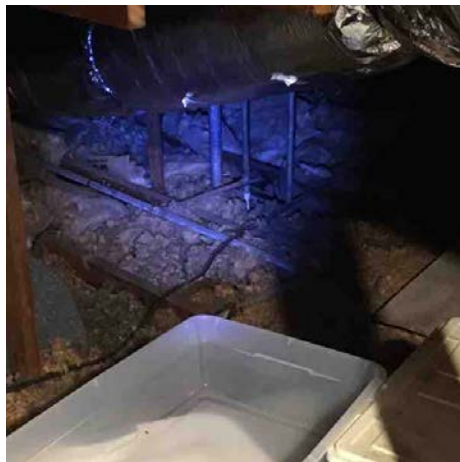
- Galvanized water lines noted in home for the main water supply. These lines can corrode and clog over time reducing or stopping water flow/pressure. While visual evidence at the time of the inspection notes the system is functioning within normal parameters, consider upgrading to PEX pipe to reduce possible failure in lines and related issues.

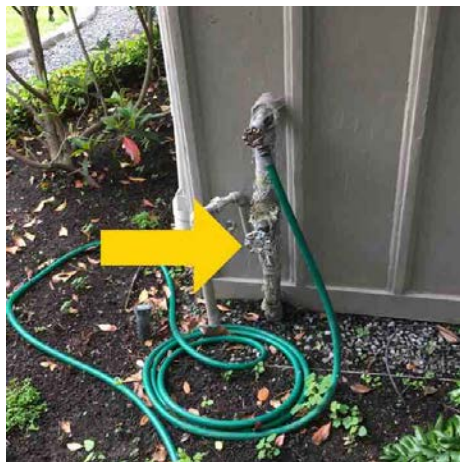
- Appears to have two water shut offs one on the exterior right side and one on the back exterior wall of the addition. Investigate with seller o Li sensed plumber. **(Right Exterior)**

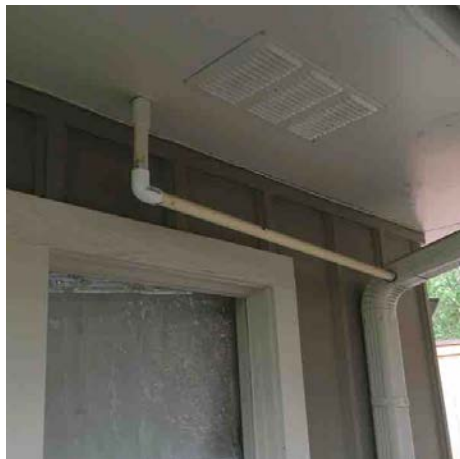
- Appears to be main condensate drain line for A/c coil above master bedroom. No access to that unit to verify

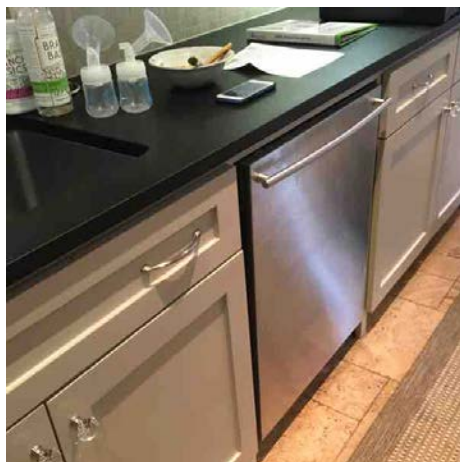
- "Dishwasher was operated in normal mode, run through a complete, normal cycle. Function and operation appear to be normal. Lower access panel not removed. At the time of the inspection the dishwasher did not leak. Care should be taken the first time the dishwasher is run after a period of inactivity because seals tend to dry out and can leak at first. If this happens dry the area inside the unit where the leak is occurring and then re-start the dishwasher. Also be sure to follow the manufactures recommendation for type of soap and amount as this can be the cause of leaking. If it continues to leak repair is required.

- **Dishwasher is not tightly secured to cabinet**

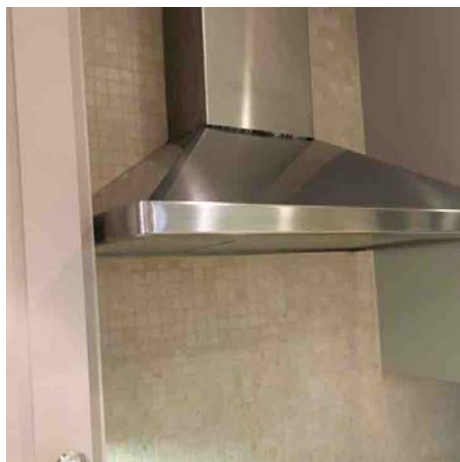
- **Not functioning. Switch not found . Investigate with seller**

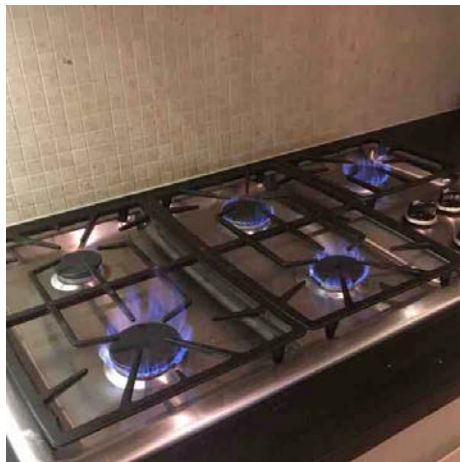
- Functioned properly  
Main gas shut off not visible. Investigate with seller
