# 2607 Bisontine Street Friendswood, Texas 77546

## Your Home Inspection Report

Client:	Jacqueline Garner
Type:	Home inspection
Inspected by:	Double Checked Home Inspections
Scheduled:	April 7, 2022, 7:00 PM
Completed:	April 8, 2022, 12:55 AM

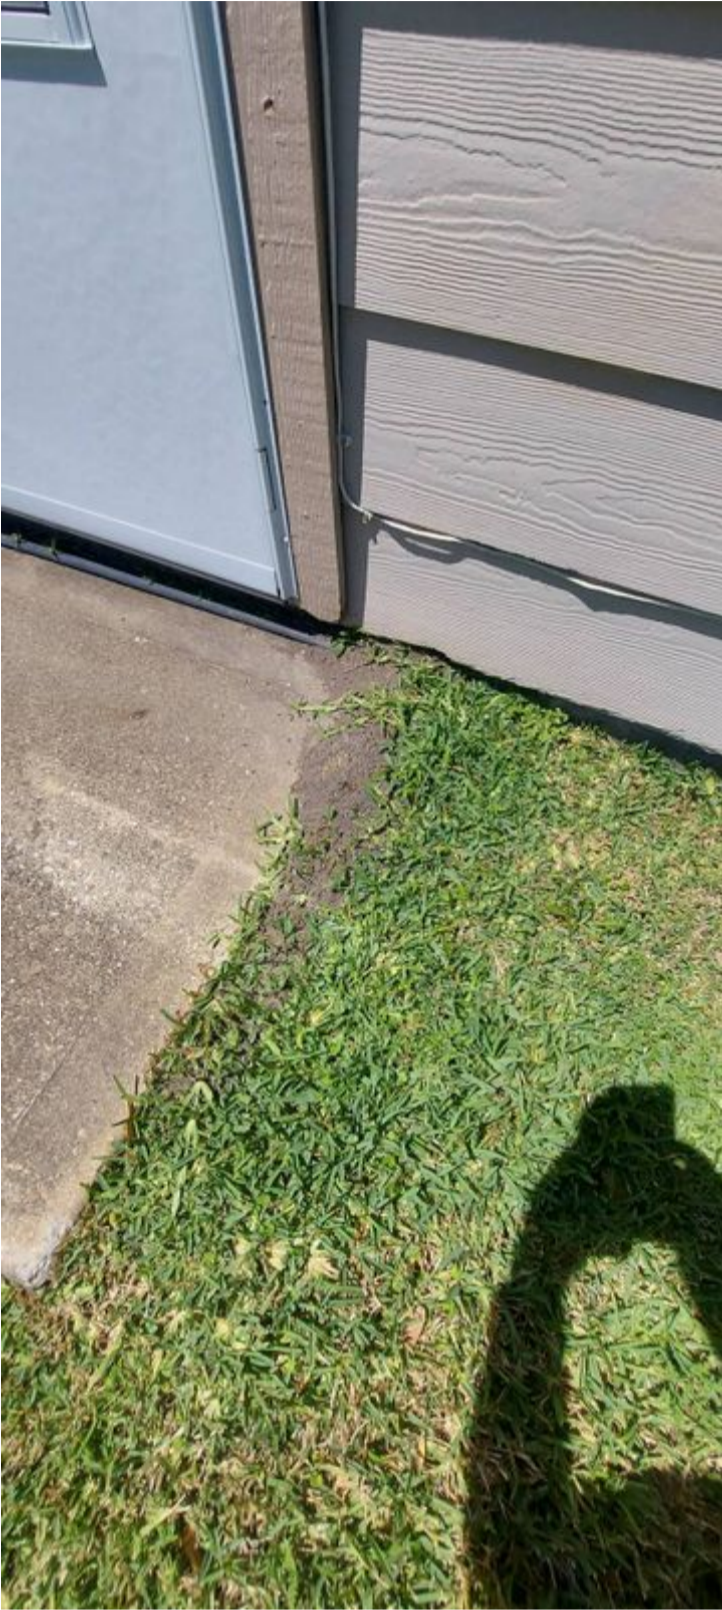
### Ant piles observed

I observed large ant piles next to the foundation in the backyard.

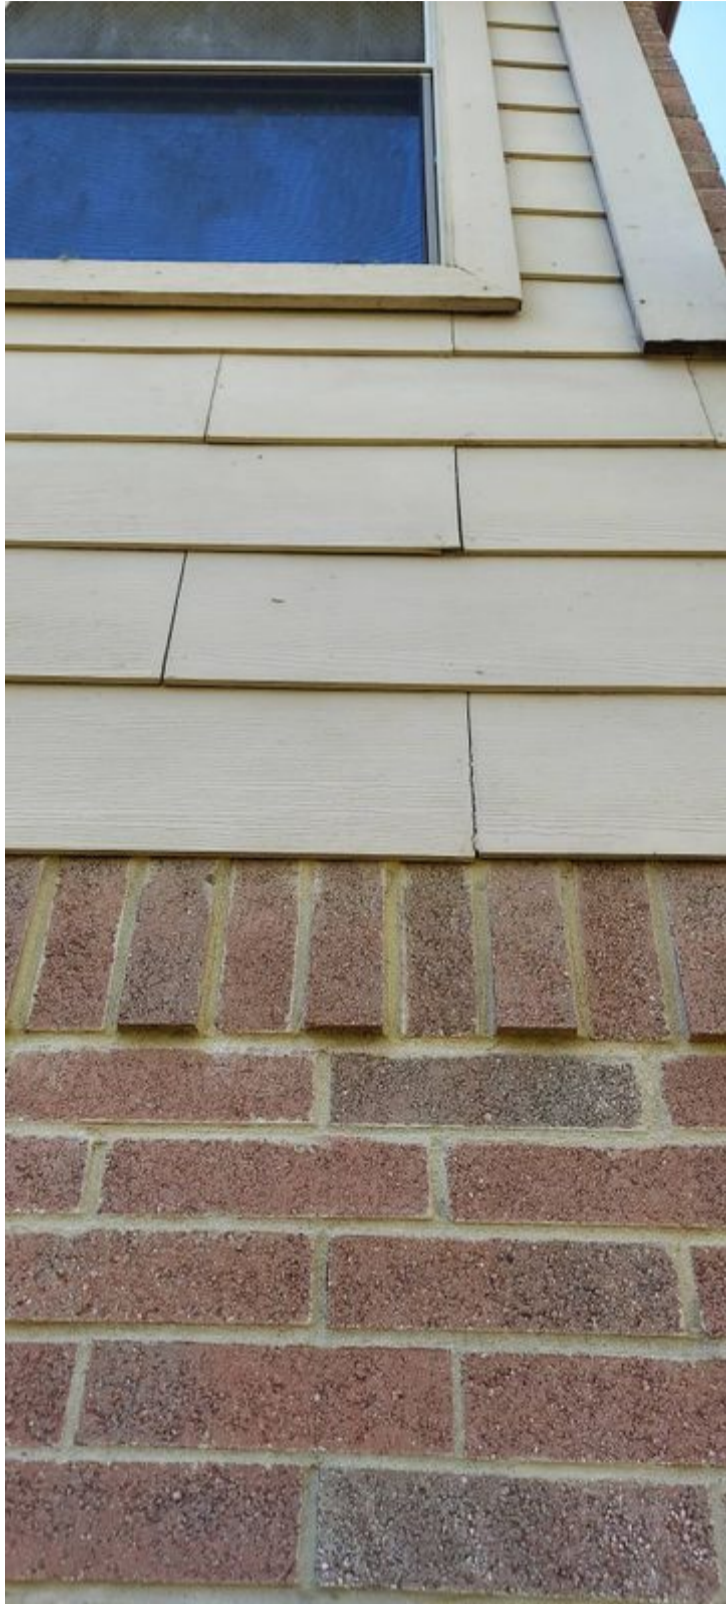
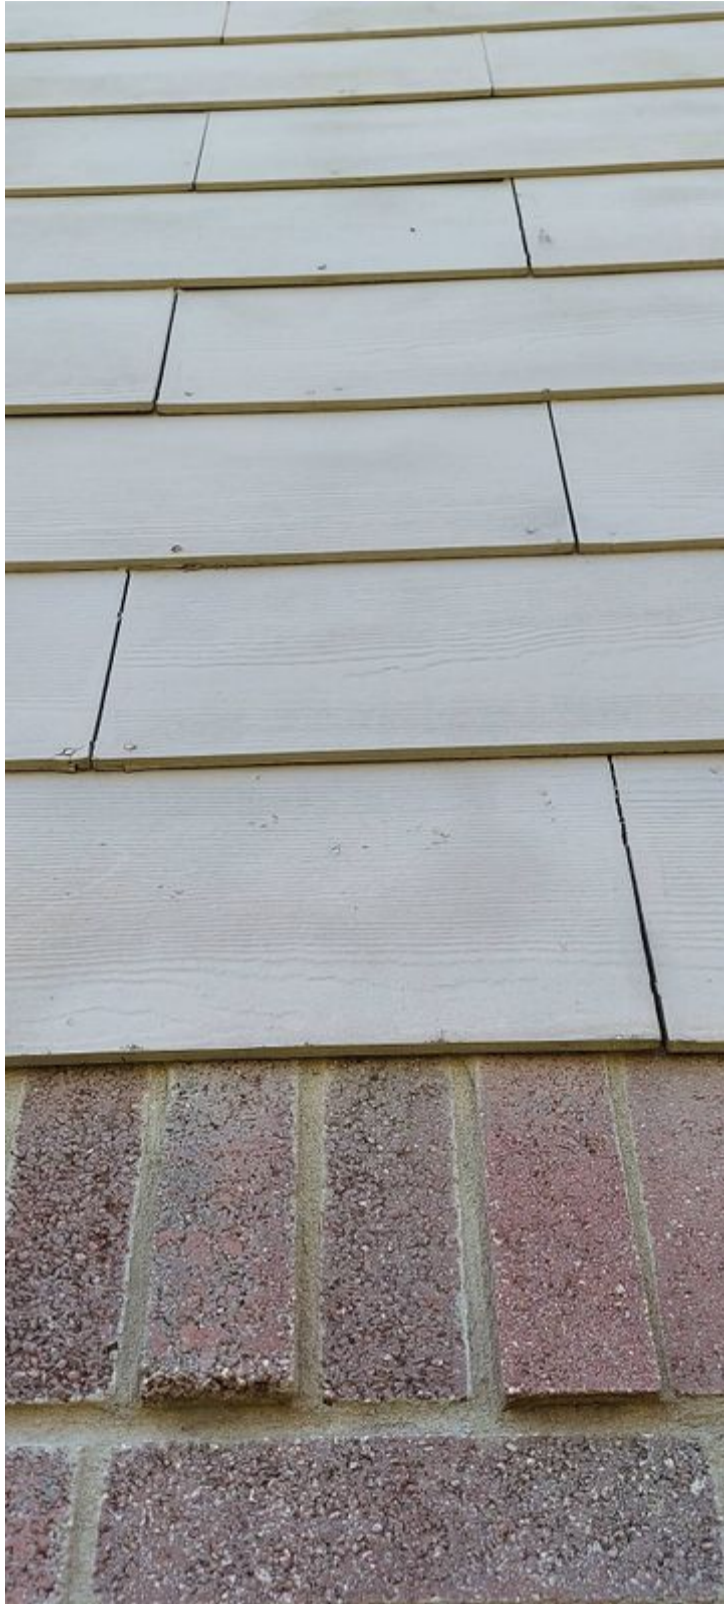
## Siding butts not sealed

One or more siding butts were not sealed with caulk.

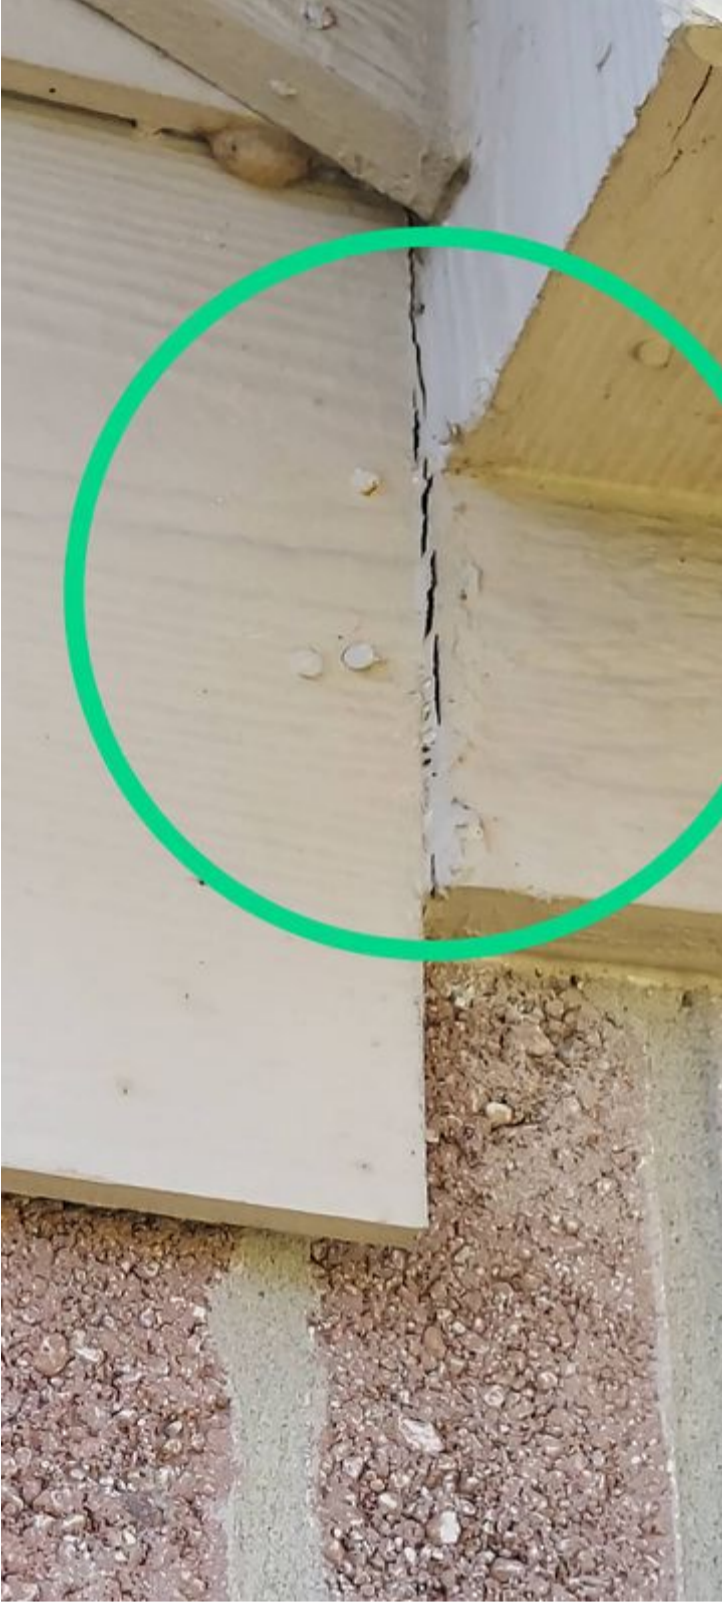
### One or more areas need caulk

One or more exterior areas need caulking.

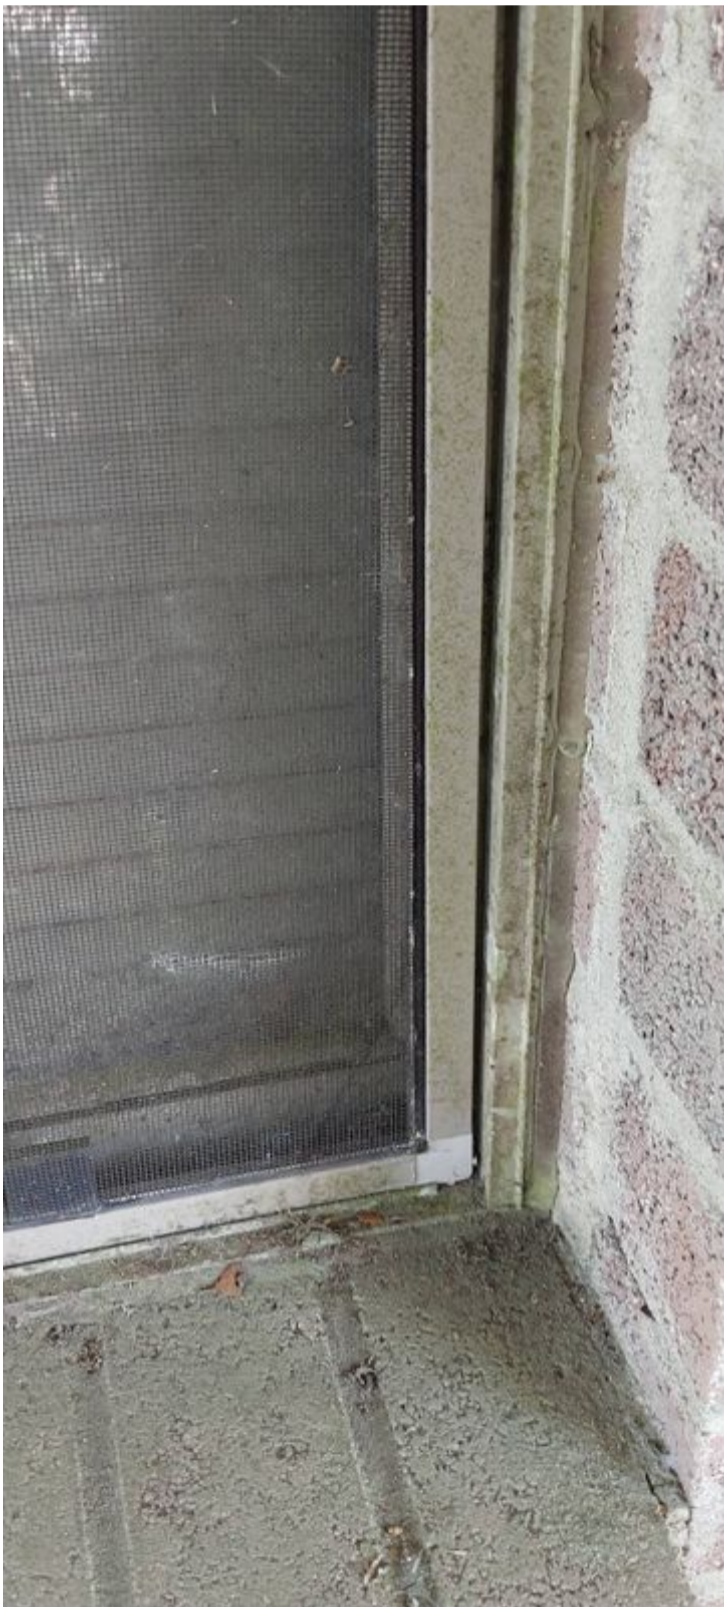
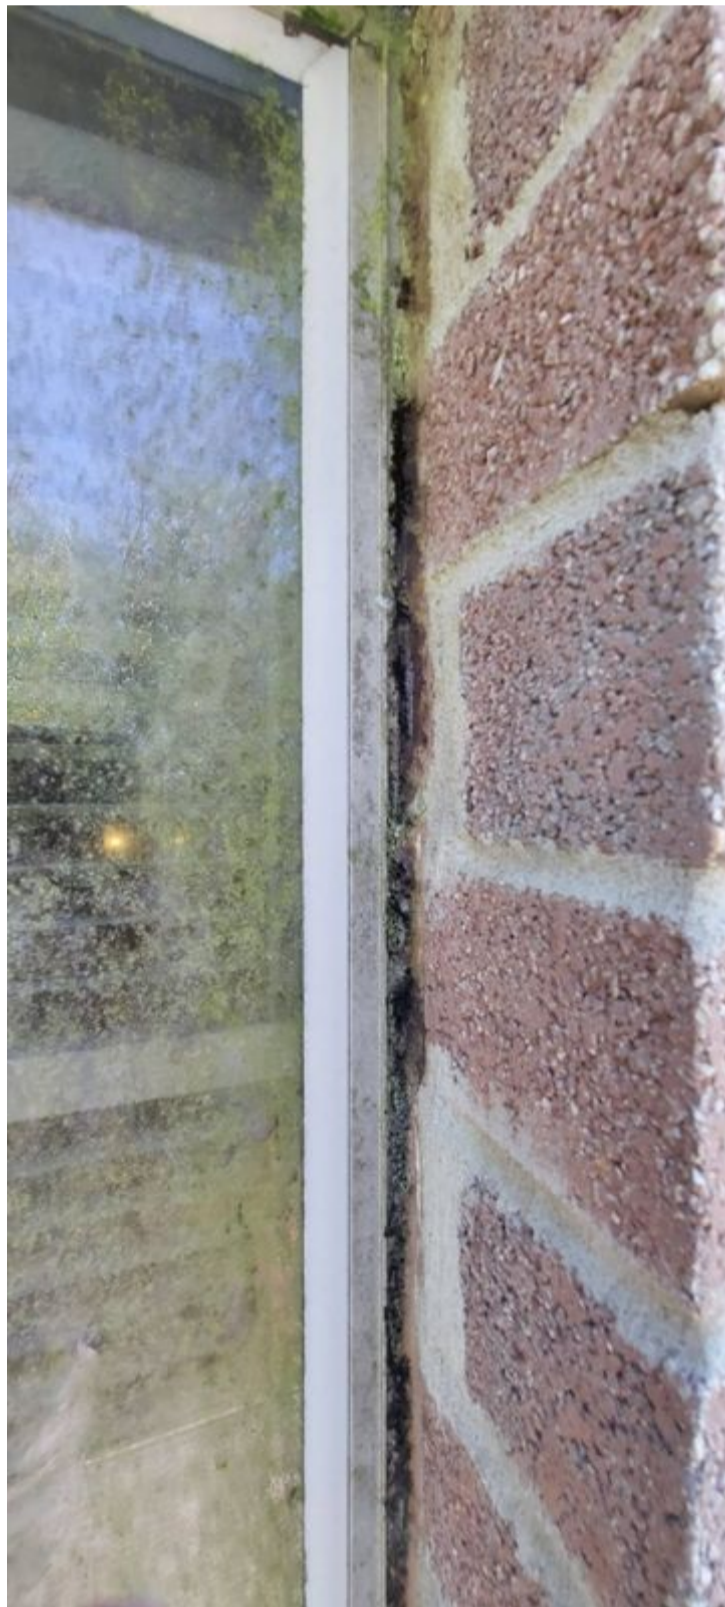
## Mildew observed on windows

I observed mildew on the exterior portion of windows.

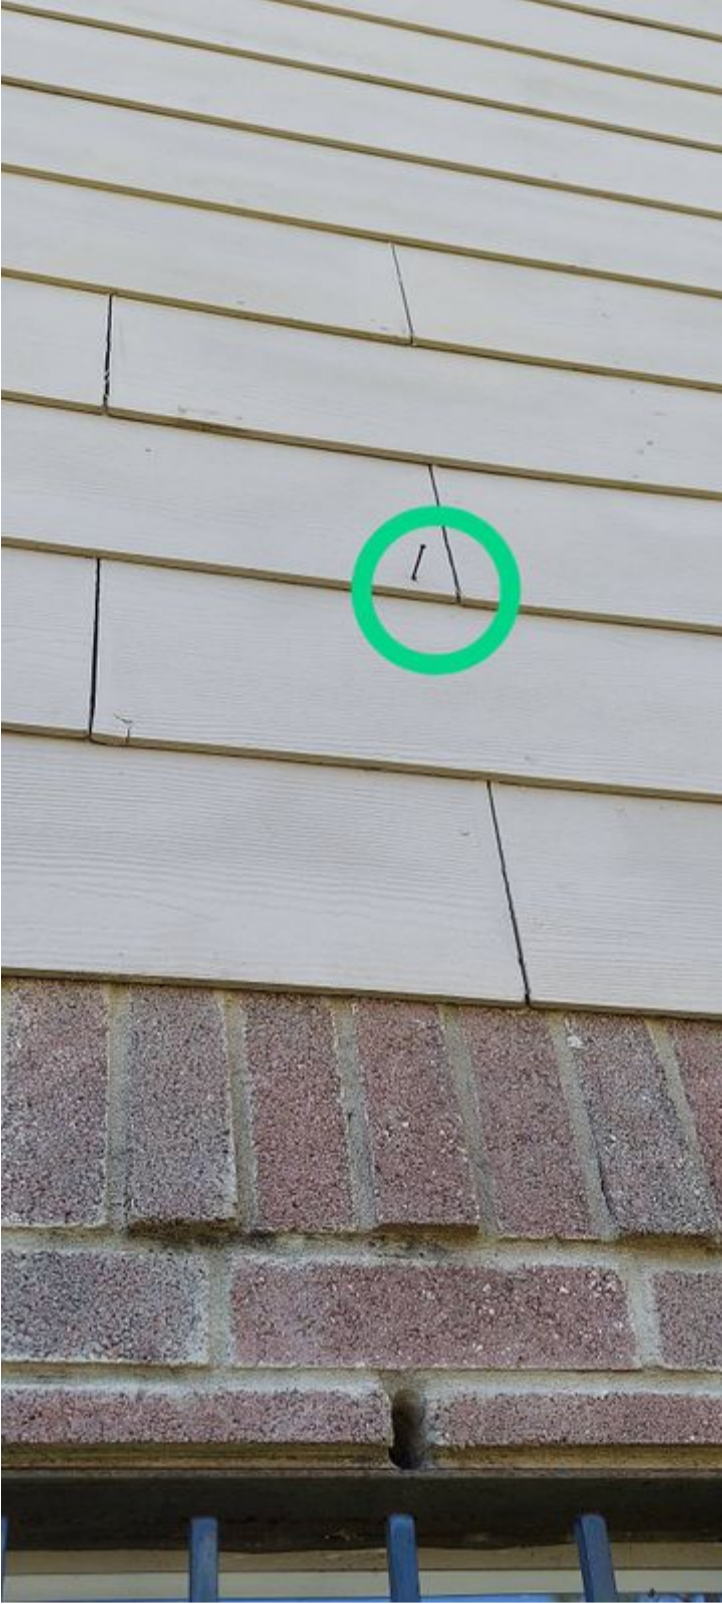
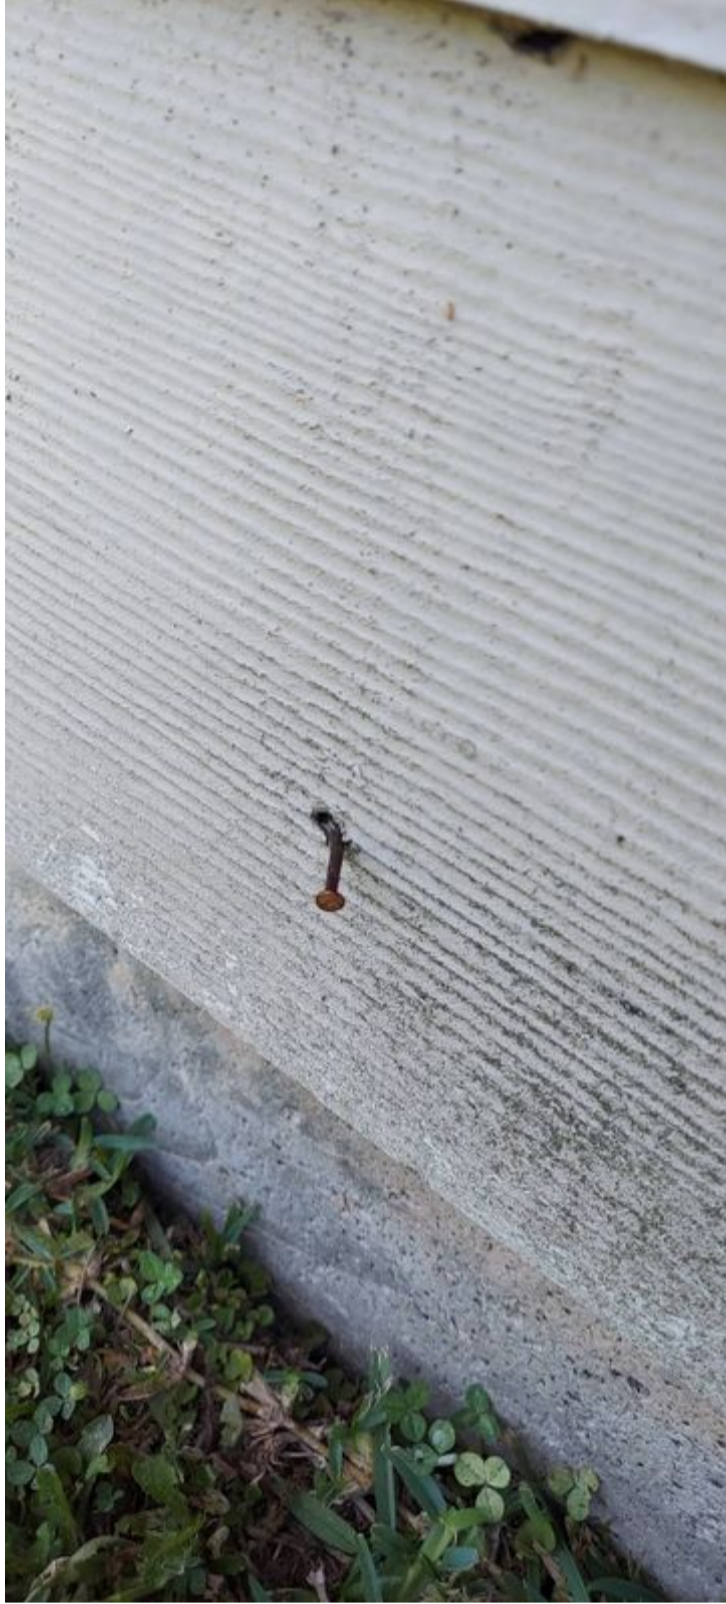
## Nails sticking out of siding observed

At the time of the inspection, I observed one or more nails protruding from the siding.

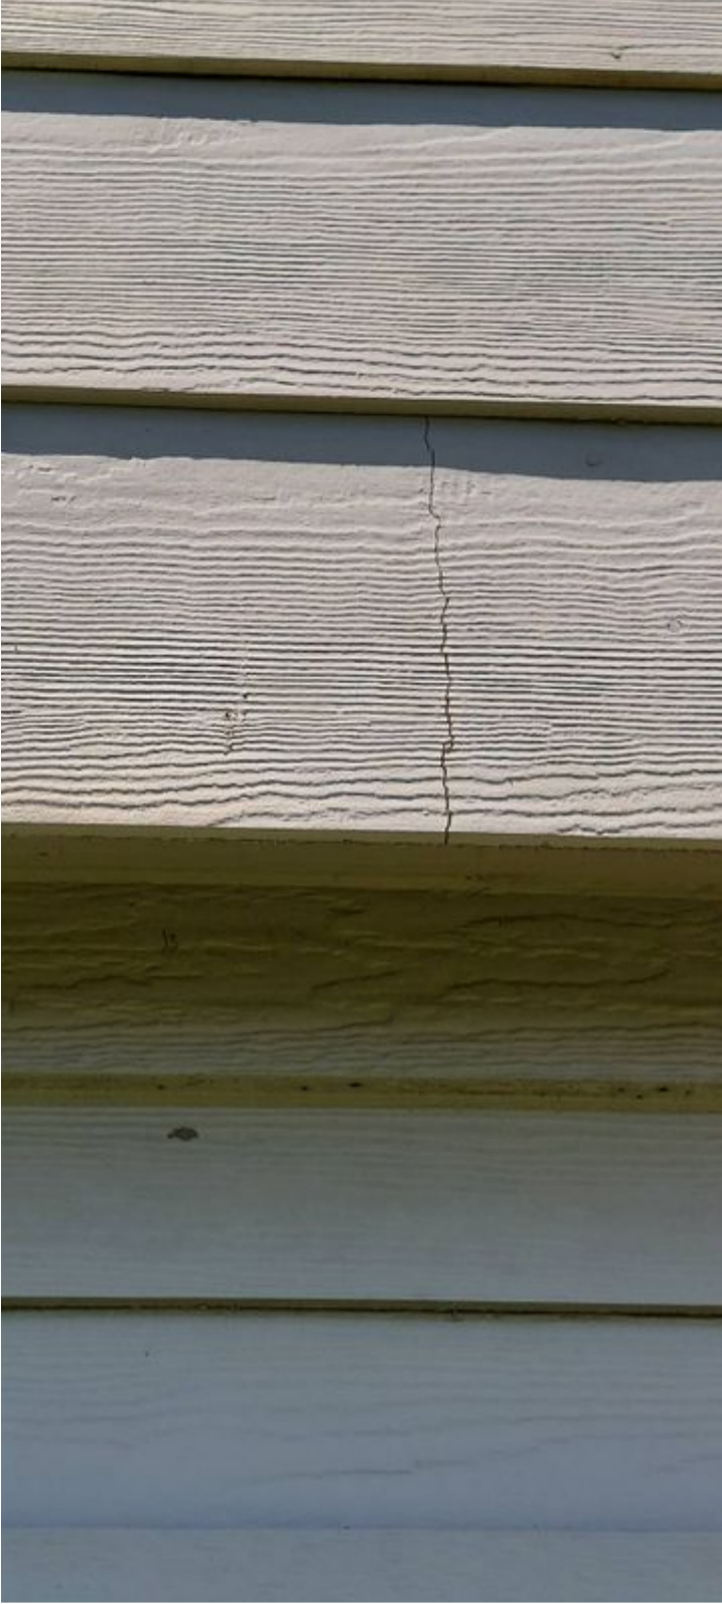
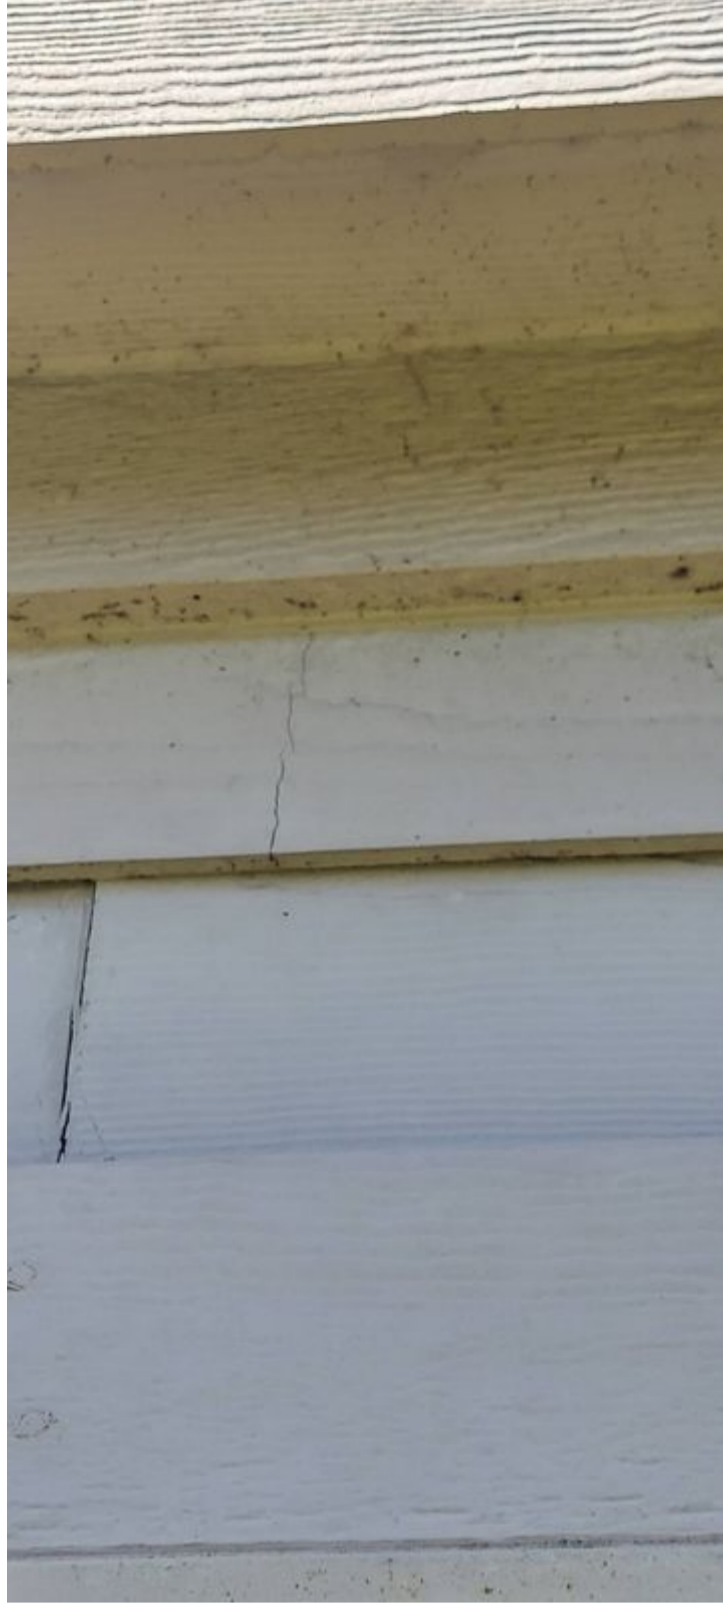
**Hardie plank siding cracking or damaged**

The Hardie plank siding is cracked or damaged.

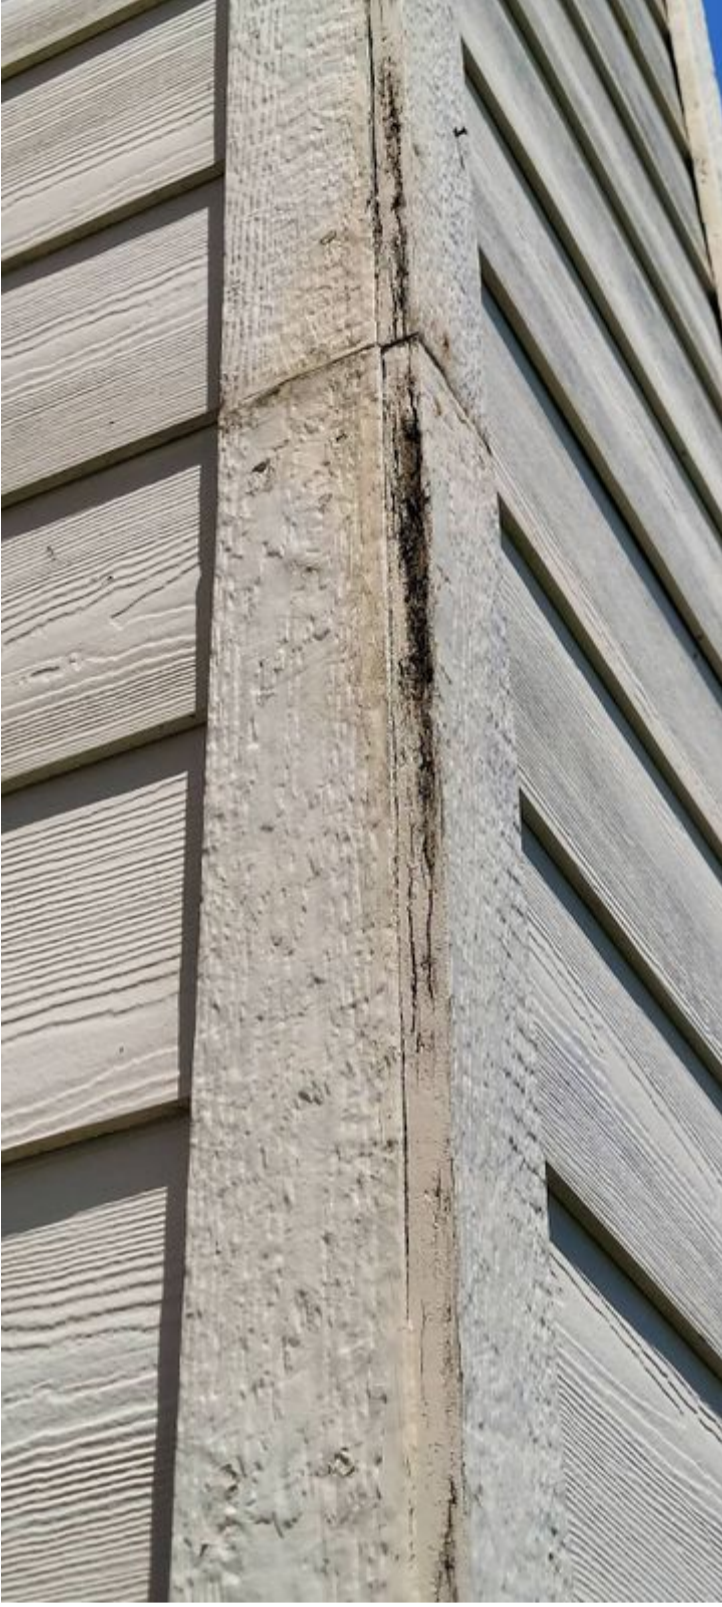
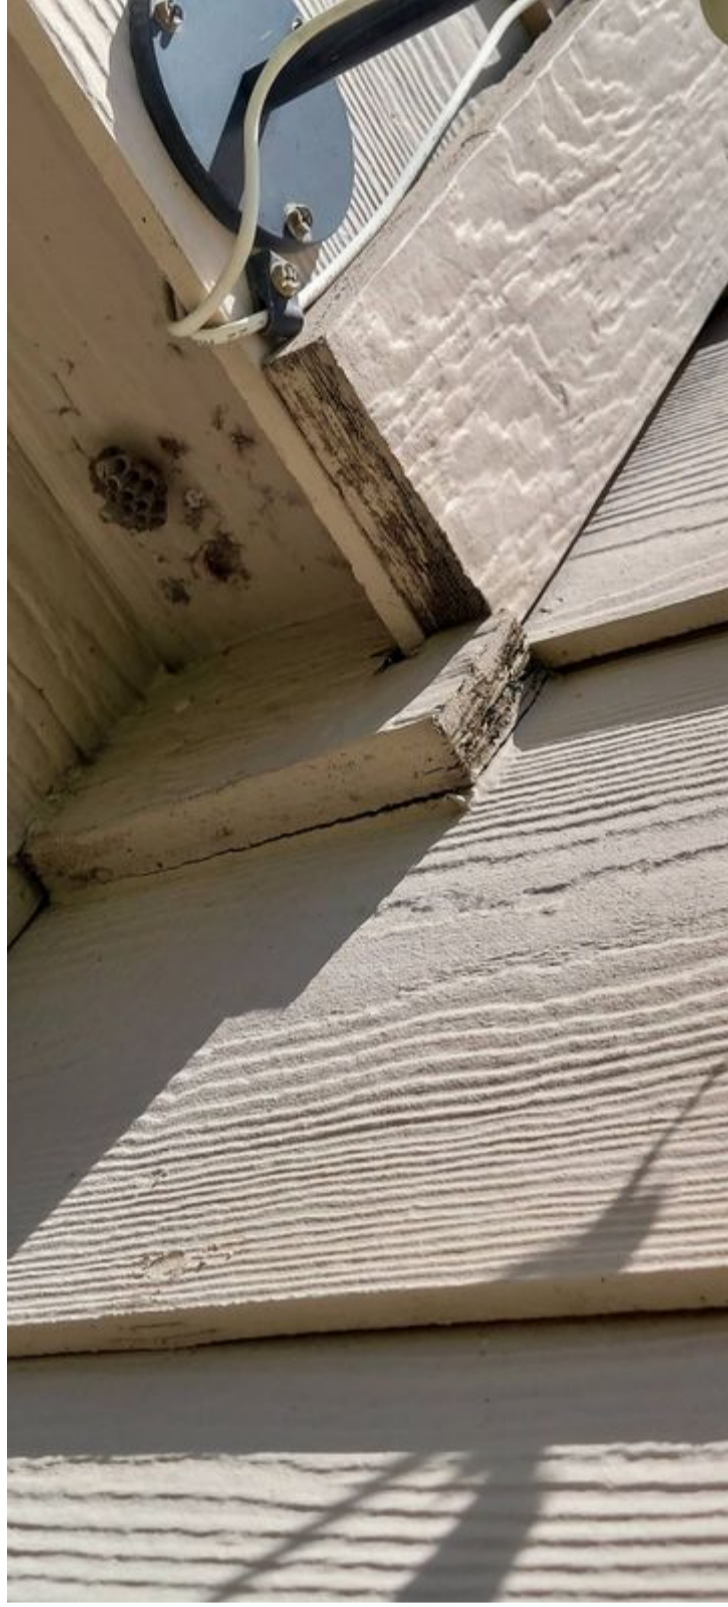
### Trim - Signs of moisture intrusion

There are signs of moisture intrusion at the trim.

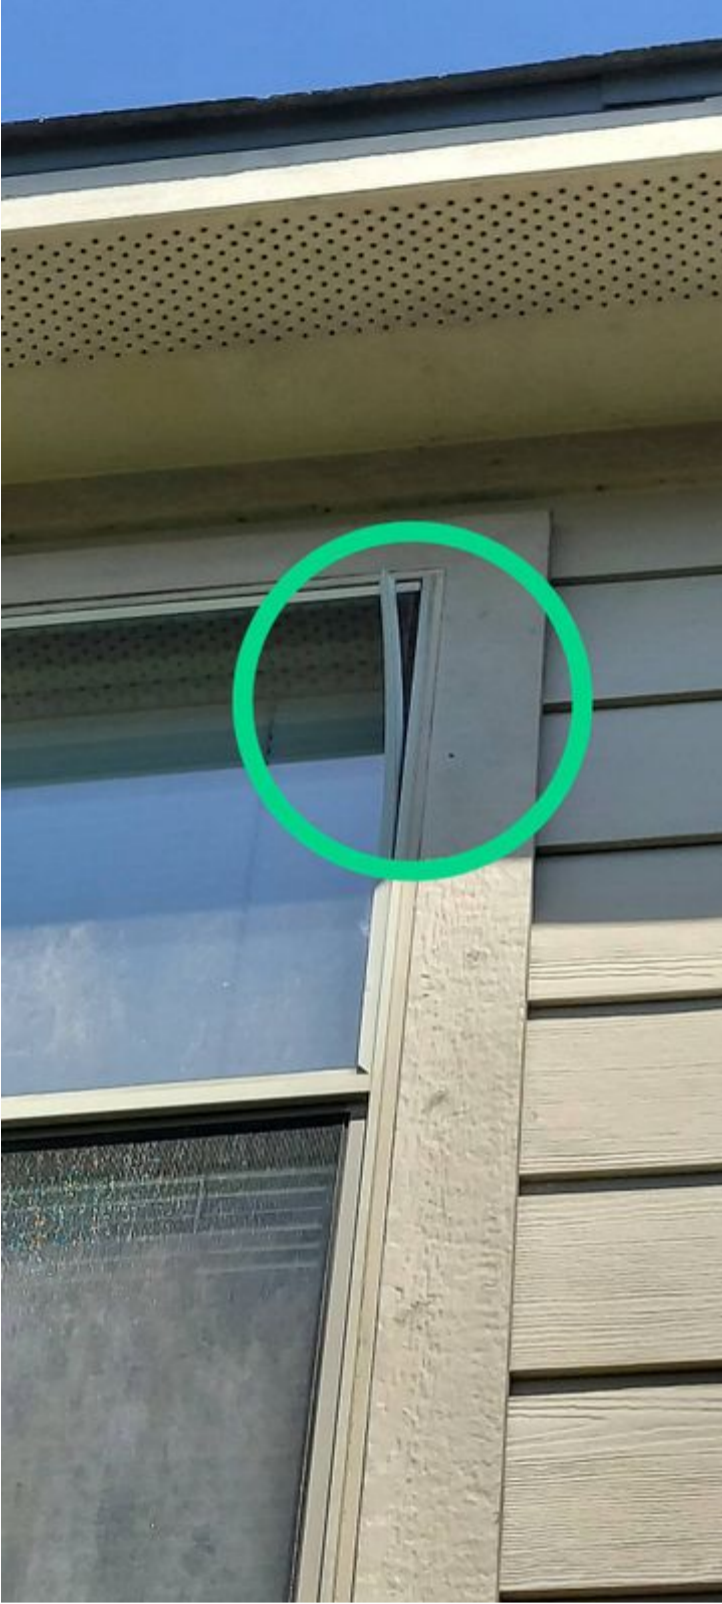
## Damaged window observed

Observed one or more windows with damage.

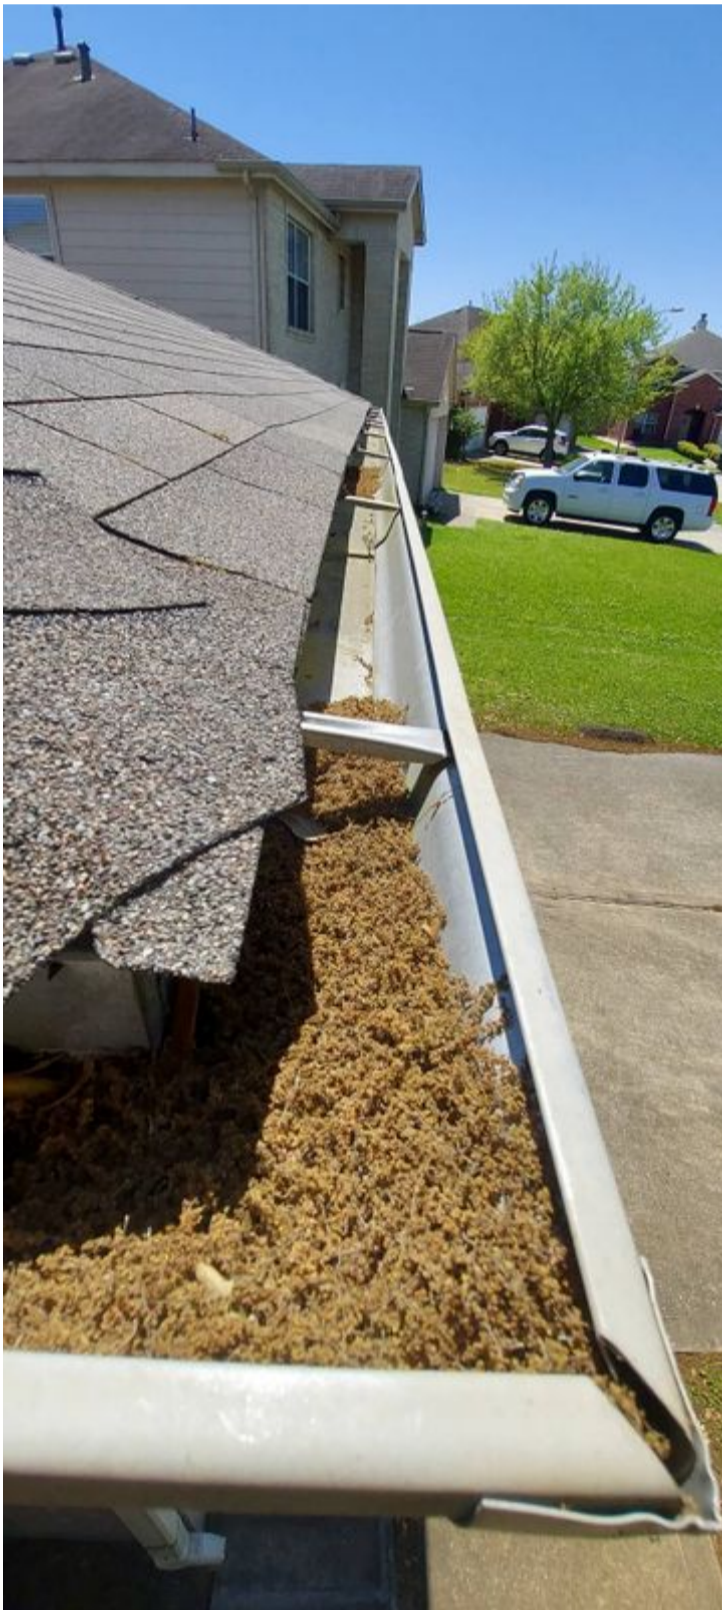
## Gutters are full of debris

Gutters have accumulated debris throughout.

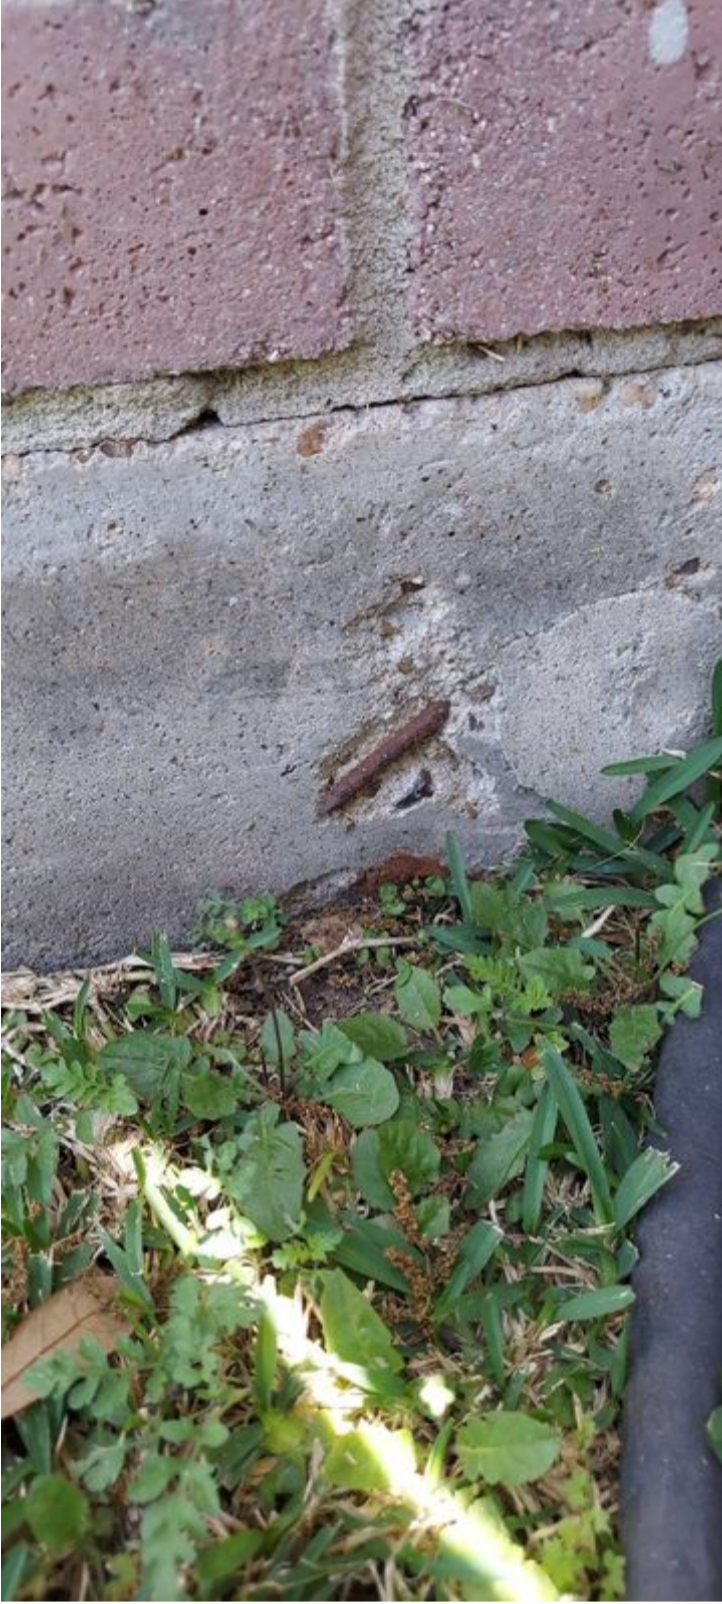
### Exposed snap ties observed on foundation

The snap ties that were holding the forms together together should be removed after the forms are pulled off. I do observe one or more areas where the snap ties were still exposed. If these rust they will swell and make cracks in the foundation.

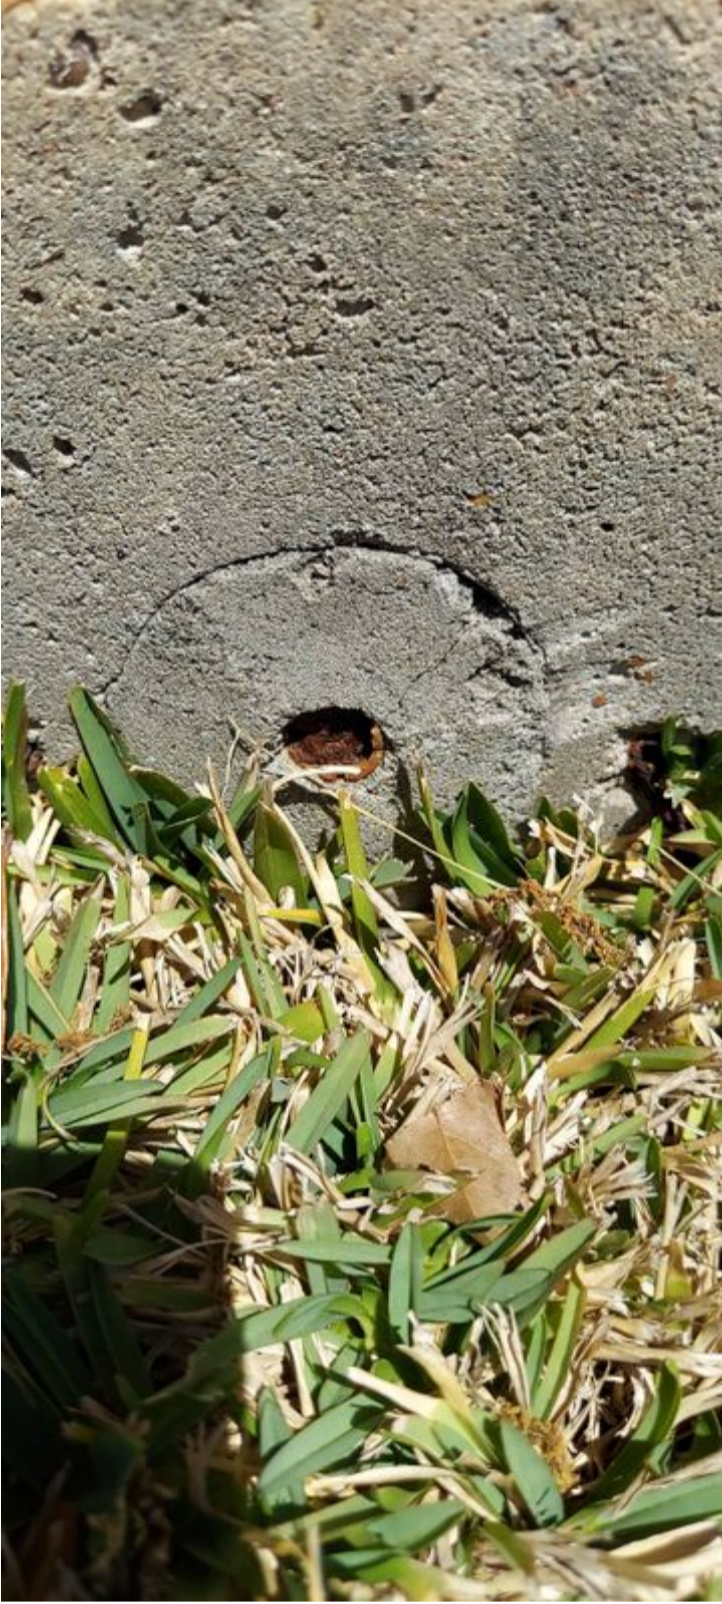
## Exposed tension anchors observed

The steel tension anchors that help support the slab are exposed. If not covered they will rust and cause issues to the foundation.

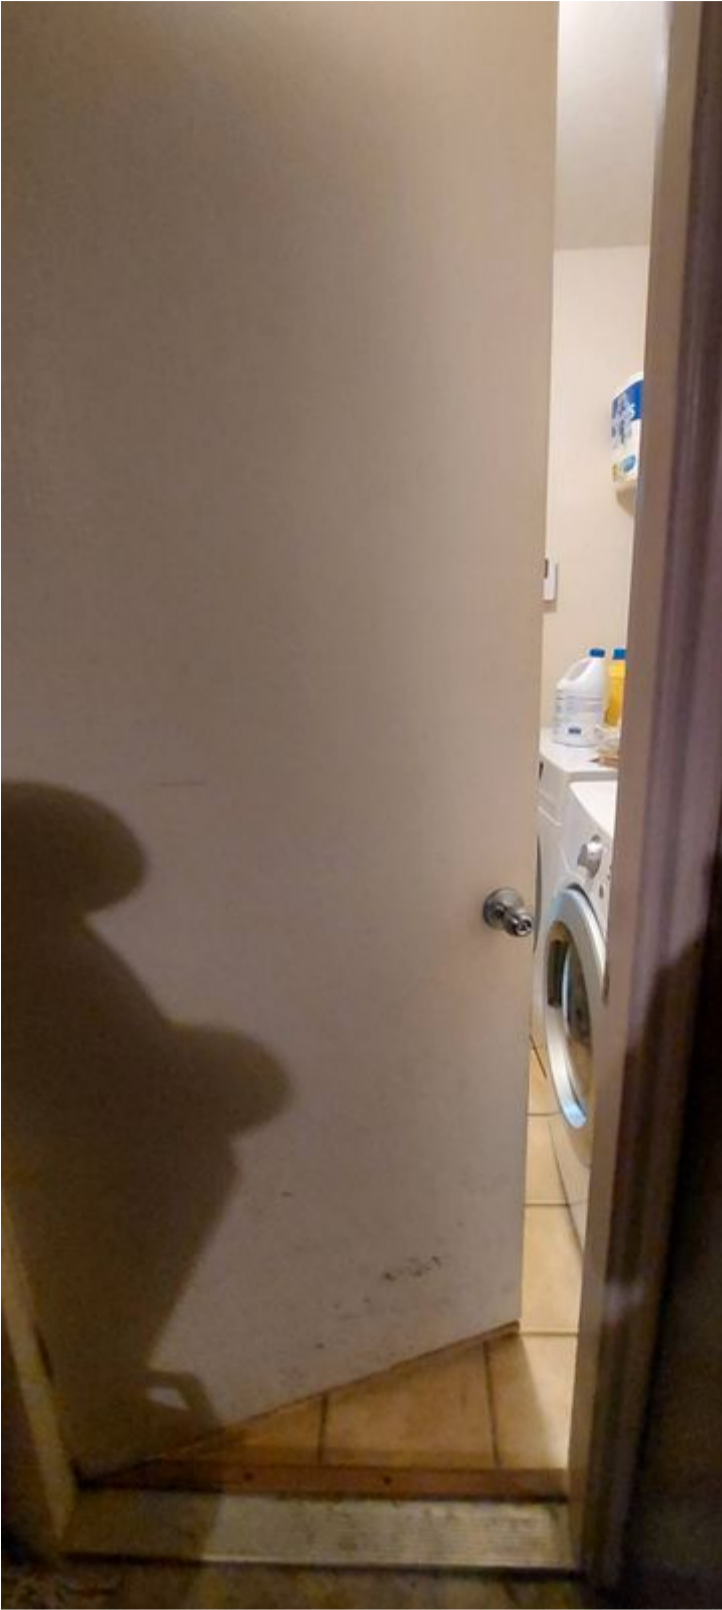
**Fire door not self closing**

The self-closing hinges aren't working.

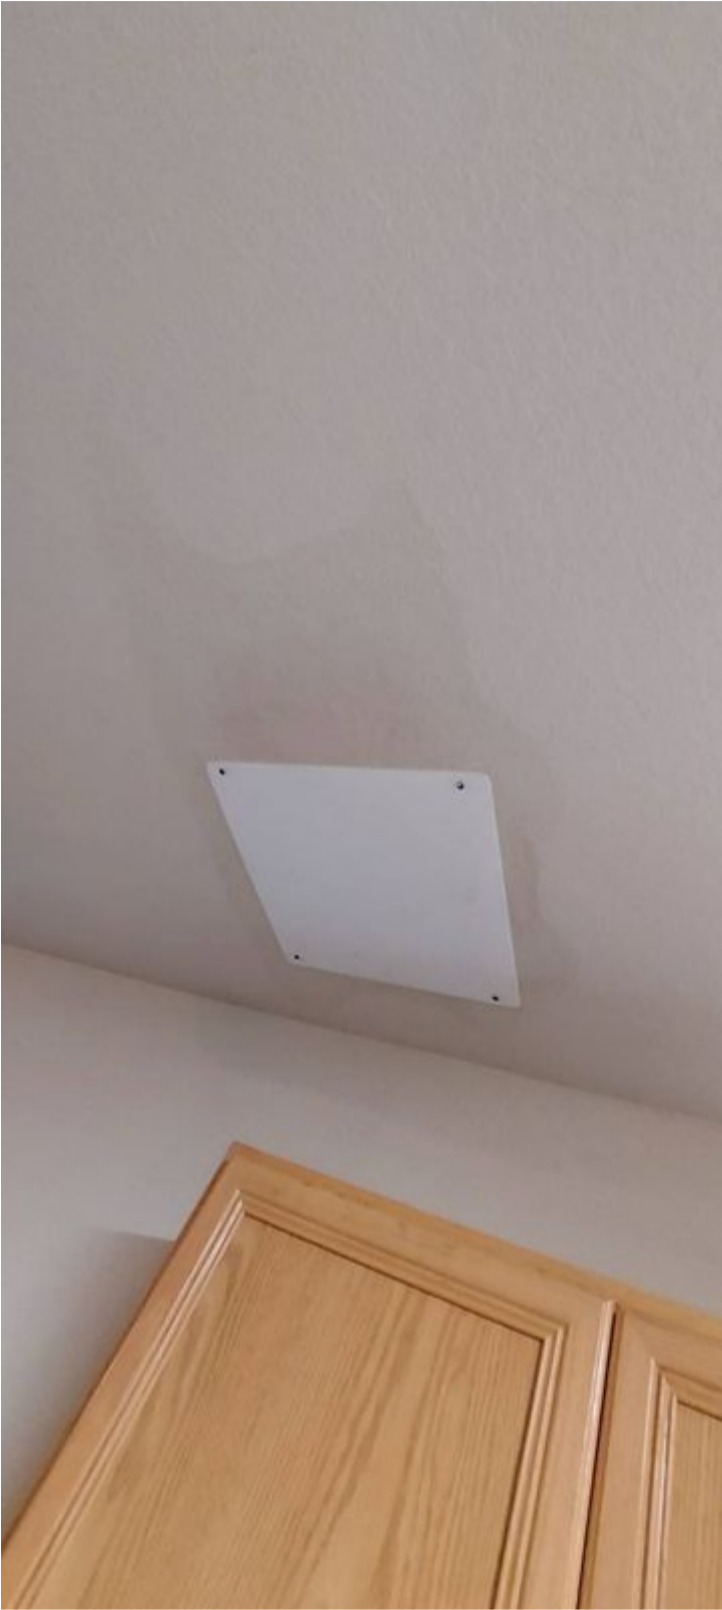
## Moisture damage to ceiling

Evidence of moisture damage on ceiling.

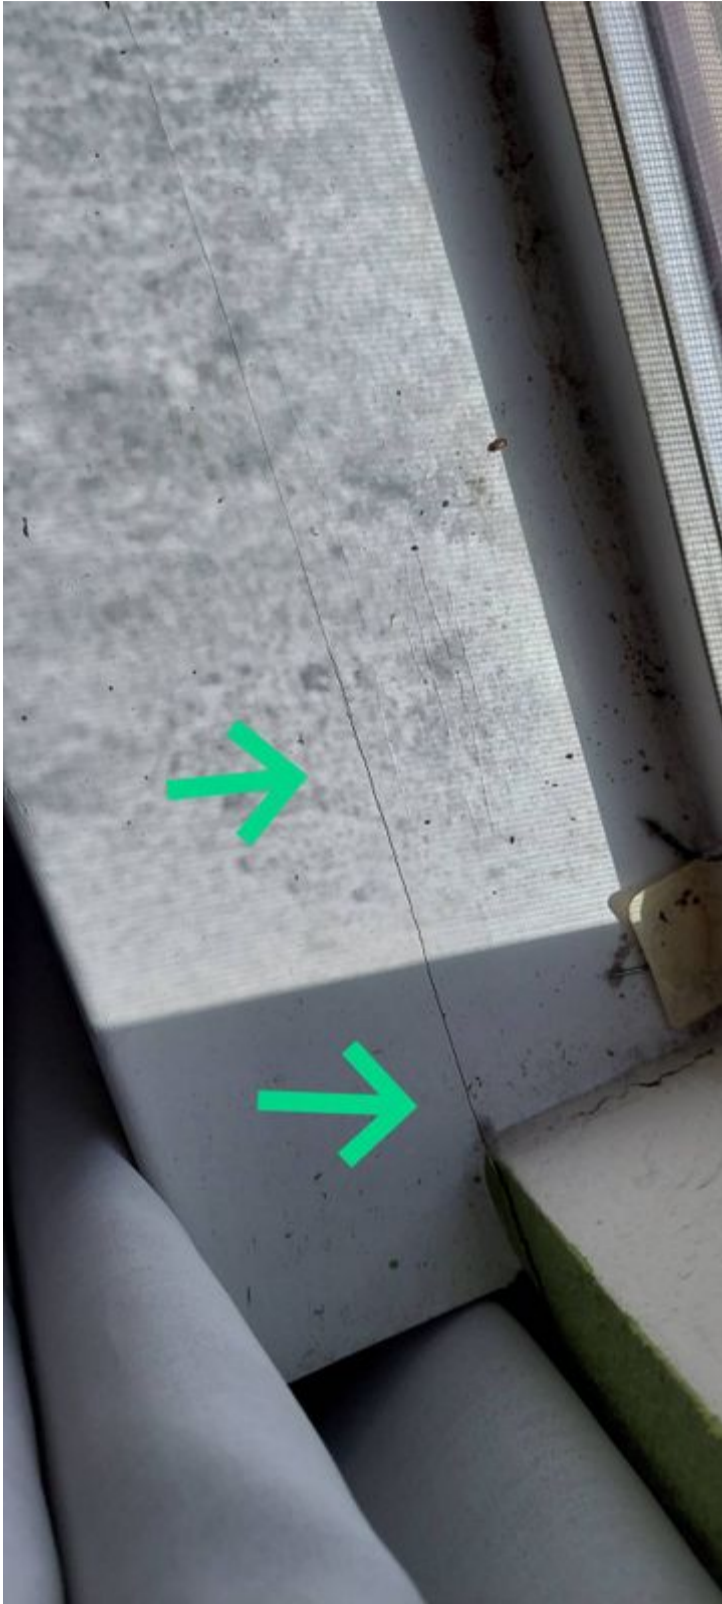
## Damaged interior window sill

At the time of the inspection one or more windows in the house had a damaged interior window sill.
