# 2607 Bisontine Street Friendswood, Texas 77546

## Your Home Inspection Report

Client:	Jacqueline Garner
Type:	Home inspection
Inspected by:	Double Checked Home Inspections
Scheduled:	April 7, 2022, 7:00 PM
Completed:	April 8, 2022, 12:55 AM

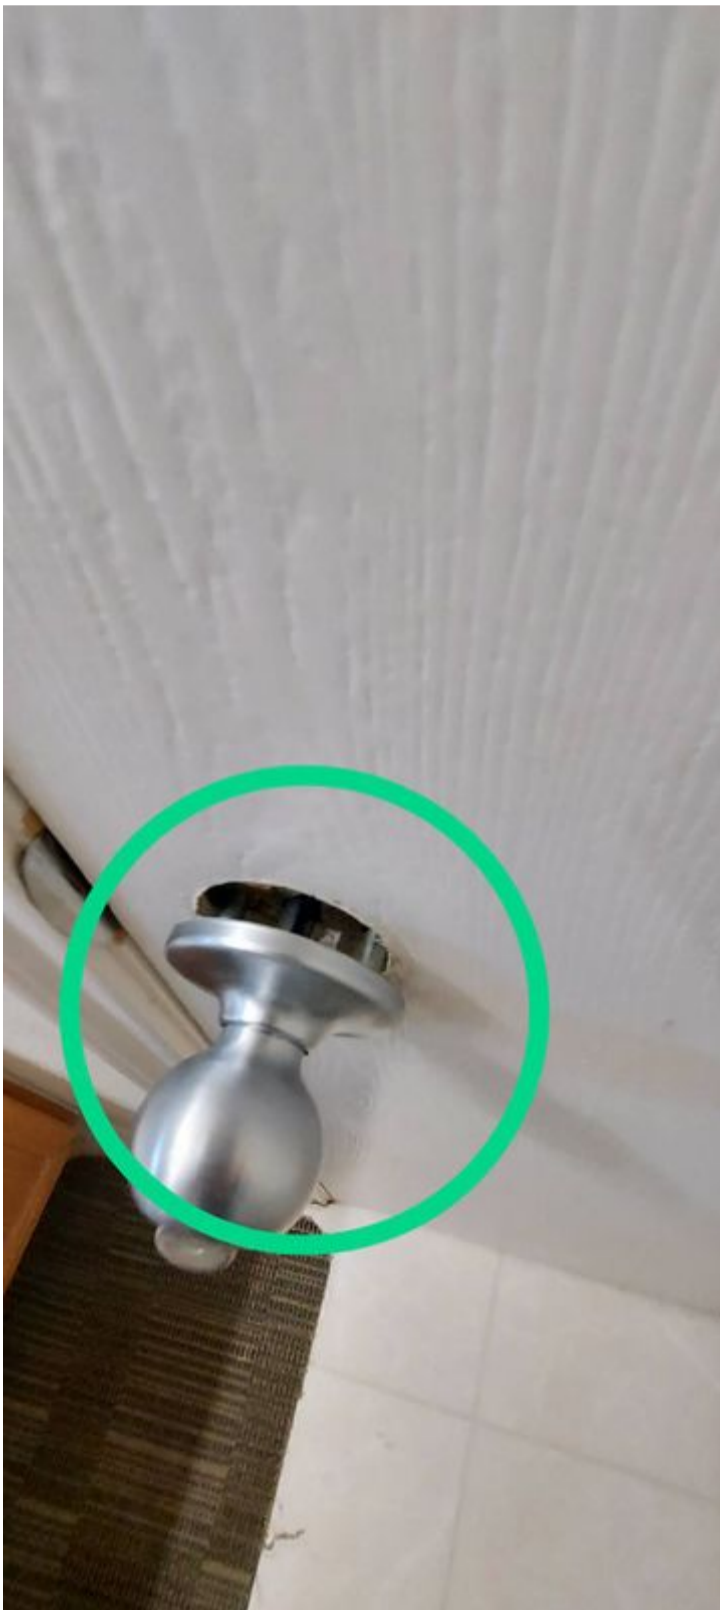
**Loose handle**

Door handle is loose.

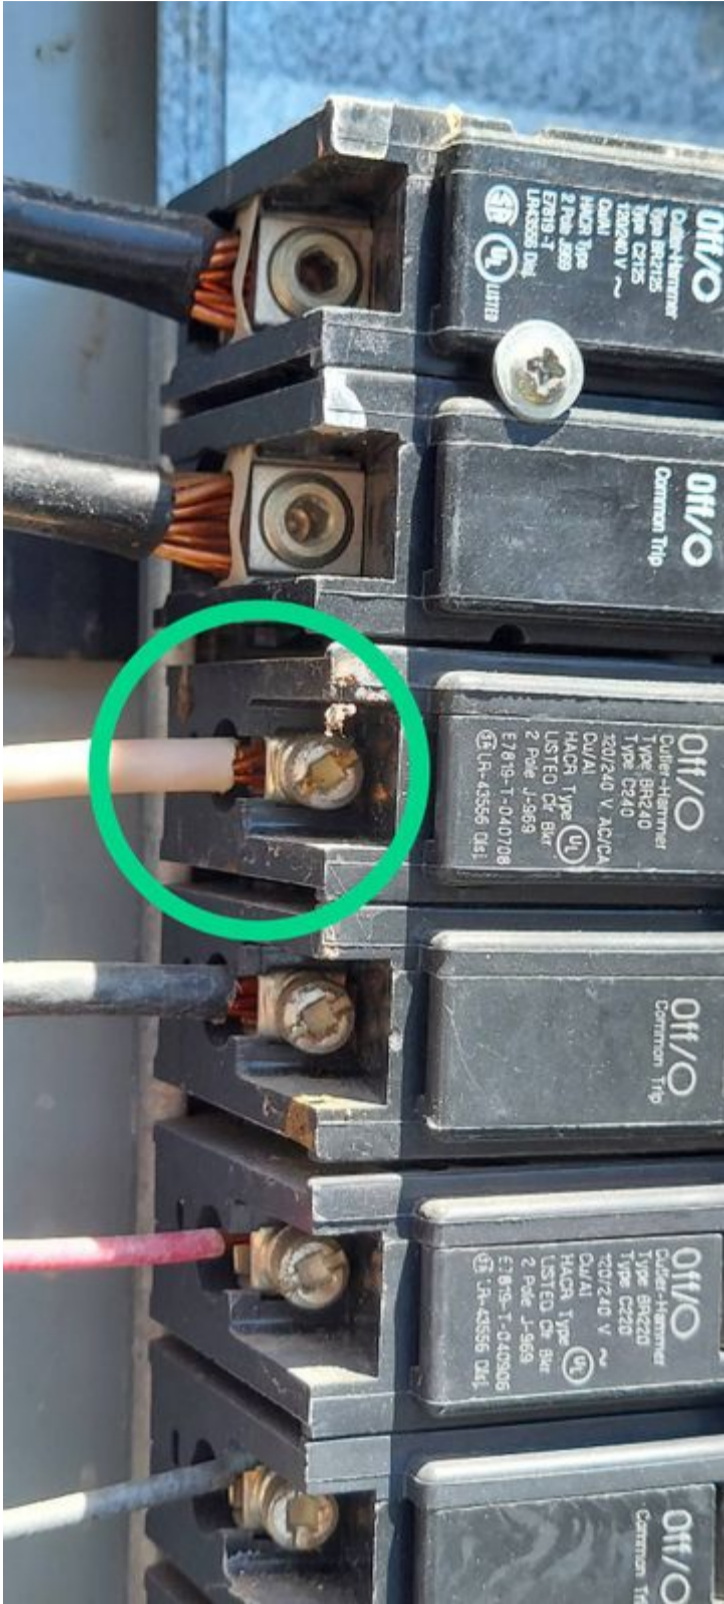
### White wire used on breaker

Whitewire should not be used on the breakers, it is only for neutral.
