PROPERTY INSPECTION REPORT

6714 Misty Dale Dr. , Katy, TX 77449
Inspection prepared for: Matt Messer
Real Estate Agent: Open House - Open House

Date of Inspection: 12/14/2022 Time: 1:30 PM
Age of Home: 2001 Size: 1,999
Weather: Clear
Structure Type: Structure is a wood framed structure
on a concrete slab foundation.

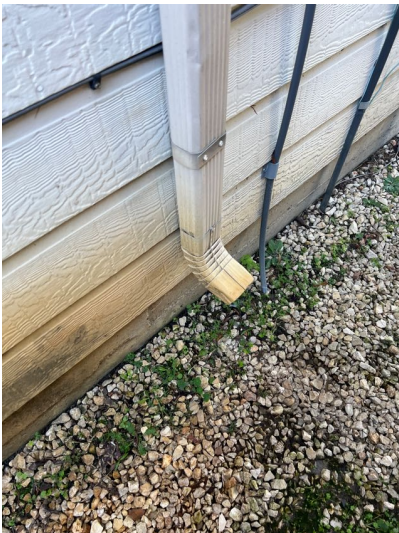
- The soil is required to slope downward away from the foundation to prevent water from pooling next to or even under foundation. The soil needs to slope 6" down in the first 10' away from house.
- Gutters downspouts should extend out beyond 5' from foundation to allow for proper runoff. All gutter downspouts should have splash blocks or diverters to control erosion and direct the roof water away from the foundation
- **The soil around the house is not correctly sloped away from the foundation.**
- **One or more gutter downspout (s) are discharging too close to foundation.**

Gutter downspout discharging too close to the foundation.

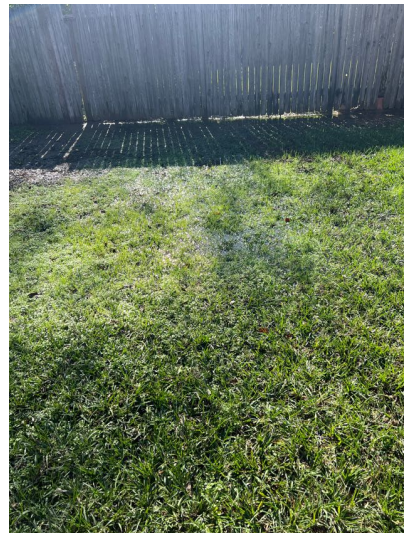
Water pooling in the backyard

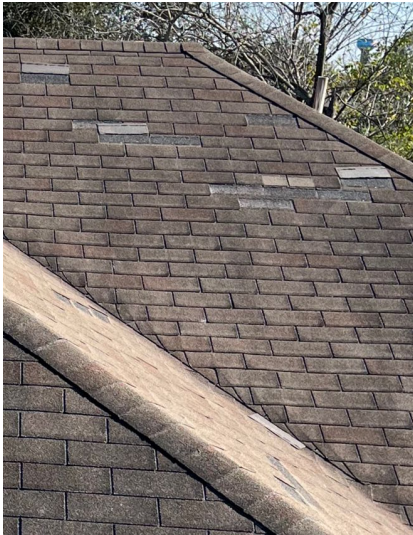
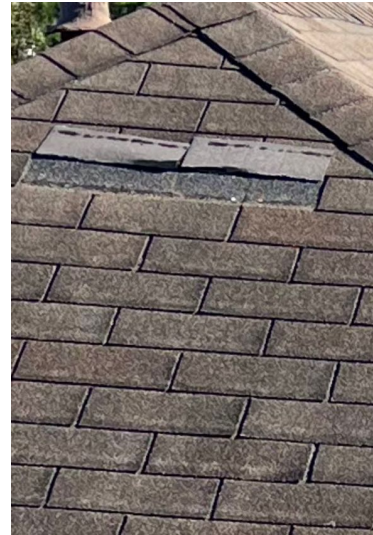
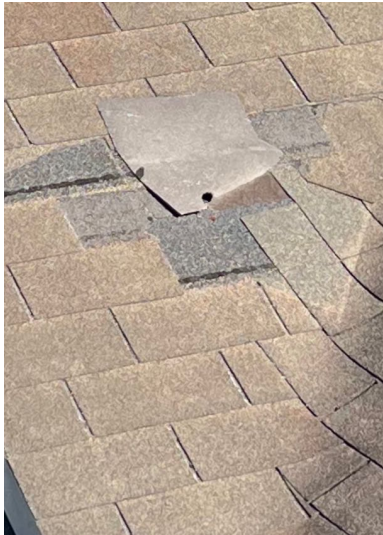
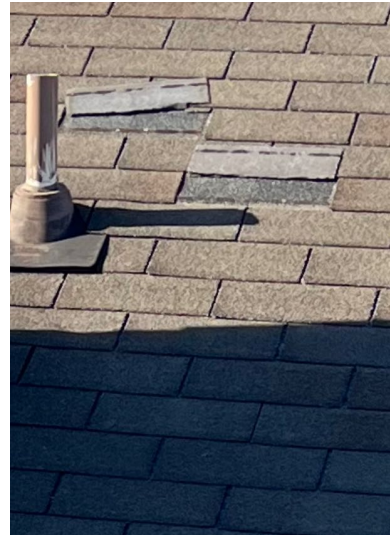
- **Damaged shingles were noted in one or more locations of roof.**
- **Having a qualified roofing contractor review is recommended.**
- **This house needs a new roof**

Damaged shingles.

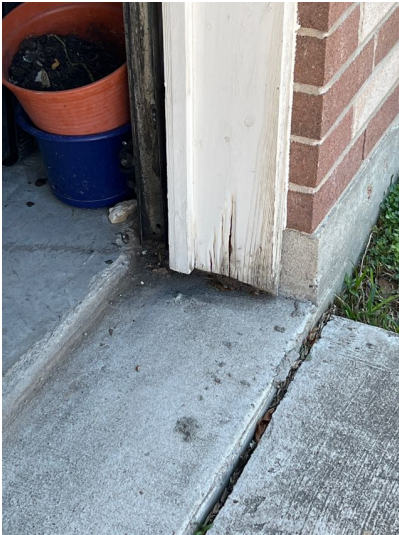
- **Damaged door trim noted in one or more locations.**

Damaged door trim.

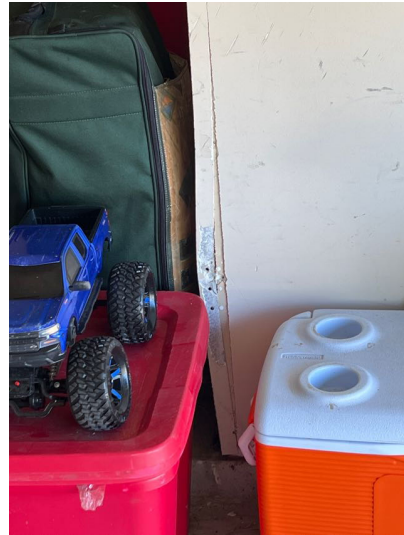
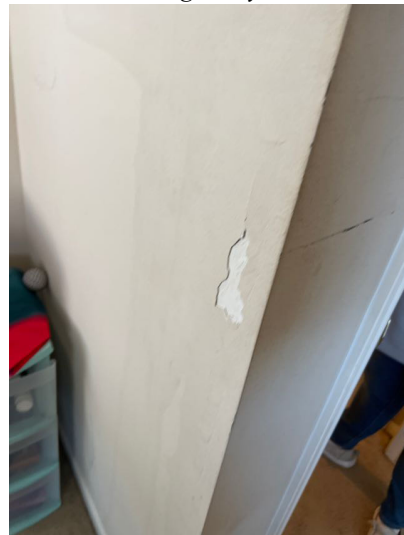
Damaged drywall

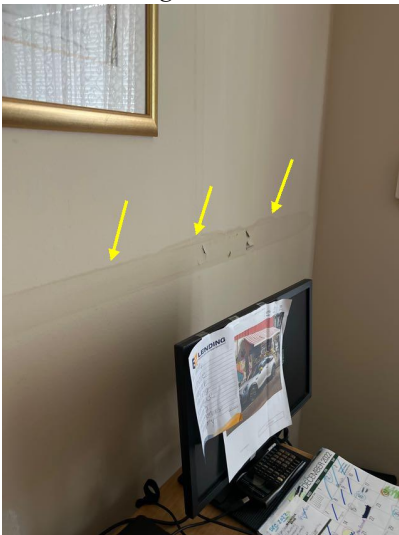
Moisture stains noted on wall in upstairs back left bedroom.

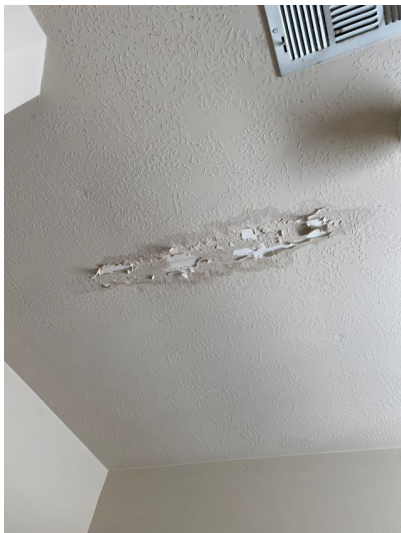
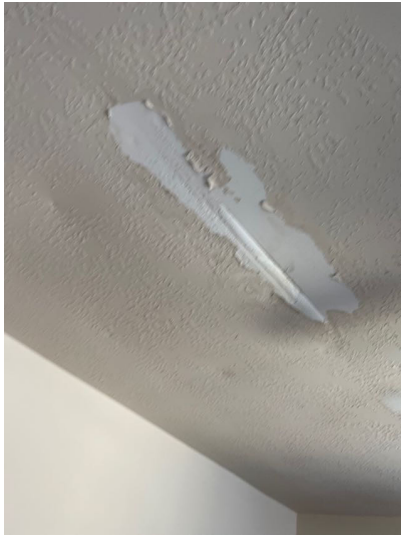
- Damaged drywall noted on ceiling in one or more locations.
- Moisture stains were noted ceiling. The cause and remedy should be further evaluated and corrected as needed.
- Nail pops or nails that have backed out were observed in one or more areas of the ceiling.

Damaged ceiling.

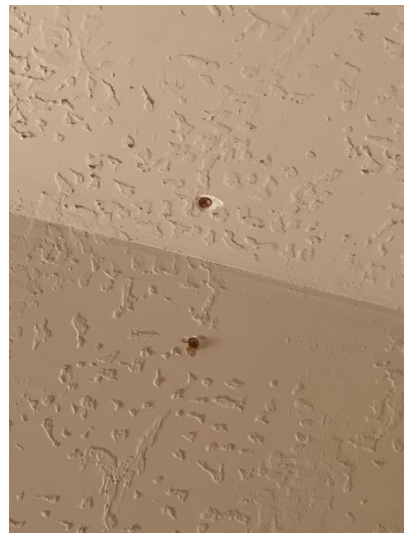
Nail pops or nails that have backed out were observed in one or more areas of the ceiling.

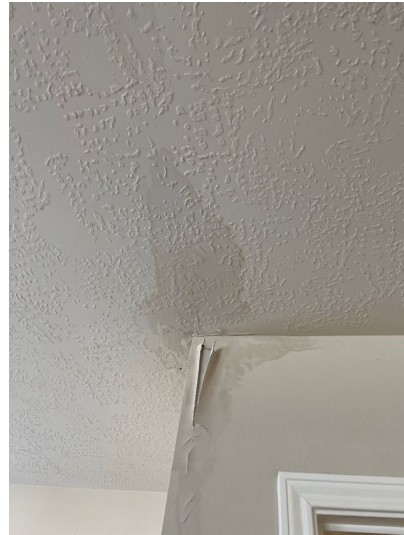
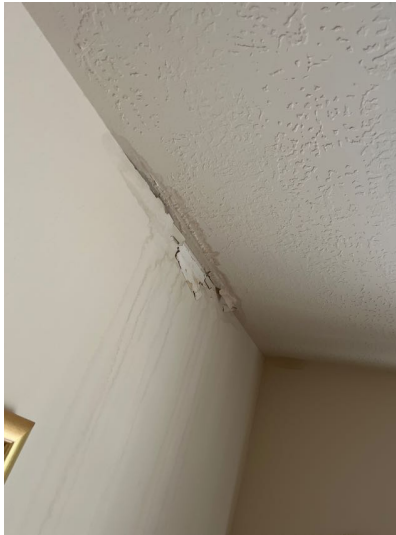
Moisture stain on ceiling.

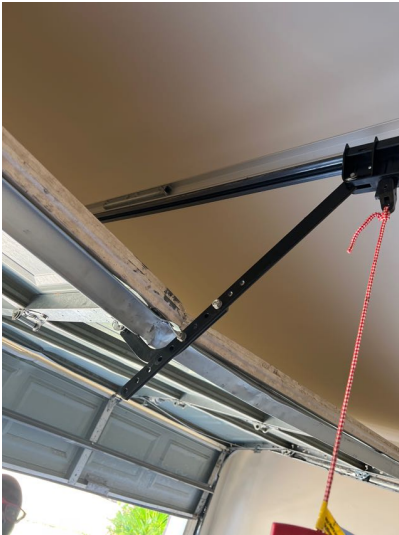
One or more of the garage door panels were observed to be damaged, weathered, warped and/or dented at the time of the inspection.

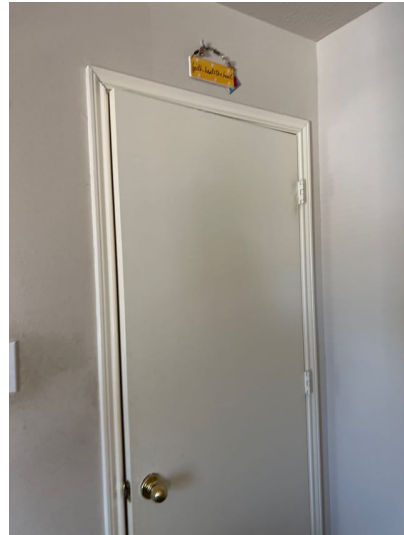
- One or more of the garage door panels were observed to be damaged, weathered, warped and/or dented at the time of the inspection.
- One or more interior doors noted to be binding in door frame.

Bedroom door binding

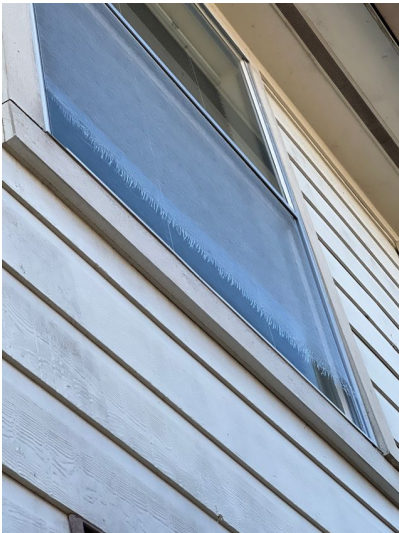
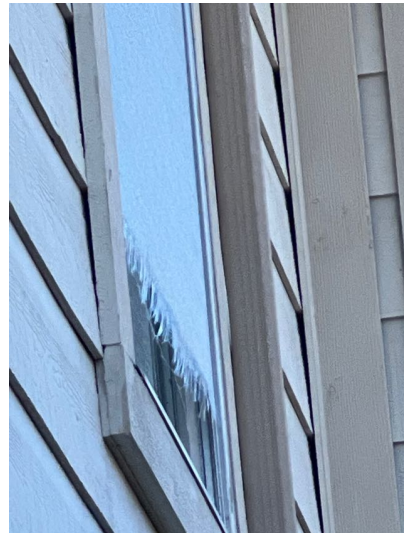
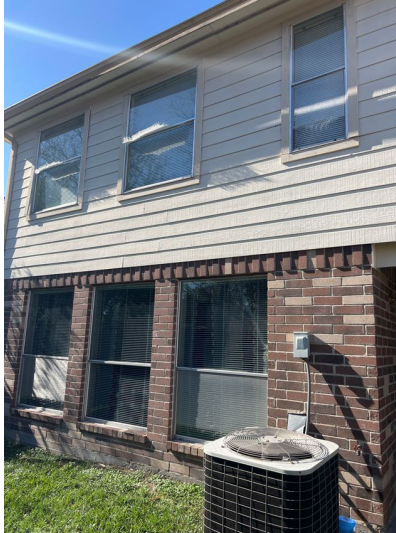
- **One or more of the window screens were observed to be damaged and/or missing. Screens are mentioned in this part of the report as they are a specific item in the T.R.E.C. Guidelines. Screens that are torn enough to allow insect infestation should be repaired or replaced. All windows that have channels for screens should have them installed.**

Damaged window screen

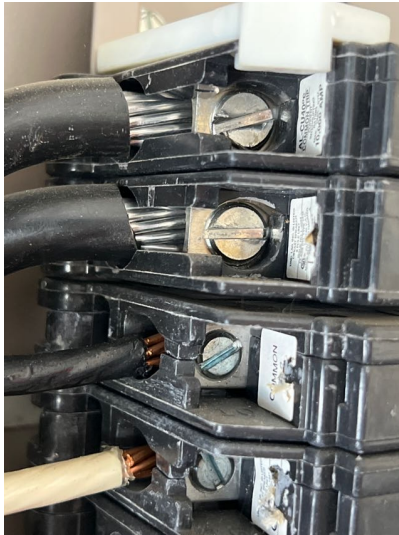
- Service entrance wiring is underground
- **The aluminum service conductors in electrical panel missing anti-oxidant grease.**

Aluminum service conductors missing anti-oxident grease.

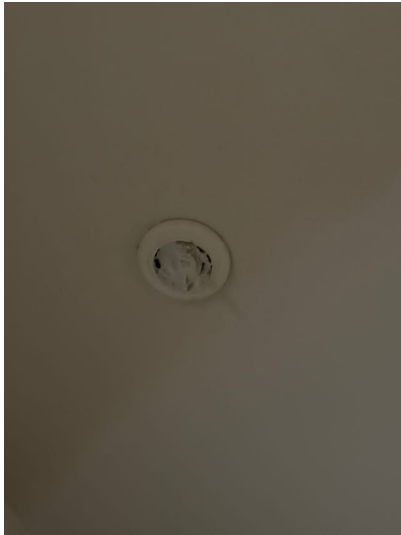
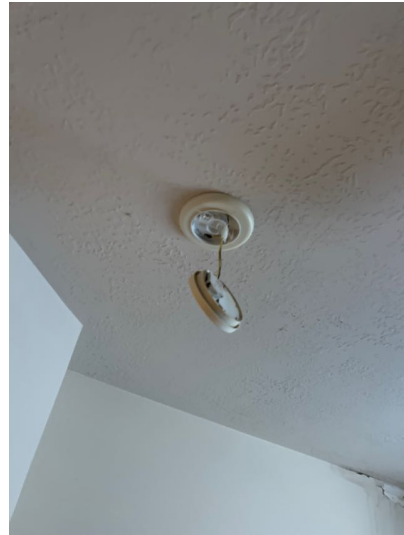
- Inadequate smoke alarm coverage was observed and it is recommended that additional smoke detectors and CO2 detectors be installed in accordance with current building standards. The NFPA {National Fire and Protection Agency} recommends one smoke alarm on each level, every bedroom and adjoining hallway, above stairwells and a CO2 detector in the garage and outside each bedroom with fuel fired appliances. A primary fire extinguisher is recommended on each level with a UL rating of 2-B:C.

Missing smoke alarm

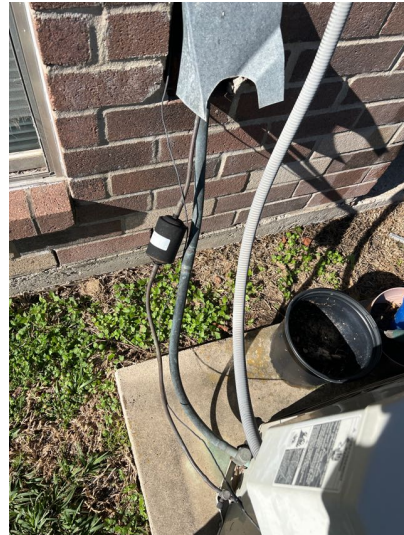
Damaged / missing insulation on freon line at AC condensing unit.

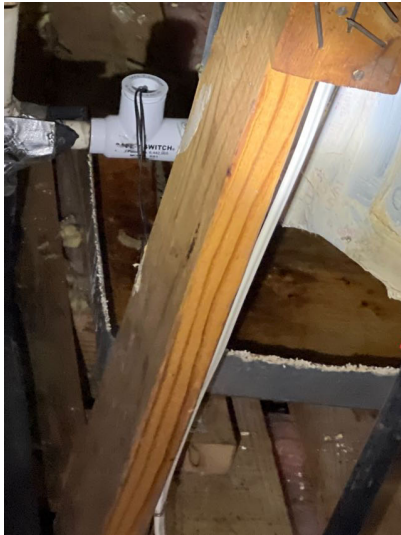
The AC Unit evaporator coil was noted defective due to water in secondary condensate containment pan.

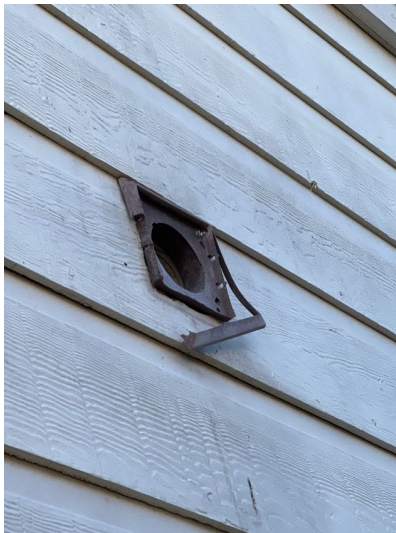
- Bathroom exhaust fan noted with damaged termination cover

Bathroom exhaust fan noted with damaged termination cover

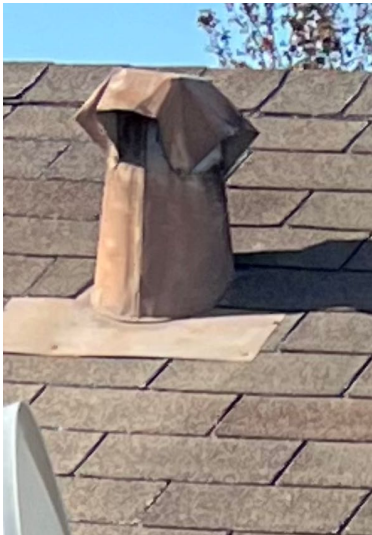
- The dryer vent pipe has been terminated through roof with an unapproved roof jack. Dryers terminated at roof requires a roof jack that is designed for this purpose. It is required to have a back draft damper to keep birds and rodents from building nests in the dryer exhaust pipe.

Unapproved roofjack used for dryer vent pipe.
