BPG Inspection, LLC

**34 North Swanwick Place
Tomball TX 77375**

Client(s): Bump
Inspection Date: 3/10/2021
Inspector: Murray Campbell , TREC #22455

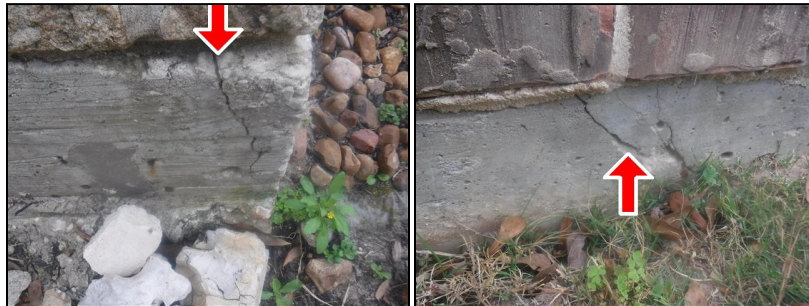
Corner cracks were observed at the corners of the slab foundation. Cracks of this nature are typical and occur when the exterior veneer is warmed by the sun and the wall expands. This condition is also a conducive condition for termite infestations. I recommend you contract foundation expert to repair mortar as needed to prevent further separation. Sidewalk repair caulking is the typical product used for this repair.

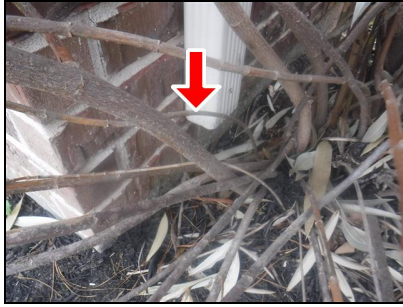
A downspout and/or turnout missing. Replace the missing components and extend 3ft from foundation.

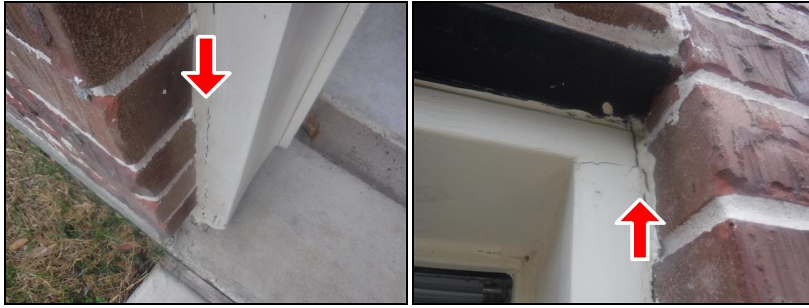
Noted areas of siding trim and edges that have missing or deteriorated caulking. These areas can be a point of water infiltration if not addressed. Noted no evidence at interior sides of home areas with previous water infiltration at time of inspection. Recommend fully and properly sealing all areas affected.

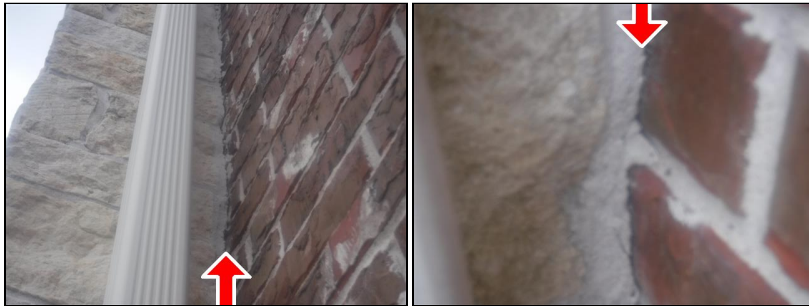
There are joint cracks on the walls in various locations. These cracks appear to be typical settlement/shifting joint cracks with no other visible displacement. Recommend sealing (mortar) crack to prevent moisture incursion and monitor for further settlement/separation

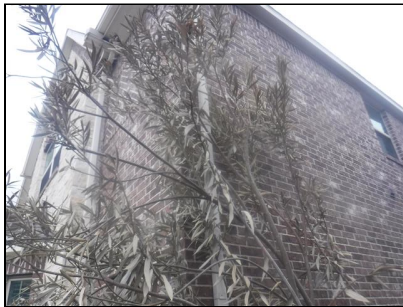
Trim all hedges, ivy and trees away from exterior wall surfaces. Heavy foliage against walls may be conducive to insect, rub or moisture damage. (Limited view of surfaces in these locations)

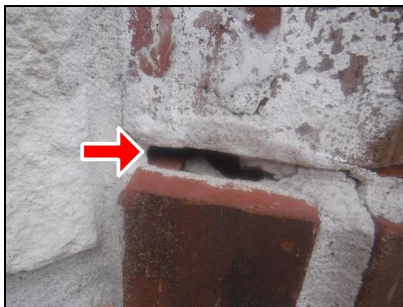
- ⚠ 2. Set cracks in brick, stone and mortar observed in various locations. These cracks should be repaired to prevent moisture intrusion and further expansion.

Set cracks in brick, stone and mortar observed in various locations. These cracks should be repaired to prevent moisture intrusion and further expansion.

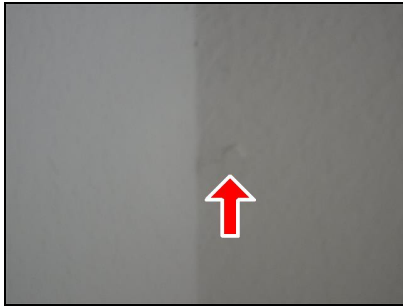
There are some nail heads "popping" through the ceiling/wall surface. Nail pops are typically cosmetic and not of any structural significance. A handy person can simply reset the nail head and fill the depressions with a patching material such as drywall or spackling compound.

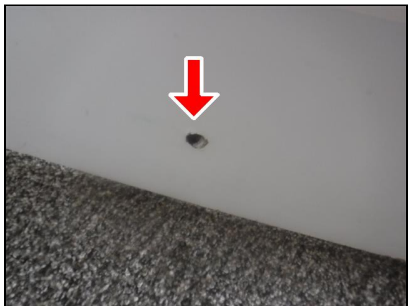
Master bedroom door functions as intended but is damaged. Repair as needed.

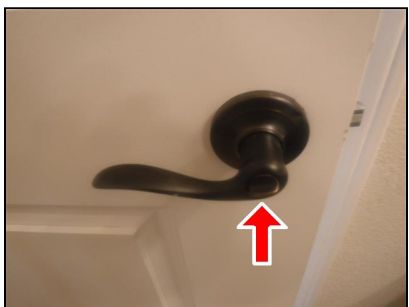
Door lock does not function upper right rear bathroom. Repair as needed.

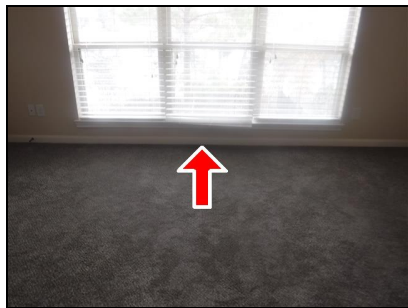
Noted one or more windows on 2nd floor that have a potential fall hazard present for small children due to their low height above floor. In dwelling units, where the opening of an operable window is located more than 72 inches above finished grade or exterior surface, the lowest part of the clear opening of the window shall be

a minimum of 24 inches above the finished floor. Recommend installing child proof lock assemblies at all windows affected.

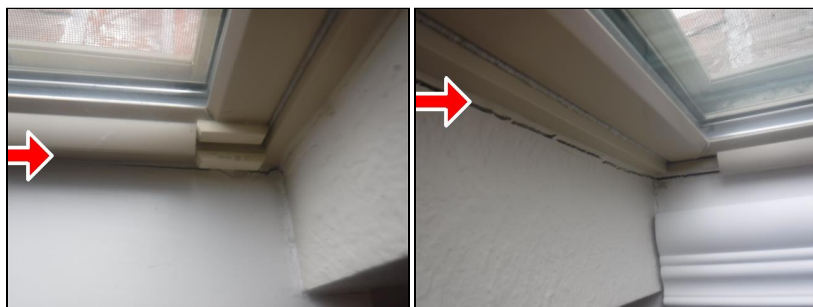
Noted several window sills at interior of home with deteriorated caulking at various sides of window frames. Deteriorated caulking at area can potentially subject framing under and behind window sill to future moisture collection concerns. Recommend having all window sills affected re-sealed with caulking. Important to check all 4 sides of window frames for deteriorated caulking concerns.

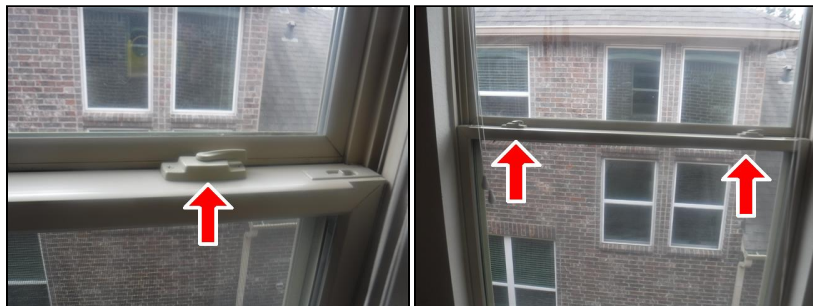
- ✘ 5. The locks on some windows of this house did not function. Window frames may have shifted with structural settling. Recommend contractor to evaluate for adjustment or repair. Located upper right rear bedroom

The locks on some windows of this house did not function. Window frames may have shifted with structural settling. Recommend contractor to evaluate for adjustment or repair. Located upper right rear bedroom

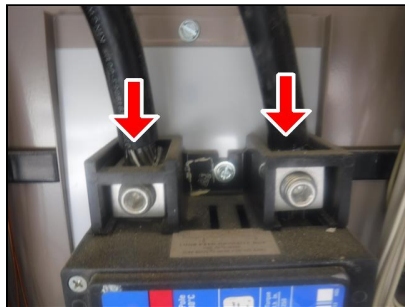
- ✘ 7. Grounding cable is loose from ground electrode. Repair needed.
- ✘ 8. The aluminium service wires should be coated with anti-oxidation grease where they are stripped back to be connected to the mains, main or branch circuit breakers.

Grounding cable is loose from ground electrode. Repair needed.

The aluminium service wires should be coated with anti-oxidation grease where they are stripped back to be connected to the mains, main or branch circuit breakers.

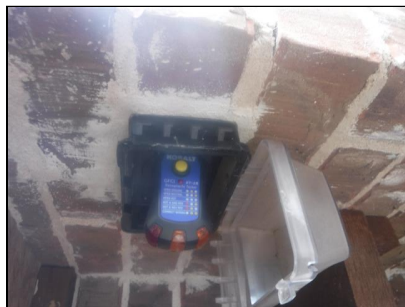
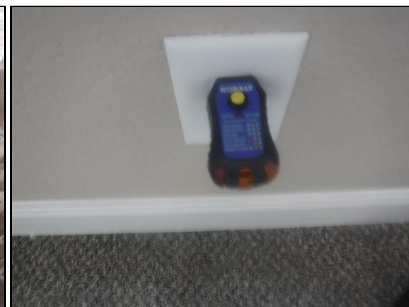
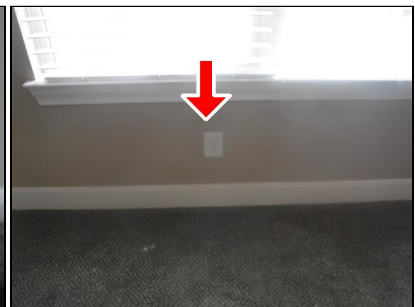
- ✘ 9. There was an outlet found to be non-functional in the master bedroom rear wall exterior rear at grill. I recommend further evaluation/diagnosis and repair by a licensed electrician.

There was an outlet found to be non-functional in the master bedroom rear wall exterior rear at grill. I recommend further evaluation/diagnosis and repair by a licensed electrician.

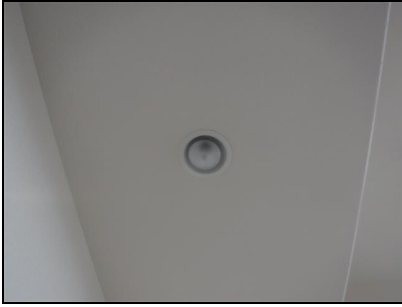
Some lights were not functioning. These are usually just a case of burned out bulbs. Recommend replacing bulbs before closing as needed. If fixtures are still not functioning, then a licensed electrician should diagnose for deficiencies.

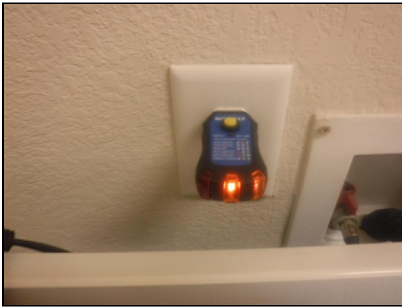
There are no GFCI (Ground Fault Circuit Interrupt) protected outlets in locations called for by today's standards: laundry,. I recommend updating to current standards.

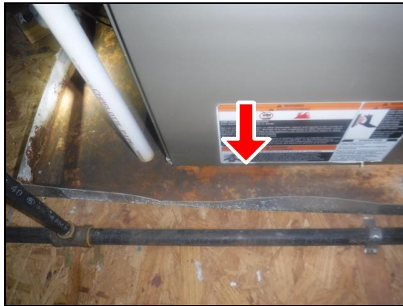
- 12. There is no emergency float electrical cutoff switch installed as called for by today's standards. These devices prevent condensate from overflowing into the interior house structure, and turn the unit off until service is performed to the unit. I recommend updating to current standards to prevent water incursion.
- 13. Rust was observed in the secondary drain pan. This is from excess condensation. This is common for cooling systems that are installed in a interior closet, or even in the attic. Ensure air flow is not restricted (dirty filters) and the condensation drain line is periodically flushed to prevent drain line blockage. Consider having the unit serviced by a licensed HVAC technician.

⚠ There is no emergency float electrical cutoff switch installed as called for by today's standards. These devices prevent condensate from overflowing into the interior house structure, and turn the unit off until service is performed to the unit. I recommend updating to current standards to prevent water incursion.

⚠ Rust was observed in the secondary drain pan. This is from excess condensation. This is common for cooling systems that are installed in a interior closet, or even in the attic. Ensure air flow is not restricted (dirty filters) and the condensation drain line is periodically flushed to prevent drain line blockage. Consider having the unit serviced by a licensed HVAC technician.

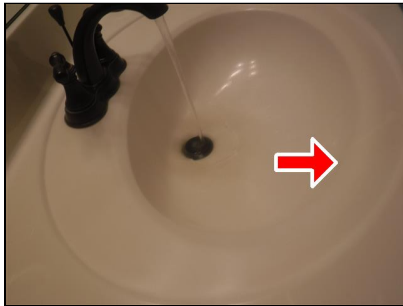
The guest bath master bath sink does not have an over-flow drain and there is a drain stopper present. Client should ensure that the sink is never left unattended during filling. Suggested recommendation is to remove stopper assembly from sink.

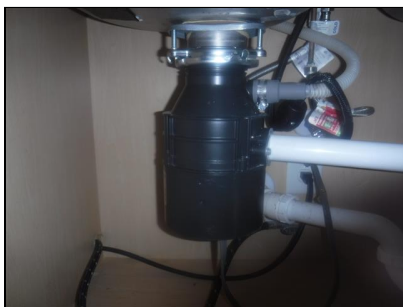
- 15. Rubber splash guard is missing. Replacement is recommended.

Rubber splash guard is missing. Replacement is recommended.

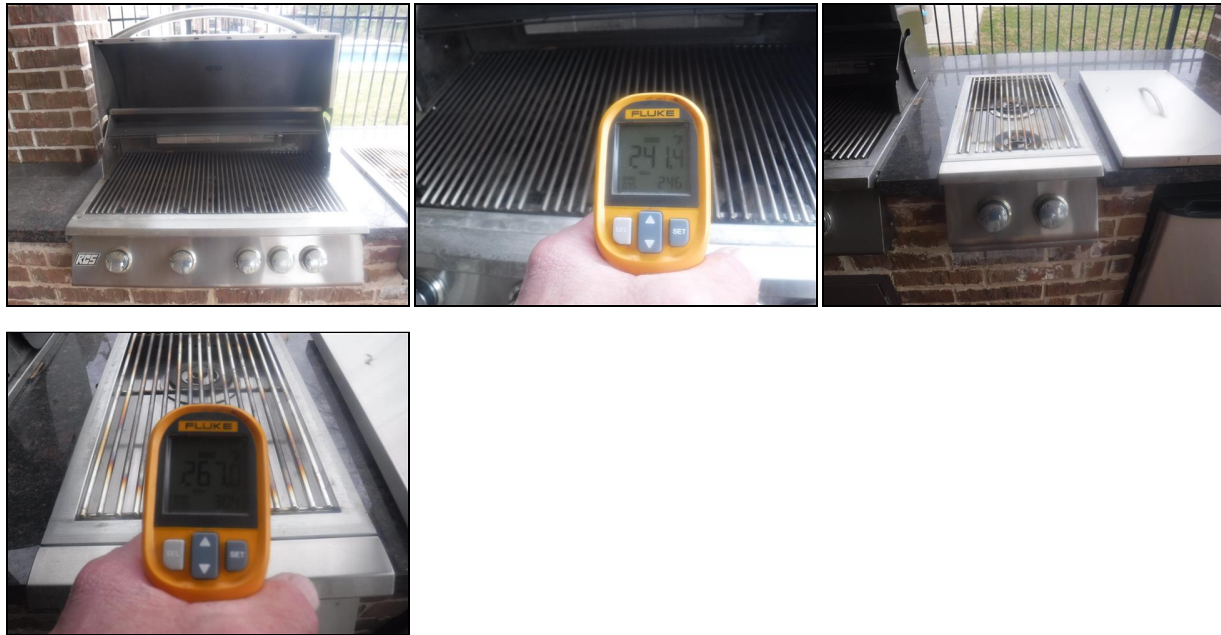
The outdoor cooking equipment functioned normally when tested during the inspection. Igniter did not function at covered grill. Replace as necessary
