ENGINEERING OPINION
INVESTIGATION OF FOUNDATION PERFORMANCE
RESIDENCE AT 420 E 26th STREET, HOUSTON, TEXAS, 77008
Date of Inspection: November 7, 2022
Date of Report: November 11, 2022

420 East 26th Street, Houston, Texas, 77008

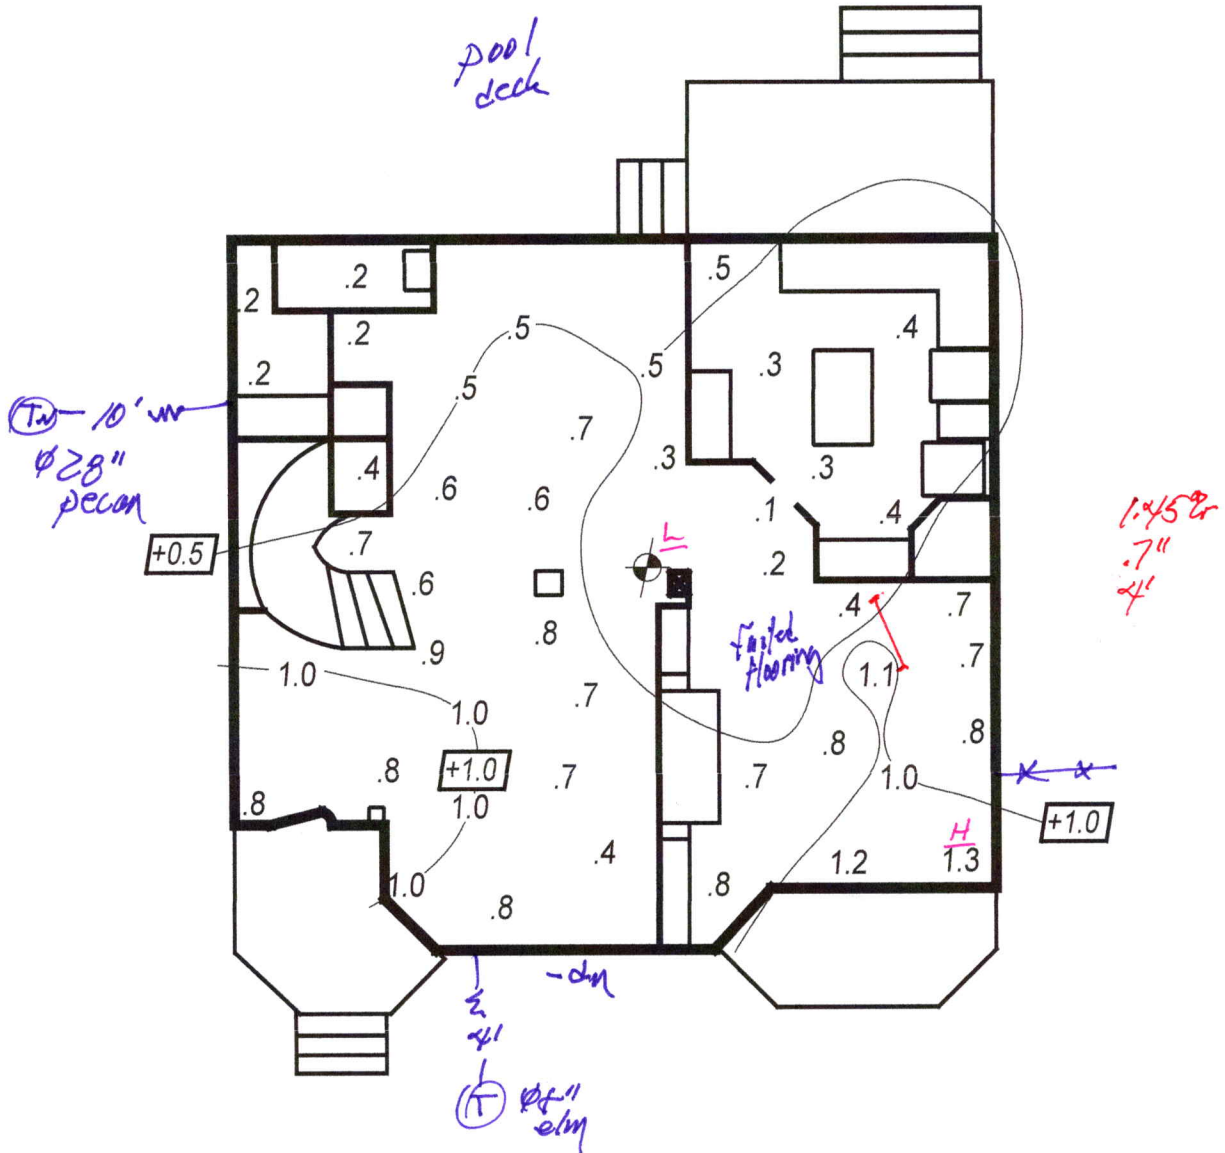
SLAB SURFACE ELEVATIONS AND OBSERVATIONS

Damages and conditions at the exterior are shown on the attached Elevation survey sheet. The exterior is clad in siding. Siding does not show damages from foundation movement readily.

Inspection of the exterior found deficient drainage and landscape conditions at the perimeter of the foundation, especially water appears to enter the crawlspace from the front, as shown on the attached Elevation survey sheet.

Damages and conditions at the interior are shown on the attached Elevation survey sheet. The only condition of interest was an area of failed flooring. No damage indicative of foundation movement was observed.

An elevation survey throughout the house was performed using a Technidea Zipllevel. The reference zero was the middle interior area. The elevations have a range of 1.3 inches, highest at the front right corner of the house, lowest at the middle interior area. The foundation generally is almost flat and level.

The elevations measured as slope of floors calculate to 1.45% (.7 inches in 4 feet, red line, worst case), which does not exceed 2.00% (1.2 inch difference across 5 feet).

I recommend the following measures to keep your foundation performing as well as possible: Maintain good drainage at the perimeter of the foundation. Monitor crawlspace conditions after heavy rains for water in the crawlspace and correct the conditions causing this water.
