**NOTICE CONCERNING HAZARDOUS CONDITIONS, DEFICIENCIES, AND CONTRACTUAL AGREEMENTS**

**ADDITIONAL INFORMATION PROVIDED BY INSPECTOR**

### I. STRUCTURAL SYSTEMS

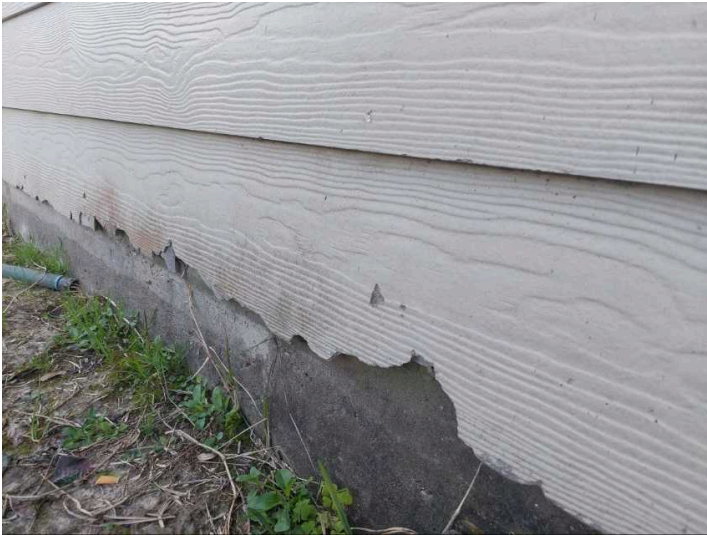
- The utility room/laundry room has an electric connection for an electric dryer; no gas connection.
- Interior - Home was partially / and or completely occupied at the time of the inspection. Stored personal belongings can affect the inspectors view of the entire wall system. Only areas free and clear of furniture and other obstructions are inspected. Observation of these areas related to structural performance and water penetration only.
- The siding was noted with damage in one or more locations.
- Unsealed wall penetration noted near back door. Holes allow water and/or insects to enter wall structure.
- Interior walls noted with damaged drywall.
- Evidence of moisture entering structure from interior water stains

*Damaged siding back side of house.*

Page 7 Item: E	Walls (Interior and Exterior)	<ul style="list-style-type: none"> <li>• The siding was noted with damage in one or more locations.</li> <li>• Unsealed wall penetration noted near back door. Holes allow water and/or insects to enter wall structure.</li> <li>• Interior walls noted with damaged drywall.</li> <li>• Evidence of moisture entering structure from interior water stains</li> </ul>
Page 11 Item: F	Ceilings and Floors	<ul style="list-style-type: none"> <li>• Transition strips were missing in one or more areas of the home.</li> <li>• Moisture stains were noted in various places on the ceiling. The cause and remedy should be further evaluated and corrected as needed.</li> </ul>
Page 13 Item: G	Doors (Interior and Exterior)	<p>Several bedroom doors have deadbolt locks installed instead of doorknobs.</p> <p>One or more interior doors noted with damage.</p>
Page 14 Item: H	Windows	<ul style="list-style-type: none"> <li>• One or more of the window screens were observed to be damaged and/or missing. Screens are mentioned in this part of the report as they are a specific item in the T.R.E.C. Guidelines. Screens that are torn enough to allow insect infestation should be repaired or replaced. All windows that have channels for screens should have them installed.</li> </ul>

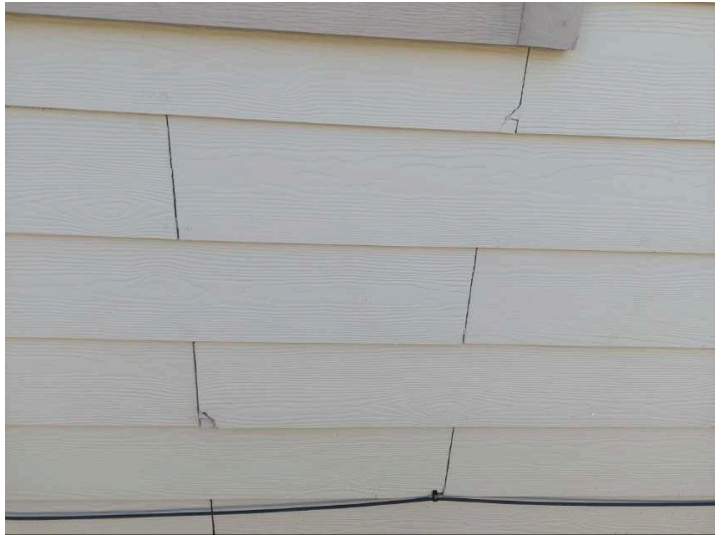
*Damaged siding left side of house.*

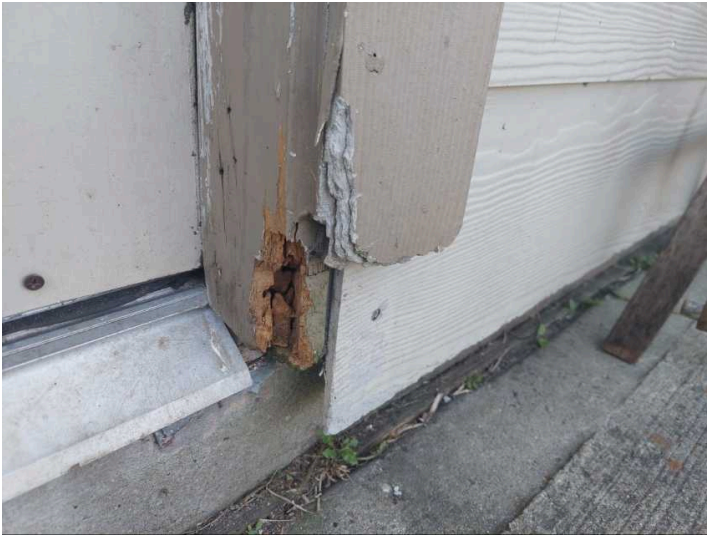
*Damaged siding/door frame back side of house*

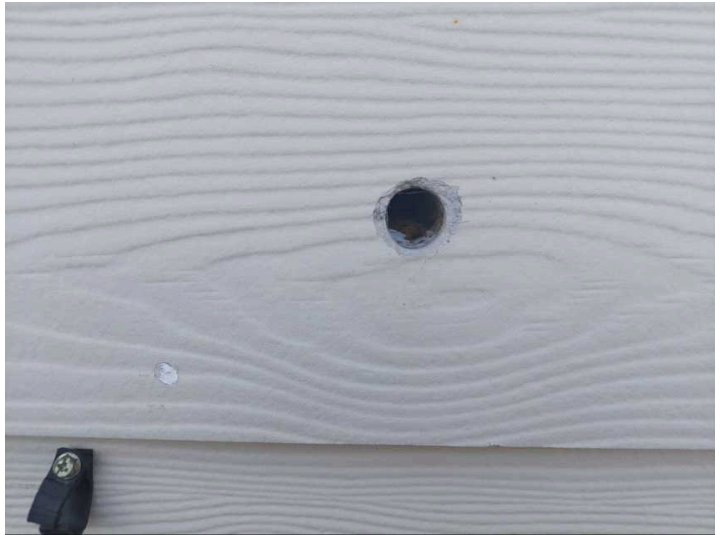
*Exposed hole in back wall should be sealed*

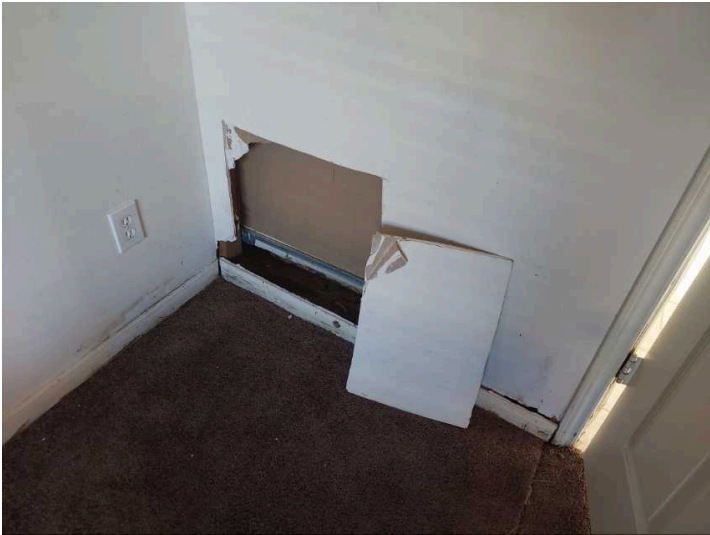
*Interior wall damage, master bedroom*

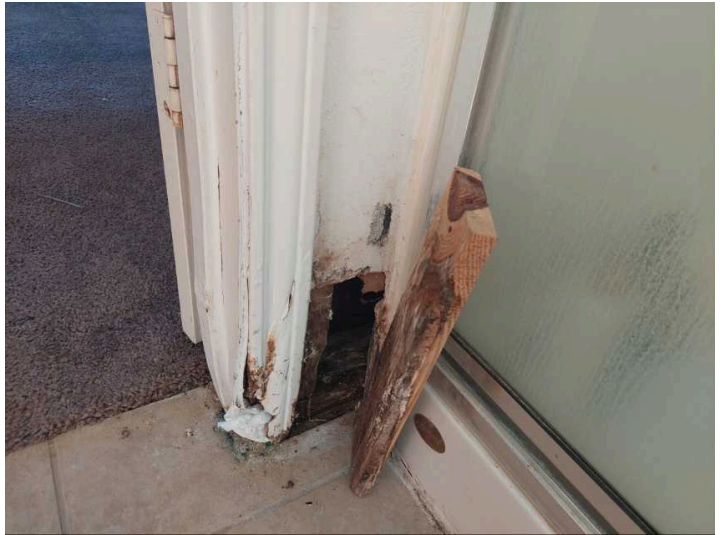
*Interior wall damage, master bathroom*

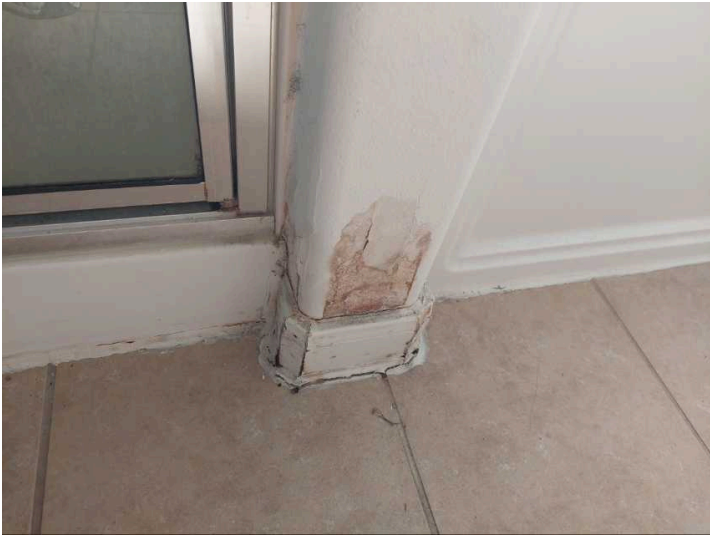
*Interior wall damage, master bathroom*

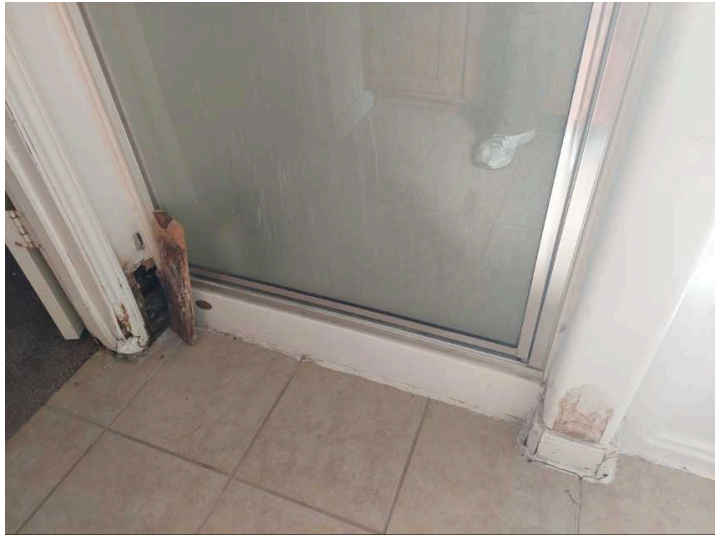
*Interior wall damage, master bathroom*

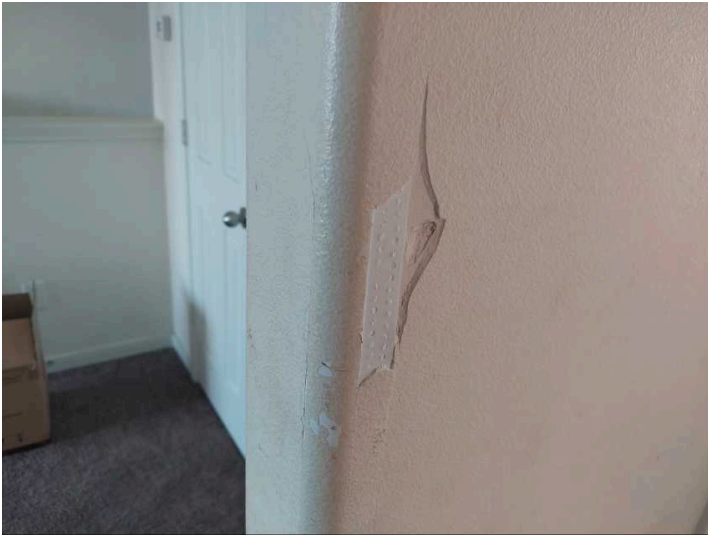
*Interior wall damage*

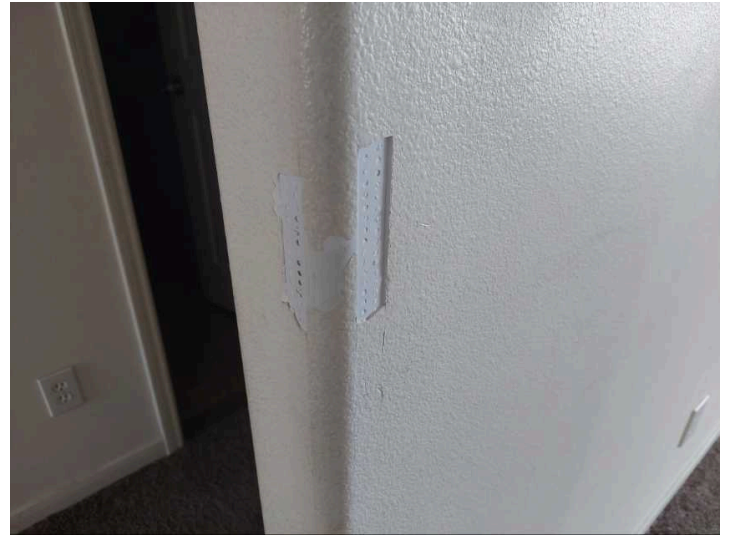
*Interior wall damage*

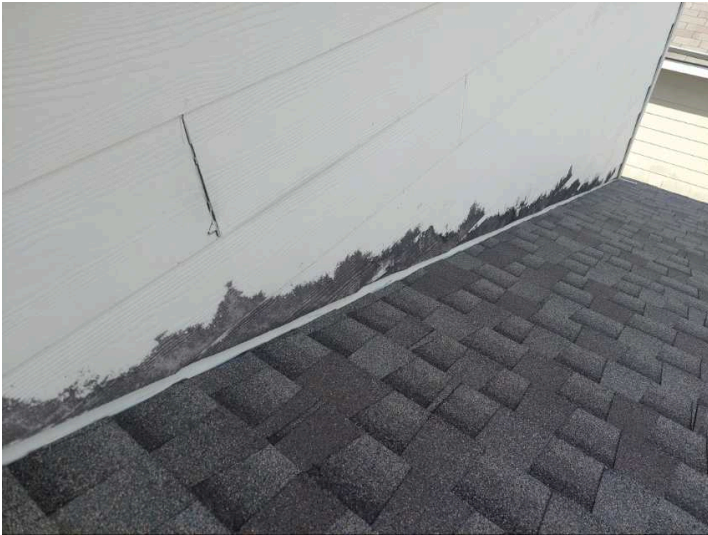
*Damaged siding back side of house.*

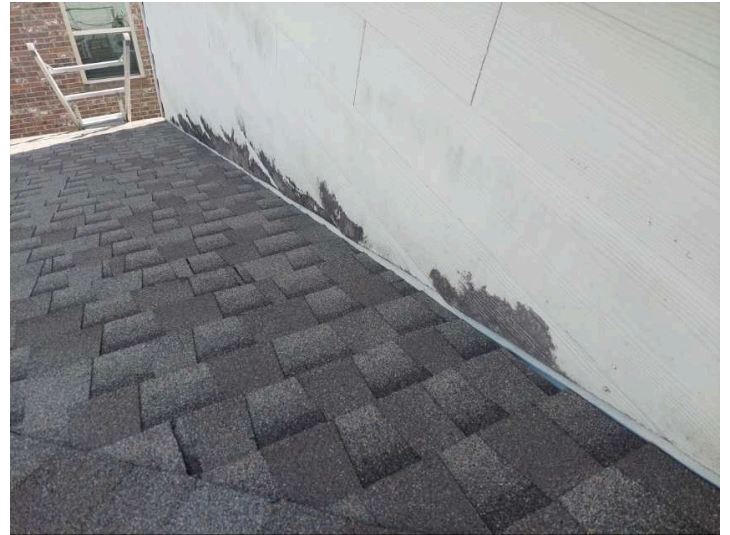
*Damaged siding back side of house.*

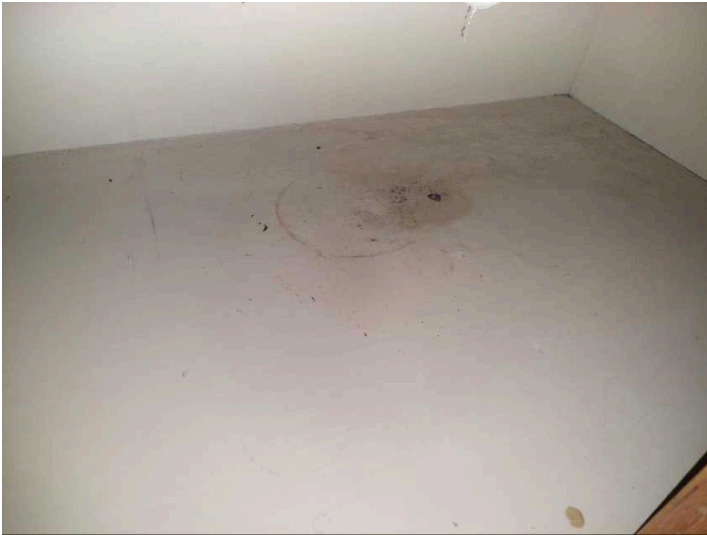
*Water damaged cabinet floor in upstairs hall bathroom*

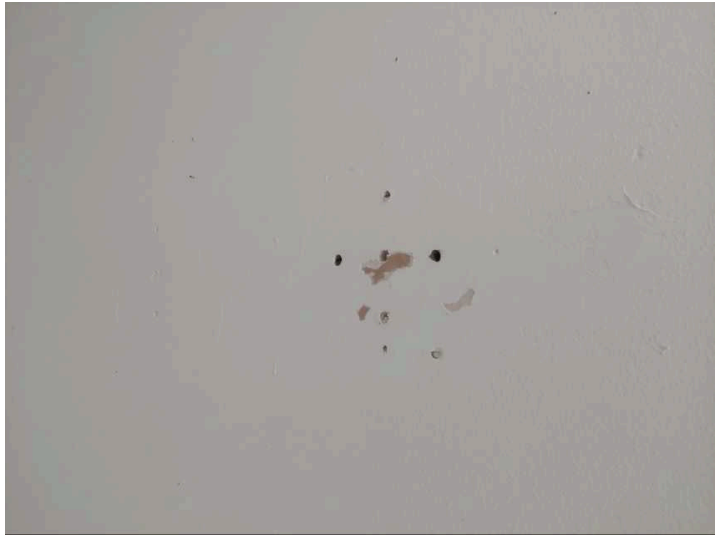
*Interior wall damage in bedroom*

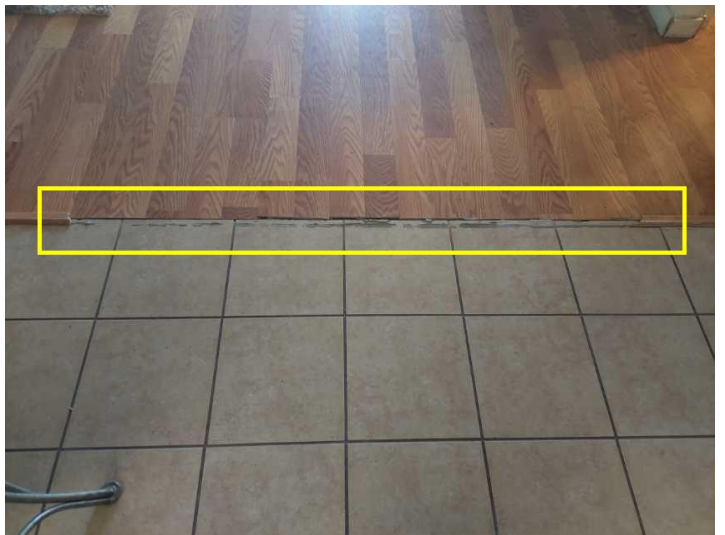
- Transition strips were missing in one or more areas of the home.
- Moisture stains were noted in various places on the ceiling. The cause and remedy should be further evaluated and corrected as needed.

*Damage transition strip*

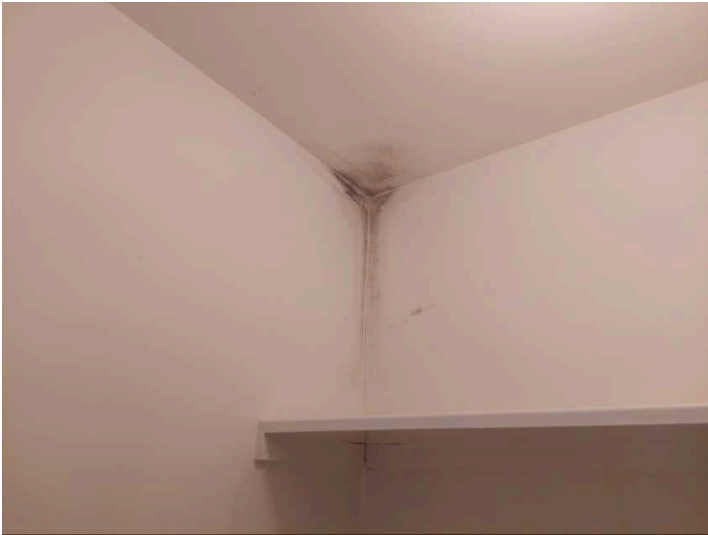
*Evidence of moisture entering structure from interior water stains, upstairs closet*

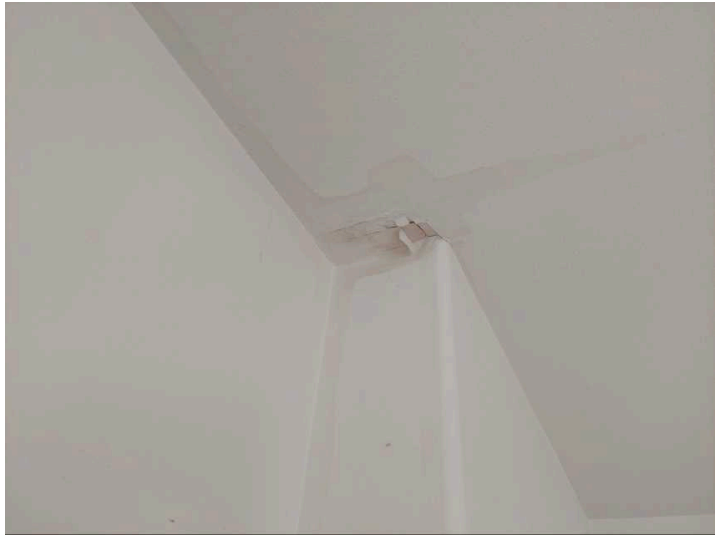
*Moisture stain on ceiling, upstairs bedroom*

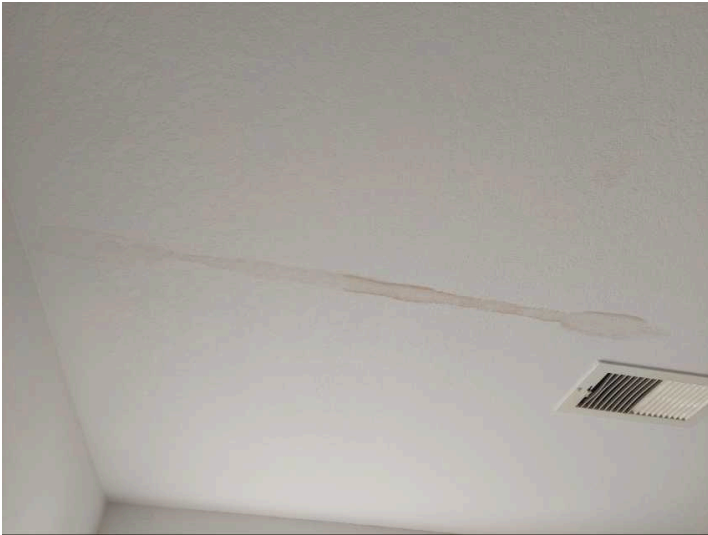
*Moisture stain on ceiling, upstairs front bedroom*

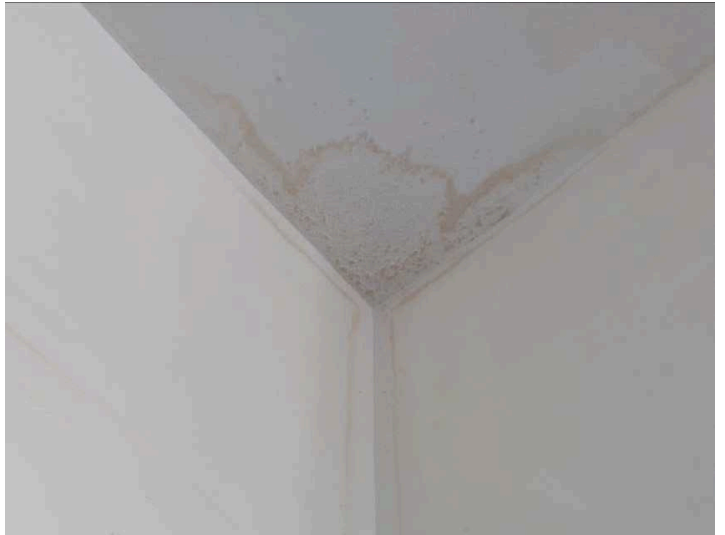
*Moisture stain on ceiling, stairway*

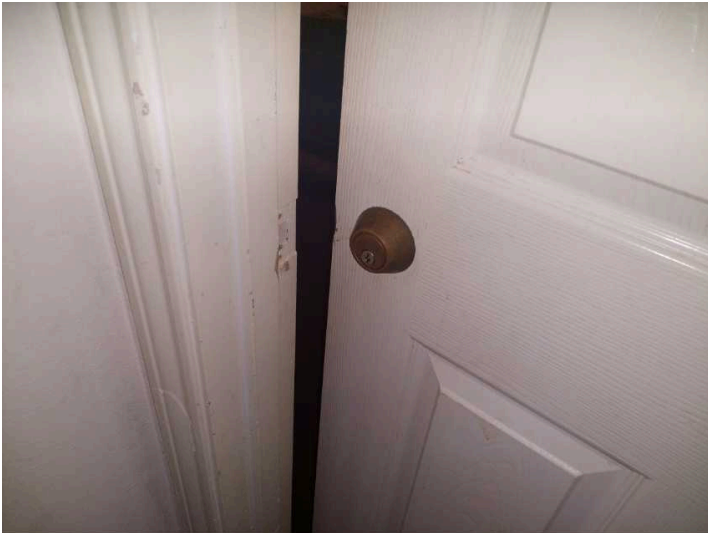
Several bedroom doors have deadbolt locks installed instead of doorknobs.  
 One or more interior doors noted with damage.

*Missing doorknob for downstairs bedroom*

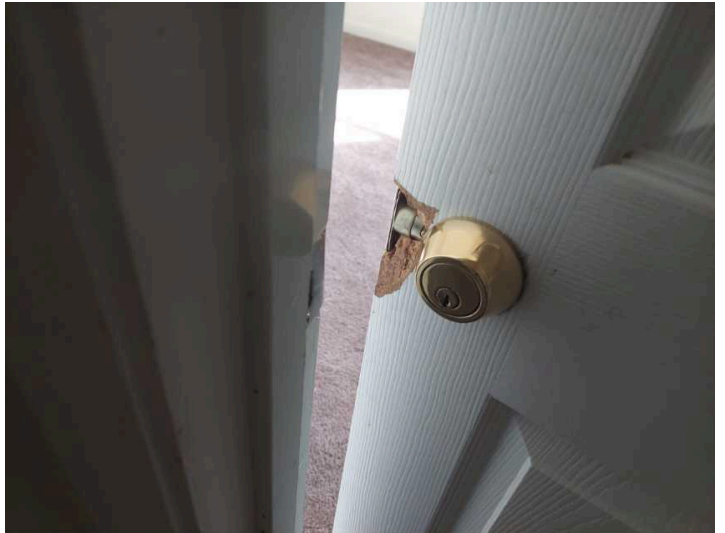
*Bedroom door does not have proper door knob*

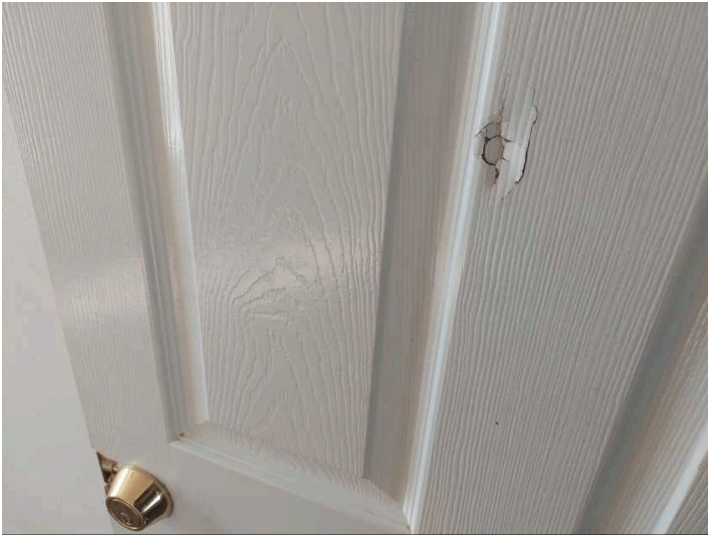
*Bedroom door is damaged.*

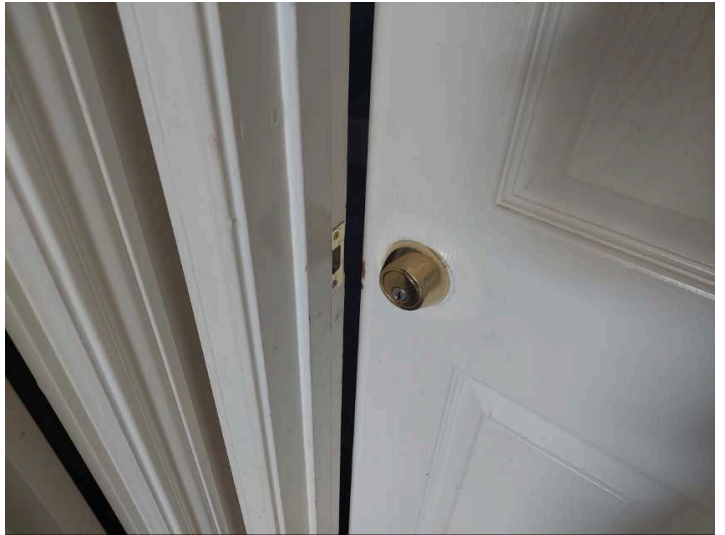
*Bedroom door does not have proper door knob*

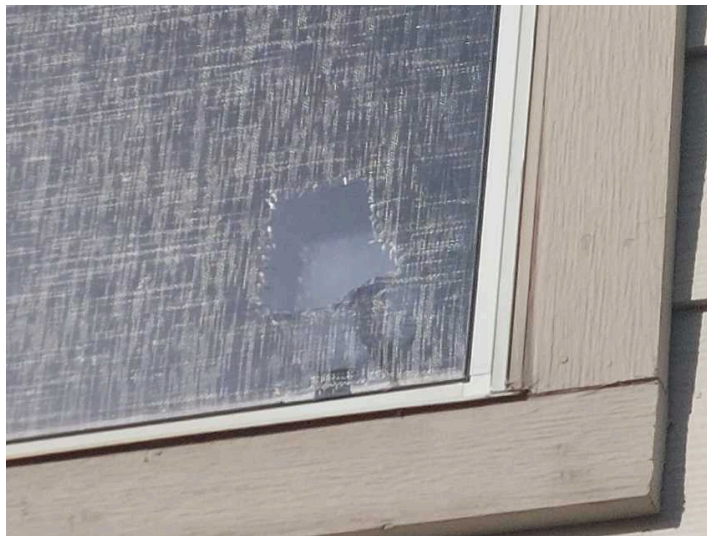
- One or more of the window screens were observed to be damaged and/or missing. Screens are mentioned in this part of the report as they are a specific item in the T.R.E.C. Guidelines. Screens that are torn enough to allow insect infestation should be repaired or replaced. All windows that have channels for screens should have them installed.

*Damaged window screen*

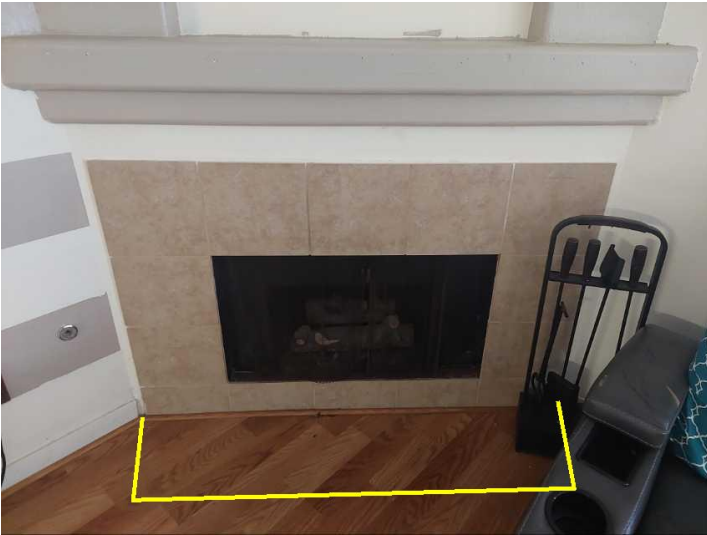
- **Fireplace missing a defined, noncombustible hearth extension.**

*Fireplace missing a defined, noncombustible hearth extension.*

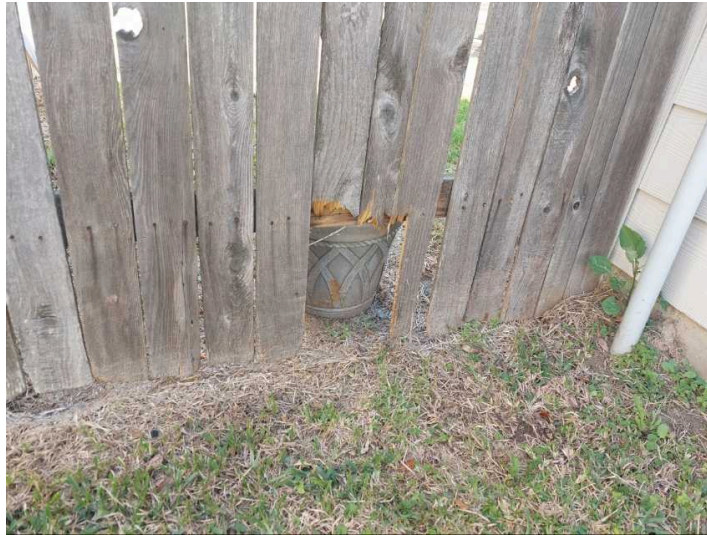
- **One or more wood pickets damaged and/or missing in fence line**

*Wood pickets damaged and/or missing in fence line*

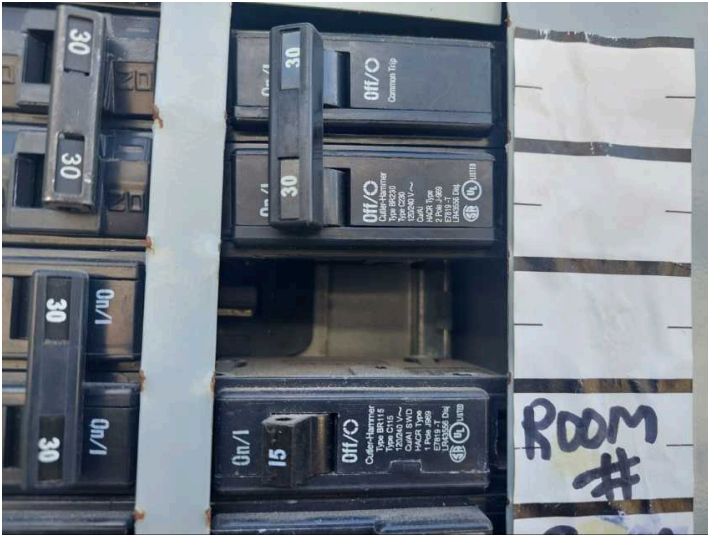
- Service entrance wiring is underground
- **Open breaker slots in the panel which presents a Safety Hazard. This is to prevent accidental electrocution by someone being able to put a screwdriver or a finger into the panel and touch a live component.**
- **The aluminum wiring in the service panel noted to be missing anti-oxidant grease.**

Open breaker slot on dead front cover panel

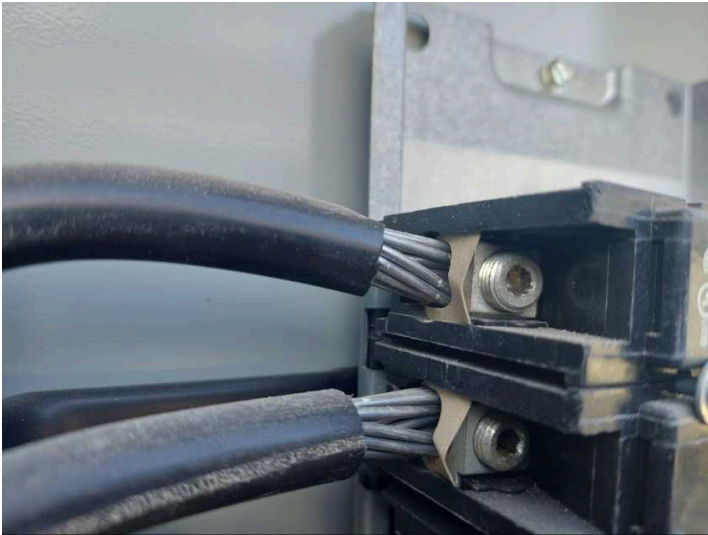
Aluminum service conductors missing anti-oxidant grease

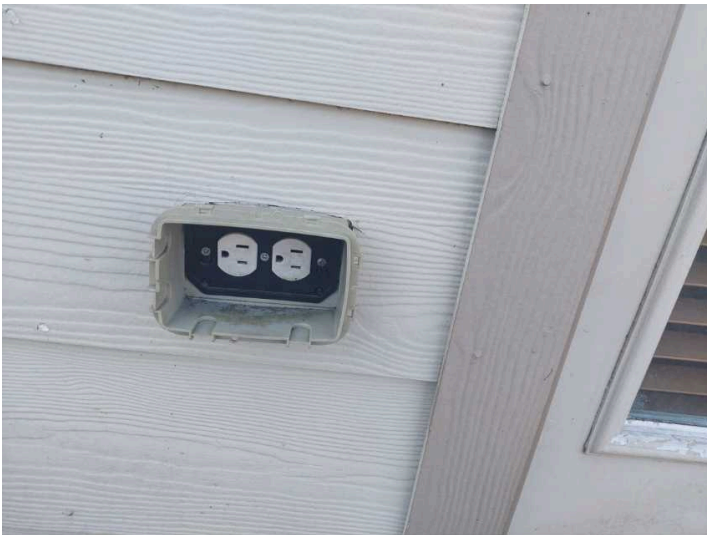
- Under current standards; exterior GFCI protected receptacles require a weatherproof bubble type cover
- Missing globe in one or more areas to protect bulbs from mechanical damage.
- One or more ceiling fans in the home were out of balance.

*Exterior GFCI protected receptacles require a weatherproof bubble type cover*

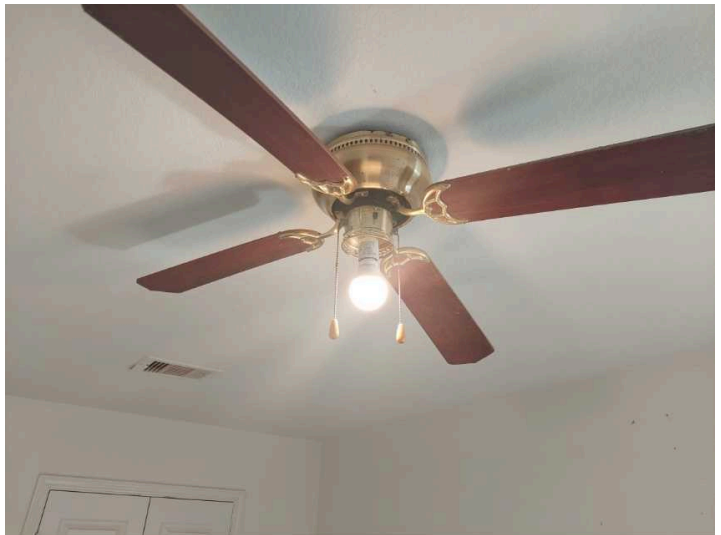
*Ceiling light missing protective globe*

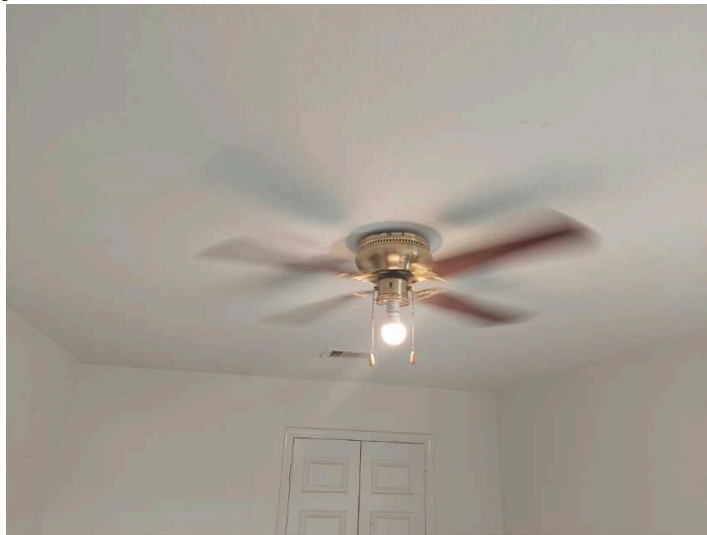
*Ceiling fan is wobbly at high speed, Upstairs bedroom*

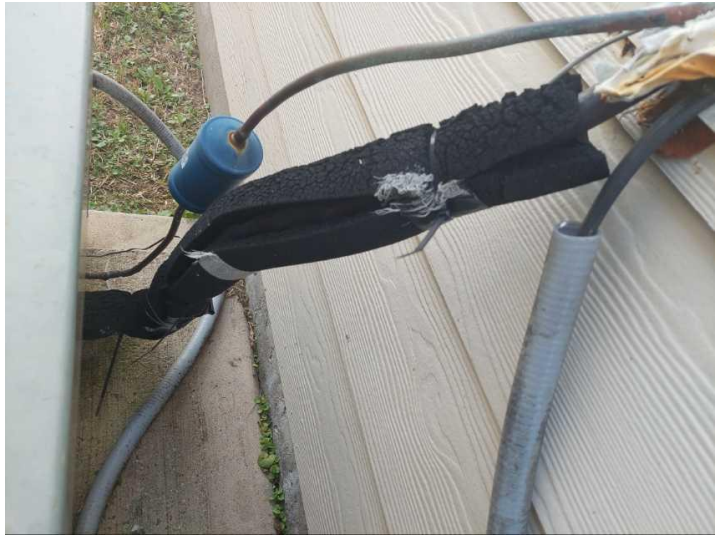
Damaged insulation on Freon line at AC condensing unit

Page 21 Item: B	Cooling Equipment	<ul style="list-style-type: none"> <li>• Refrigerant lines have damaged insulation at the Condensing Unit.</li> <li>• Rust and/or corrosion was noted in the condensate drip pan</li> </ul>
-----------------	-------------------	---

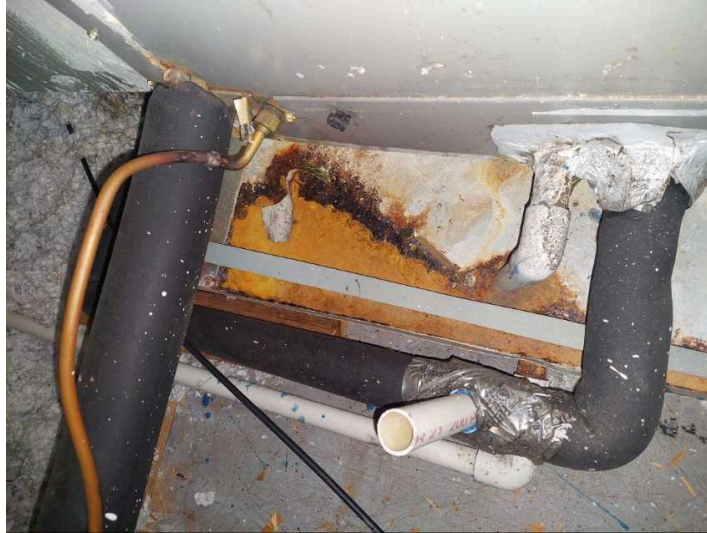
- Number of AC Units : 1
- AC Unit #1 Brand Name: RHEEM
- AC Unit #1 Manufacture Date: 2004
- Unable to test the cooling system due to the outside temperature being below {60} degrees per the Texas Real Estate Inspector's Standards of Practice.
- Refrigerant lines have damaged insulation at the Condensing Unit.
- Rust and/or corrosion was noted in the condensate drip pan

*Corrosion present in evaporator overflow pan*

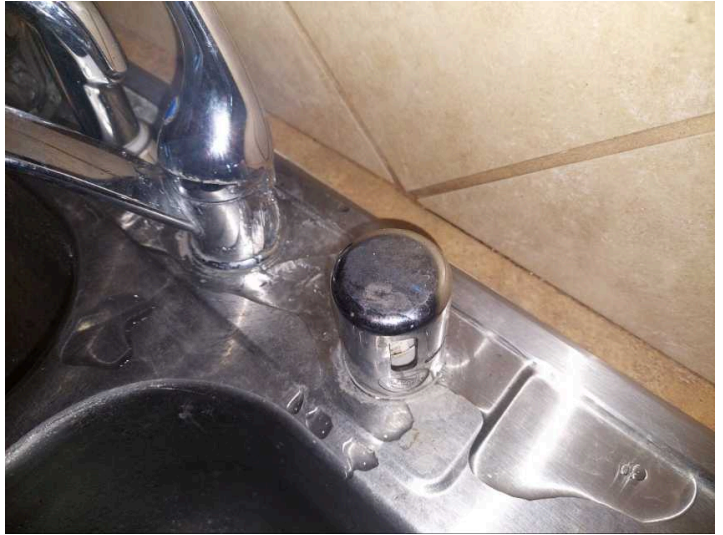
- Type of Supply Piping Material: Copper
- Static Water Pressure Reading: psi. Unable to attach water pressure gauge due to covered hose bibs.
- The kitchen sink faucet was leaking water at base.
- One or more toilets did not flush at time of inspection.
- Water appeared to be leaking from the shower pan to the adjacent areas in Master Bathroom and should be evaluated by a qualified plumber.
- Damaged caulking was noted at the downstairs hall bathroom sink.

*Leakage noted at kitchen faucet when turned on*

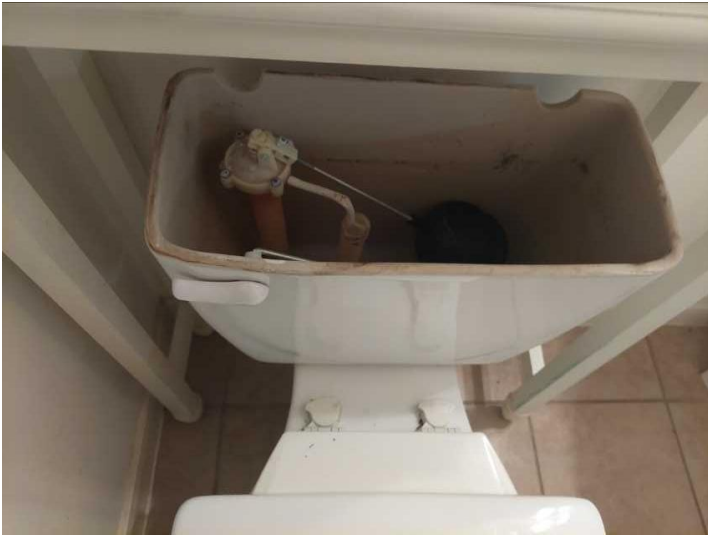
*Downstairs hall bathroom toilet does not flush*

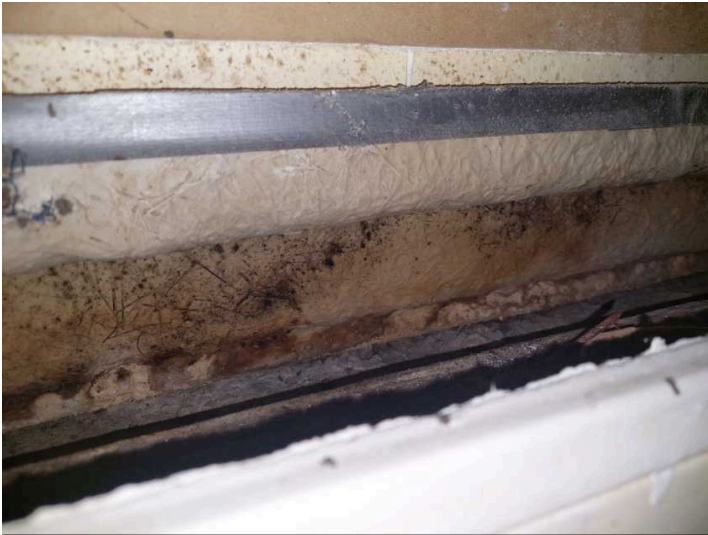
*Possible master bathroom shower pan leakage has caused damage to walls*

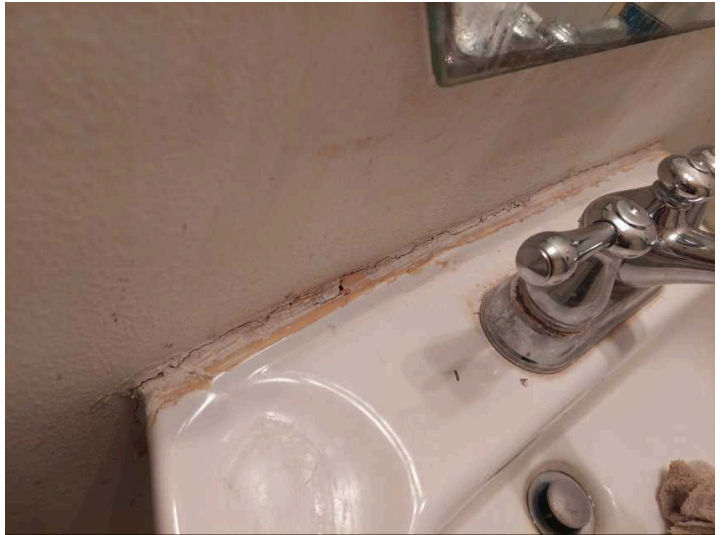
*Caulking at downstairs hall bathroom is in need of repair*

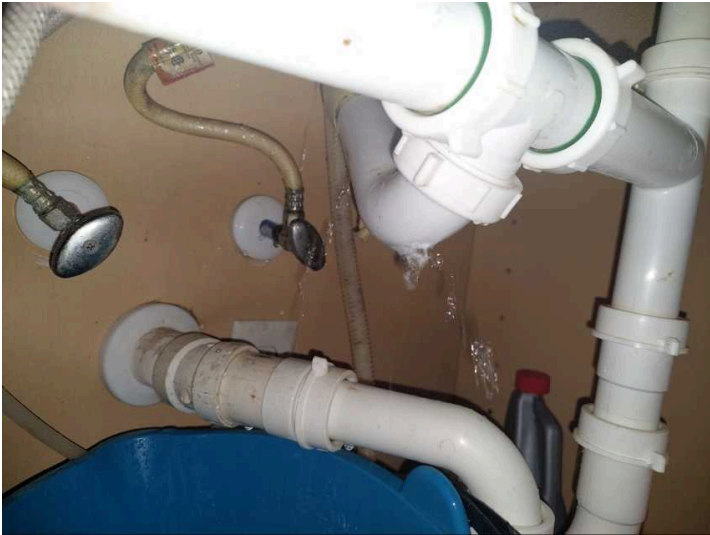
- Type of Drain Piping Material:PVC
- **Leakage was observed under the kitchen and bathroom sink drain lines.**

*Kitchen sink drain piping noted with water leak.*

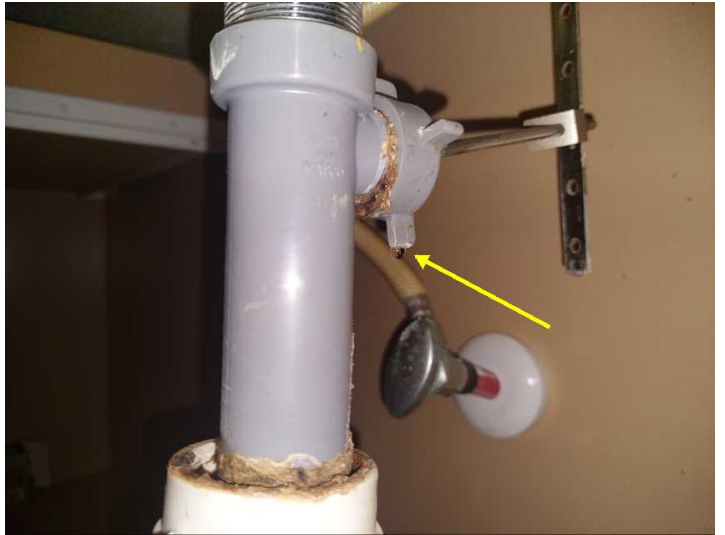
*Hall bathroom vanity drain piping noted with water leak.*

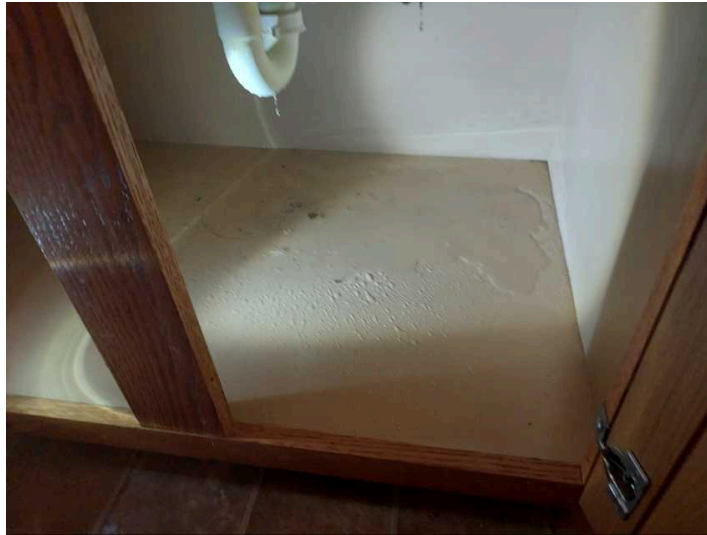
*Hall bathroom vanity drain piping noted with water leak.*

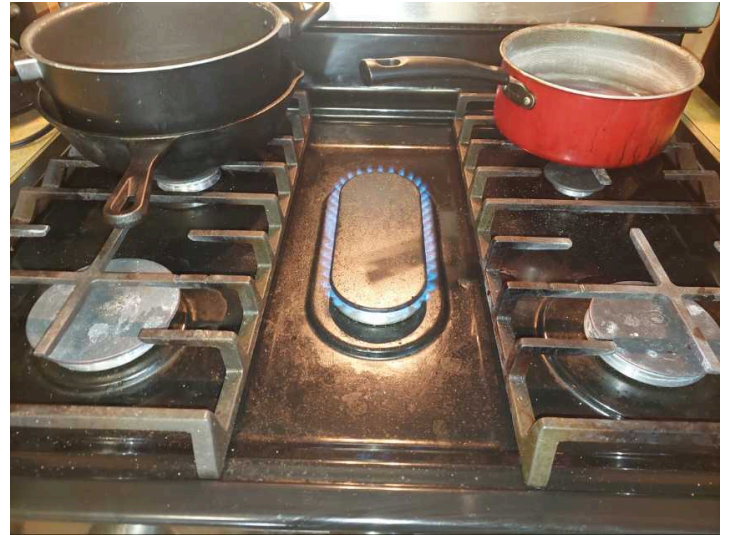
- Oven: Natural gas
- The gas range and oven were functional at the time of the inspection
- **The center burner is missing the grate that should be above it.**

Missing center grate

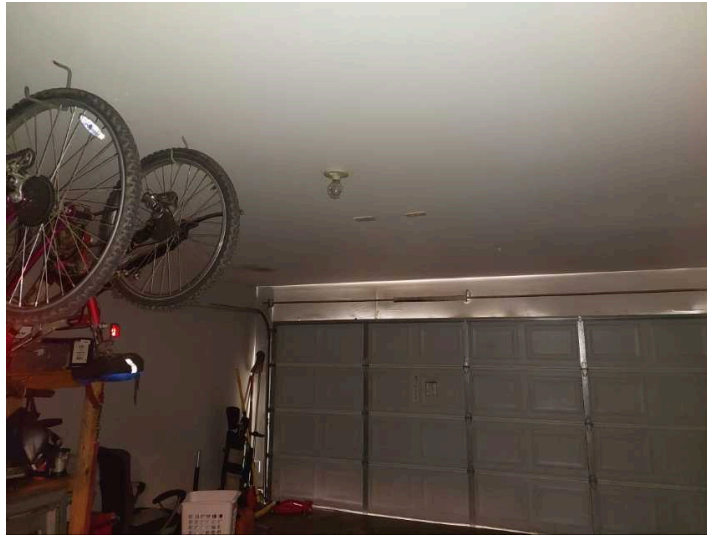
*Garage door operator not installed*

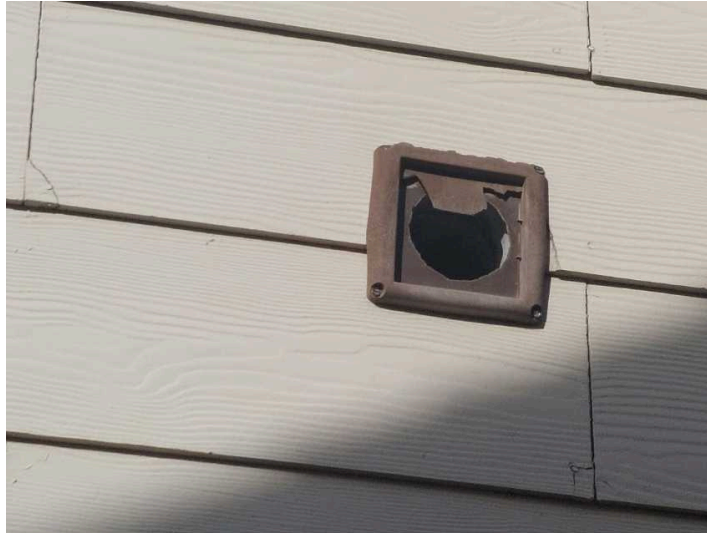
- The dryer vent cover is damaged, has missing or broken louvers or damper.

*Dryer vent cover is missing backdraft damper*
