PROPERTY INSPECTION REPORT

Concerning: 1611 W 24th St A, Houston, TX 77008
(Address or Other Identification of Inspected Property)

By: Michael Garcia, Lic #20817 06/10/2019
(Name and License Number of Inspector) (Date)

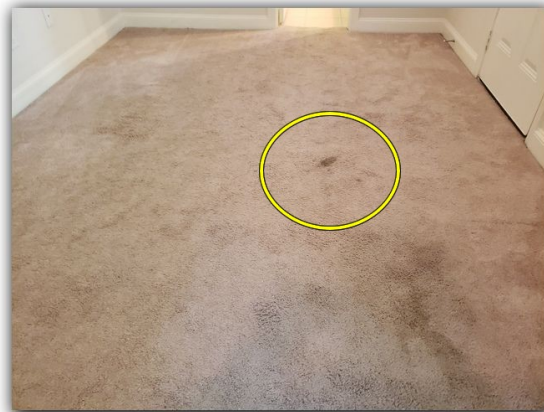
There are stains at the carpet in various areas. (Picture Below)

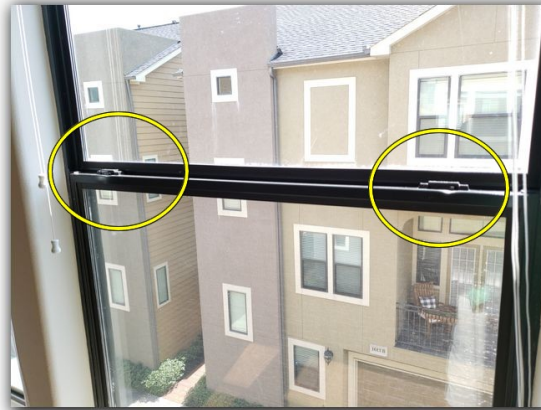
D – Window locks within the home were broken.

Repair/Replacement is recommended.
