## BUILDING ENVELOPE MOISTURE INSPECTION

1611a W 24th St  
Houston, TX 77008

Menglin Wu  
DECEMBER 14, 2021

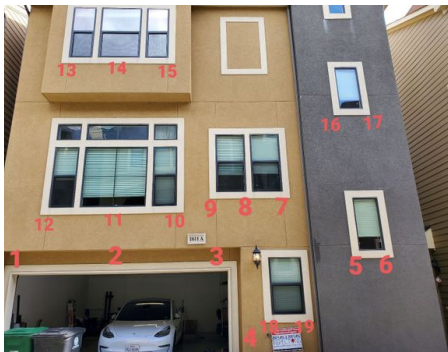
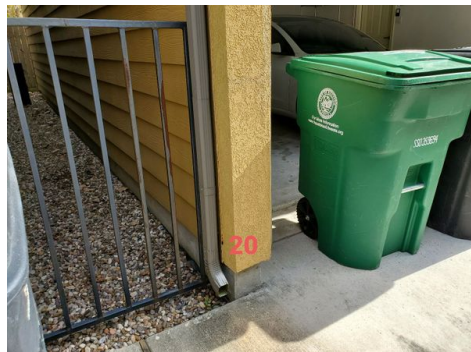
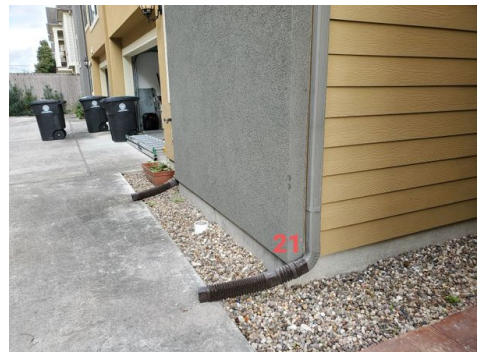
**Photo of elevation with test sites: Photo of Elevation**

Elevation 1 Site(s): 9, 20,

The substrate appears soft or severely deteriorated indicating the wall is not performing as intended. A small area of stucco should be removed in this area to verify the inspectors findings and the damaged substrate should be repaired. Further evaluation by a stucco contractor to determine the best method of remedy is recommended. All repairs should be performed by qualified contractors according to industry standard installation instructions.

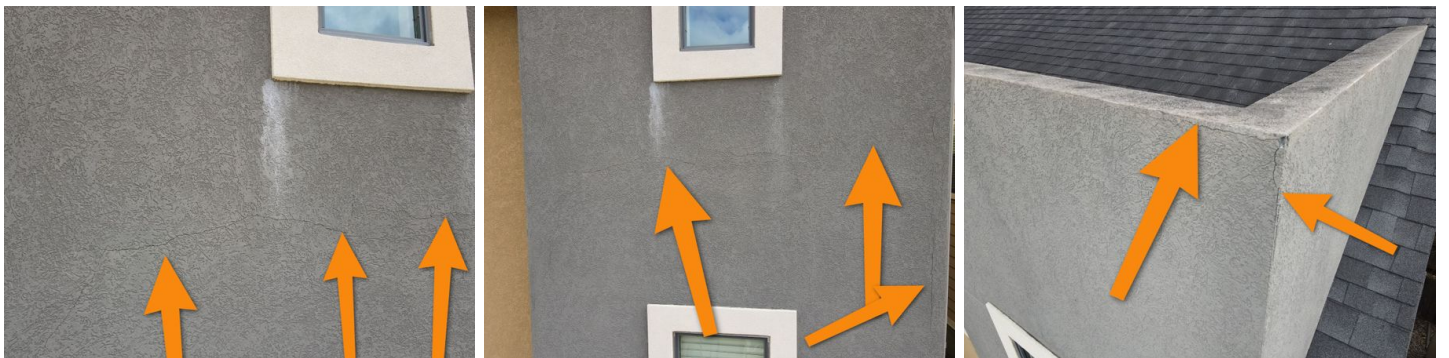
#### 4.1.1 Visible Cracking or Damage

#### **HAIRLINE CRACK HORIZONTAL**

There are multiple horizontal hairline cracks at the exterior stucco material. These cracks may be an indication of poor fastener patterns in the lathe supporting the stucco. Repair may be necessary to prevent moisture intrusion and further cracking.

Recommendation

Contact a qualified professional.

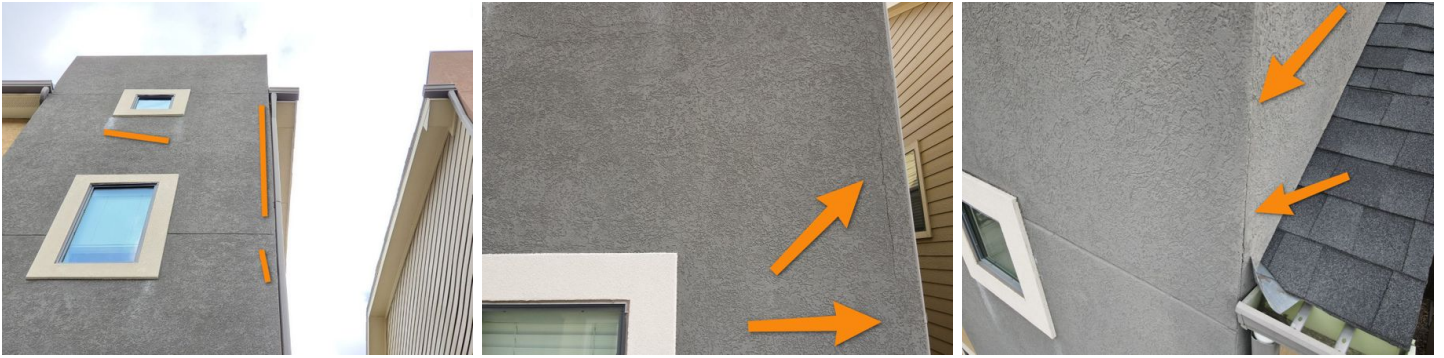
#### 4.1.2 Visible Cracking or Damage

#### **HAIRLINE CRACKS**

There are cracks in the stucco exterior cladding in multiple areas. These cracks appear to be caused by typical settlement of the house.

Recommendation

Contact a stucco repair contractor

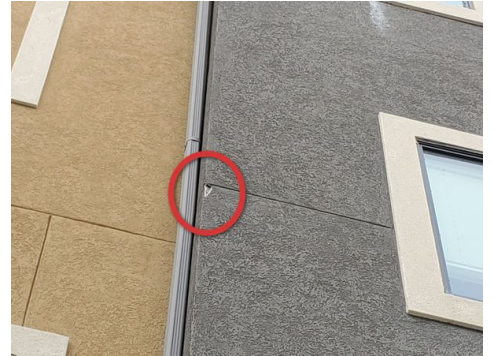
4.2.1 Exposed Mesh or Foam

**EXPOSED MESH**

The fiberglass mesh for the EIFS trim is exposed. This can allow moisture intrusion. Further evaluation and repair is recommended by a qualified stucco repairman.

Recommendation

Contact a stucco repair contractor

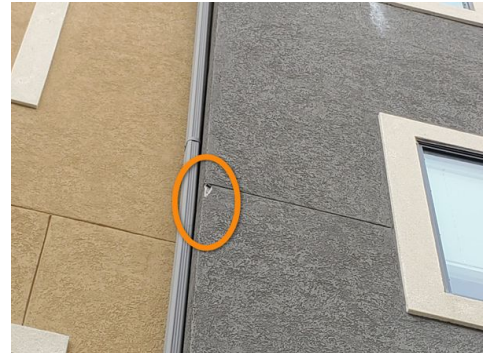
4.3.1 Impact Damage

**IMPACT DAMAGE**

There is visible impact damage to the stucco and/ or the EIFS exterior cladding. This damage appears to be primarily cosmetic and this is for your information.

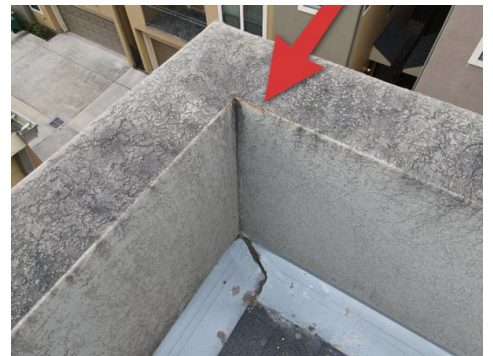
4.4.1 Rusting Aggregates and Accessories

**VISIBLE RUSTING DUE TO POSSIBLE MOISTURE CONTACT**

There is visible rusting on or in the Stucco material near metal components such as near windows and the bottom of the wall. This may indicate long term moisture contact. Recommend modifying or repairing these areas by a stucco contractor.

Recommendation

Contact a stucco repair contractor

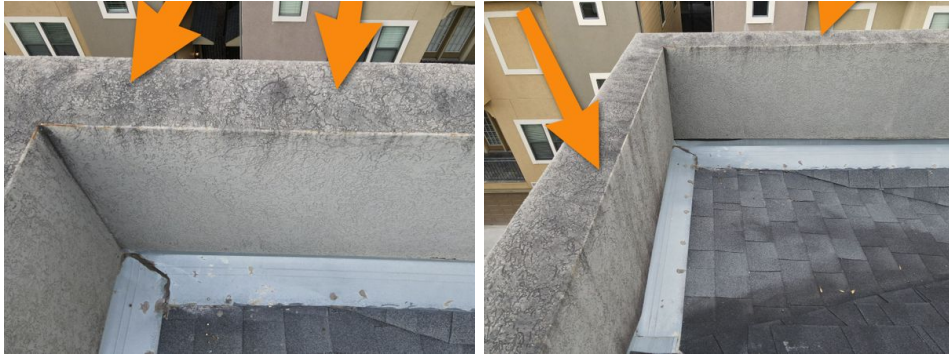
4.6.1 Microbial Growth

**VISIBLE MILDEW GROWTH ON EXTERIOR**

Visible mildew on a stucco exterior can be washed away. This is a cosmetic issue.

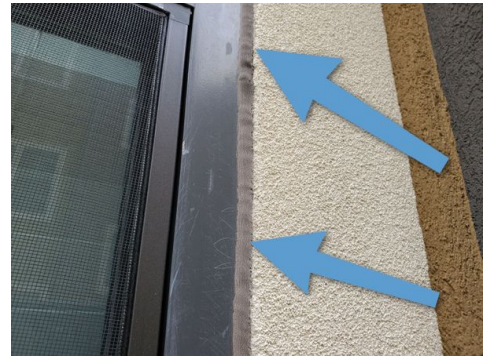
### 5.1.1 Window Frames

#### ADEQUATE SEALANT

The window frames had adequate and properly installed sealant according to current building standards.

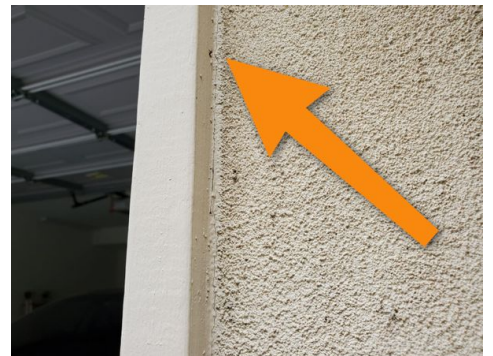
### 5.2.1 Door Frames

#### STUCCO INSTALLED UP TO DOOR FRAME

GARAGE DOOR

Stucco/EIFS was installed directly against door frame. Current building standards call for a proper caulk joint between the cladding and the door frame.

Recommendation

Contact a stucco repair contractor

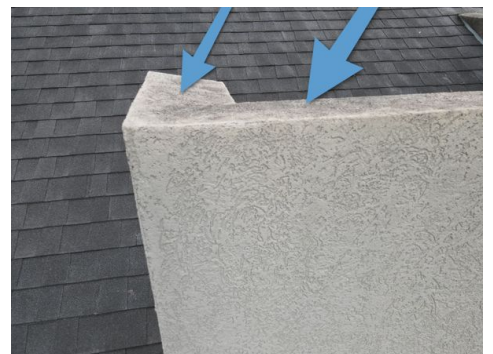
### 5.6.1 Flat Accents Are Sealed or Sloped

#### ADEQUATE SLOPE

The flat accents had an adequate slope according to current building standards.

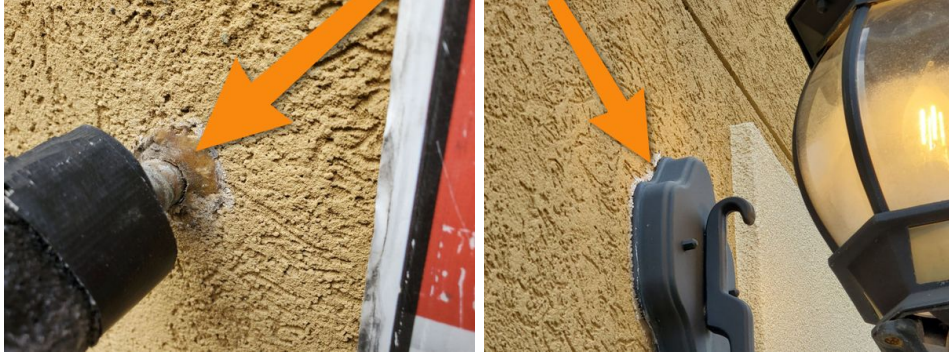
## 5.7.1 Wall Penetrations

Maintenance Item**MISSING OR DETERIORATED SEALANT**

Missing or deteriorated sealant was observed at one or more wall penetrations or items that are mounted to the walls. Sealing anything that is mounted to or passes through the walls to help prevent moisture intrusion is recommended.

## Recommendation

Contact a stucco repair contractor

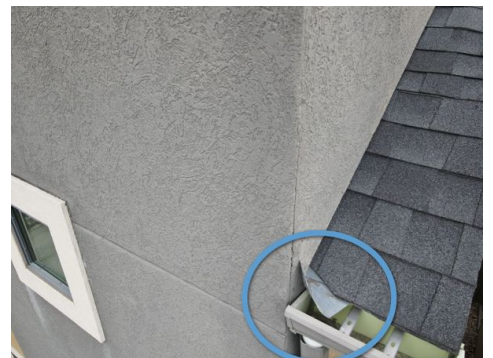
### 6.1.1 Kick-outs and Diverters

#### **KICKOUT FLASHINGS ADEQUATE**

The kickout flashings meet or exceed current building standards and appear to be functioning adequately.

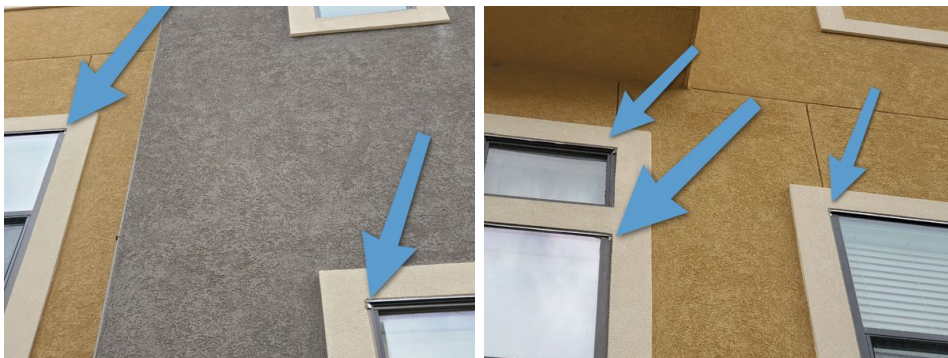
### 6.2.1 Window Headers

#### **WINDOW HEAD FLASHINGS ADEQUATE**

The window head flashings meet or exceed current building standards and appear to be functioning adequately.

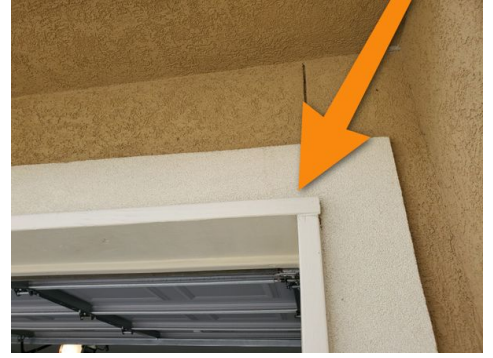
### 6.3.1 Door Headers

#### **MISSING DOOR HEAD FLASHING**

Head flashing was not installed above the doors. Current building standards call for head flashing above doors to help direct any moisture that may get behind the stucco to escape.

Recommendation

Contact a stucco repair contractor

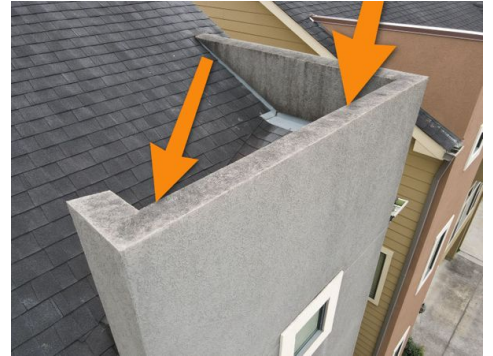
#### 6.4.1 Parapet Wall Cap Flashings

### **MISSING/INADEQUATE CAP FLASHINGS**

The cap flashing on the parapet wall was either missing or inadequate according to current building standards.

Recommendation

Contact a stucco repair contractor

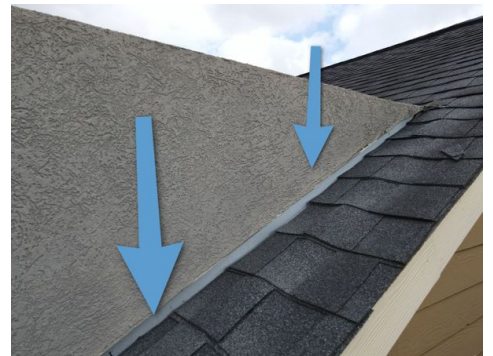
7.1.1 At Roofline

### ADEQUATE ROOF TO WALL TERMINATIONS

Roof to wall terminations meet or exceed current building standards.

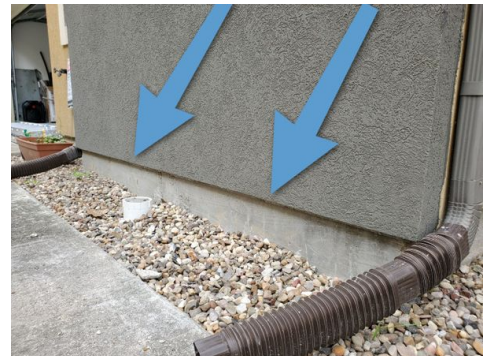
7.2.1 At Grade and Flatwork

### FLAT WORK AND GRADE TERMINATIONS ADEQUATE

Flat work and grade terminations meet or exceed current building standards.

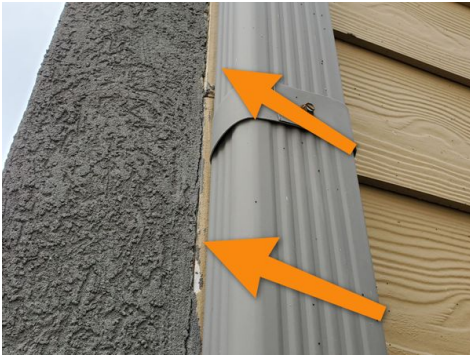
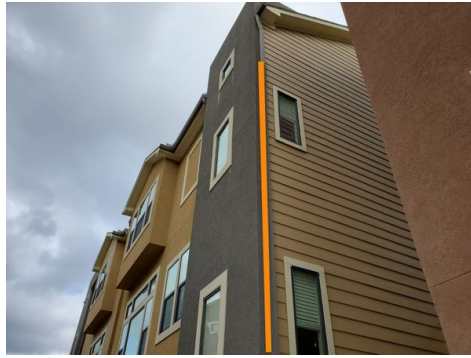
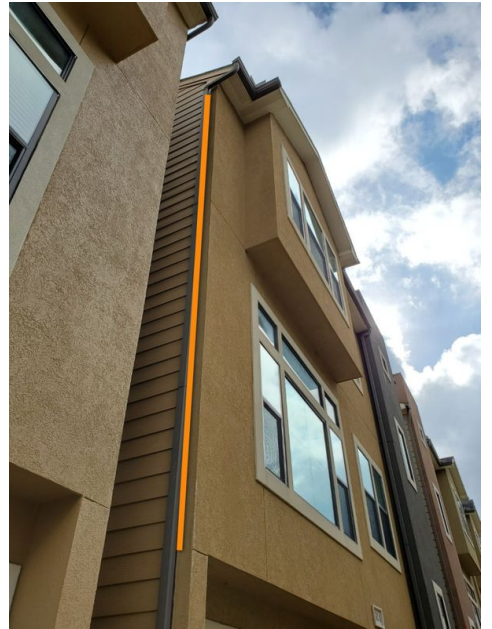
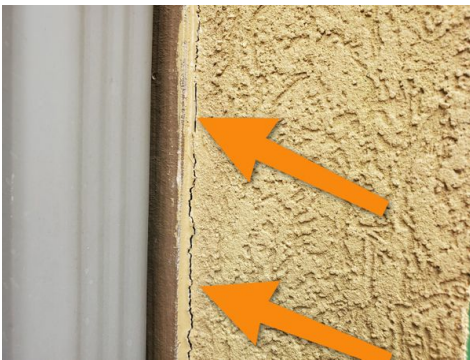
7.3.1 Transition joints (stucco to brick, etc.)

### IMPROPER TRANSITION BETWEEN DIFFERENT CLADDINGS

MULTIPLE LOCATIONS

Transitions between different cladding materials (e.g. stucco to brick, stucco to trim boards, stucco to stone.) should have a proper caulk joint.

Recommendation

Contact a stucco repair contractor

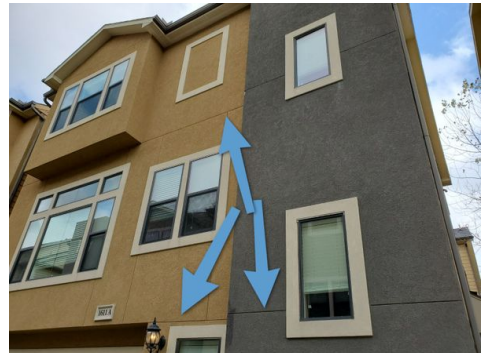
7.4.1 Expansion joints/ Control joints

**EXPANSION/TRANSITION JOINTS ADEQUATE**

Expansion/Transition joints meet or exceed current building standards.

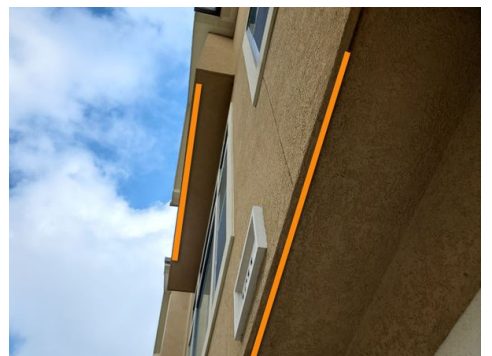
7.5.1 Provisions for Drainage

**MISSING RELIEF UNDER BALCONY**

MULTIPLE LOCATIONS

A relief or drainage track under the balcony beams was missing. Current building standards call for some type of drainage to be installed under balcony beams when stucco has been installed under the balcony. Without some type of drainage any moisture that gets behind the stucco will be trapped and prematurely deteriorate the wooden beams. Further evaluation by probe testing these locations to determine the condition of the wooden beams is recommended.

Recommendation

Contact a stucco repair contractor
