812 W Blum St, Alvin, TX 77511

Inspection prepared for: Pierre Charland

Date of Inspection: 1/18/2023 Time: 12:30 PM

PROPERTY INSPECTION REPORT FORM

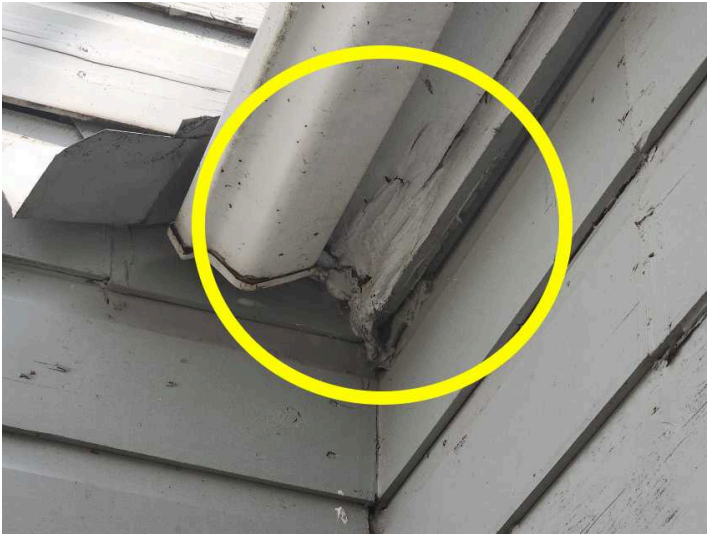
• Wood deterioration noted to fascia and soffits in one or more locations. It is recommended to properly repair or replace all affected material as well as caulk, prime and paint as needed.

Wood deterioration

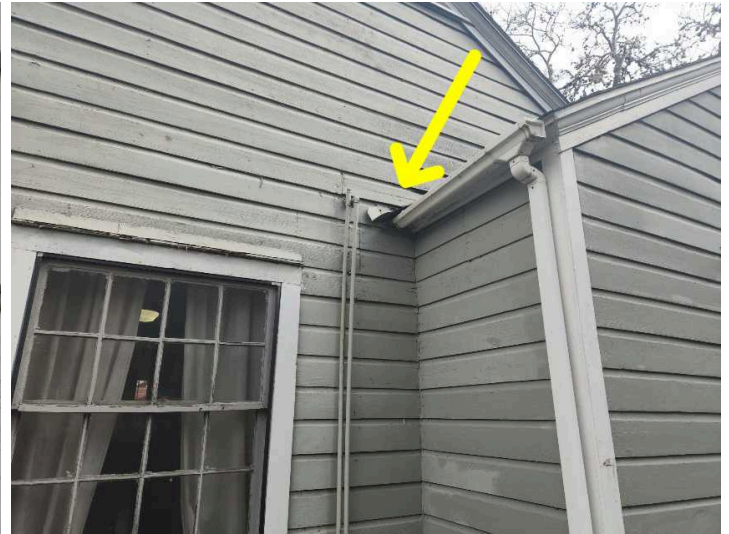
- There is no kickout flashing at one or more vertical wall intersections. This may allow roof runoff to drain onto the wall and/or behind the siding. Kickout flashing should be installed to help divert roof runoff away from the wall. R905.2.8.3 Sidewall flashing. Base flashing against a vertical sidewall shall be continuous or step flashing and shall be a minimum of 4 inches (102 mm) in height and 4 inches (102 mm) in width and shall direct water away from the vertical sidewall onto the roof and/or into the gutter. Where siding is provided on the vertical sidewall, the vertical leg of the flashing shall be continuous under the siding. Where anchored masonry veneer is provided on the vertical sidewall, the base flashing shall be provided in accordance with this section and counter flashing shall be provided in accordance with Section R703.7.2.2. Where exterior plaster or adhered masonry veneer is provided on the vertical sidewall, the base flashing shall be provided in accordance with this section and Section R703.6.3.

No kickout flashing

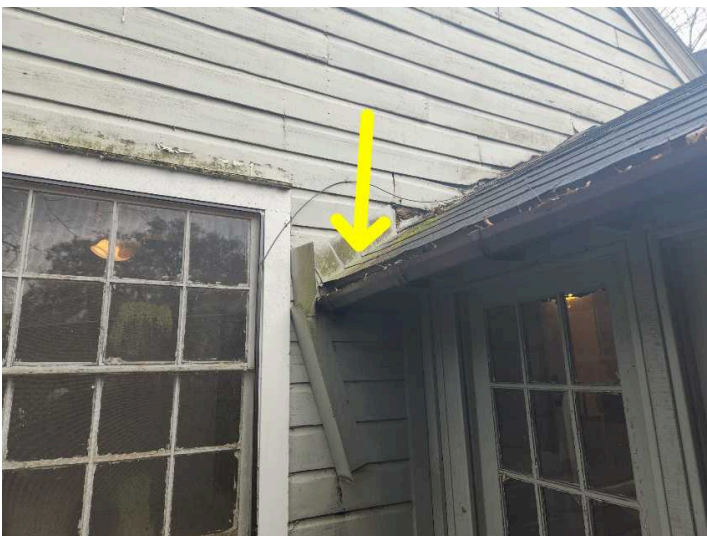
No kickout flashing

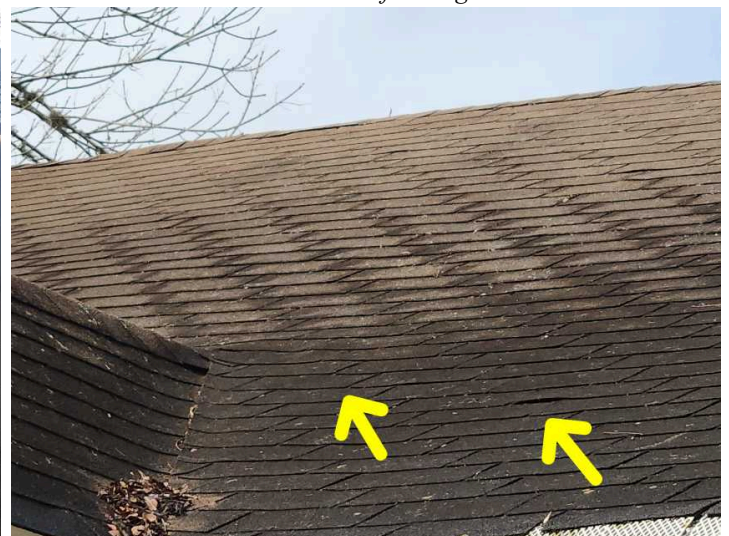
• Exposed nail heads were noted at the roof protrusions and/or ridge shingles. Nail heads at either the vent & roof flashing or at the composition shingles can allow water to penetrate past the roof covering given enough time. As the exposed portion of the nail rusts, more space will become available between the nail and the roofing material for water to penetrate. This condition can usually be remedied by sealing or caulking affected areas.

Nail pop

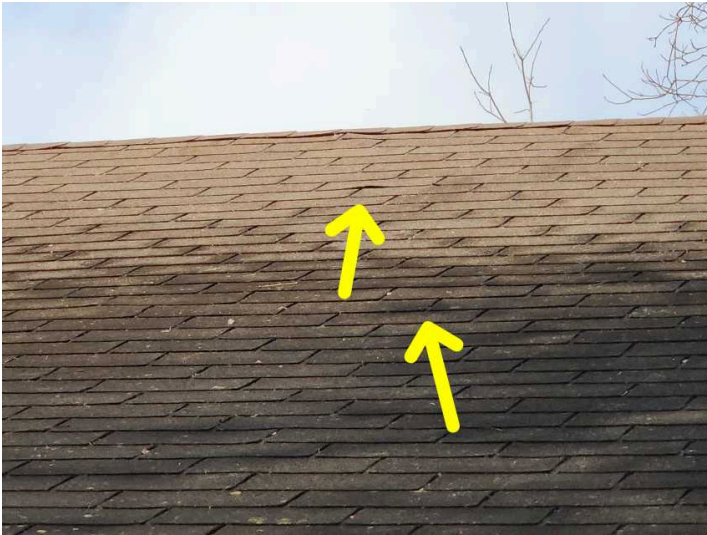
Nail pop

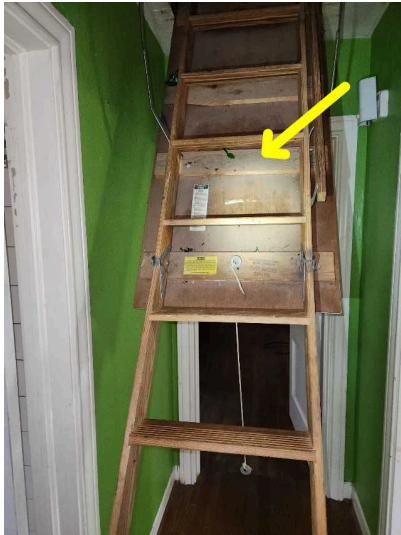
Missing insulation

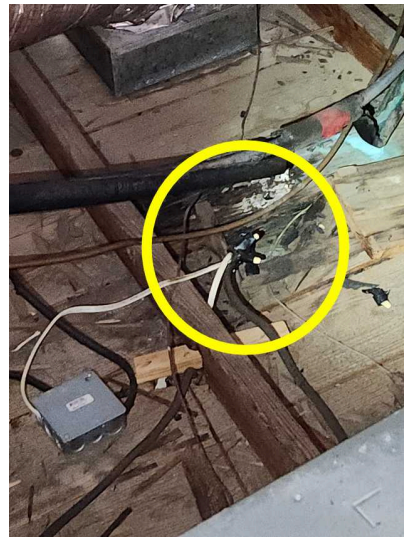
Exposed wiring

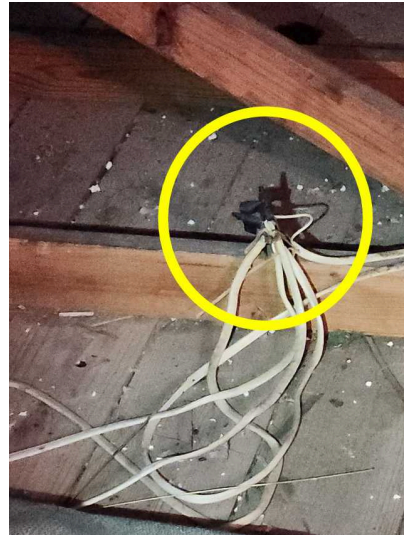
Exposed wiring

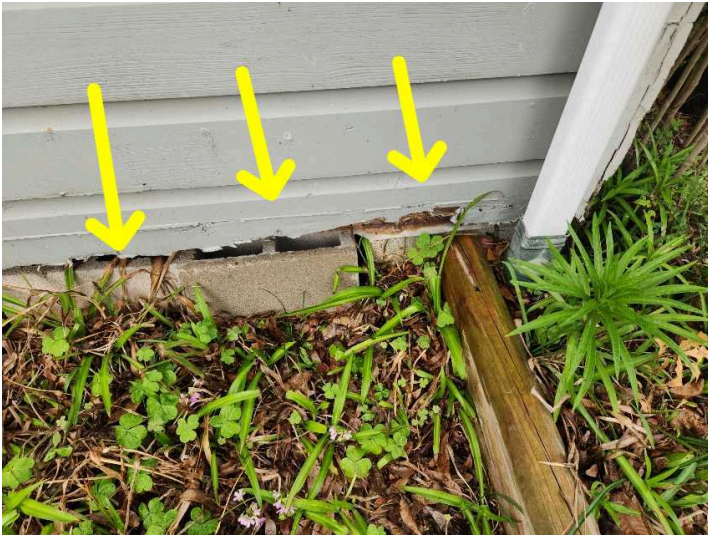
- Wood deterioration in one or more locations on the exterior siding and trim. It is recommended to be repaired or replaced as needed insuring that all joints and edges are caulked and painted to prevent further deterioration of siding and trim.

Wood deterioration

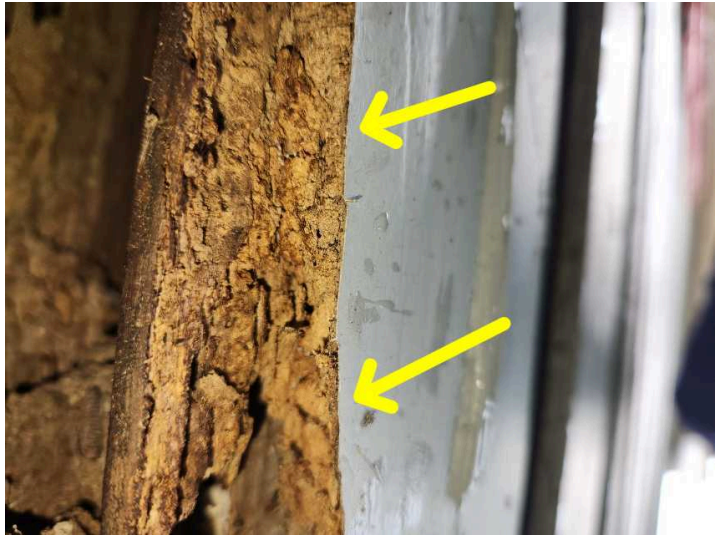
Wood deterioration

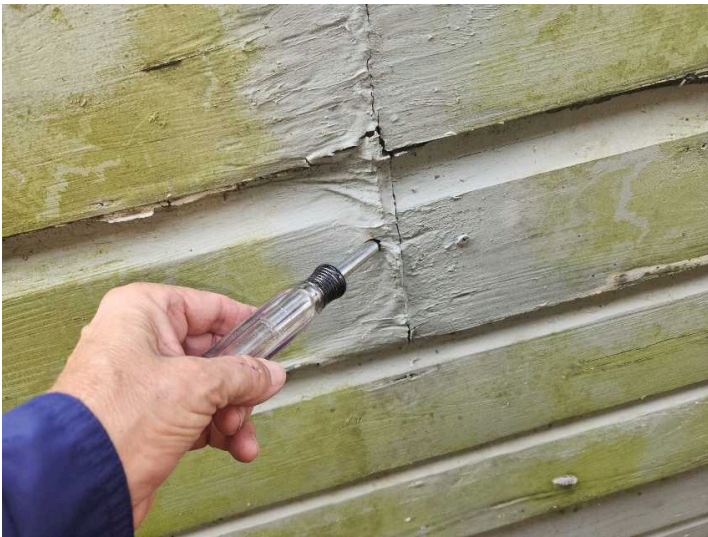
Wood deterioration

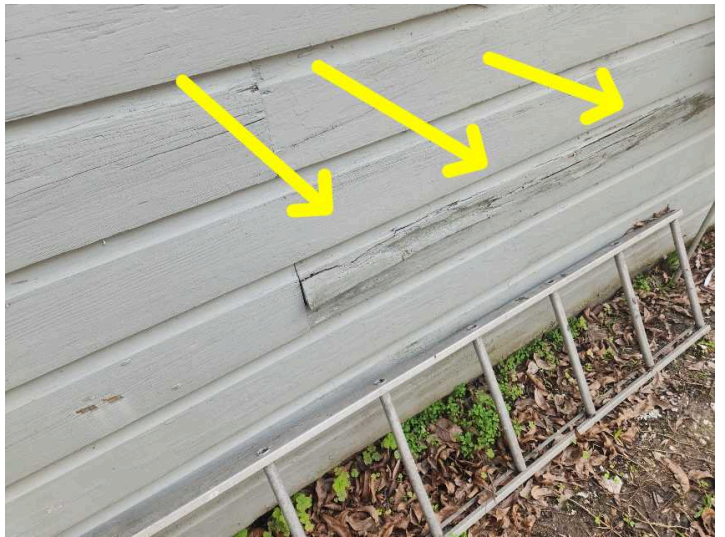
Wood deterioration

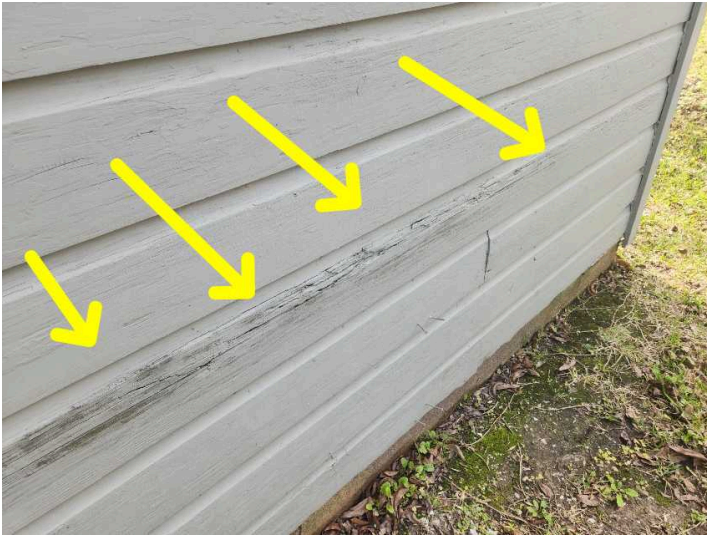
Wood deterioration

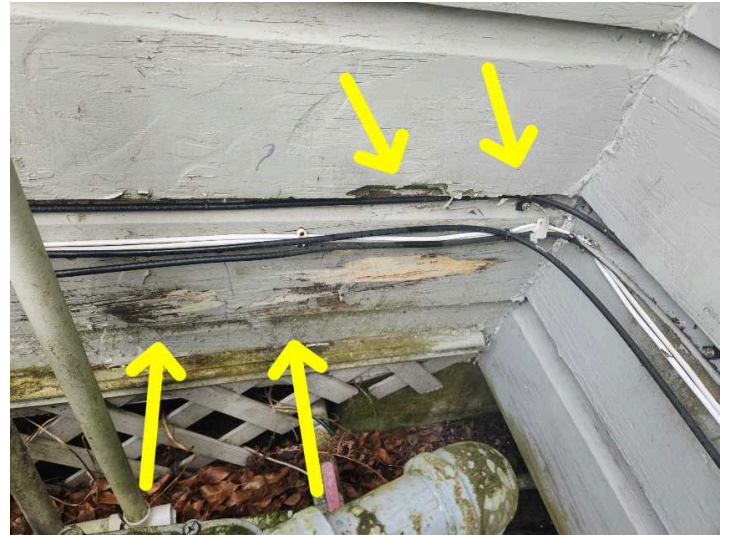
Wood deterioration

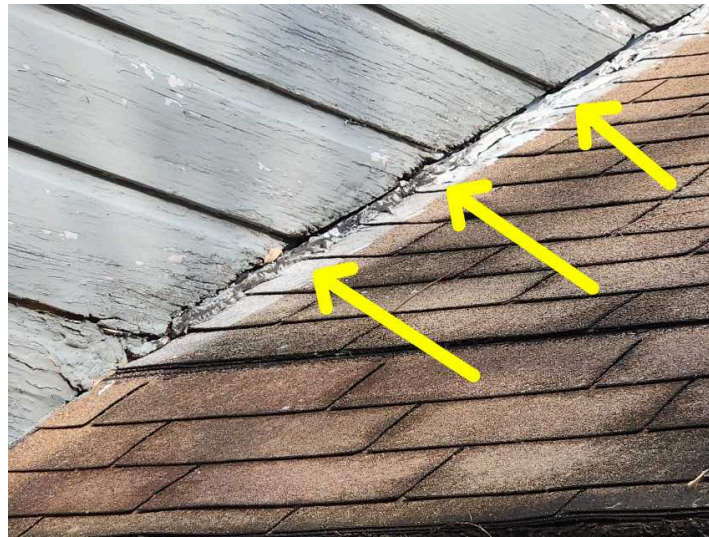
- Exterior wooden siding is too close to roofing materials. It is recommended to be properly repaired as needed allowing a minimum of 1 1/2 inch gap.

Too close

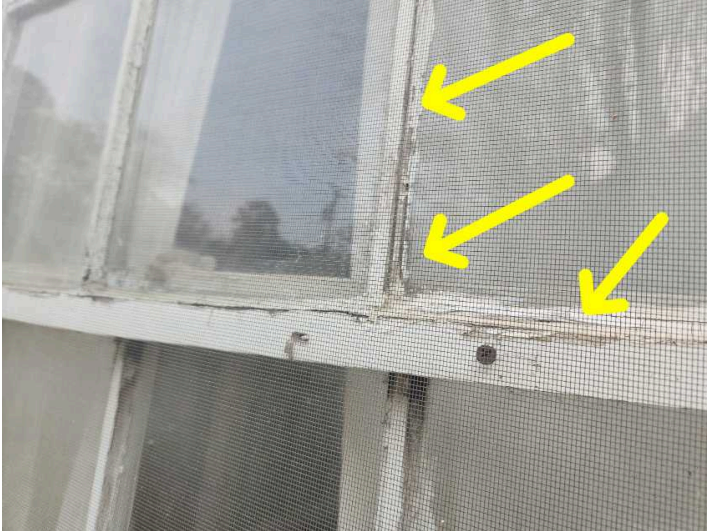
Glazing damaged

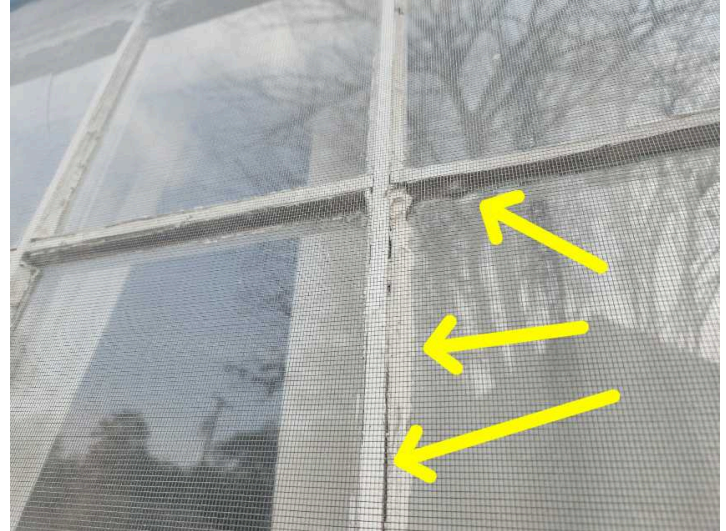
Glazing damaged

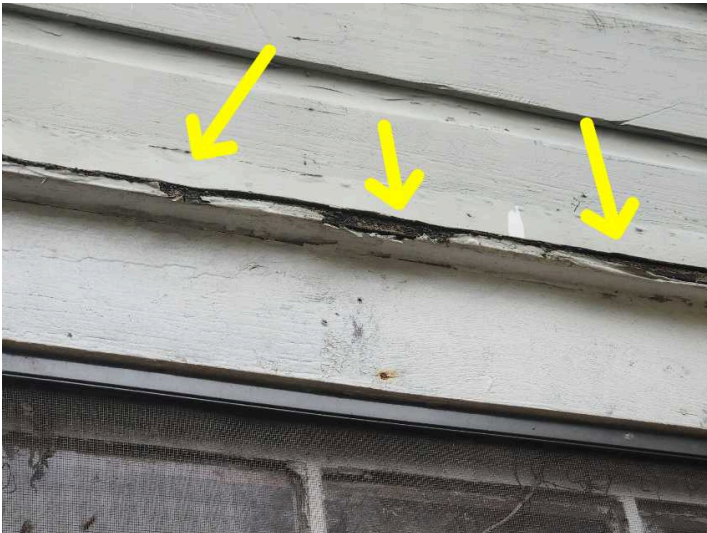
Wood deterioration

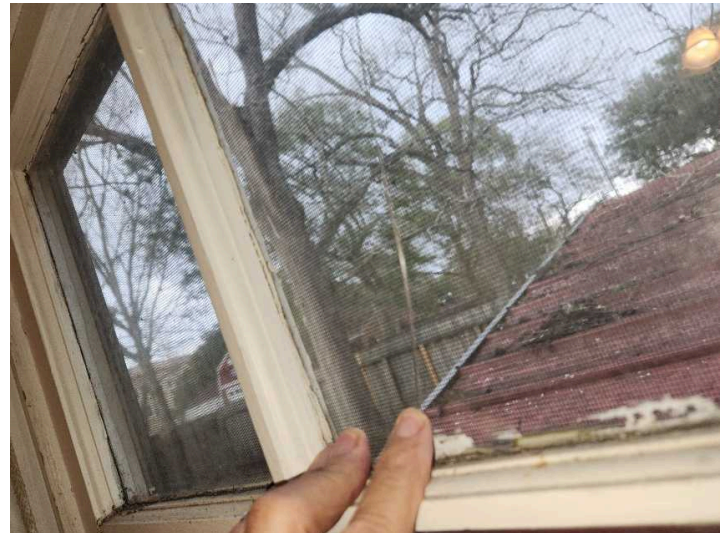
Broken glass

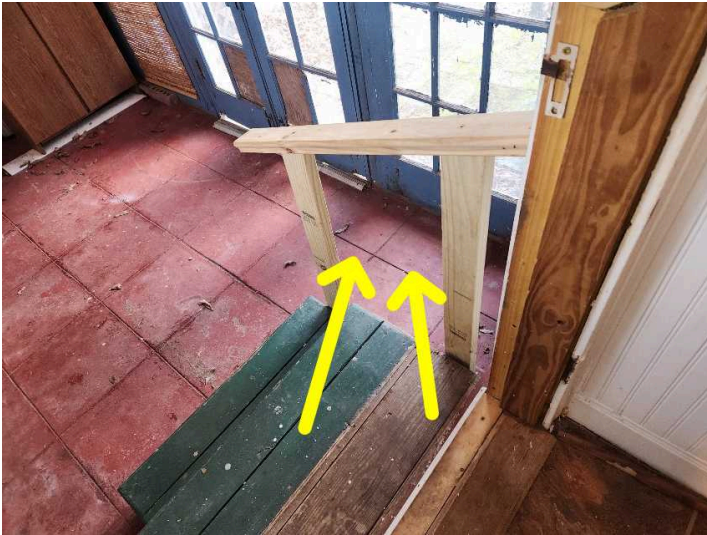
Spindles missing

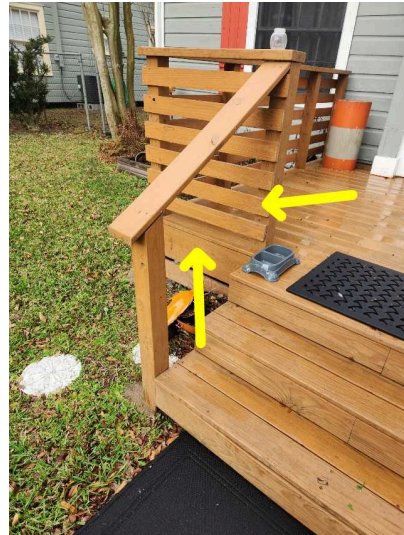
Spindles missing

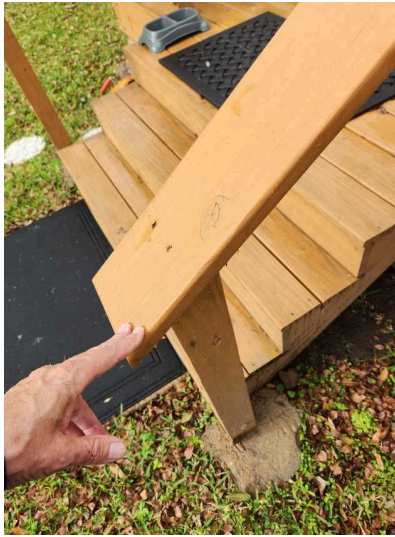
Not a grippable handrail

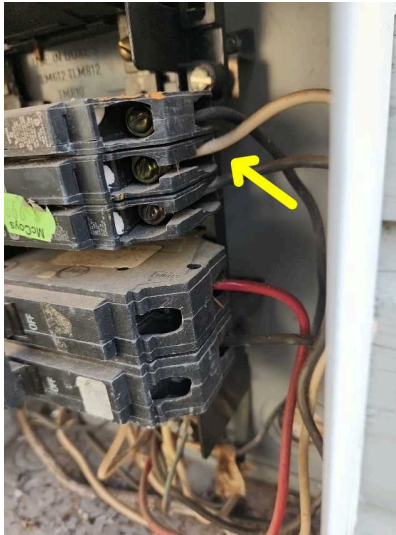
White wire unmarked

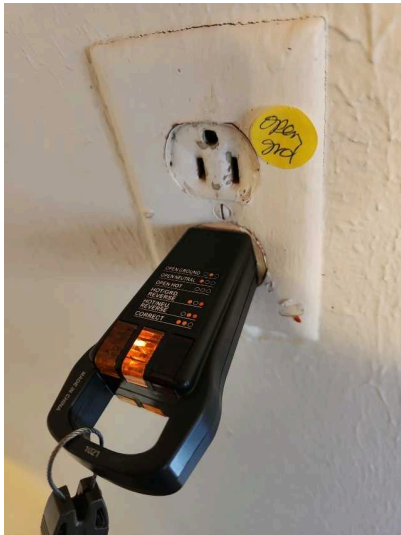
Open ground

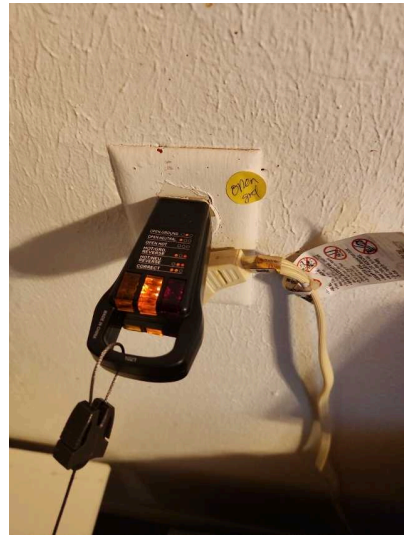
Open ground

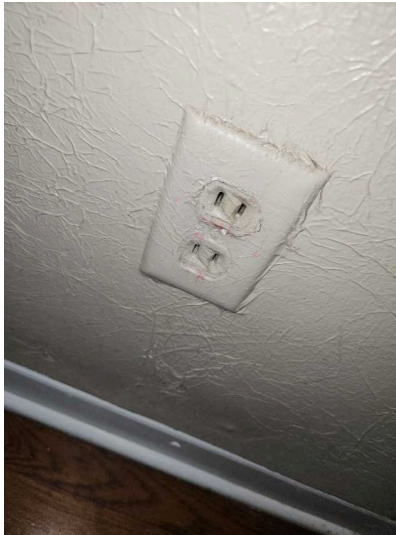
Two prong plug

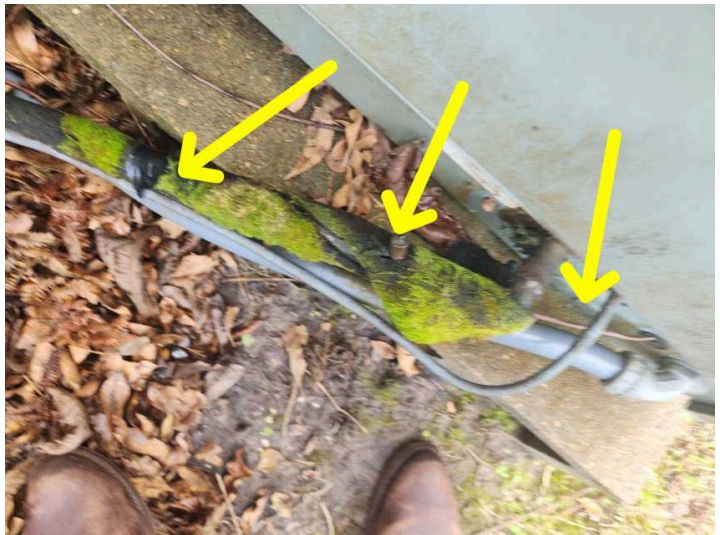
Insulation deterioration

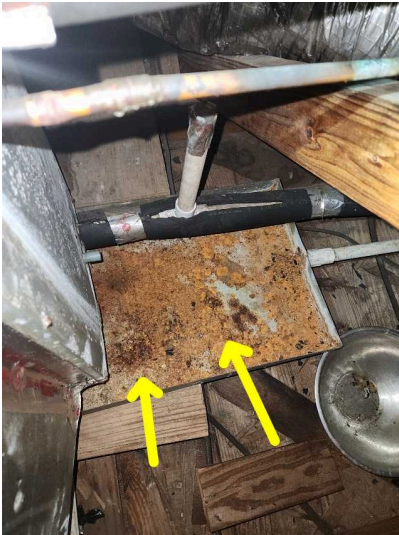
Rust in pan

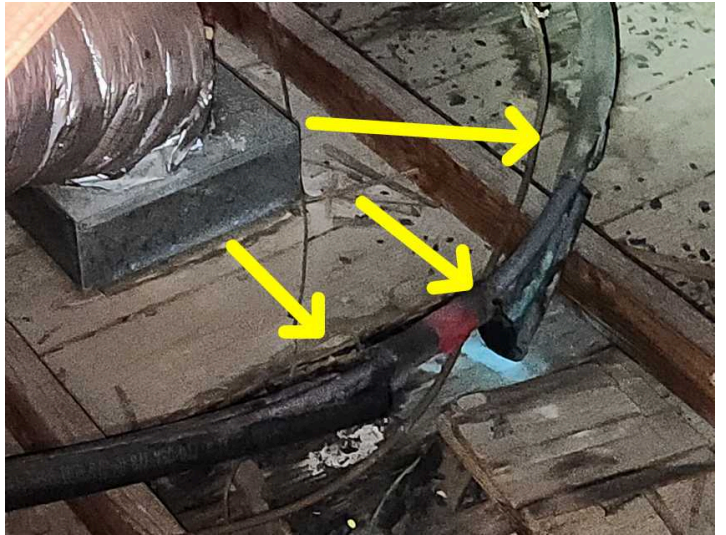
Insulation missing

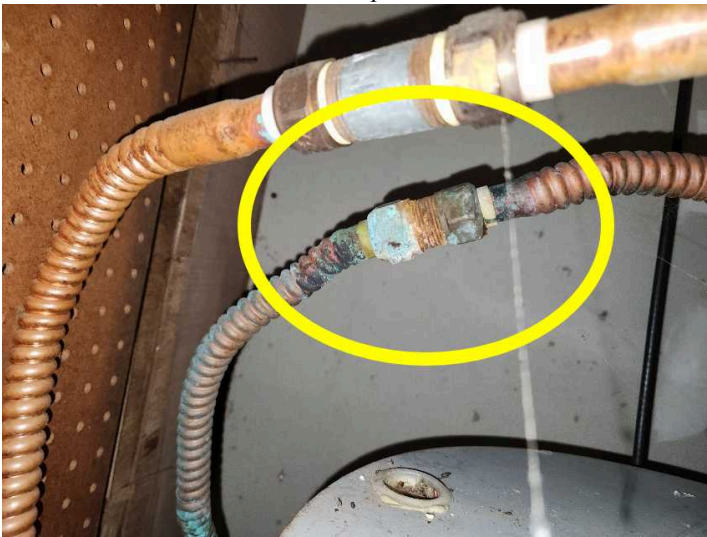
Corrosion

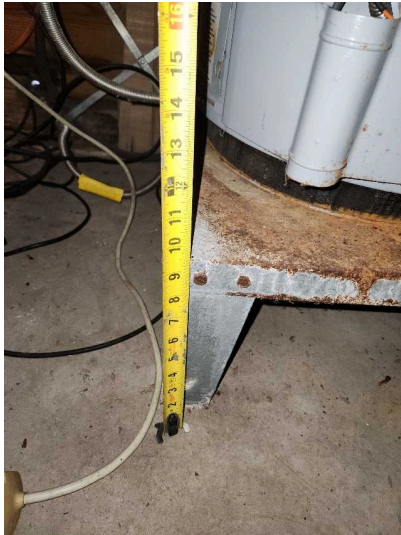
Water heater too low

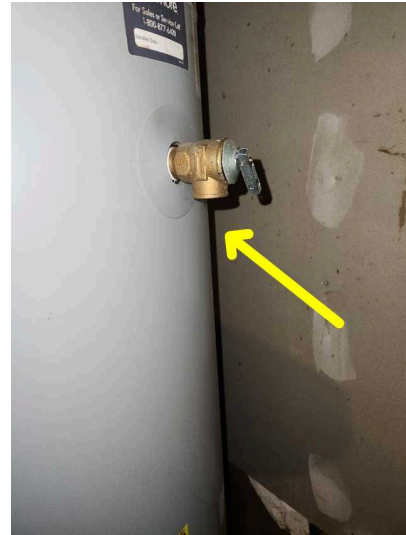
TPRV Disconnected
