# GlobeSpec

## Photo Attachments

Seegoolam Home Photos.alb

**These pictures are intended to facilitate the understanding of the defects cited in the Property Assessment Report. They are a sample representation and may not include all of the deficiencies cited in the body of the report.**

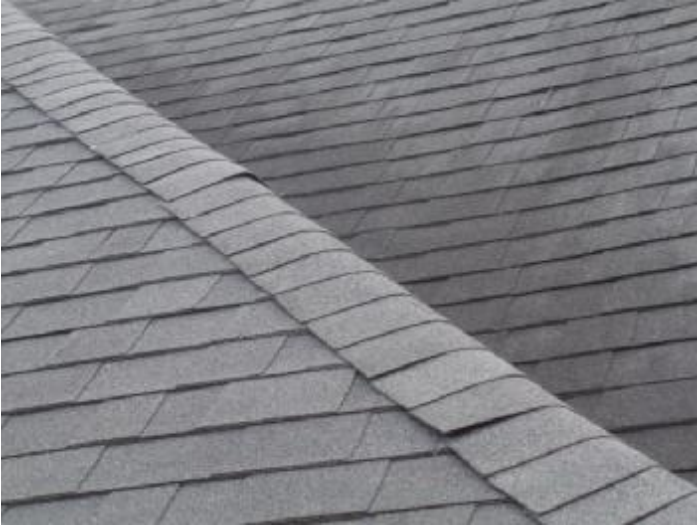
Raised shingles at front of roof

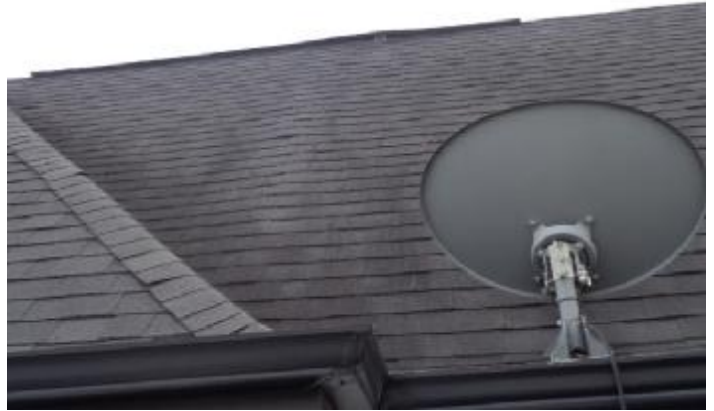
Raised shingles at front of roof

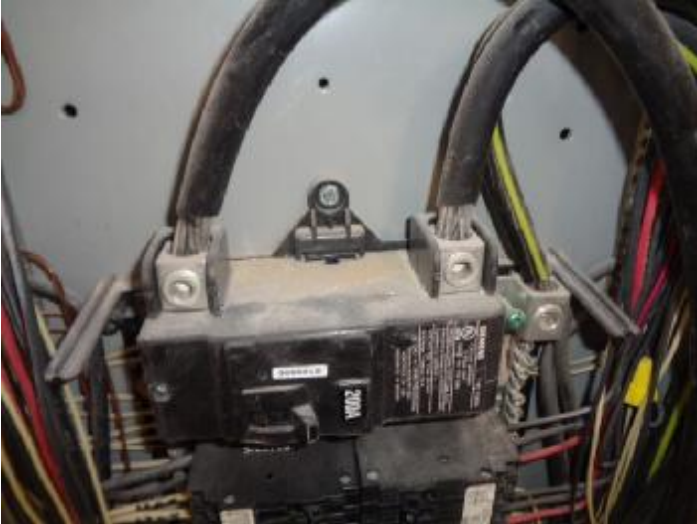
No anti-oxidant paste at the aluminum service wire connections in the electric panel

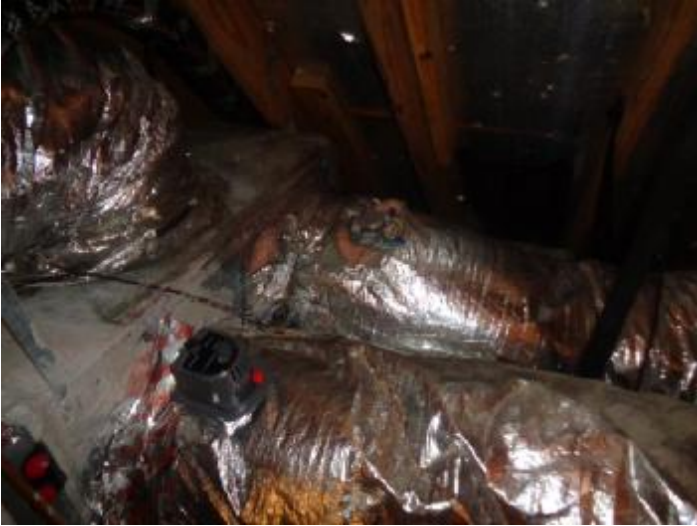
Damaged HVAC ducts in attic

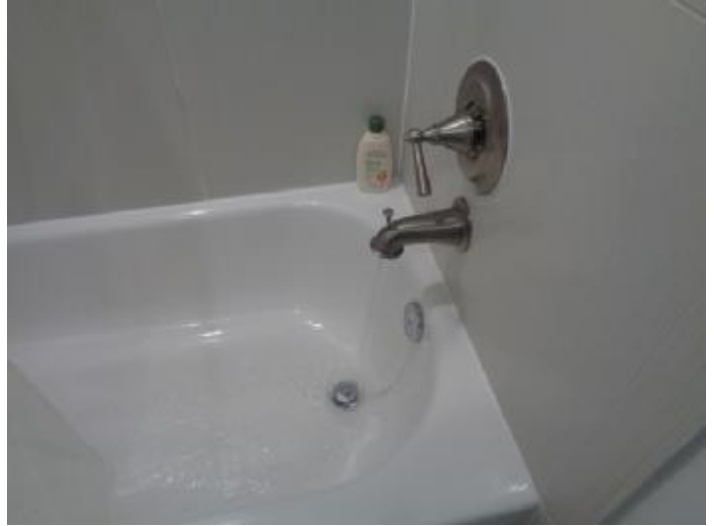
Shower diverter does not completely divert all water from tub spout to shower head when in shower position in downstairs bath

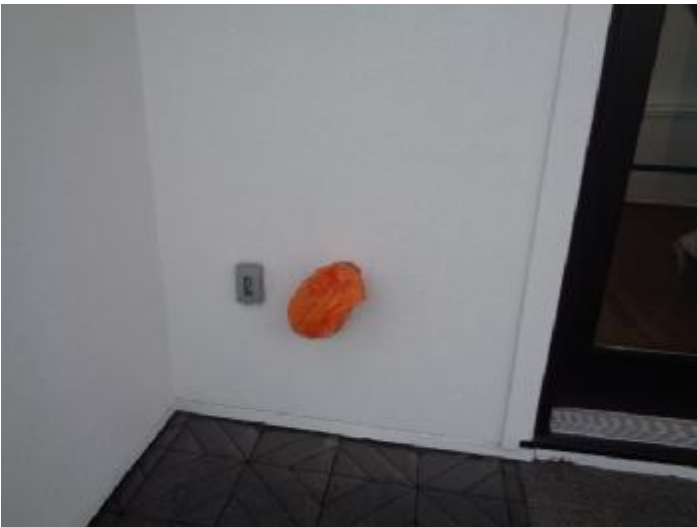
Exterior hose faucet is winterized

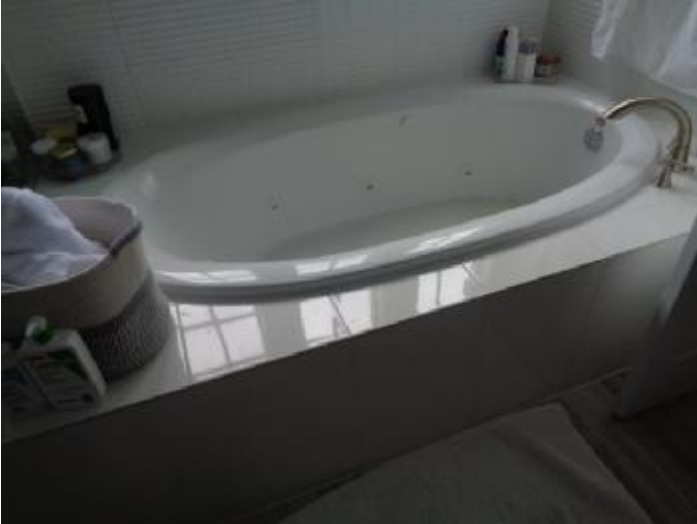
No visible access panel to whirlpool tub equipment

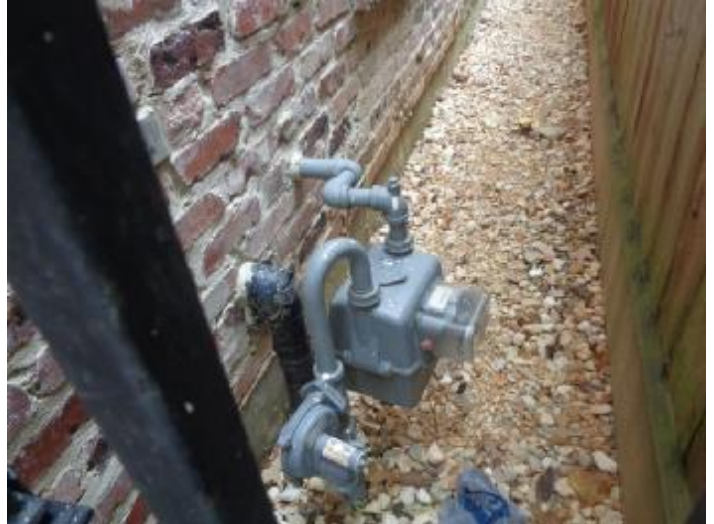
No visible bond/ground wire to main gas pipe
