Lone Star Stucco, LLC

Moisture Assessment Report

1843 Sul Ross St

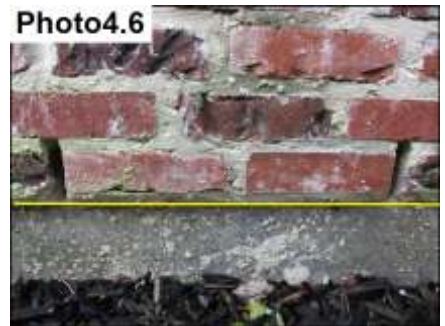
Photo4.6

Proper Grade Termination w/ Weep Screed and Holes/ Positive Detail

Grid Location	Item Description	Moisture Readings	Substrate Condition	Observations
Yellow Lines	Grade Termination			Stucco/brick appears to be typically detailed at grade for the time of this construction. The inspector suggests that this is a positive detail and recommends no modification at this time but to always keep soil away from the structure. Please refer to photos #4.2, #4.3, #4.4, #4.5 and #4.6 for more detail.

- Stucco/brick appears to be typically detailed at grade for the time of this construction. The inspector suggests that this is a positive detail and recommends no modification at this time but to always keep soil away from the structure. Please refer to photos #4.2, #4.3, #4.4, #4.5 and #4.6 for more detail.

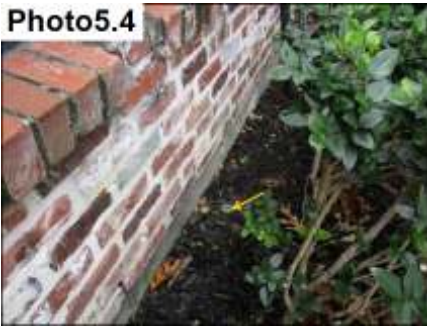
Photo5.4

Sprinklers / Redirect as Needed

Grid Location	Item Description	Moisture Readings	Substrate Condition	Observations
Orange Arrows	Sprinklers			Sprinklers have been noted on this home. The inspector suggests to always redirect sprinkler heads away from the system and windows as needed in an effort to prevent moisture intrusion. Please refer to photos #5.2, #5.3 and #5.4 for more detail.

- Sprinklers have been noted on this home. The inspector suggests to always redirect sprinkler heads away from the system and windows as needed in an effort to prevent moisture intrusion. Please refer to photos #5.2, #5.3 and #5.4 for more detail.

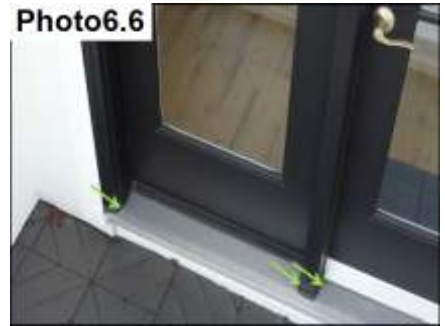
Photo6.6

Door Trim and Miter Sealant / Maintain

Grid Location	Item Description	Moisture Readings	Substrate Condition	Observations
Green Arrows	Doors			Door trim and miter sealants are present at this location. The inspector states that this is a positive detail and suggests maintaining these sealants in an effort to prevent moisture intrusion. Please refer to photos #6.2, #6.3, #6.4, #6.5, #6.6, #7.1, #7.2, #7.3 and #7.4 for more detail.

- Door trim and miter sealants are present at this location. The inspector states that this is a positive detail and suggests maintaining these sealants in an effort to prevent moisture intrusion. Please refer to photos #6.2, #6.3, #6.4, #6.5, #6.6, #7.1, #7.2, #7.3 and #7.4 for more detail.

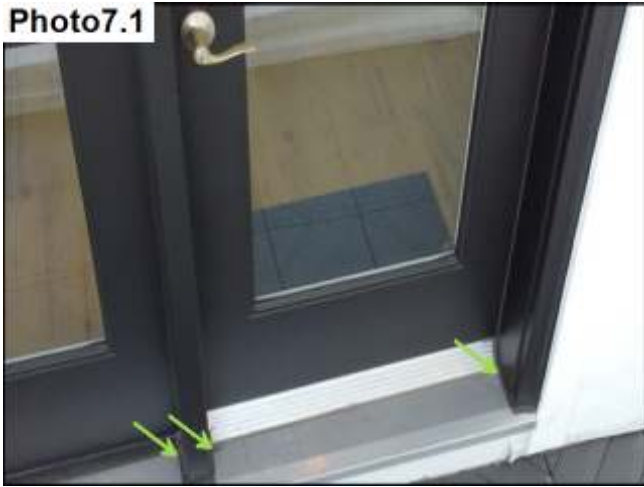
Door Trim and Miter Sealant / Maintain

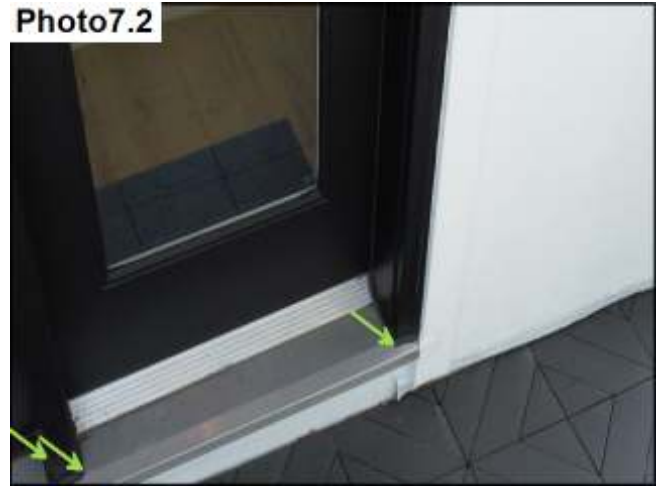
Door Trim and Miter Sealant / Maintain

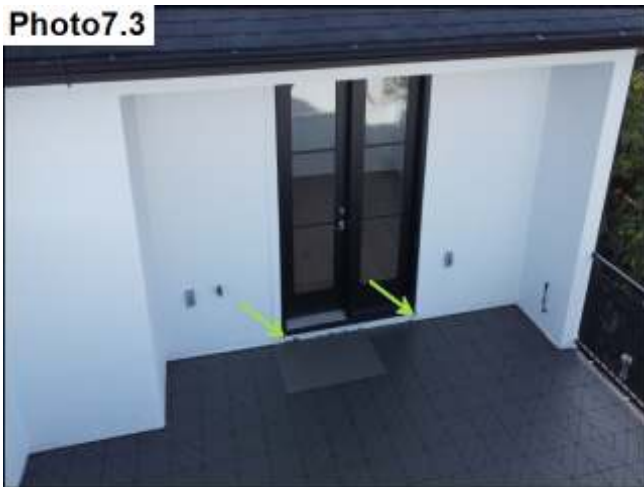
Door Trim and Miter Sealant / Maintain

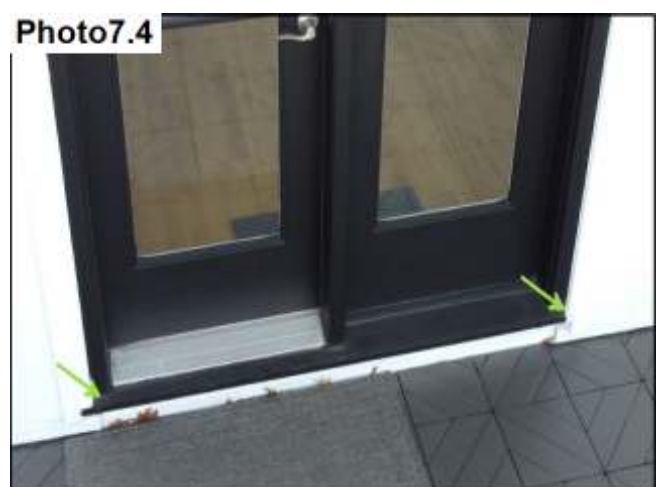
Door Trim and Miter Sealant / Maintain

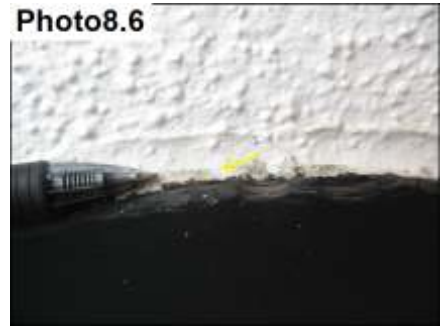
Photo8.6

Penetrations / Maintain

Grid Location	Item Description	Moisture Readings	Substrate Condition	Observations
Yellow Arrows	Penetrations			Penetration sealants are present at these locations. The inspector states that this is a positive detail and suggests maintaining these sealants in an effort to prevent moisture intrusion. Please refer to photos #8.2, #8.3, #8.4, #8.5 and #8.6 for more detail.

- Penetration sealants are present at these locations. The inspector states that this is a positive detail and suggests maintaining these sealants in an effort to prevent moisture intrusion. Please refer to photos #8.2, #8.3, #8.4, #8.5 and #8.6 for more detail.

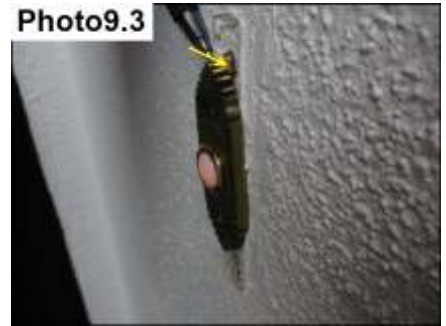
Photo9.3

Penetration Sealants / Seal

Grid Location	Item Description	Moisture Readings	Substrate Condition	Observations
Yellow Arrows	Penetrations			The doorbell is detached from the home. The inspector suggests to have a qualified contractor reattach this doorbell and seal this area with a low modulus sealant in an effort to prevent moisture intrusion. These types of sealants are of high quality and compatible with stucco and other termination points. Please refer to photos #9.2 and #9.3 for more detail.

- The doorbell is detached from the home. The inspector suggests to have a qualified contractor reattach this doorbell and seal this area with a low modulus sealant in an effort to prevent moisture intrusion. These types of sealants are of high quality and compatible with stucco and other termination points. Please refer to photos #9.2 and #9.3 for more detail.

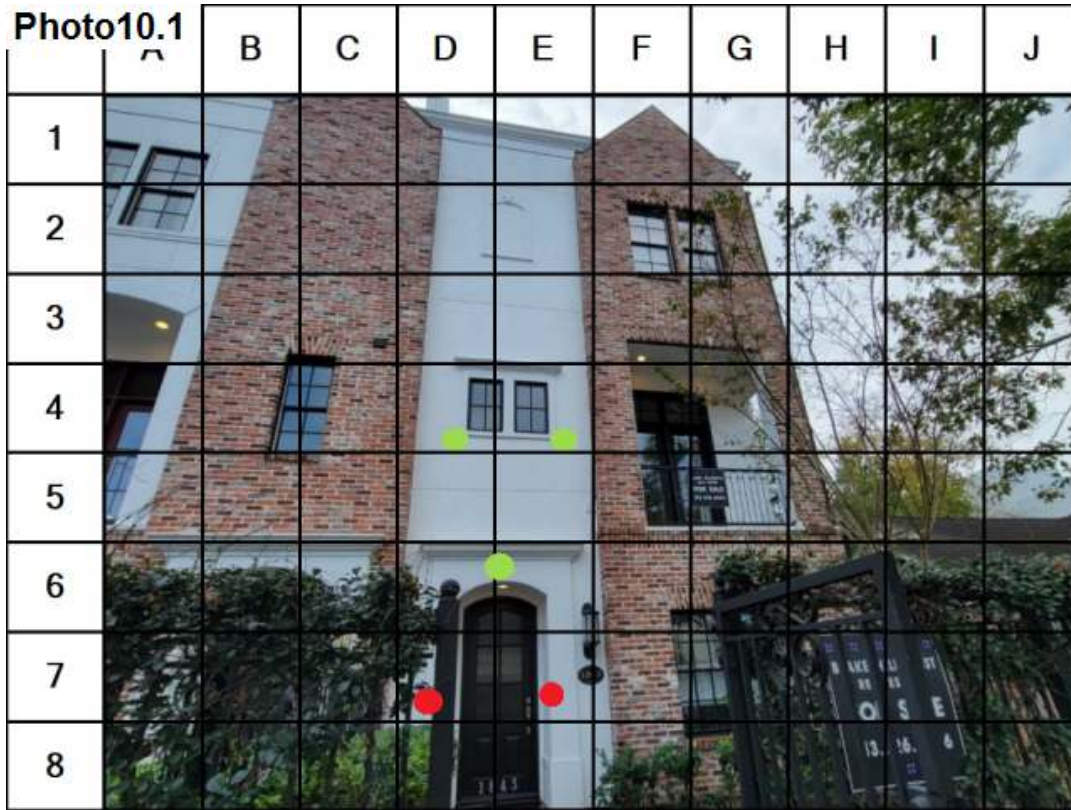
Grid Location	Item Description	Moisture Readings	Substrate Condition	Observations
D7	Entryway Left	20%	Firm	A moisture probe was made at the entryway wall left. An elevated moisture reading was noted with a firm substrate.
F8	Window Lower Right	19%	Firm	A moisture probe was made at the entryway wall right. An elevated moisture reading was noted with a firm substrate.
D5	Entry Way Arch	18%	Firm	A moisture probe was made at the entry arch. The substrate was firm with no damage noted at this time.
D4	Window Lower Left	17%	Firm	A moisture probe was made below the window bottom left. An elevated moisture reading was noted with a firm substrate.
E4	Window Lower Right	18%	Firm	A moisture probe was made below the window bottom right. The substrate was firm with no damage noted at this time.

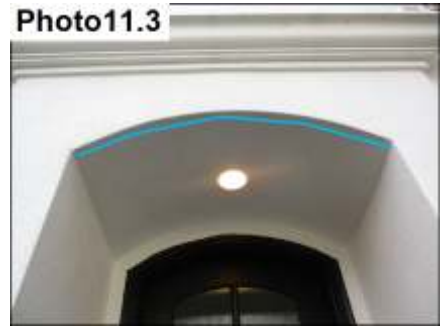
Photo11.3

No Relief Present / No Modification

Grid Location	Item Description	Moisture Readings	Substrate Condition	Observations
Blue Lines	Relief			Although the bottom of the wall noted does not have a proper relief, this was a proper detail at the time of construction. Upon invasive testing at this location, the substrate was firm with low moisture readings. The inspector recommends no modification at this point in time but recommends to maintain all sealants above this location to prevent potential moisture intrusion. Please refer to photos #11.2 and #11.3 for more detail.

- Although the bottom of the wall noted does not have a proper relief, this was a proper detail at the time of construction. Upon invasive testing at this location, the substrate was firm with low moisture readings. The inspector recommends no modification at this point in time but recommends to maintain all sealants above this location to prevent potential moisture intrusion. Please refer to photos #11.2 and #11.3 for more detail.

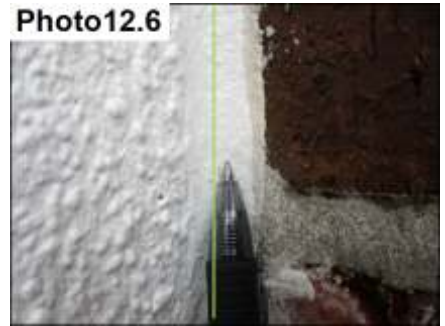
Photo12.6

Brick/Stucco Termination / Maintain

Grid Location	Item Description	Moisture Readings	Substrate Condition	Observations
Green Lines	Stucco Termination			Brick and stucco sealants are present at this location. The inspector states that this is a positive detail and suggests maintaining these sealants in an effort to prevent moisture intrusion. Please refer to photos #12.2, #12.3, #12.4, #12.5 and #12.6 for more detail.

- Brick and stucco sealants are present at this location. The inspector states that this is a positive detail and suggests maintaining these sealants in an effort to prevent moisture intrusion. Please refer to photos #12.2, #12.3, #12.4, #12.5 and #12.6 for more detail.

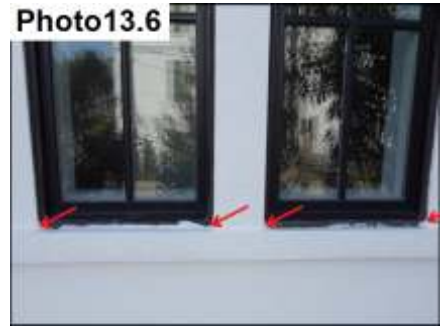
Photo13.6

Window Sealants / Seal

Grid Location	Item Description	Moisture Readings	Substrate Condition	Observations
Red Arrows	Windows			The window sealants are separated. The inspector suggests to have a qualified waterproofing contractor further assess and seal this area with a low modulus sealant in an effort to prevent moisture intrusion. These types of sealants are of high quality and compatible with stucco and other termination points. Please refer to photos #13.2, #13.3, #13.4, #13.5, #13.6, #14.1, #14.2, #14.3 and #14.4 for more detail.

- The window sealants are separated. The inspector suggests to have a qualified waterproofing contractor further assess and seal this area with a low modulus sealant in an effort to prevent moisture intrusion. These types of sealants are of high quality and compatible with stucco and other termination points. Please refer to photos #13.2, #13.3, #13.4, #13.5, #13.6, #14.1, #14.2, #14.3 and #14.4 for more detail.

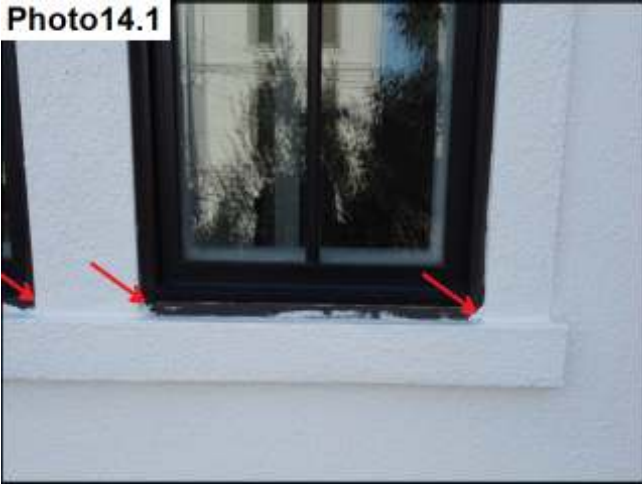
Photo14.1

Window Sealants / Seal

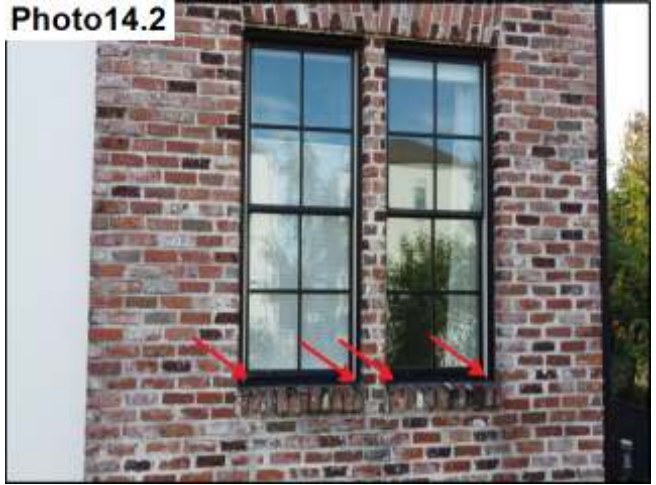
Photo14.2

Window Sealants / Seal

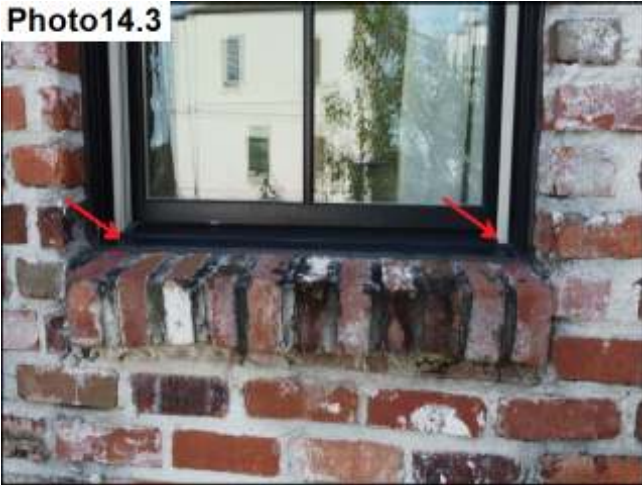
Photo14.3

Window Sealants / Seal

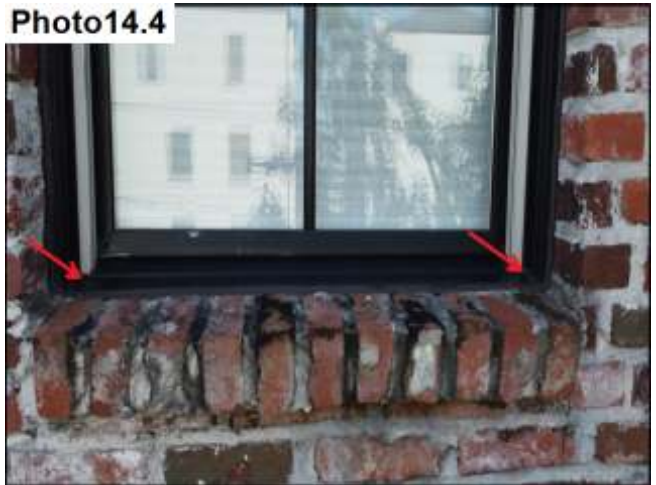
Photo14.4

Window Sealants / Seal

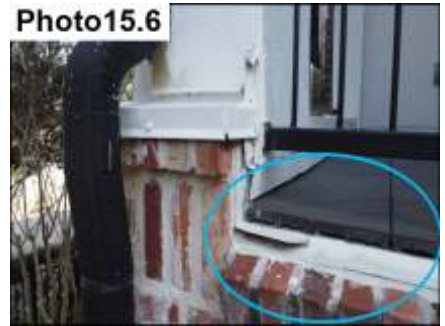
Photo15.6

Balcony Flashing / Seal

Grid Location	Item Description	Moisture Readings	Substrate Condition	Observations
Blue Circles	Flashing			The balcony flashing sealants are aged and separated at this location. The inspector suggests to have a qualified waterproofing contractor further assess and seal this area with a low modulus sealant in an effort to prevent moisture intrusion. These types of sealants are of high quality and compatible with stucco and other termination points. Please refer to photos #15.2, #15.3, #15.4, #15.5 and #15.6 for more detail.

- The balcony flashing sealants are aged and separated at this location. The inspector suggests to have a qualified waterproofing contractor further assess and seal this area with a low modulus sealant in an effort to prevent moisture intrusion. These types of sealants are of high quality and compatible with stucco and other termination points. Please refer to photos #15.2, #15.3, #15.4, #15.5 and #15.6 for more detail.

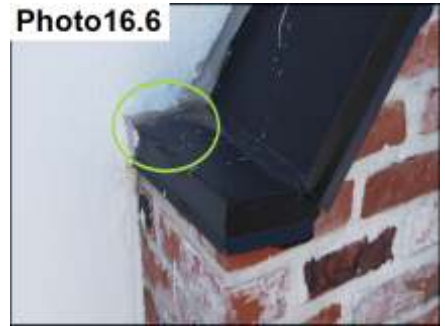
Photo16.6

Kickout Flashing Location / Seal

Grid Location	Item Description	Moisture Readings	Substrate Condition	Observations
Green Circles	Flashing			The parapet cap flashing sealants are aged and separated at this location. The inspector suggests to have a qualified waterproofing contractor further assess and seal this area with a low modulus sealant in an effort to prevent moisture intrusion. These types of sealants are of high quality and compatible with stucco and other termination points. Please refer to photos #16.2, #16.3, #16.4, #16.5 and #16.6 for more detail.

- The parapet cap flashing sealants are aged and separated at this location. The inspector suggests to have a qualified waterproofing contractor further assess and seal this area with a low modulus sealant in an effort to prevent moisture intrusion. These types of sealants are of high quality and compatible with stucco and other termination points. Please refer to photos #16.2, #16.3, #16.4, #16.5 and #16.6 for more detail.

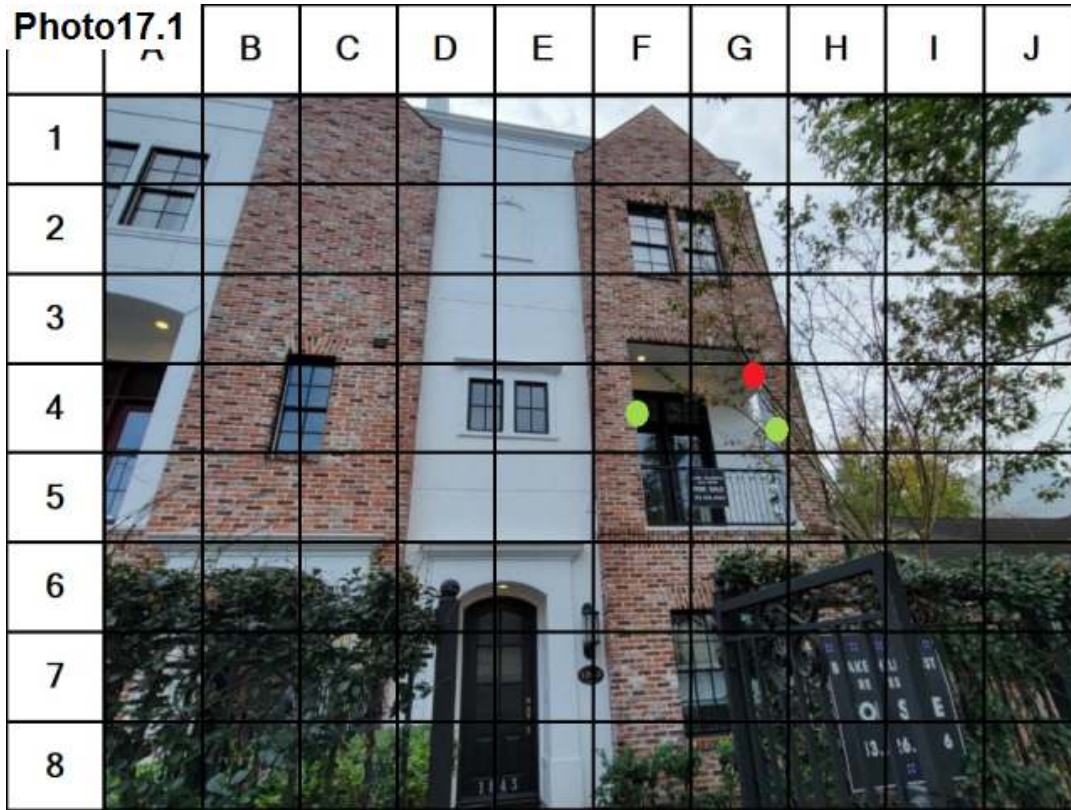
Grid Location	Item Description	Moisture Readings	Substrate Condition	Observations
D3	Left Wall	17%	Firm	A moisture probe was made at the right wall. The substrate was firm with no damage noted at this time.
E3	Right Wall	18%	Firm	A moisture probe was made at the left wall. The substrate was firm with no damage noted at this time.
G4	Bottom Wall	20%	Firm	A moisture probe was made at the bottom wall. The substrate was firm with no damage noted at this time.

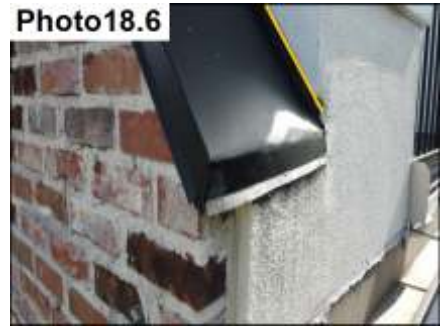
Photo18.6

Metal Cap/Stucco Termination / Seal

Grid Location	Item Description	Moisture Readings	Substrate Condition	Observations
Orange Lines	Metal Cap			The metal cap sealants are aged and separated at these locations with paint overspray. The inspector suggests to have a qualified waterproofing contractor further assess and seal this area with a low modulus sealant in an effort to prevent moisture intrusion. These types of sealants are of high quality and compatible with stucco and other termination points. Please refer to photos #18.2, #18.3, #18.4, #18.5 and #18.6 for more detail.

- The metal cap sealants are aged and separated at these locations. The inspector suggests to have a qualified waterproofing contractor further assess and seal this area with a low modulus sealant in an effort to prevent moisture intrusion. These types of sealants are of high quality and compatible with stucco and other termination points. Please refer to photos #18.2, #18.3, #18.4, #18.5 and #18.6 for more detail.

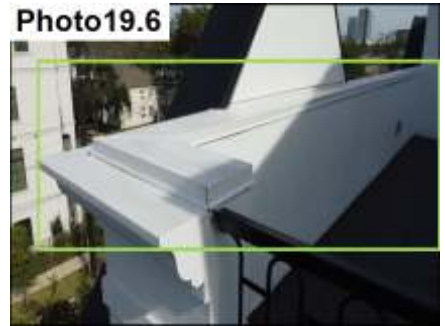
Photo19.6

Rooftop Parapet Cap / Seal

Grid Location	Item Description	Moisture Readings	Substrate Condition	Observations
Green Boxes	Flashing			The rooftop parapet cap flashing sealants are aged and separated at this location. The inspector suggests to have a qualified waterproofing contractor further assess and seal this area with a low modulus sealant in an effort to prevent moisture intrusion. These types of sealants are of high quality and compatible with stucco and other termination points. Please refer to photos #19.2, #19.3, #19.4, #19.5 and #19.6 for more detail.

- The rooftop parapet cap flashing sealants are aged and separated at this location. The inspector suggests to have a qualified waterproofing contractor further assess and seal this area with a low modulus sealant in an effort to prevent moisture intrusion. These types of sealants are of high quality and compatible with stucco and other termination points. Please refer to photos #19.2, #19.3, #19.4, #19.5 and #19.6 for more detail.

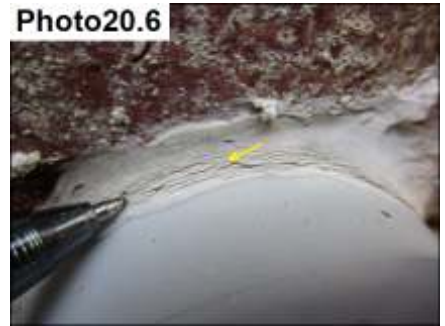
Photo20.6

Penetration Sealants / Seal

Grid Location	Item Description	Moisture Readings	Substrate Condition	Observations
Yellow Arrows	Penetrations			The penetration sealants are aged. The inspector suggests to have a qualified waterproofing contractor seal this area with a low modulus sealant in an effort to prevent moisture intrusion. These types of sealants are of high quality and compatible with stucco and other termination points. Please refer to photos #20.2, #20.3, #20.4, #20.5 and #20.6 for more detail.

- The penetration sealants are aged. The inspector suggests to have a qualified waterproofing contractor seal this area with a low modulus sealant in an effort to prevent moisture intrusion. These types of sealants are of high quality and compatible with stucco and other termination points. Please refer to photos #20.2, #20.3, #20.4, #20.5 and #20.6 for more detail.

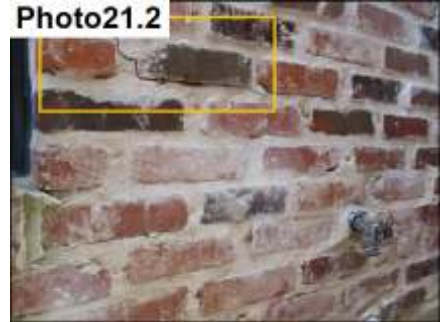
Photo21.2

Crack Noted / Re Point As Needed

- Cracks are noted in the mortar at this location. The inspector suggests to have a qualified waterproofing contractor further assess and properly re point as needed to prevent moisture intrusion. All cracking was not necessarily identified in this report. Please refer to photos #21.2, #21.3, #21.4 and #21.5 for more detail.

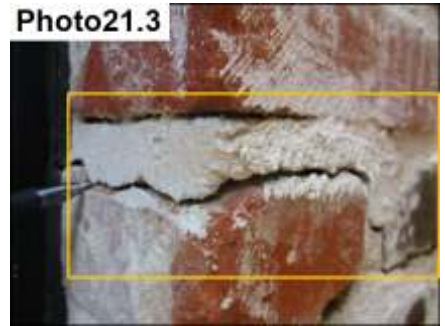
Photo21.3

Crack Noted / Re Point As Needed

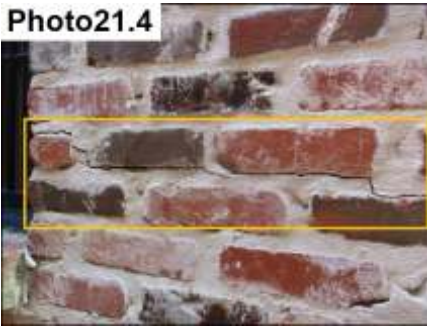
Photo21.4

Crack Noted / Re Point As Needed

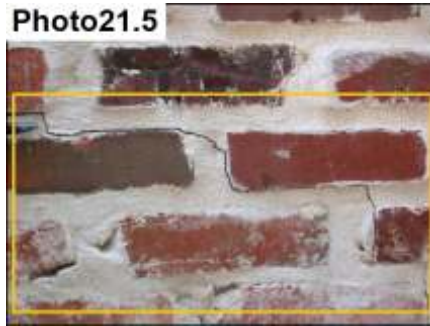
Photo21.5

Crack Noted / Re Point As Needed

Grid Location	Item Description	Moisture Readings	Substrate Condition	Observations
Orange Boxes	Cracks			Cracks are noted in the mortar at this location. The inspector suggests to have a qualified waterproofing contractor further assess and properly re point as needed to prevent moisture intrusion. All cracking was not necessarily identified in this report. Please refer to photos #21.2, #21.3, #21.4 and #21.5 for more detail.

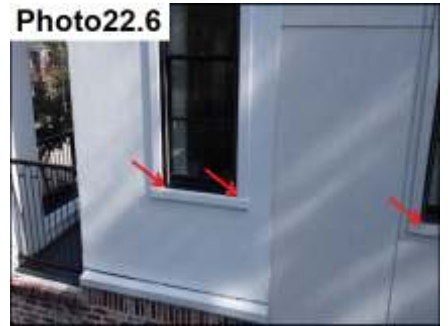
Photo22.6

Window Sealants / Seal

Grid Location	Item Description	Moisture Readings	Substrate Condition	Observations
Red Arrows	Windows			The window sealants are aged and separated. The inspector suggests to have a qualified waterproofing contractor further assess and seal this area with a low modulus sealant in an effort to prevent moisture intrusion. These types of sealants are of high quality and compatible with stucco and other termination points. Please refer to photos #22.2, #22.3, #22.4, #22.5, #22.6, #23.1, #23.2, #23.3 and #23.4 for more detail.

- The window sealants are aged and separated. The inspector suggests to have a qualified waterproofing contractor further assess and seal this area with a low modulus sealant in an effort to prevent moisture intrusion. These types of sealants are of high quality and compatible with stucco and other termination points. Please refer to photos #22.2, #22.3, #22.4, #22.5, #22.6, #23.1, #23.2, #23.3 and #23.4 for more detail.

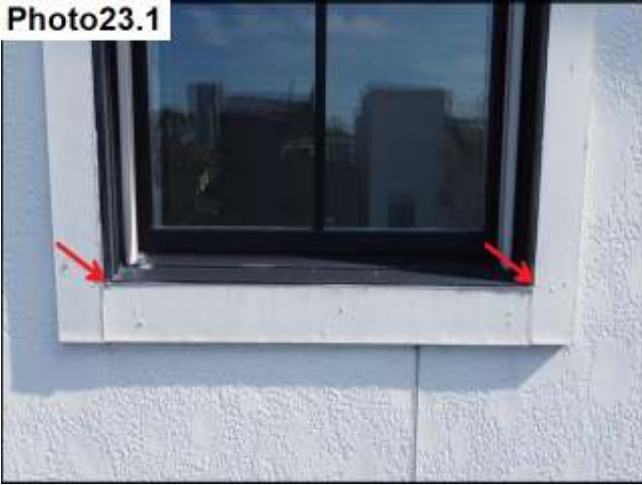
Photo23.1

Window Sealants / Seal

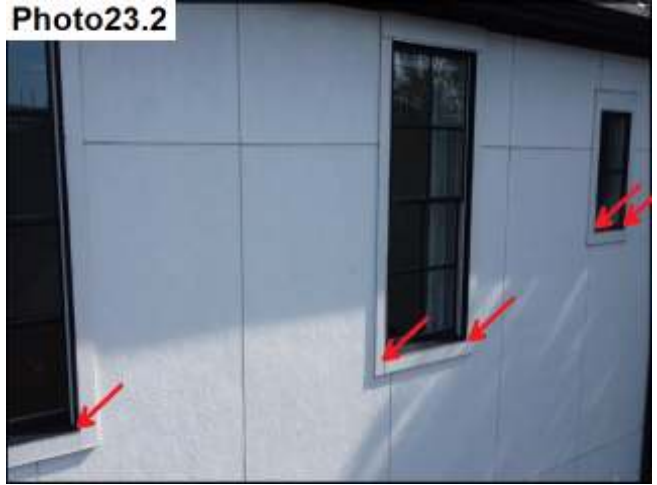
Photo23.2

Window Sealants / Seal

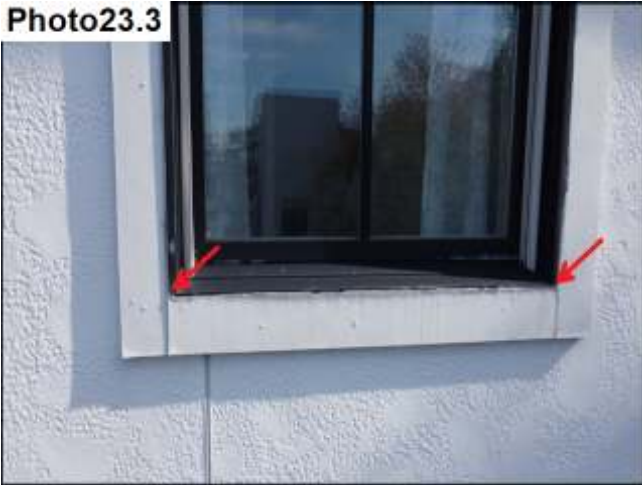
Photo23.3

Window Sealants / Seal

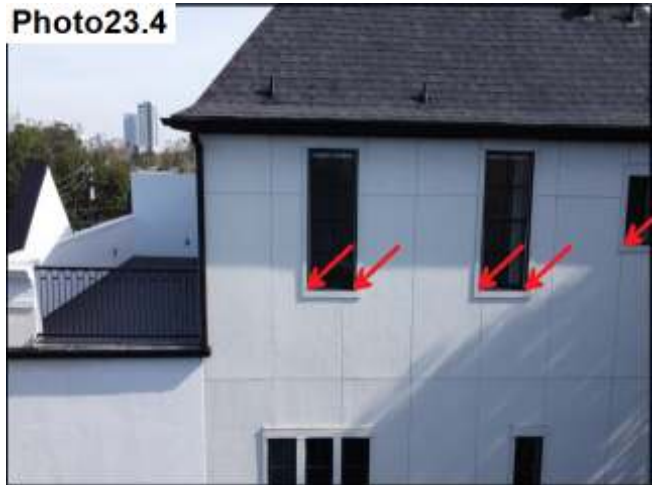
Photo23.4

Window Sealants / Seal

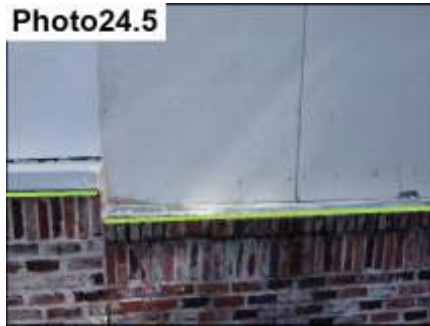
Photo24.5

Brick/Stucco Termination / Maintain

Grid Location	Item Description	Moisture Readings	Substrate Condition	Observations
Green Lines	Stucco Termination			Brick and stucco sealants are present at this location. The inspector states that this is a positive detail and suggests maintaining these sealants in an effort to prevent moisture intrusion. Please refer to photos #24.2, #24.3, #24.4 and #24.5 for more detail.

- Brick and stucco sealants are present at this location. The inspector states that this is a positive detail and suggests maintaining these sealants in an effort to prevent moisture intrusion. Please refer to photos #24.2, #24.3, #24.4 and #24.5 for more detail.

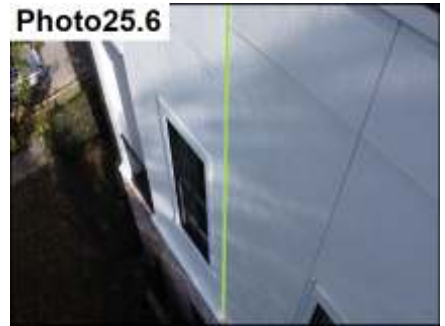
Photo25.6

CFB/Stucco Termination / Seal

Grid Location	Item Description	Moisture Readings	Substrate Condition	Observations
Green Lines	Stucco Termination			The CFB/stucco termination sealants are aged. The inspector suggests to have a qualified waterproofing contractor further assess and seal this area with a low modulus sealant in an effort to prevent moisture intrusion. These types of sealants are of high quality and compatible with stucco and other termination points. Please refer to photos #25.2, #25.3, #25.4, #25.5 and #25.6 for more detail.

- The CFB/stucco termination sealants are aged. The inspector suggests to have a qualified waterproofing contractor further assess and seal this area with a low modulus sealant in an effort to prevent moisture intrusion. These types of sealants are of high quality and compatible with stucco and other termination points. Please refer to photos #25.2, #25.3, #25.4, #25.5 and #25.6 for more detail.

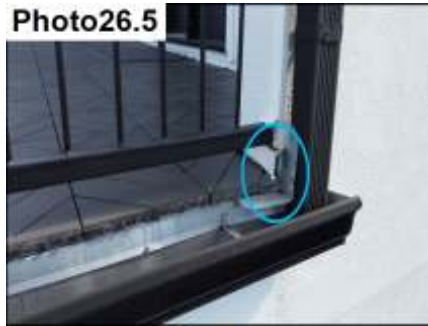
Photo26.5

Balcony Flashing / Seal

Grid Location	Item Description	Moisture Readings	Substrate Condition	Observations
Blue Circles	Flashing			The balcony flashing sealants are aged at this location. The inspector suggests to have a qualified waterproofing contractor further assess and seal this area with a low modulus sealant in an effort to prevent moisture intrusion. These types of sealants are of high quality and compatible with stucco and other termination points. Please refer to photos #26.2, #26.3, #26.4 and #26.5 for more detail.

- The balcony flashing sealants are aged at this location. The inspector suggests to have a qualified waterproofing contractor further assess and seal this area with a low modulus sealant in an effort to prevent moisture intrusion. These types of sealants are of high quality and compatible with stucco and other termination points. Please refer to photos #26.2, #26.3, #26.4 and #26.5 for more detail.

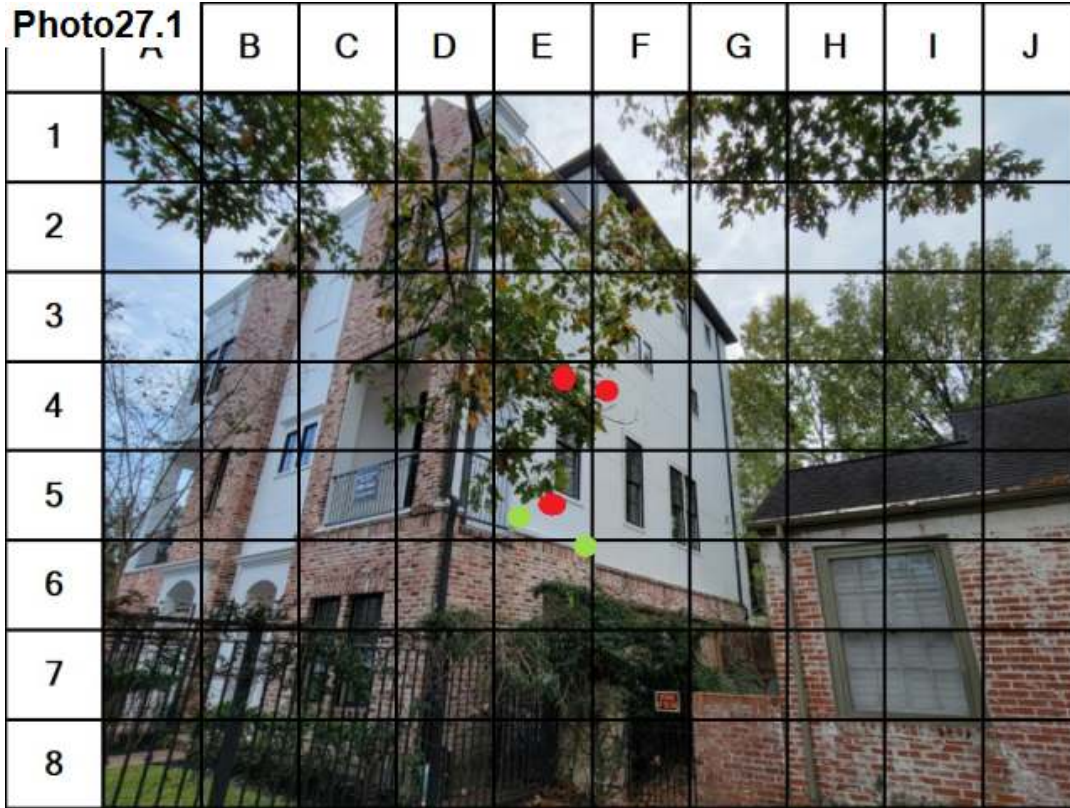
Grid Location	Item Description	Moisture Readings	Substrate Condition	Observations
E5 (left)	Below Balcony Flashing	17%	Firm	A moisture probe was made bottom wall below the balcony. The substrate was firm with no damage noted at this time.
E6	Below Balcony Flashing	19%	Firm	A moisture probe was made bottom wall below the balcony. An elevated moisture reading with firm substrate was noted.
E5 (right)	Window Lower Left	21%	Firm	A moisture probe was taken at the window bottom left. An elevated moisture reading with firm substrate was noted.
E4	Window Header Left	23%	Firm	A moisture probe was taken at the window header left. An elevated moisture reading with firm substrate was noted.
F4	Window Header Right	22%	Firm	A moisture probe was taken at the window header right. An elevated moisture reading with firm substrate was noted.

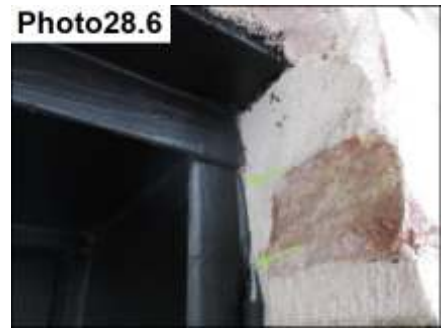
Photo28.6

Door Sealant Separation / Seal

Grid Location	Item Description	Moisture Readings	Substrate Condition	Observations
Green Arrows	Doors			The door trim sealants are aged and separated. The inspector suggests to have a qualified waterproofing contractor seal this area with a low modulus sealant in an effort to prevent moisture intrusion. These types of sealants are of high quality and compatible with stucco and other termination points. Please refer to photos #28.2, #28.3, #28.4, #28.5 and #28.6 for more detail.

- The door trim sealants are aged and separated. The inspector suggests to have a qualified waterproofing contractor seal this area with a low modulus sealant in an effort to prevent moisture intrusion. These types of sealants are of high quality and compatible with stucco and other termination points. Please refer to photos #28.2, #28.3, #28.4, #28.5 and #28.6 for more detail.

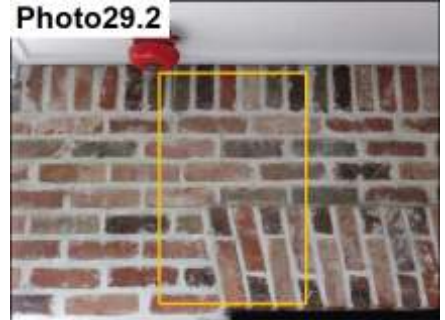
Photo29.2

Crack Noted / Re Point As Needed

- Cracks are noted in the mortar at this location. The inspector suggests to have a qualified waterproofing contractor further assess and properly re point as needed to prevent moisture intrusion. All cracking was not necessarily identified in this report. Please refer to photos #29.2, #29.3, #29.4, #29.5 and #29.6 for more detail.

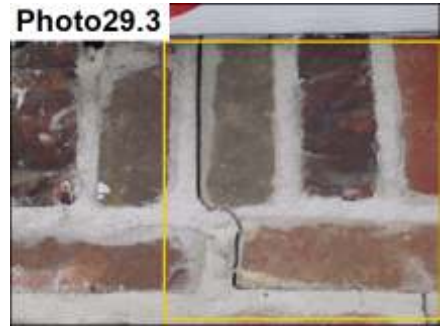
Photo29.3

Crack Noted / Re Point As Needed

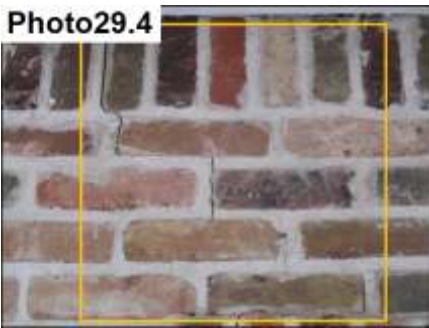
Photo29.4

Crack Noted / Re Point As Needed

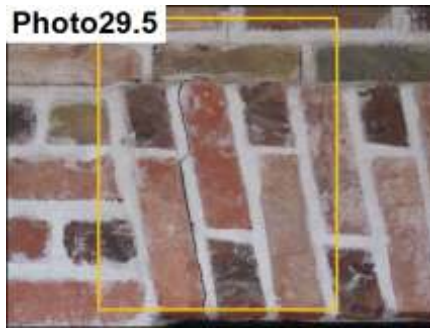
Photo29.5

Crack Noted / Re Point As Needed

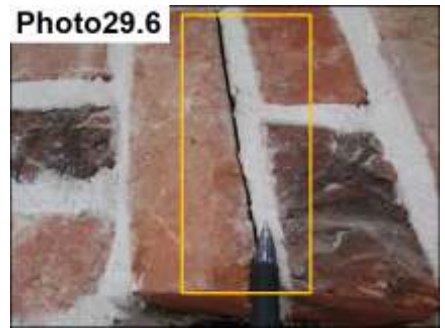
Photo29.6

Crack Noted / Re Point As Needed

Grid Location	Item Description	Moisture Readings	Substrate Condition	Observations
Orange Boxes	Cracks			Cracks are noted in the mortar at this location. The inspector suggests to have a qualified waterproofing contractor further assess and properly re point as needed to prevent moisture intrusion. All cracking was not necessarily identified in this report. Please refer to photos #29.2, #29.3, #29.4, #29.5 and #29.6 for more detail.

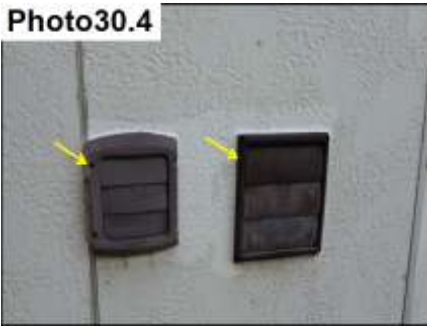
Photo30.4

Penetration Sealants / Seal

Grid Location	Item Description	Moisture Readings	Substrate Condition	Observations
Yellow Arrows	Penetrations			The penetration sealants are aged and separated. The inspector suggests to have a qualified waterproofing contractor seal this area with a low modulus sealant in an effort to prevent moisture intrusion. These types of sealants are of high quality and compatible with stucco and other termination points. Please refer to photos #30.2, #30.3 and #30.4 for more detail.

- The penetration sealants are aged and separated. The inspector suggests to have a qualified waterproofing contractor seal this area with a low modulus sealant in an effort to prevent moisture intrusion. These types of sealants are of high quality and compatible with stucco and other termination points. Please refer to photos #30.2, #30.3 and #30.4 for more detail.

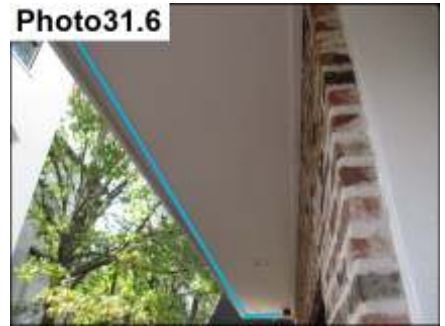
Photo31.6

Relief Present / Clean Out Excess Sealant

Grid Location	Item Description	Moisture Readings	Substrate Condition	Observations
Blue Lines	Relief			Although a relief is present at this location, excess sealant was applied to the drainage plane obstructing proper moisture evacuation of the system. The inspector recommends having a qualified waterproofing contractor further assess, clean out excess material and verify the house back wrap has been cut. This will provide the proper functioning of the system at this location. Please refer to photos #31.2, #31.3, #31.4, #31.5 and #31.6 for more detail.

- Although a relief is present at this location, excess sealant was applied to the drainage plane obstructing proper moisture evacuation of the system. The inspector recommends having a qualified waterproofing contractor further assess, clean out excess material and verify the house back wrap has been cut. This will provide the proper functioning of the system at this location. Please refer to photos #31.2, #31.3, #31.4, #31.5 and #31.6 for more detail.

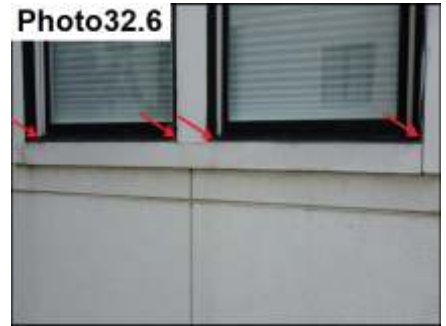
Window Sealants / Seal

Grid Location	Item Description	Moisture Readings	Substrate Condition	Observations
Red Arrows	Windows			The window sealants are aged and separated. The inspector suggests to have a qualified waterproofing contractor further assess and seal this area with a low modulus sealant in an effort to prevent moisture intrusion. These types of sealants are of high quality and compatible with stucco and other termination points. Please refer to photos #32.2, #32.3, #32.4, #32.5 and #32.6 for more detail.

- The window sealants are aged and separated. The inspector suggests to have a qualified waterproofing contractor further assess and seal this area with a low modulus sealant in an effort to prevent moisture intrusion. These types of sealants are of high quality and compatible with stucco and other termination points. Please refer to photos #32.2, #32.3, #32.4, #32.5 and #32.6 for more detail.

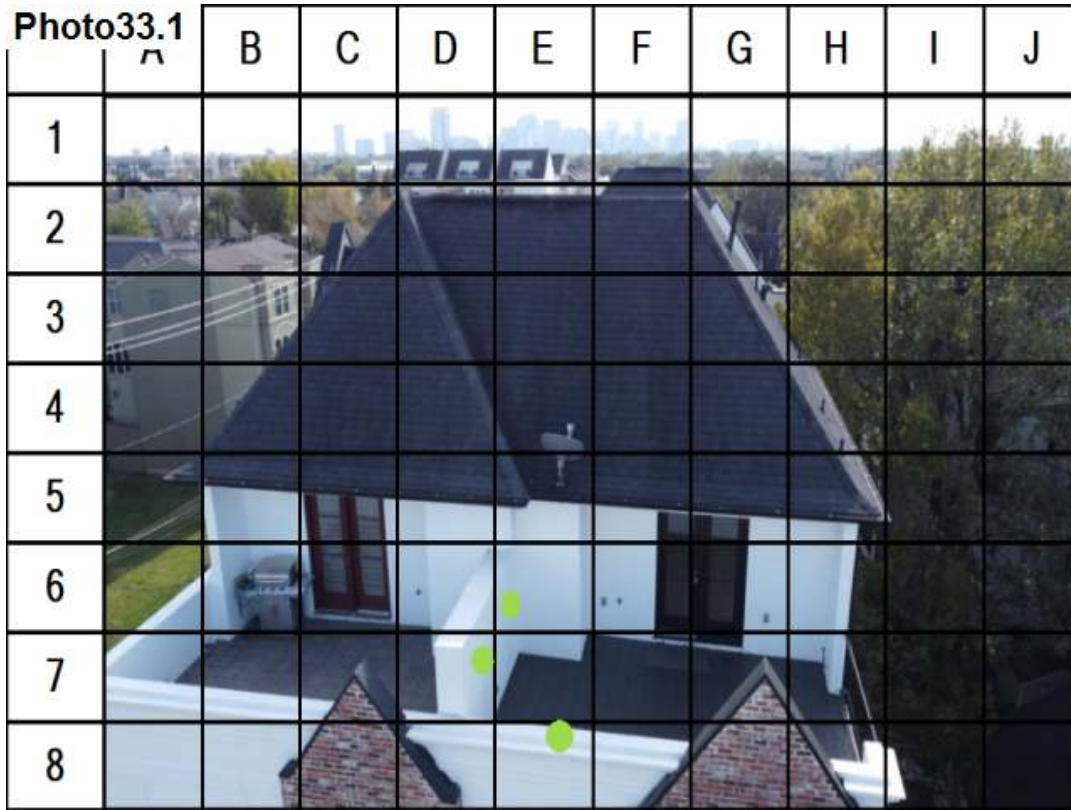
Grid Location	Item Description	Moisture Readings	Substrate Condition	Observations
E6	Common Wall	17%	Firm	A moisture probe was made at the common wall. The substrate was firm and no damage was noted at this time.
D7	Common Wall	18%	Firm	A moisture probe was made at the common wall. The substrate was firm and no damage was noted at this time.
E8	Front Wall	17%	Firm	A moisture probe was made at the front wall. The substrate was firm and no damage was noted at this time.
